ABANDONED OR INACTIVE URANIUM  
MINES IN NEW MEXICO

A report of investigation carried out  
between August 1979 and May 1980 under  
contract with the New Mexico Energy and  
Minerals Department.

New Mexico Bureau of Mines and  
Mineral Resources  
Open-File Report 148

Mine name(s) Hogan County McKinley

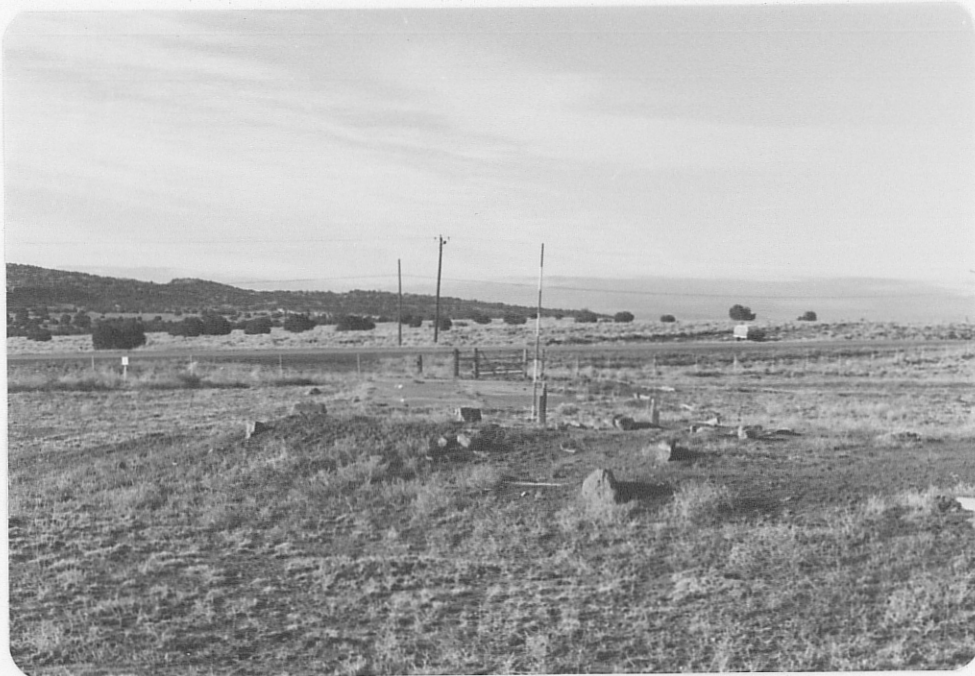
The mine shaft site is shown in photo (a) with highway no. 53 in the background. The site is level and clean. The reinforced concrete slab over the shaft and one of the head-frame footings are shown in photo (b). At the west edge of the slab a small amount of caving has begun. The shaft was not backfilled because of the possibility of mine rejuvenation. The upper shaft was cross timbered and a 10-15 foot thick concrete plug was poured (Irving Rapaport, oral communication). Scintillometer counts around the shaft site range up to 450 cps, or 9 x background.

Photo (a) Looking southwest at Hogan Mine shaft site; note highway no. 53 in background and range pole (center) for scale.

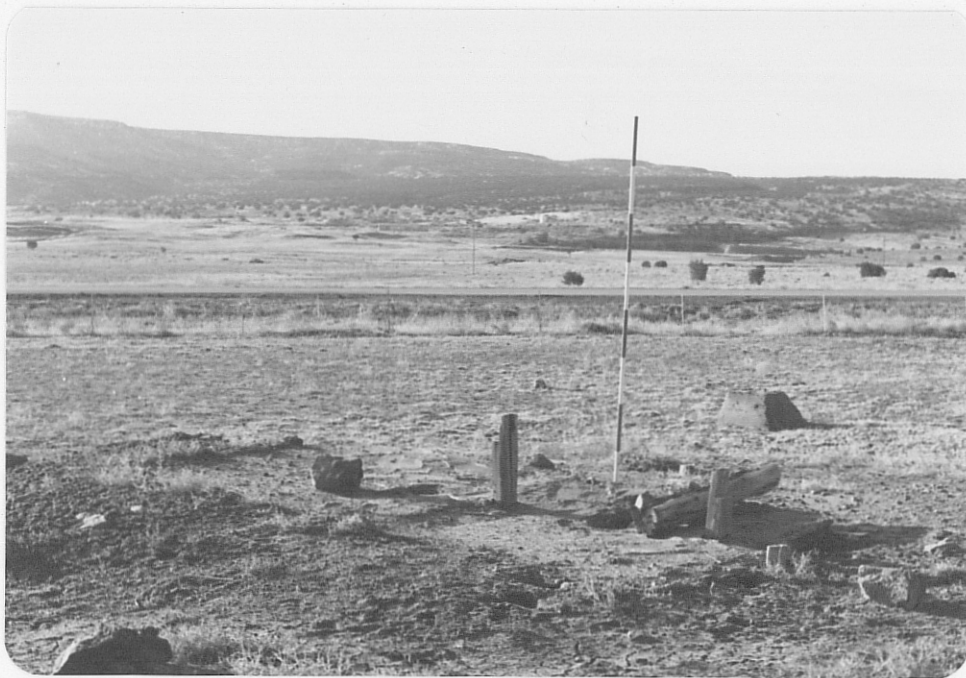
Photo (b) Close-up looking south at concrete slab over the mine shaft. Note head frame footing behind slab to right. A small amount of caving has begun near corner of slab at right. Marquez Mine is visible at center background.

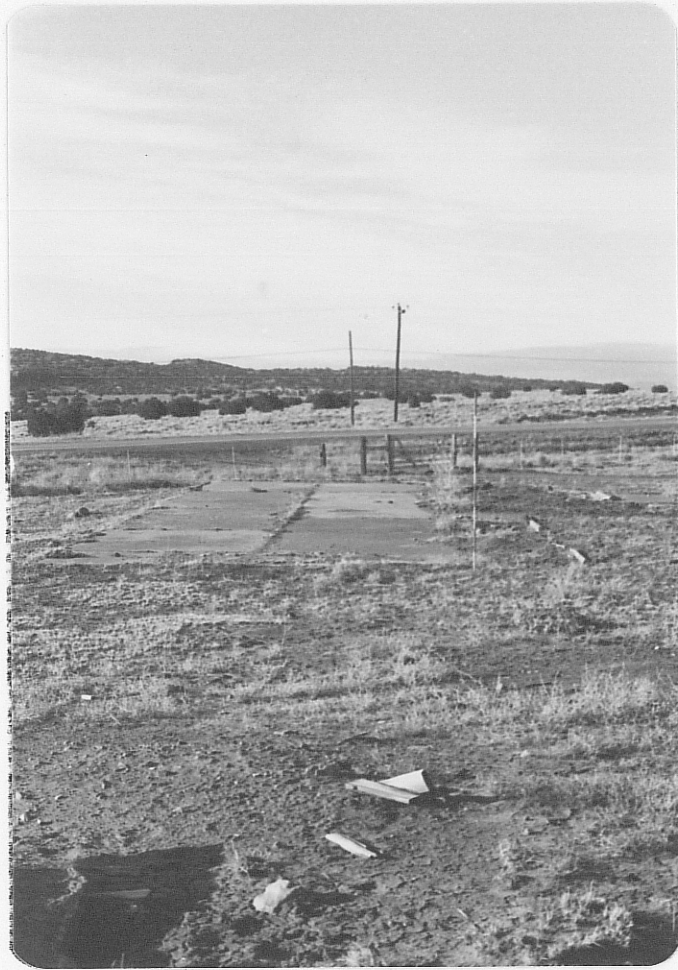
Immediately southwest of the shaft is a concrete slab, measuring approximately 30' x 70', that was the site of the hoist and drum and a maintenance shop, (see photo c).

Photo (c) Looking southwest at concrete slab for hoisting equipment and maintenance shop.

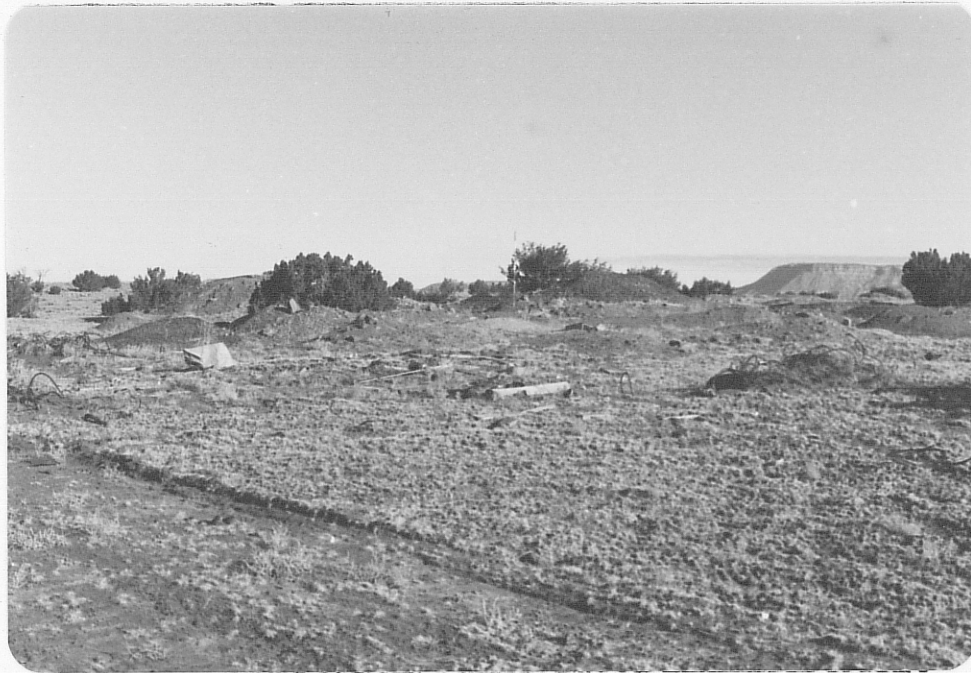
The dump area to the northwest of the mine shaft measures about 220' (N-S) by 120', however, patches within this area contain no waste. It is an area with closely spaced individual conical piles up to 4' high, (see photos d & e). Scintillometer readings recorded on traverse of dump were in the 200-400 cps range.

Photo (d) View northward at south edge of main dump area; note range pole (center) for scale.

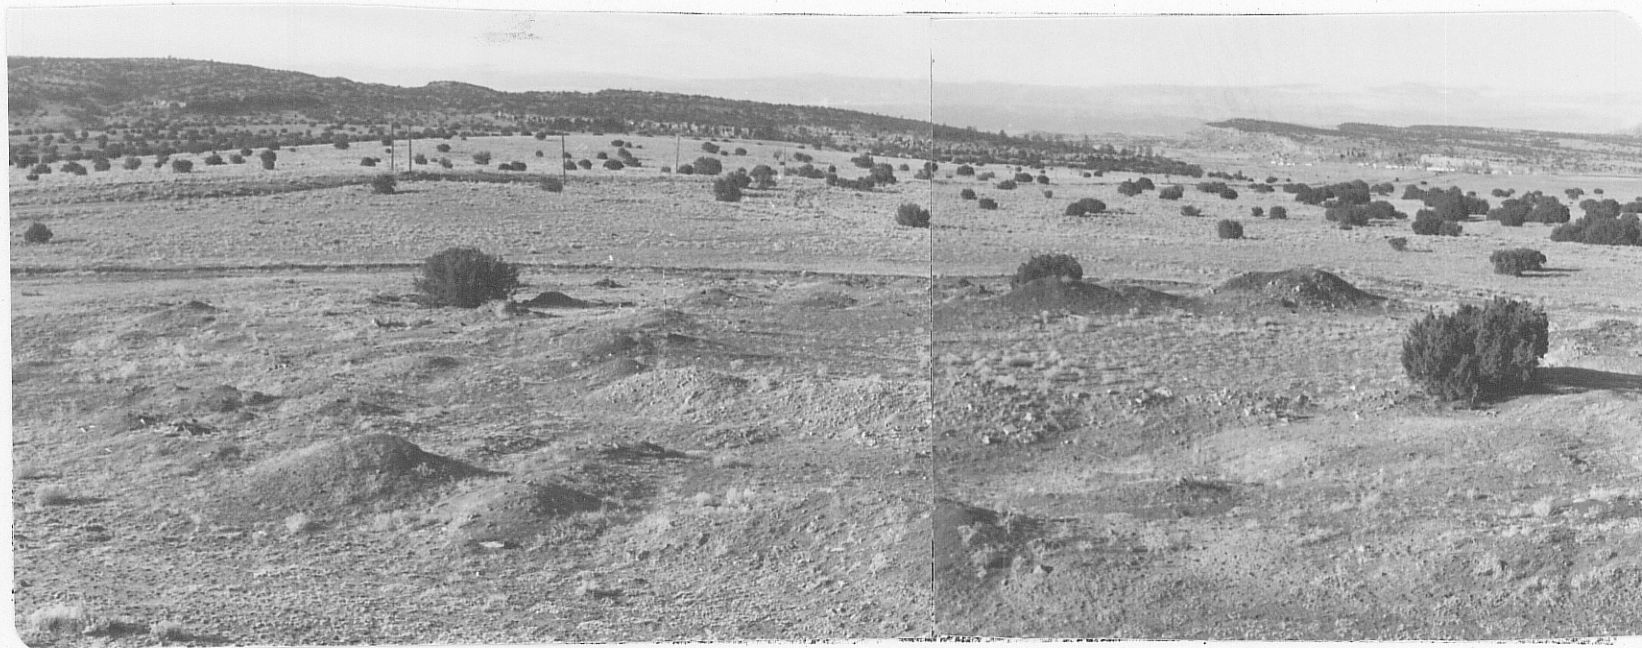
Photo (e) Looking westward showing dump area with small scattered 3'-4' high waste piles; area measures 220' N-S, but there are patches within that have no waste material. Ambrosia Lake junction (numerous light colored buildings) is visible at right in the distance  $1\frac{1}{4}$  mi. away; note range pole at left of center for scale.
