MEMORANDUM

RE: Cabresto Creek Field Evaluation

Cabresto Creek was evaluated by Chadwick Ecological Consultants, Inc. (CEC) on October 4-6, 2005, from just upstream of the confluence with the Lake Fork upstream to its headwaters. The purpose of this survey was to determine segment boundaries and obtain estimates of fish species composition, density, biomass, and habitat conditions in each segment (Table 1). A single site in each segment was electrofished to obtain population parameters. Extended reaches of Cabresto Creek were evaluated by walking and continuous electrofishing to determine habitat conditions and define the distribution of cutthroat trout, brook trout, and brown trout in the upper Cabresto Creek watershed. Additionally, 20 fin clips were taken from Rio Grande cutthroat trout (RGCT) in two locations upstream of the furthest distribution of non-native salmonids to determine the genetic purity of Rio Grande cutthroat trout in the upper Cabresto Creek watershed. Results of the genetic analysis will be available by December 1, 2005. These activities were conducted to provide preliminary information on the viability of restoring Cabresto Creek to an allopatric population

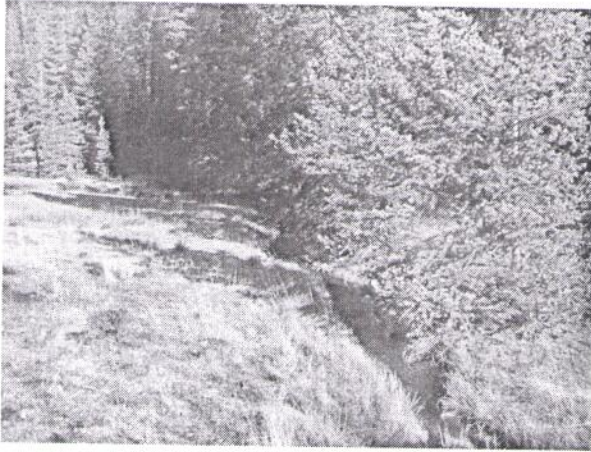
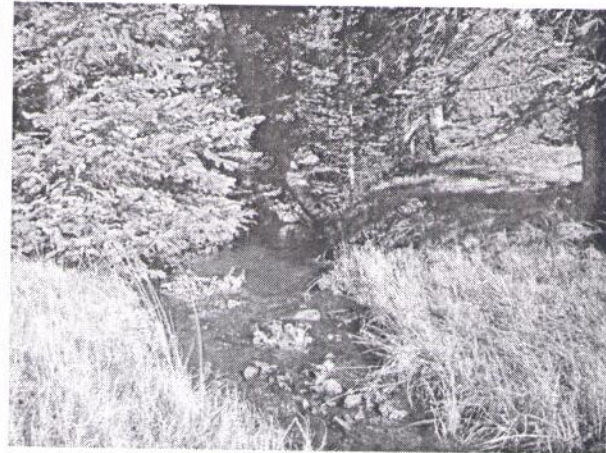
PHOTOS 5, 6, 7, AND 8:

Site Cabresto Creek NRD-1 bottom of site looking downstream (top left) and upstream (top right) and top of site looking downstream (bottom left) and upstream (bottom right).

Segment 2 was sampled both qualitatively and quantitatively. The quantitative site sampled for fish populations (Site NRD-1) was located 8.6 road mi upstream of Forest Service Road 134A (Lake Fork Road) and 3.6 road mi upstream of Site NRD-2. A total of 308 ft of stream was sampled. This reach of stream was characterized by a wide meadow downstream (photos 5, 6, 7, 8, 9, and 10), with a small, narrow canyon at the upstream end (Photos 11 and 12). Pool habitat was generally confined to the outside of stream meanders and undercutting in run habitat. Rocks and woody debris were uncommon. The riparian area was dominated by grass, and banks were fairly stable except where some evidence of cattle grazing was evident. Only cutthroat trout were found at this site (Table 2) and no obvious signs of hybridization with rainbow trout were observed. Density and biomass estimates were fairly low, due to the smaller stream size and less available cover than in the downstream segments.

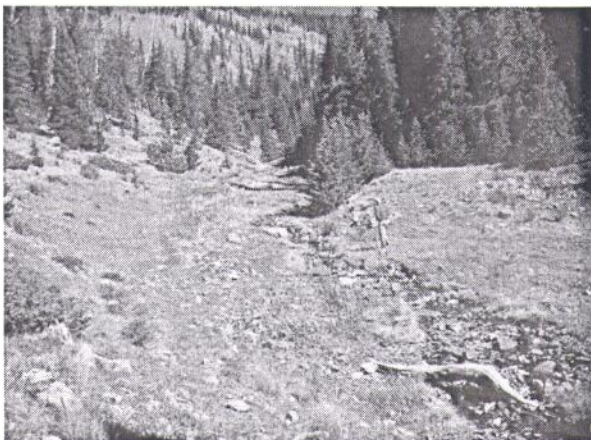
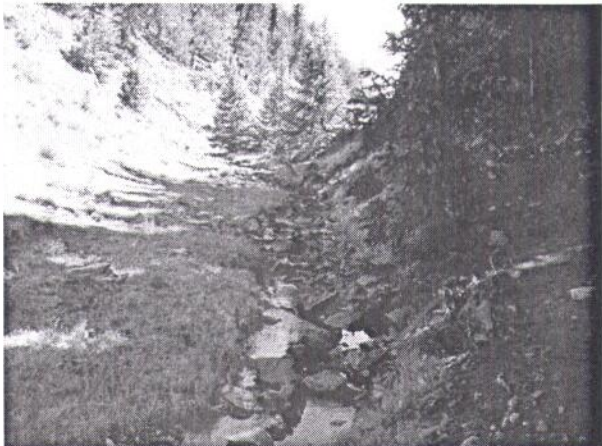
PHOTOS 11 AND 12: Cabresto Creek entering last short canyon section downstream of Cabresto Park (left) and within the last canyon section (right).
