# Abandoned Uranium Mine Site Assessment for the Red Bluff Nos. 1-5, 9 Site (NM0077)

**FINAL REPORT**

NM0077

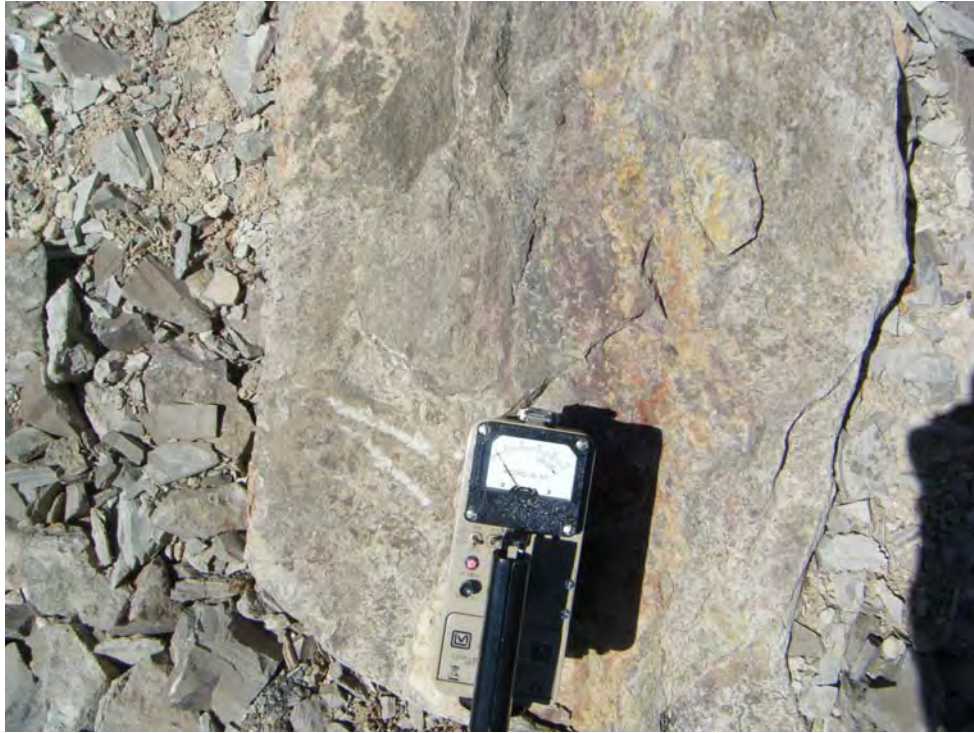
Photo 1-Radiation survey point 1 (800  $\mu$ R/hr at contact; Red Bluff No. 5 claim).

Rad 1 - west end of Pile Ply 1; 0m - 800 uR/h; 1m - 180 uR/h

Photo 1 - rock from Rad 1

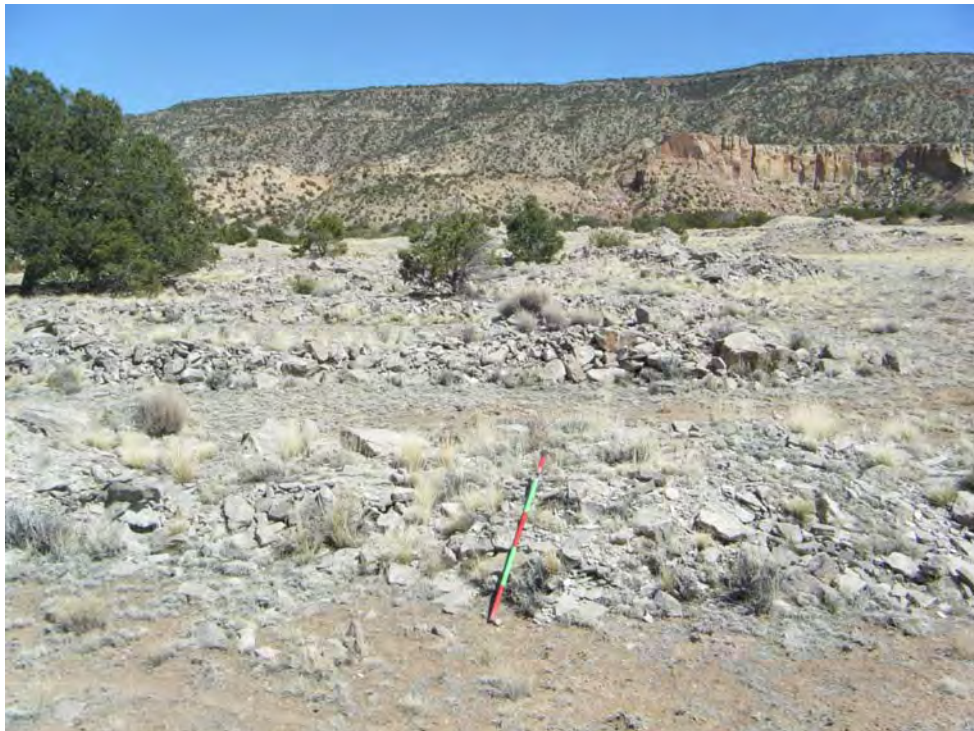
Photo 2-Looking east at PilePly-1 (Red Bluff No. 5 claim).

Pile Ply 1 - numerous pile ridges ~~and cones~~ <sup>ACT</sup>; 50' wide,  
200' long; 3' high

Photo 2 - looking east at Pile Ply 1

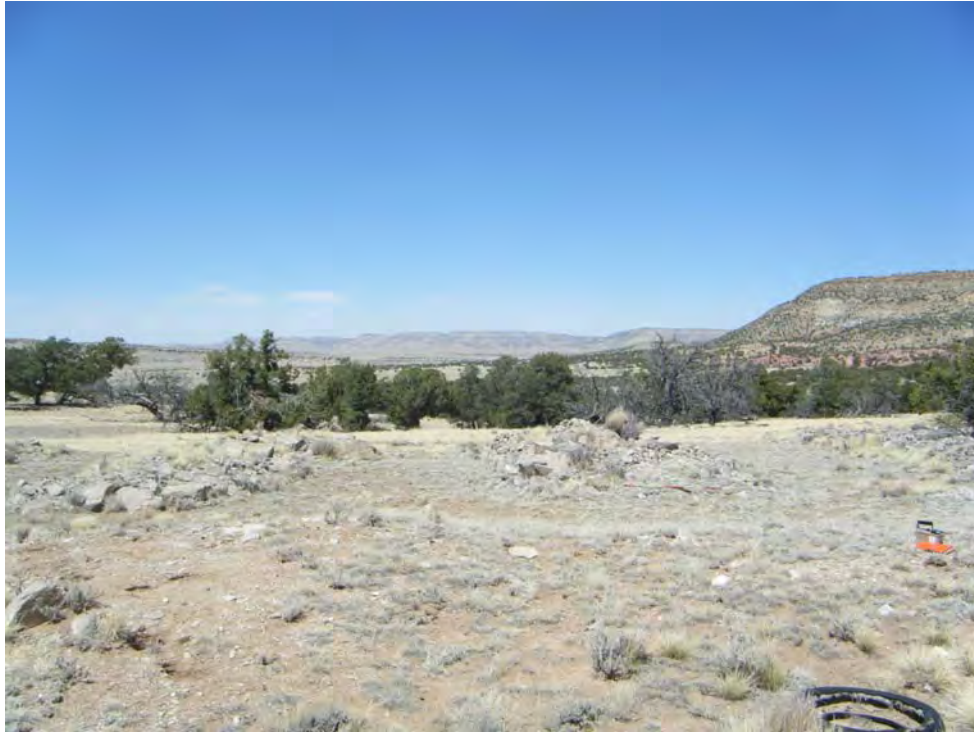
Photo 3-Looking north at PilePly-1 (Red Bluff No. 5 claim).

Photo 3 - looking north at Pile Ply 1

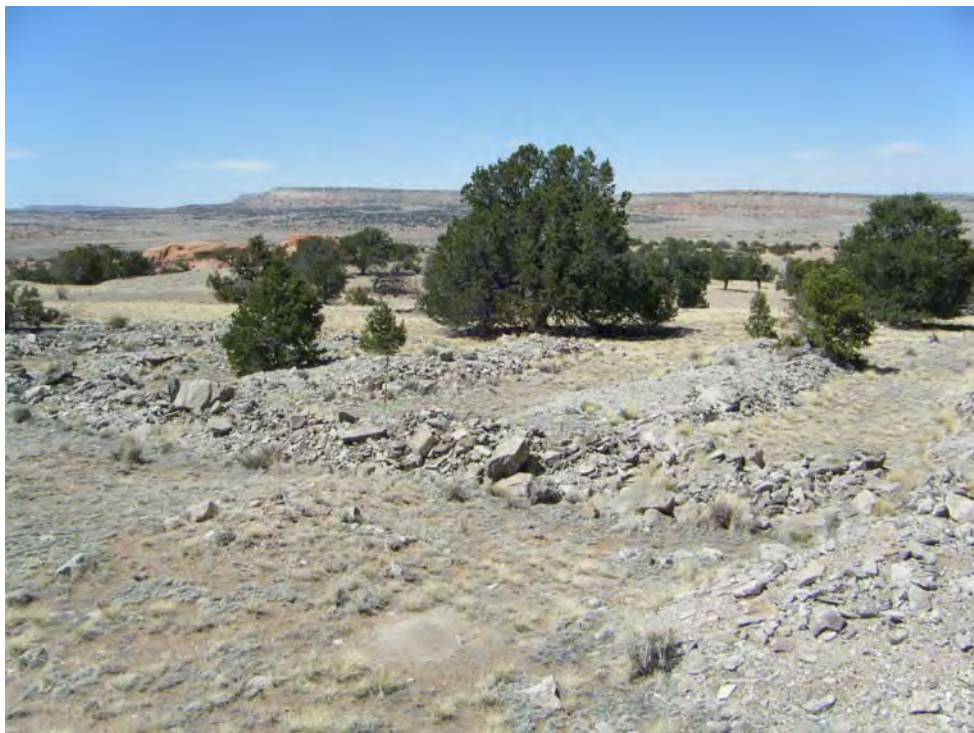
Photo 4-Looking northwest at PilePly-1 (Red Bluff No. 5 claim).

Photo 4 - looking north west at Pile Ply 1

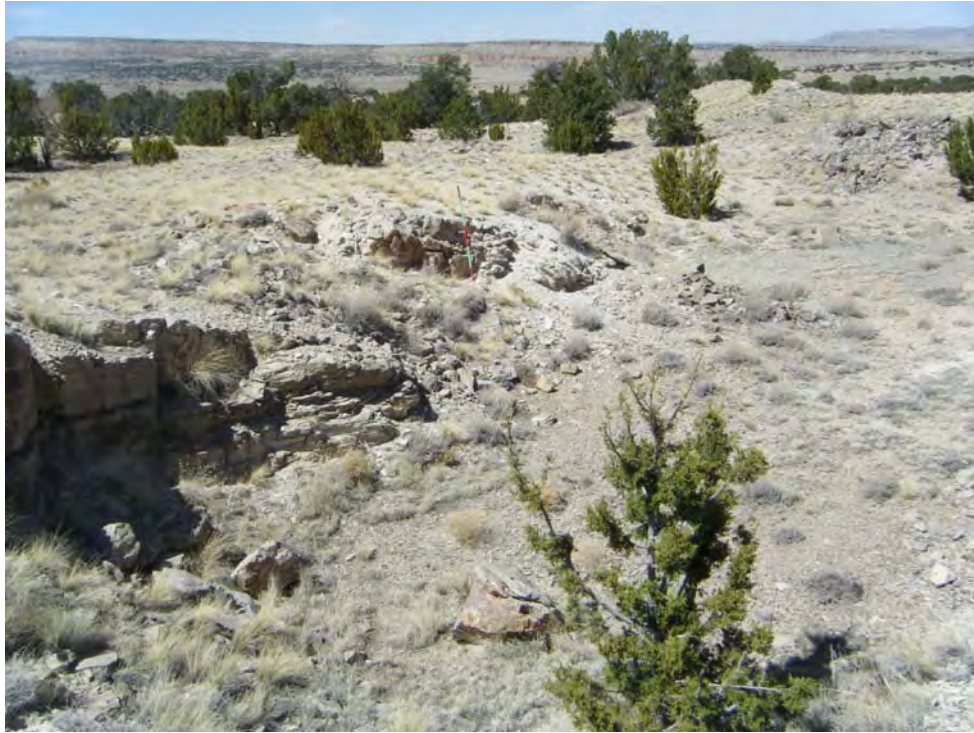
Photo 5-Looking northwest at Pit-1 (Red Bluff No. 5 claim).

Pit Ply 1 - 10' deep, 50' wide, 125' long

Photo 5 - looking northwest at Pit Ply 1

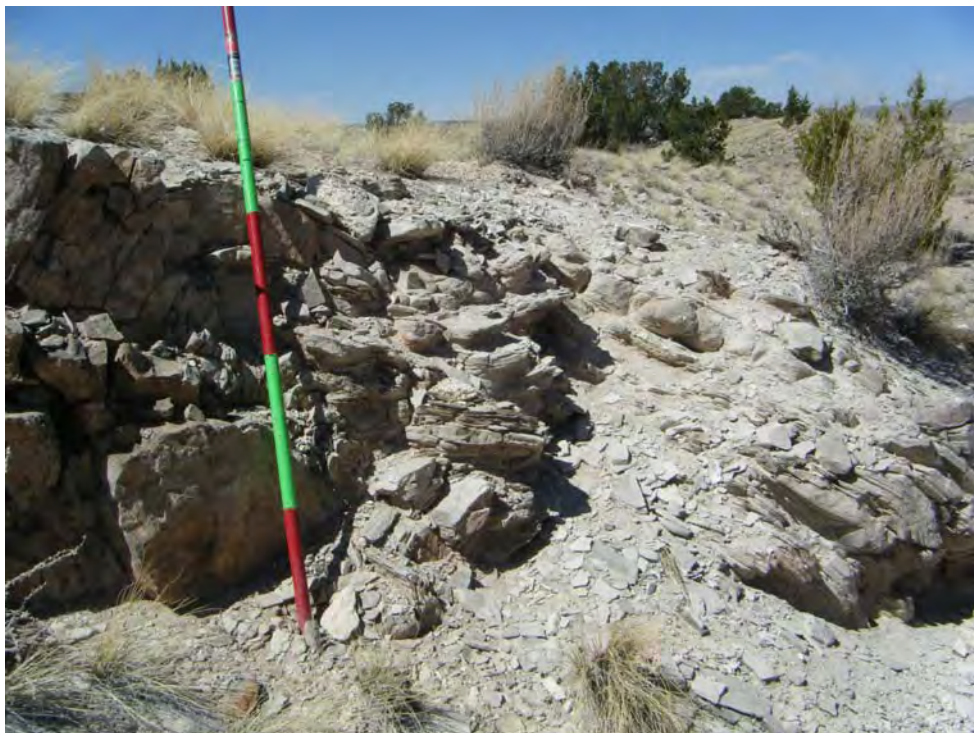
Photo 6-Folded Todilto Formation in Pit-1 (Red Bluff No. 5 claim).

Photo 6 - looking at folds in the Todito in Pit Ply 1

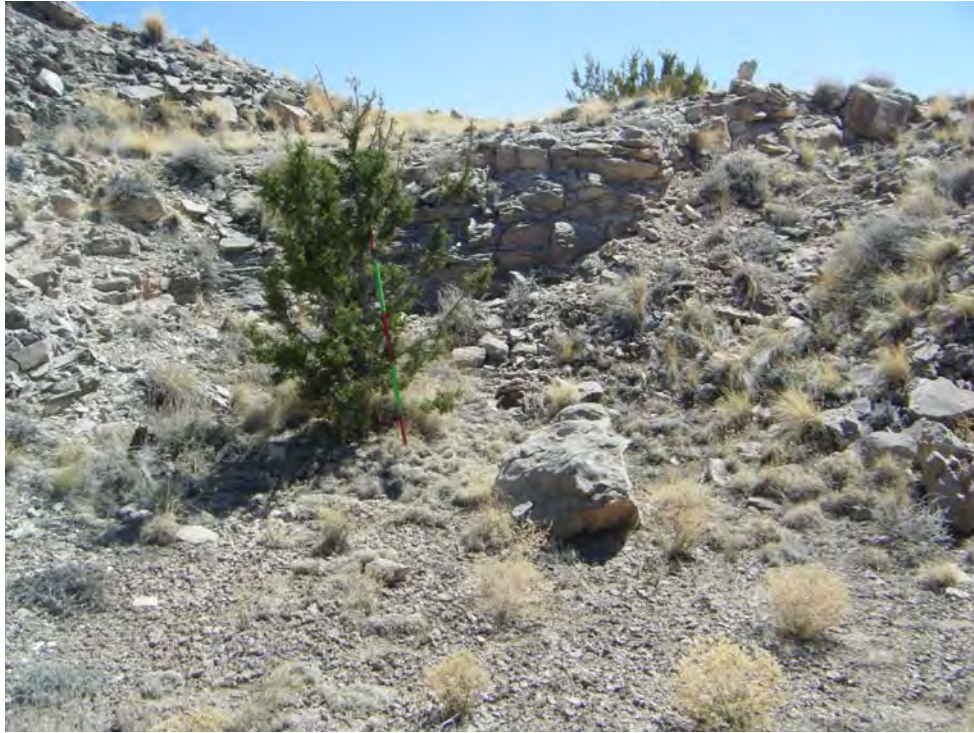
Photo 7-Looking south at Pit-1 (Red Bluff No. 5 claim).

Photo 7 - looking south at Pit Ply 1

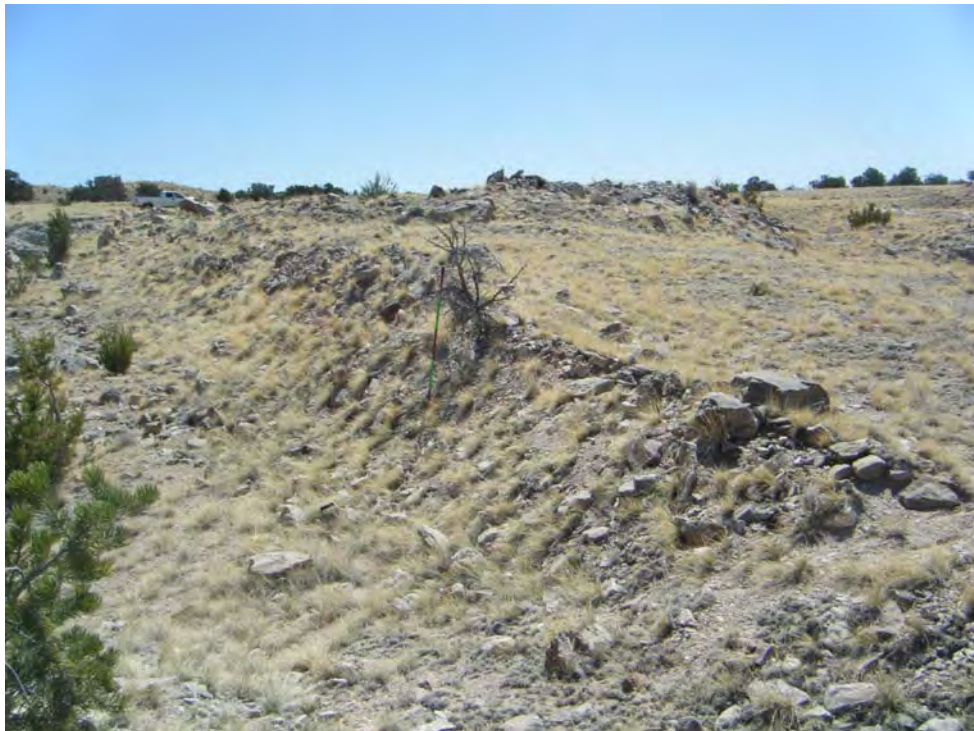
Photo 8-Looking south at PilePly-2 (Red Bluff No. 5 claim).

Pile Ply 2 - 10' high; 150' long; 100' wide

Photo 8 - looking south at Pile Ply 2

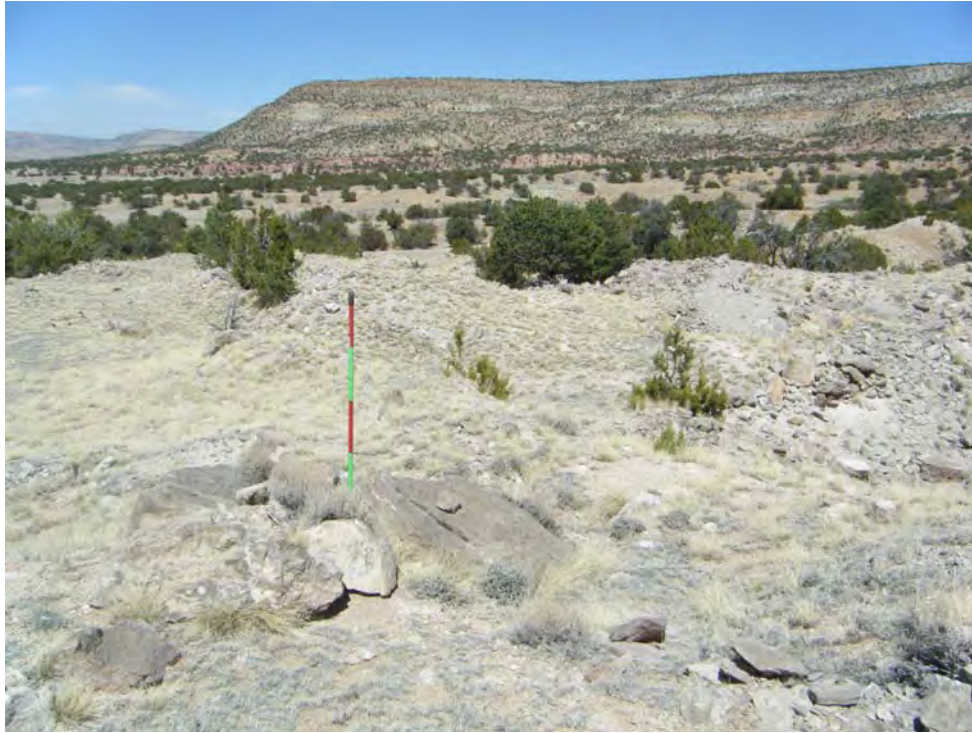
Photo 9-Looking north at PilePly-2 (Red Bluff No. 5 claim).

Photo 9 - looking north at Pile Ply 2

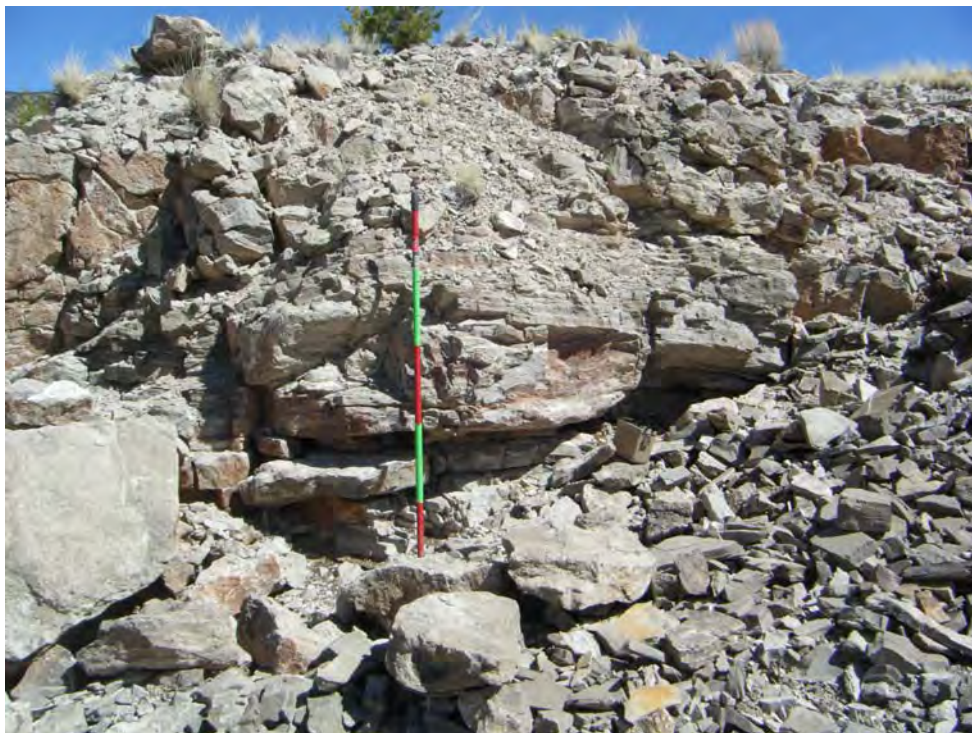
Photo 10-Looking south at CutLn-1 (Red Bluff No. 5 claim).

Cutln 1 - 15" deep, 30' wide, 75' long

Photo 10 - looking south at Cutln 1

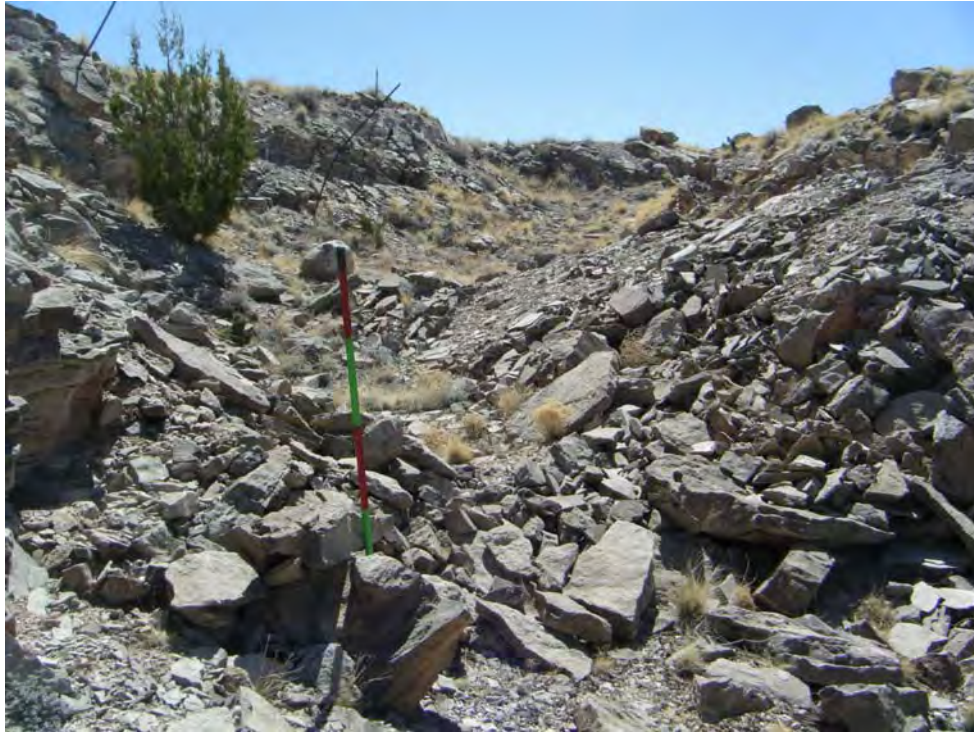
Photo 11-Looking east at CutLn-1 (Red Bluff No. 5 claim).

Photo 11 - looking ~~south~~ <sup>ACT</sup> east at Cutln 1

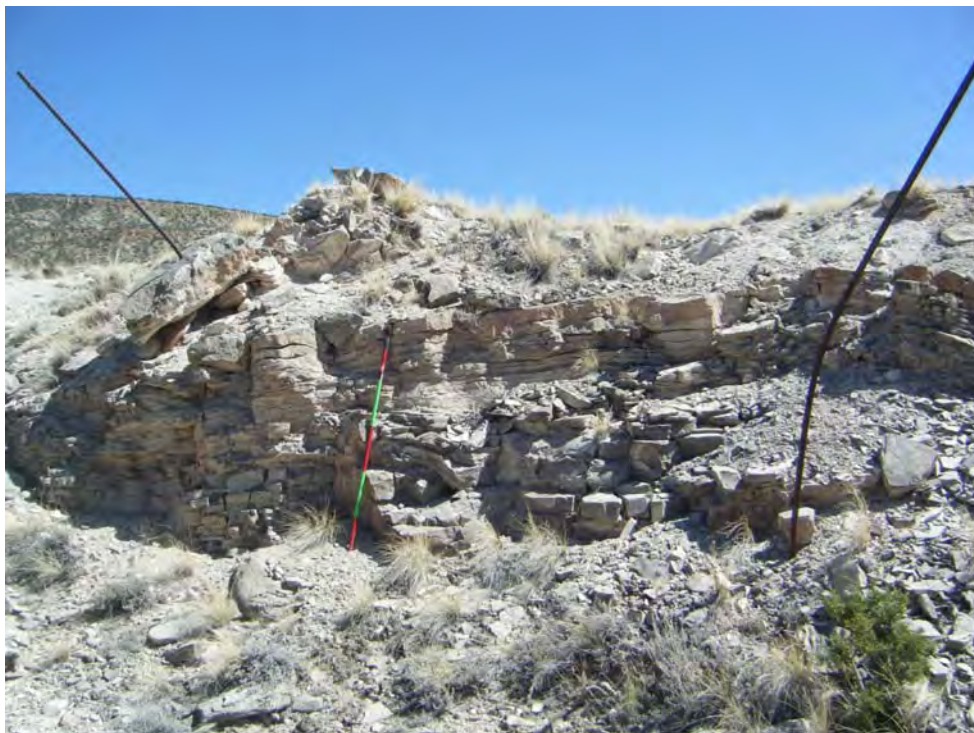
Photo 12-Looking southeast at CutLn-1 (Red Bluff No. 5 claim). Note steel rods in the rock face.

Photo 12 - looking southeast at Cutln 1; with  
steel rods in rock face

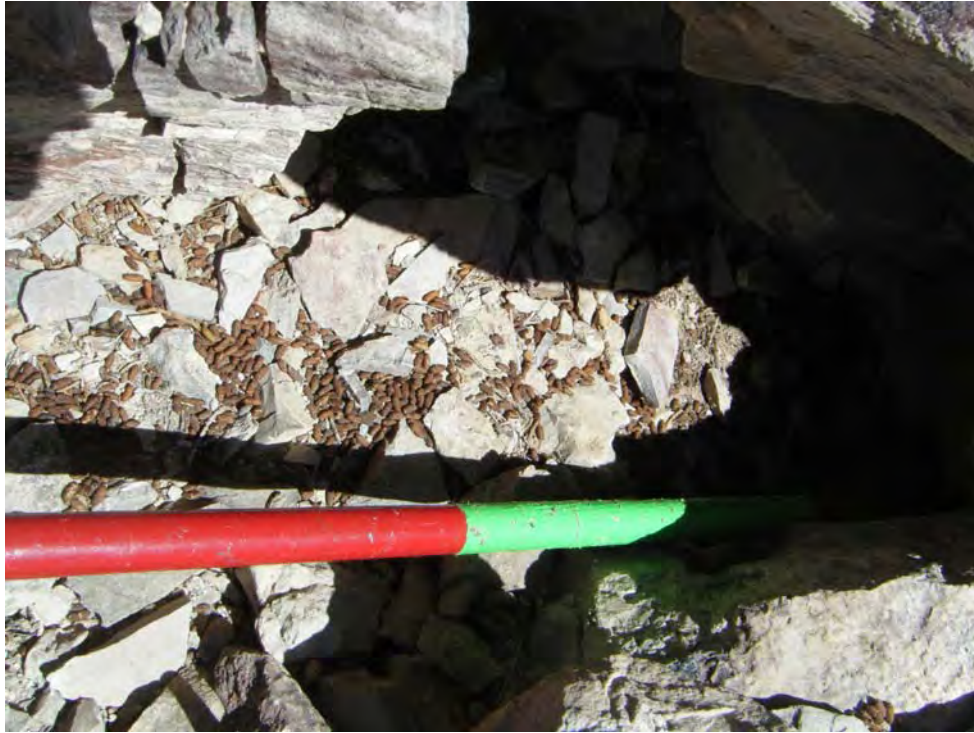
Scrub jays, cottontails, and jackrabbits were observed onsite. Deer scat was also found. Rodent droppings were present in CutLn-1 (see Photo 13 in Appendix A).

Photo 13-Pack rat den and droppings in CutLn-1 (Red Bluff No. 5 claim).

Photo 13 - Pack rat den and scat in Cutln 1

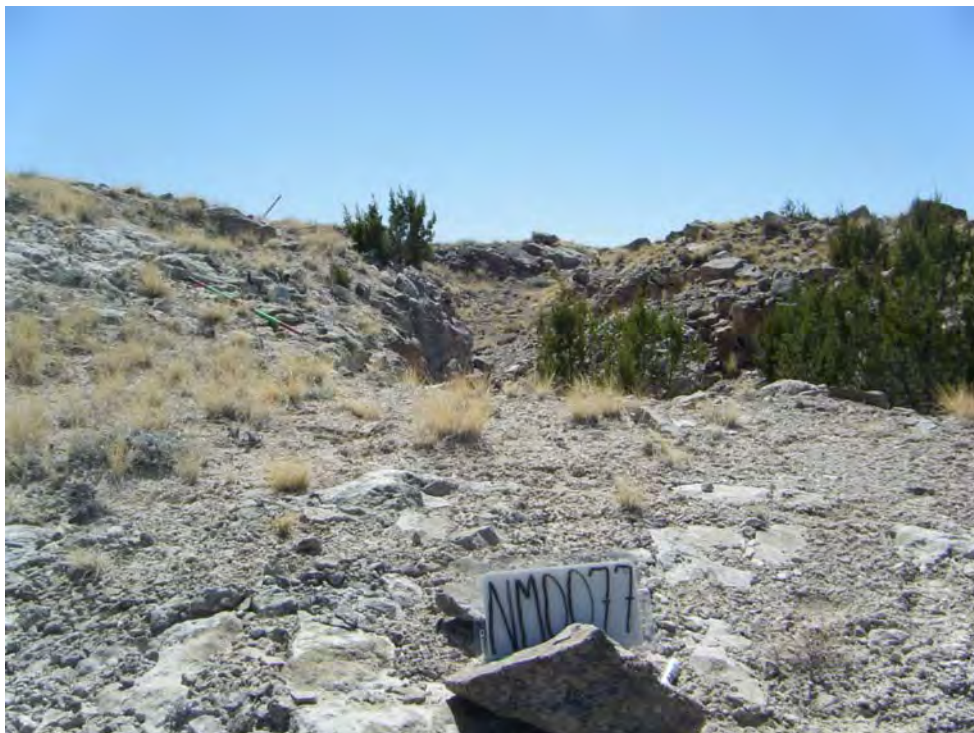
Photo 14-Site photo, looking west at Red Bluff No. 5 claim.

Photo 14 - Site name, looking south west at Red  
Bluff No. 5

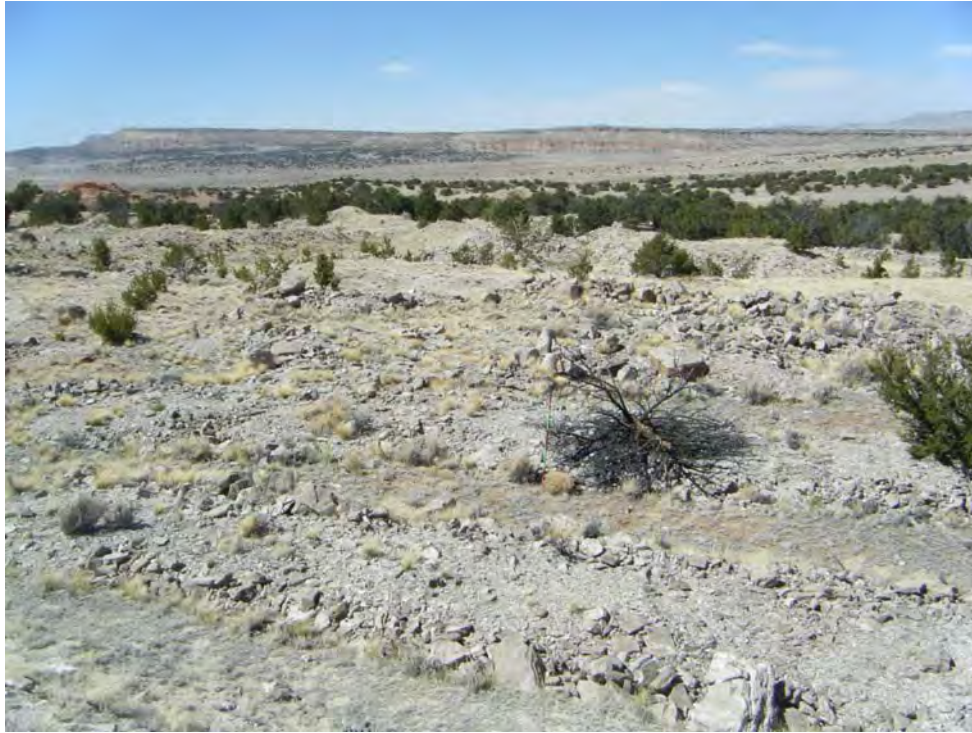
Photo 15-Looking northwest at PilePly-3 (Red Bluff No. 3 claim), per Anderson Report Photo A.

Pile Ply 3 - 3' high; 70' wide, 100' long; pile ridges and  
pile conc

Photo 15 - looking north west at Pile Ply 3

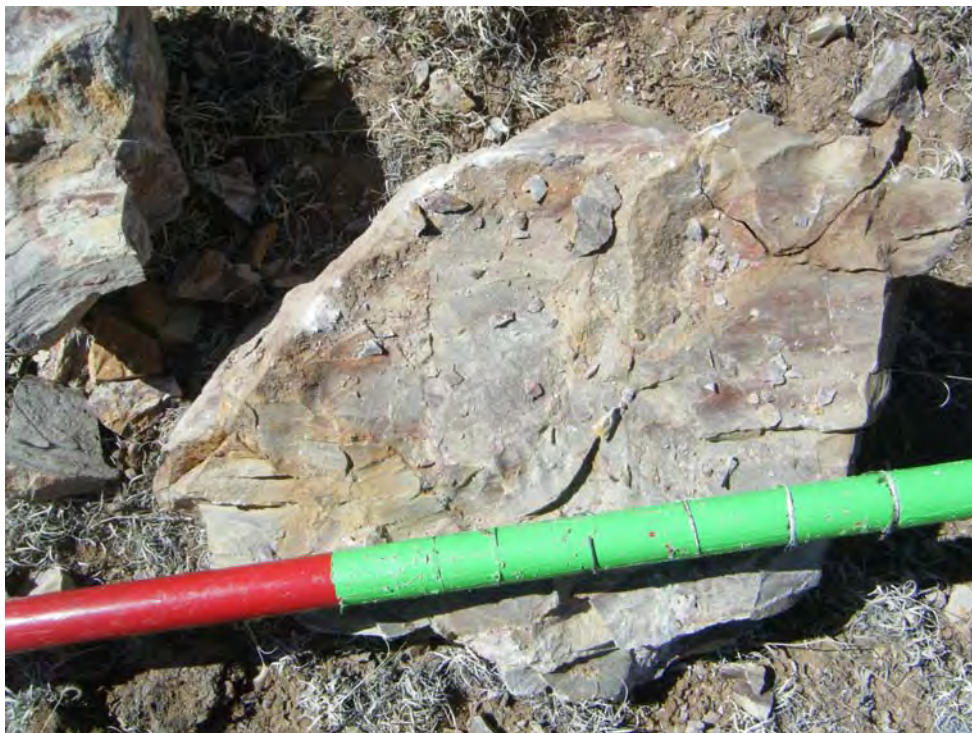
The maximum gamma radiation reading for the AUM Site was 1250  $\mu\text{R/hr}$  at 0 ft above ground at radiation survey point Rad-7 (see Photo 16 in Appendix A) on PilePly-3. This reading was taken on a mineralized boulder from a pile of waste rock. Other notable radiation readings were taken at radiation survey point Rad-13 (1100  $\mu\text{R/hr}$  at 0 ft above ground) in Pit-3 and radiation survey point Rad-1 (800  $\mu\text{R/hr}$  at 0 ft above ground; see Photo 1 in Appendix A) on a mineralized boulder in PilePly-1.

Photo 16-Radiation survey point Rad-7 (1250  $\mu$ R/hr at contact; Red Bluff No. 3 claim).

Rad 7 - Pile Ply 3 - 0m - 1250 uR/h; 1m - 100 uR/h

Photo 16 - Rad 7 Rock

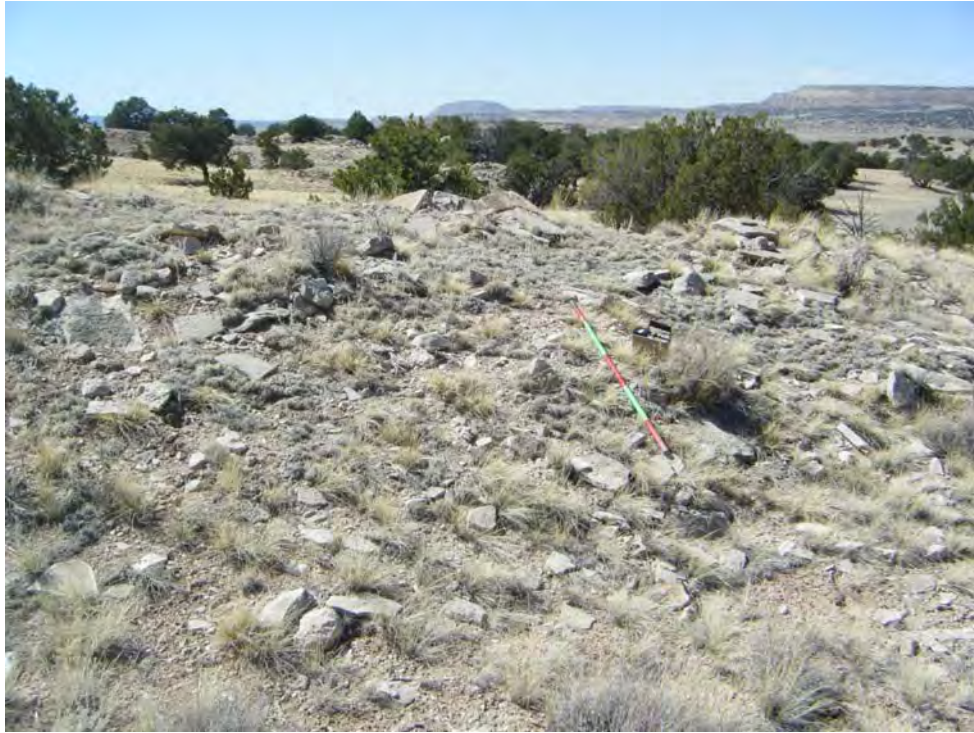
Photo 17-Looking west at PilePly-4 (Red Bluff No. 3 claim).

Pile Ply 4 - 5' high; 75' wide; 75' long; waste rock

Photo 17 - looking west at Pile Ply 4

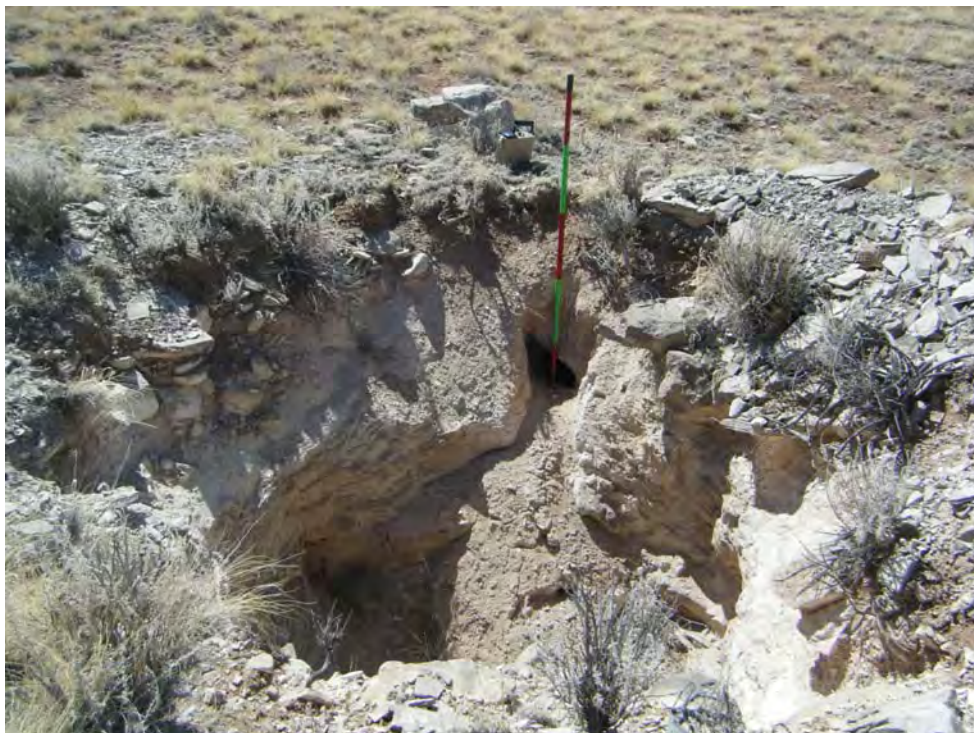
One shaft was found on the Red Bluff No. 3 claim. This shaft was about 10 feet deep (see Photos 18 and 19 in Appendix A). Anderson (1980) photographed an adit on the southwest end of the Red Bluff No. 2 claim, but this adit was not seen during the present survey. This feature may have been buried beneath blow sand and was not located.

Photo 18-Looking west at ShaftPly-1 (Red Bluff No. 3 claim).

Shaft Ply 1 - collapsed; 10' deep, 8' diameter

Photo 18 - looking west at shaft ply 1

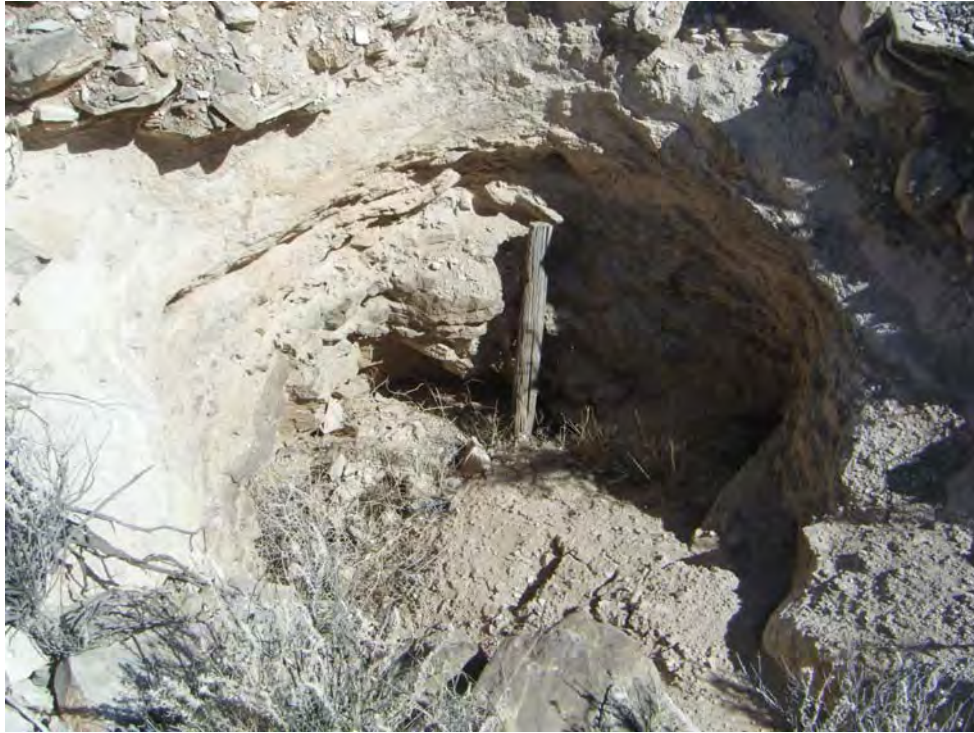
Photo 19-Looking south into ShaftPly-1 (Red Bluff No. 3 claim).

Photo 19 - looking south into shaft ply 1

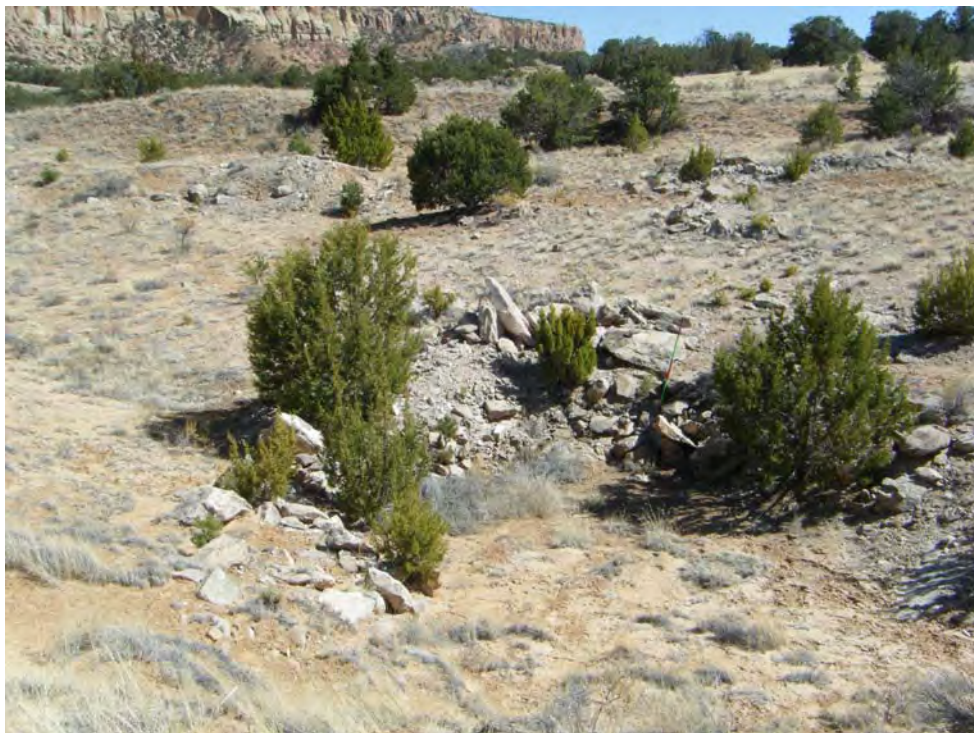
Six pits and one open cut were found onsite. The Red Bluff No. 1 claim had one pit (Pit-2), which consisted of a shallow, broad depression (see Photo 20 in Appendix A). The Red Bluff No. 2 claim contained one large pit (Pit-4). Overburden and some Todilto Formation were removed from this pit (see Photos 30-34 in Appendix A). No pits or open cuts were observed in the Red Bluff No. 3 claim. The Red Bluff No. 4 claim contained two small pits, Pit-5 and Pit-6. These pits were dug up to 15 feet into the Todilto Formation, and associated piles were located nearby (see Photos 36, 37, 39 and 40 in Appendix A). The Red Bluff No. 5 claim had one pit (Pit-1) and one open cut (CutLn-1). Both features were cut into the Todilto Formation (see Photos 5-7, 10-13 in Appendix A). The Red Bluff No. 9 claim had one large pit (Pit-3). Overburden has been removed from this pit, exposing Todilto Formation (See Photos 22-24 in Appendix A).

Photo 20-Looking south into Pit-2 (Red Bluff No. 1 claim).

Pit 2 - 20' on <sup>ACT</sup> north end, 2' deep on south end  
100' wide; 150' long; Todilto under blow  
sand

Photo 20 - looking south into Pit 2

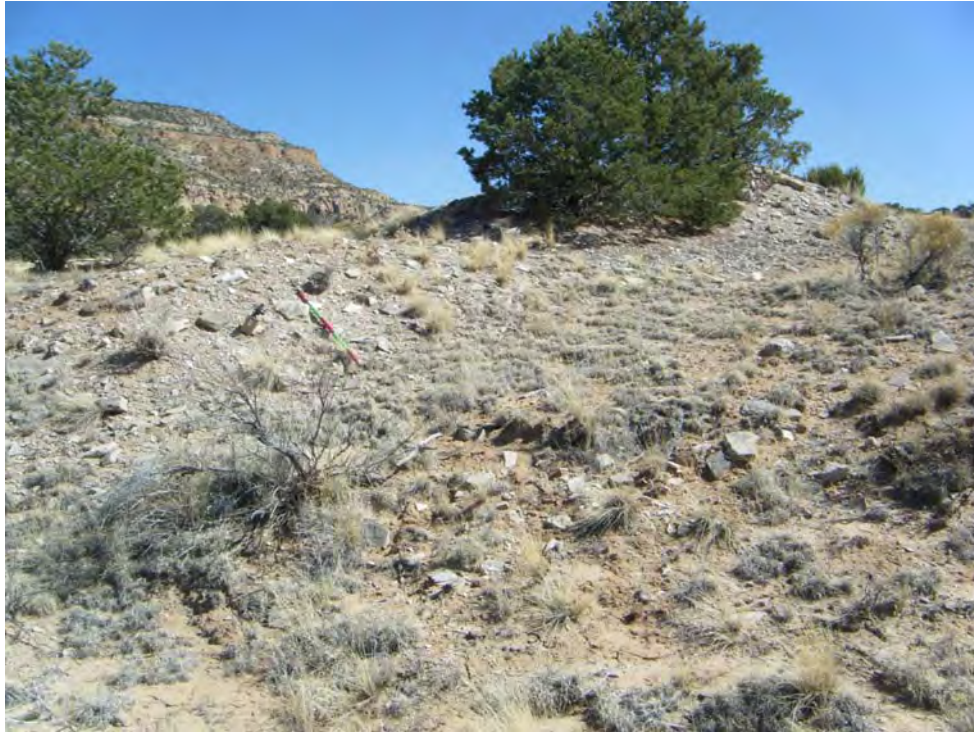
Eight piles were found onsite. The Red Bluff No. 1 claim contained one pile (PilePly-5) consisting of overburden and waste rock (see Photo 21 in Appendix A). The Red Bluff No. 2 claim did not have any obvious piles, though nearby sand dunes may be overburden piles reworked by wind. The Red Bluff No. 3 claim had two piles, PilePly-3 and PilePly-4. PilePly-3 consists of low mounds of waste rock (see Photo 15 in Appendix A) while PilePly-4 consists of revegetated overburden and waste rock (see Photo 17 in Appendix A). The maximum gamma reading obtained onsite (1250  $\mu$ R/hr at 0 ft above ground) was recorded on PilePly-3. The Red Bluff No. 4 claim contained one pile area (PilePly-8; see Photo 38 in Appendix A). These piles were likely waste rock from Pit-5 and Pit-6. The Red Bluff No. 5 claim had two piles, PilePly-1 and PilePly-2. PilePly-1 was a broad, flat mound of waste rock (see Photos 2-4 in Appendix A) and PilePly-2 appeared to have overburden as well as waste rock (see Photos 8 and 9 in Appendix A). The Red Bluff No. 9 claim contained PilePly-6 and PilePly-7. PilePly-6 lies on the eastern edge of Pit-3 and represents overburden removed from the pit (see Photo 25 in Appendix A). PilePly-7 is a broad, flat mound of poorly vegetated waste rock on the extreme eastern edge of the Site (see Photo 26 in Appendix A).

Photo 21-Looking southeast at PilePly-5 (Red Bluff No. 1 claim).

Pile Ply 5 - 150' diameter; 25' high; waste rock and  
sediment

Photo 21 - looking southeast at Pile Ply 5

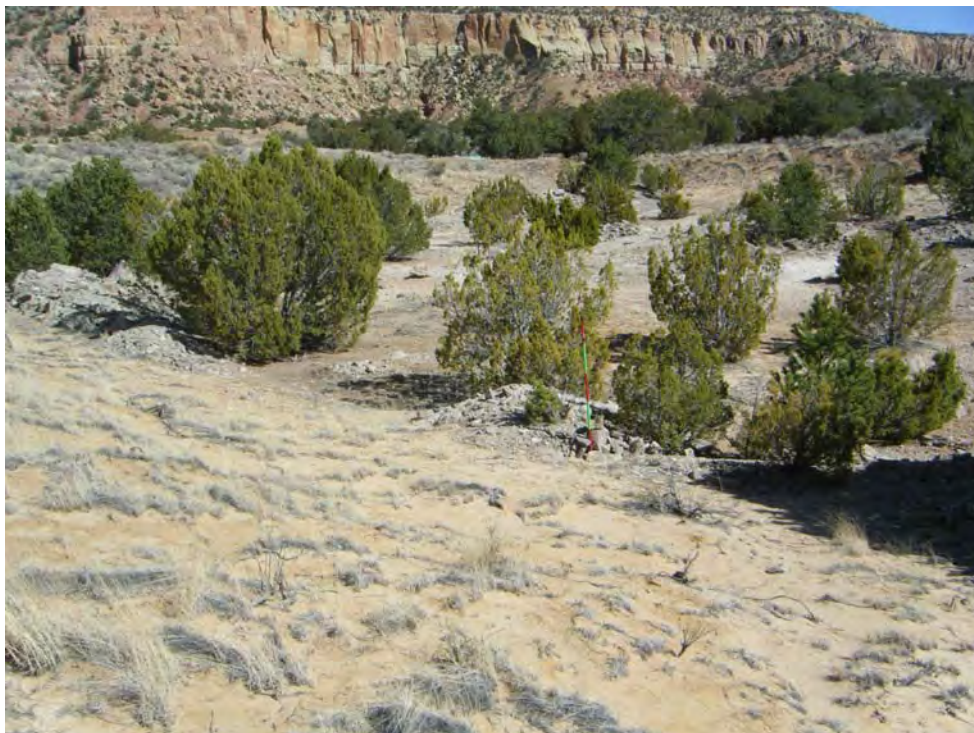
Photo 22-Looking southeast at Pit-3 (Red Bluff No. 9 claim).

Pit 3; 15' deep, 150' <sup>ACT</sup> ~~long~~ wide; 250' long

Photo 22 - looking southeast at Pit 3

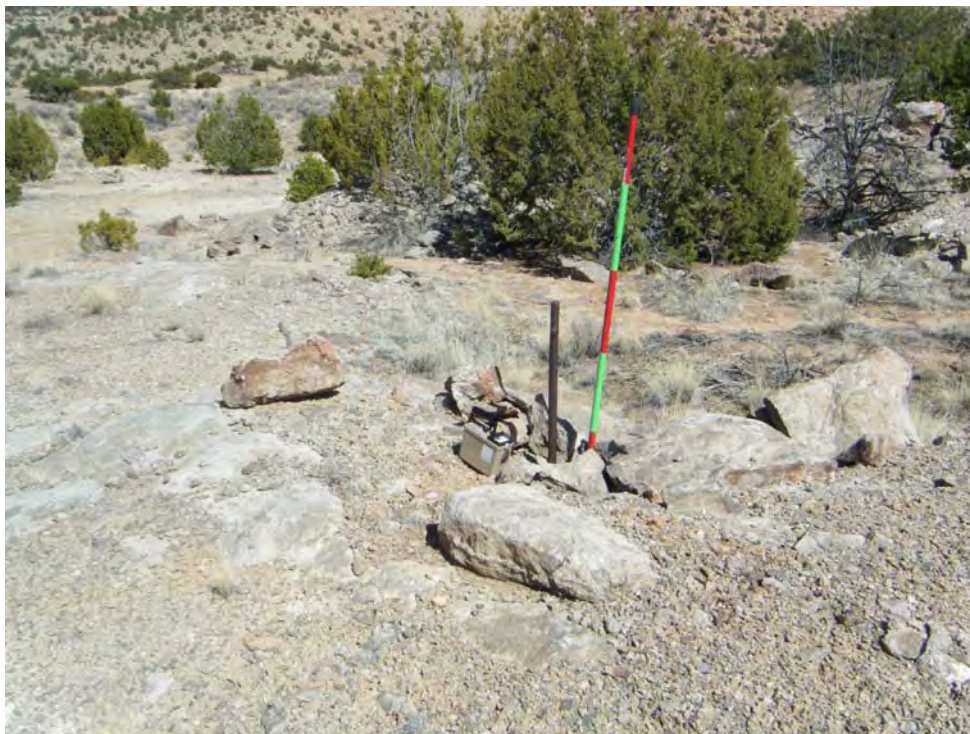
Photo 23-Looking east at steel rod in Pit-3 (Red Bluff No. 9 claim).

Photo 23 - looking east at steel rod in Pit 3

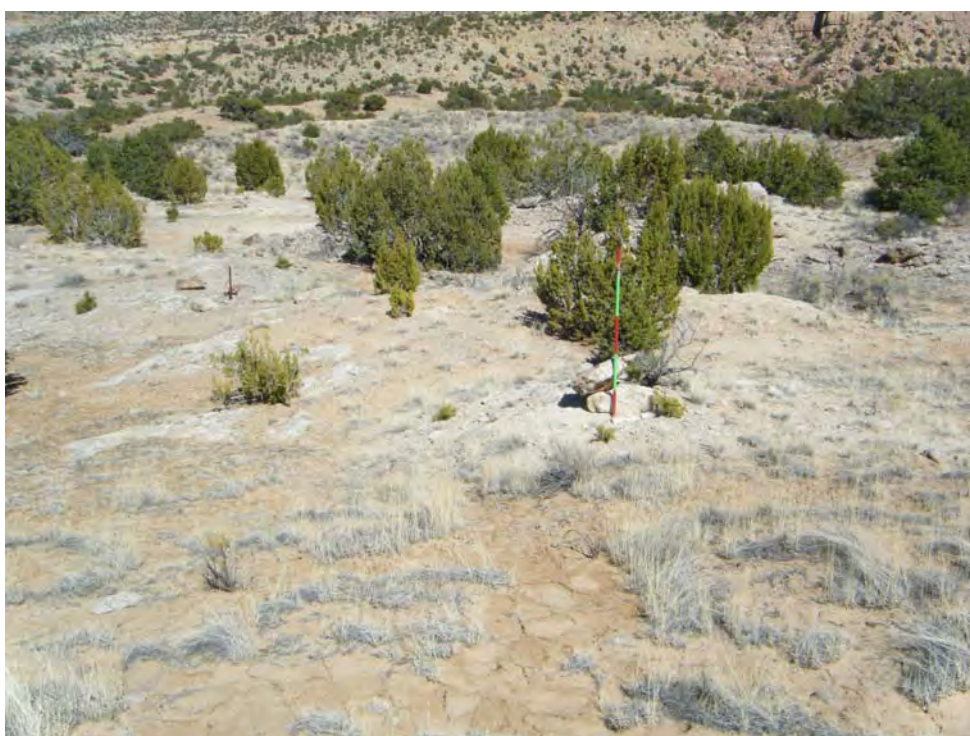
Photo 24-Looking east at Pit-3 (Red Bluff No. 9 claim).

Photo 24 - looking east at Pit 3

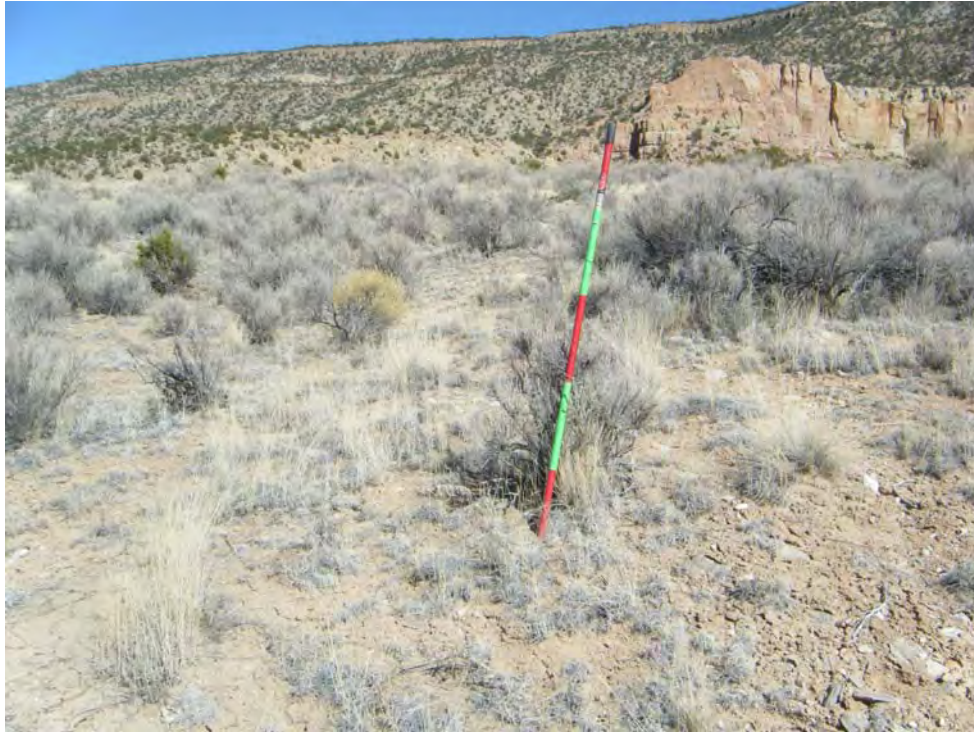
Photo 25-Looking east at PilePly-6 (Red Bluff No. 9 claim).

Pile Ply 6 - overburden sand from Pit 3, scraped  
out to expose Todilto; 20' high, 75' x 75'

Photo 25 - looking east at Pile Ply 6

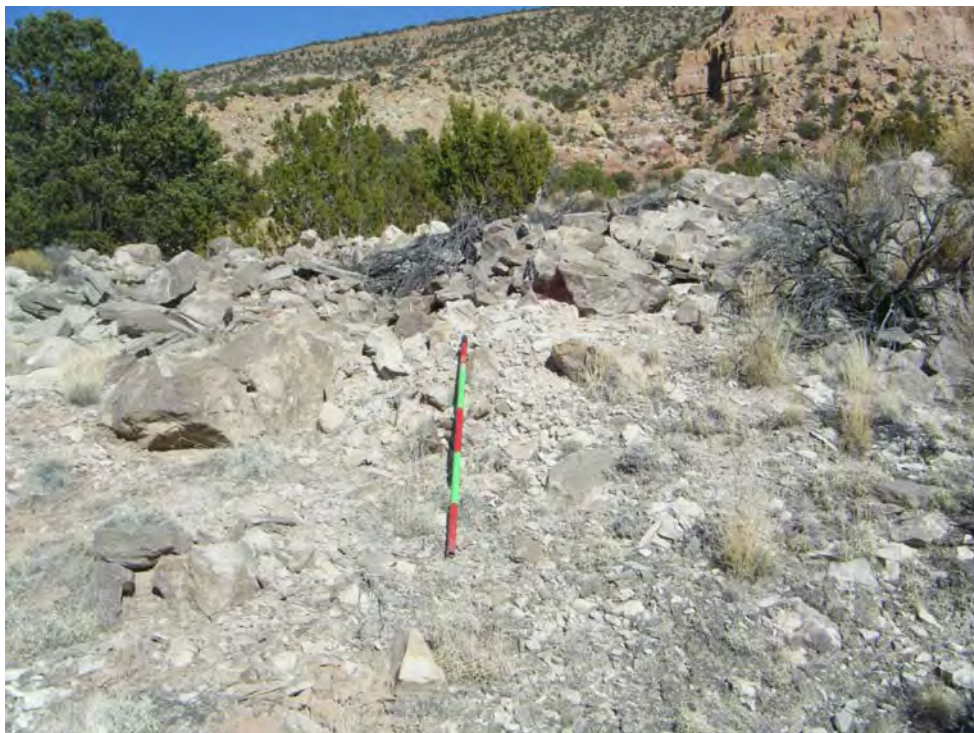
Photo 26-Looking east at PilePly-7 (Red Bluff No. 9 claim).

Pile Ply 7 - 5' high; 50' wide; 200' long; waste rock

Photo 26 - looking east at Pile Ply 7

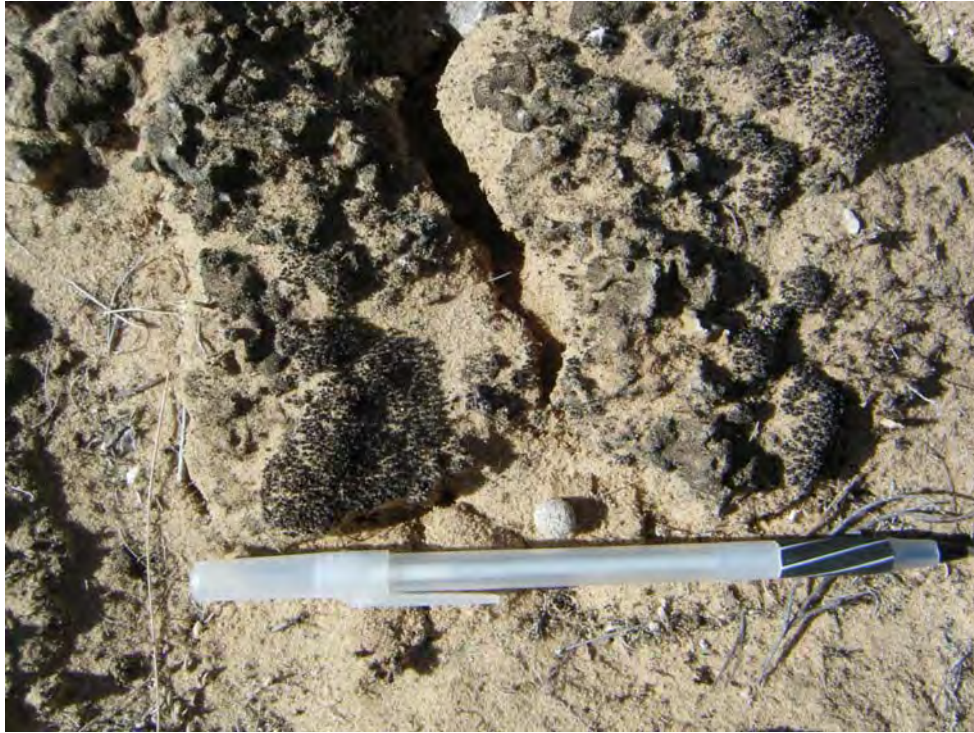
Photo 27-Cryptobiotic soils on the AUM Site.

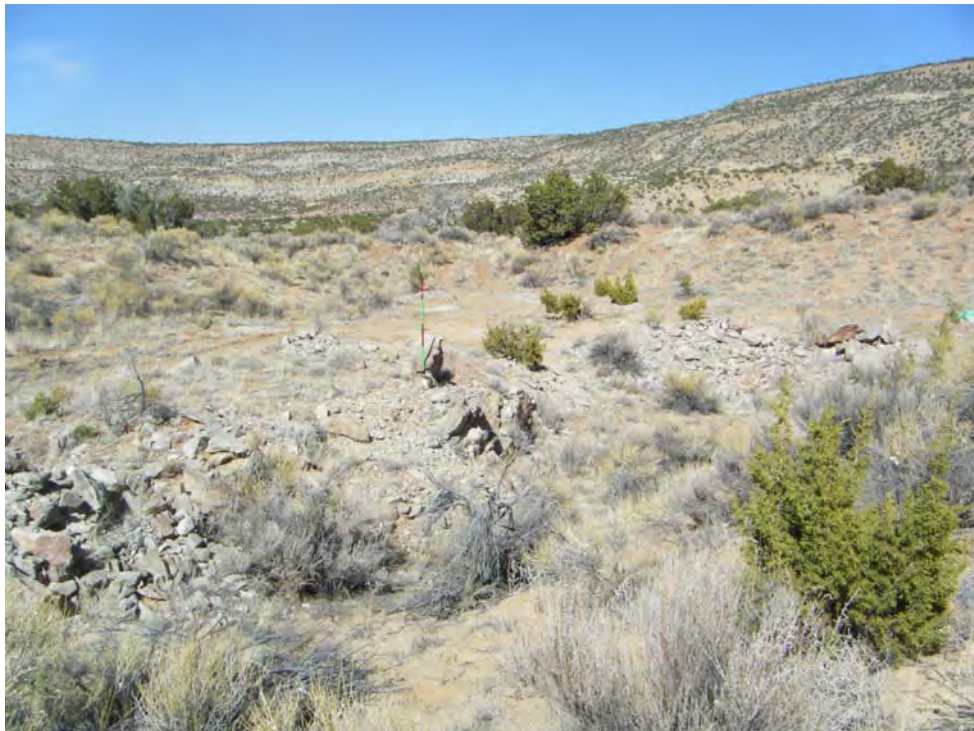
Photo 30-Looking northeast at Pit-4 (Red Bluff No. 2 claim).

Pit 4 - aeolian sand on top of <sup>ACT</sup> ~~Todilto~~ Todilto  
25' deep; 300' long, 200' wide

Photos 30-31 - looking <sup>ACT</sup> ~~south~~ northeast at Pit 4

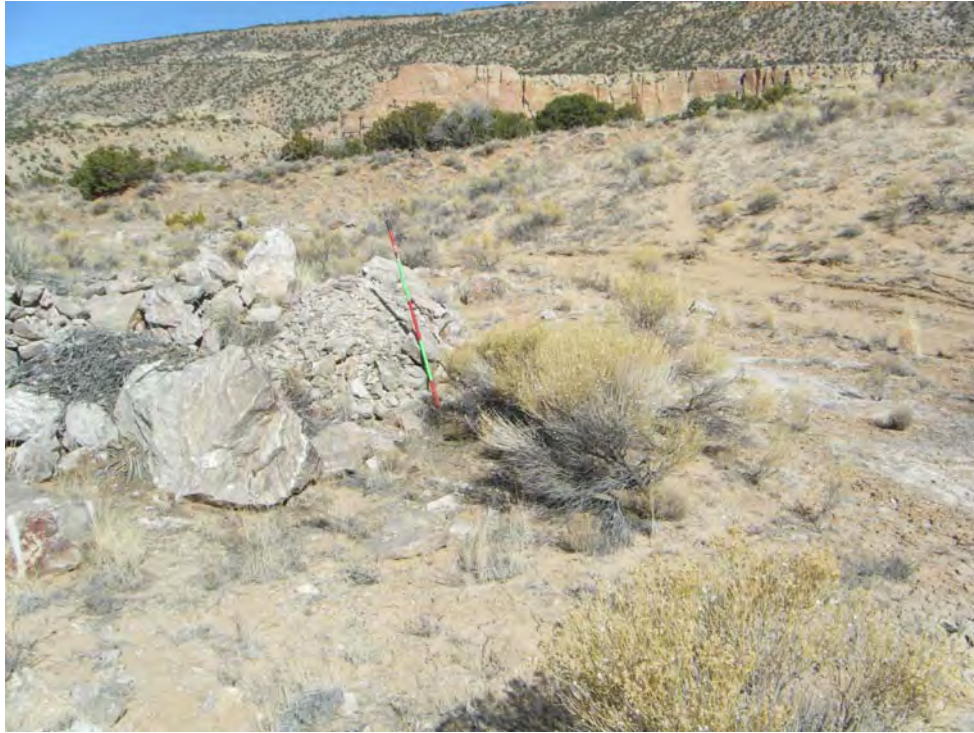
Photo 31-Looking northeast at Pit-4 (Red Bluff No. 2 claim).
