# Abandoned Uranium Mine Site Assessment for the Red Bluff Nos. 1-5, 9 Site (NM0077)

**FINAL REPORT**

NM0077

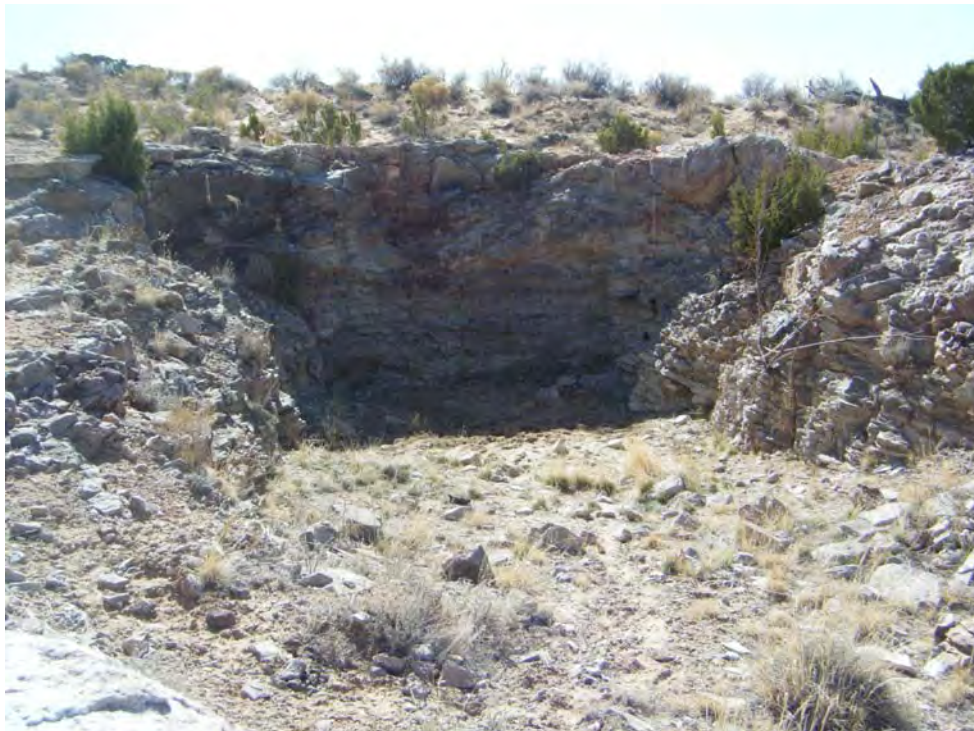
Photo 32-Looking southwest at Pit-4 (Red Bluff No. 2 claim), replicating Photo (C) in Anderson (1980).

Photos 32-33 - looking southwest at Todillo cut in Pit 4

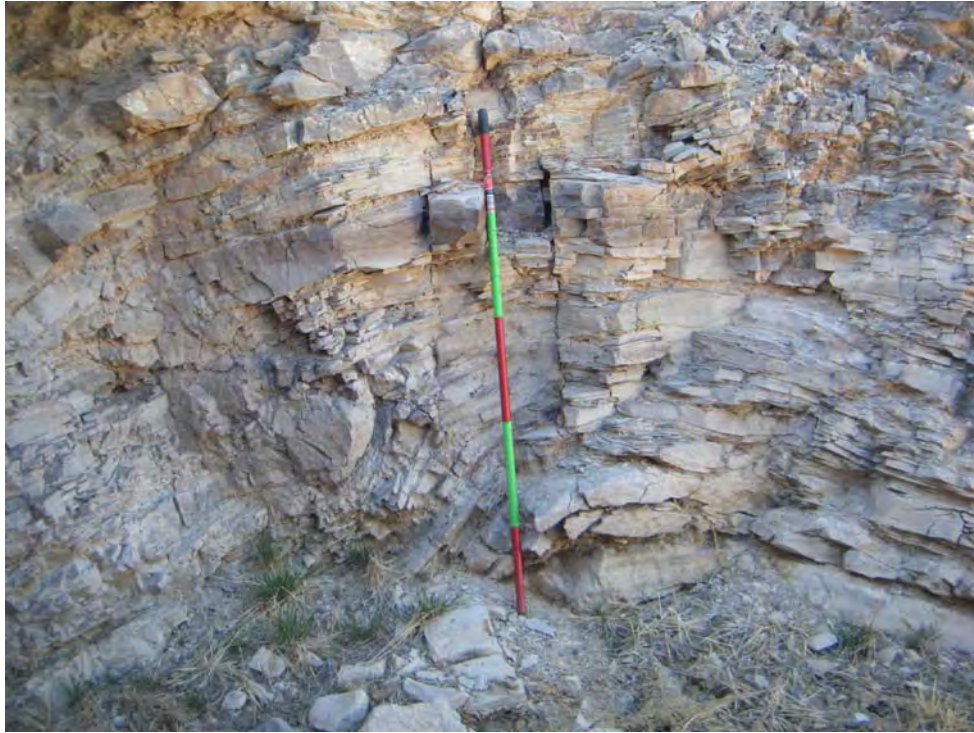
Photo 33-Closeup of Todilto Formation in Pit-4 (Red Bluff No. 2 claim).

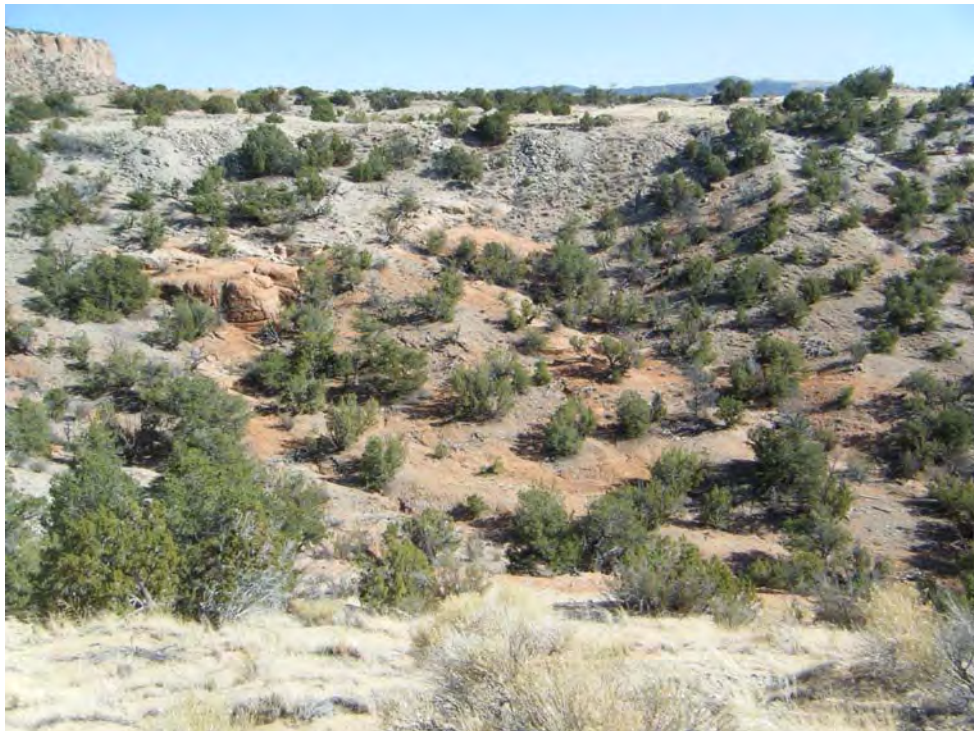
Photo 34-Looking southeast from the MMD-provided shapefile on the Red Bluff No. 2 claim.

Photo 34 & 35 - looking southeast and northwest in Red Bluff No. 2 polygon

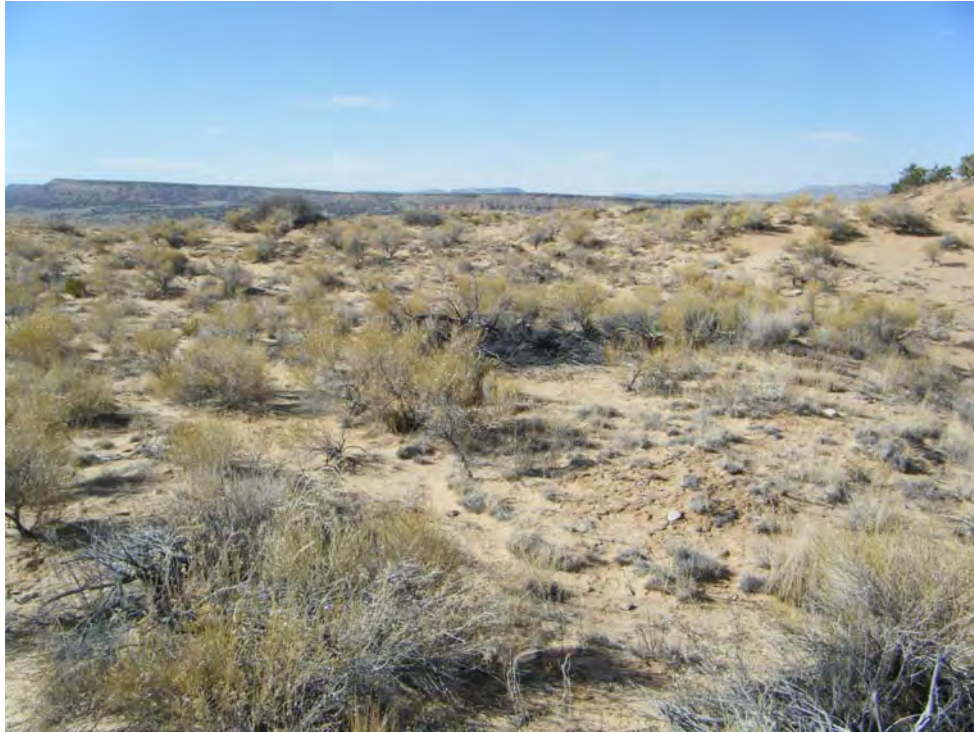
Photo 35- Looking northwest from the MMD-provided shapefile on the Red Bluff No. 2 claim.

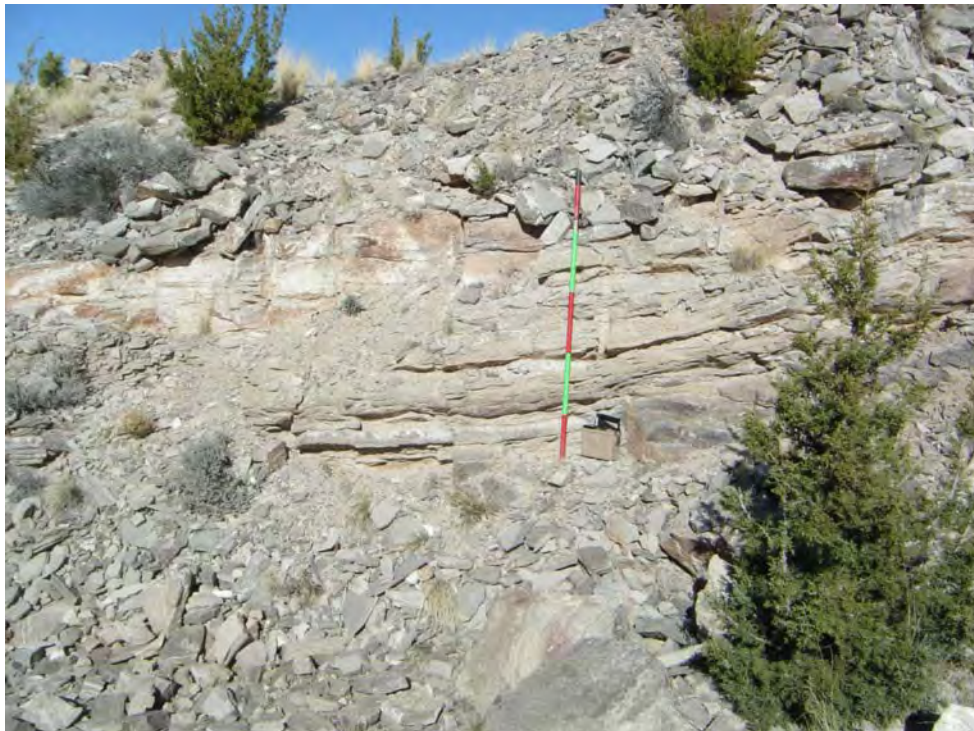
Photo 36-Looking east at Pit-5 (Red Bluff No. 4 claim).

Pit 5 - 15' deep, 25' wide, 55' long

Photo 36 - looking east at Pit 5

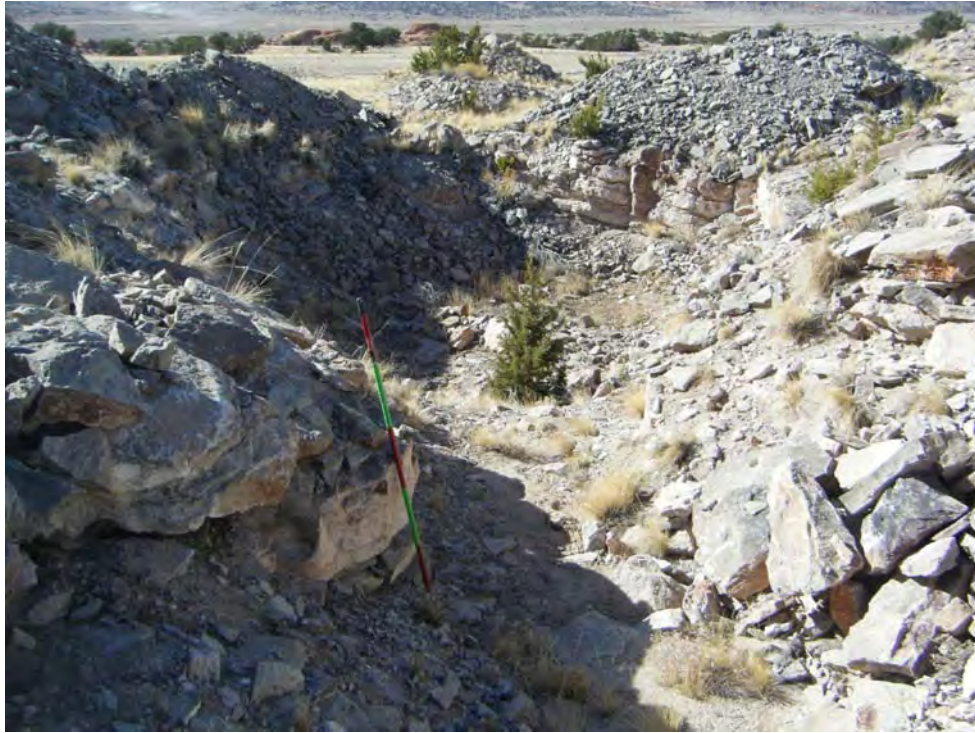
Photo 37-Looking north at Pit-5 (Red Bluff No. 4 claim).

Photo 37 - looking north at Pit 5

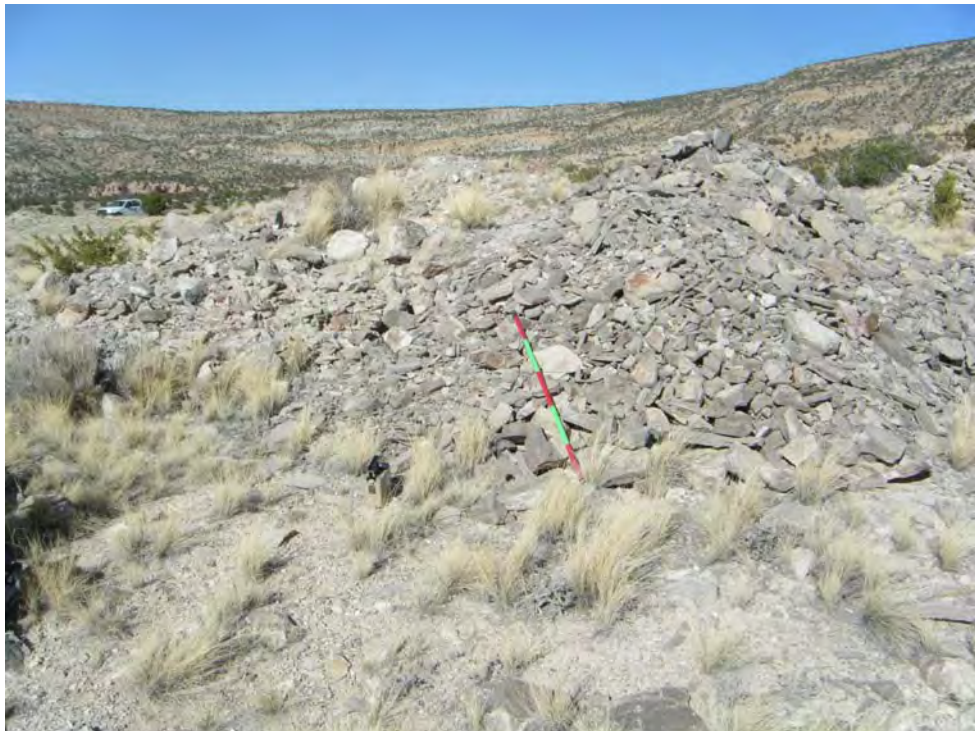
Photo 38-Looking east at PilePly-8 (Red Bluff No. 4 claim).

Pile Ply 8 - waste rock, numerous cones 8' high, 300' long, 200' wide

Photo 38 - looking east at cones in Pile Ply 8

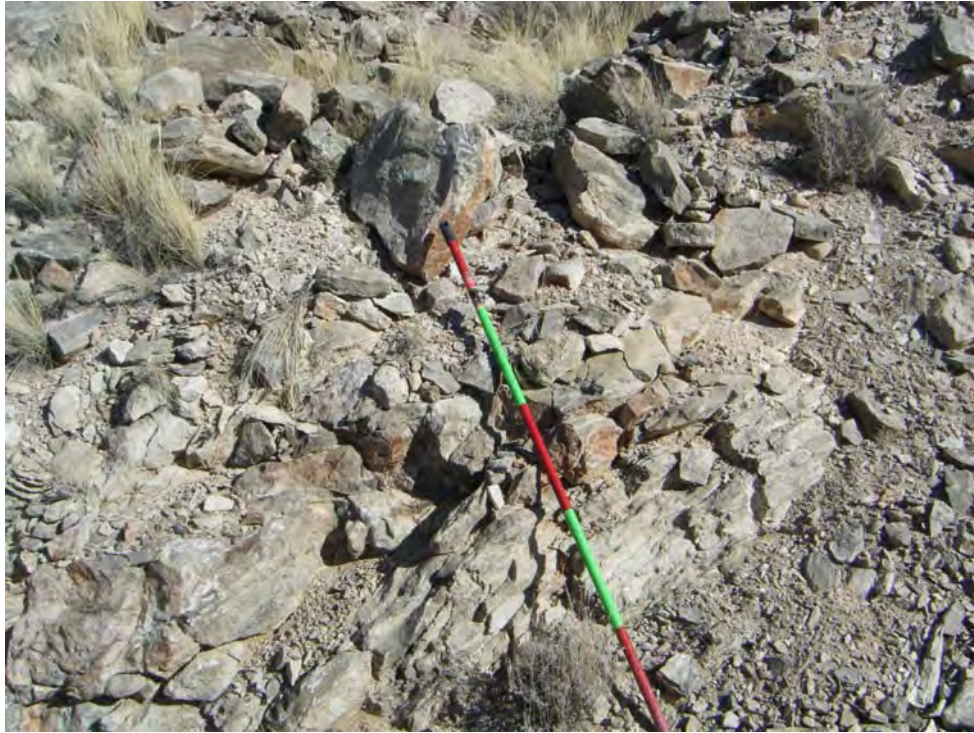
Photo 39-Looking east at Pit-6 (Red Bluff No. 4 claim).

Pit 6 - 8' deep; 15' wide; 35' long

Photo 39 - looking east at Pit 6

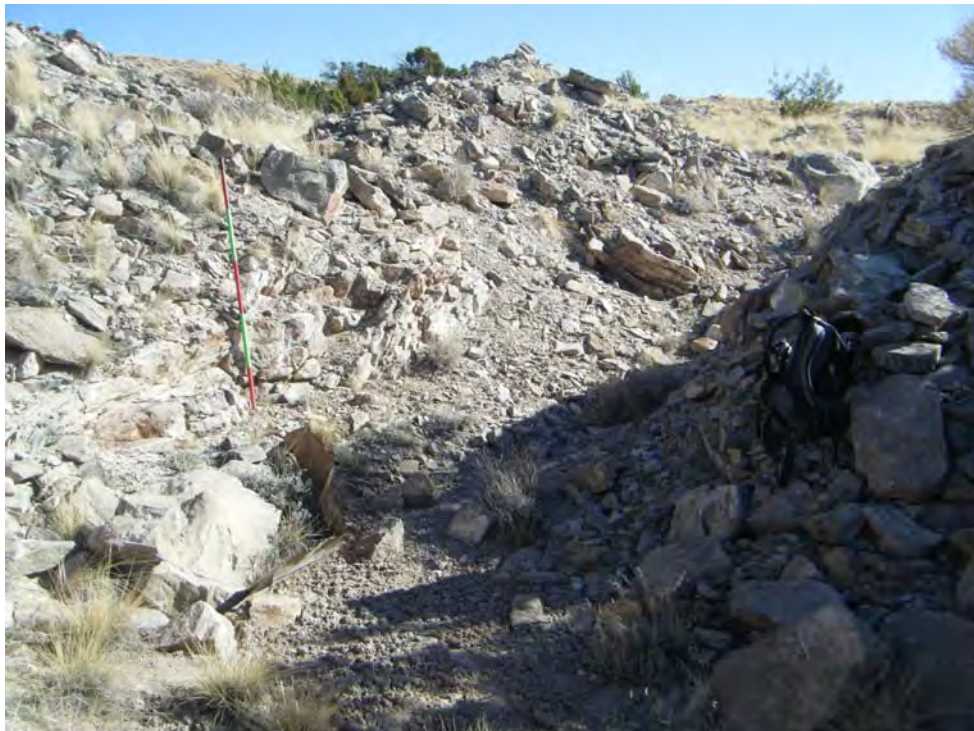
Photo 40-Looking south at Pit-6 (Red Bluff No. 4 claim).

Photo 40 - looking south at Pit 6
