## SAN MATEO - EXHIBIT S

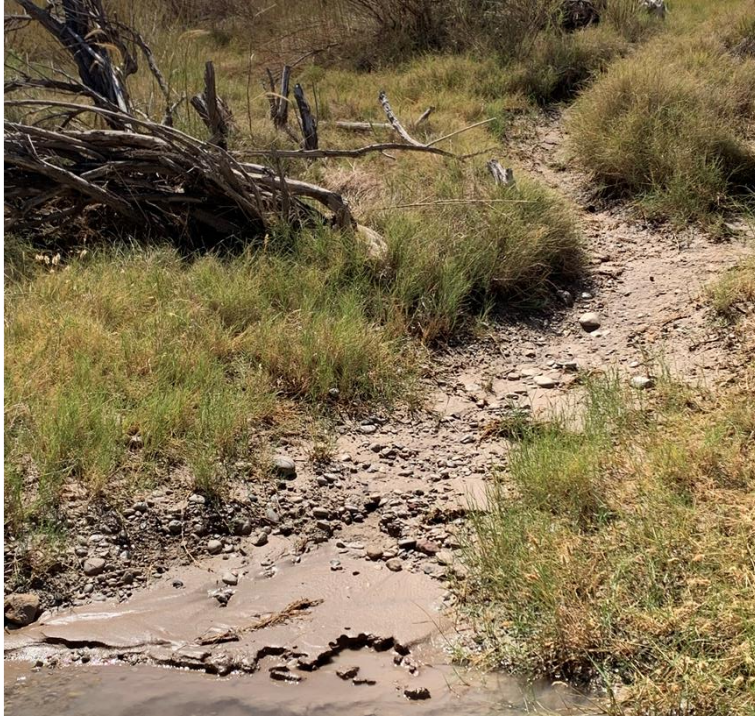
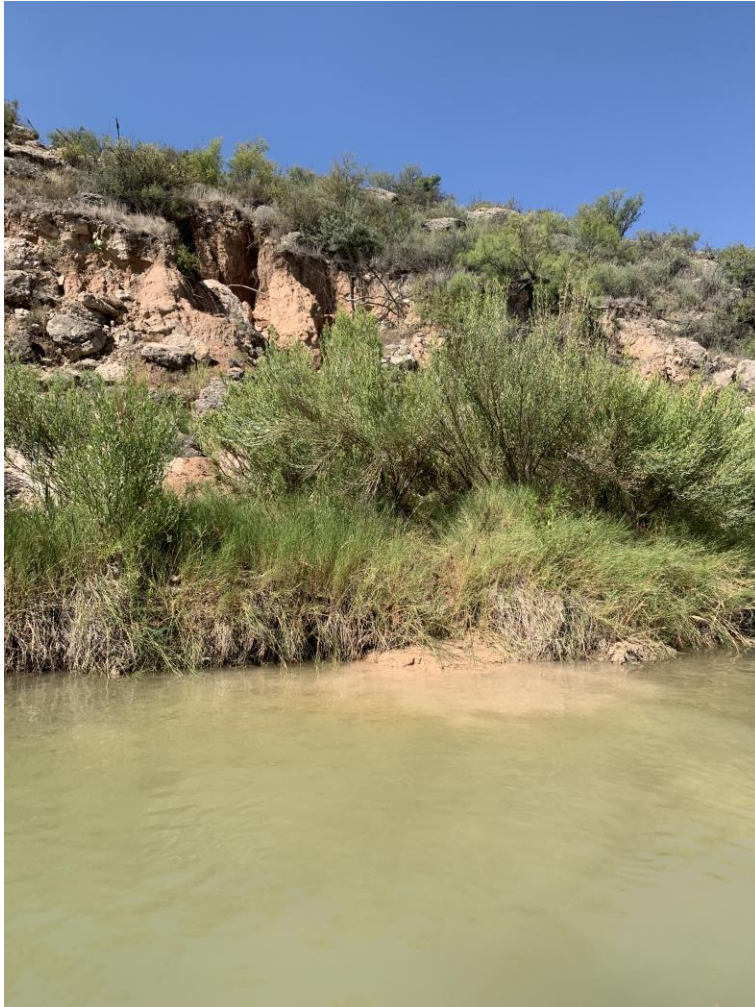
The photos at the left, taken on July 31, 2020, during the kayak-based inspection, depict two discrete deposits of light-tan, pudding-like sediment identified by Vertex and Respondents that match the deposits Impac Labs confirmed were caliche, not bentonite.
