Abandoned Uranium Mine Site Assessment for the Inez-Hummer Site (NM0132)

FINAL REPORT

NM0132

April 14, 2010

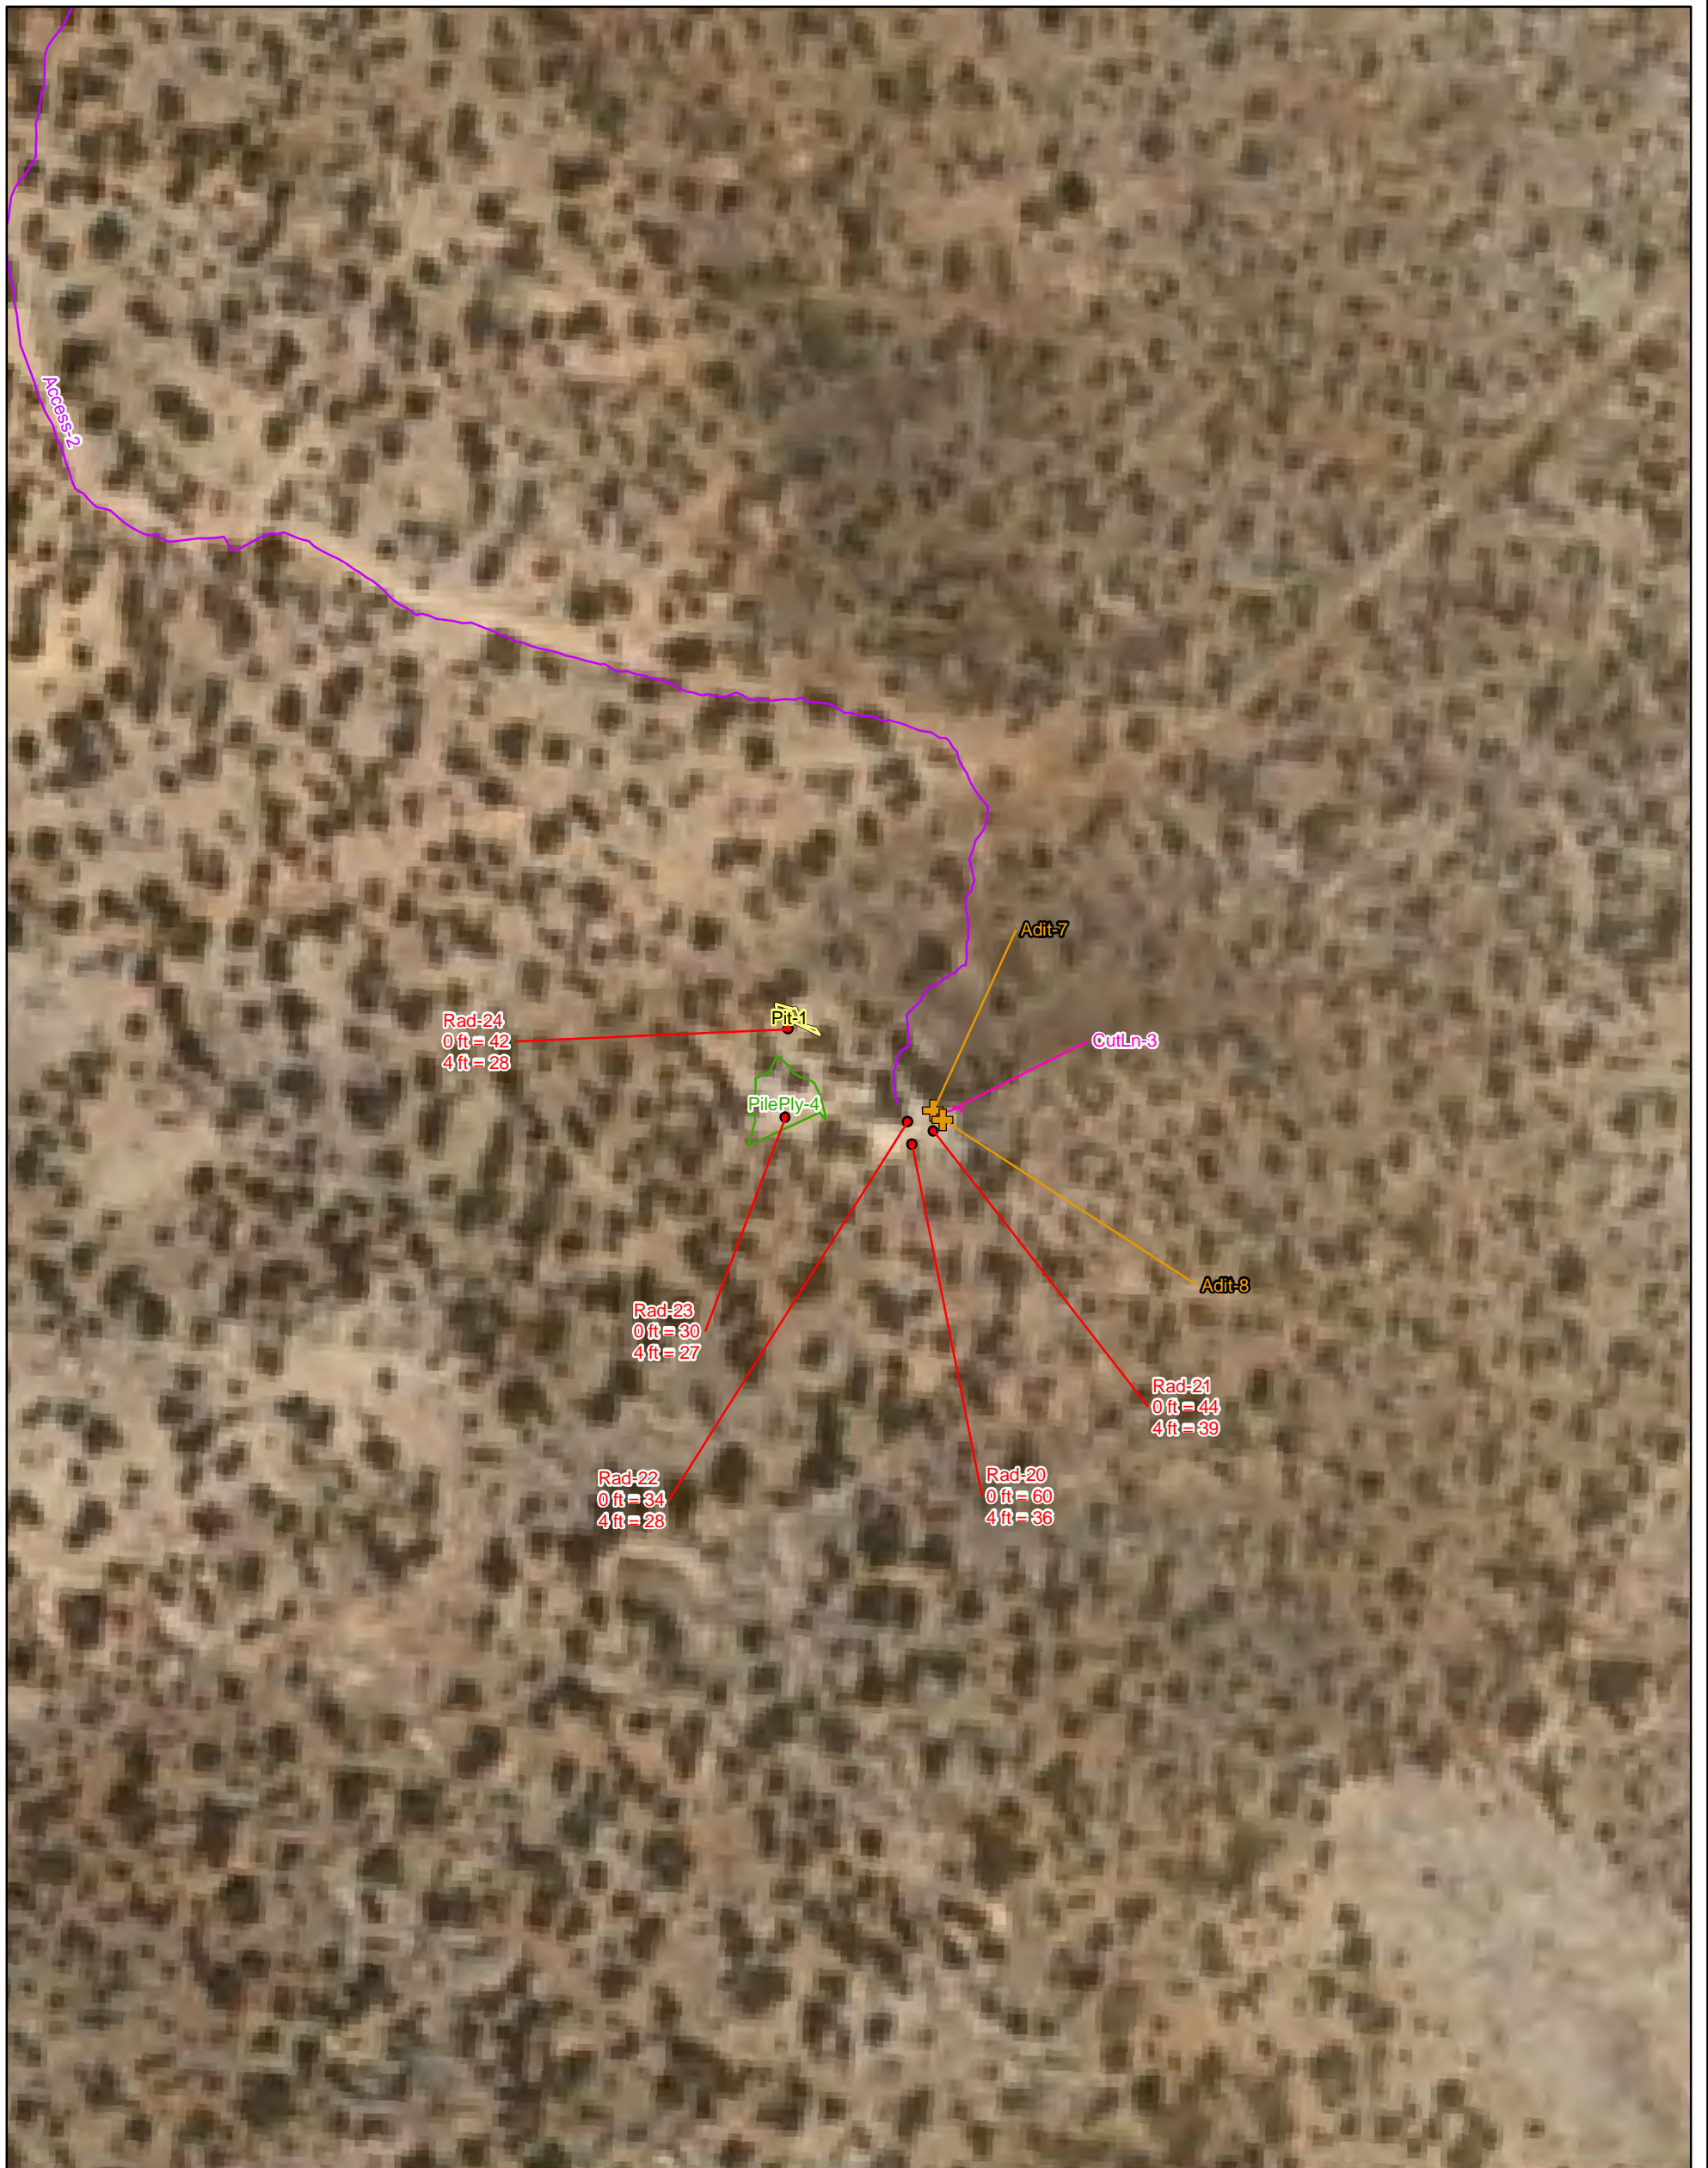
Figure 4a
Site Map on
Aerial Photo
NM0132-Inez-Hummer
Western Area
 Abandoned Uranium
 Mine Assessment

Three open cuts and one pit were identified at the AUM Site. CutLn-3 and Pit-1 were identified in the Western Area of the AUM Site (Figure 4). CutLn-3 was an open cut trending east-west into the slope of Saddle Mountain and contained the openings for adits 7 and 8. Pit-1 was an

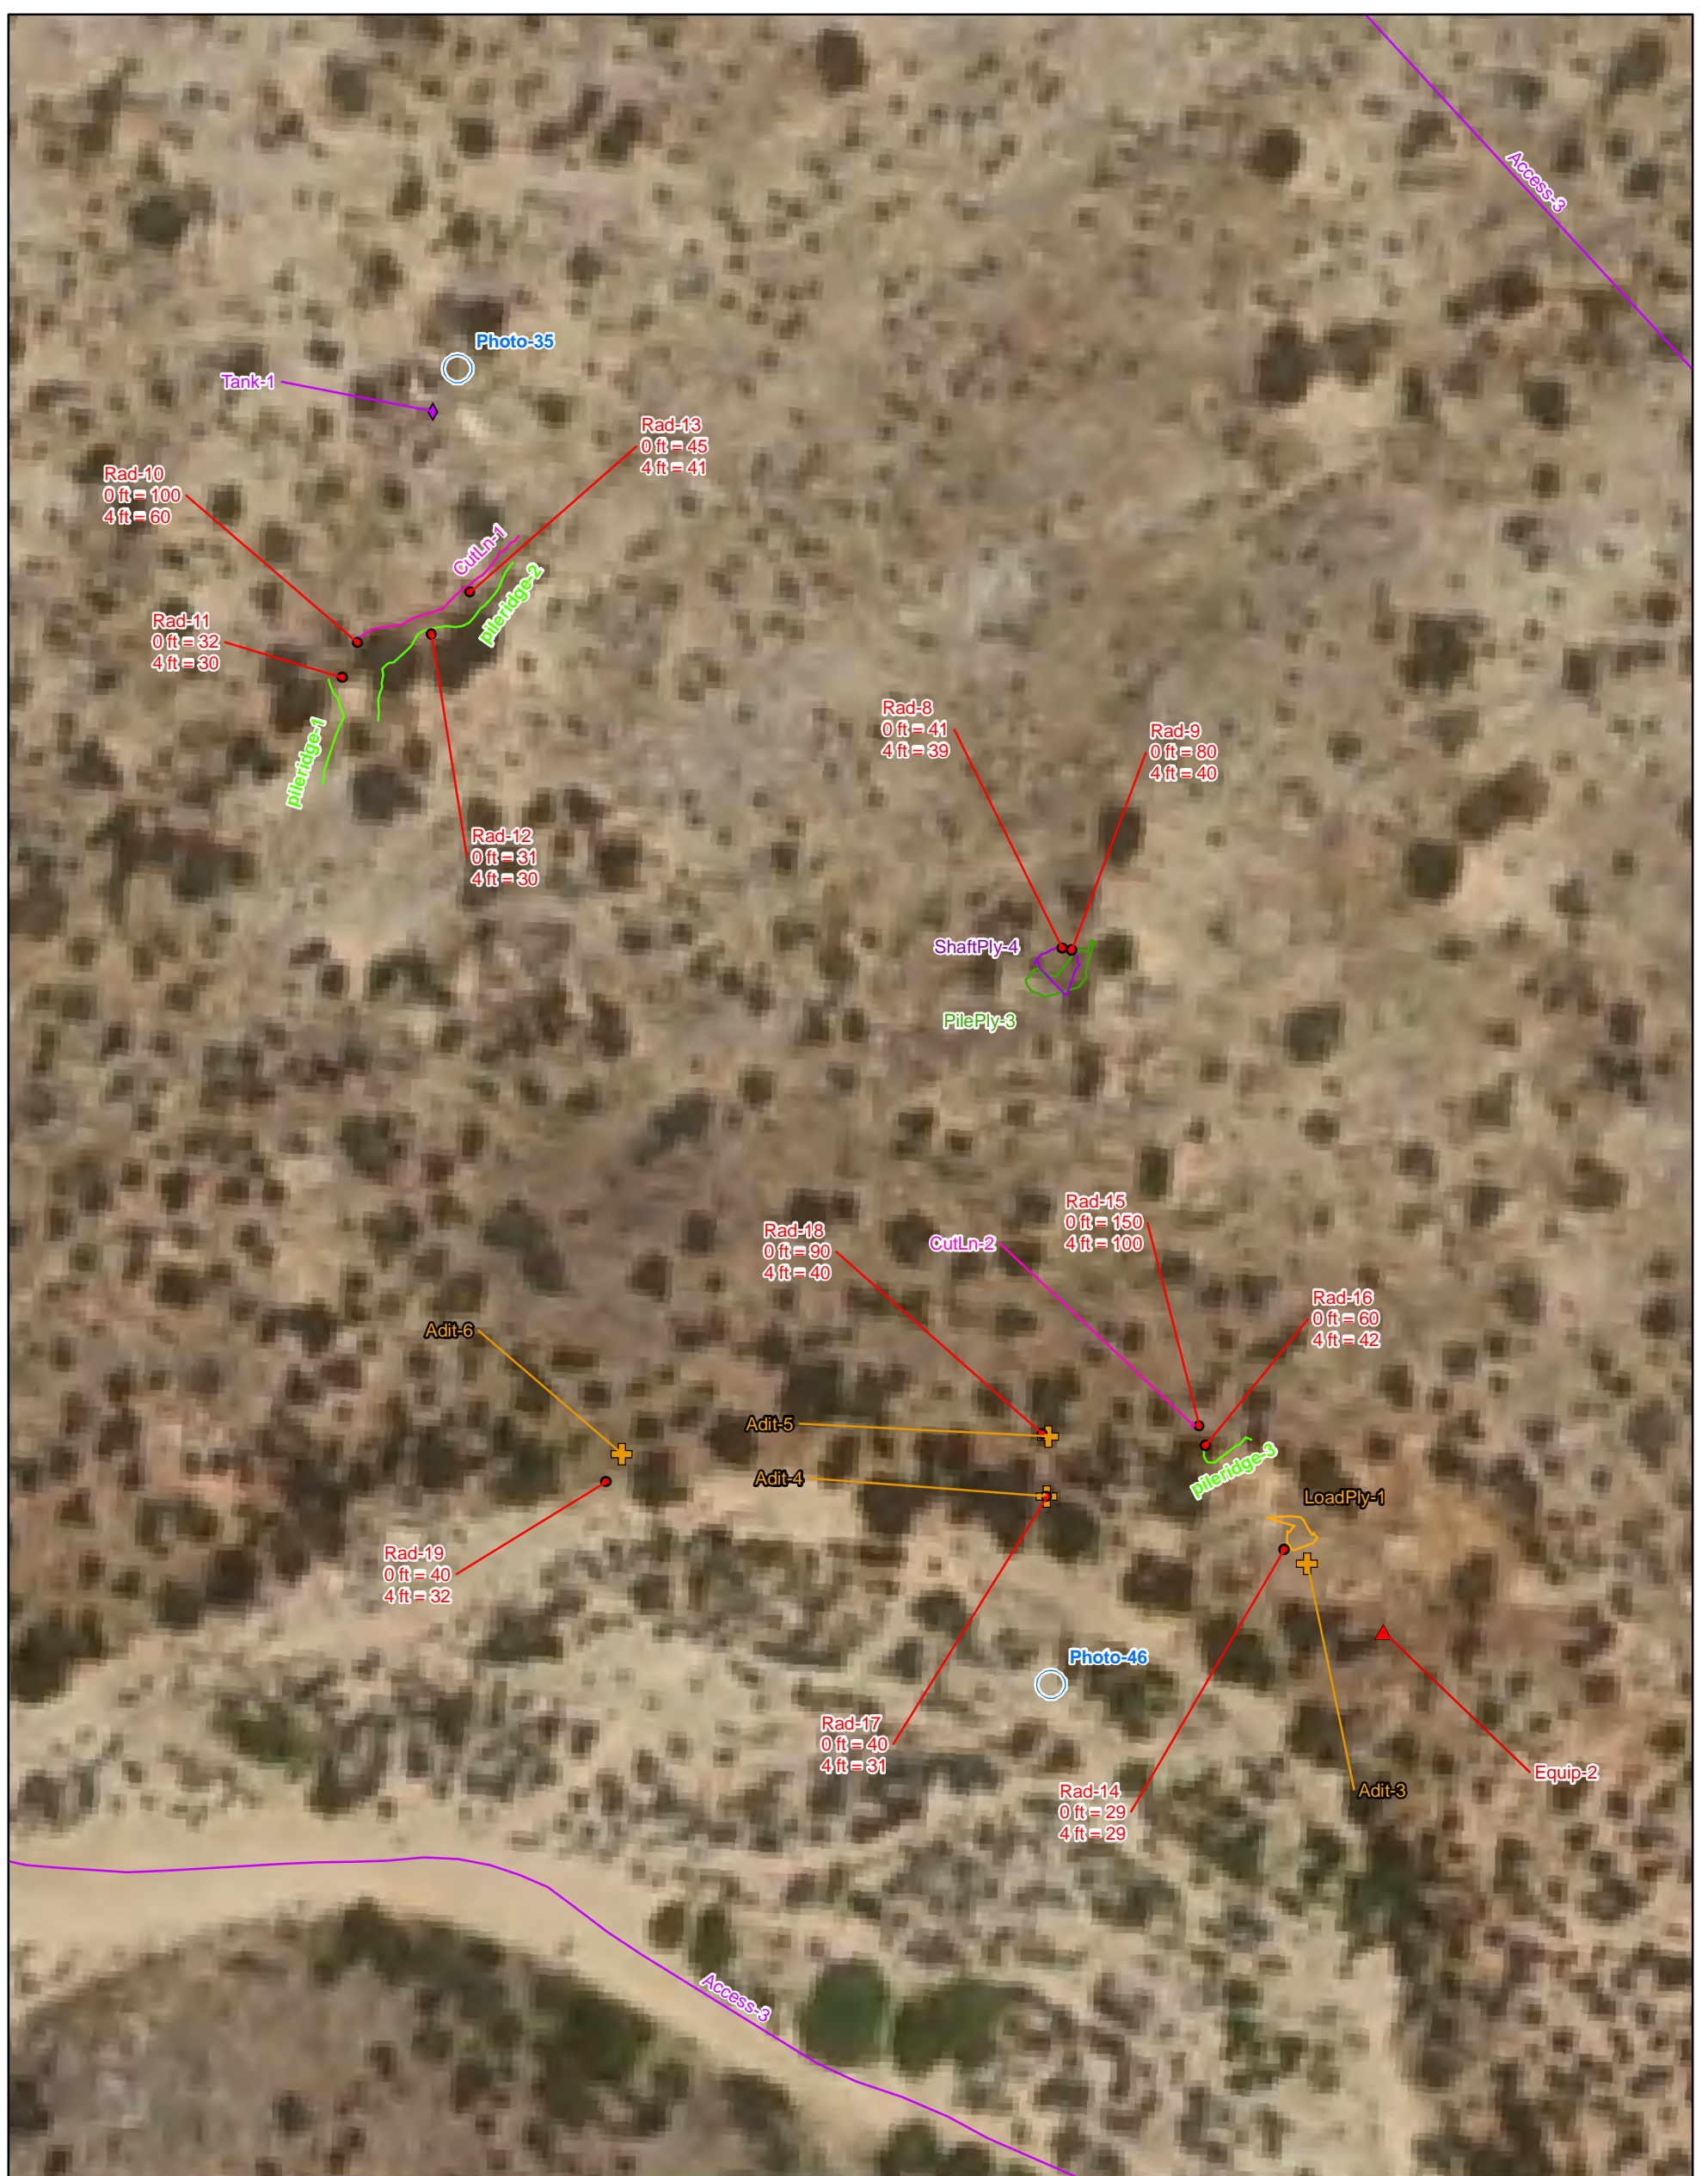
Figure 5a
Site Map on
Aerial Photo
NM0132-Inez-Hummer
Northern Area
 Abandoned Uranium
 Mine Assessment

One shaft was found on the Northern Area of the AUM Site (ShaftPly-4), a 12 feet deep decline to water (Figure 5). The shaft found was open at the ground surface and not fenced off. Eight adits were found at the AUM Site. Two adits (Adit-1 and 2), both approximately 20 feet long were found at the Eastern Area (Figure 6). Four adits (Adit-3, 4, 5, and 6) were found at the Northern Area (Figure 5). One of these adits (Adit-3) was collapsed, this adit was at one time a very large adit with timbers for structural support and a loadout at its entrance. Adit-4 is a small adit, approximately 5 feet long, connecting to Adit-5. Adit-5 had an unknown length and extended into the hill to the northeast. Adit-6, west of Adit-4 and 5, extended approximately 10 feet into the hill in the same direction as Adit-5. Adits-7 and 8 were found in the Western Area of the AUM Site (Figure 4). Adit-7 extends approximately 15 feet into the southern wall of CutLn-3 and adit-8 extends to an unknown depth into the eastern wall of CutLn-3.

Five waste piles were found onsite. Four of the five piles were found in the Northern Area (Figure 5). Two (PileRidge-1 and 2) are associated with CutLn-1, PilePly-3 is associated with ShaftPly-4, and the other (PileRidge-3) is associated with CutLn-2. The remaining waste pile was found in the Western Area (Figure 4). PilePly-4 is associated with CutLn-3. All of the piles are associated with exploration or mining features and consist of waste rock material.

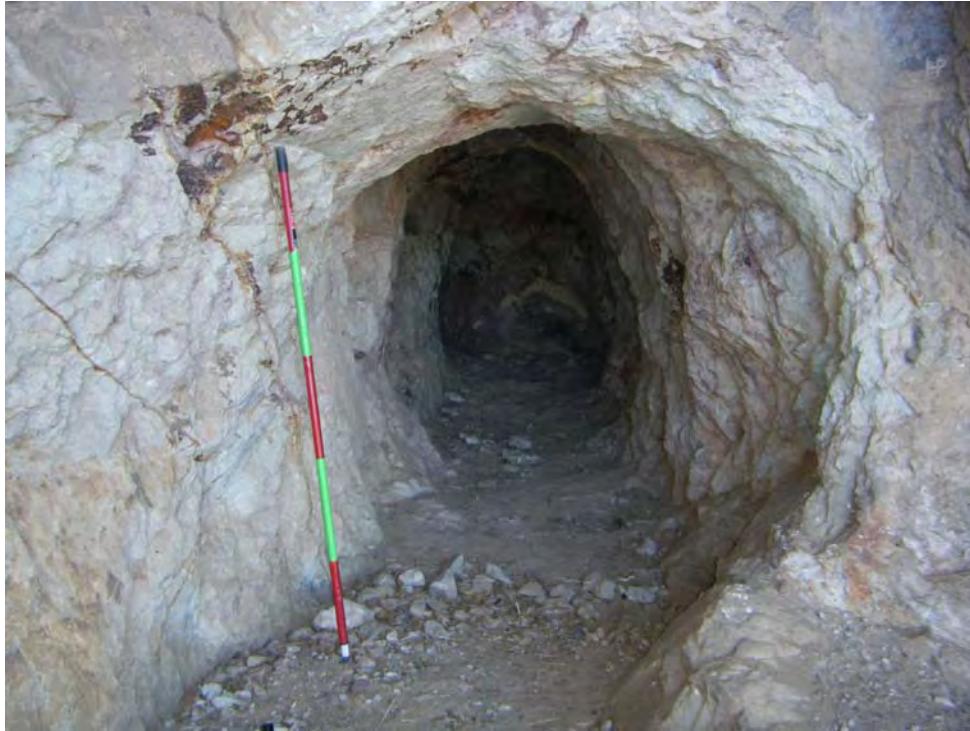
Photo 17-Looking southwest into Adit-1, Eastern Area.

Rad-6 - Adit 1; 0m - 47 uR/h; 1m - 44 uR/h

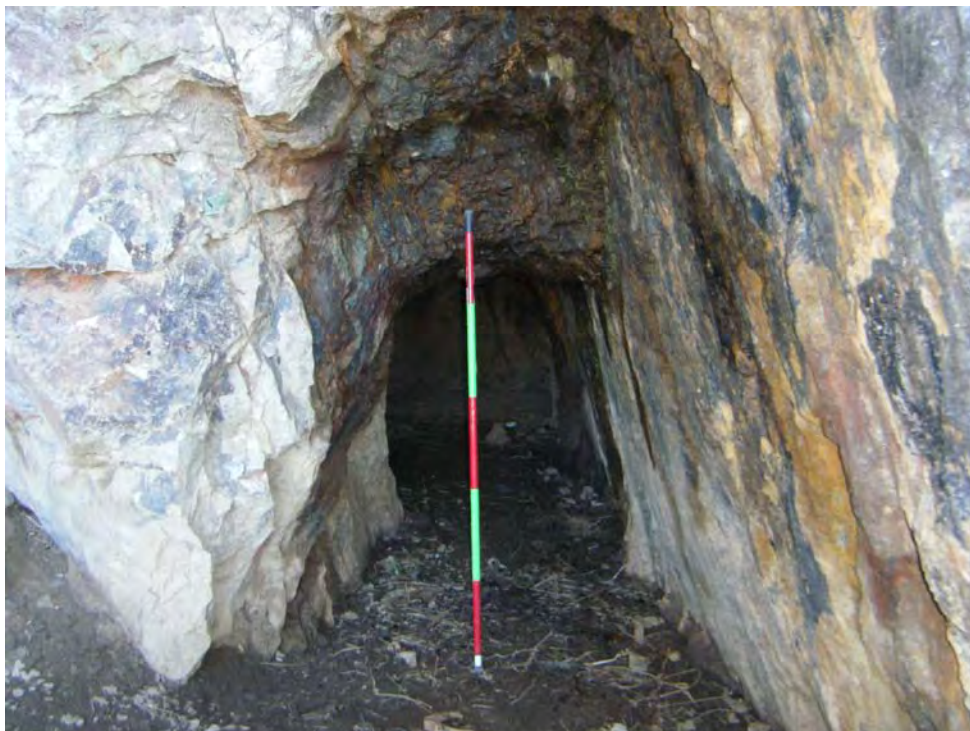
Photo 18-Looking southwest into Adit-2, Eastern Area.

Rad-7 - Adit 2; 0m - 40 uR/h; 1m - 38 uR/h

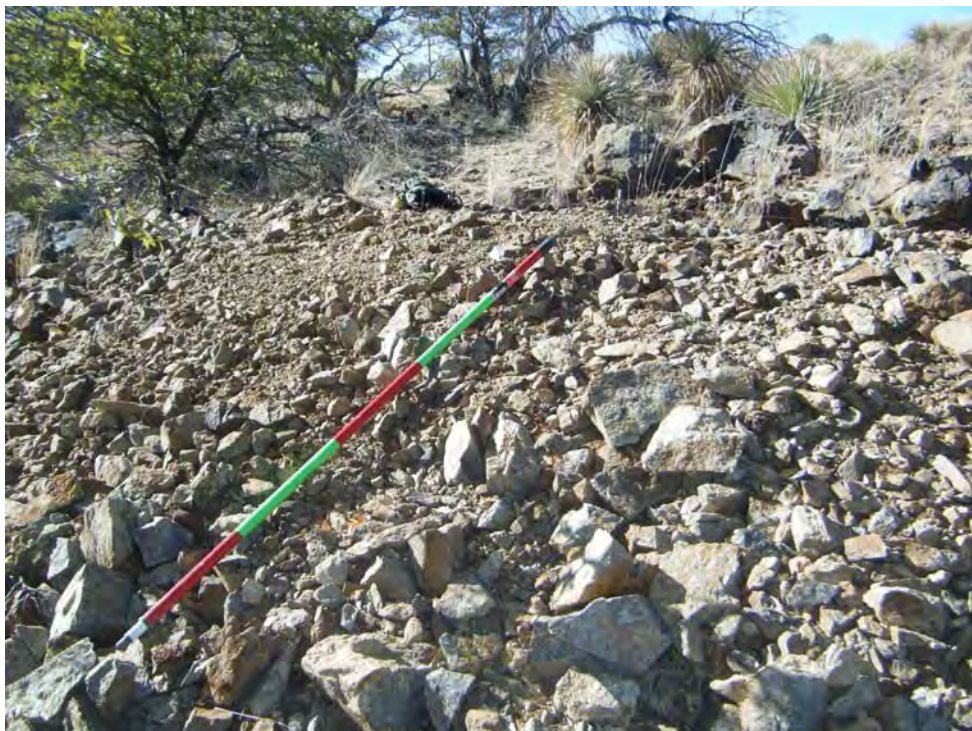
Photo 22-Looking north at PilePly-3, Northern Area.

Pile Ply-3 - near shaft Ply 4; 3' high; 10' wide, 15' long

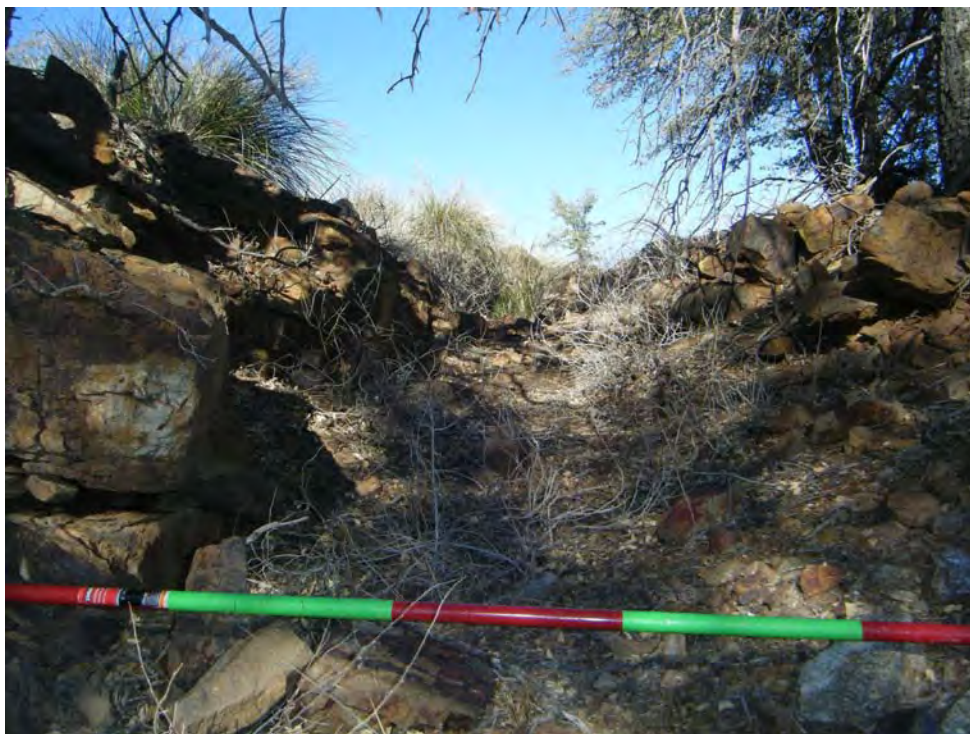
Photo 31-Looking east up CunLn-1, Northern Area.

exploration pit located northwest of the open cut in the Western Area. CutLn-1 and 2 were found in the Northern Area of the AUM Site (Figure 5). CutLn-1 is a long, narrow cut on the top of the ridge and CutLn-2 is located approximately 60 feet northwest of collapsed Adit-3.

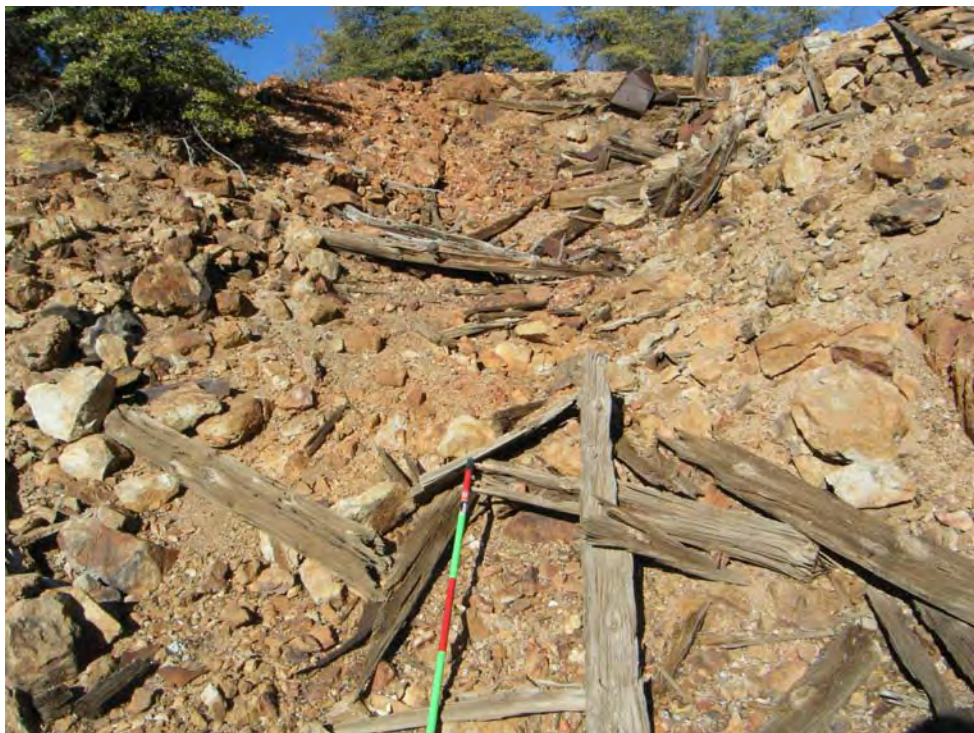
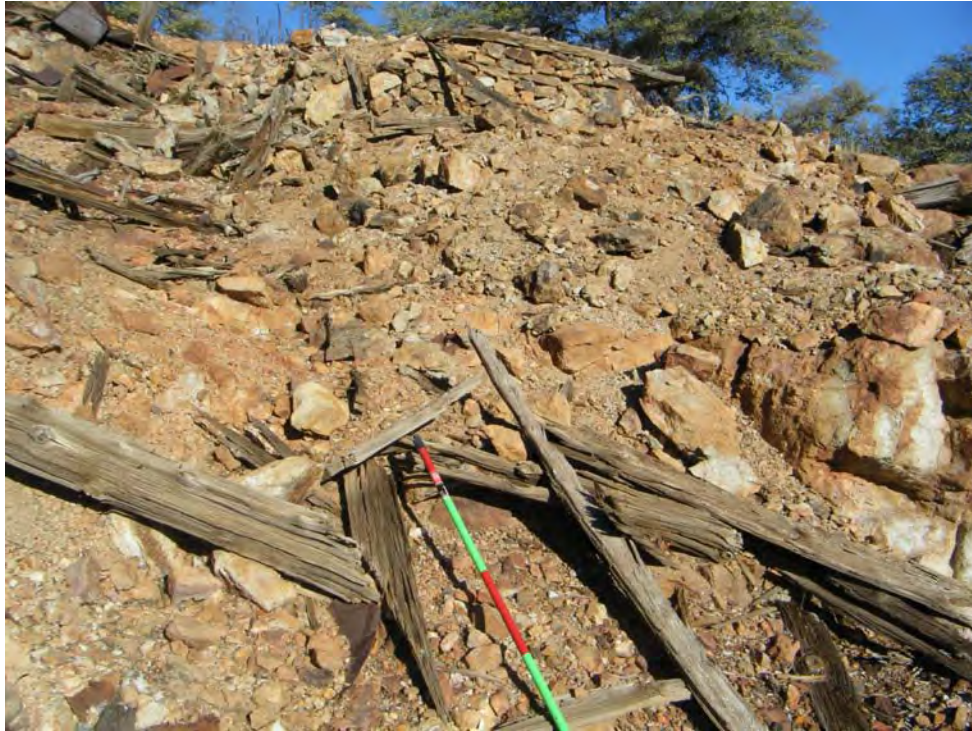
Photo 38-Looking east at collapsed Adit-3, Northern Area.

Photo 39- Looking east at collapsed Adit-3, Northern Area.

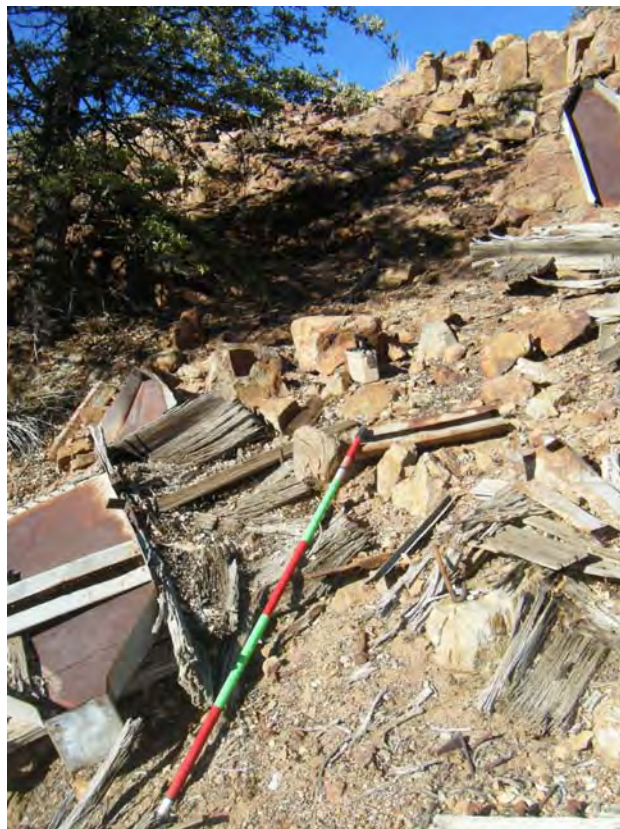
Photo 40-Looking east at sluice boxes (Equip-2), Northern Area.

One loadout feature consisting of a ramp (Loadply-1) and timber was found at the entrance to Adit-3 in the Northern Area (see Photo 41). A number of metal sluice boxes (Equip-1) were found near Adit-3 in the Northern Area of the AUM Site.

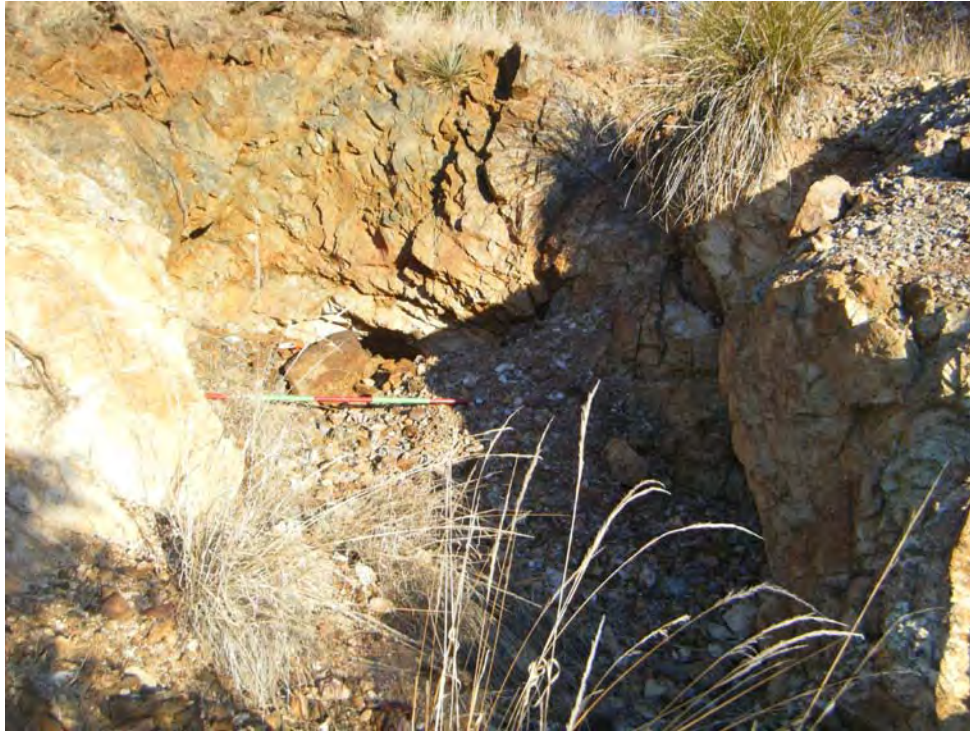
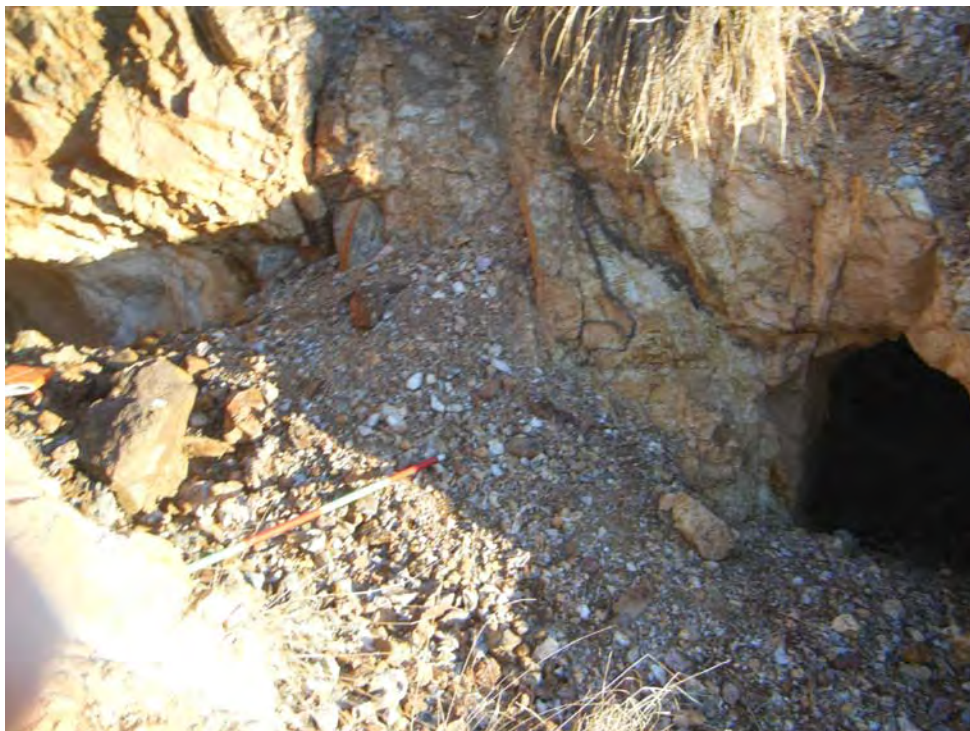
Photo 52-Looking east at CutLn-3, Western Area.

Photo 53-Looking southeast at CutLn-3, Western Area.
