Abandoned Uranium Mine Site Assessment for the Bel Aro Site (NM0174)

FINAL REPORT

INTERA Incorporated (INTERA) has prepared this Abandoned Uranium Mine (AUM) Site Assessment Report for the Mining and Minerals Division (MMD) of the New Mexico Energy, Minerals and Natural Resources Department (EMNRD) in compliance with the Professional Service Agreement dated November 2, 2009. INTERA visited the Bel Aro Site (AUM Site), MMD ID: NM0174, on March 10, 2010.

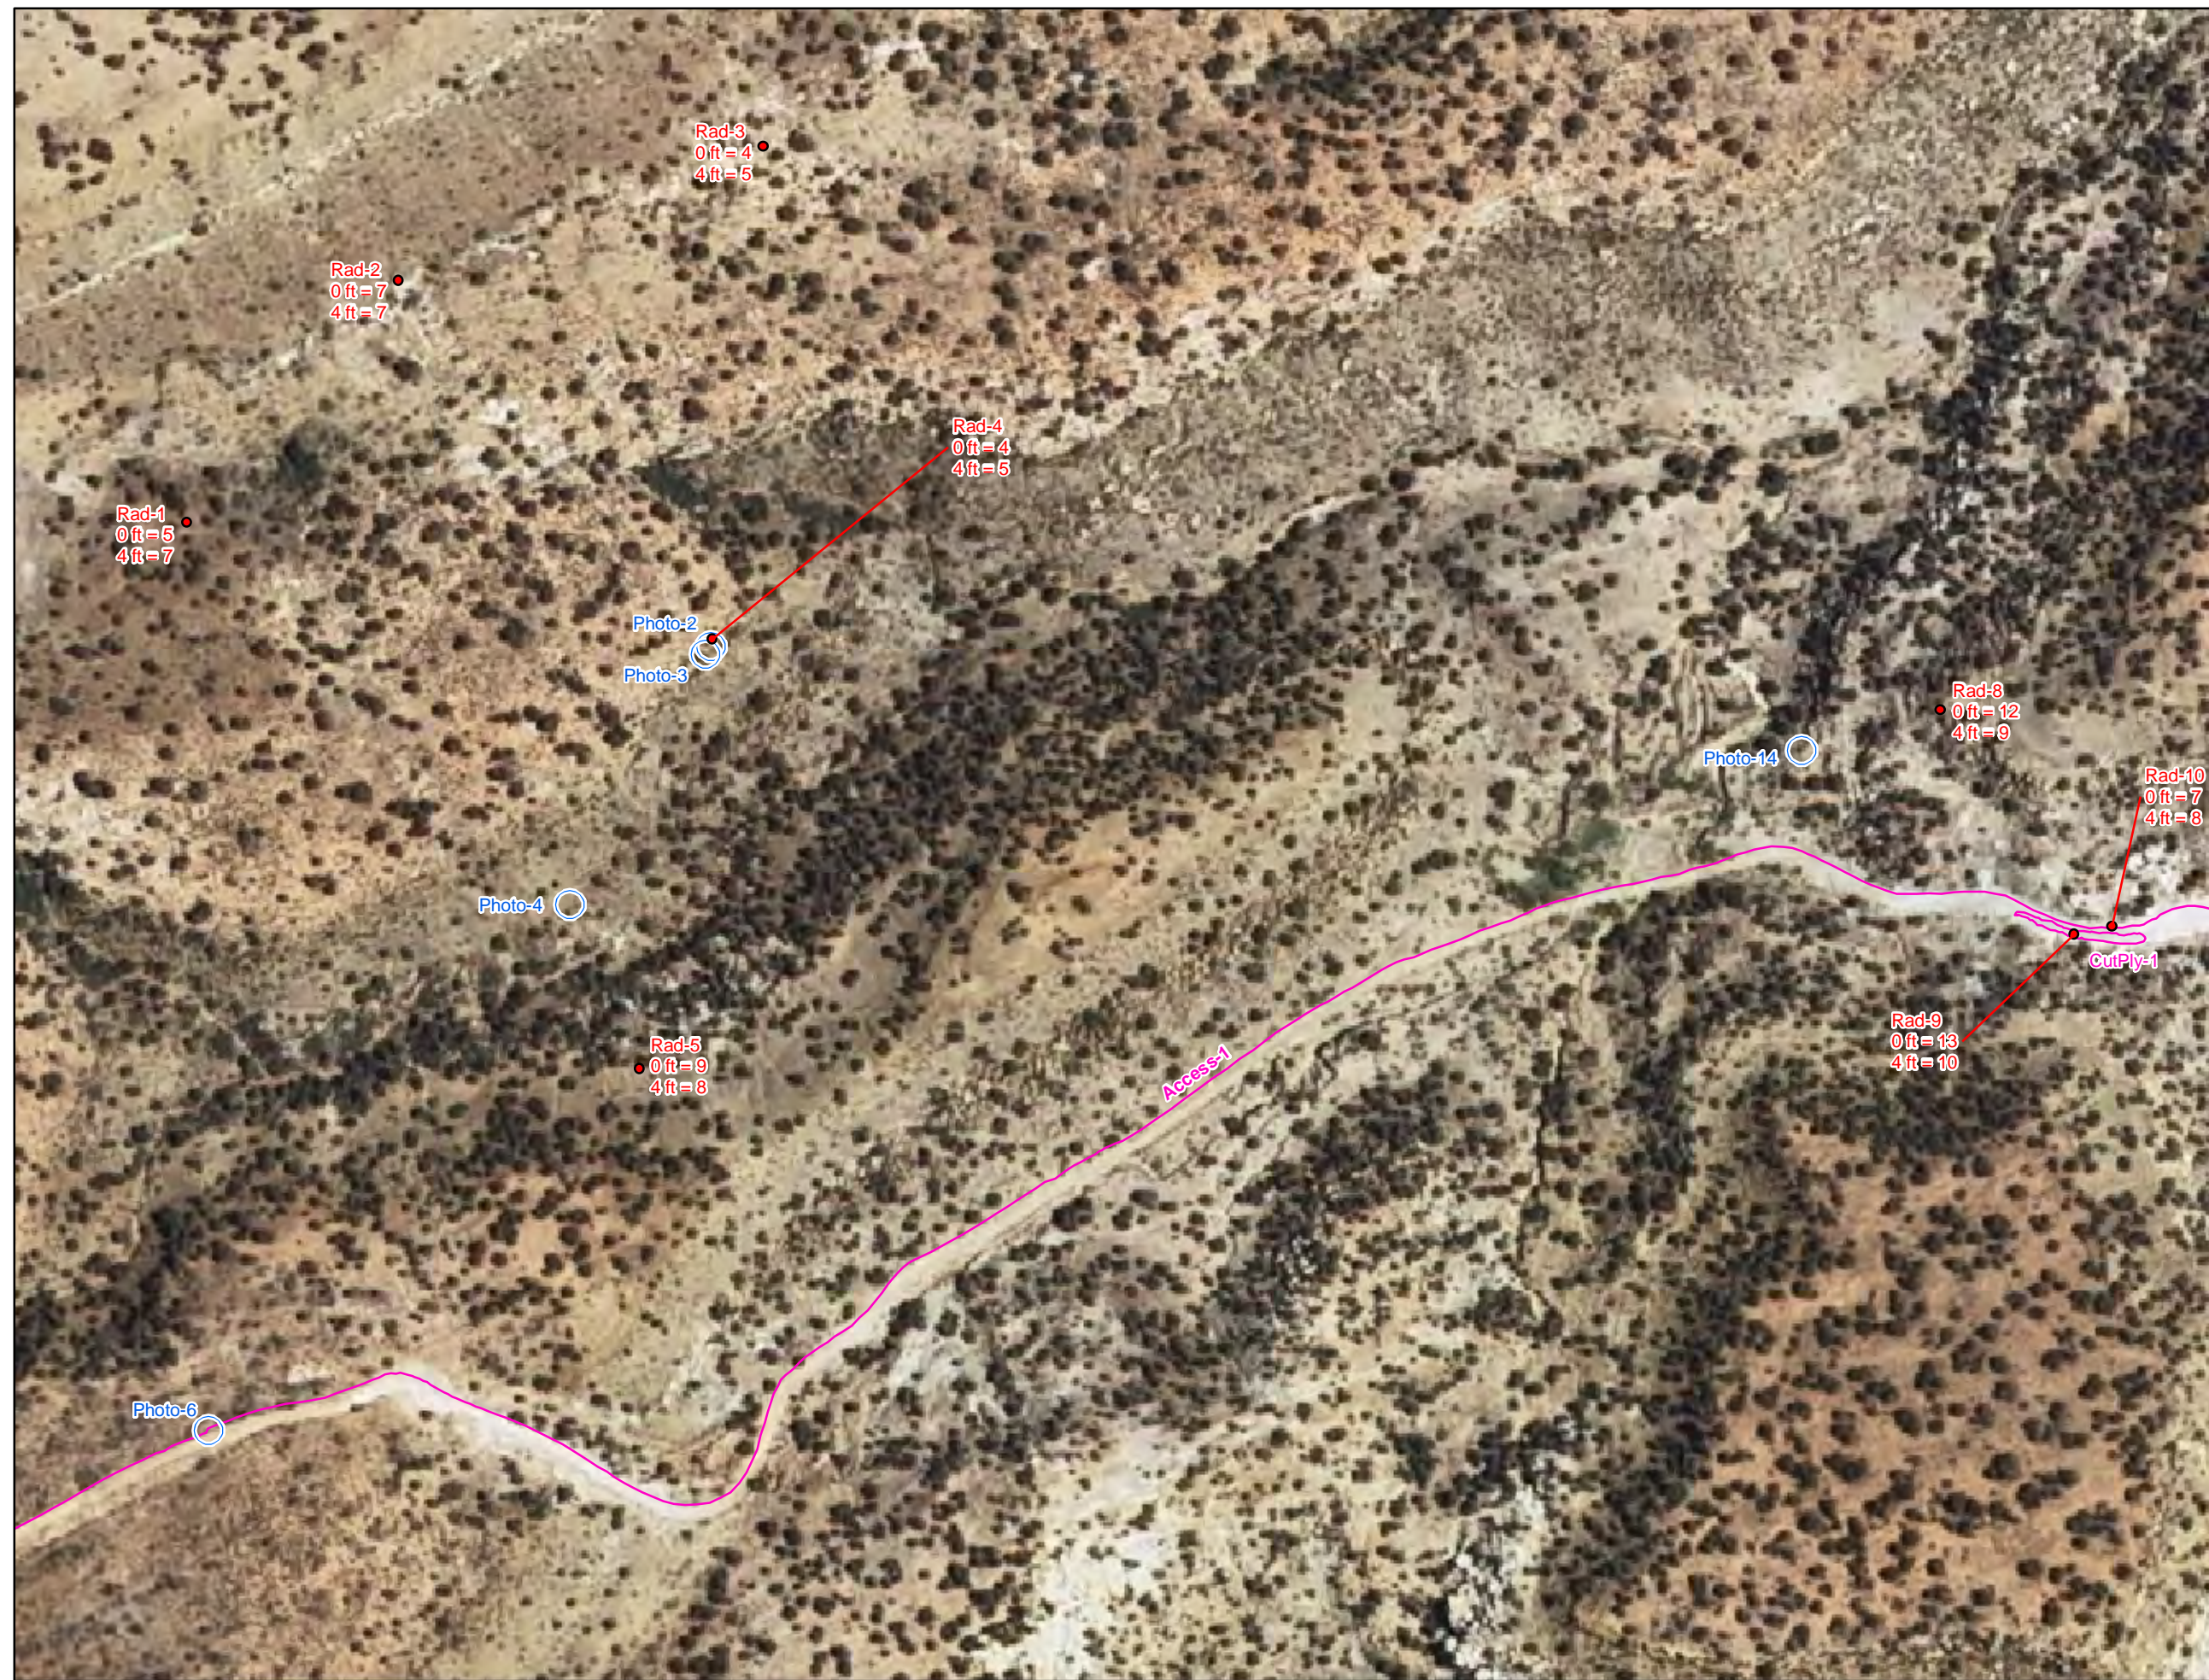
Figure 4a
Site Map on
Aerial Photo
NM0174-Bel Aro
 Abandoned Uranium
 Mine Assessment

The mine features described below are based on the features provided to INTERA by MMD in the GIS Data Dictionary (MMD, 2009). INTERA marked the locations of the AUM Site features using a Trimble Global Positioning System (GPS), and entered details about the features into the GPS using the MMD data dictionary. One open cut and one road were found onsite. In addition, a possible equipment staging area was seen on private land just offsite. Please see the Photo Log in Appendix A, Table 1 for a list of AUM Site features, and Figures 4a and 4b for the locations of the AUM Site features.

One background gamma radiation reading was taken at the AUM Site, recording 9 $\mu\text{R/hr}$ at contact and 9 $\mu\text{R/hr}$ at 4 ft above ground. Please see Table 2 for all of the gamma radiation readings taken at the AUM Site and Figures 4a and 4b for the locations of the radiation readings.

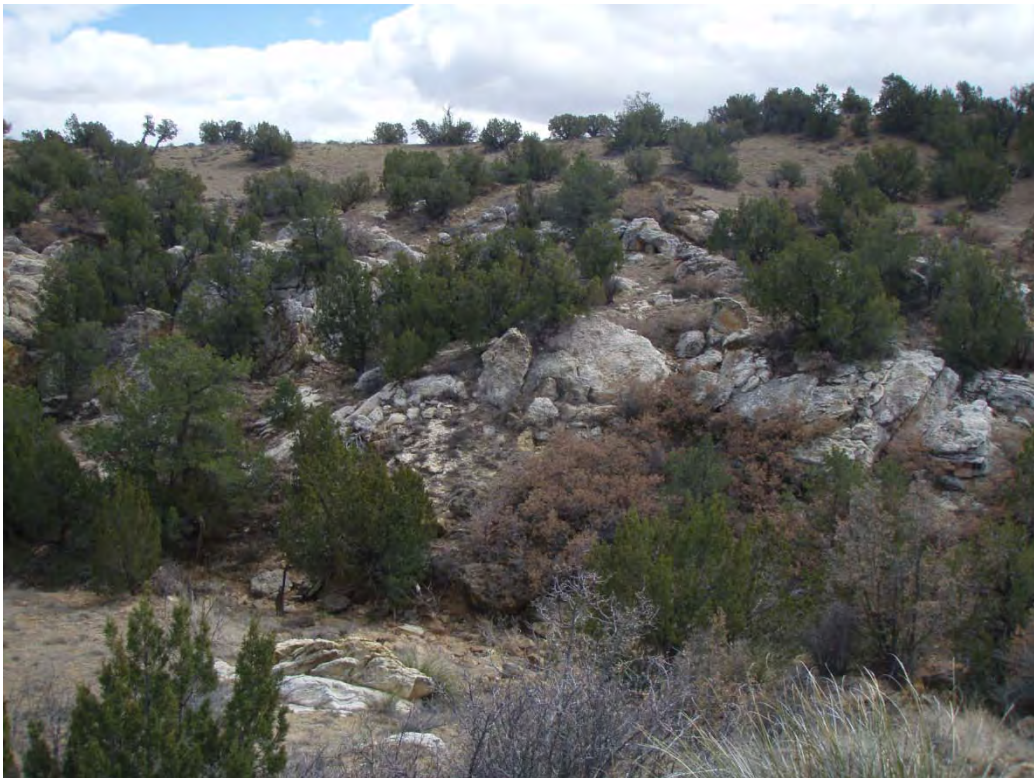
Photo 4-Looking south at an outcrop of white, crossbedded sandstone.

White Rock is fine grain, well sorted,
very little matrix, rounded

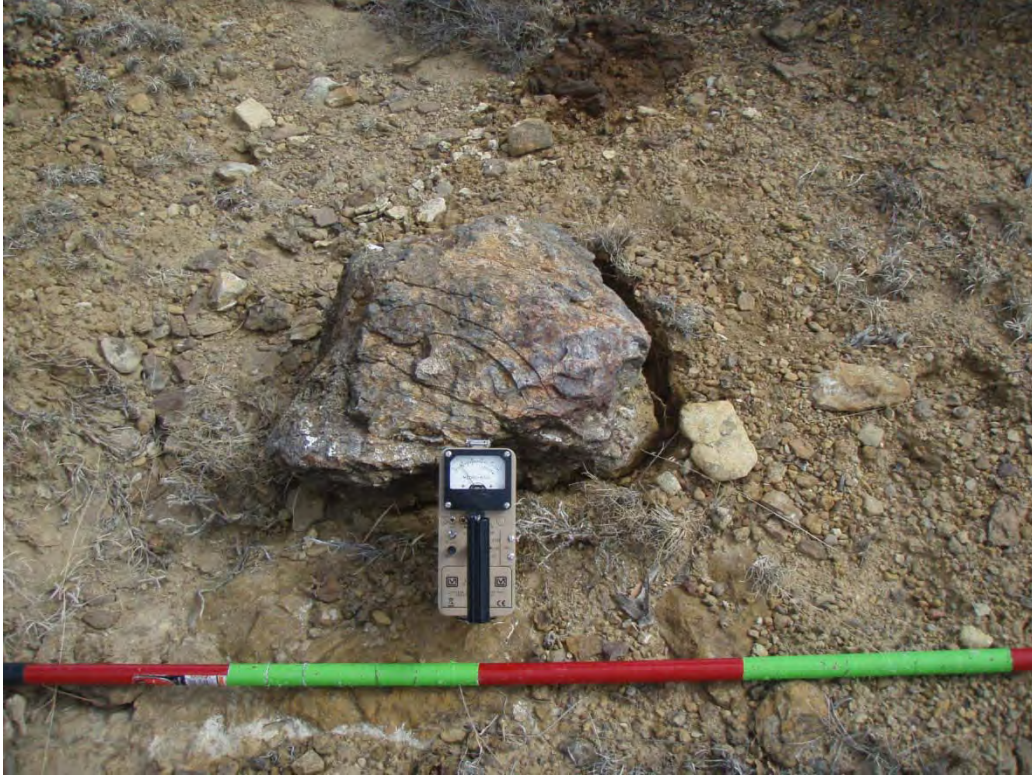
Numerous Cretaceous clam and oyster fossils and a large fragment of petrified wood were found at radiation survey point 5 (see Photo 5 in Appendix A). Organic material was found in a road cut (see Photo 20 in Appendix A). However, the petrified wood and organic material did not have radiation levels above background.

The maximum gamma radiation reading for the AUM Site was 13 $\mu\text{R/hr}$ at contact at radiation survey point Rad-9. This reading was taken inside an open cut (CutPly-1). A radiation survey point was also taken on a boulder of petrified wood, reporting 9 $\mu\text{R/hr}$ at contact (Rad-5, see Photo 5 in Appendix A).

Photo 5-A piece of petrified wood at radiation survey point 5 (Rad-5).

Photo 5 - Rad 5, looking SE
petrified wood

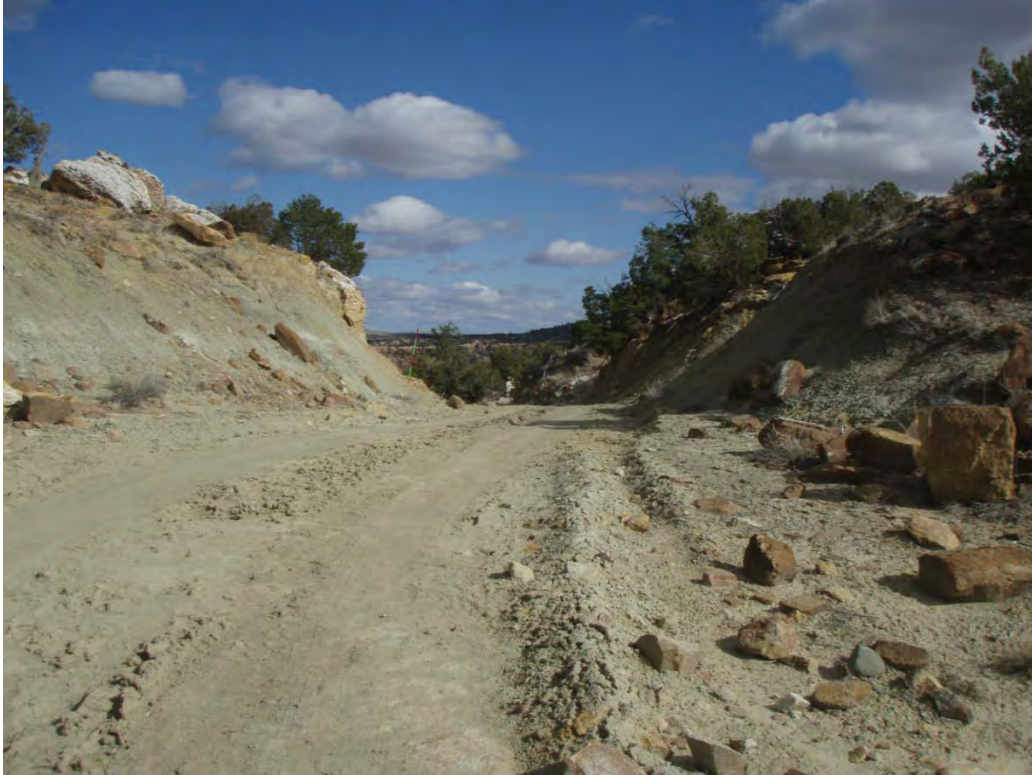
One open cut was found at the AUM Site (CutPly-1). This open cut exposed carbonaceous material in a shale layer of the Morrison Formation, but no anomalous radiation was detected.

Photo 15-Looking east at CutPly-1. The road Access-1 is visible in the foreground.

^{AEA} Photo 15+16 - cutply 1, looking E

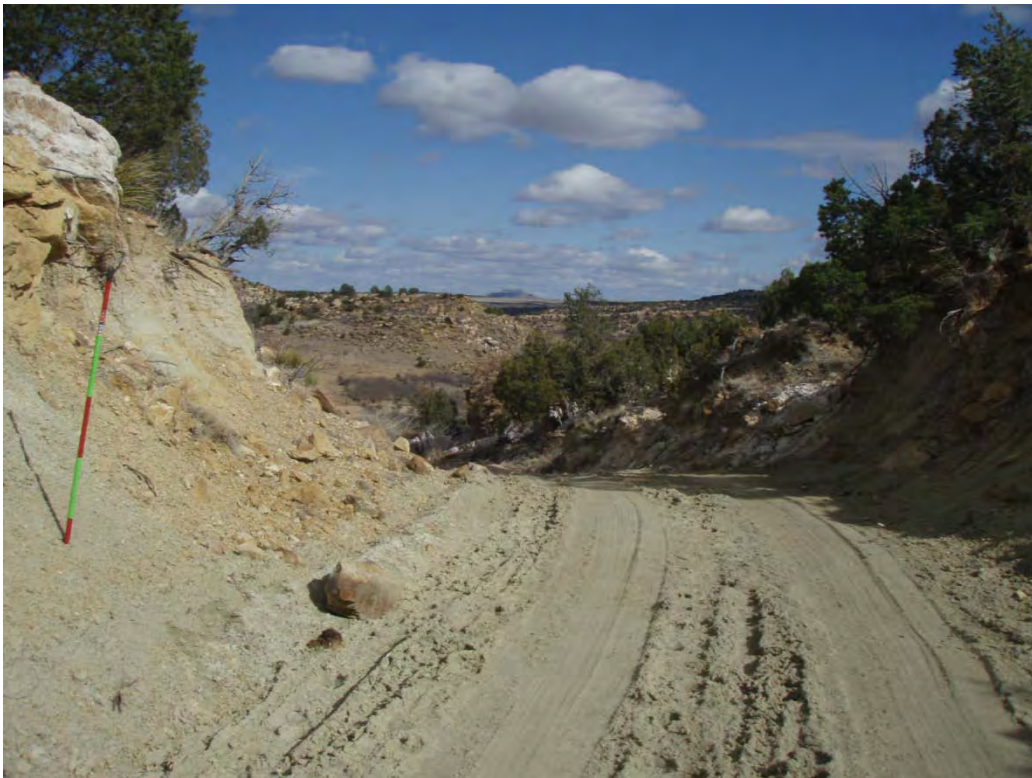
Photo 16-Another view, looking east at CutPly-1. The road Access-1 is visible in the foreground.

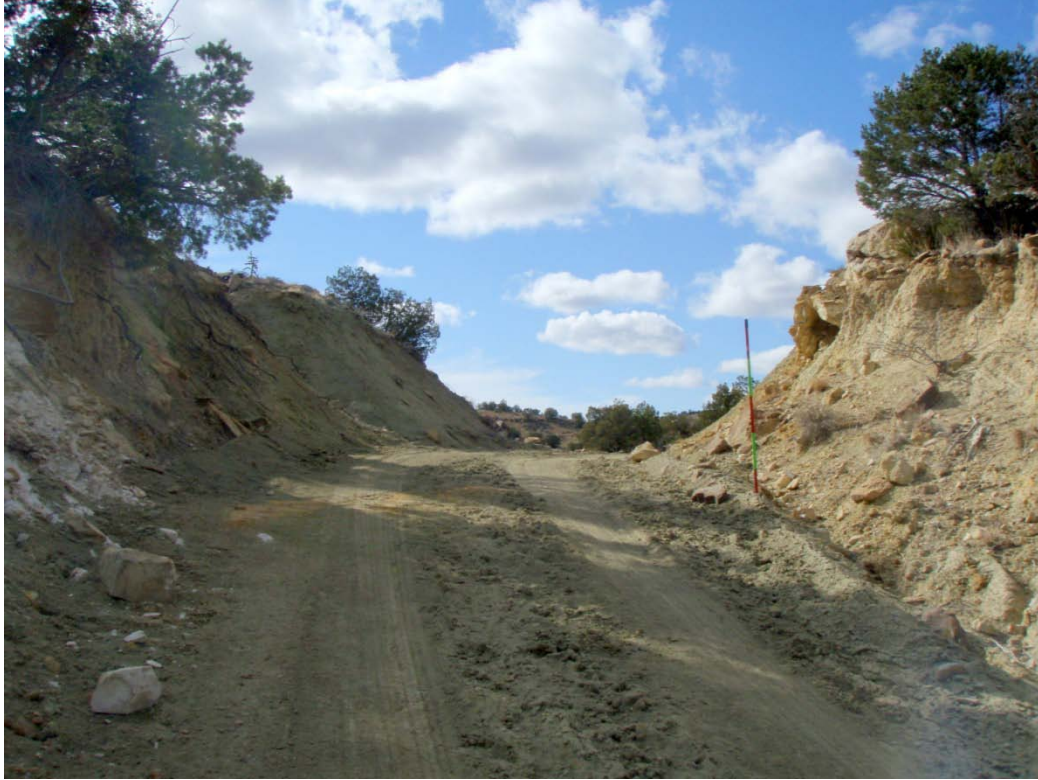
Photo 17-Looking west at CutPly-1. The road Access-1 is visible in the foreground.

Photos 17+18 - cutply 1, looking W

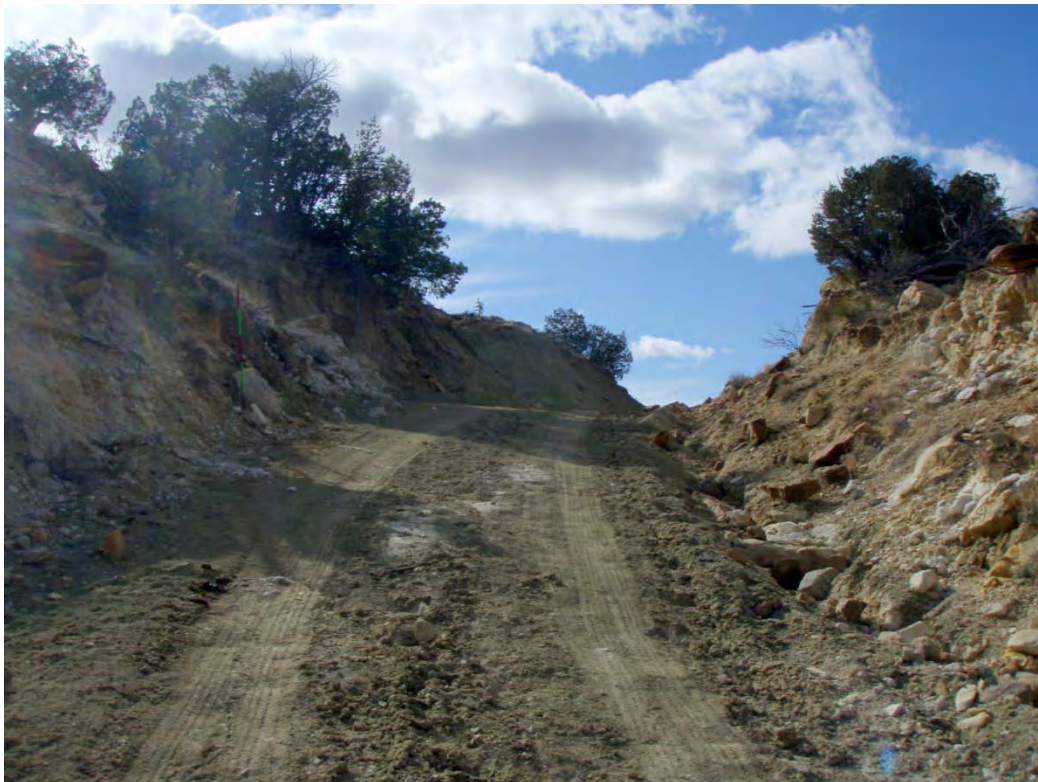
Photo 18-Another view, looking west at CutPly-1. The road Access-1 is visible in the foreground.

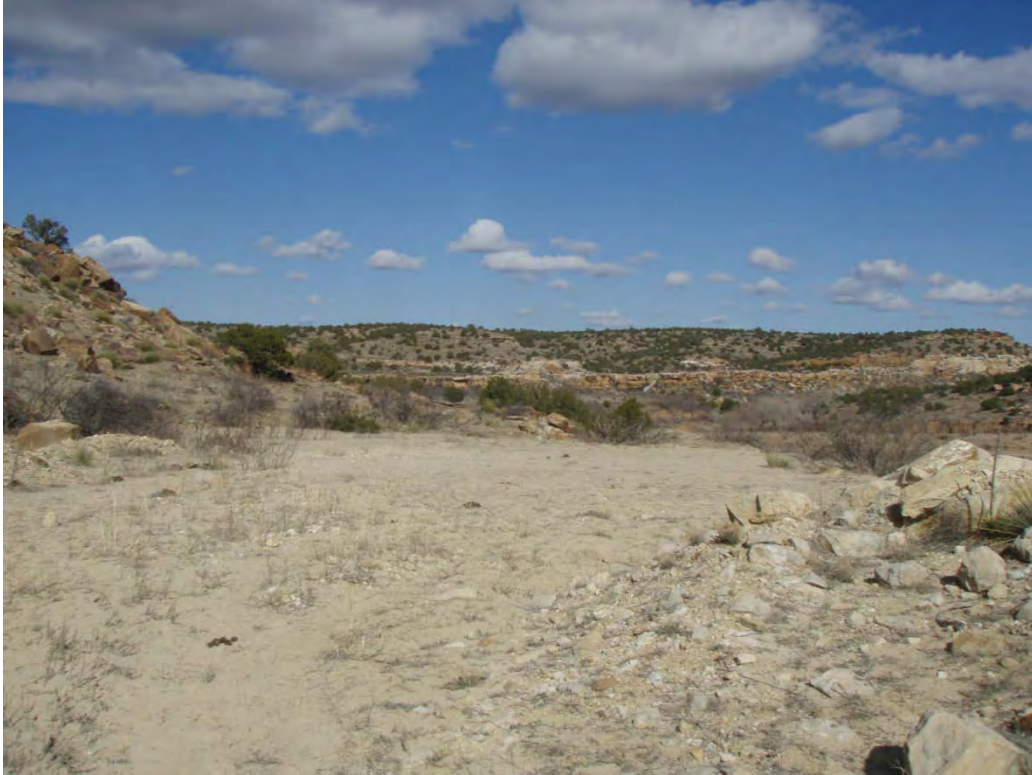
Photo 19-A possible staging area west of CutPly-1. Photo is looking northeast.

Photo 19 - Staging area to the West of
cutply 1, looking NE, but is in
wrong section, so probably not
part of the mine

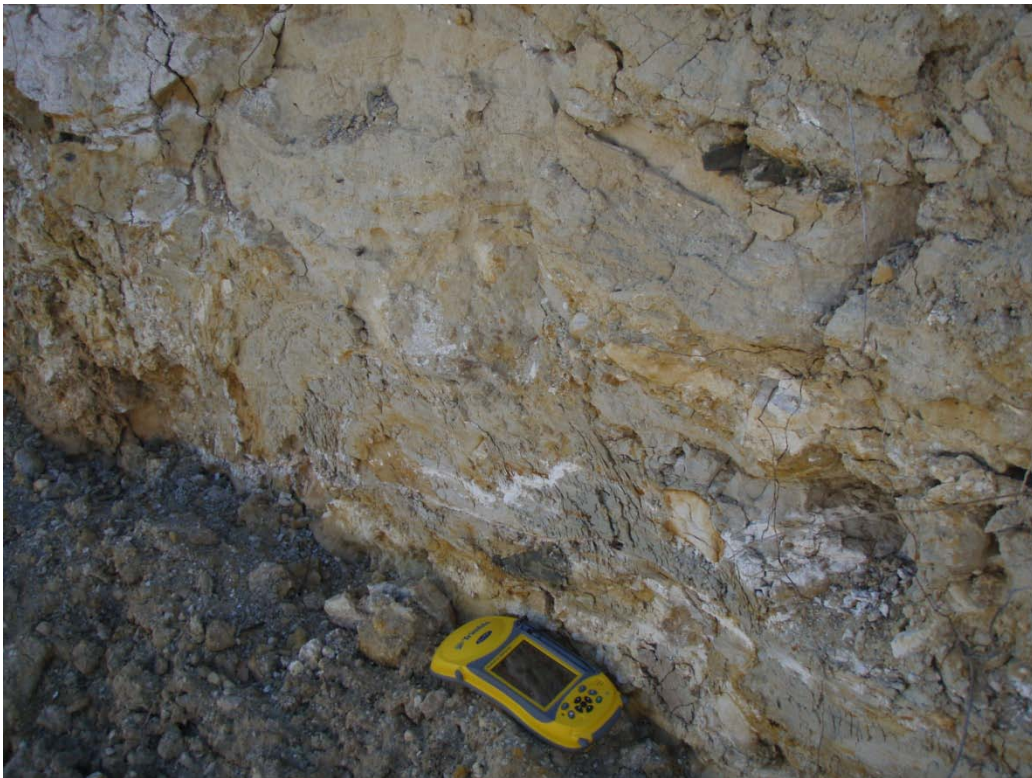
Photo 20-Shale and fossilized organic matter in CutPly-1.

We suspect that cutply 1 may have originally
been the mine prospect, and that they
removed all economic material already.
McEmore refers to "fossilized logs" as the
ore material, small pieces of fossilized wood
are noted inside the cut.

Photo 20 - Fossilized wood in cutply 1
