# Abandoned Uranium Mine Site Assessment for the Glory and Empire Site (NM0246)

**FINAL REPORT**

**February 23, 2010**

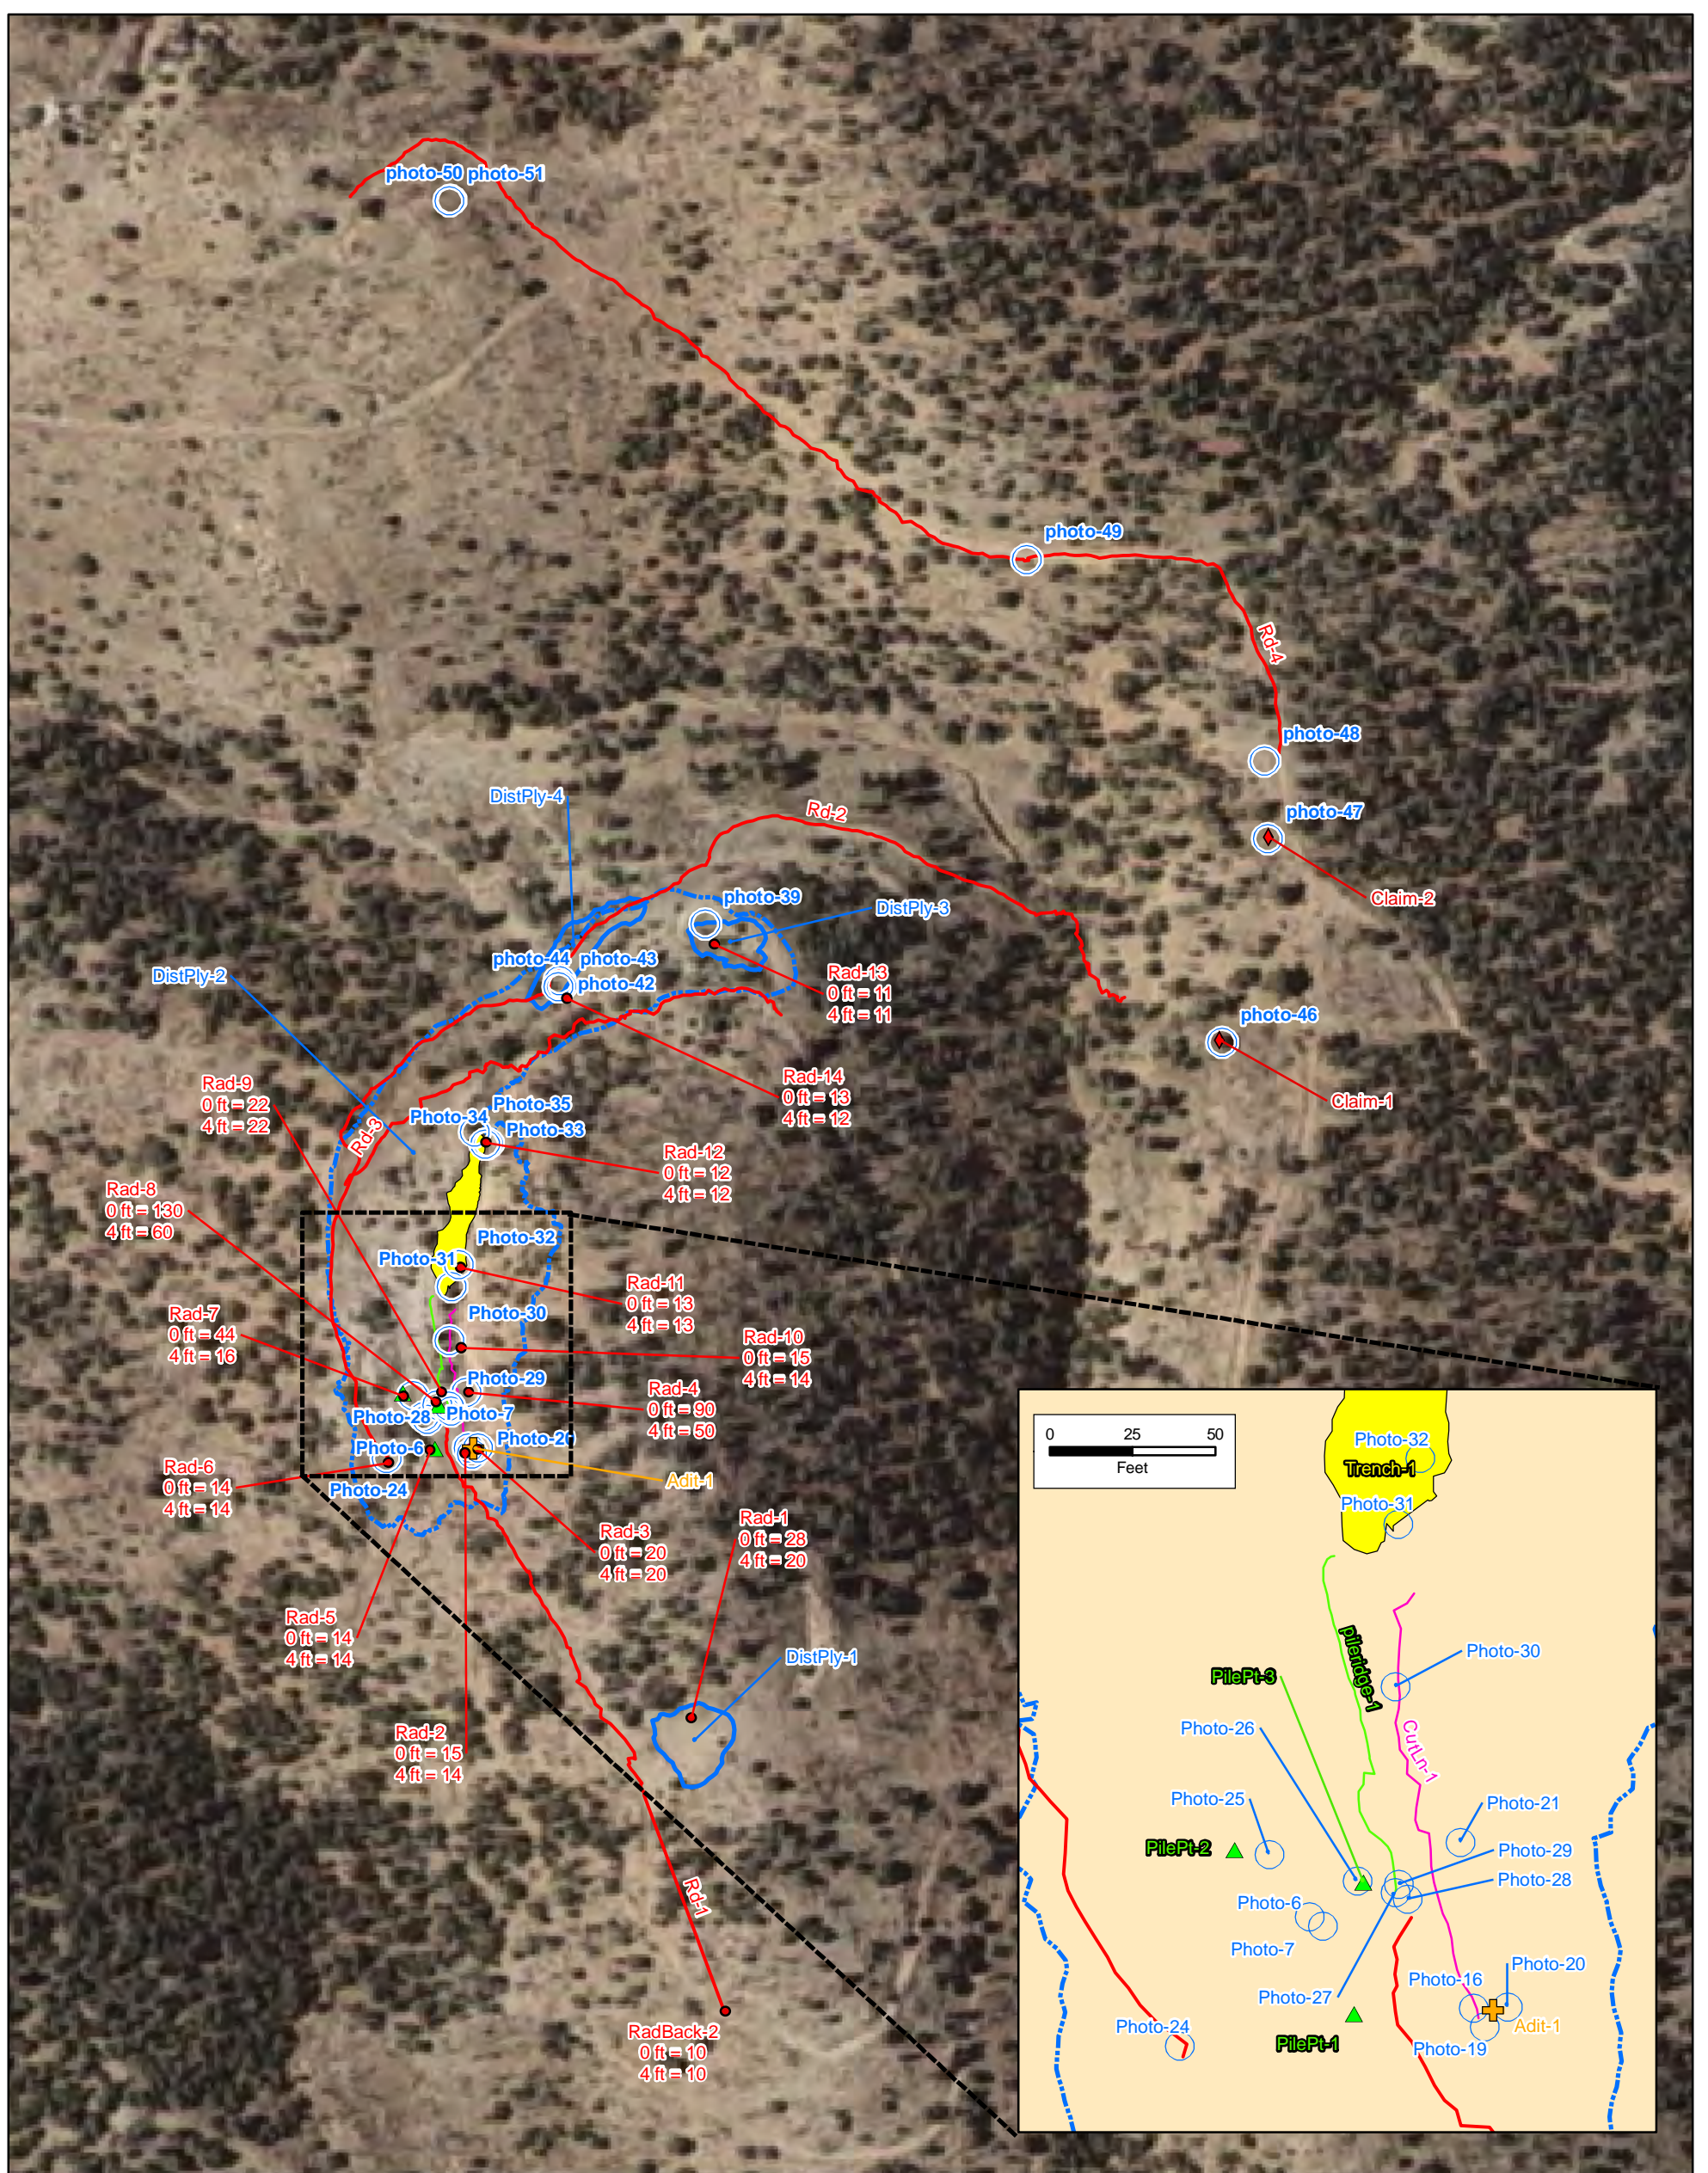
**Figure 4a**  
**Site Map on Aerial Photo**  
**NM0246-Glory and Empire**  
 Abandoned Uranium  
 Mine Assessment

The mine features described below are based on the features provided to INTERA by MMD in the GIS Data Dictionary (MMD, 2009). INTERA marked the locations of the AUM Site features using a Trimble Global Positioning System (GPS), and entered details about the features into the GPS using the MMD data dictionary. Please see the Photo Log in Appendix A, Table 1 for a list of AUM Site features, and Figures 4a and 4b for the locations of the AUM Site features.

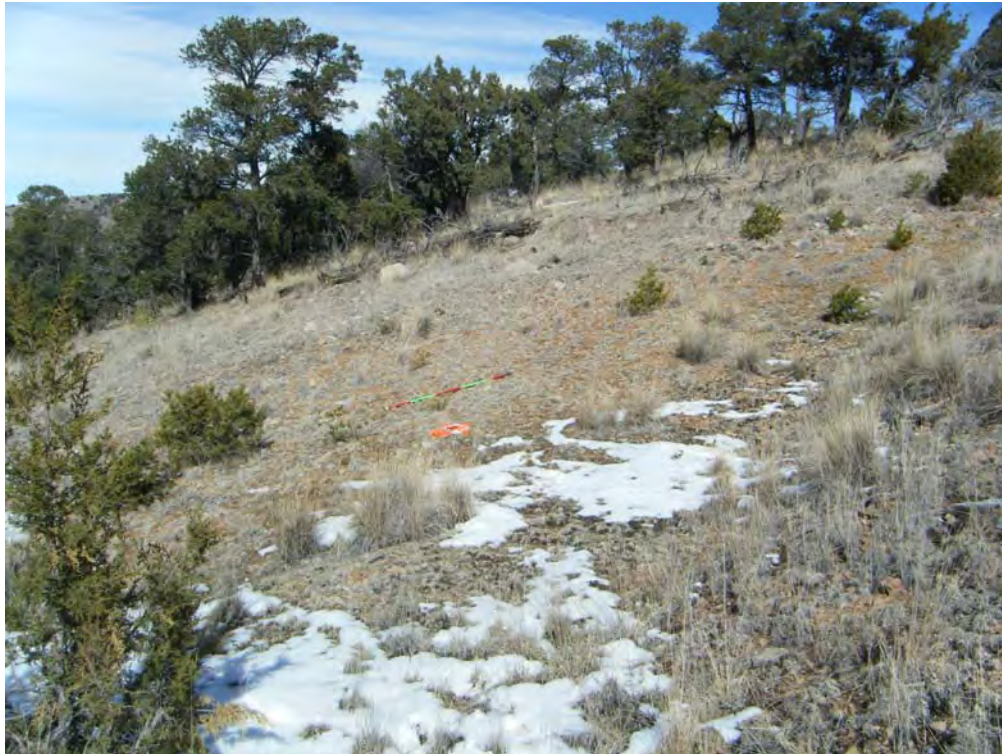
Photo 4 – View of DistPly-1, looking west.

Dist Ply-1 - 36ft x 56ft on west slope of hill

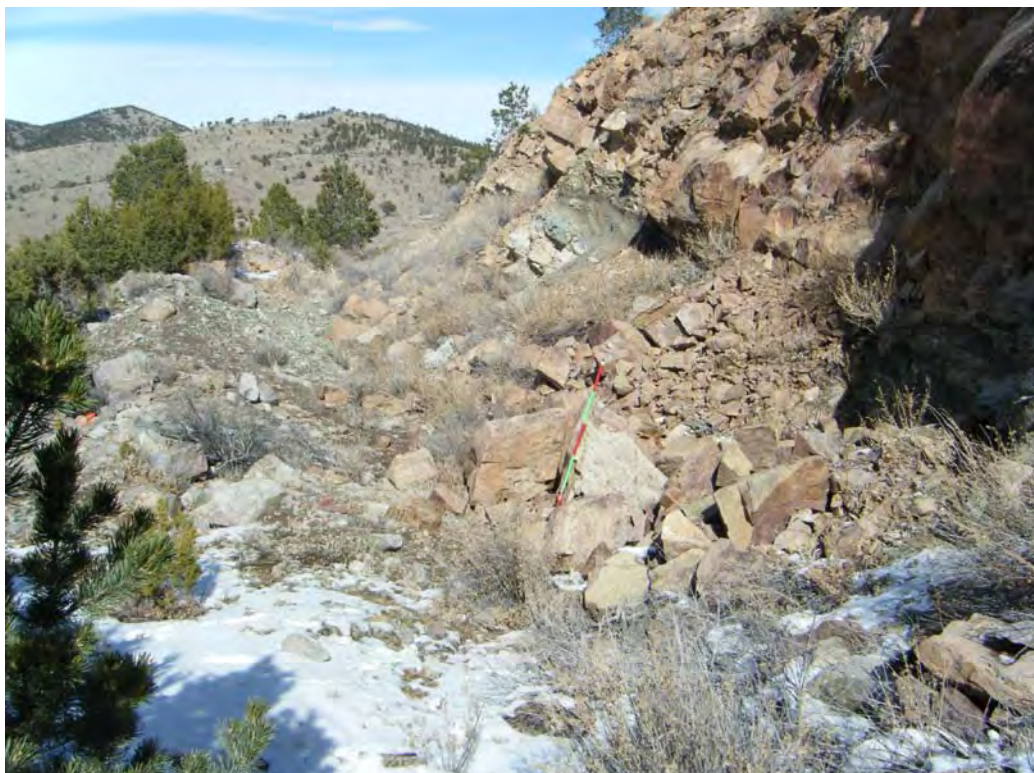
Photo 16 – Looking north along CutLn-1.

One open cut (CutLn-1) and one trench (Trench-1) were found at the AUM Site. This large open cut trends north to south along the western face of a hill and measures 46 ft by 126 ft. In the face of the open cut, a siltstone with green mineralization was found to have 90  $\mu\text{R/hr}$  (microroentgens per hour, rad-4, photo 21).

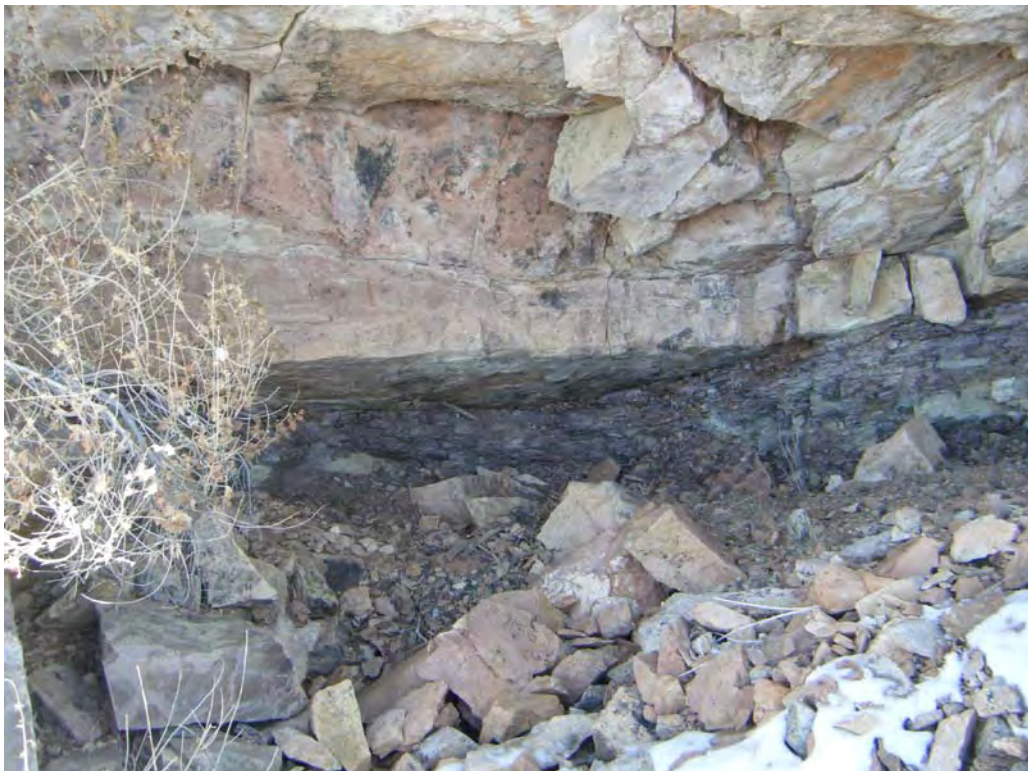
Photo 19 – Adit-1, looking east into slope wall.

One small adit (adit-1) was found at the AUM Site. The adit is 9 ft high, 8 ft wide, and 9 ft deep. It is found at the south end of an open cut (CutLn-1).

Adit 1 - 5ft tall, 9ft deep, 3ft wide; at south end of Cut In 1

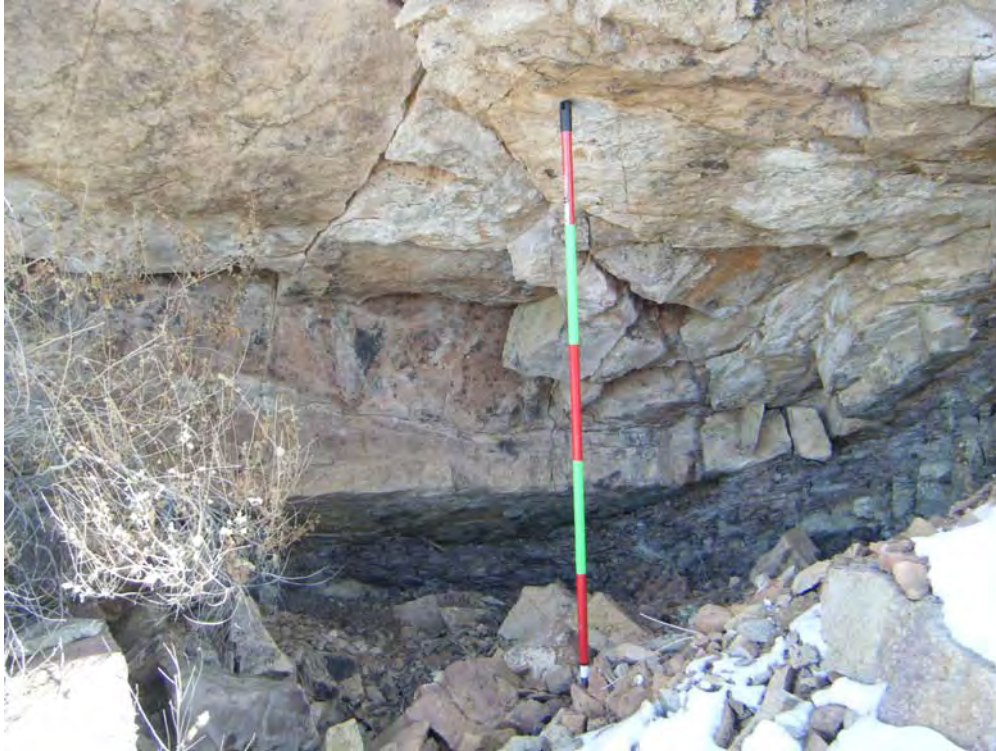
Photo 20 – Adit-1, looking northeast.

Rad 3 - Adit 1; 0ft - 20MR/hr 4ft - 20MR/hr

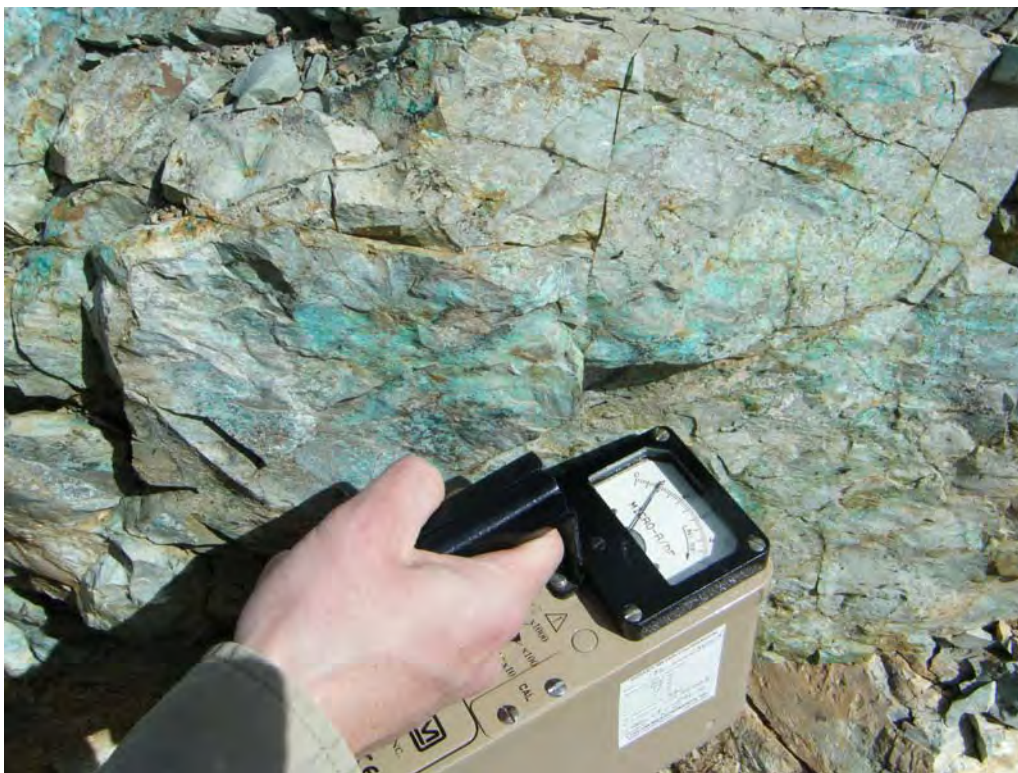
Photo 21 – Taking a radiation measurement at mineralization in CutLn-1 (Rad-4).

The maximum gamma radiation reading for the AUM Site was 130  $\mu\text{R/hr}$  at bedrock contact at point Rad-8 on PilePt-3. Another reading of 90  $\mu\text{R/hr}$  at bedrock contact was recorded on a mineralized siltstone bed inside of CutLn-1 (point Rad-4).

Rad 4 - On vein of siltstone with greenish coloring  
0ft - 90MR/hr, 4ft - 50MR/hr

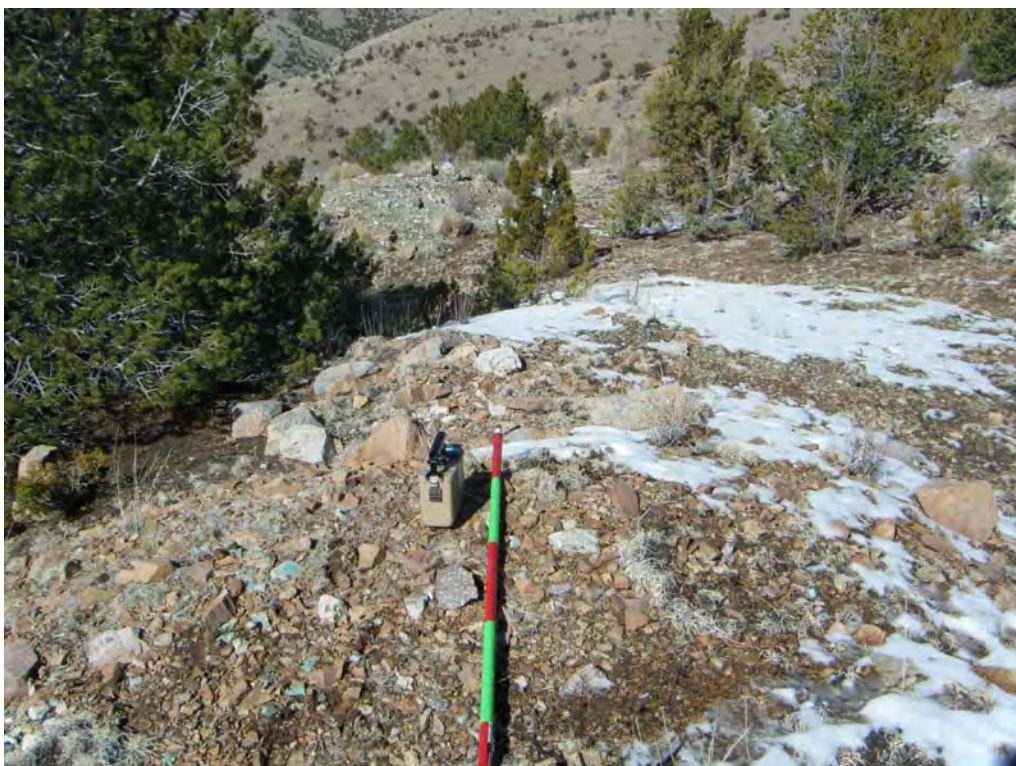
Photo 23 – PilePt-1, looking north.

Rad 5 - at Pile Pt-1 - 0ft - 14MR/hr 4ft - 14MR/hr

Pile Pt 1 - west of cut 1; ~3ft tall, 12' long, 6' wide

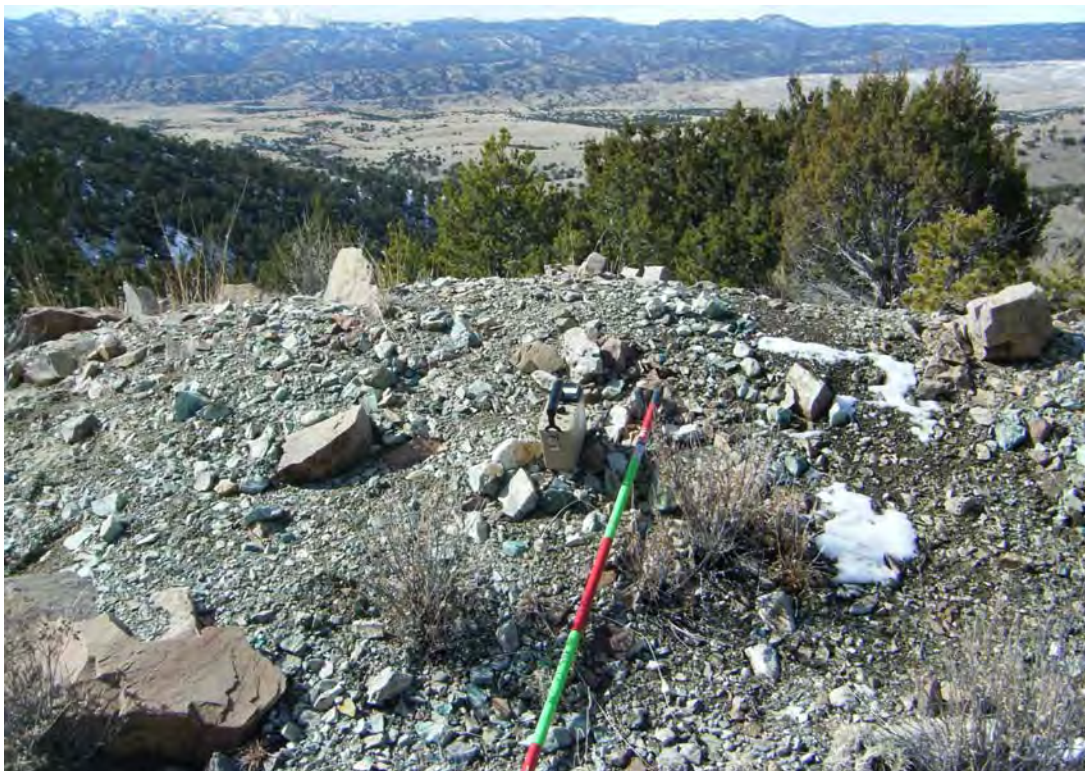
Photo 25 – PilePt-2, looking west.

Pile Pt 2 - south west of cut 1; ~2.5' tall, 16' long, 10' wide

Rad 7 - Pile Pt 2 - 0ft - 44 MR/hr, 4ft - 16 MR/hr

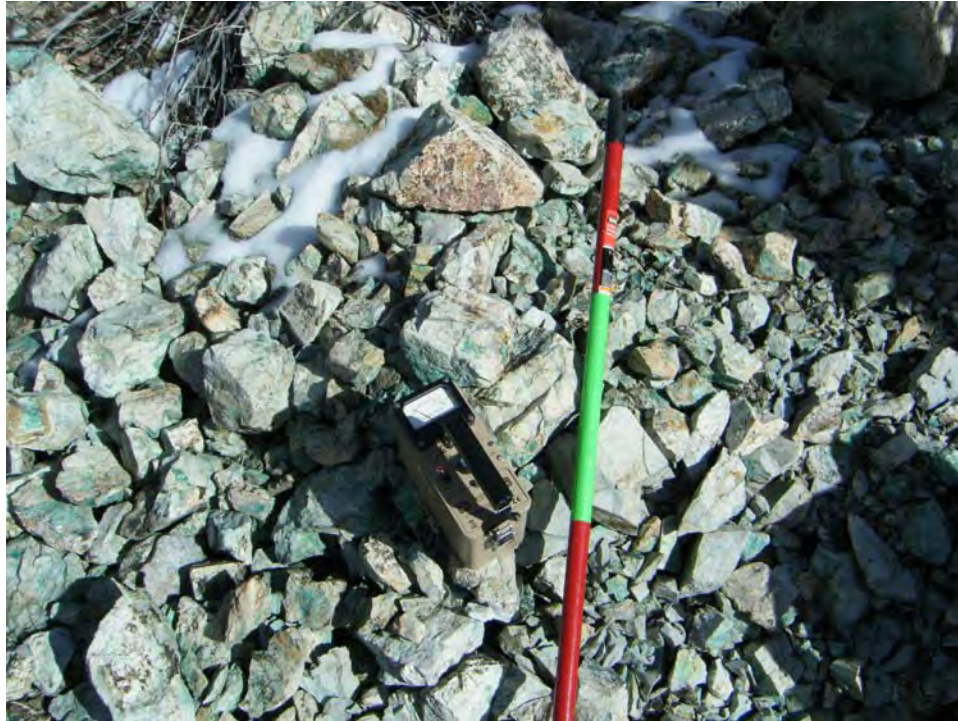
Photo 26 – PilePt-3 and Rad-8 (measured 130  $\mu$ R/hour at contact).

Pile Pt 3 - waste pile of rock found in vein (ore rock)  
1ft tall, 5ft wide, 6ft long

Rad 8 - Pile Pt 3 - 0ft - 130 MR/hr, 4ft - 60 MR/hr

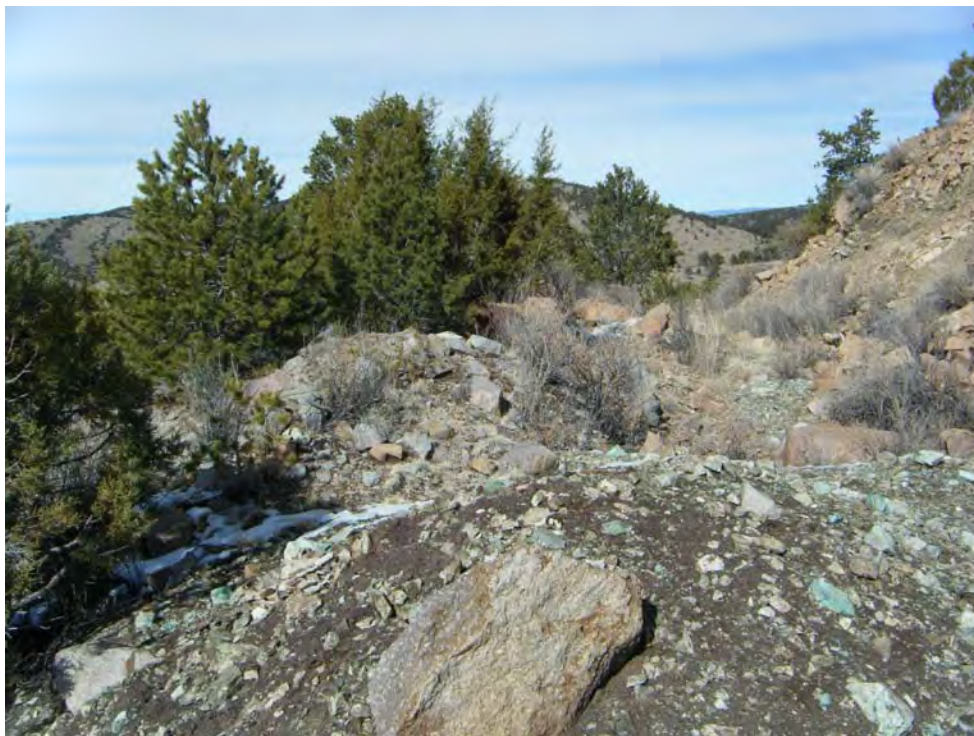
Photo 27 – Looking north along pileridge-1.

The pile ridge (pileridge-1) appears to be material from CutLn-1 that has been pushed back and formed into a small ridge 4-5 feet tall. The three piles (PilePt-1, PilePt-2, and PilePt-3) also appear to be material from CutLn-1. PilePt-3 contains rocks with vivid green mineralization (see Photo 26) and measured 130  $\mu\text{R/hr}$  at contact (Rad-8).

Pile Ridge 1 - linear pile of waste rock ~5-4ft tall  
10-15ft wide

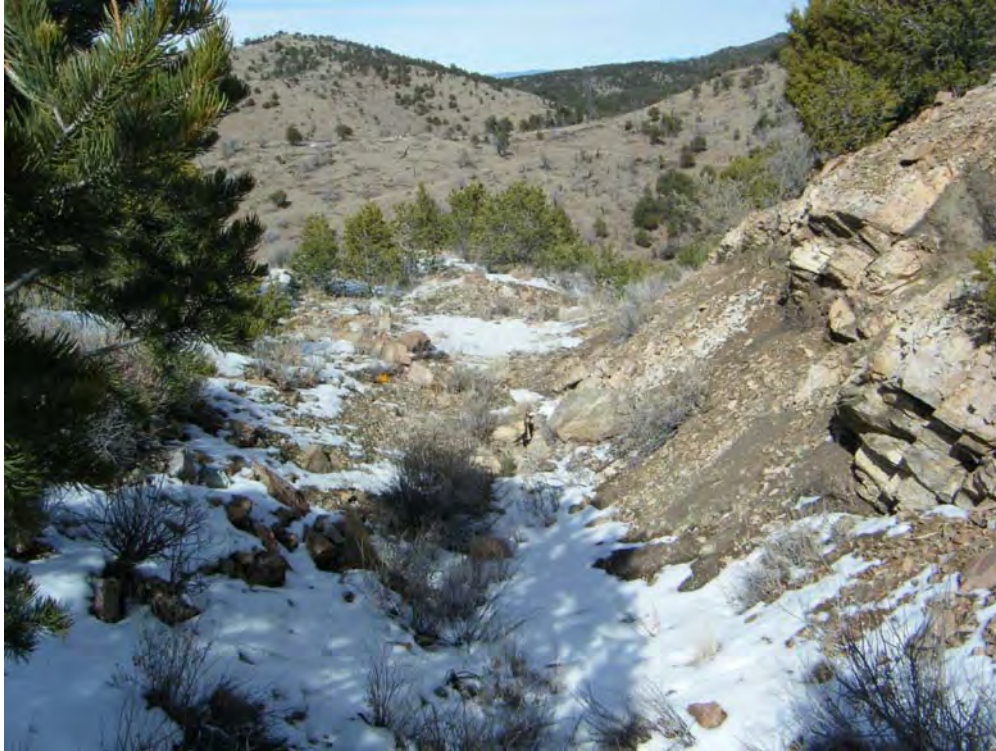
Photo 31 – Looking north along trench-1.

Trench 1 - ~10ft deep north of cut 1

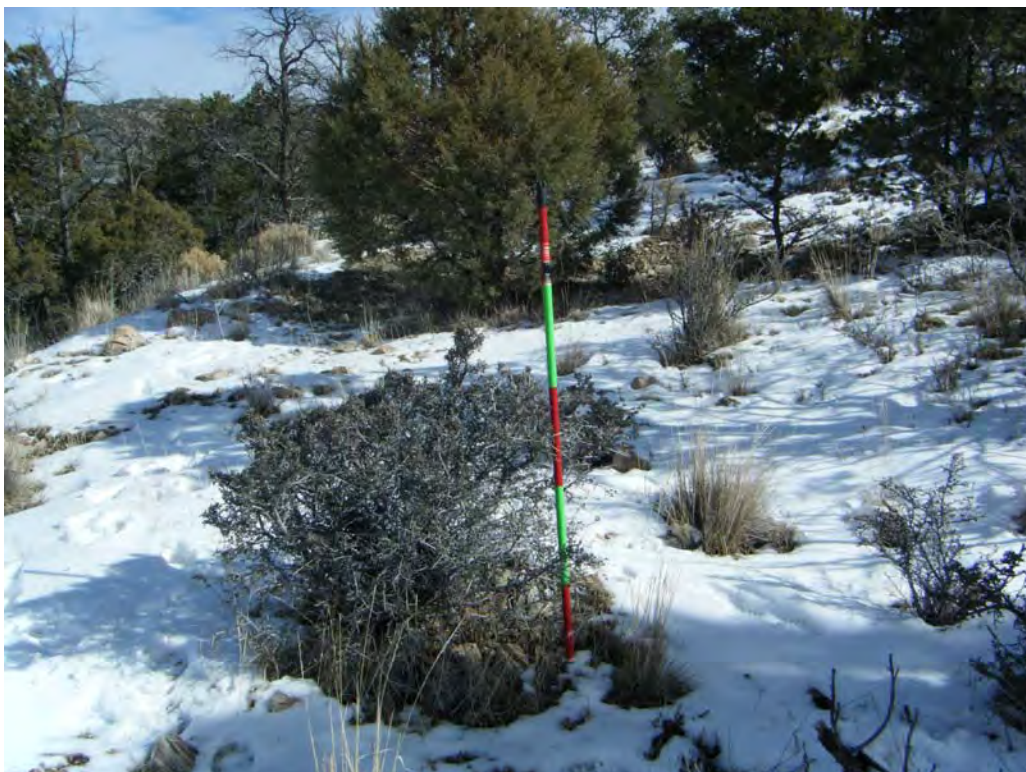
Photo 39 – Looking east at DistPly-3.

Dist Ply 3 - on northeast side of Dist Ply 2 (site boundary) 15ft wide, 50ft long, 10ft deep

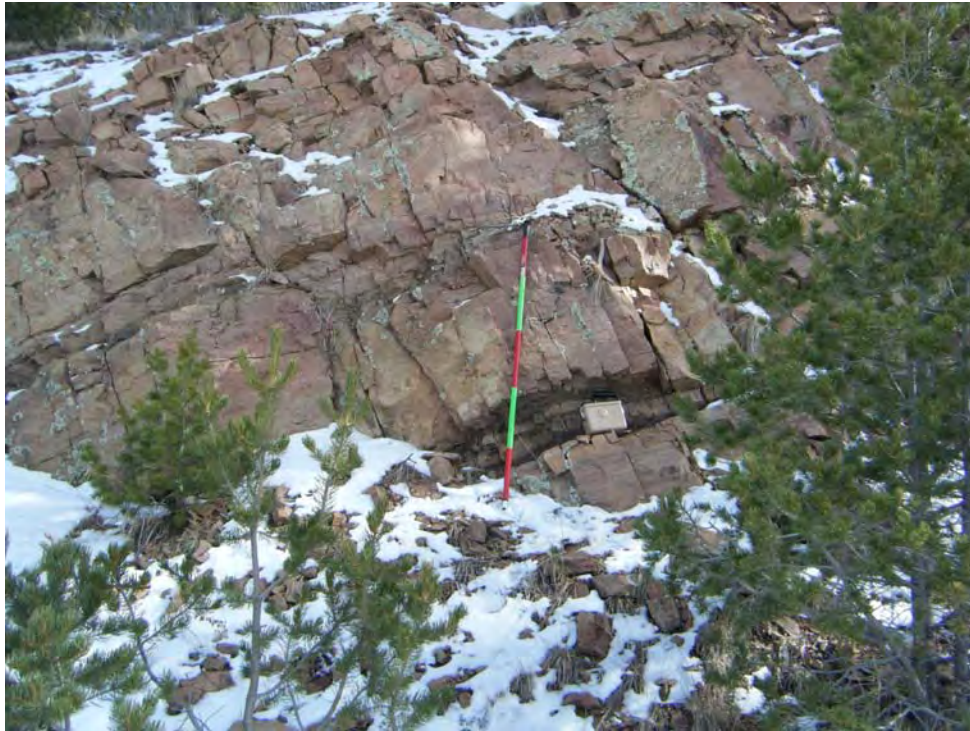
Photo 42 –Rock face in DistPly-4, looking southeast.

Dist Ply 4 - north ~~front~~ <sup>ALT</sup> end of site, along road  
35ft wide, 120ft long  
Rock Face ~ 10-30ft high  
Rock with green mineralization found here also
