# Navajo Abandoned Uranium Mine Site Screen Report

## **Section 34 AUM Site**

### **Navajo AUM Eastern Region**

**May 2009**

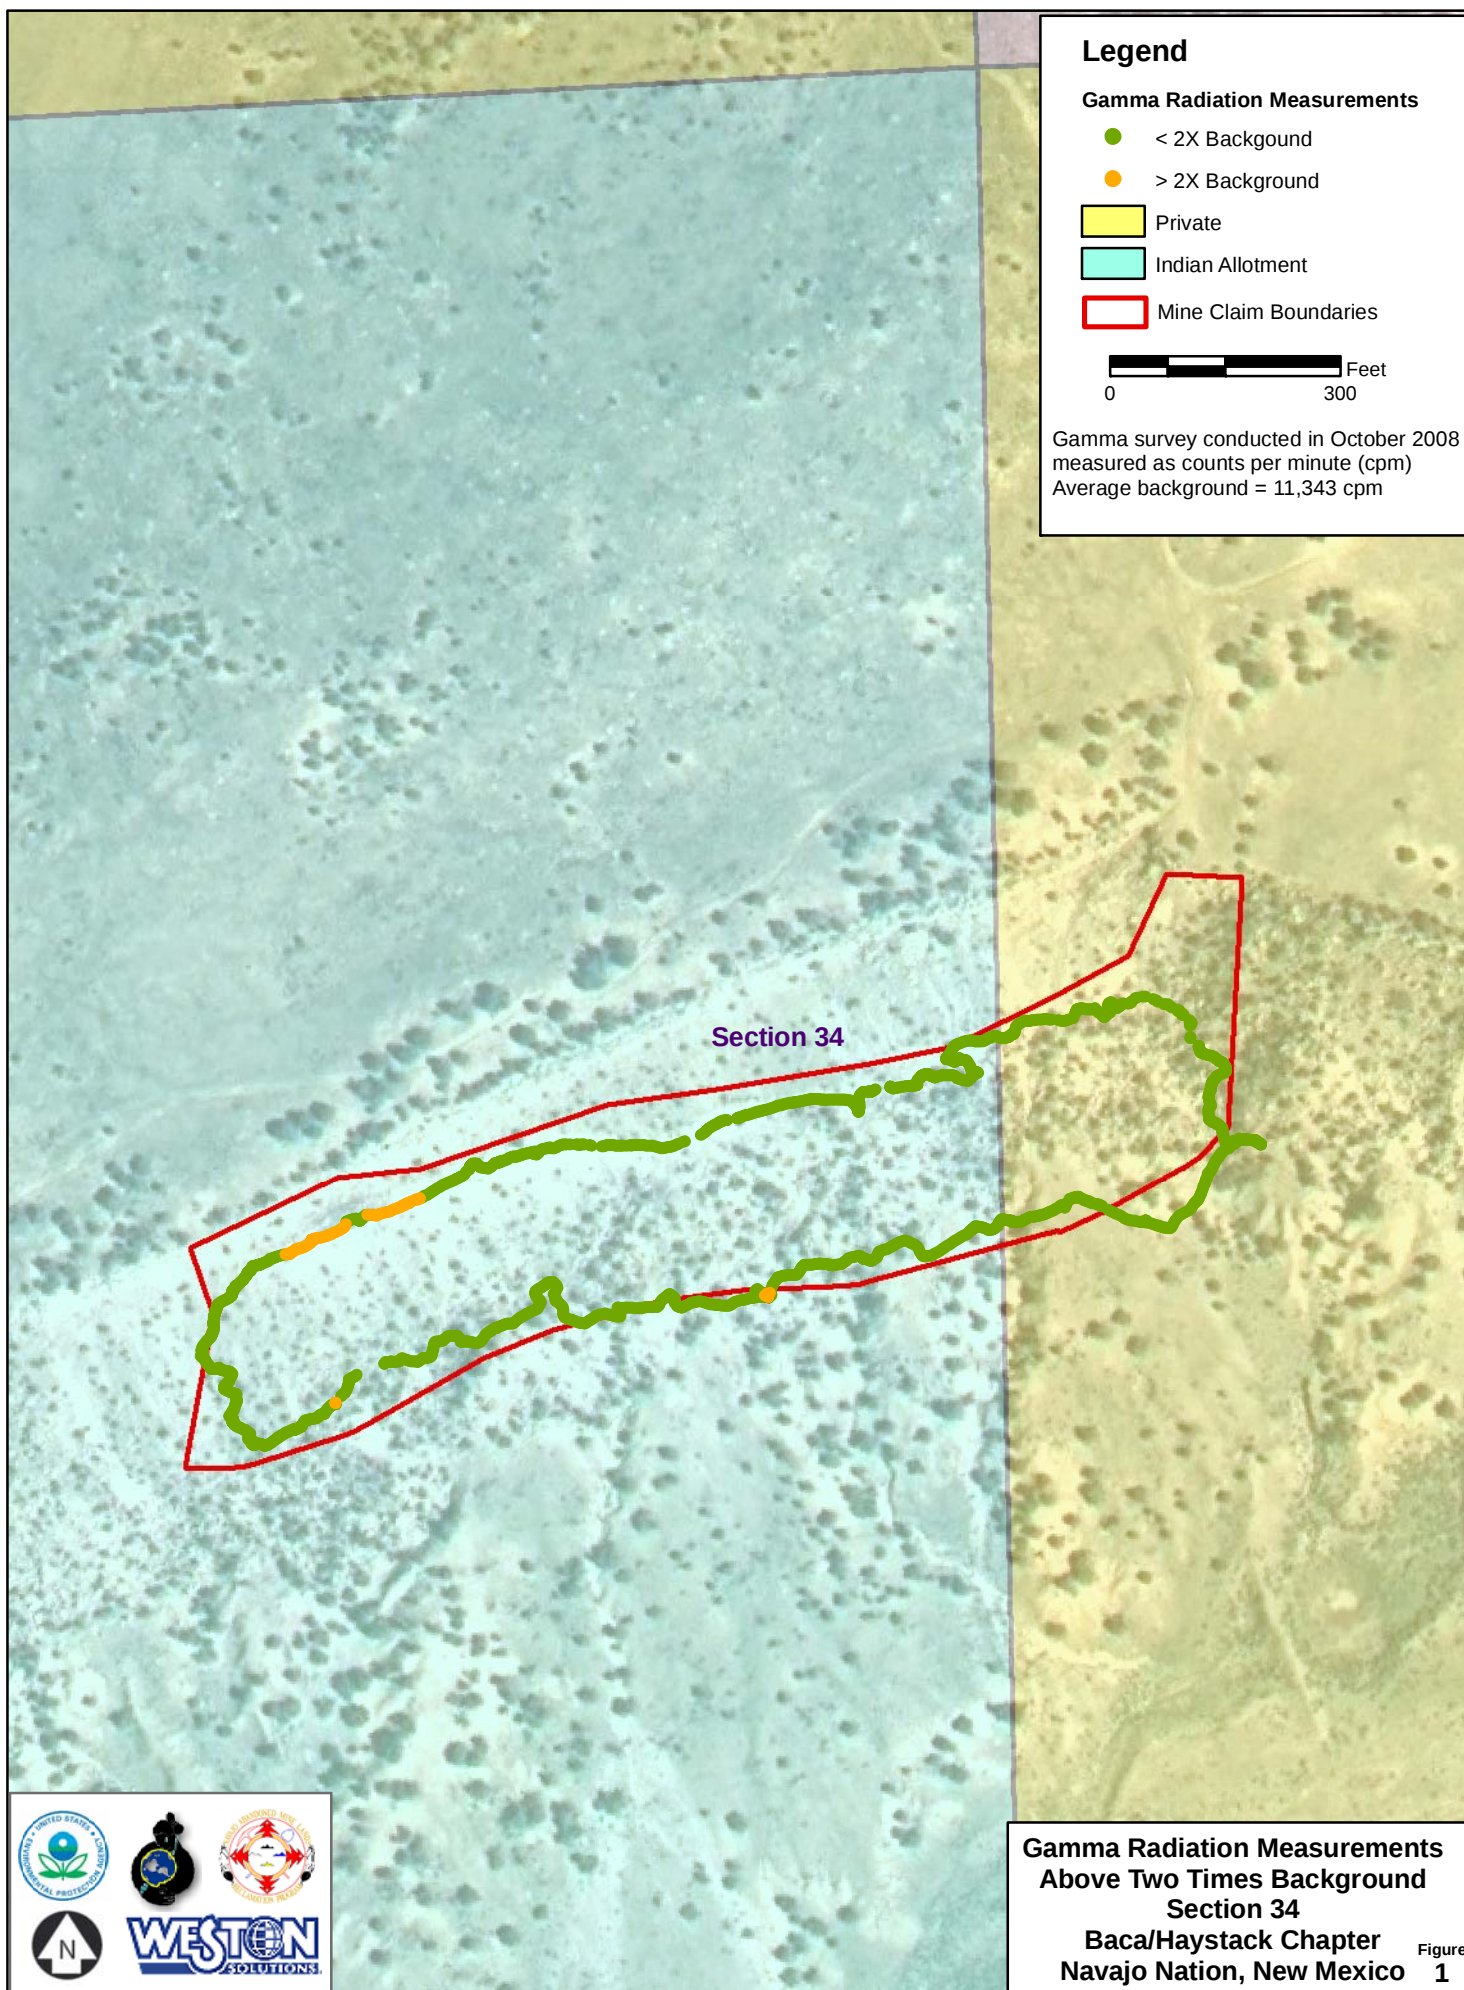
Figure  
2

A total of 2,677 gamma radiation measurements were collected from mine sites, ranging from 6,544 cpm to 75,736 cpm. The measurements are represented in Figures 1 and 2.

Gamma survey conducted in October 2008  
measured as counts per minute

Gamma Radiation Measurements
