ABANDONED OR INACTIVE URANIUM  
MINES IN NEW MEXICO

A report of investigation carried out  
between August 1979 and May 1980 under  
contract with the New Mexico Energy and  
Minerals Department.

New Mexico Bureau of Mines and  
Mineral Resources  
Open-File Report 148

Mine name(s) Isabella County McKinley

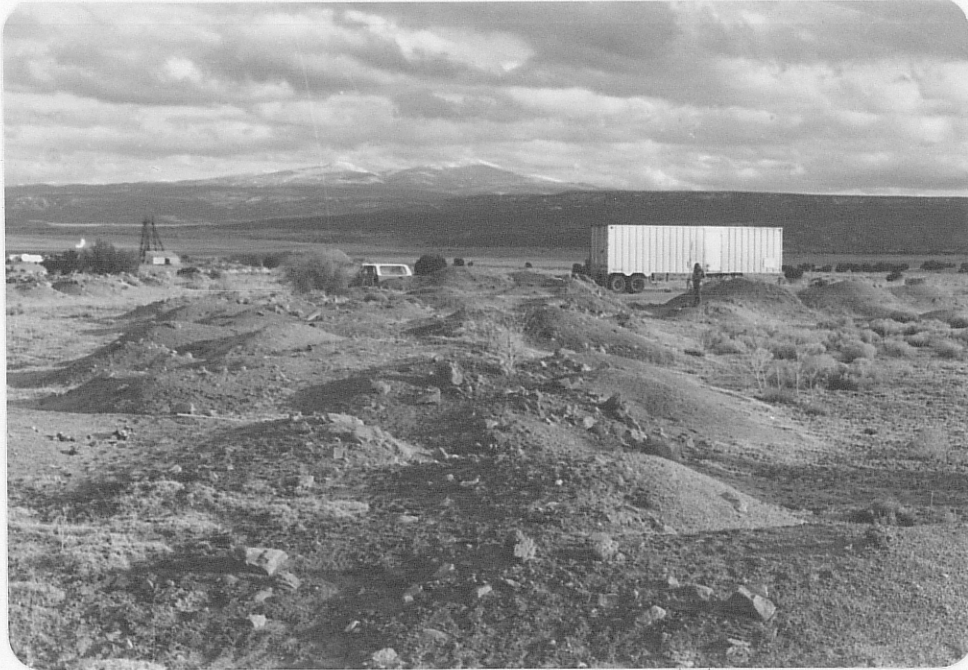
Photo (c) Looking northward at a dumping area just north of the mine shaft. Trailer rig is property of Koppen Mining Construction Co.; Mt. Taylor in background.

The tailings dump covers a considerable area to the north and west of the shaft site, with a small, but rather high dump immediately southwest of the shaft, (see photos b & c). Some of the waste dumps are actually lower grade ore deposits that would currently be acceptable at the mill; scintillometer counts on these run 1,000 to 1,700 cps with "hotter" areas up to 2,000 cps. A small drainage line passes just 100' south of the edge of the dump (see photo d). Scintillometer readings indicate that a small amount of material may be moving into the drainage; readings at the upper surface at the bank edge were 1,000 cps; on the banks of the drainage 750 cps; and 500' below the point of entry; down to 250 cps. Beyond 500' counts drop to the 80-90 cps range very quickly. Normal background in this area is about 80 cps. A 4' x 4' timbered shaft filled with sand was found just south of this drainage line across from the dump area; it was perhaps a ventilation shaft. A diagrammatic sketch of the site is shown in Fig. 1.

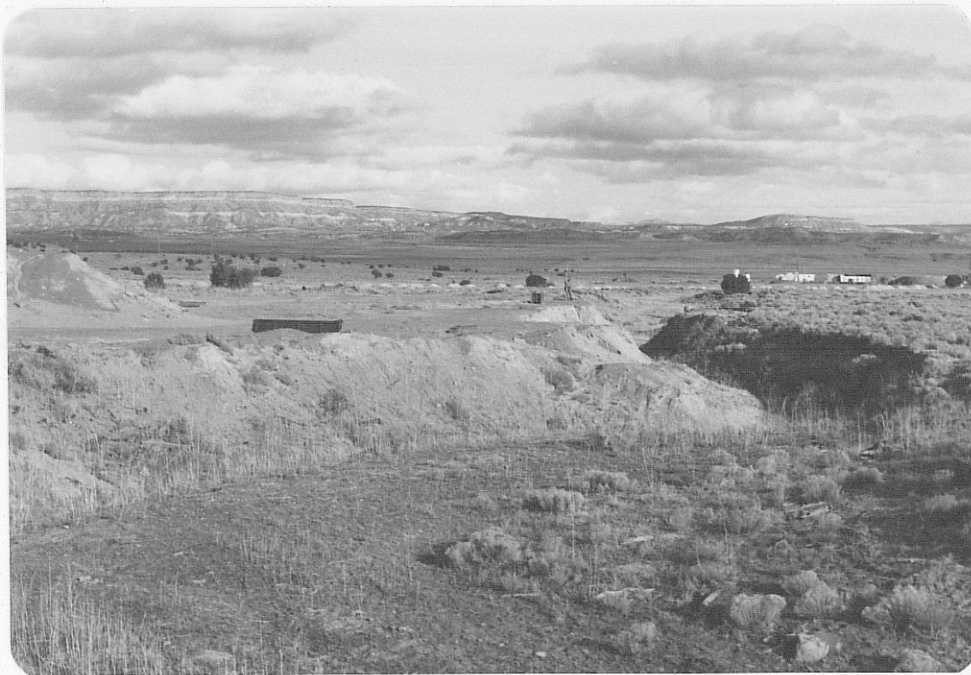
Photo (d) Looking eastward down small drainage that passes near southern edge of the dump area. Note person on left bank of drainage for scale.

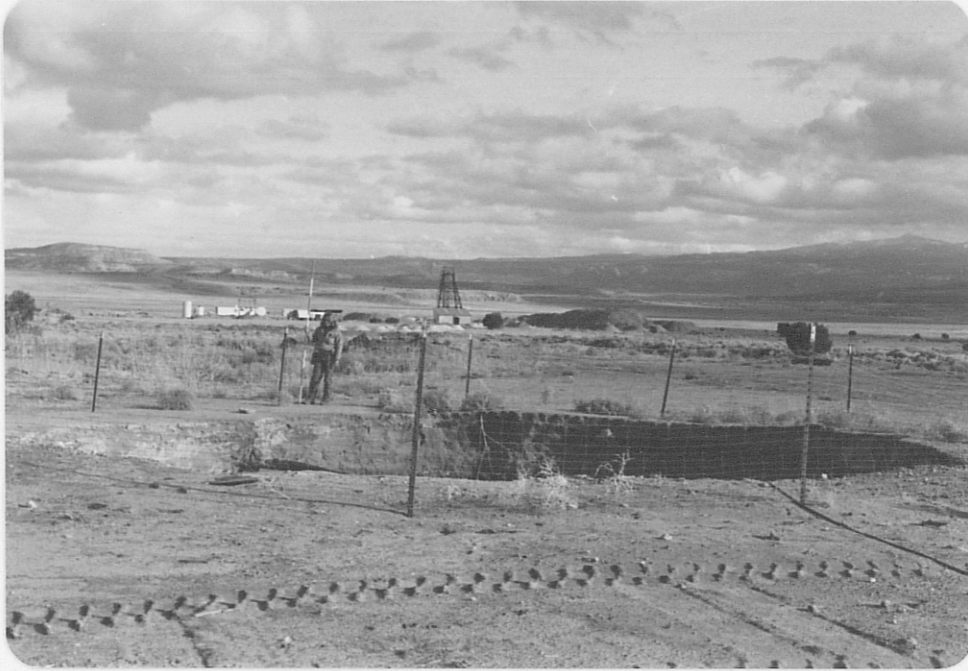
The shaft has subsequently caved in leaving a 30' diam. depression, 25' deep, (see photo a); some shaft timbers are exposed at the bottom of the depression; scintillometer readings in the shaft area outside the fence range up to 350 cps.

Photo (a) View eastward of caved mine shaft at Isabella Mine; Spencer Shaft is visible in background.

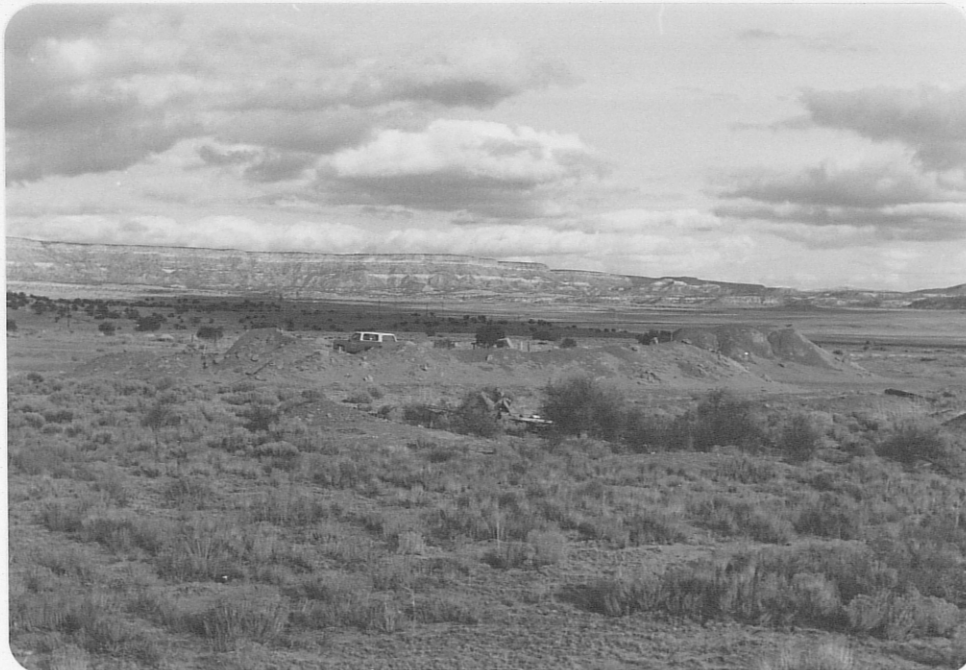
Photo (b) View northeastward of dump area on south and west sides of mine shaft; shaft location is to immediate right of vehicle in photo.
