**RE: DELIVERABLE 3179-5, FINAL PROJECT REPORT FOR CONOCO MINI MART, 3837
HWY 64, CHAMA, NEW MEXICO**

FINAL PROJECT REPORT

CONOCO MINI MART UST REMOVAL AND EXCAVATION

3837 HWY 64, CHAMA, NEW MEXICO

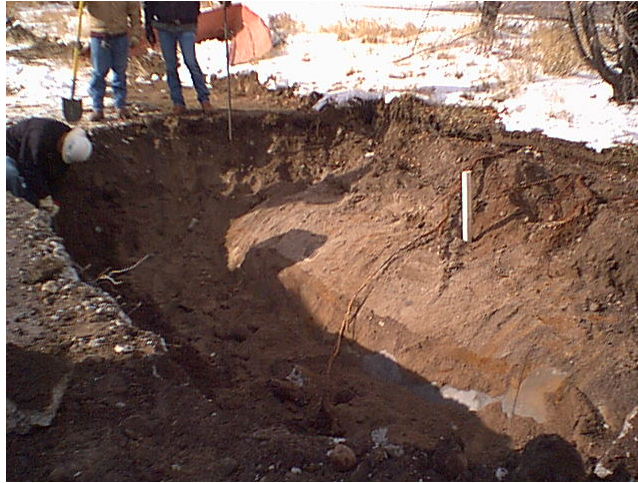
Photo 1: Excavation of UST.

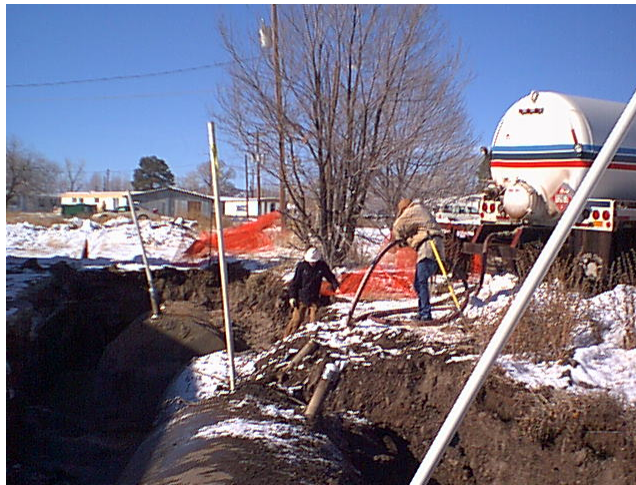
Photo 5: Fluid removal from USTs.

- ◆ Removal and disposal of approximately 2,870 gallons of gasoline/water from the USTs at Envirotech's landfarm. The Bill of Lading for fluid disposal was included in SMA's letter report dated December 29, 2006.

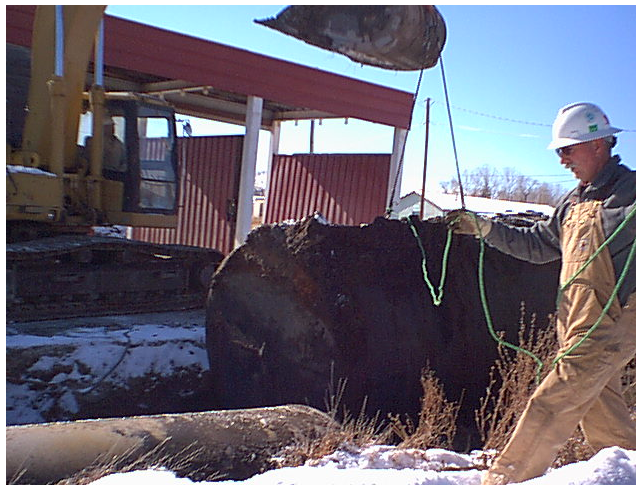
Photo 6: Removal of UST.

- ◆ Removal of three USTs, which included two 6,000 gallon steel tanks and one 3,000 gallon steel tank. The location of the third, smaller tank was unexpected and prompted the amendment to the original workplan. Based on previous site assessments and a geophysical survey, the location of a third tank was suspected on the southeast corner of the building; however, the smaller tank was discovered between the two larger tanks. The tanks were delivered to the Envirotech Yard and the certificate of destruction was included in SMA's letter report dated December 29, 2006.

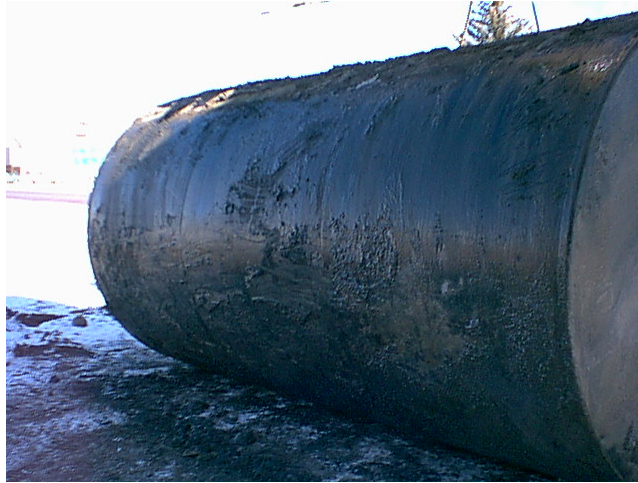
Photo 7: Sheen on bottom of UST.

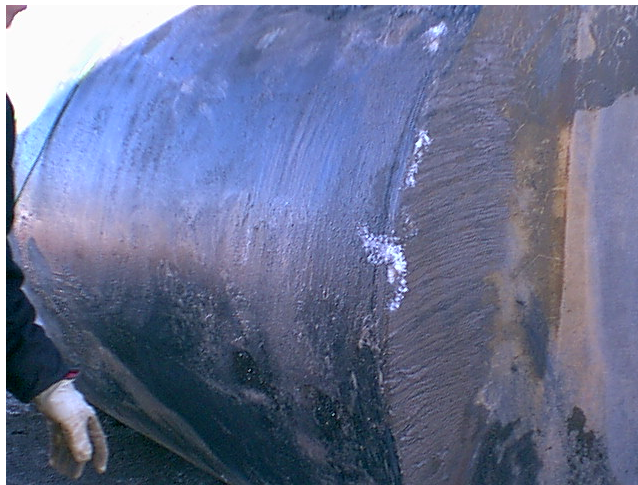
Photo 9: Sheen on UST.

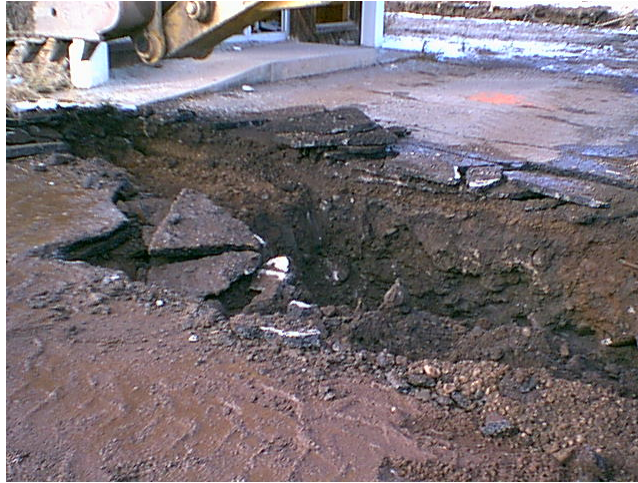
Photo 13: Test pit on southeast side of canopy.

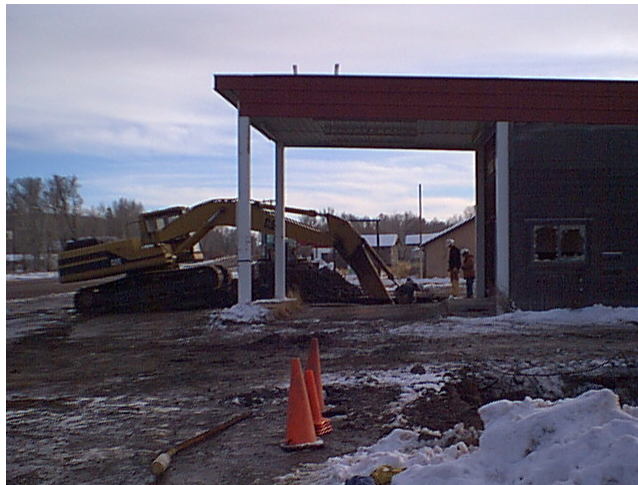
Photo 14: Test pit on southeast side of canopy.

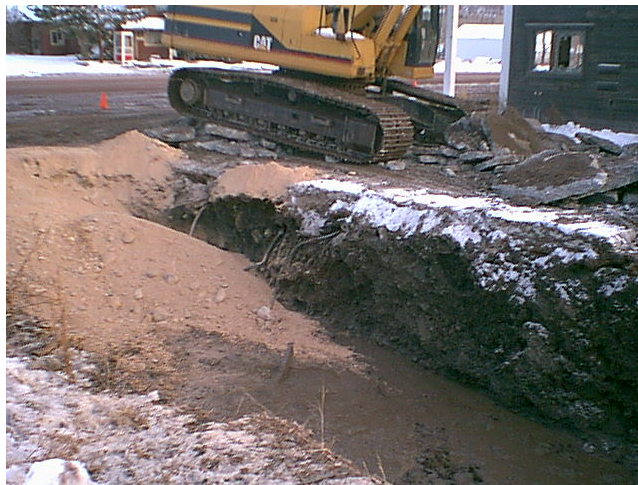
Photo 15: Backfill of tank trench.

- Pit run/cobble material (140 yds³) was placed from total excavation depth to 1 foot above the water table to provide a stable structural base for the overlying compacted fill.
- Proctored backfill (840 yds³) was backhauled from Landfarm #3, backfilled above the pit run and compacted.
- Base course (40 yds³) was spread on the surface and compacted to restore the original land surface.

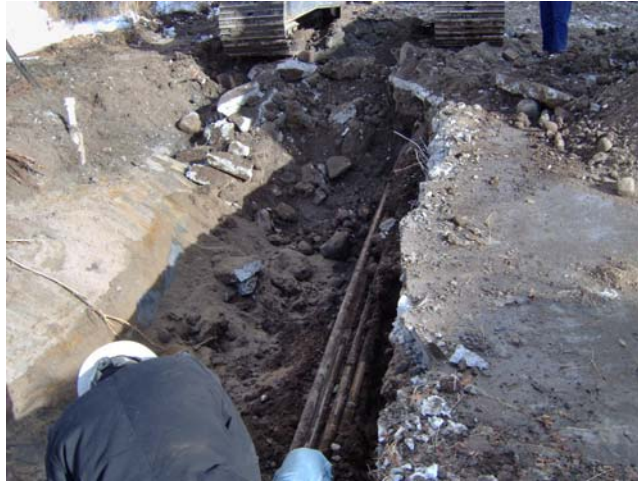
Photo 16: Product lines on north side of property.

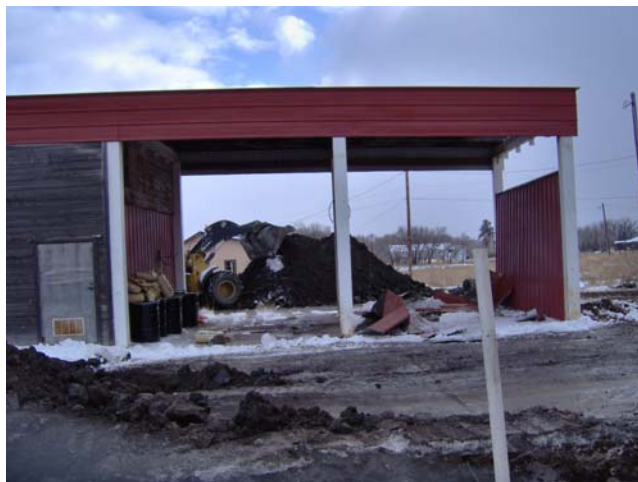
Photo 18: Stock pile of contaminated soils on concrete pad.

Soil Disposal: The contaminated soil was disposed at Envirotech's NMED Permitted Soil Facility Landfarm #3 near Hilltop, New Mexico.

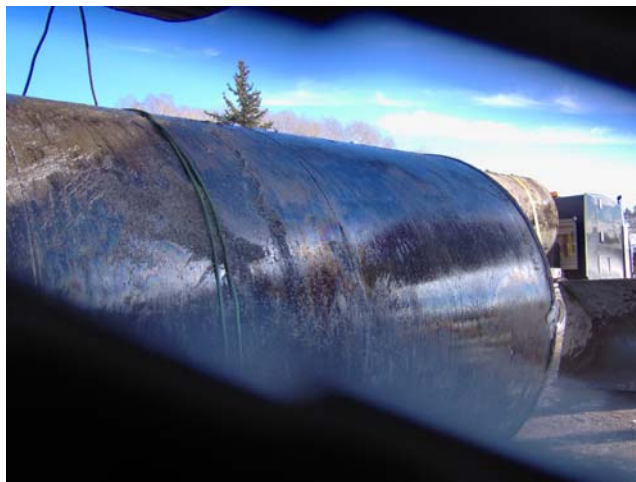
Photo 21: Sheen on UST.

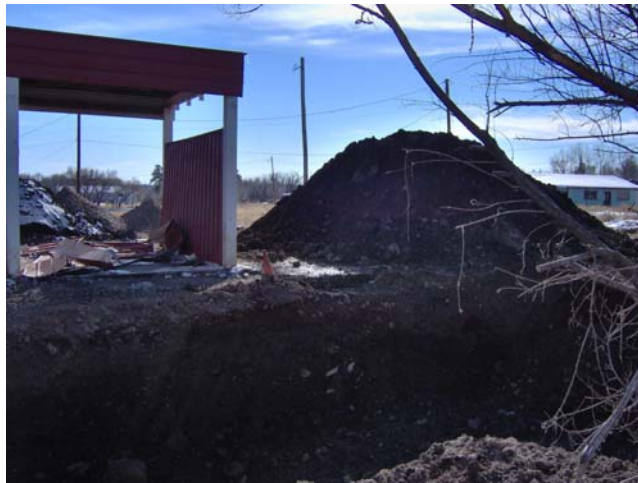
Photo 23: Stock pile of contaminated soils on asphalt pad.

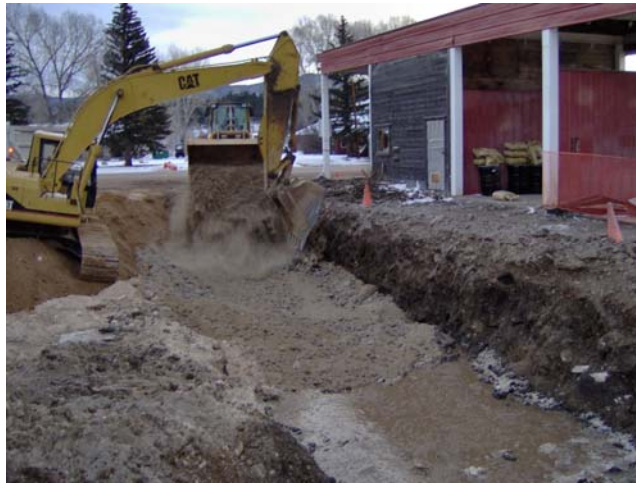
Photo 25: Backfill of second trench.

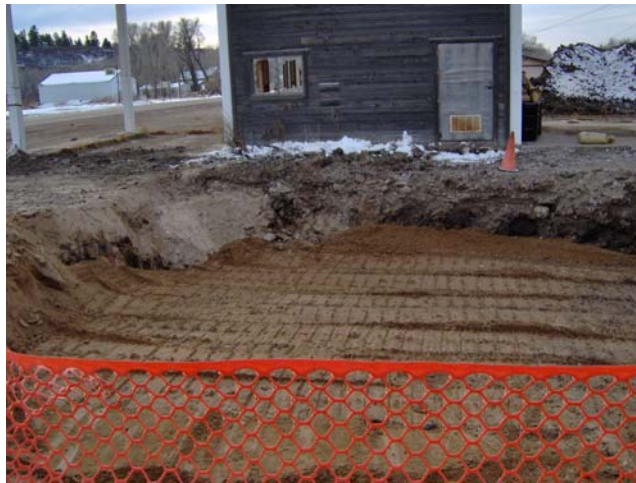
Photo 26: Backfill of excavation area.

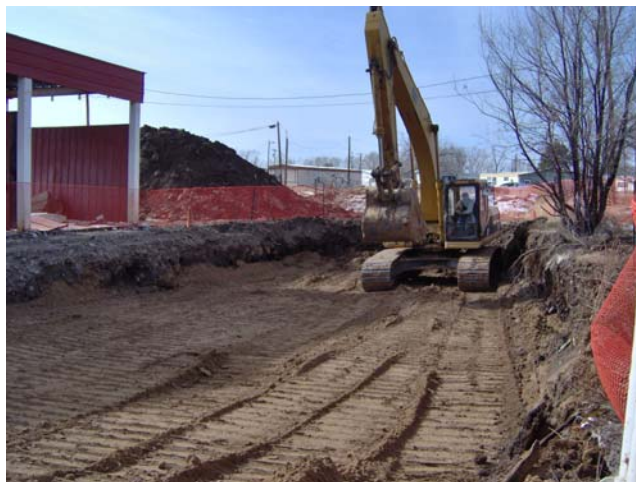
Photo 27: Compaction of excavation area.

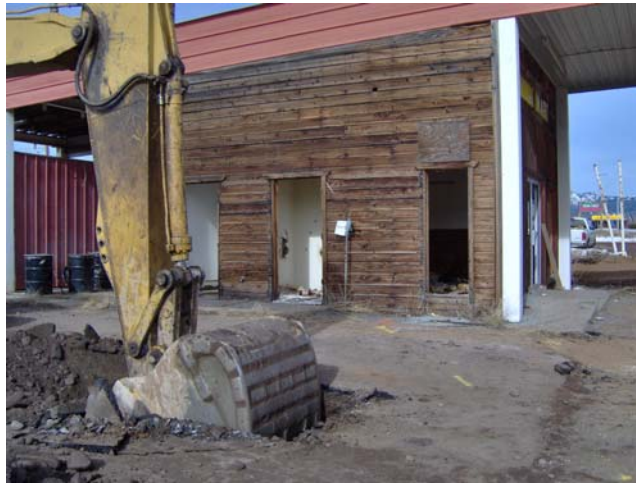
Photo 28: Test pit on south side of car wash.

Three test pits were excavated from the south side of the subject property. Soil samples were collected from each test pit in order to document the soils conditions on the south side of the car wash. The test pit on the southwest corner of the subject property was below NMED Tier 1 RBSLs for contaminants of concern. The two test pits excavated near the south east corner of the store were above NMED Tier 1 RBSLs for contaminants of concern. SMA concludes that the soil contamination extends through the south side of the subject property.

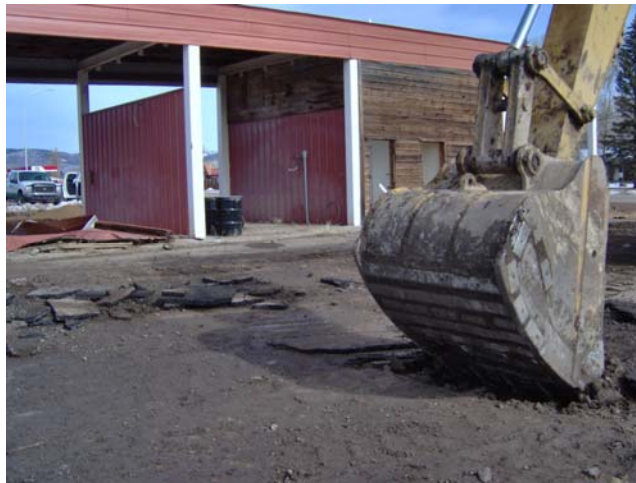
Photo 29: Test pit on south side of car wash.

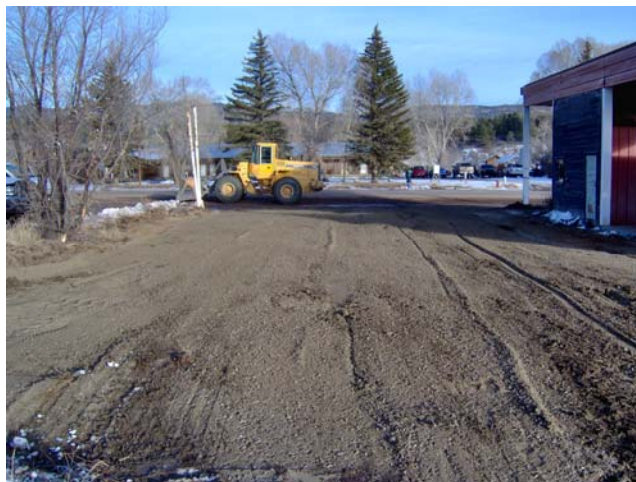
Photo 29: Backfill and final grade of excavation area.

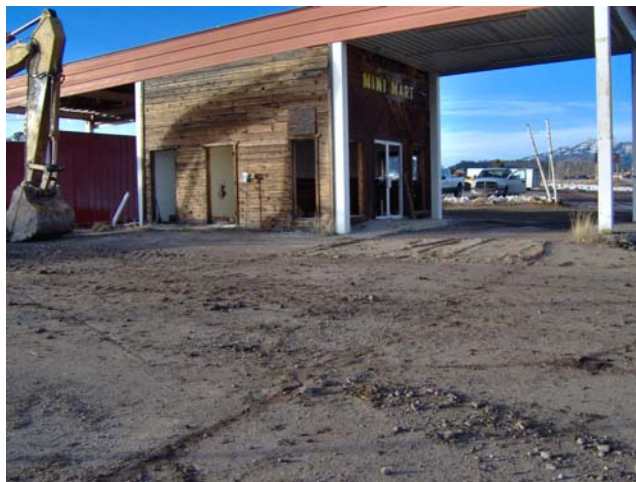
Photo 32: Backfill test pit areas.

Backfill and Compaction: The main excavation area and test pits were backfilled and compacted by the following method:
