ABANDONED OR INACTIVE URANIUM
MINES IN NEW MEXICO

A report of investigation carried out
between August 1979 and May 1980 under
contract with the New Mexico Energy and
Minerals Department.

New Mexico Bureau of Mines and
Mineral Resources
Open-File Report 148

Mine name(s) Lucky Don (Bonanza) County Socorro

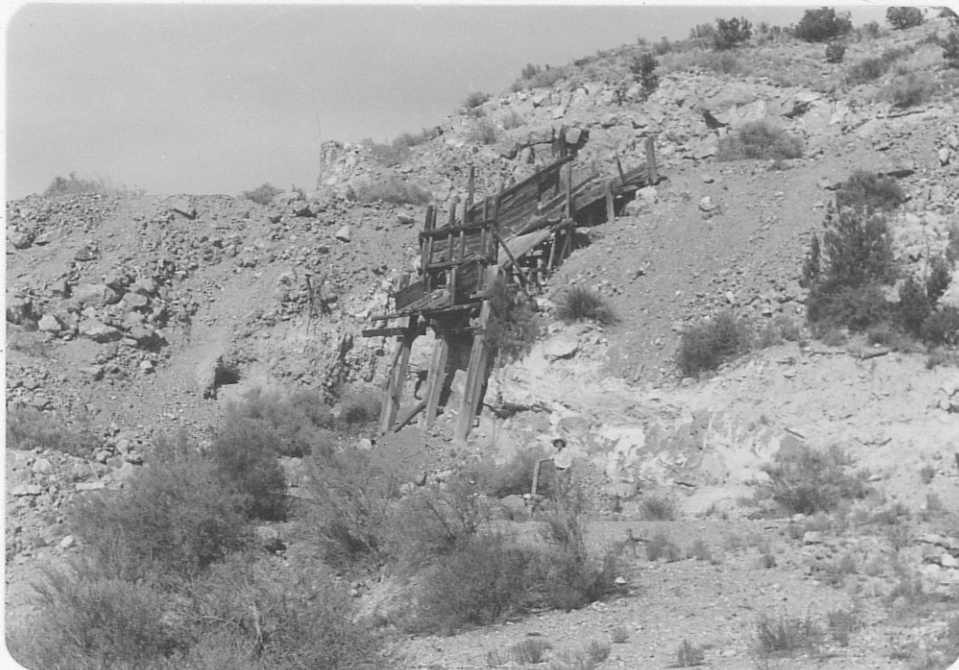
The Lucky Don (Bonanza) is located in the NE $\frac{1}{4}$ NE $\frac{1}{4}$ sec. 35 on the west side of a San Andreas limestone ridge. It is accessible by the dirt ranch road that leaves highway no. 380 about 10 miles east of San Antonio. Follow the ranch road northward along the east side of the hogbacks for about 19 miles to sec. 35; look for old wooden loadout facility and tailings dump on right hand side of road (see photos a & b).

Photo (b) Looking northward at wooden ore chute and load out area at Lucky Don Mine; note person at claim marker in load out area for scale.

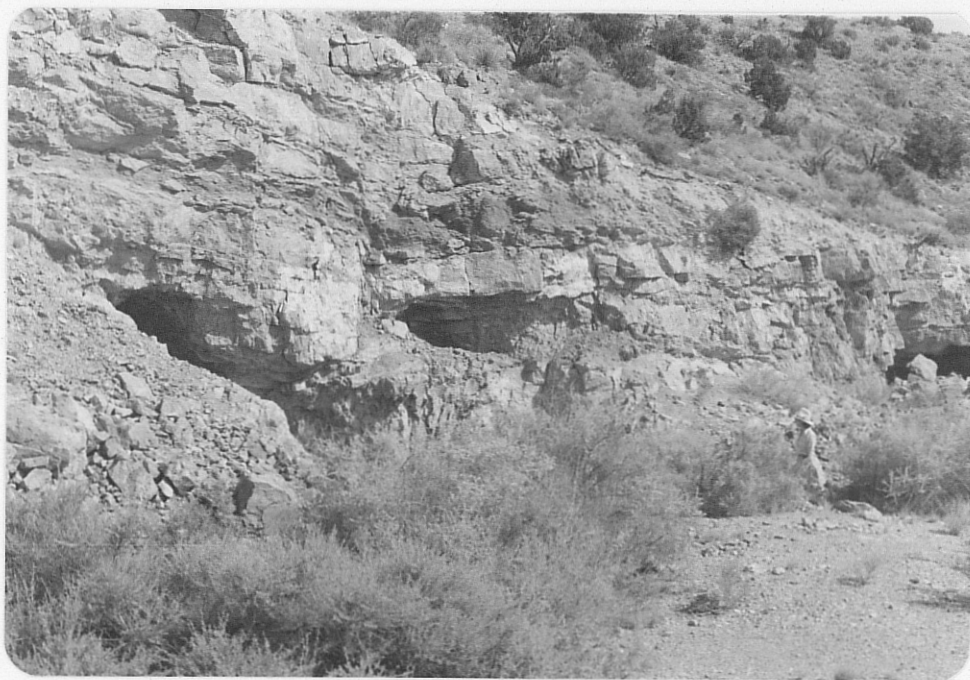
The mine consists of a face cut about 170' long on a moderate slope in dense gray limestone of the San Andreas fm. (photo c). A cluster of 4 gopher holes or stub adits have been driven into the face, following small mineralized fracture zones or bedding planes, (photos c, d, and e). Maximum length of underground workings is about 20'; roofs in general appeared stable, but were not closely examined.

Photo (c) Looking eastward at open cut showing gopher holes or stub adits driven into face-close ups on following two photographs.

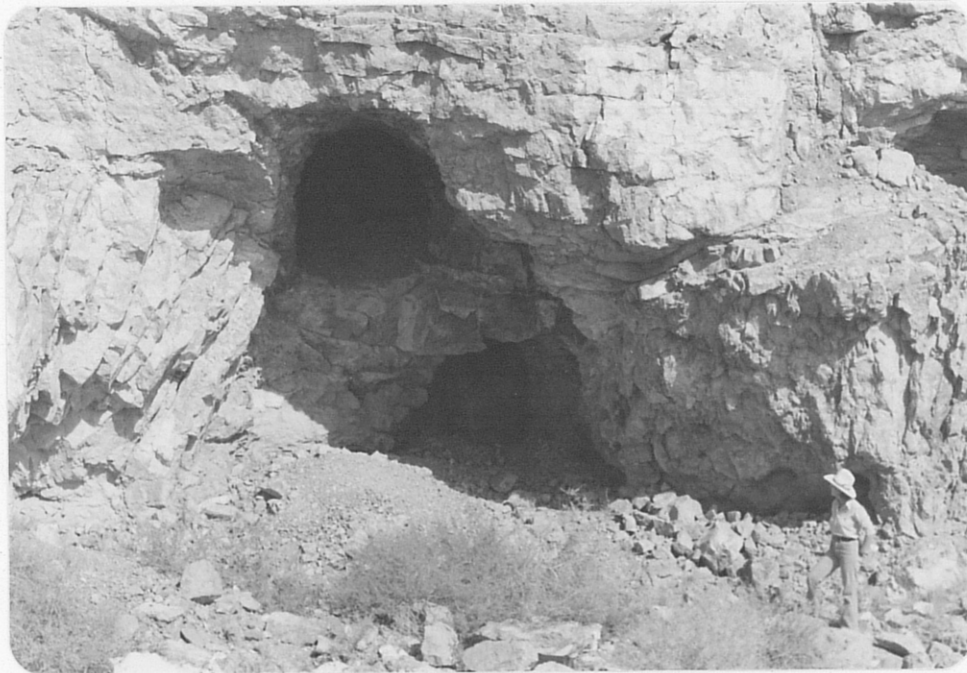
051 50-5

Photo (e) Close-up of gopher holes shown at left in photo (d); note person at lower right for scale.
