# Abandoned Uranium Mine Field Survey Project

prepared for  
New Mexico Energy, Minerals and Natural Resources Department  
Mining and Minerals Division

## **Butler Brothers Mine**

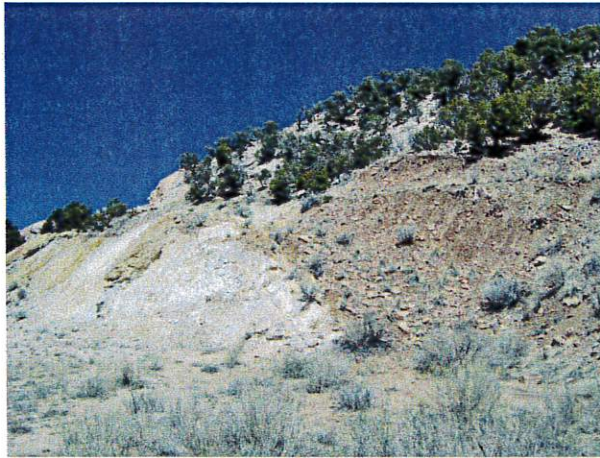
**4. Mine Disturbance:** The mine consists of two open excavations into the ridge. The jeep path winds to the top of the excavation and ends. Erosion through the center of the lower workings has removed enough material to disguise the excavation as being no more than a road cut.

View northwest

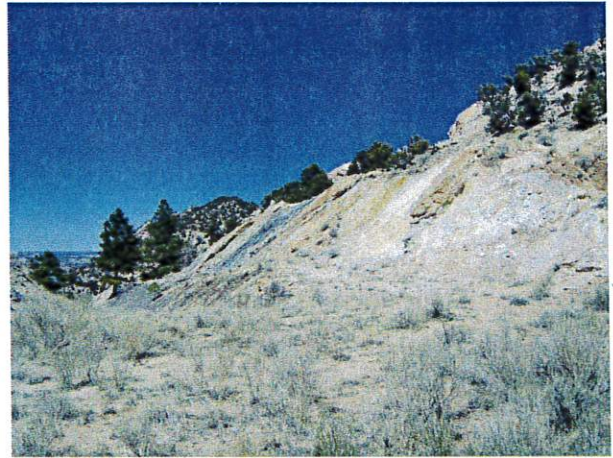
View northwest to workings

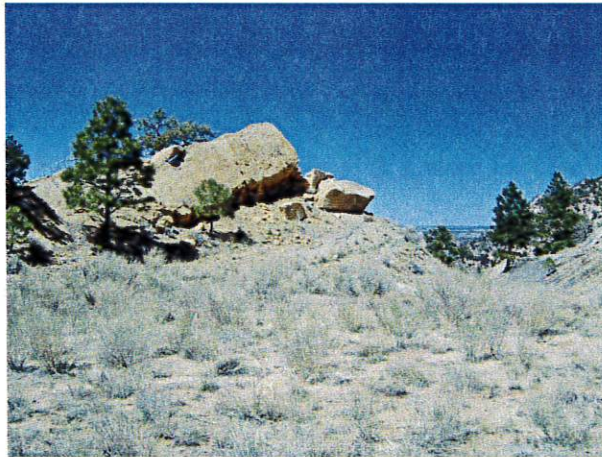
**10. Topographic Features:** The site is cut into the steep side of a mesa. Active erosion of the cut is present.

View west of cut

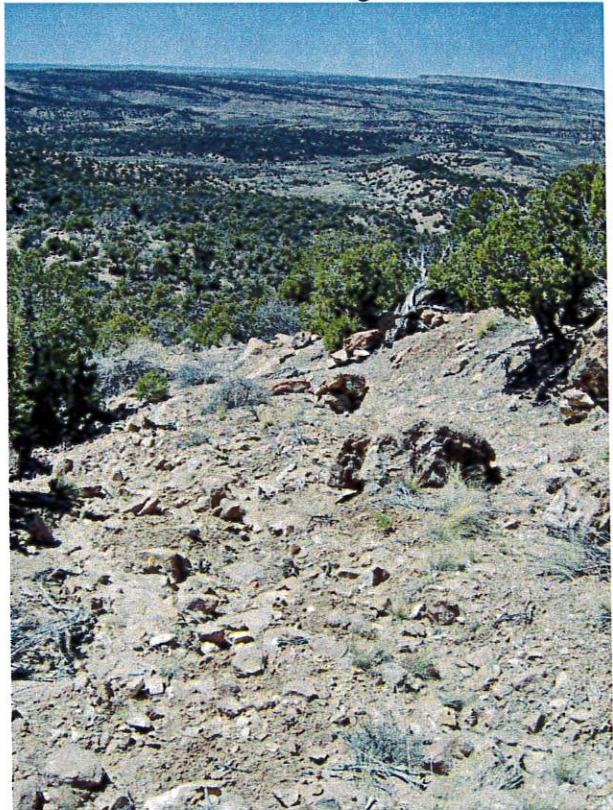
View to West

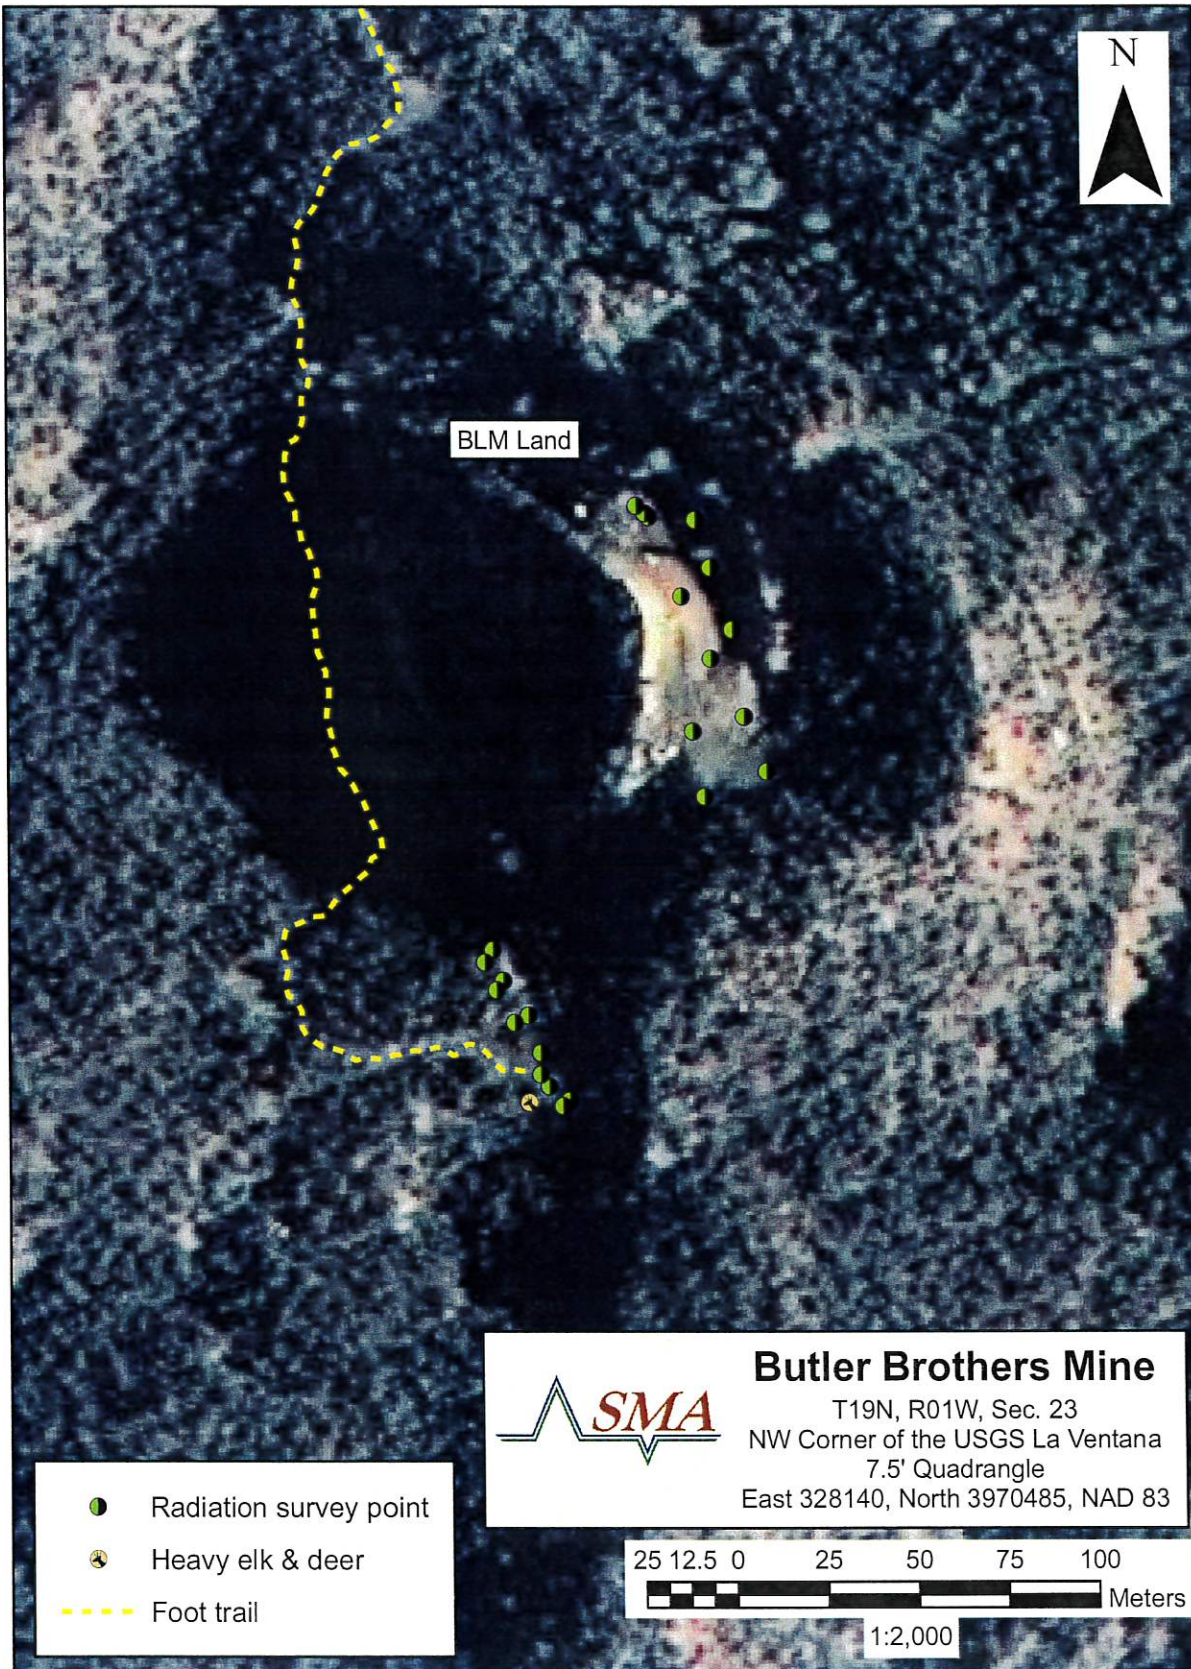
### Butler Brothers Mine

- Radiation survey point
- 🦌 Heavy elk & deer
- Foot trail

T19N, R01W, Sec. 23  
NW Corner of the USGS La Ventana  
7.5' Quadrangle  
East 328140, North 3970485, NAD 83
