Abandoned Uranium Mine Assessment for the Midcontinent Site (NM0182)

FINAL REPORT

November 05, 2010

NM0182

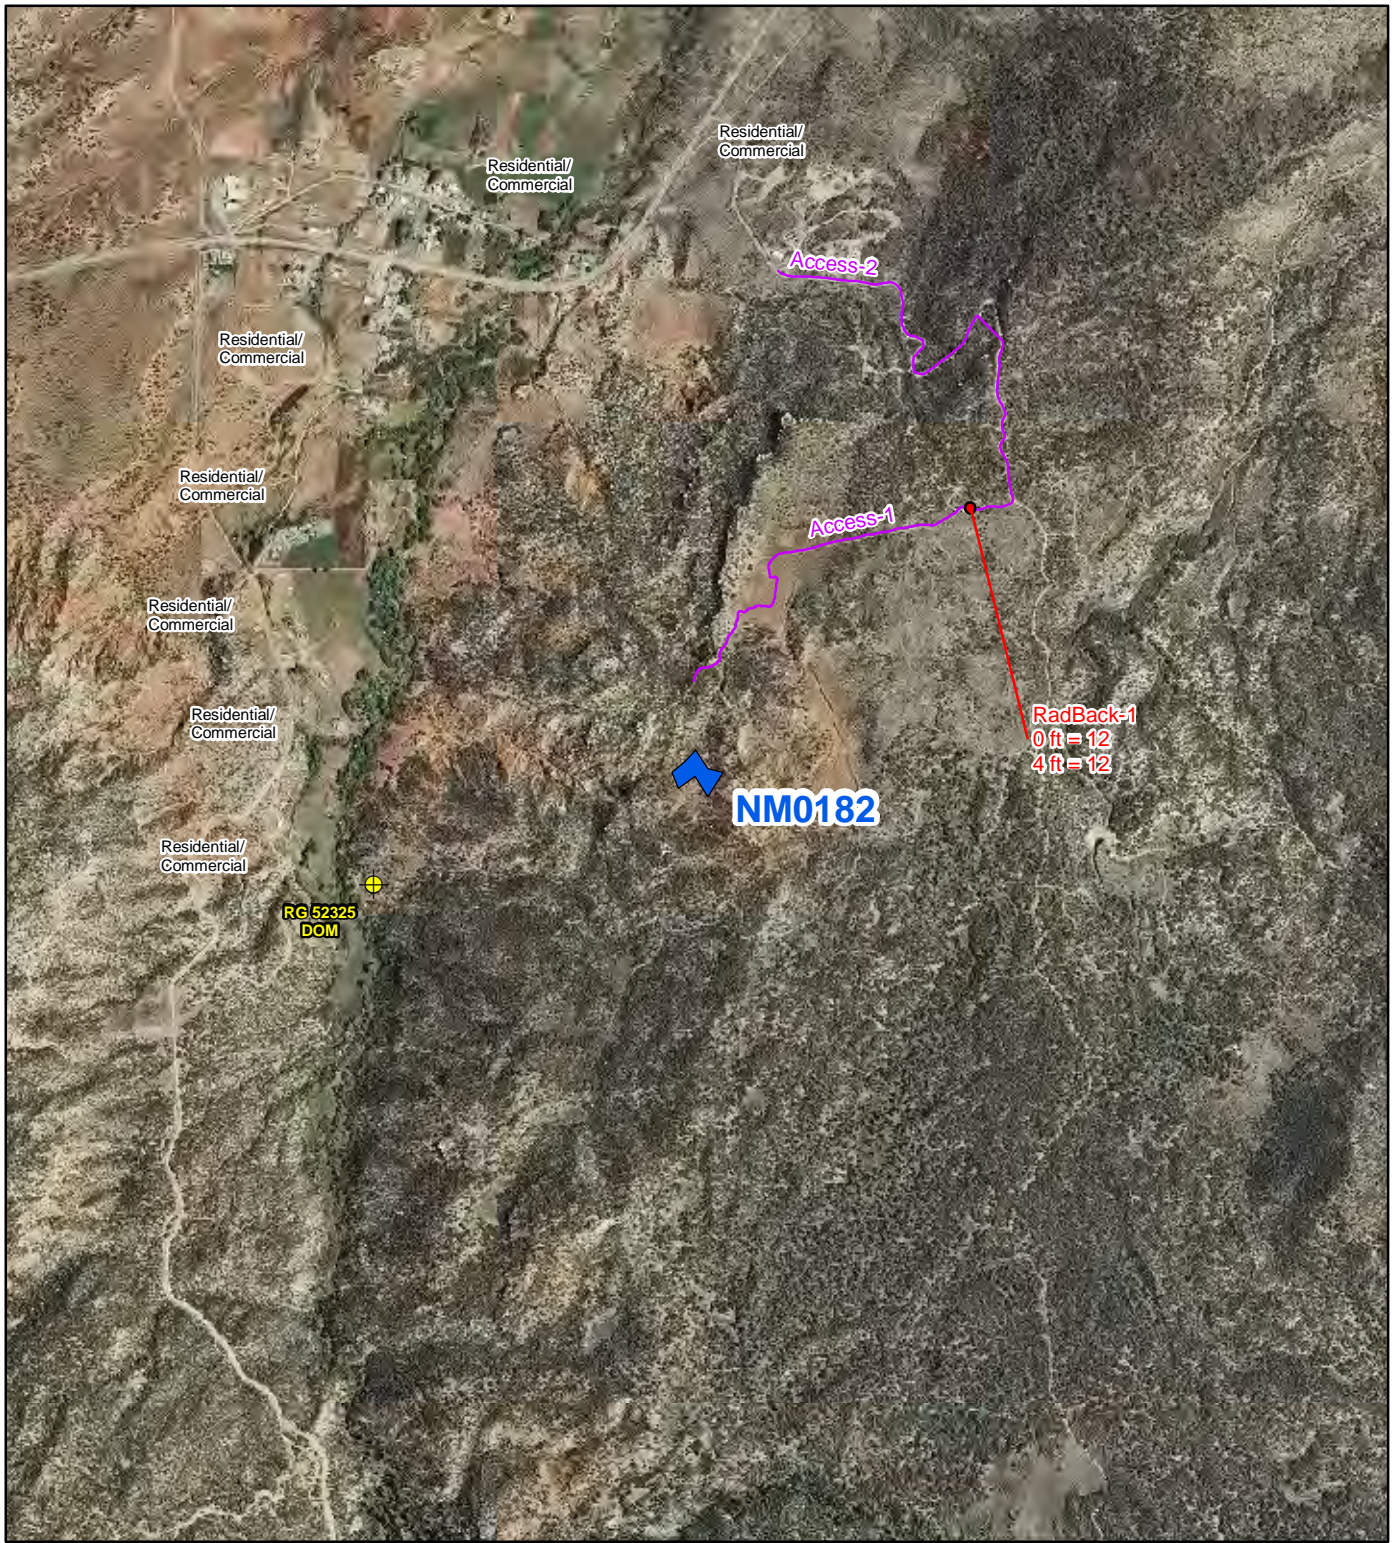
Figure 3
Aerial Photo
NM0182-Midcontinent
 Abandoned Uranium
 Mine Assessment

The AUM Site is found on the Youngsville 7.5 minute United States Geological Survey topographic map at an elevation of approximately 7,000 ft above mean sea level (please see Figure 2). The AUM Site is located in the northern foothills of the Jemez Mountains along the cliffs that form the eastern slope of the Coyote Creek drainage. Figure 3 shows an aerial photograph of the terrain surrounding the AUM Site.

Human activity at the AUM Site and in the surrounding area included grazing and domestic dwellings within a 1 mile radius of the site (please see Figure 3).

One domestic well lies within one mile of the AUM Site. This domestic well was drilled in 1991 to a depth of 140 feet below ground surface with a depth to water of 65 feet below ground surface (NMOSE, 2008). Please see Figures 2 and 3 for the location of this well.

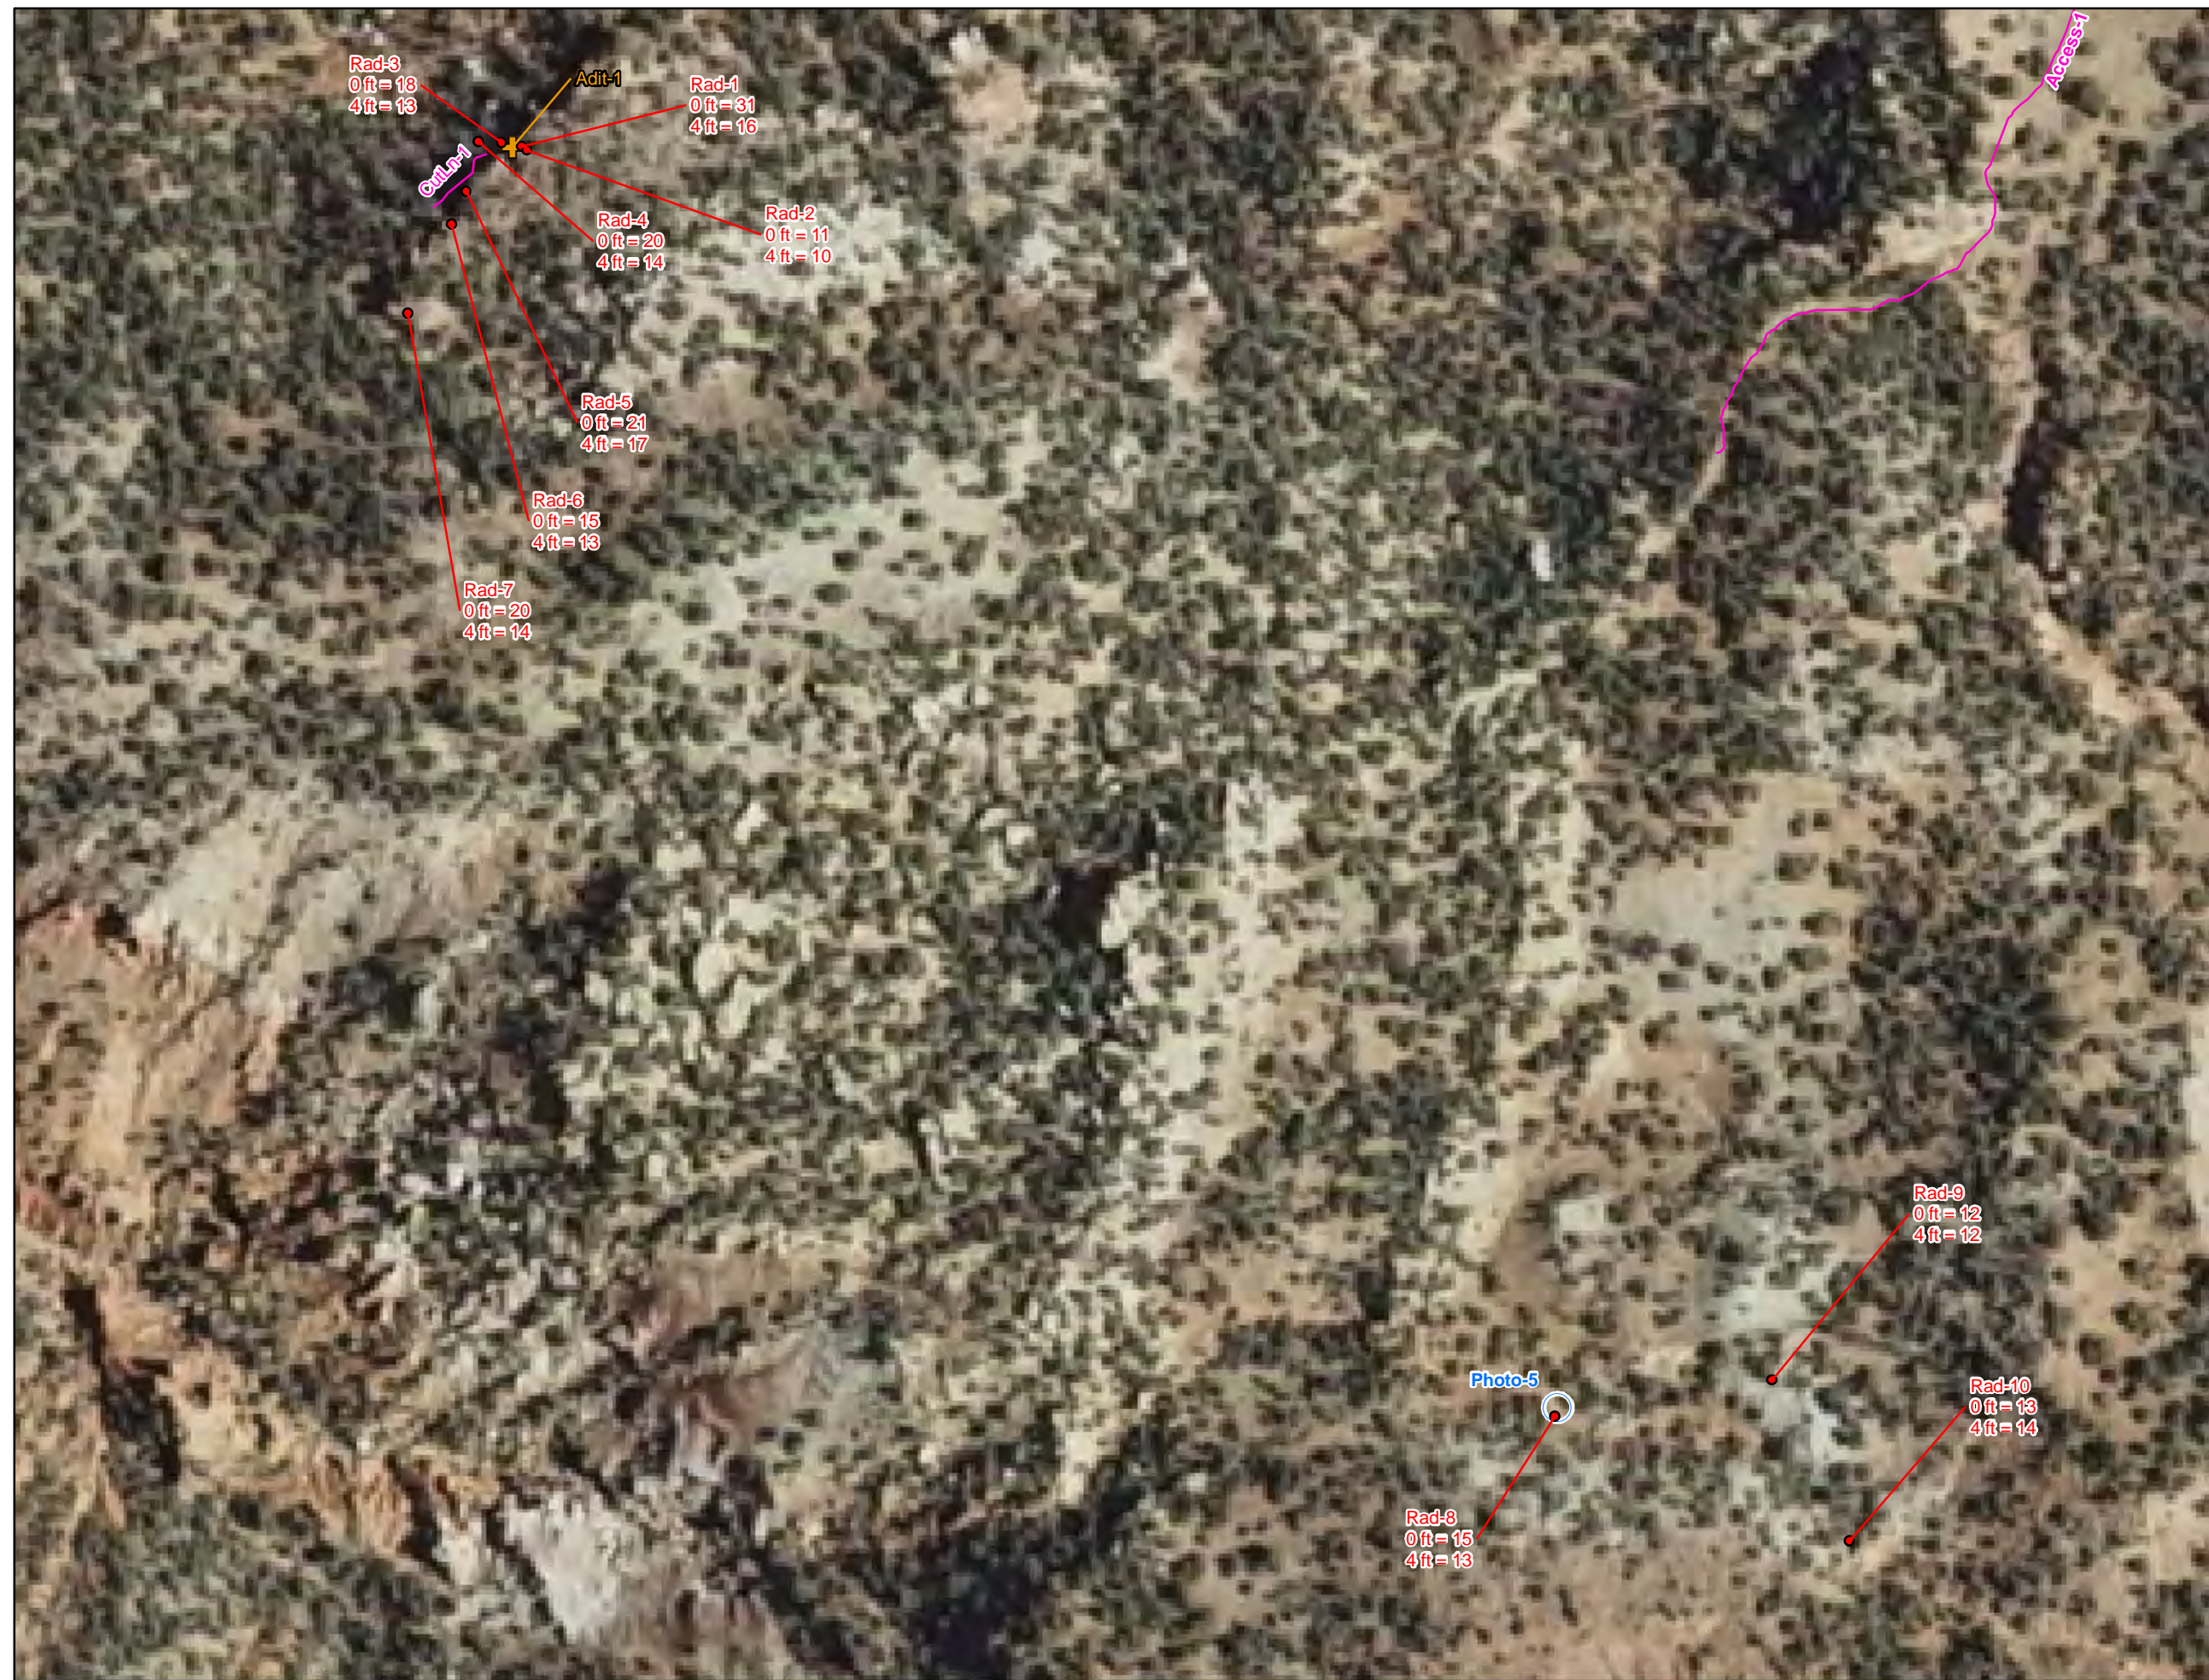
Figure 4a
Site Map on
Aerial Photo
NM0182-Midcontinent
 Abandoned Uranium
 Mine Assessment

The mine features described below are based on the features provided to INTERA by MMD in the GIS Data Dictionary (MMD, 2009). INTERA marked the locations of the AUM Site features using a Trimble Global Positioning System (GPS) and entered details about the features into the GPS using the MMD data dictionary. One open cut and one adit were identified onsite. Please see the Photo Log in Appendix A for photos of the AUM Site features, Table 1 for a list of the AUM Site features, and Figures 4a and 4b for the locations of the AUM Site features.

One background gamma radiation reading was taken near the AUM Site, recording 12 $\mu\text{R/hr}$ at 0 ft above ground and 12 $\mu\text{R/hr}$ at 4 ft above ground. Please see Table 2 for all of the gamma radiation readings taken at the AUM Site and Figures 4a and 4b for the locations of the radiation readings.

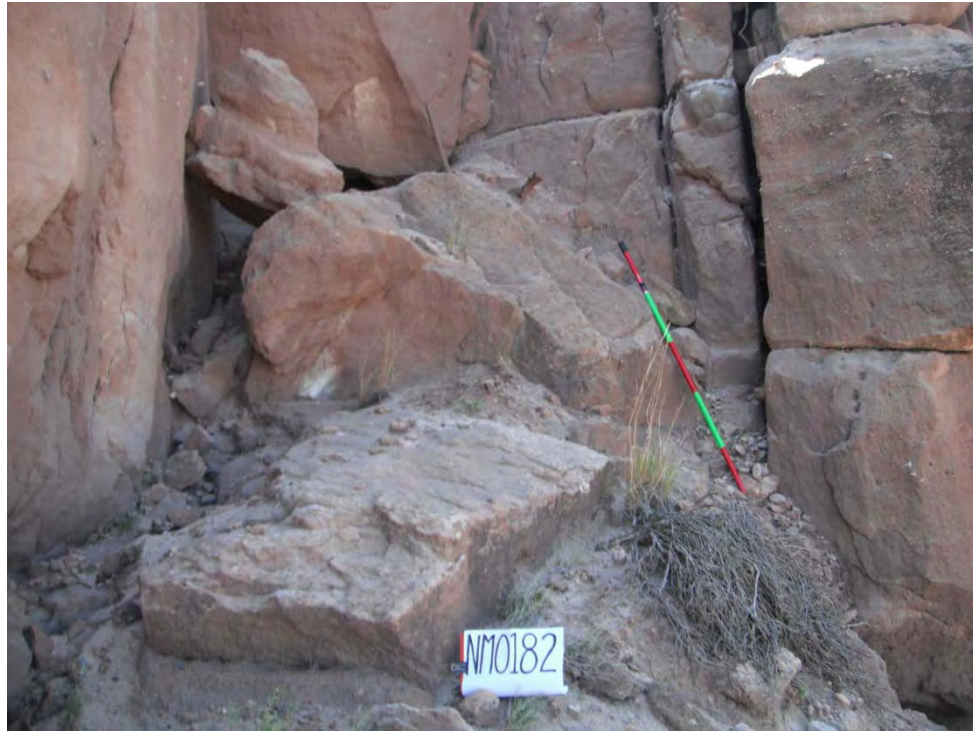
An adit (Adit-1) was found at the AUM Site. The adit extended southeast into an exposure of Agua Zarca sandstone. The opening of the adit is collapsed (see Photo 1 in Appendix A). Gamma radiation near the entrance to the adit measured 31 $\mu\text{R/hr}$ (microrentgens per hour) at 0 ft above ground at radiation survey point Rad-1 (see Table 2). On the east wall of Adit-1 is an horizontal blast hole, approximately 3 inches in diameter and 1 ft deep (see Photo 3 in Appendix A).

Photo 1-Site location photo, looking south at collapsed Adit-1.

Adit-1 - collapsed, landowner said it was a hole

Photo-1 - Adit-1 looking south

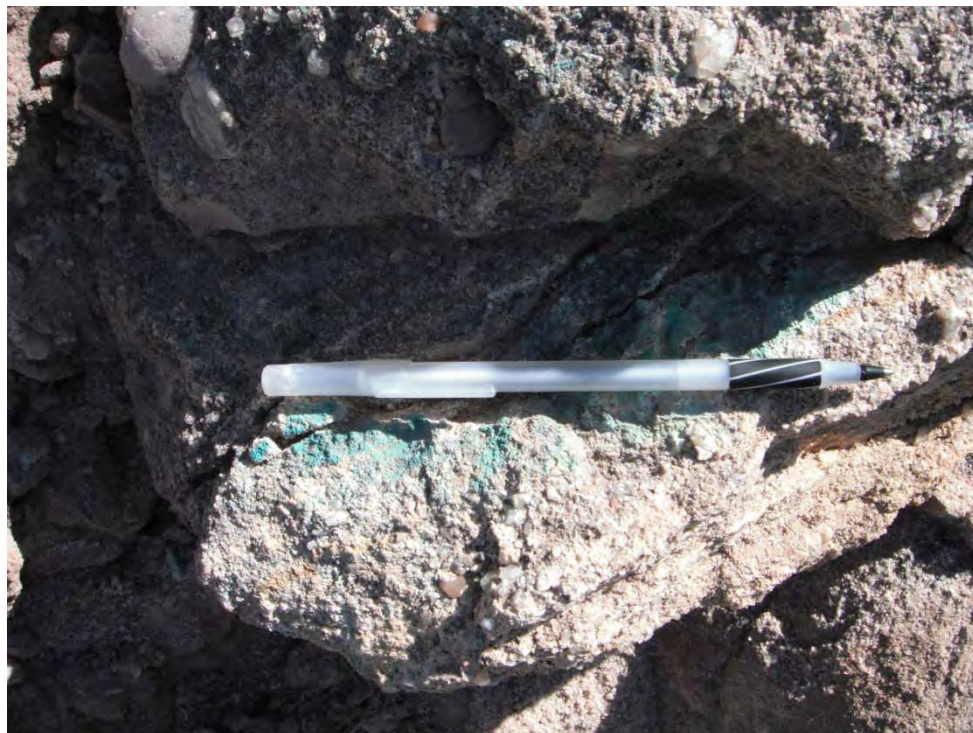
Photo 2-Closeup of rocks at Rad-3.

Rad-3 - below Adit-1; 0m - 18 uR/h; 1m - 13 uR/h

Photo 2 - close up of Rad-3

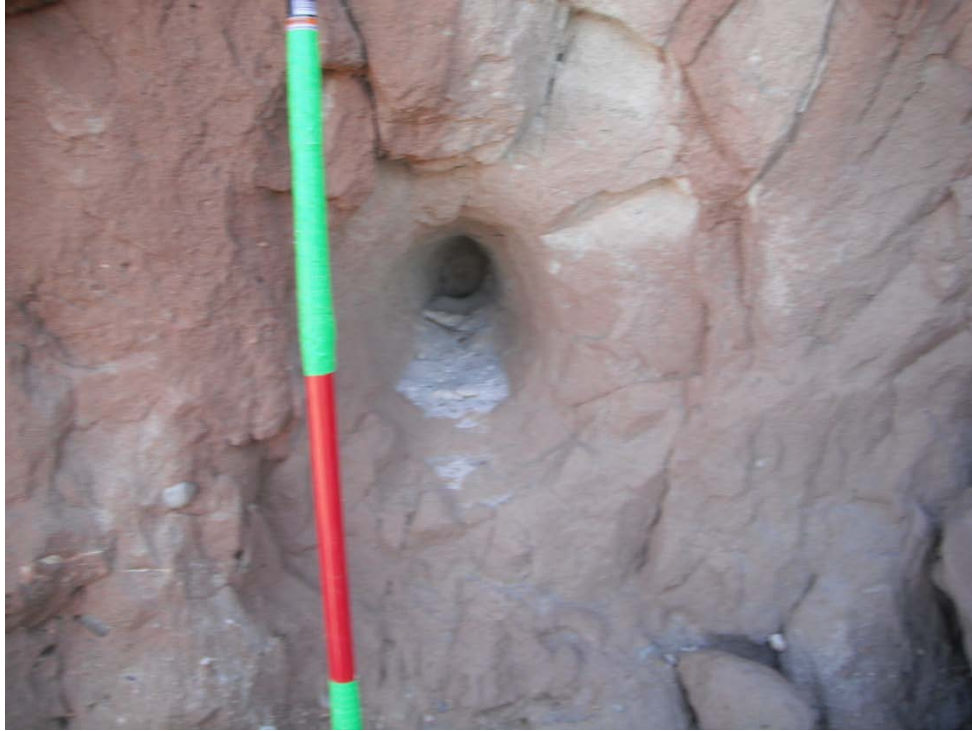
No boreholes were found at the AUM Site, however an horizontal blast hole was identified near the entrance to Adit-1 (see Section 2.1 and Photo 3 in Appendix A).

Photo 3-Looking east at hole in outcrop near Adit-1.

Photo 3 - explosive hole in Adit-1 wall looking east

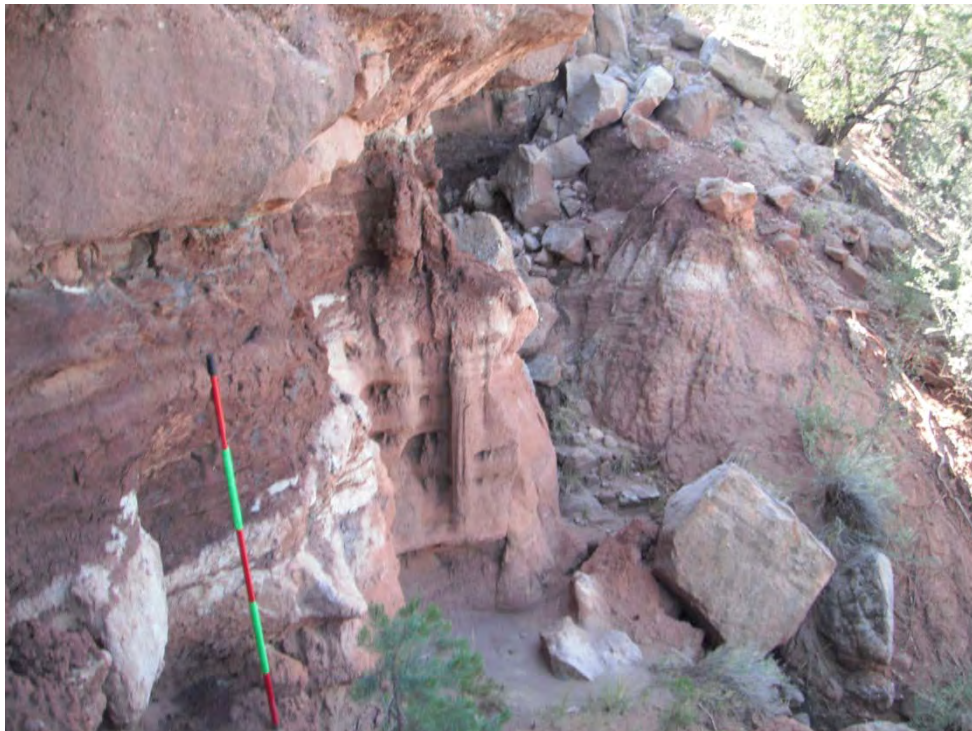
One open cut (CutLn-1) was identified at the AUM Site. This feature is a 15 ft-high and 40 ft-long rim cut that exposes the Triassic sediments forming the cliff (see Photo 4 in Appendix A). Several gamma radiation measurements were taken along the surface of the cut but none of the readings varied significantly above background level. The maximum gamma radiation measurement along CutLn-1 was 21 $\mu\text{R/hr}$ (microrentgens per hour) at 0 ft above ground at radiation survey point Rad-5 (see Table 2).

Photo 4-Looking south at CutLn-1.

Cut In-1 - 15' tall, 5' wide, 40' long

Photo 4 - Cut In-1 looking south

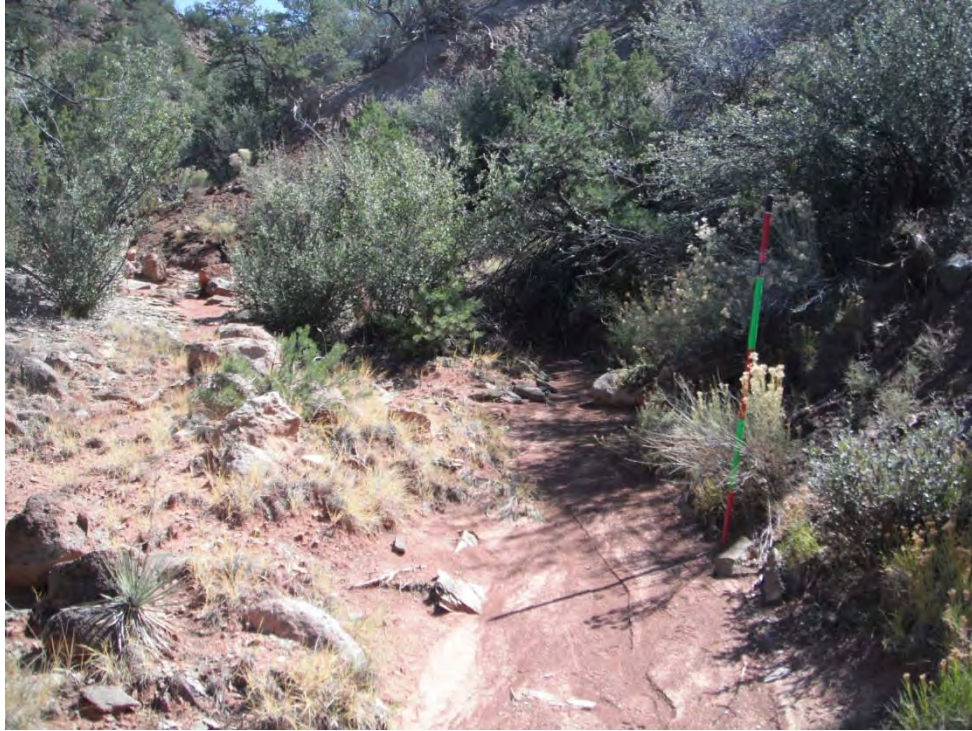
Photo 5-Looking east at MMD polygon area.

1240 At AUM polygon - no visible mine features

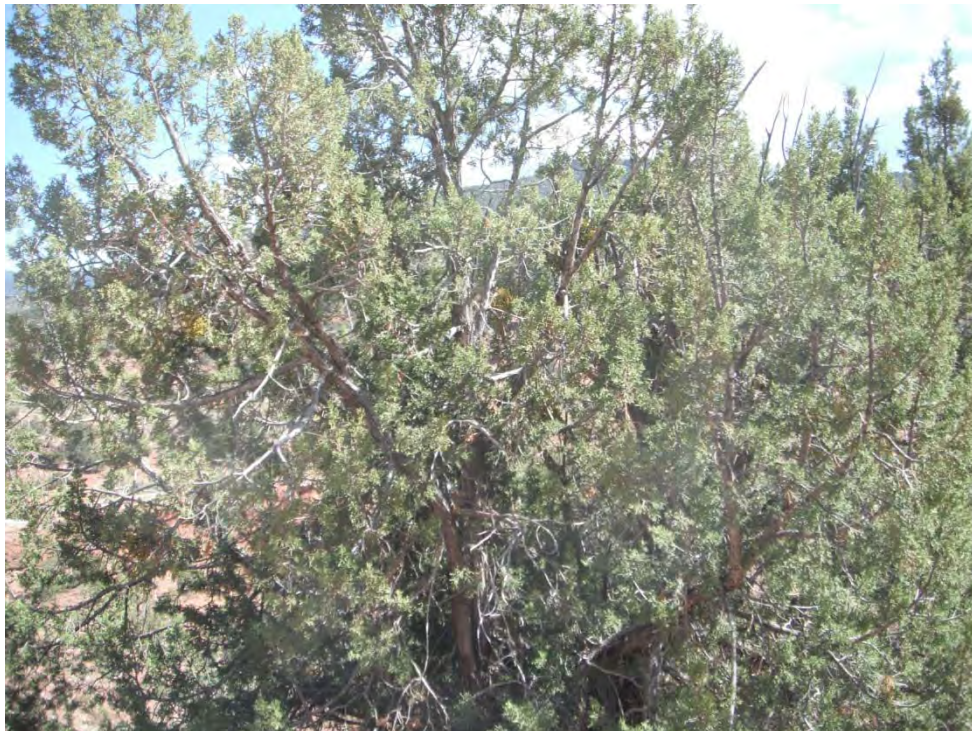
Photo 6-Vegetation representative of the AUM Site.

The Midcontinent, Coyote Hill, and Red Head sites are located in the Coniferous and Mixed Woodland vegetation type (Dick-Peddie, 1999). The vegetation photographs and samples collected are representative of these three sites (please see Photos 6 – 11 in Appendix A). Woody vegetation is dominated by pinyon pine, Utah juniper, rabbitbrush, and ephedra species. The grass species included blue grama and slender wheatgrass. Forb species are limited to barbwire Russian thistle and little hogweed. No noxious weeds were observed at the AUM Site.
