# Abandoned Uranium Mine Site Assessment for the Tom Site (NM0127)

**FINAL REPORT**

INTERA Incorporated (INTERA) has prepared this Abandoned Uranium Mine (AUM) Site Assessment Report for the Mining and Minerals Division (MMD) of the New Mexico Energy, Minerals and Natural Resources Department (EMNRD) in compliance with the Professional Service Agreement dated November 2, 2009. INTERA visited the Tom Site (AUM Site), MMD ID: NM0127 on April 16, 2010.

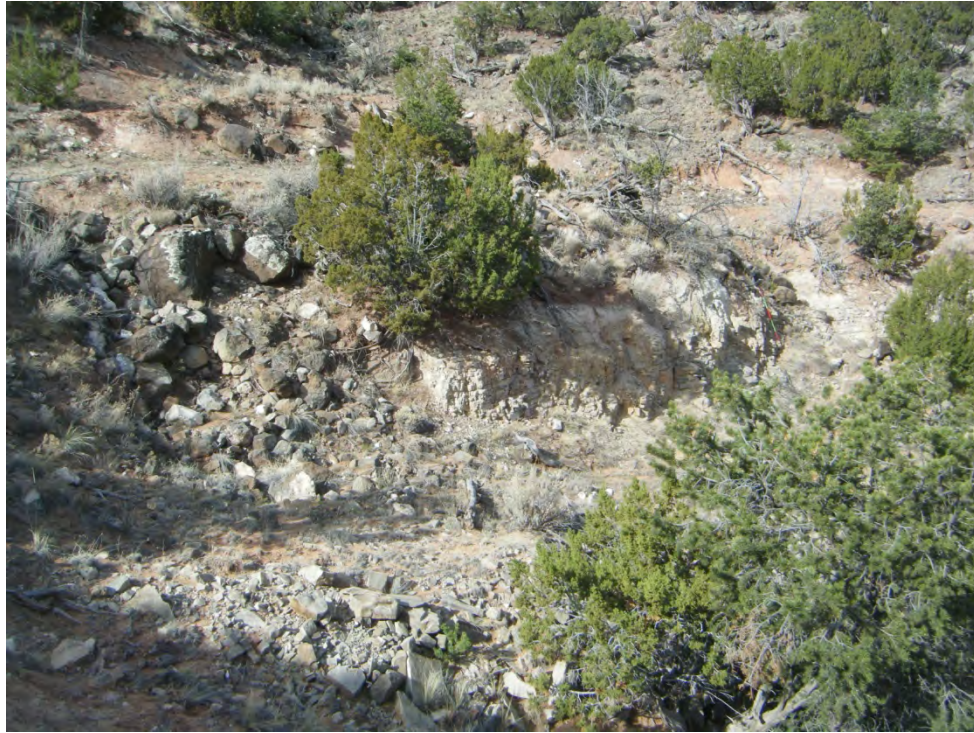
Five open cuts were found at the AUM Site. CutPly-1 is the rim-stripped area mentioned by Anderson (1980); see Photos 1-3 in Appendix A of this report and Photo (a) in Anderson (1980). The highest gamma radiation reading on this open cut was 70  $\mu$ R/hr at 0 ft above ground at radiation survey point Rad-1. CutPly-2 (see Photo 5 in Appendix A) is due west of CutPly-1,

Photo 1-Looking southwest at CutPly-1, replicating Anderson Photo (a).

Photo 1 - looking southwest at CutPly 1, per Anderson photo a.

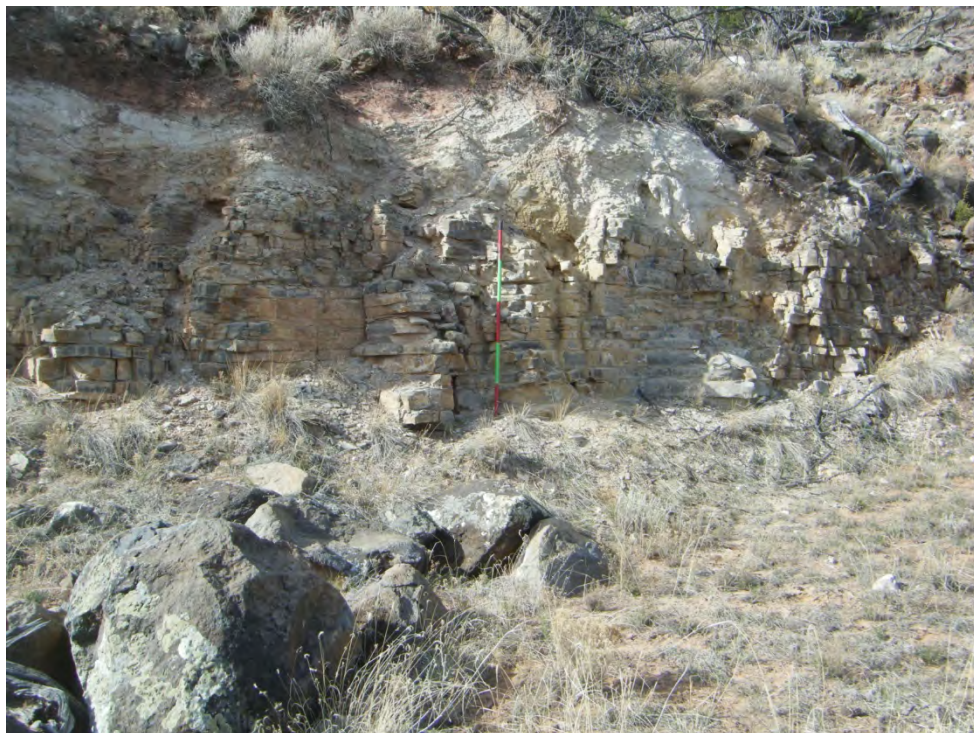
Photo 2-Looking south at CutPly-1.

Photo 2 - looking south at cutply 1

Rad 1 - CutPly 1 face; 0m - 70 uR/h; 1m - 17 uR/h

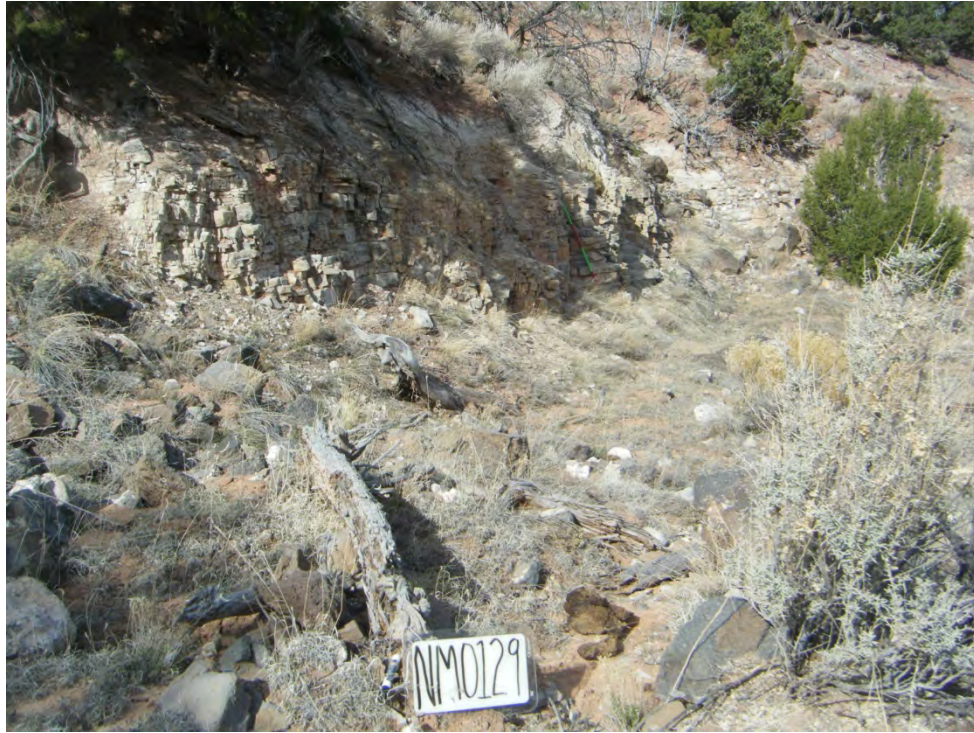
Photo 3-Site photo, looking southwest at CutPly-1. The mine number on the white board is incorrect. It should read "NM0127".

Photo 3 - Site name looking southwest at CutPly 1

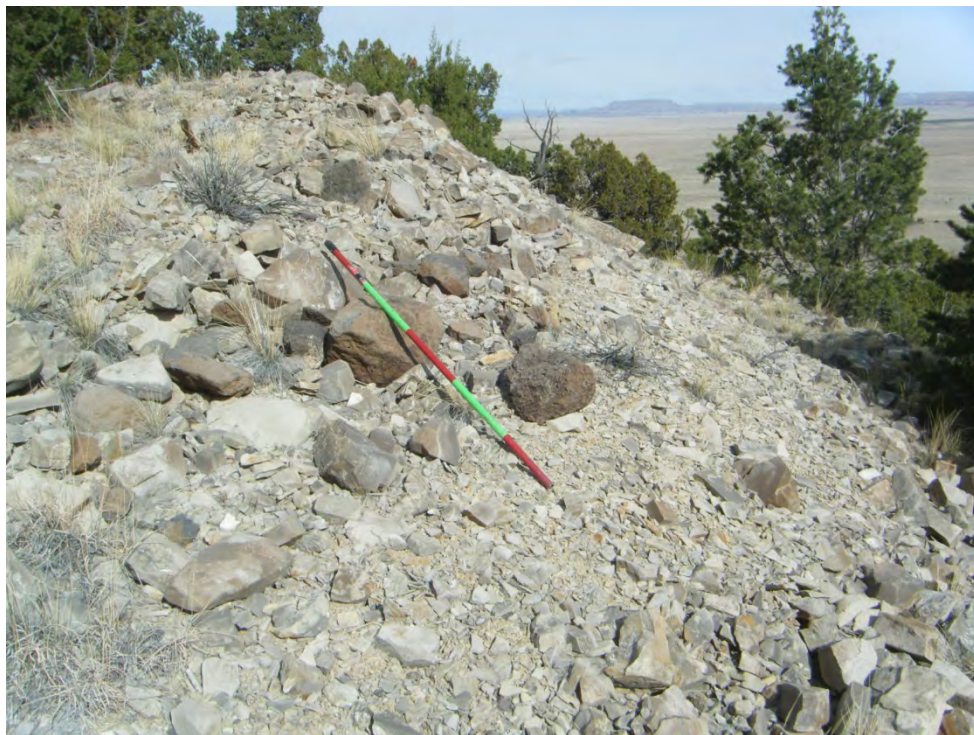
One waste pile (PilePly-1) and two pile ridges (PileRidge-1 and PileRidge-2) were found at the AUM Site. PilePly-1 lies west and downslope of CutPly-1 (see Photo 4 in Appendix A). The maximum gamma radiation reading on this pile was 18  $\mu\text{R/hr}$  at 0 ft above ground at radiation survey point Rad-3. PileRidge-1 (see Photo 6 in Appendix A) and PileRidge-2 (see Photo 7 in Appendix A) lie between CutPly-2 and CutPly-3. The maximum gamma radiation measured on these pile ridges was 15  $\mu\text{R/hr}$  at 0 ft above ground at radiation survey point Rad-6.

Photo 4-Looking northwest at PilePly-1.

Pile Ply 1 - 3' high, 15' wide, 45' long

Rad 3 - Pile Ply 1; 0m - 18 uR/h; 1m - 9 uR/h

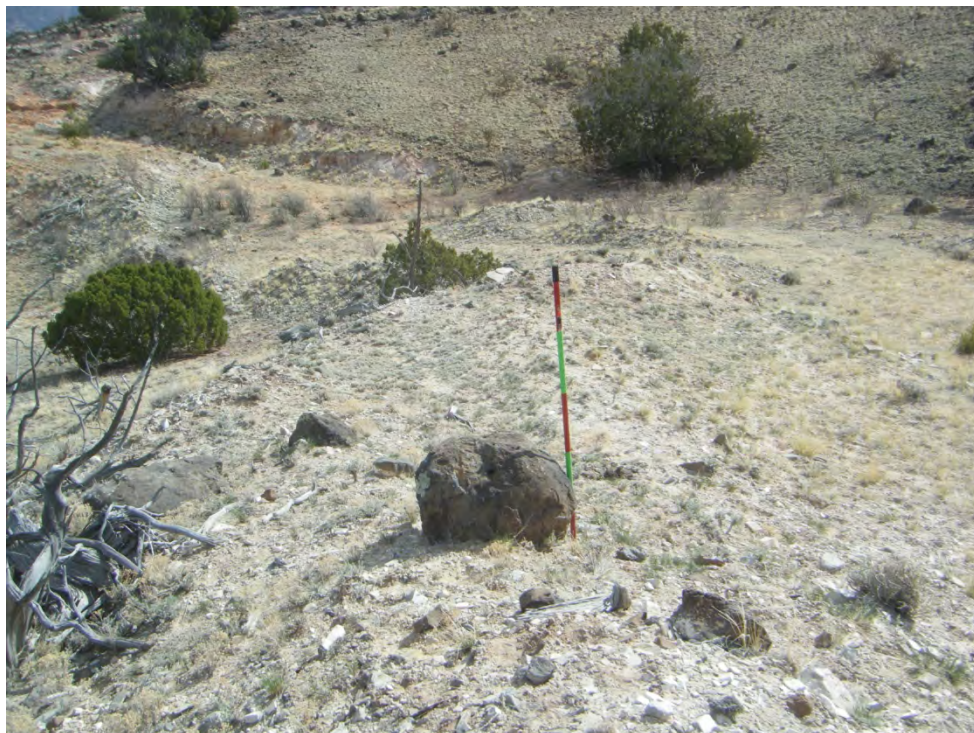
Photo 6-Looking east at PileRidge-1.

Pile Ridge 1 - 3' high, 10' wide, 225' long

Rad 4 - Pile Ridge 1; 0m - 6 uR/h; 1m - 6 uR/h

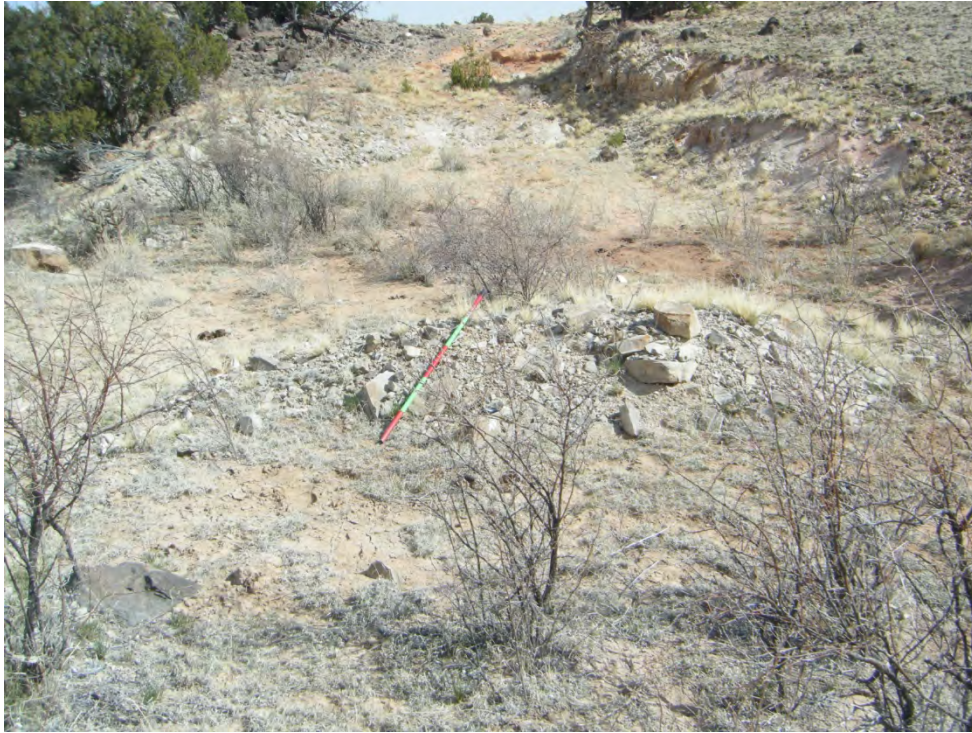
Photo 7-Looking north at PileRidge-2.

Pile Ridge 2 - 2' high, 5' wide, 40' long

Rad 6 - Pile Ridge 2; 0m - 5 uR/h; 1m - 9 uR/h

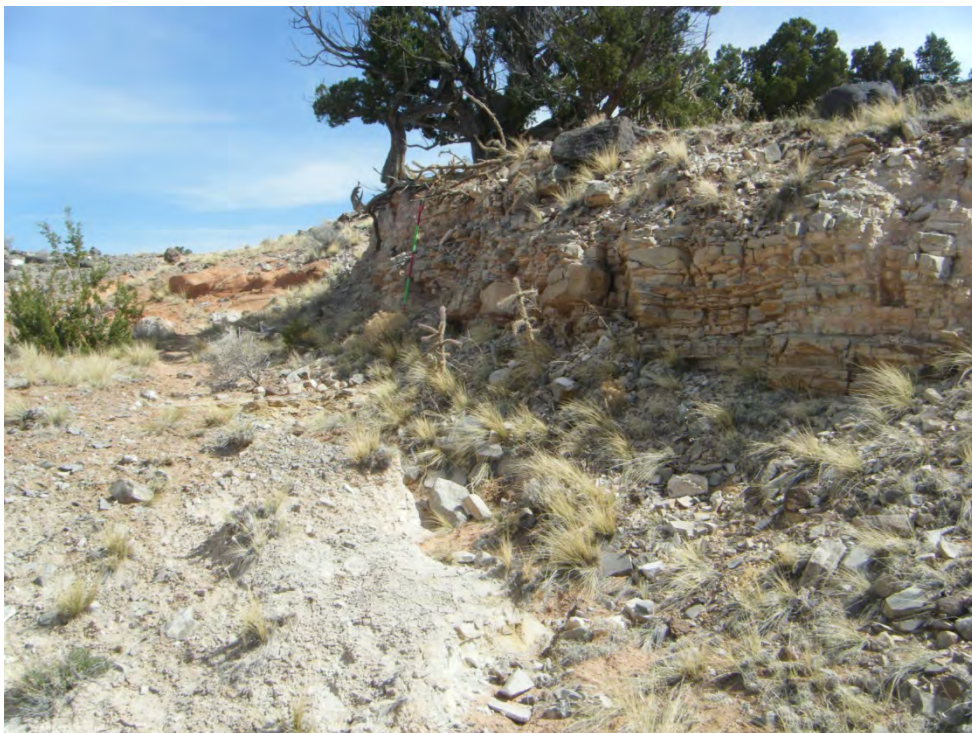
Photo 8-Looking north at CutPly-3.

CutPly 3 - 5' high, 20' wide, 90' long

Rad 7 - CutPly 3; 0m - 250 uR/h; 1m - 27 uR/h

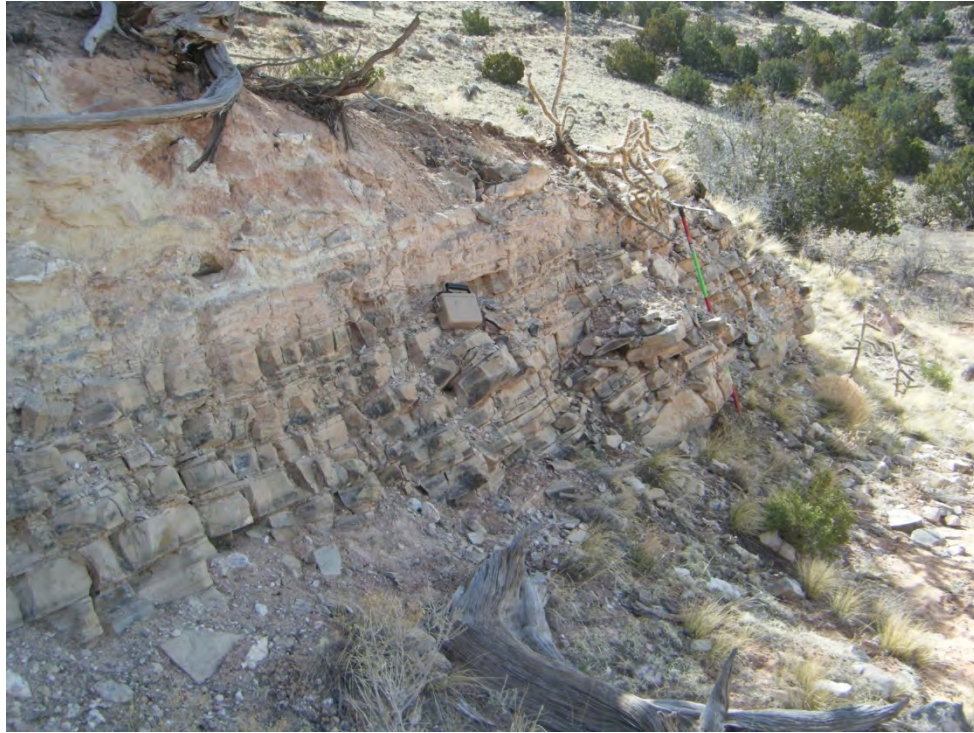
and the maximum gamma radiation reading was 16  $\mu\text{R/hr}$  at 0 ft above ground at radiation survey point Rad-5. CutPly-3 (about 150 ft northeast of CutPly-2; see Photos 8 and 9 in Appendix A) had some yellow uranium mineralization on fracture surfaces. The maximum gamma radiation reading at this open cut was 250  $\mu\text{R/hr}$  above ground at radiation survey point Rad-7. CutPly-4 (see Photo 10 in Appendix A) lies downslope and to the northwest of CutPly-2. The maximum gamma radiation reading at this open cut was 240  $\mu\text{R/hr}$  at 0 ft above ground at radiation survey point Rad-8. CutPly-5 is the bench cut mentioned in Anderson (1980); see Photos 11, 13, and 14 in Appendix A of this report and Photo (b) in Anderson (1980). CutPly-5 is along the current mine road (Access-1). The maximum gamma radiation reading at this open cut was 360  $\mu\text{R/hr}$  at 0 ft above ground at radiation survey point Rad-9.

Photo 9-Looking southeast at CutPly-3.

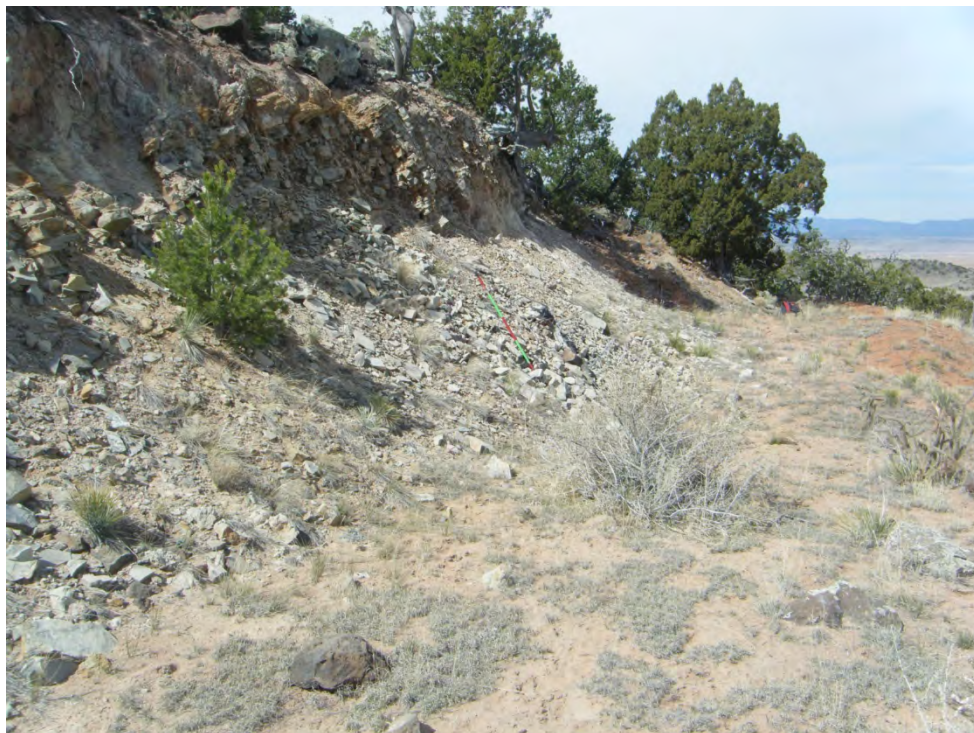
Photo 10-Looking southwest at CutPly-4.

CutPly 4 - 15' deep, 25' wide, 75' long

Rad 8 - CutPly 4; 0m - 240 uR/h; 1m - 40 uR/h

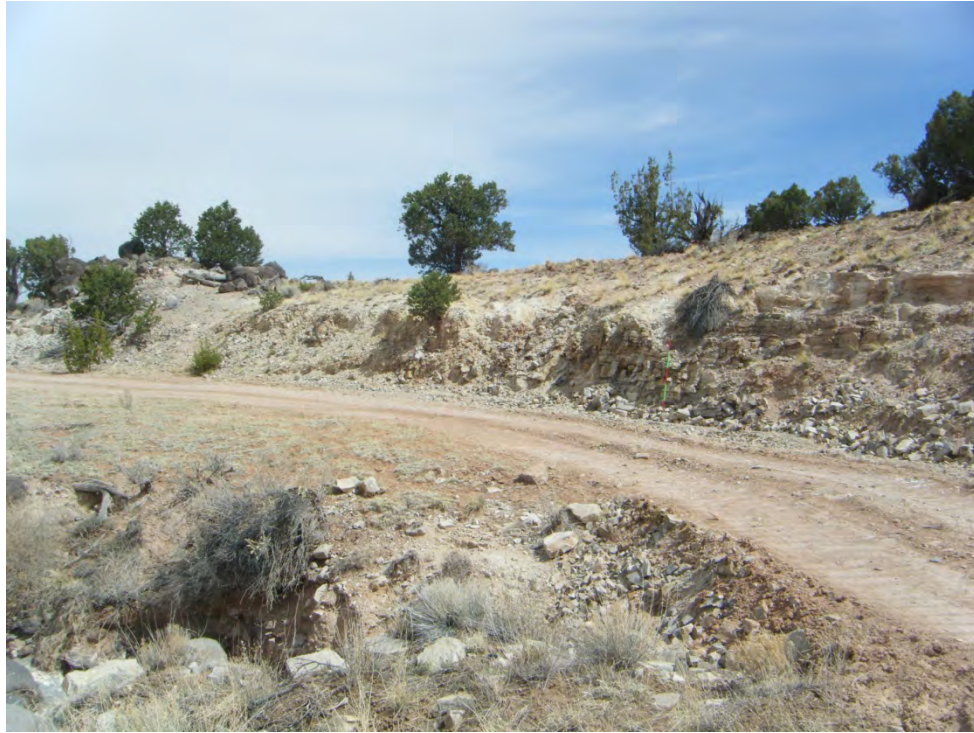
Photo 11-Looking north-northeast at CutPly-5.

CutPly 5 - 8' tall, 15' wide, 120' long; New access/mine road

Rad 9 - CutPly 5; 0m - 360 uR/h; 1m - 40 uR/h

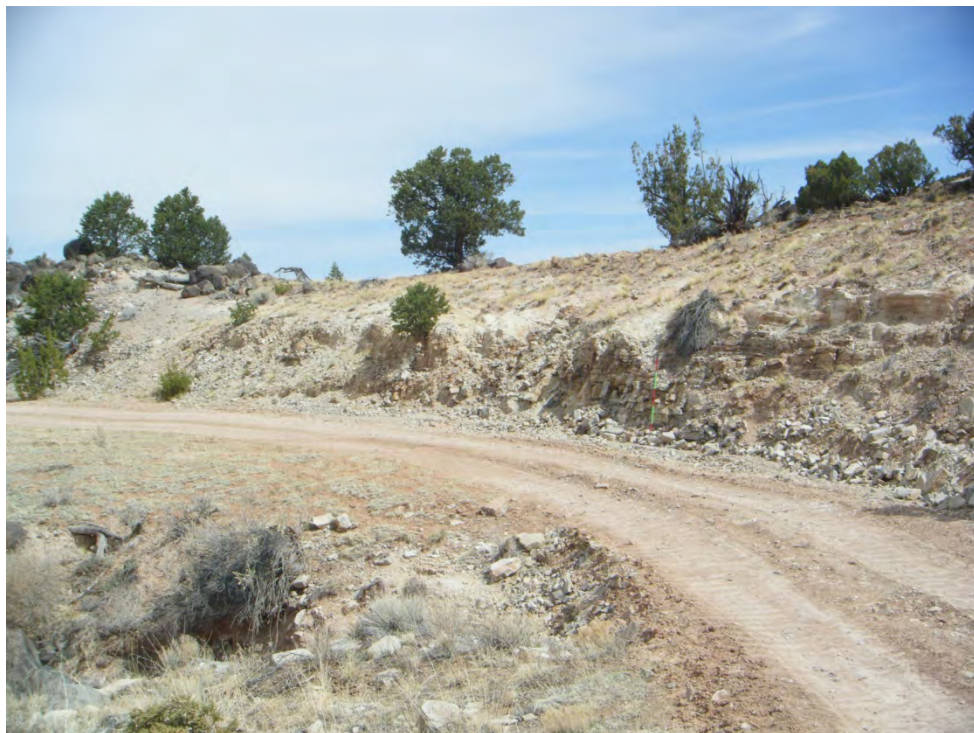
The maximum gamma radiation measured onsite was 360  $\mu\text{R/hr}$  at 0 ft above ground at radiation survey point Rad-9, associated with CutPly-5. Another notable radiation reading was 250  $\mu\text{R/hr}$  at 0 ft above ground at radiation survey point Rad-7, associated with CutPly-3. In addition, a radiation reading at CutPly-4 measured 240  $\mu\text{R/hr}$  at 0 ft above ground at radiation survey point Rad-8.

Photo 13-Looking north-northeast at CutPly-5, replicating Anderson Photo (b).

Photos 11-13 - looking north-northeast at CutPly 5,  
per Anderson photo b.

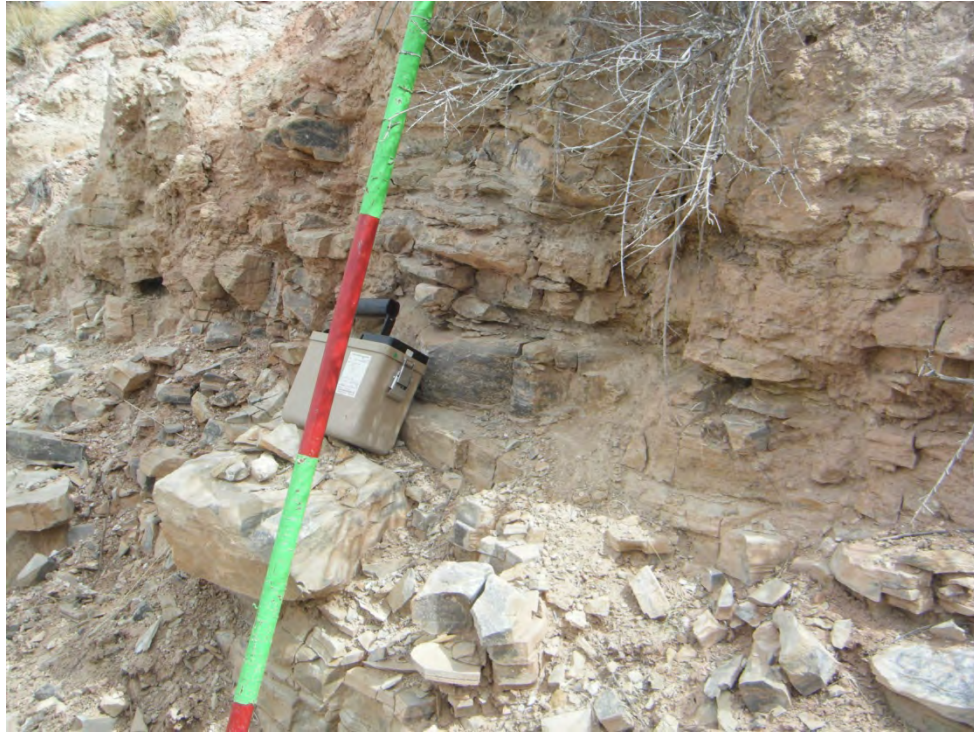
Photo 14-Looking northwest at radiation survey point Rad-10 (250  $\mu$ R/hr at 0 ft above ground).

Rad 10 - CutPly 5; 0m - 250 uR/h; 1m - 40 uR/h

Photo 14 - looking northeast at CutPly 5 face and Rad 10

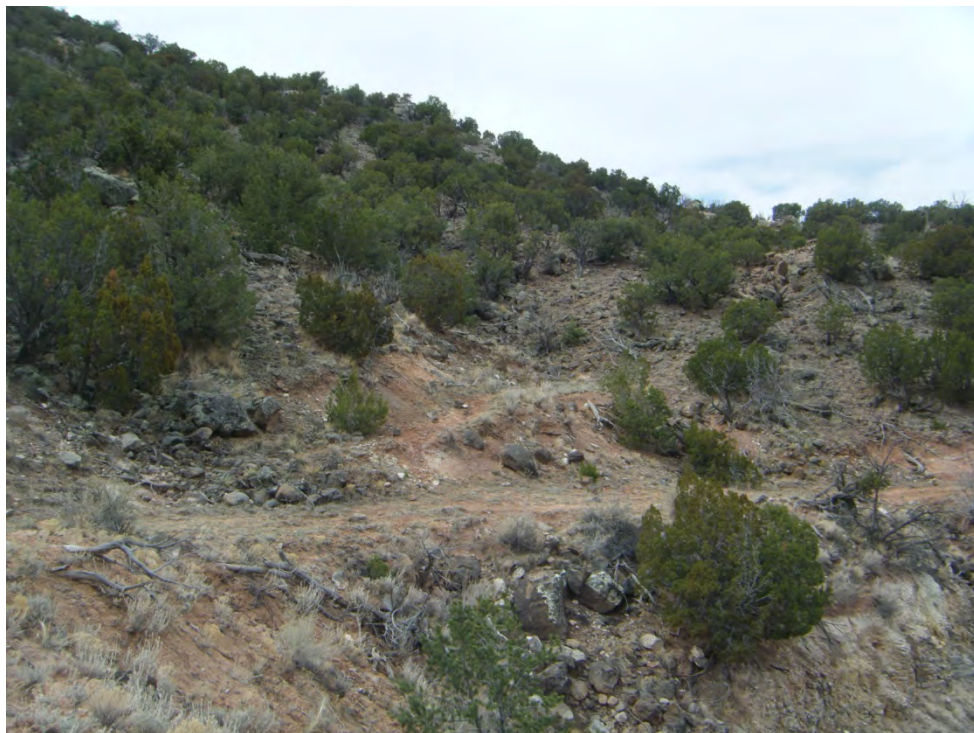
The Tom site is located between in the Coniferous and Mixed Woodland vegetation type. Vegetation is dominated by pinyon pine and several juniper species. Other woody species include fourwing saltbush, yucca, and cholla. Forbs were present at the site and included different aster species. Grass species present were Indian ricegrass, hairy grama, and curly-mesquite. No evidence of noxious weeds was found onsite.

Photo 28-AUM Site vegetation.
