# Lee Ranch Mine Use Attainability Analysis Sampling Plan

*September 2015*

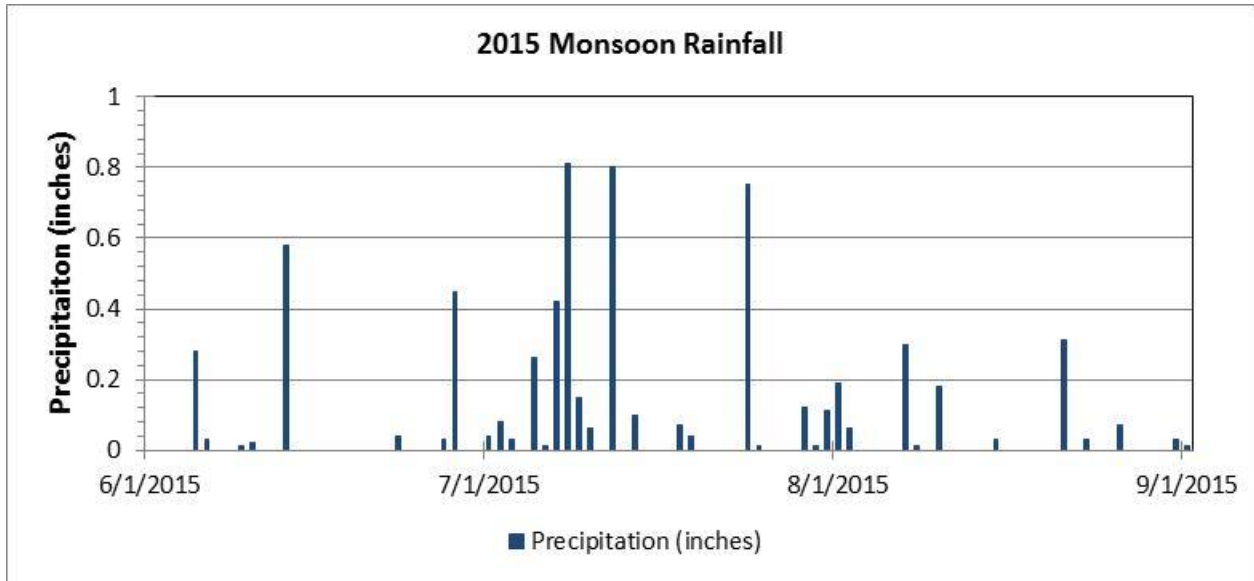
Figure 2: 2015 Monsoon rainfall recorded at Lee Ranch Mine during 2015.

The hydrology protocol recommends conducting the hydrology protocol between mid-September and early-November to avoid influence from monsoon rainfall. Cumulative rainfall recorded at LRM for the period of June through August of 2015 was 6.52 inches (Figure 2). The 12-month Standardized Precipitation Index (SPI) shows that the site is currently within the range of +0.8 – 1.29, indicative of above average rainfall conditions (Figure 3). Although the data show that conditions are above average moisture at this time, a field reconnaissance was conducted on September 2 and 3 for the proposed sampling locations and the majority of sites had dry stream beds. LRM personnel intend to conduct the field work for the hydrology protocol in late October and early November, 2015. This should be enough time for the streams to stabilize following the monsoon rain events.
