QUARTERLY GROUNDWATER  
MONITORING REPORT  
DOÑA ANA DAIRIES  
MESQUITE, NEW MEXICO

August 2021

EA Project No. 1464108.02

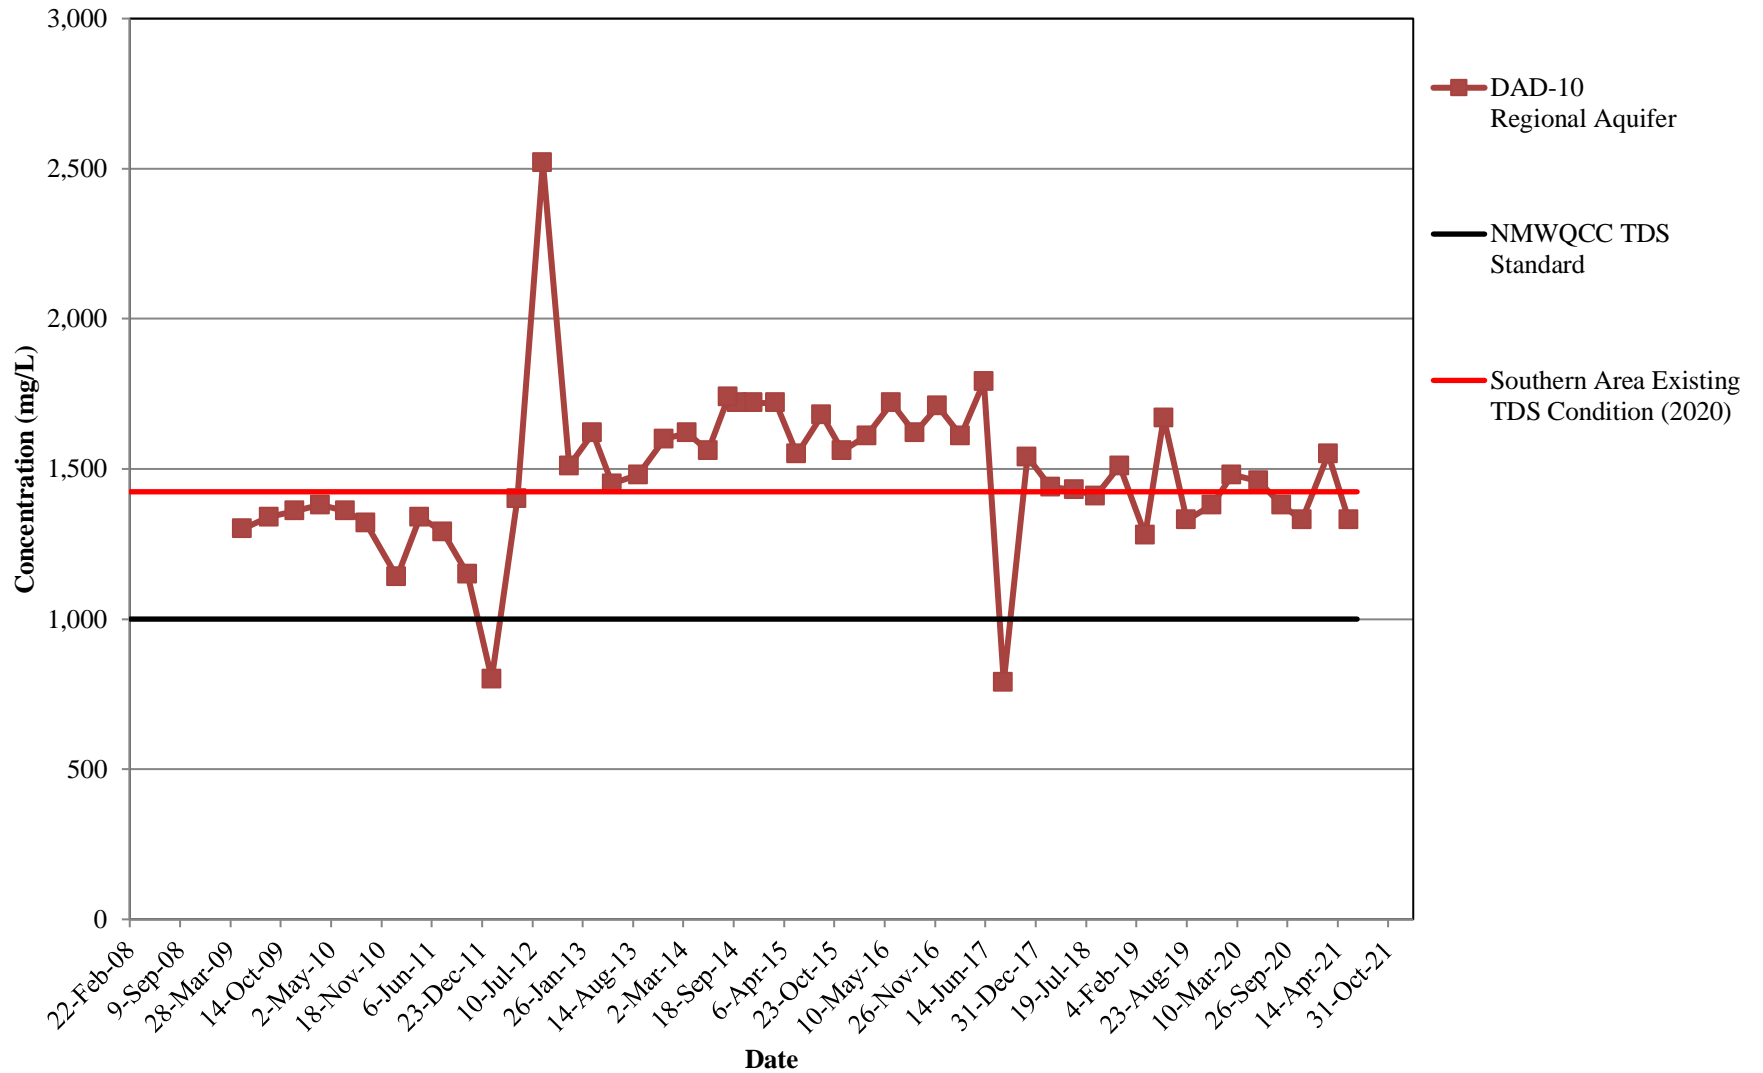
**TDS CONCENTRATION TRENDS  
SOUTHERN ABATEMENT PLAN MONITORING WELLS  
IN THE REGIONAL AQUIFER  
DONA ANA DAIRIES, DONA ANA COUNTY, NEW MEXICO**
