Abandoned Uranium Mine Site Assessment for the Bear Canyon Group Site (NM0138)

FINAL REPORT

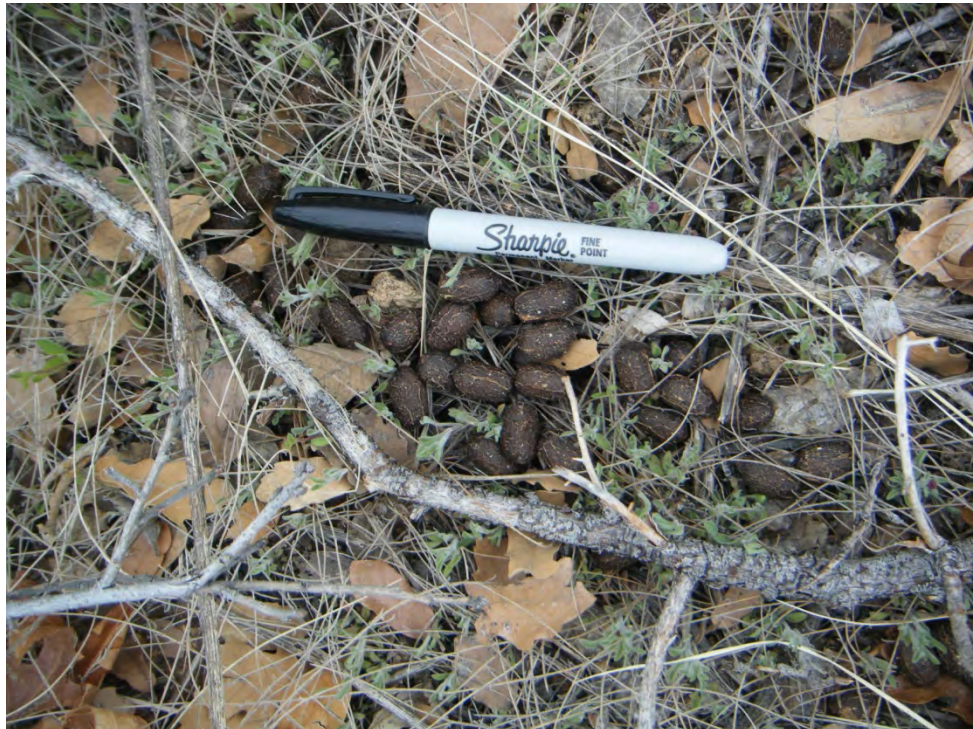
Photo 31-Deer scat found at the AUM Site.

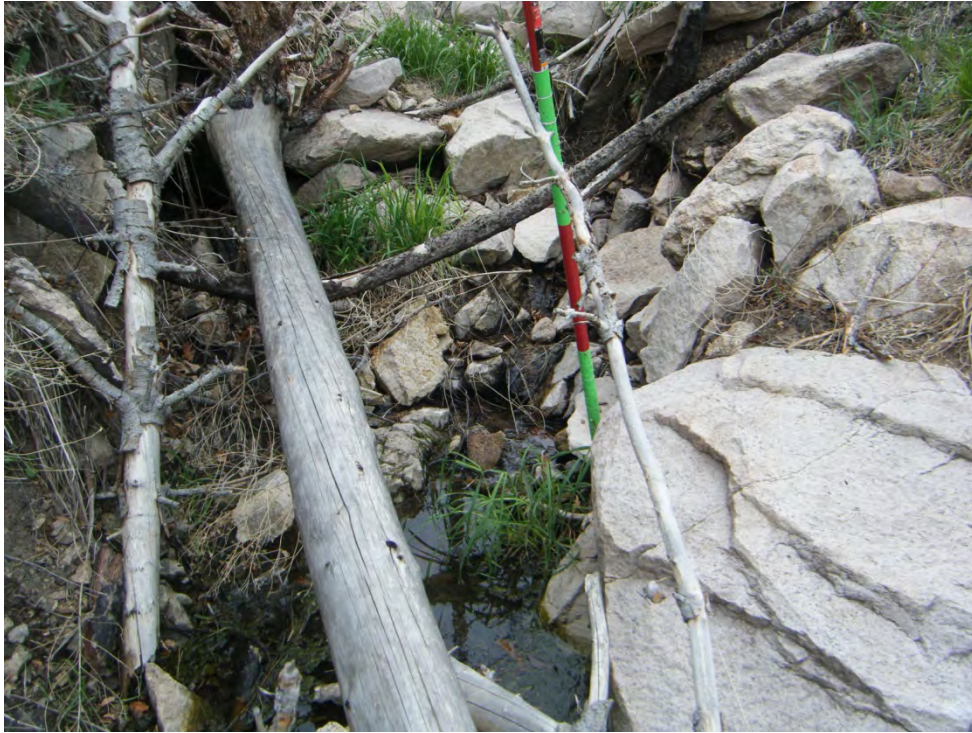
Photo 33-A spring found downstream from the AUM Site.

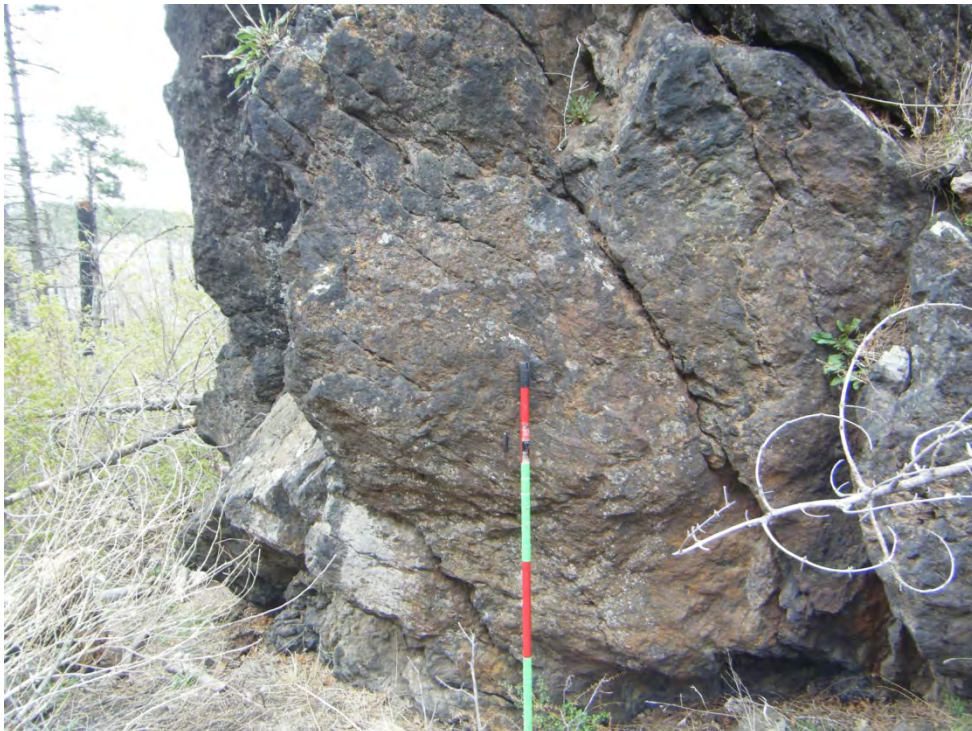
Photo 34- Outcrop onsite (radiation survey point Rad-10, 19 μ R/hr at 4 ft above ground). Outcrop will attract magnets.

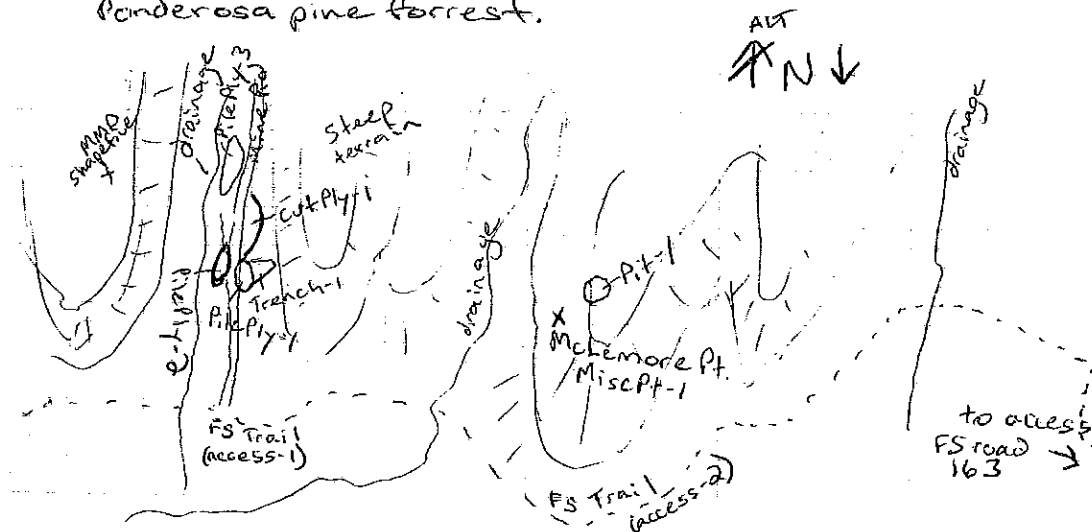
Wildlife: Gray squirrel, hawks, mountain bluebird, nuthatch, other small birds. Deer and cottontail droppings. Coyote scat. Ponderosa pine forest.
