ABANDONED OR INACTIVE URANIUM

MINES IN NEW MEXICO

New Mexico Bureau of Mines and
Mineral Resources
Open-File Report 148

Mine name(s) Williams & Thompson (Sec. 18) County McKinley

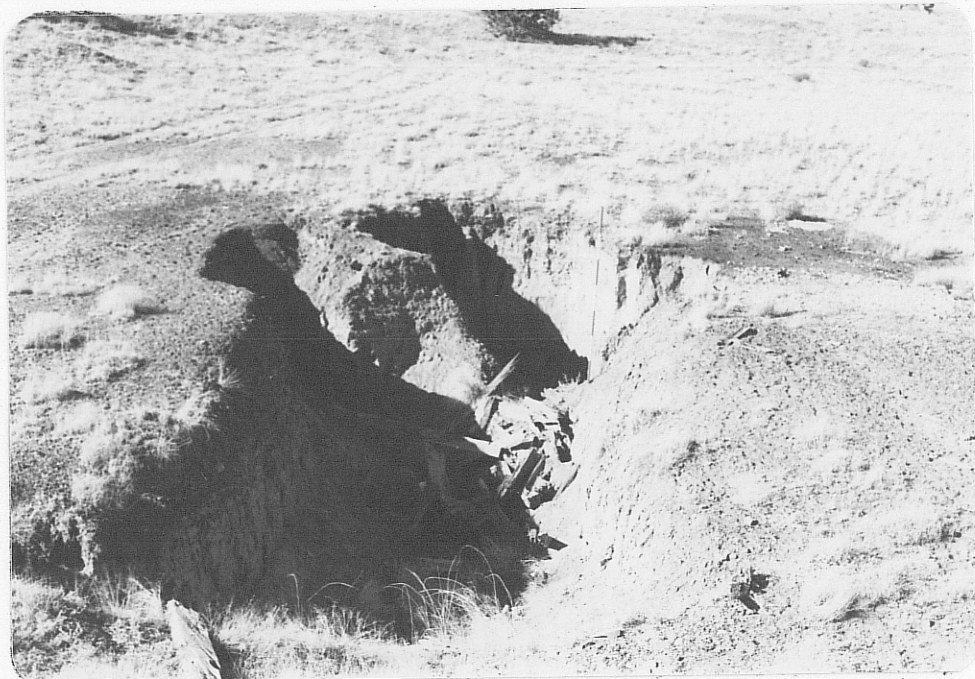
Photo (a) Looking north at caved shaft; note range pole at right side of shaft for scale.

The mine consists of a shaft, a loadout facility, and a long trench with a decline driven at the end; (see Fig. 1). The shaft has caved (photo a) but a portion of the collar or timbering is still visible in the hole. Present depression is circular in plan and is about 10' deep. The shaft may have been inclined.

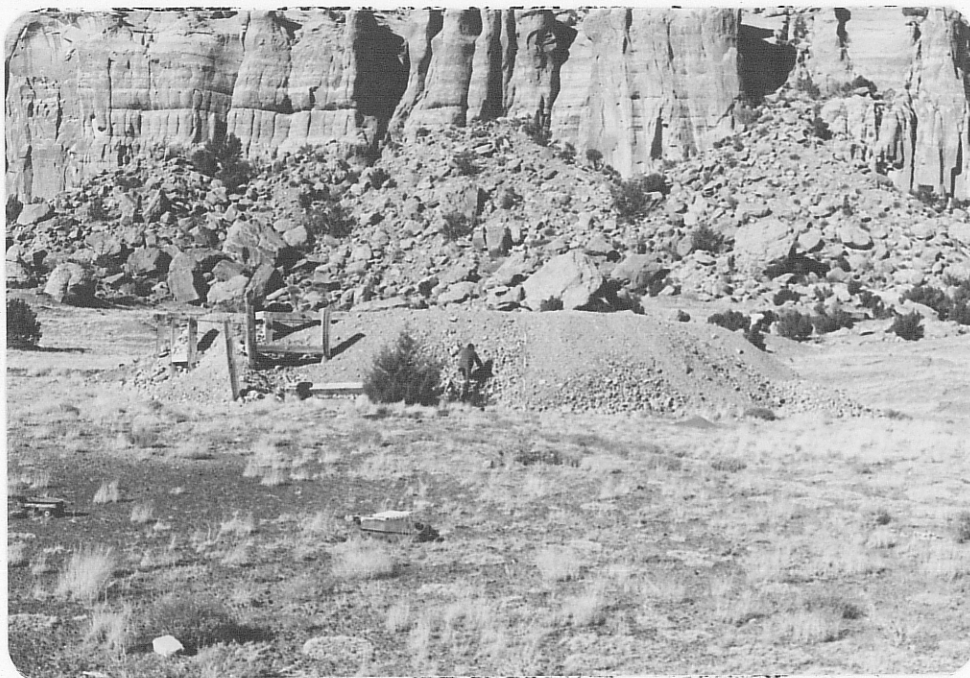
Photo (b) Looking north at mine dump and wooden load out facility at left; note person at center on toe of dump for scale.

The dump, shown in photo (b), is about 60' x 40', 8'-9' high, and is immediately south of the shaft. A deteriorating wooden load out structure is at west edge of dump. A stockpile area for low grade ore lies 100' south of the mine dump, and consists of a cluster of conical piles up to 3' high spread over an area that measures 100' x 100' (see photo c). Scintillometer readings on these piles ranged up to 1,000 cps. The only building structure remaining on the site is a metal shed (photo d) which stands about 350' southwest of the shaft.

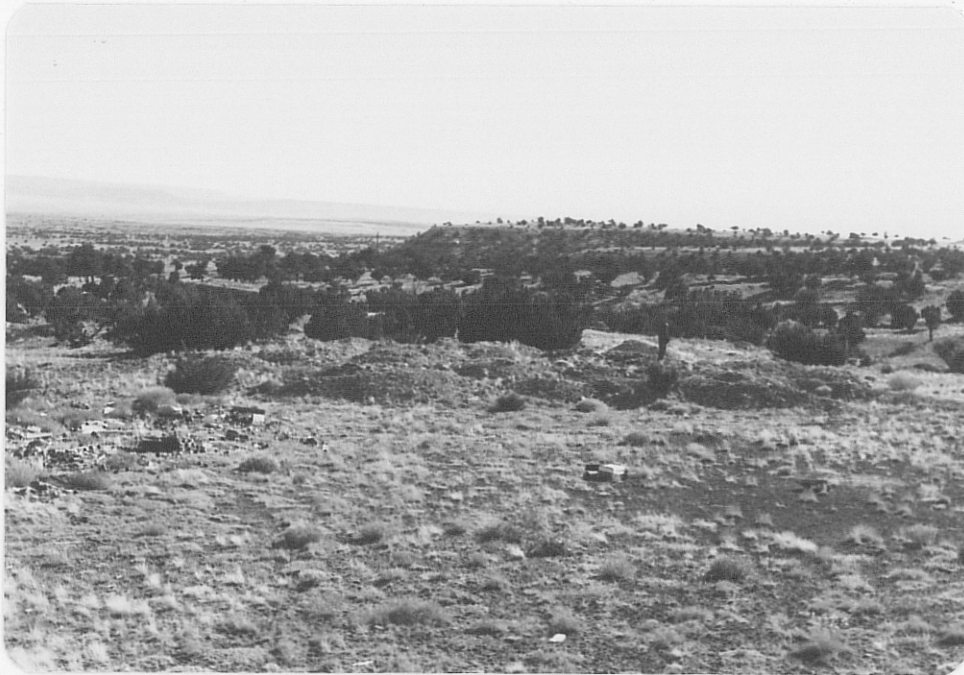
Photo (c) Looking south at low grade ore stock pile area 200' south of the shaft in photo (b); note person at right on pile for scale.

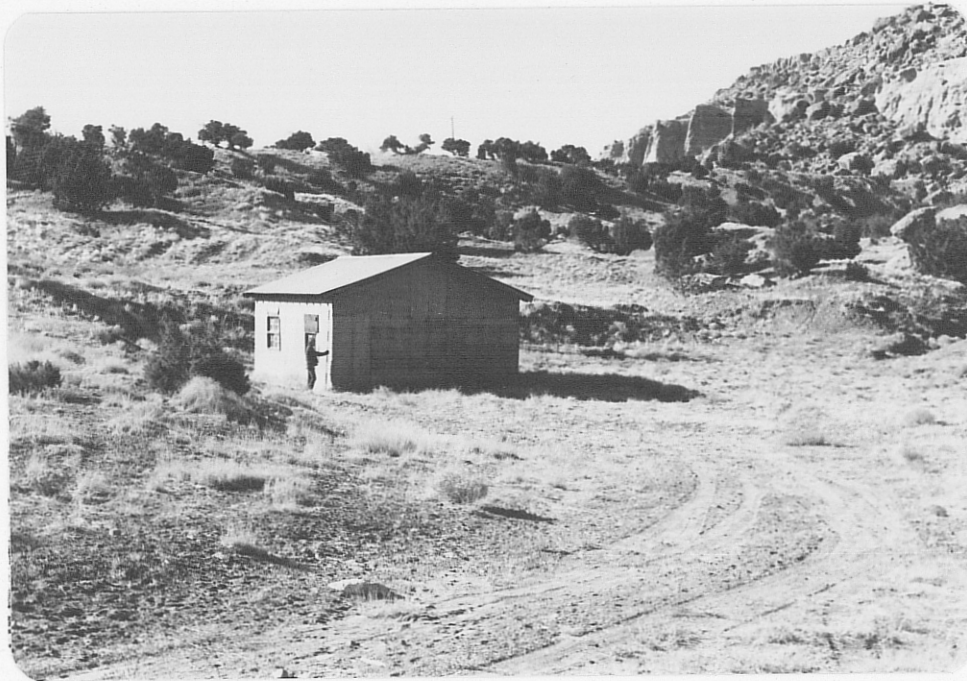
Photo (d) Metal shed about 350' southwest of shaft; note person at left side of shed for scale.

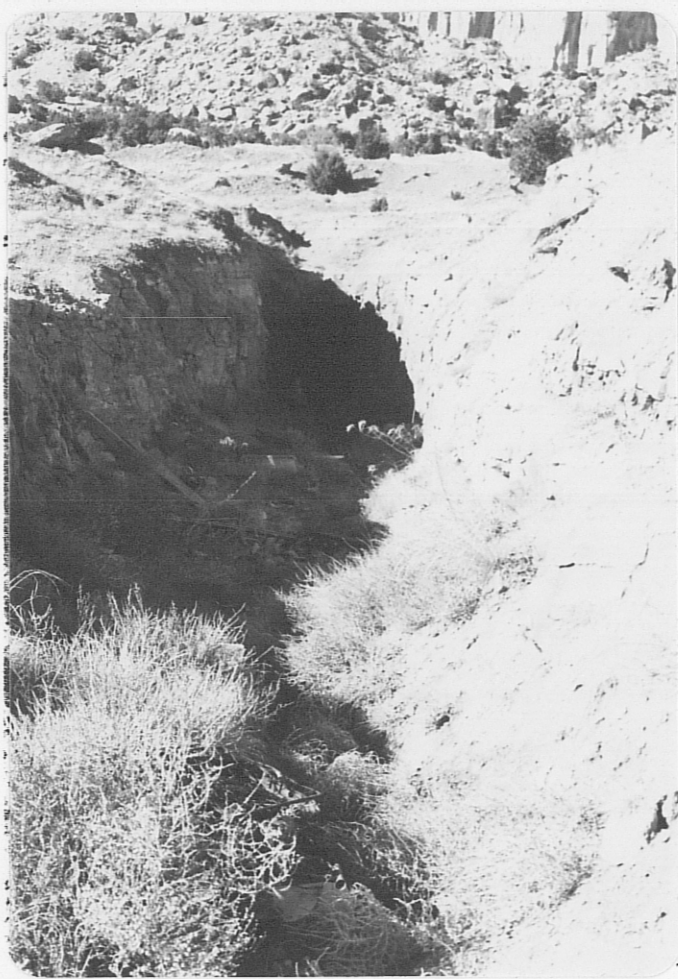
Photo (e) Looking NW into trench with drift at far end; note person standing on floor of trench at upper center.

Also southwest of the above described workings is a 250' long NW trending trench that descends gently to an open stope (see photo e) with a timbered drift driven NW into the north face (see photo f). Opening is about 4 $\frac{1}{2}$ ' high and 12' wide; length of drift is about 12'. Scintillometer readings in stope near opening to drift were about 150 cps.

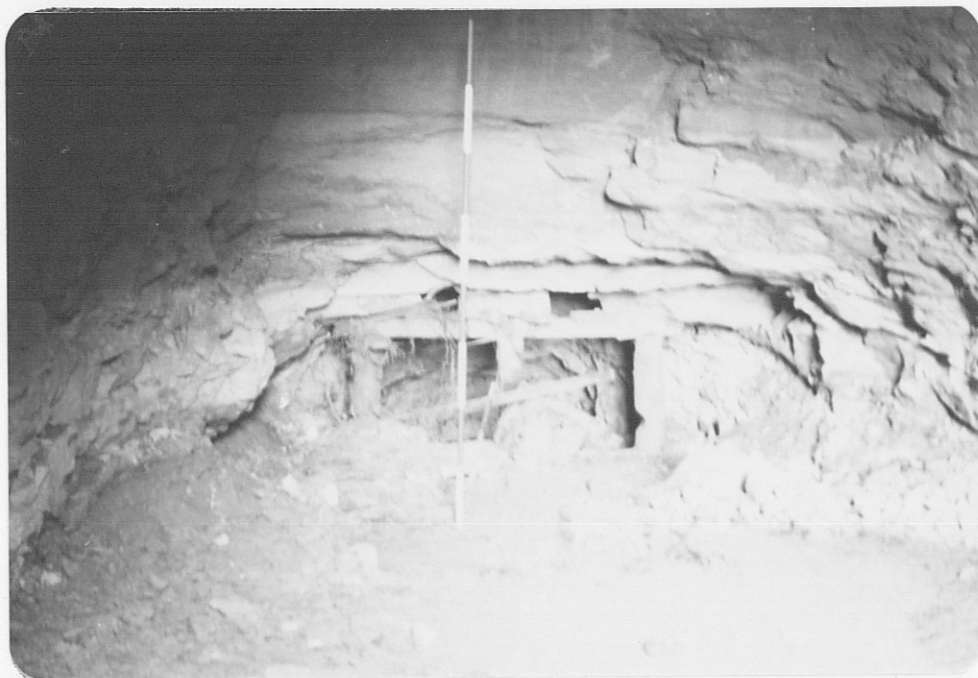
Photo (f) Drift driven NW at end of trench shown in photo (e); trench terminates in a 25' high open slope, and drift is driven into north face of slope; range pole at center for scale.
