ABANDONED OR INACTIVE URANIUM
MINES IN NEW MEXICO

New Mexico Bureau of Mines and
Mineral Resources
Open-File Report 148

Mine name(s) Sec. 24 (Glen & Edith) County McKinley

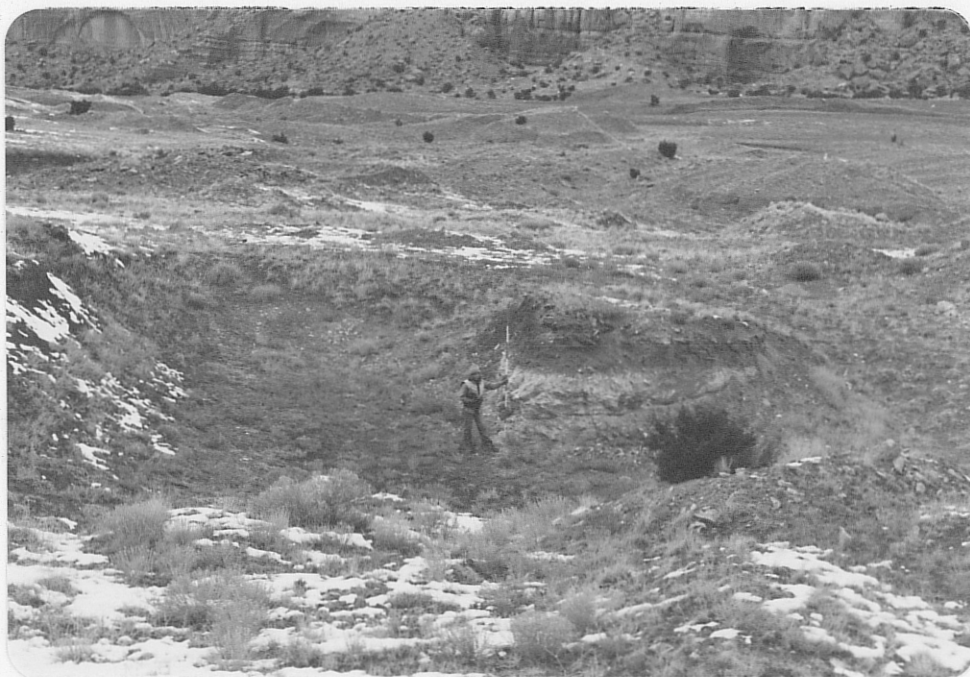
Photo (a) Looking NW into stripped area from SE edge of sec. 24 mine; note overburden piles at upper center and upper left extending for nearly 1,000' away from viewer. Mine trends NW.

The mine consists of an extensively worked NW trending area measuring about 900' by 300' (see photo a). The stripping sometimes involved removing more than 10' of unconsolidated overburden from the underlying Todilto limestone, forming conspicuous piles (photo b). Some of the cuts and pits extend for several hundred feet in maximum dimension (see photos b, c, and d). Photo (e) shows a small mine dump near the center of the strip complex. Photo (f) is a view "backward" toward the starting point shown in photo (a).

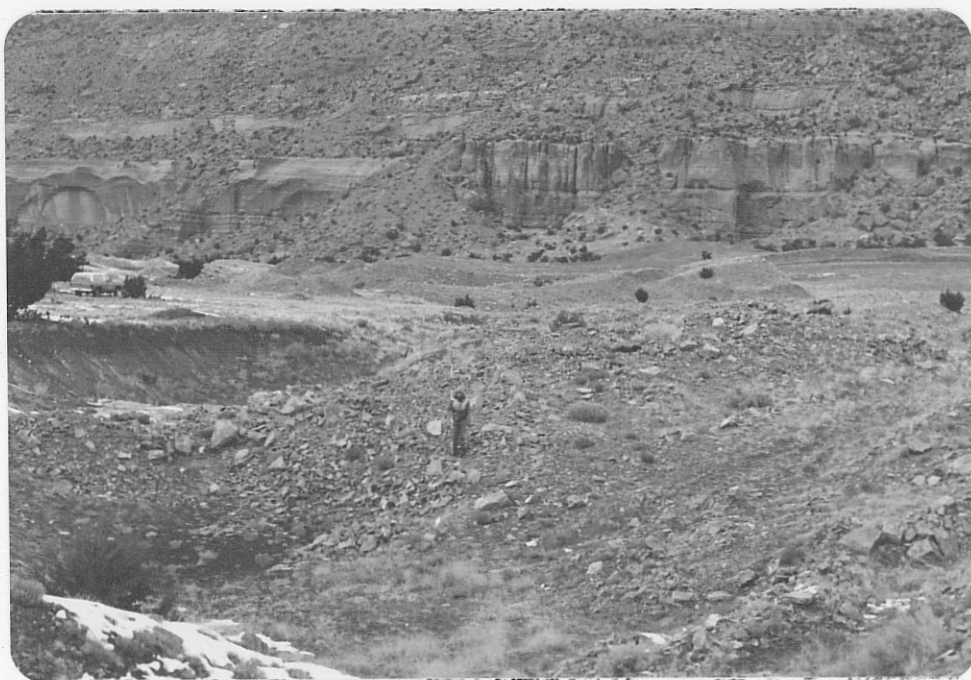
Photo (b) Looking again to NW, from within mine area, showing size and nature of individual pits; unconsolidated overburden is often more than 10' thick as seen in highwall below vehicle at left. Note large overburden and waste piles at center, middle distance.

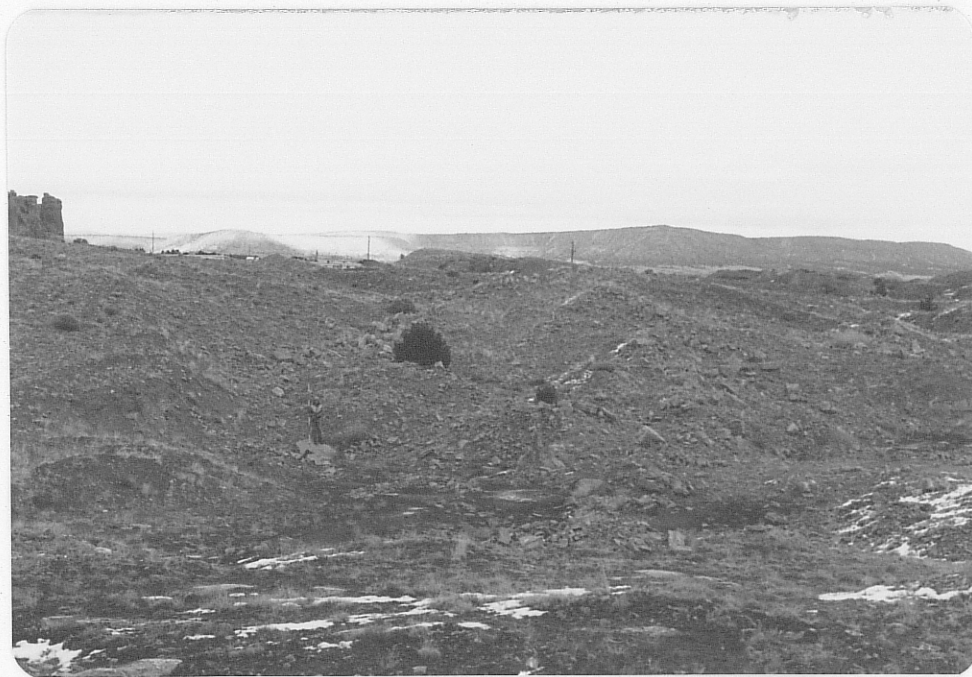
Photo (c) Looking NE at SE trending cut with waste piles on far side; note person at left for scale. Todilto Exploration Co., offices are just visible at left between last two utility poles.

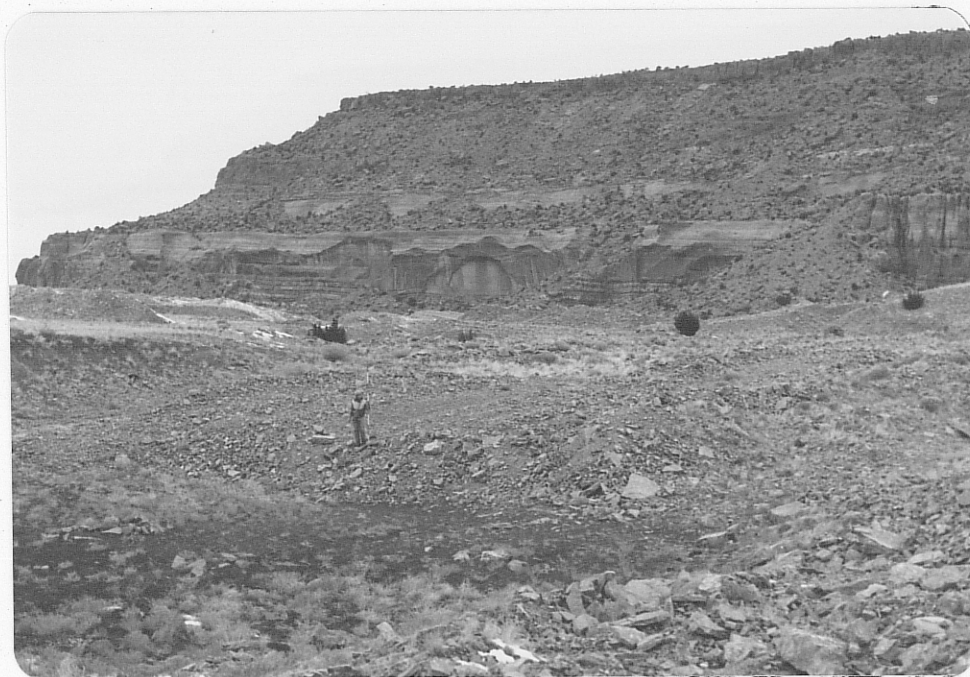
Photo (d) View to NW from small pit within the mine complex showing proximity of Haystack Mountain.

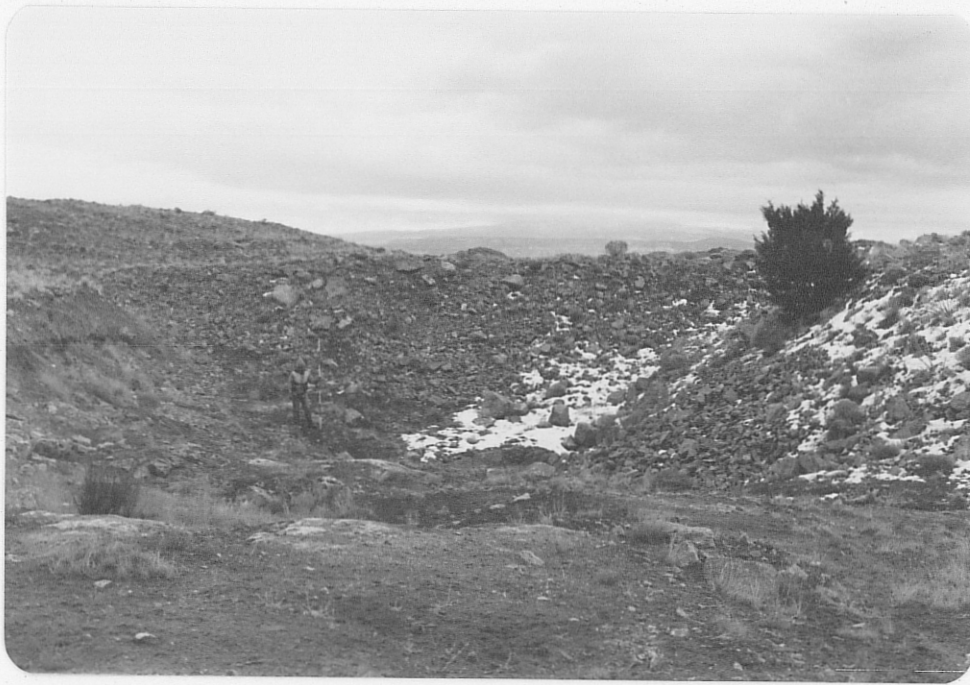
Photo (e) View eastward from near the center of the mine showing veneer of mine waste on slope behind shallow cut.

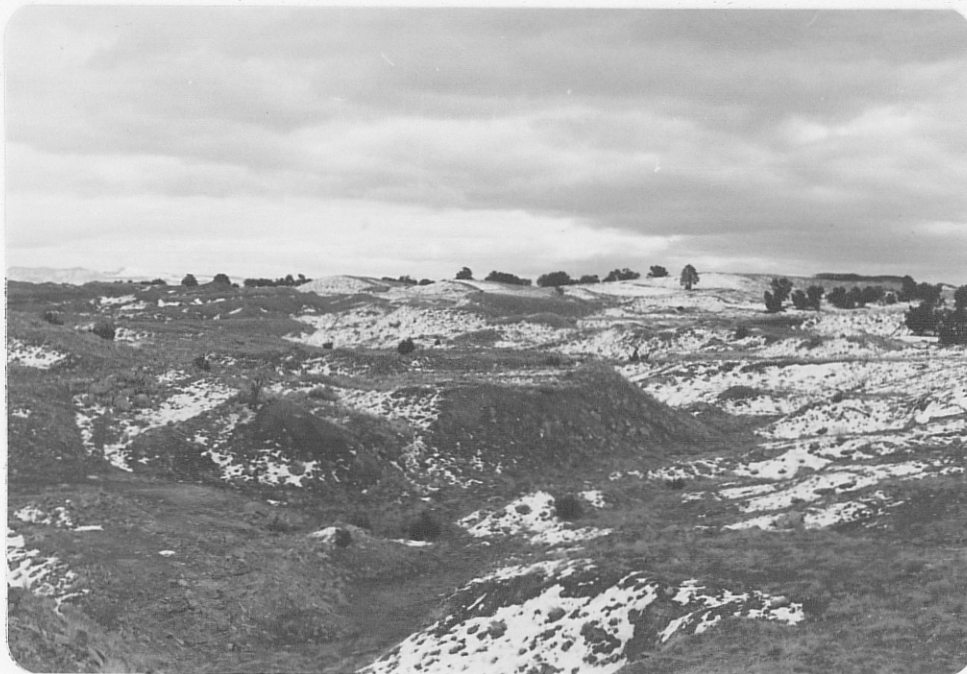
Photo (f) Looking SE back toward starting point in photo (a).
