Abandoned Uranium Mine Site Assessment for the Mitchell Price Mine (NM0250)

FINAL REPORT

INTERA Incorporated (INTERA) has prepared this Abandoned Uranium Mine (AUM) Site Assessment Report for the Mining and Minerals Division (MMD) of the New Mexico Energy, Minerals, and Natural Resources Department (EMNRD) in compliance with the Professional Service Agreement dated November 2, 2009. INTERA visited the Mitchel Price Site (AUM Site), MMD ID: NM0250, on December 22, 2009.

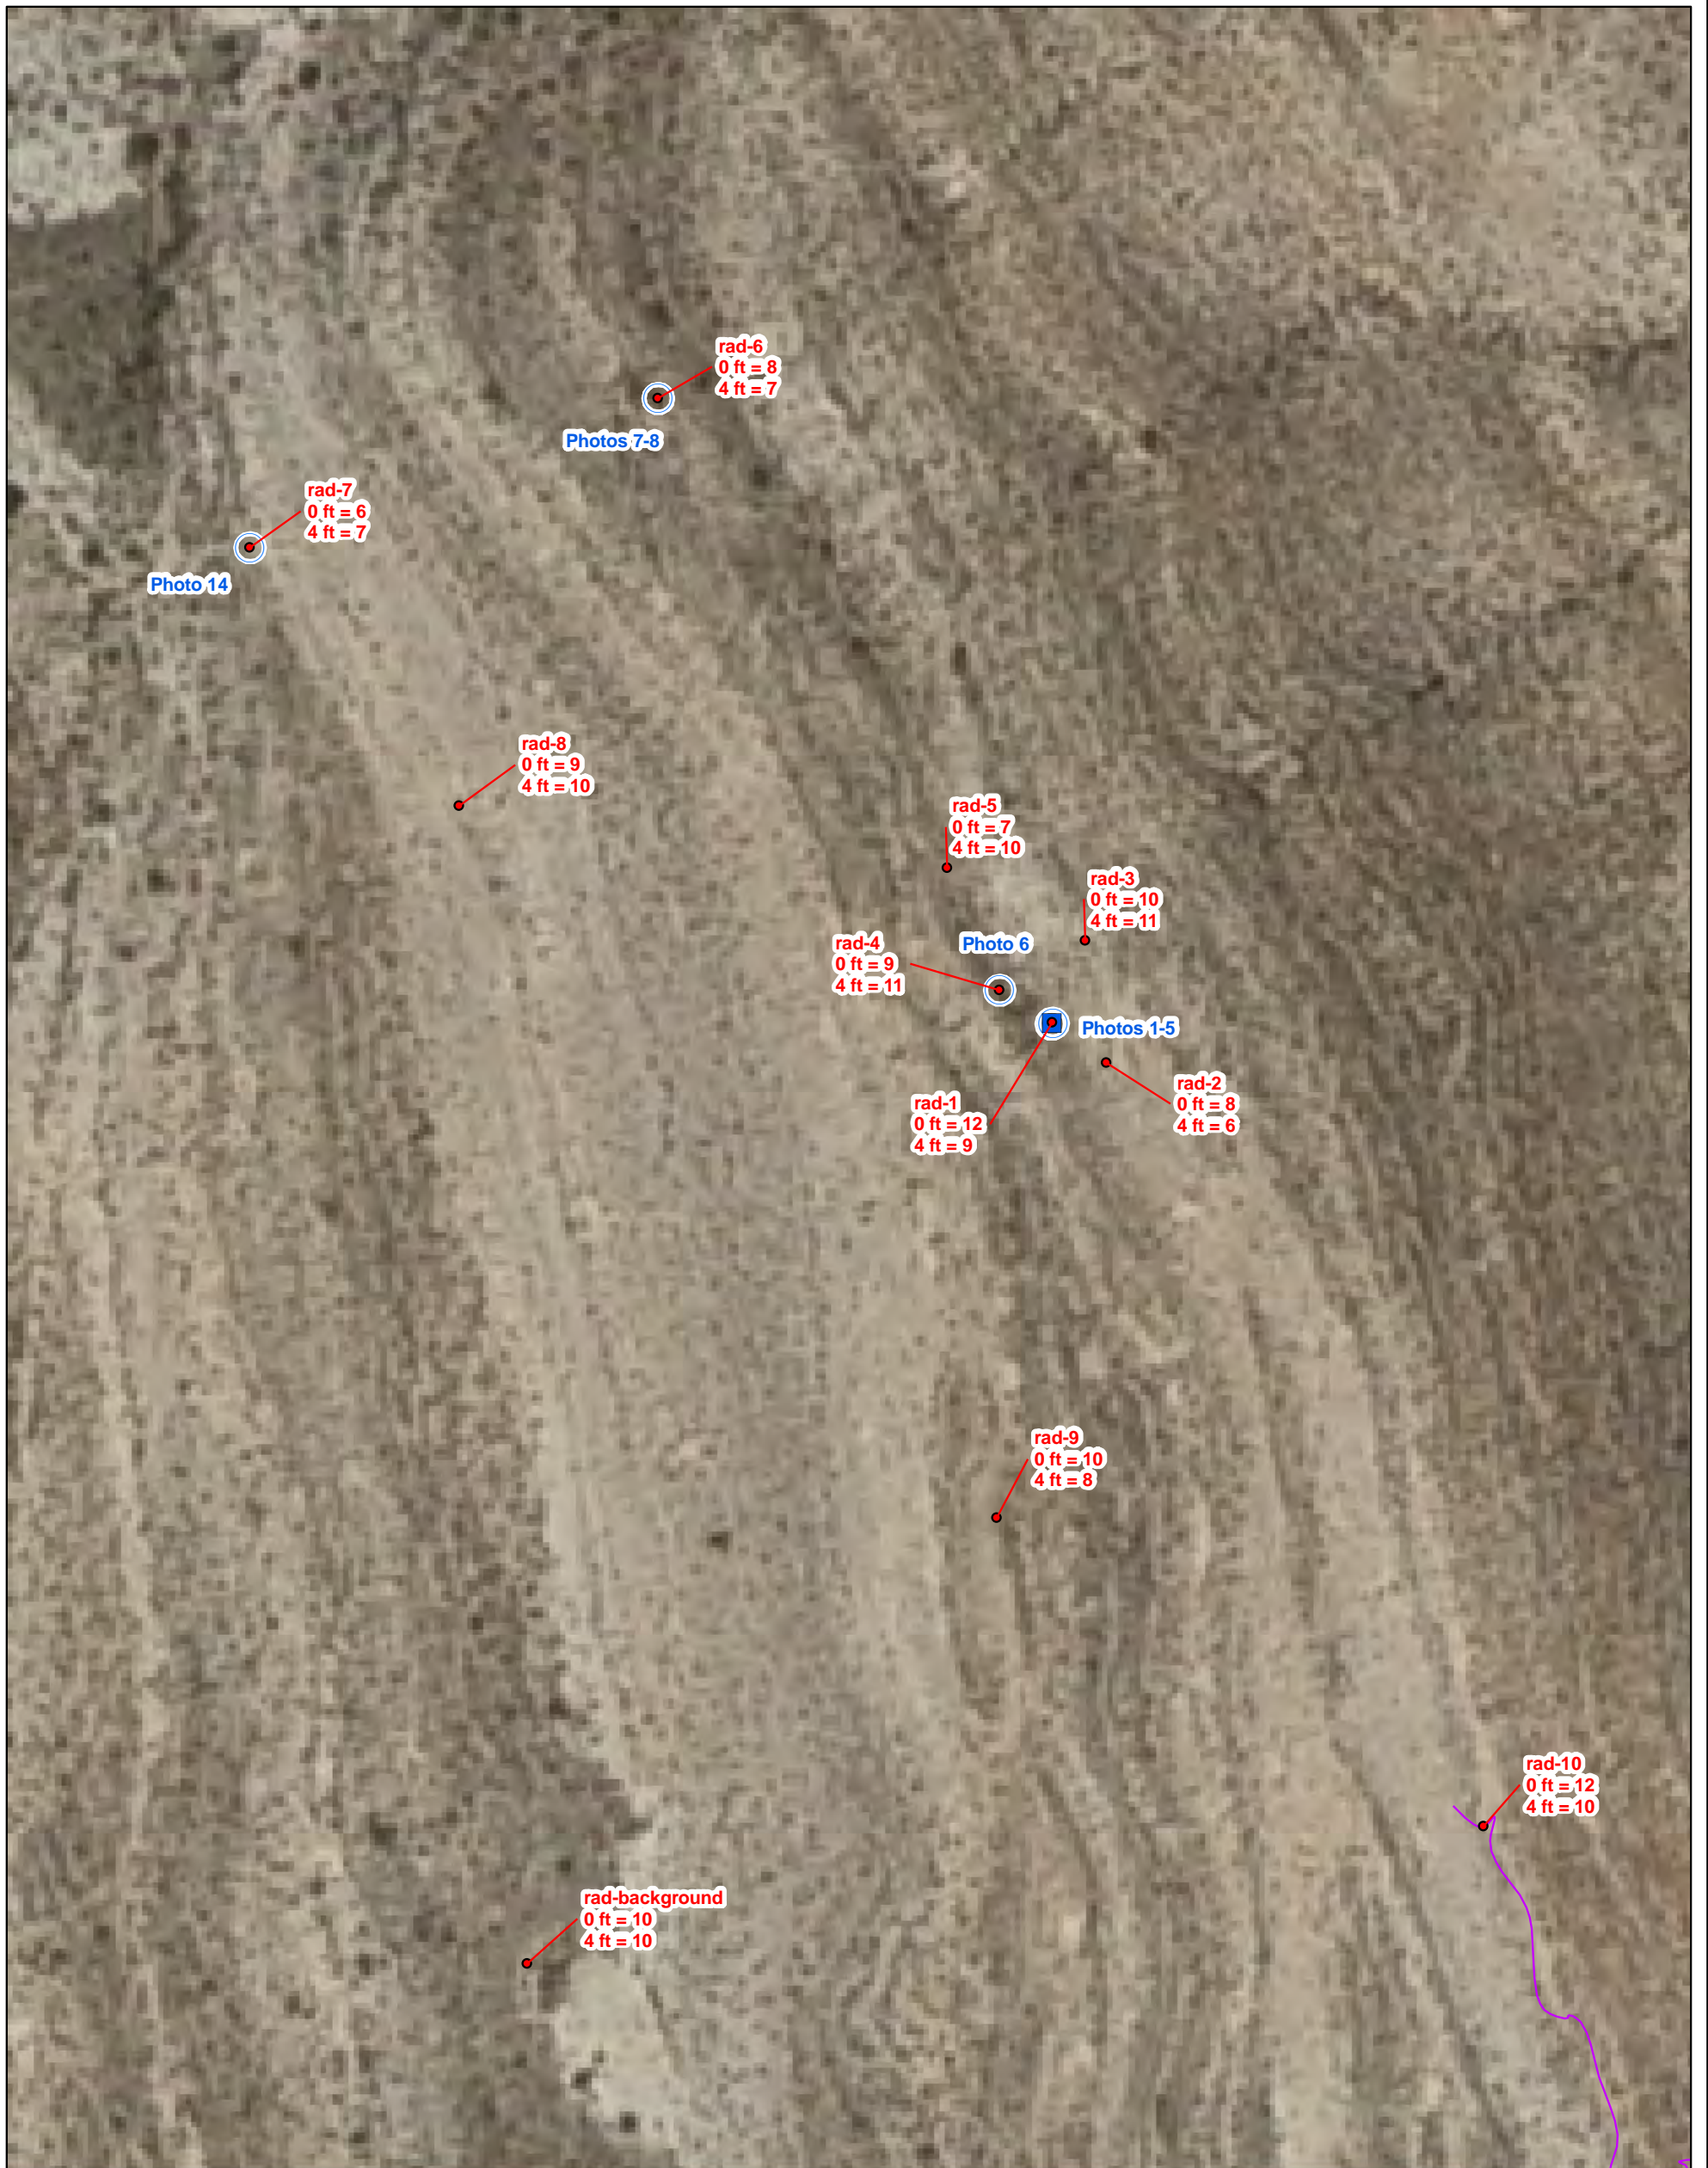
Figure 4a
Site Map on
Aerial Photo
NM0250-Mitchel Price
 Abandoned Uranium
 Mine Assessment

The mine features described below are based on the features provided to INTERA by MMD in the GIS Data Dictionary (MMD, 2009). INTERA marked the locations of the AUM Site features using a Trimble Global Positioning System (GPS), and entered details about the features into the GPS using the MMD data dictionary. No mine features were identified at the given AUM Site

location. Please see the Photo Log in Appendix A, Table 1 for a list of AUM Site features, and Figures 4a and 4b for the locations of the AUM Site features.

Note: No mining features found on the site.

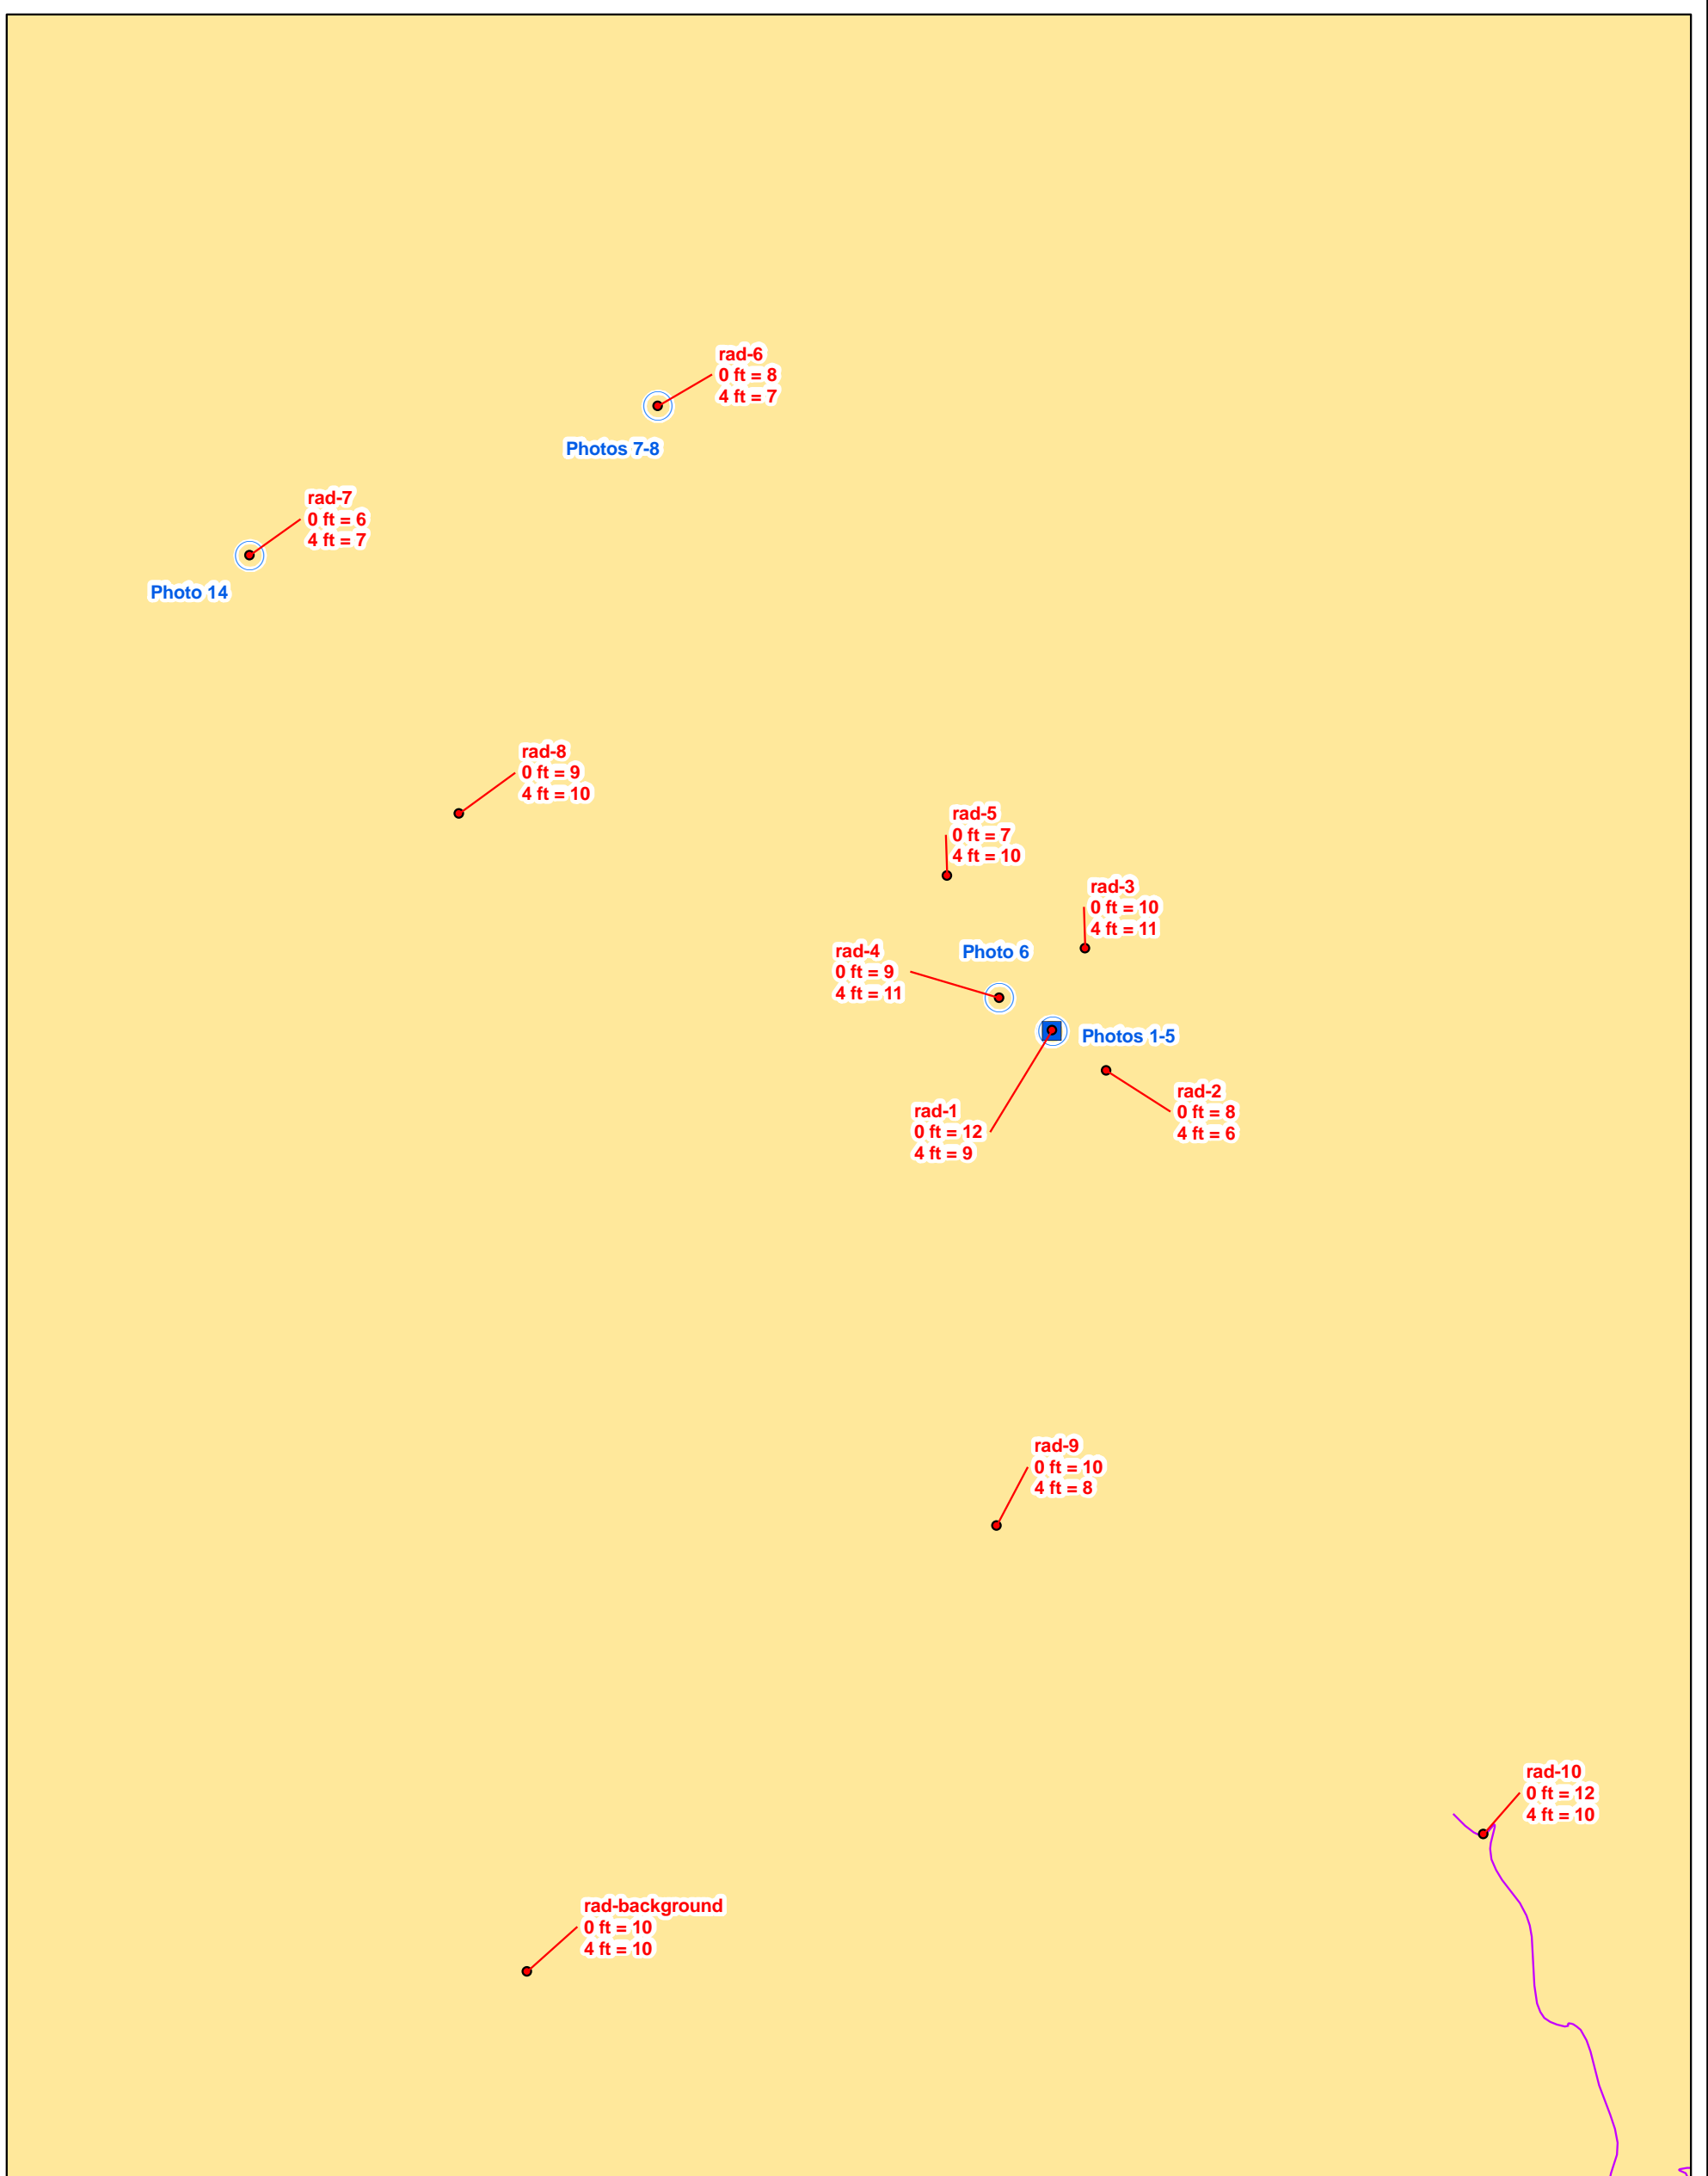
Figure 4b
Site Map with
Surface Ownership
NM0250-Mitchel Price
Abandoned Uranium
Mine Assessment

The background gamma radiation readings at the AUM Site were measured approximately 200 yards southwest of the site location, based on GPS location. The background gamma readings measured approximately 10 microroentgens per hour ($\mu\text{R/hr}$) at the ground surface. Please see Table 2 for all of the gamma radiation readings taken at the AUM Site and Figures 4a and 4b for the locations of the radiation readings.

Note: No mining features found on the site.

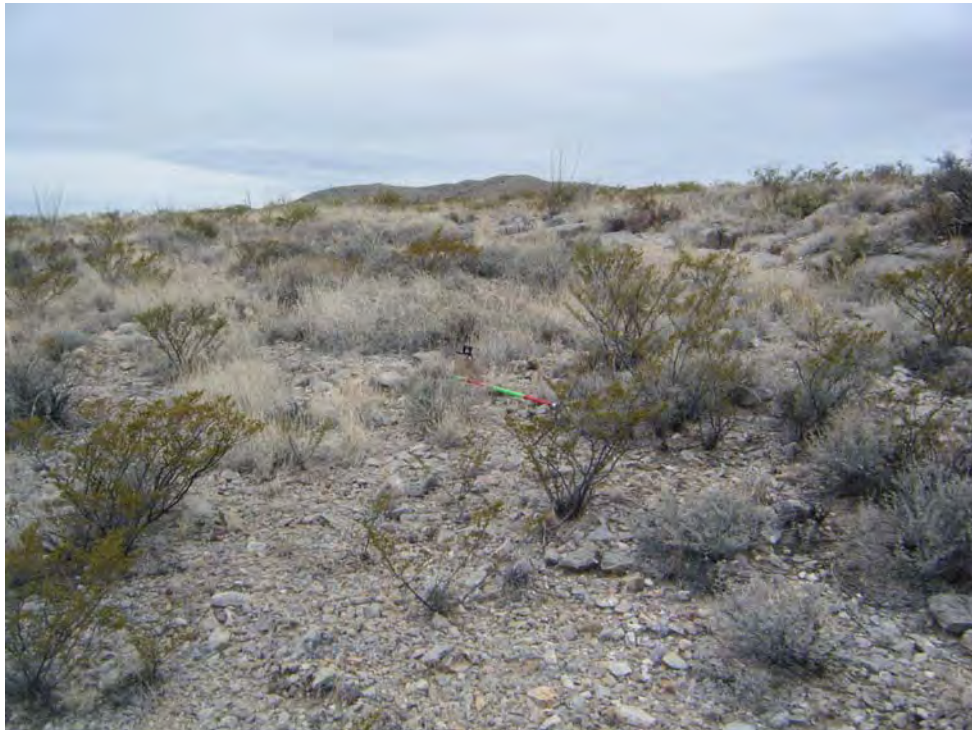
Photo 1 – Given AUM Site location, looking west.

Photo 1 - ^{East ALT} ~~West~~ of Given Site location, looking ^{west} ~~east~~
Photo 2 - Looking north at Given Site Location,
south of site

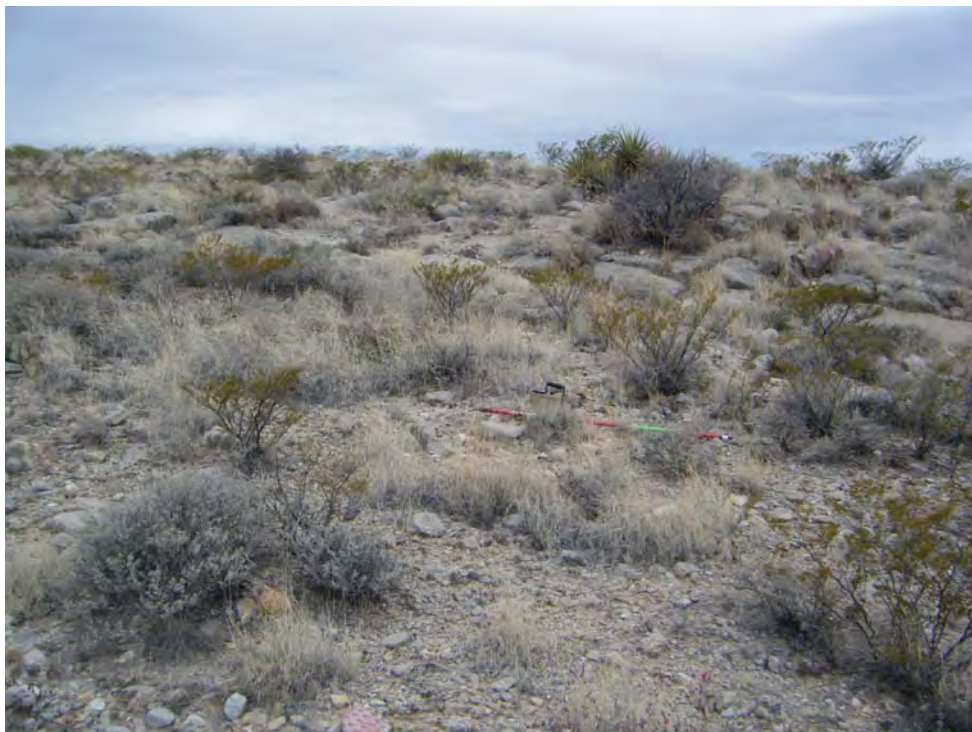
Photo 2 – Given AUM Site location, looking north.

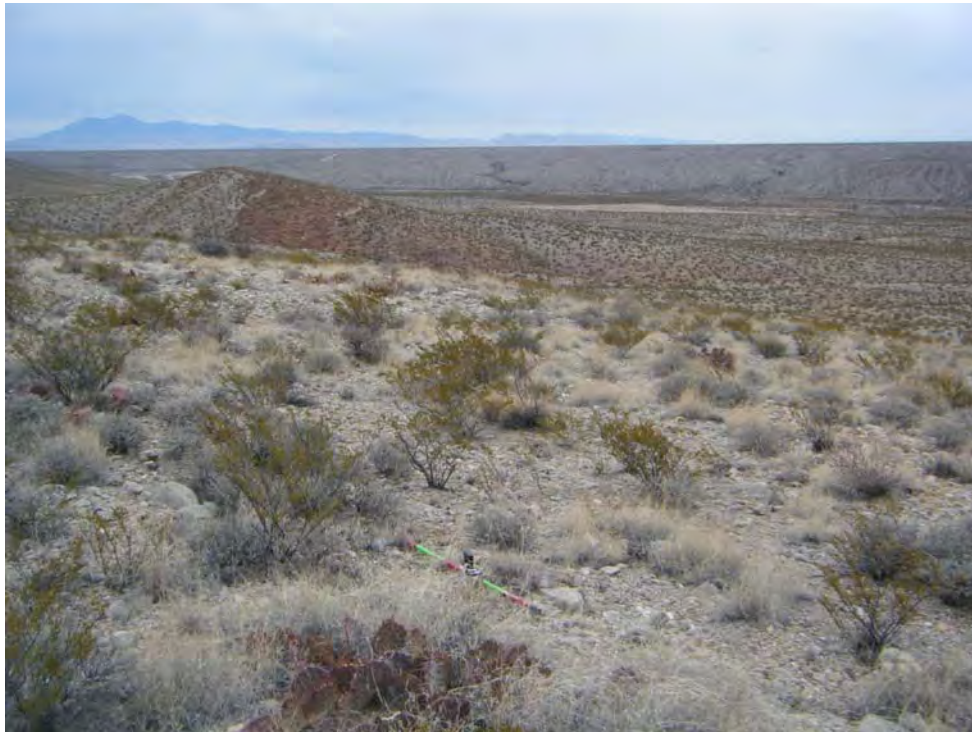
Photo 3 – Given AUM Site location, looking east.

Photo 3 - Looking east at given site location

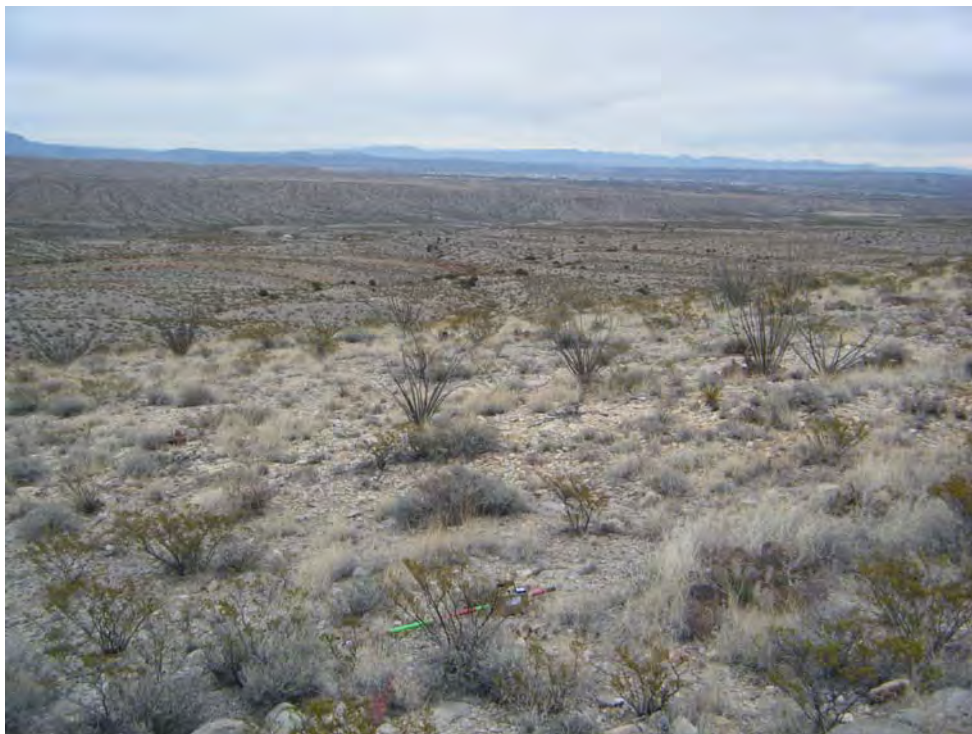
Photo 4 – Given AUM Site location, looking south.

Photo 4 - Looking south at given site location

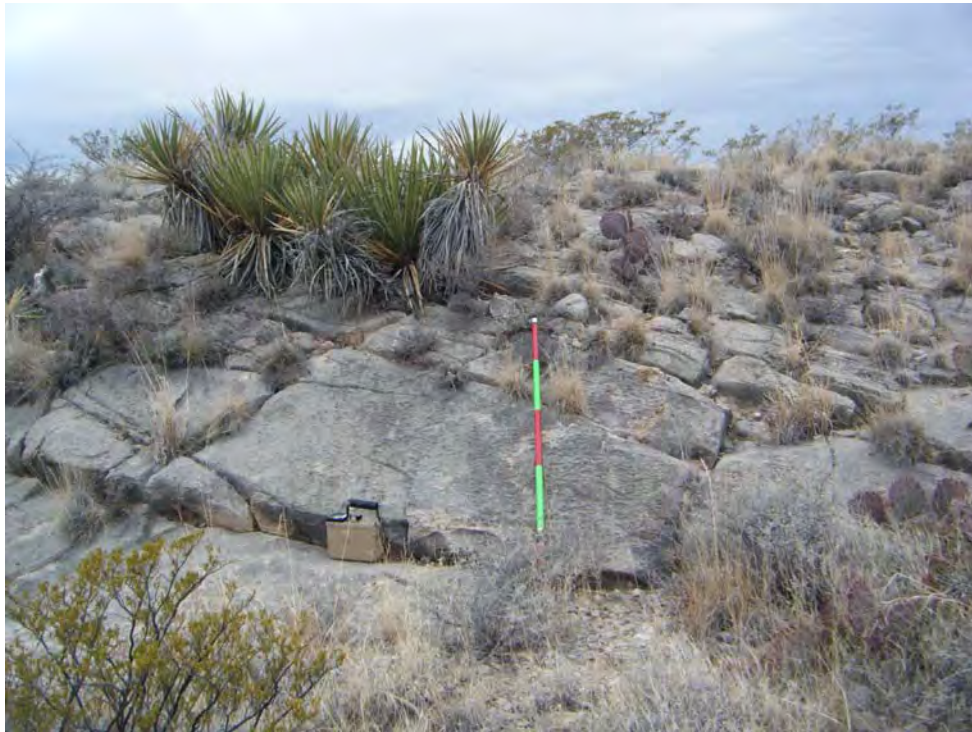
Photo 6 – Rock outcrop west of the given AUM Site location, looking west.

Rad 4 - West of Given Site location, on exposed rock outcrop - 0ft: 9 MR/hr, 4ft: 11 MR/hr

Photo 6 - Rock outcrop, west of Given Site location looking west

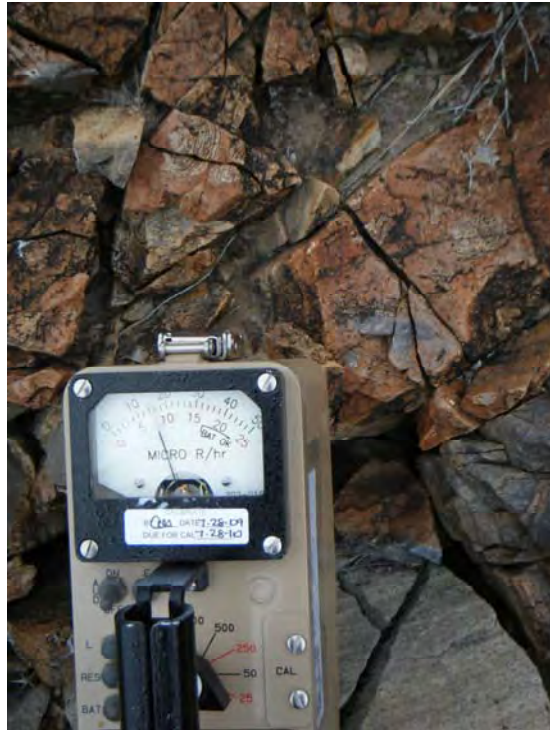
Photo 8 – Ludlum reading for rock outcrop northeast of the given AUM Site location.

Rad 6 - NE of site - 0ft: 8 MR/hr, 4ft: 7 MR/hr

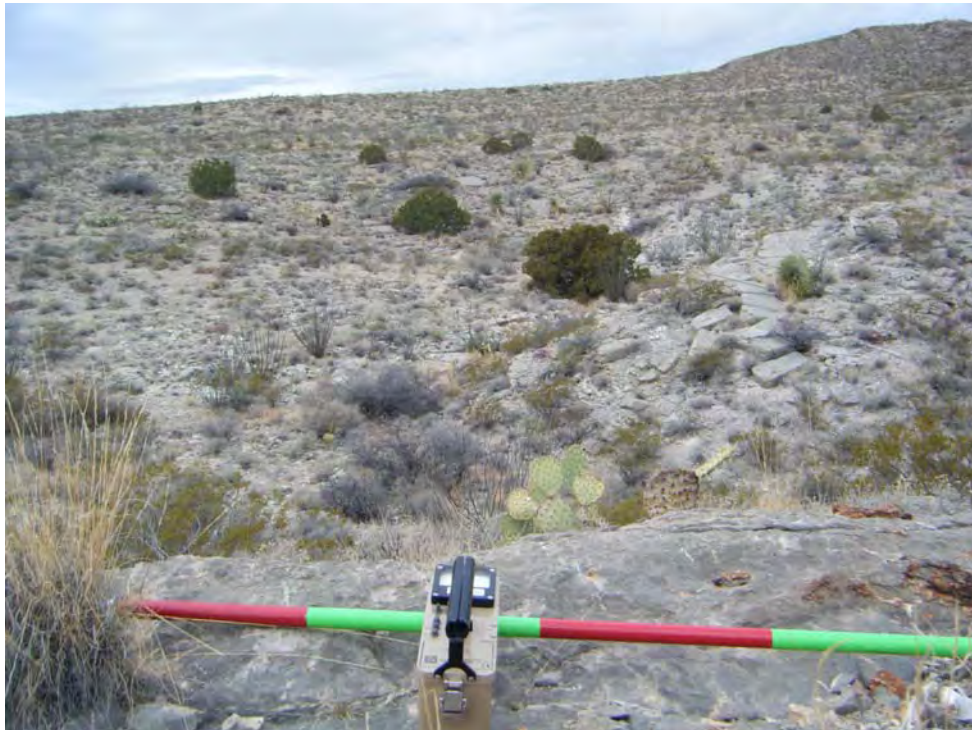
Photo 14 – Drainage north of the given AUM Site location, gray rock contained marine fossils, looking northeast.

Rad 7 - Drainage N of site - 0ft: 6 MR/hr, 4ft: 7 MR/hr

Photo 14 - Drainage N of site with Rad 7
Gray-tan limestone with crinoid fossils

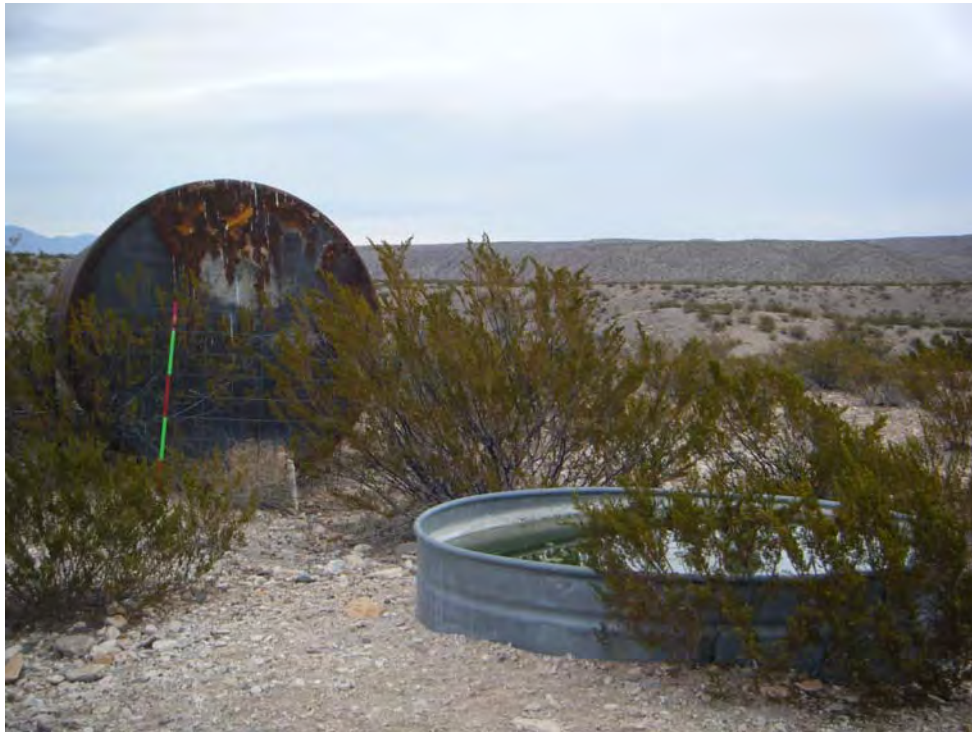
During the site assessment evidence of the presence of cows was noted. A water tank was identified, approximately 1 mile from the AUM Site, along the access road. Fences and cattle guard crossings were present on the land.

Photo 16 – Water tank south of the given AUM Site location along the access road.

Photo 16 - Water tank south of site along access road.
