NEW MEXICO
ENVIRONMENT DEPARTMENT

Memorandum

Subject: Pre-CERCLIS Screening Assessment of Malpais Mine, McKinley
County, New Mexico: Further action under CERCLA
recommended

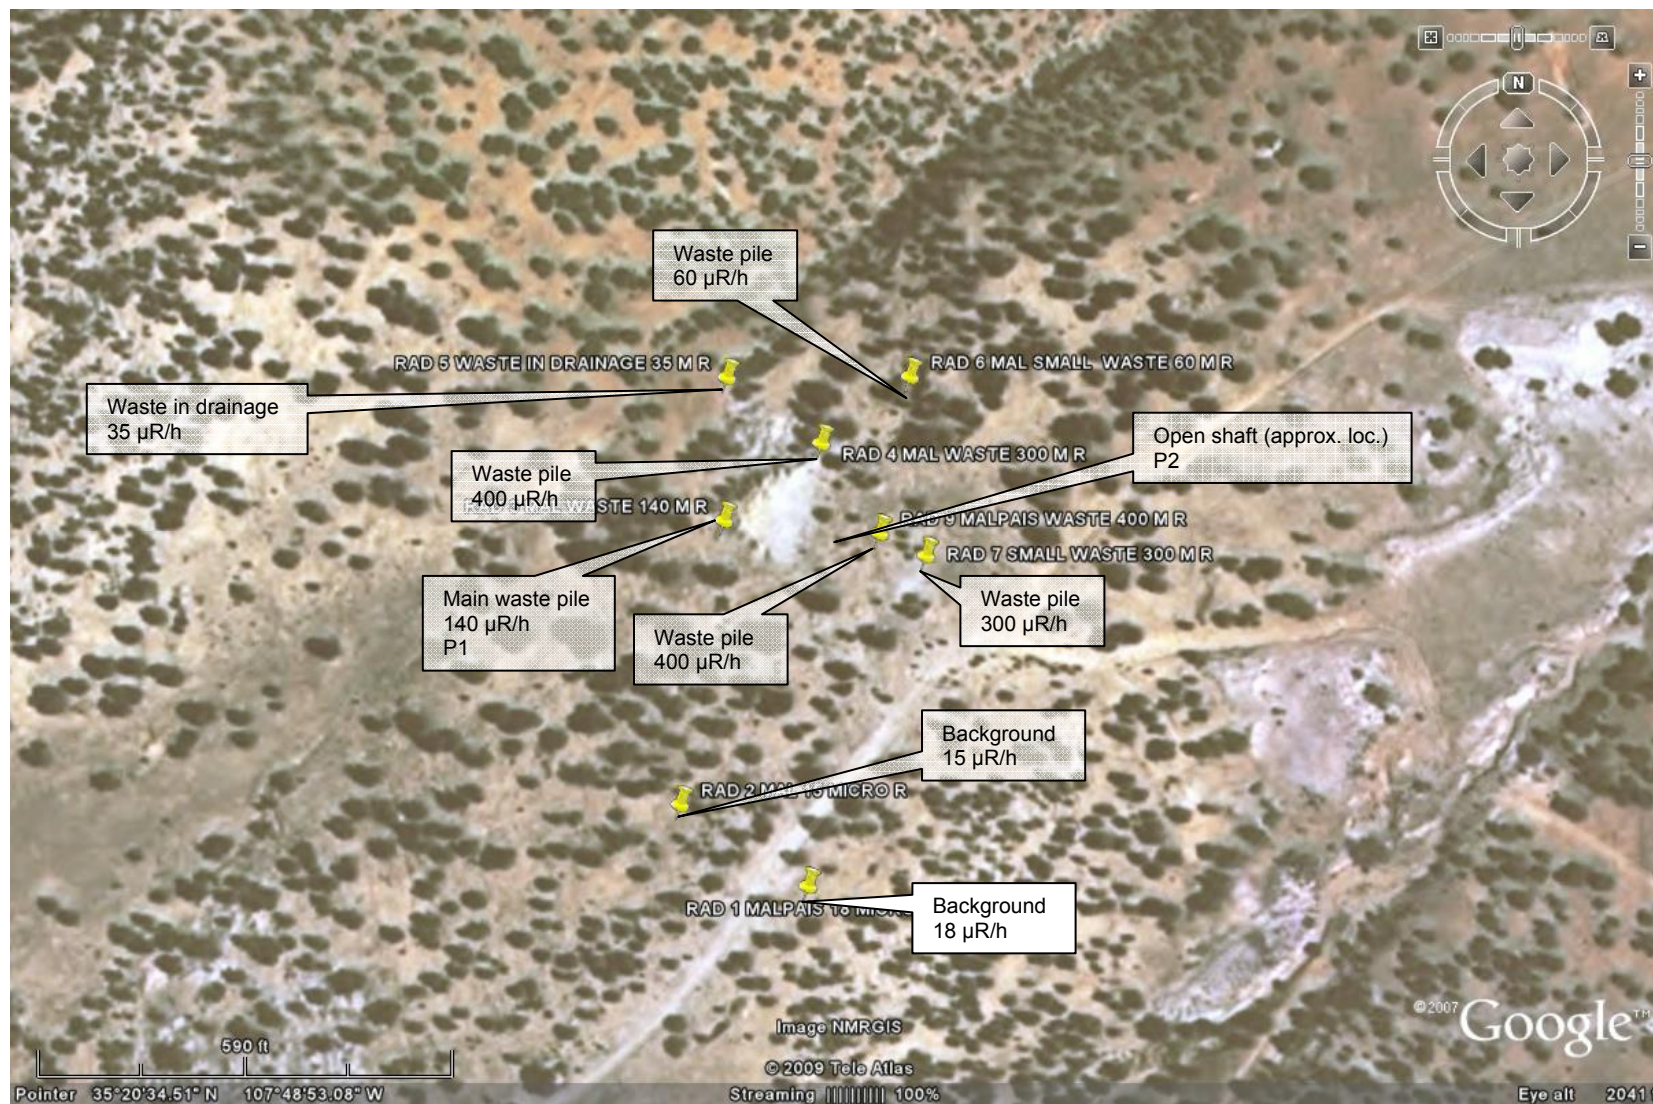
Figure 1: Malpais Mine

Site summary: Observations made during NMED's Site reconnaissance are shown on the accompanying figures. The largest pile of waste material had radioactivity readings between 140 and 400 micro Roentgens/hour (µR/h); background was measured at 15—18 µR/h. The open and unfenced shaft presents a hazard to livestock, wildlife, and humans. Contamination of vicinity soils and surface drainages by precipitative erosion and wind dispersion comprise the primary contaminant pathways that may be associated with this

“Px” reference the location of photographs on pages following.

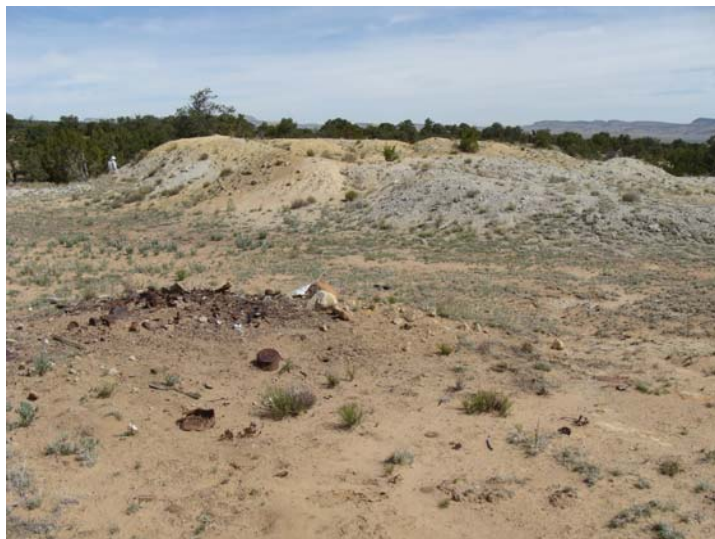
P1: Malpais Mine main waste pile

1. Remove waste with elevated radioactivity.
2. Plug open shaft.

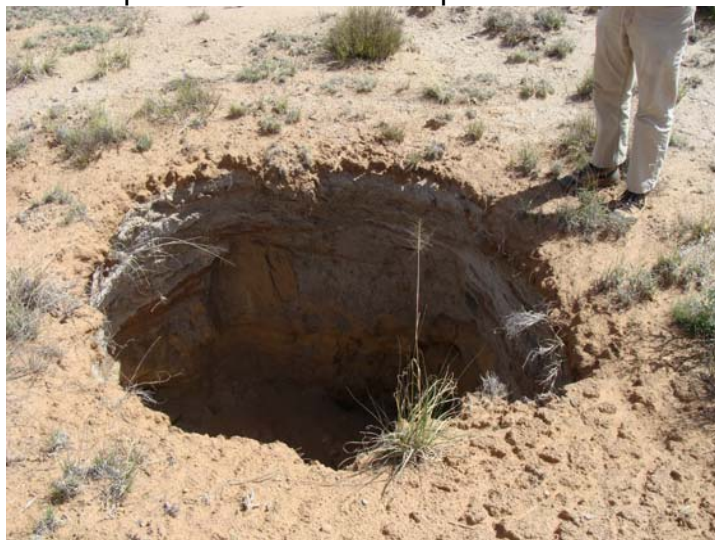
Site physical description: The Malpais Mine currently has an open and unfenced shaft and numerous waste material piles bordering or within drainages.

P2: Malpais Mine open shaft
