Abandoned Uranium Mine Assessment for the Box Canyon Site (NM0177)

FINAL REPORT

NM0177

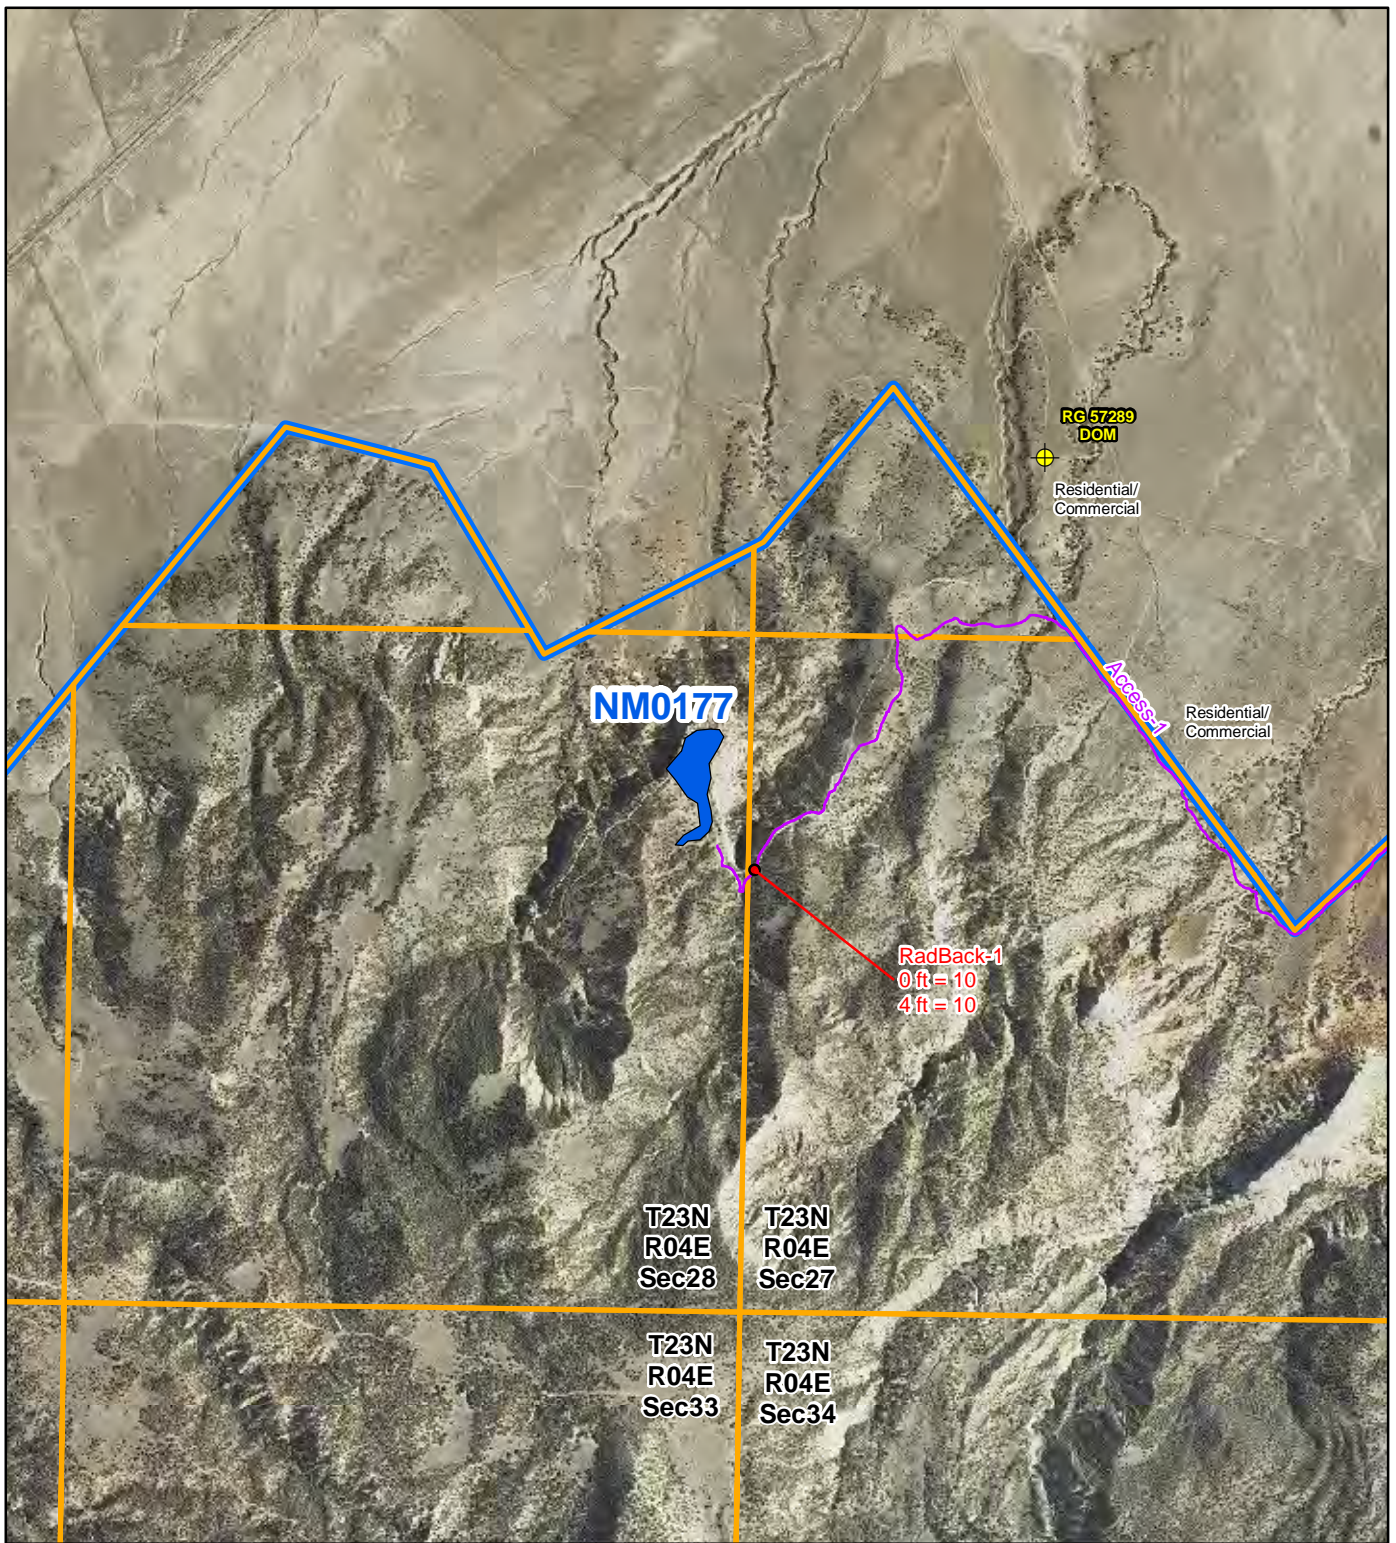
Figure 3
Aerial Photo
NM0177-Box Canyon
 Abandoned Uranium
 Mine Assessment

Human activity at the AUM Site and in the surrounding area included grazing, ATV tracks and domestic dwellings within a 1 mile radius of the site (please see Figure 3).

One domestic well lies within one mile of the AUM Site. This domestic well was drilled in 2000 to a depth of 70 feet below ground surface with a depth to water of 9 feet below ground surface (NMOSE, 2008). Please see Figures 2 and 3 for the location of this well.

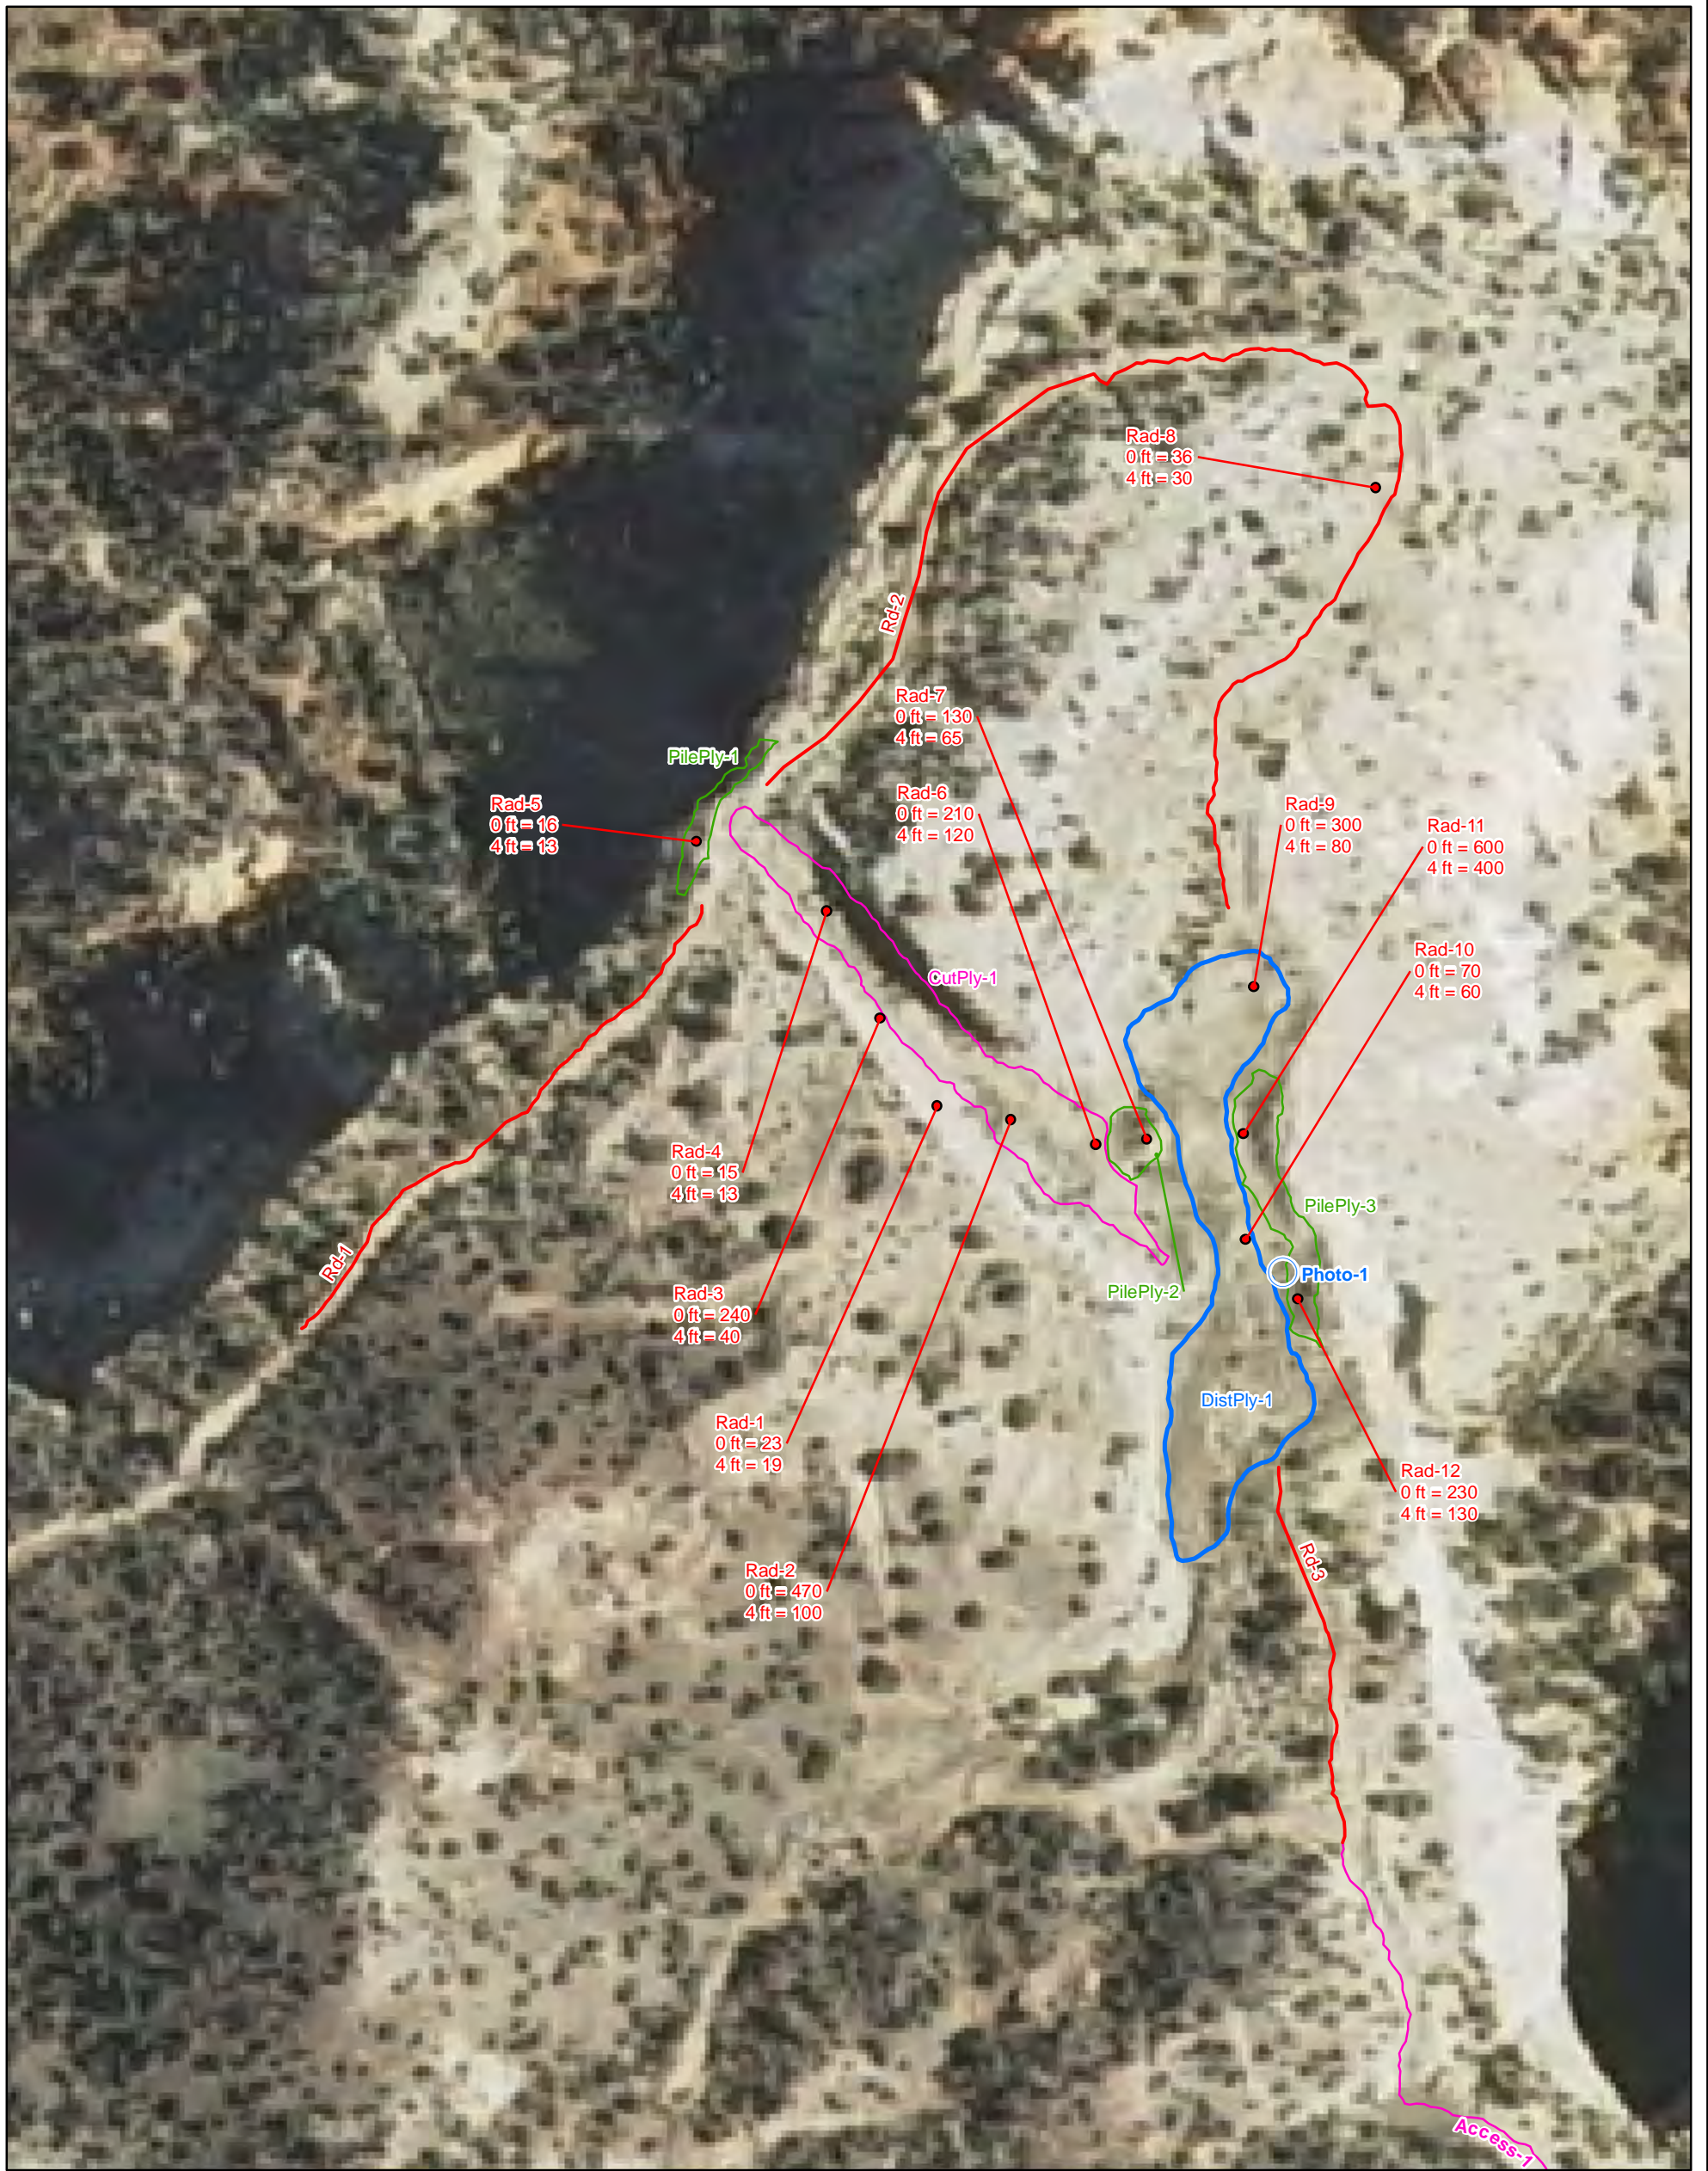
Figure 4a
Site Map on
Aerial Photo
NM0177-Box Canyon
 Abandoned Uranium
 Mine Assessment

The mine features described below are based on the features provided to INTERA by MMD in the GIS Data Dictionary (MMD, 2009). INTERA marked the locations of the AUM Site features using a Trimble Global Positioning System (GPS) and entered details about the features into the GPS using the MMD data dictionary. One open cut, one disturbed area, three piles, and three mine roads were identified onsite. Please see the Photo Log in Appendix A for photos of the AUM Site features, Table 1 for a list of the AUM Site features, and Figures 4a and 4b for the locations of the AUM Site features.

Three waste rock piles and one disturbance area were identified at the AUM Site. PilePly-1 was 5 ft high, 10 wide, and 70 ft long and was located west of the open cut (see Figures 4a and 4b). PilePly-2 was a conical pile near the east end of the open cut and was 10 ft high, 20 ft wide, and 30 ft long. West of PilePly-2 was PilePly-3, a linear pile along the top of the steep ridge on the eastern edge of the site. PilePly-3 measured 10 ft high, 15 ft wide, and 250 ft long. DistPly-1 was an area that had been bulldozed measuring 20 ft deep, 100 ft wide, and 300 ft long to the east of the open cut. The maximum gamma radiation measurement found on these features was 600 $\mu\text{R/hr}$ at 0 ft above ground and 400 $\mu\text{R/hr}$ at 4 ft above ground at radiation survey point Rad-11 taken on PilePly-3.

Three mine roads were found at the AUM Site. Rd-1 extends south from the open cut along the western end of the AUM Site. Rd-2 extends north from the western end of the open cut and follows the mesa edge around to the eastern end of the open cut (see Figures 4a and 4b). Rd-3 extends south from the eastern end of the AUM Site. All roads contained berms along their path and were passable only on foot.

One background gamma radiation reading was taken near the AUM Site, recording 10 $\mu\text{R/hr}$ at 0 ft above ground and 10 $\mu\text{R/hr}$ at 4 ft above ground. Please see Table 2 for all of the gamma radiation readings taken at the AUM Site and Figures 4a and 4b for the locations of the radiation readings.

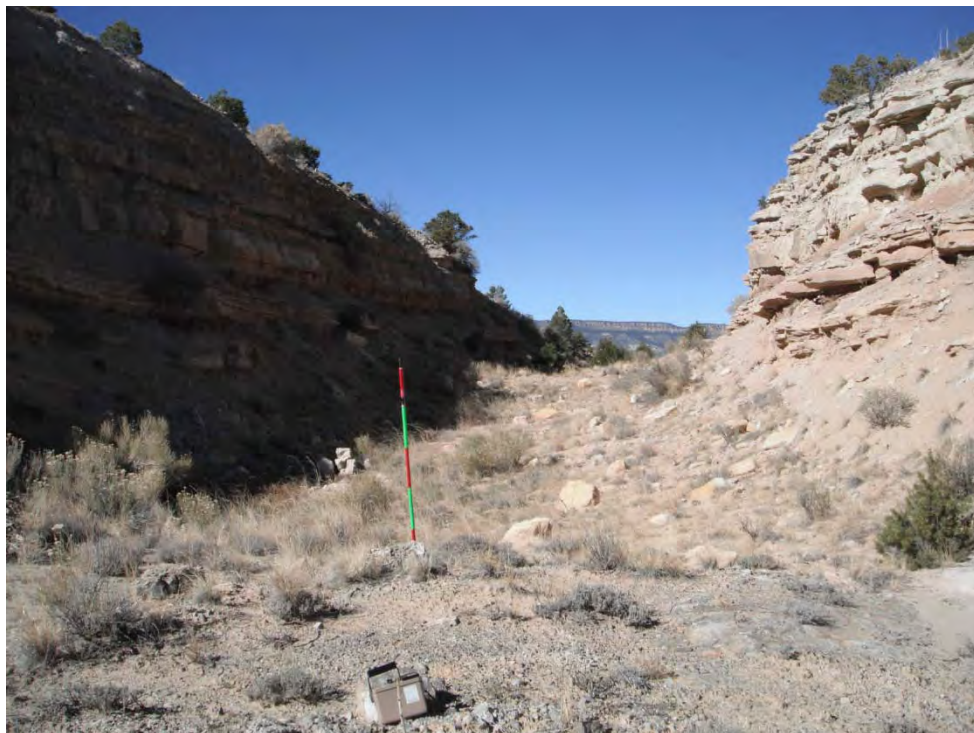
One open cut (CutPly-1) was identified at the AUM Site. This feature is a 30 ft deep, 50 ft wide and 275 ft long rim cut that exposes the Jurassic units that form the top of the ridge at the site (see Photos 2-6 in Appendix A). The south wall of the cut exposes a low amplitude fold and a fault in the limestone (see Photo 4 and 6 in Appendix A). The maximum gamma radiation measurement found on CutPly-1 was at survey point Rad-2, measuring 470 $\mu\text{R/hr}$ (microrentgens per hour) at 0 ft above ground and 100 $\mu\text{R/hr}$ at 4ft above ground.

Photo 2-Looking northwest at CutPly-1.

Cut-1 - 275' long, 50' wide, and 30' deep cut (or trough) trends northwest to southeast

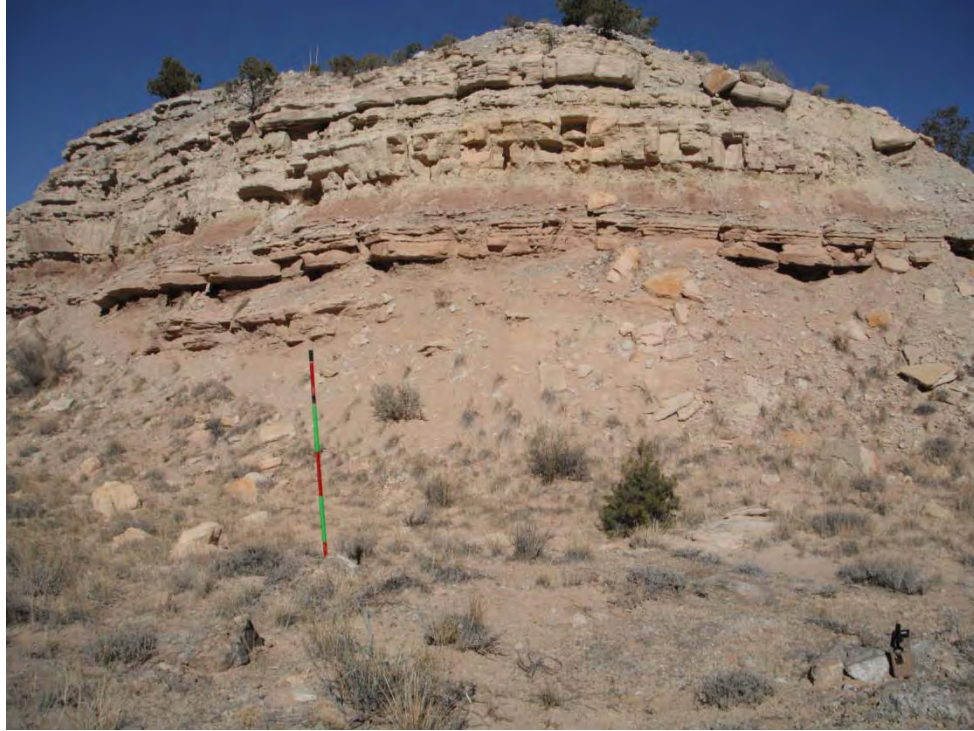
Photo 3-Looking north at northern wall of CutPly-1.

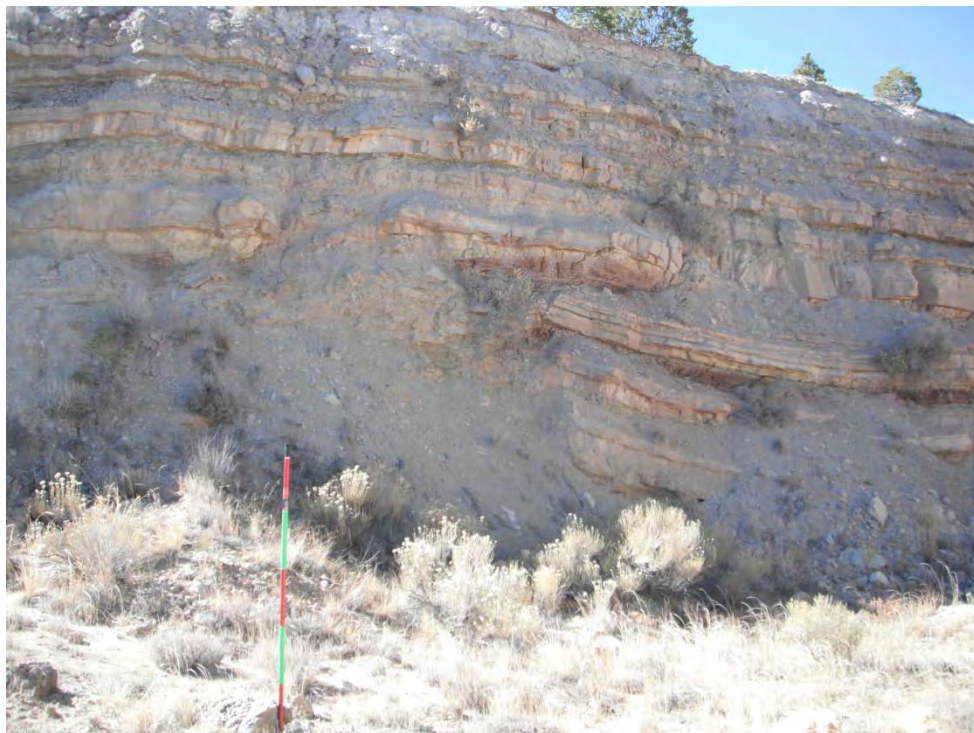
Photo 4-Looking southwest at southern wall of CutPly-1.

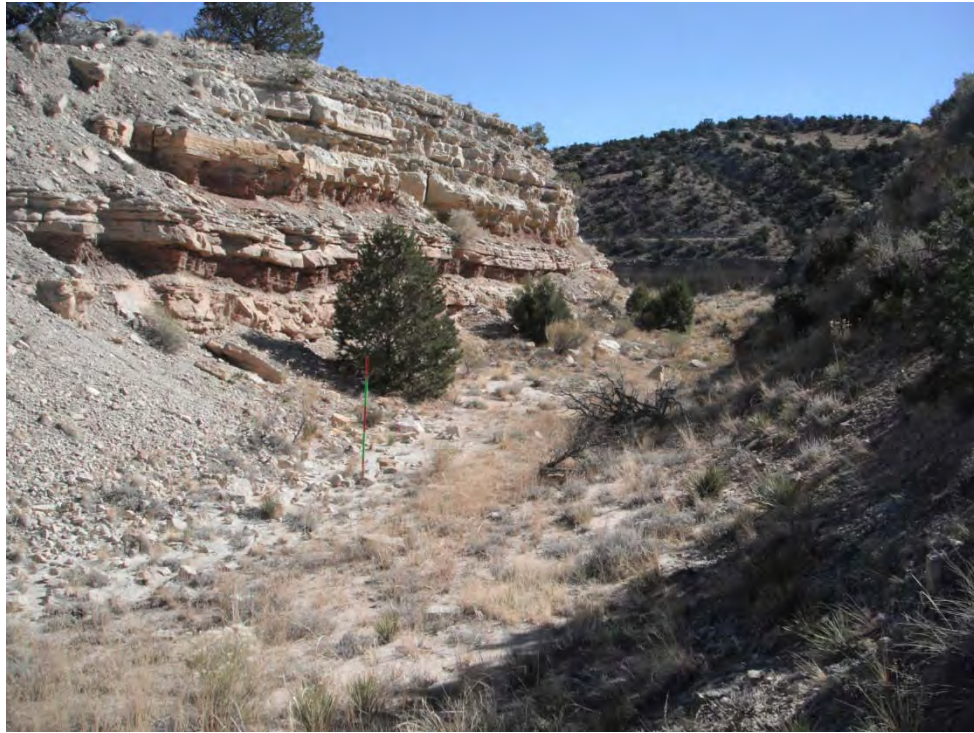
Photo 5-Looking east-southeast at CutPly-1, replicating Anderson photo B.

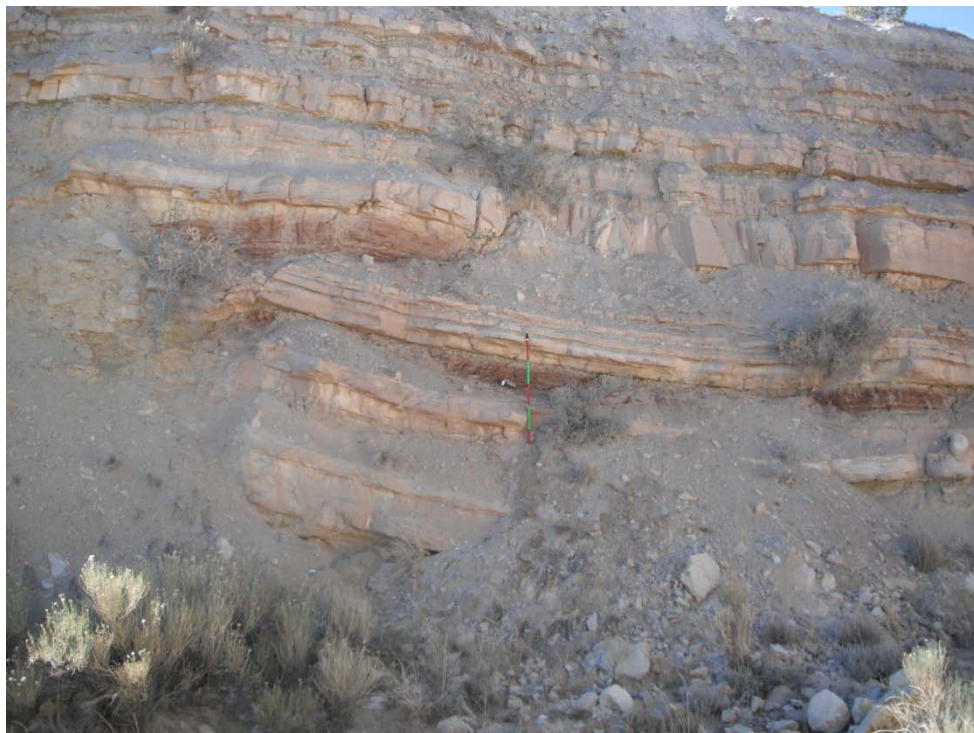
Photo 6-Looking south at radiation survey point Rad-1, replicating Anderson photo C.

Rad 1 - Om - 23 uR/h; Im - 19 uR/h - south wall of cut-1

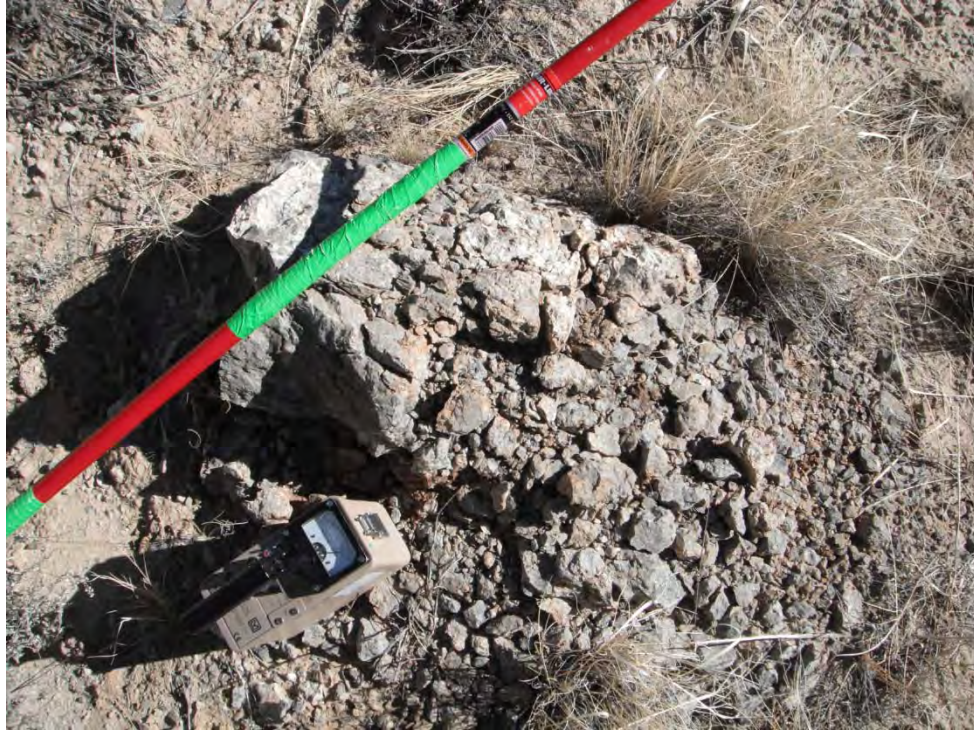
2 and PilePly-3. Radiation survey point Rad-2 recorded 470 $\mu\text{R/hr}$ at 0 ft above ground in CutPly-1 and radiation survey point Rad-9 recorded 300 $\mu\text{R/hr}$ at 0 ft above ground in DistPly-1. See Table 2 for details on site gamma radiation readings.

Photo 7-Looking down at radiation survey point Rad-2, grey limestone with brown mineralization.

Rad 2 - Om - 470 uR/h; Im - 100 uR/h in cut-1

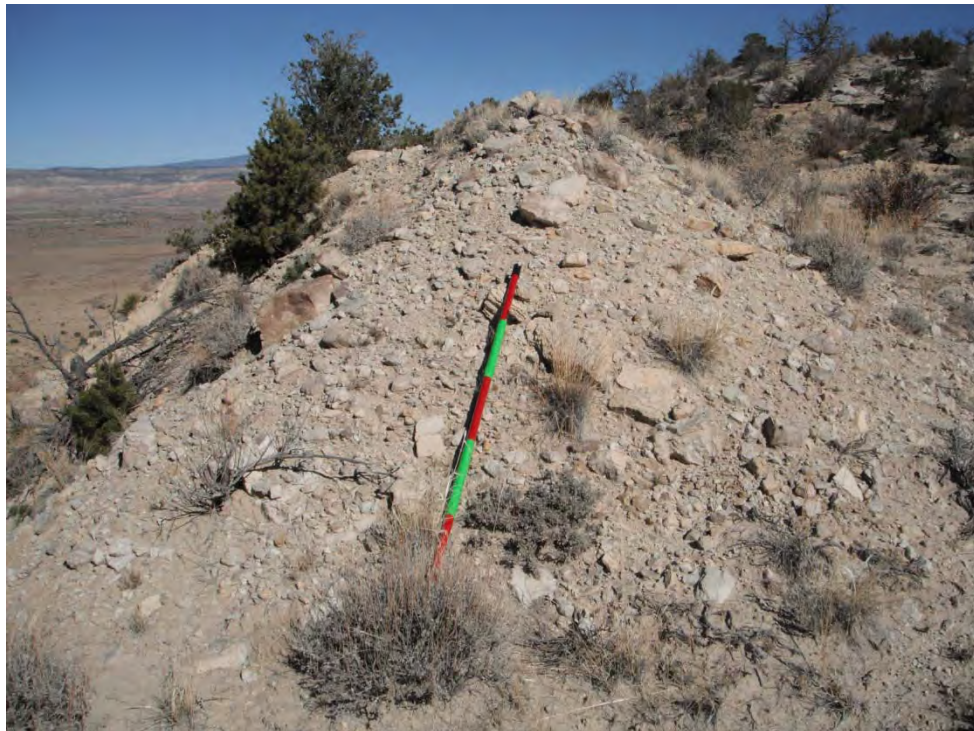
Photo 8-Looking north at PilePly-1.

1200
Pile Ply-1 - west of cut-1, along edge of mesa
Photo 8 - Pile Ply-1 - 70ft long, 10' wide, 5' tall

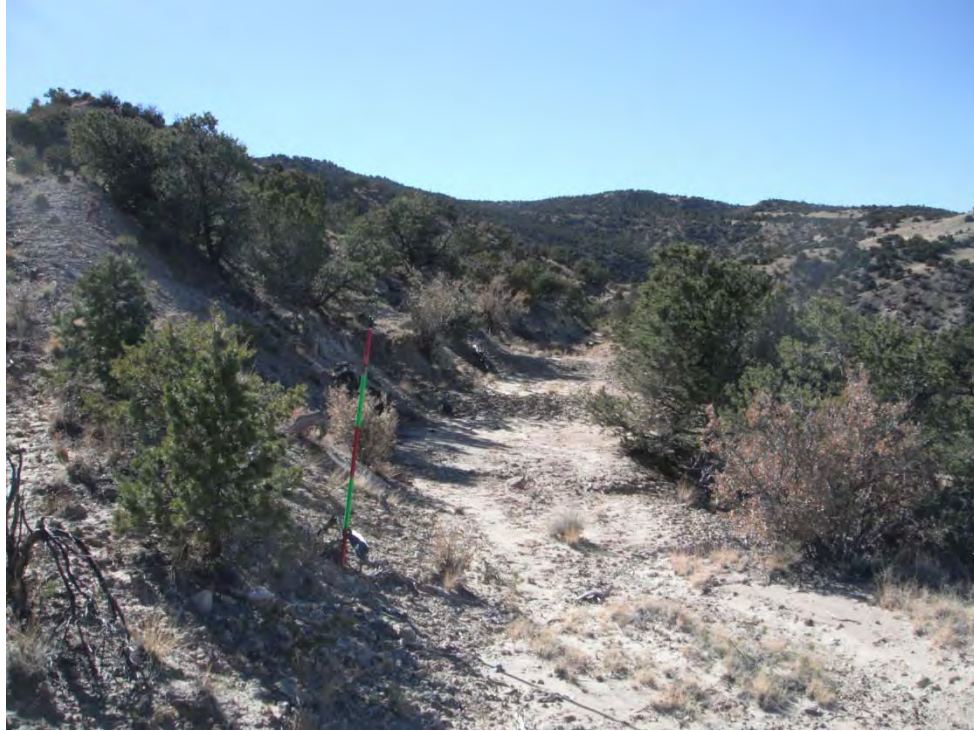
Photo 9-Looking south at Rd-1.

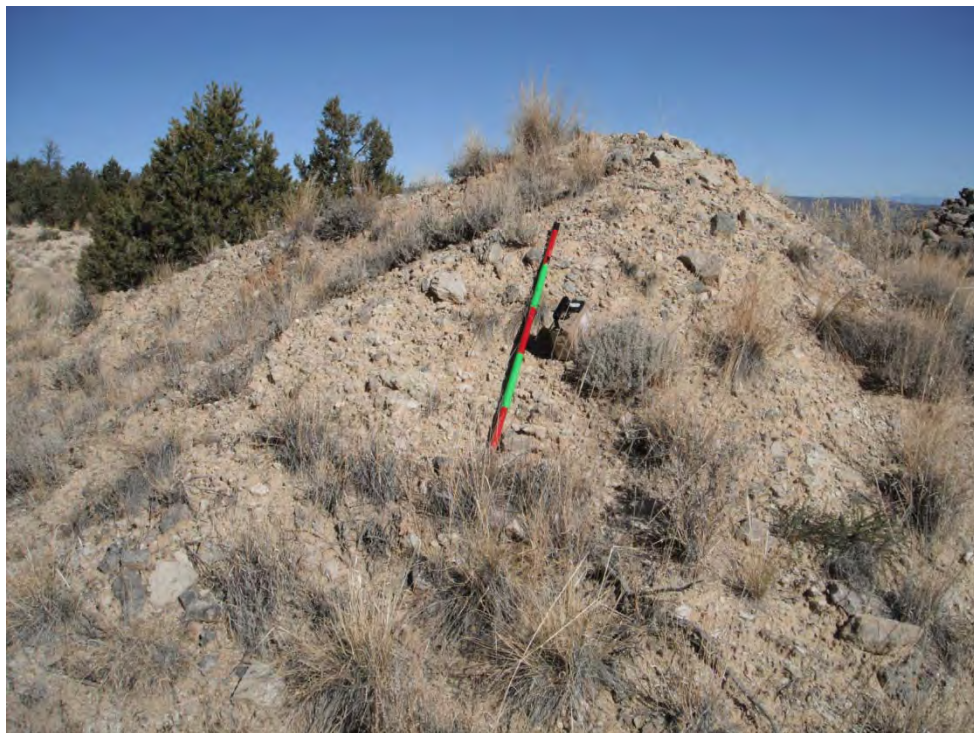
Photo 10-Looking north at PilePly-2.

Pile Ply-2 - 10' tall, 20' wide, 30' long, 30° slope

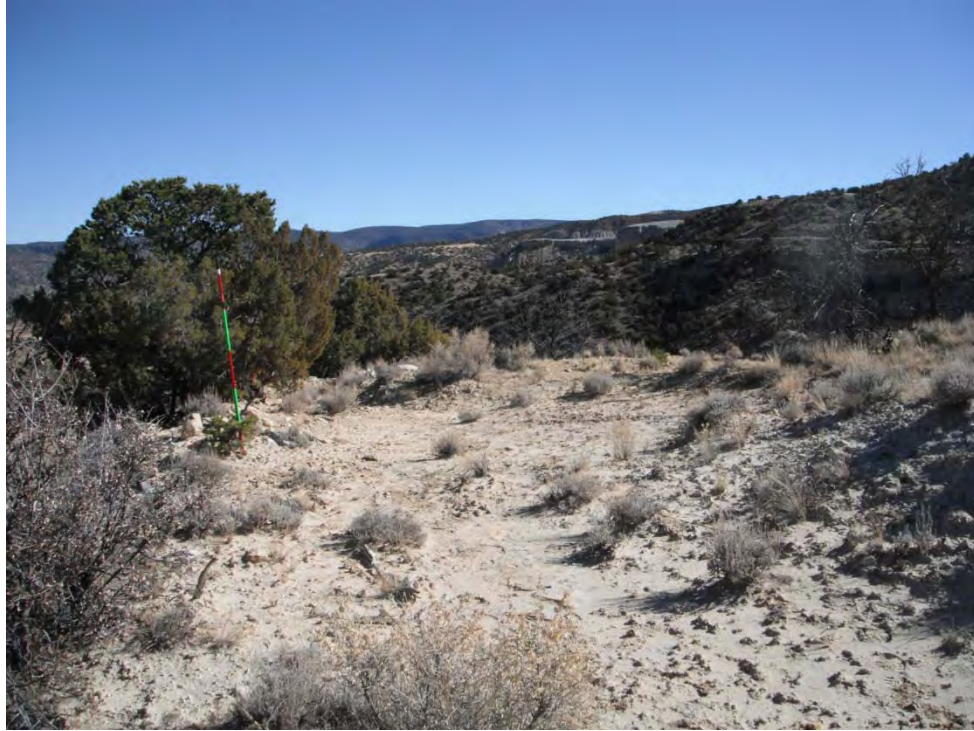
Photo 11-Looking east at Rd-2.

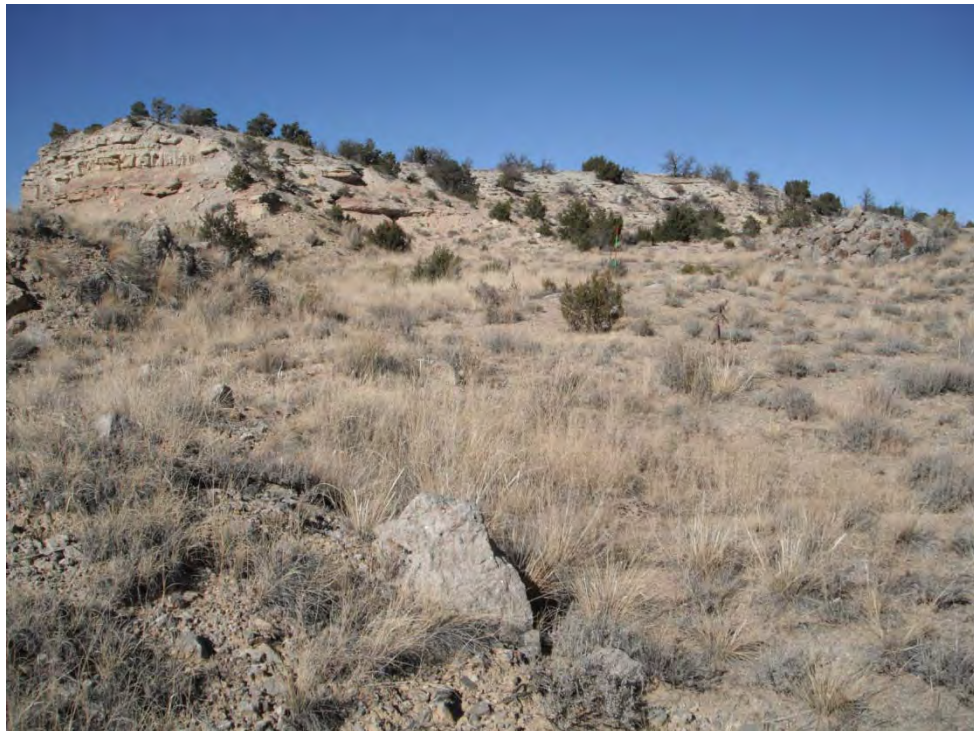
Photo 12-Looking north at DistPly-1.

Dist Ply-1 - 100' wide x 300' long x 20' high; east end of cut-1

Rad 9 - Dist Ply-1; Om - 300 uR/h; Im - 80 uR/h

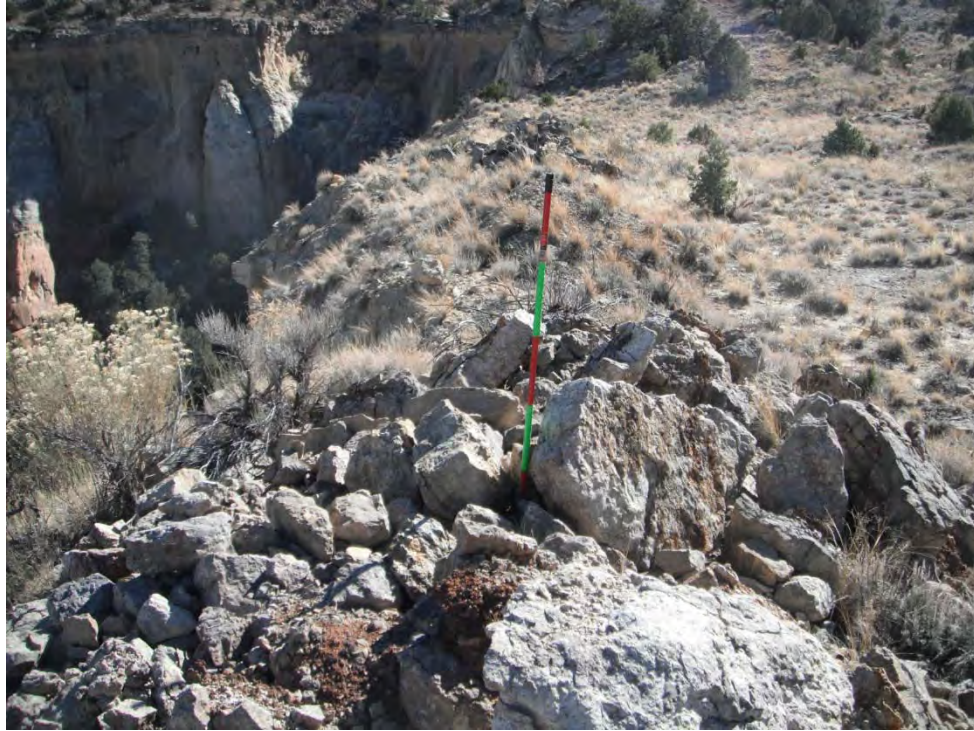
Photo 13-Looking south at PilePly-3.

Pile Ply-3 - 10' tall, 15' wide, 250' long

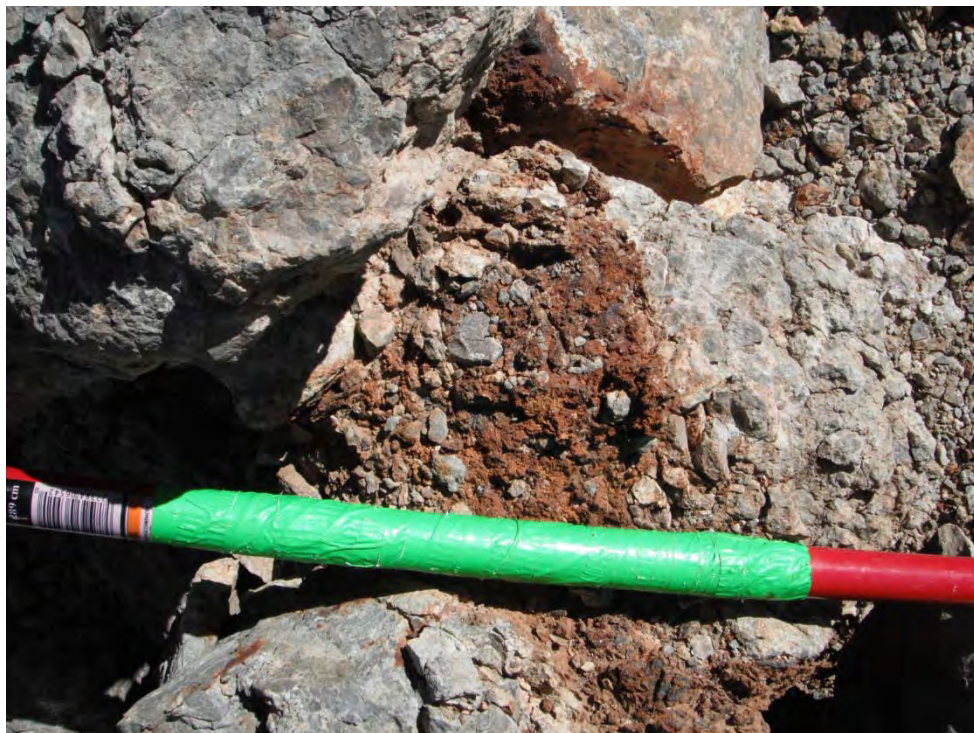
The maximum gamma radiation reading was 600 $\mu\text{R/hr}$ recorded at 0 ft above ground at survey point Rad-11 on PilePly-3. The gamma radiation readings at the AUM Site were most elevated at exposures of limestone in the base of CutPly-1 and DistPly-1 and in the waste rock in PilePly-

Photo 14-Looking down at radiation survey point Rad-11.

Rad 11 - Pile Ply-3; Om - 600 uR/h; Im - 400 uR/h

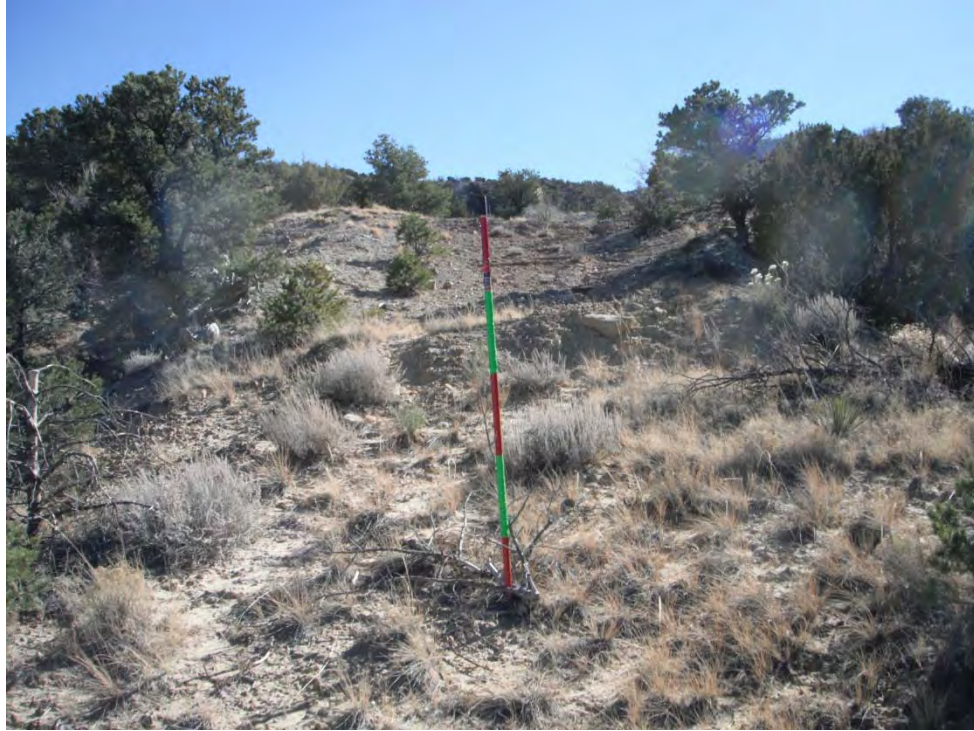
Photo 15-Looking south at Rd-3.
