# New Mexico Rapid Assessment Method (NMRAM) *Riverine Wetlands*

## Channel Equilibrium

## CHANNEL EQUILIBRIUM (MONTANE)

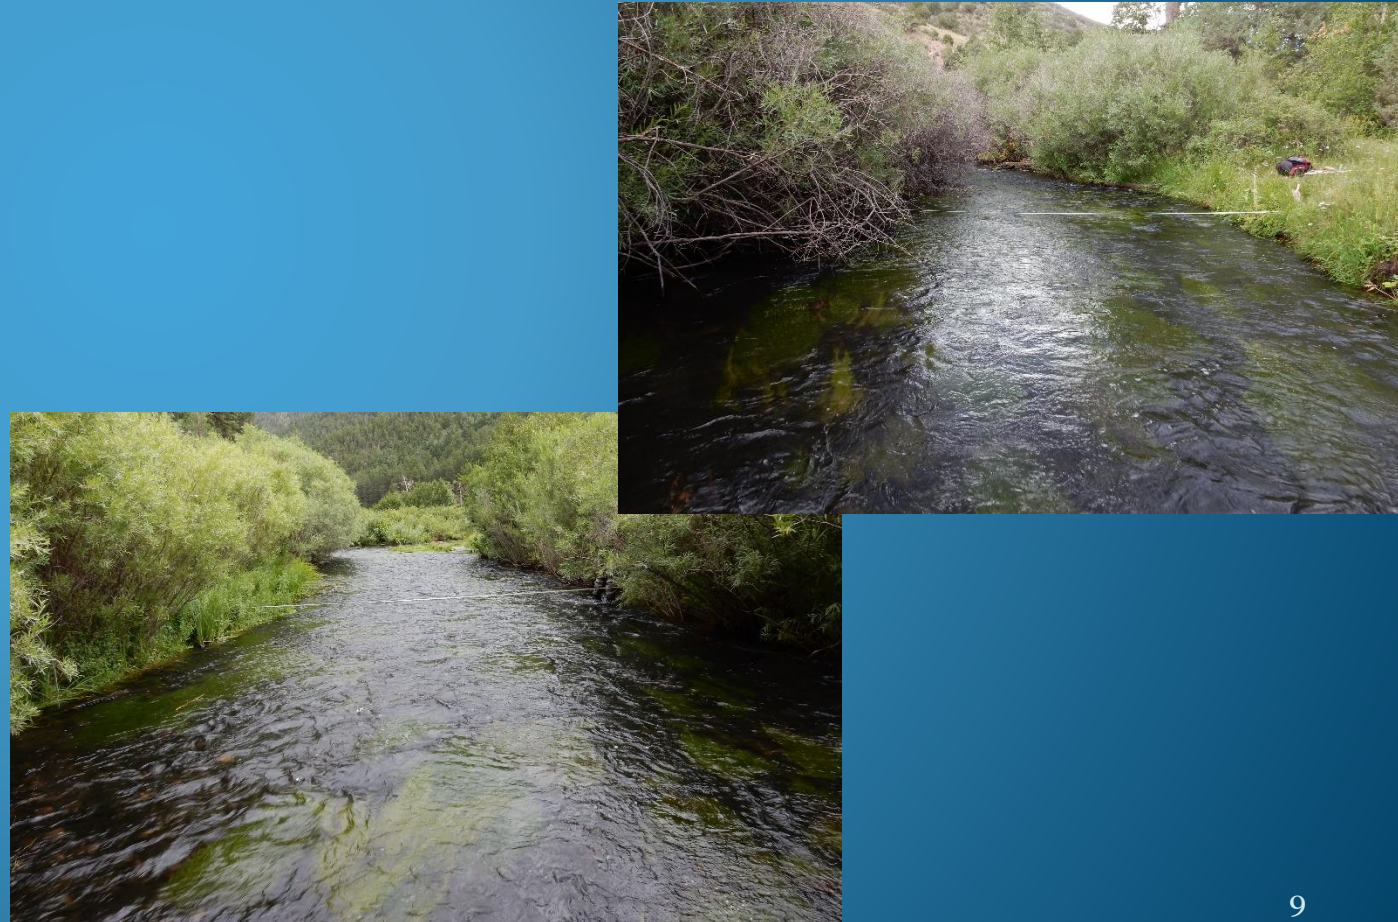
From notes on example SA *"Banks are low and obvious...There are multiple slow water habitats including eddies and backwaters...some deep pools exist"*

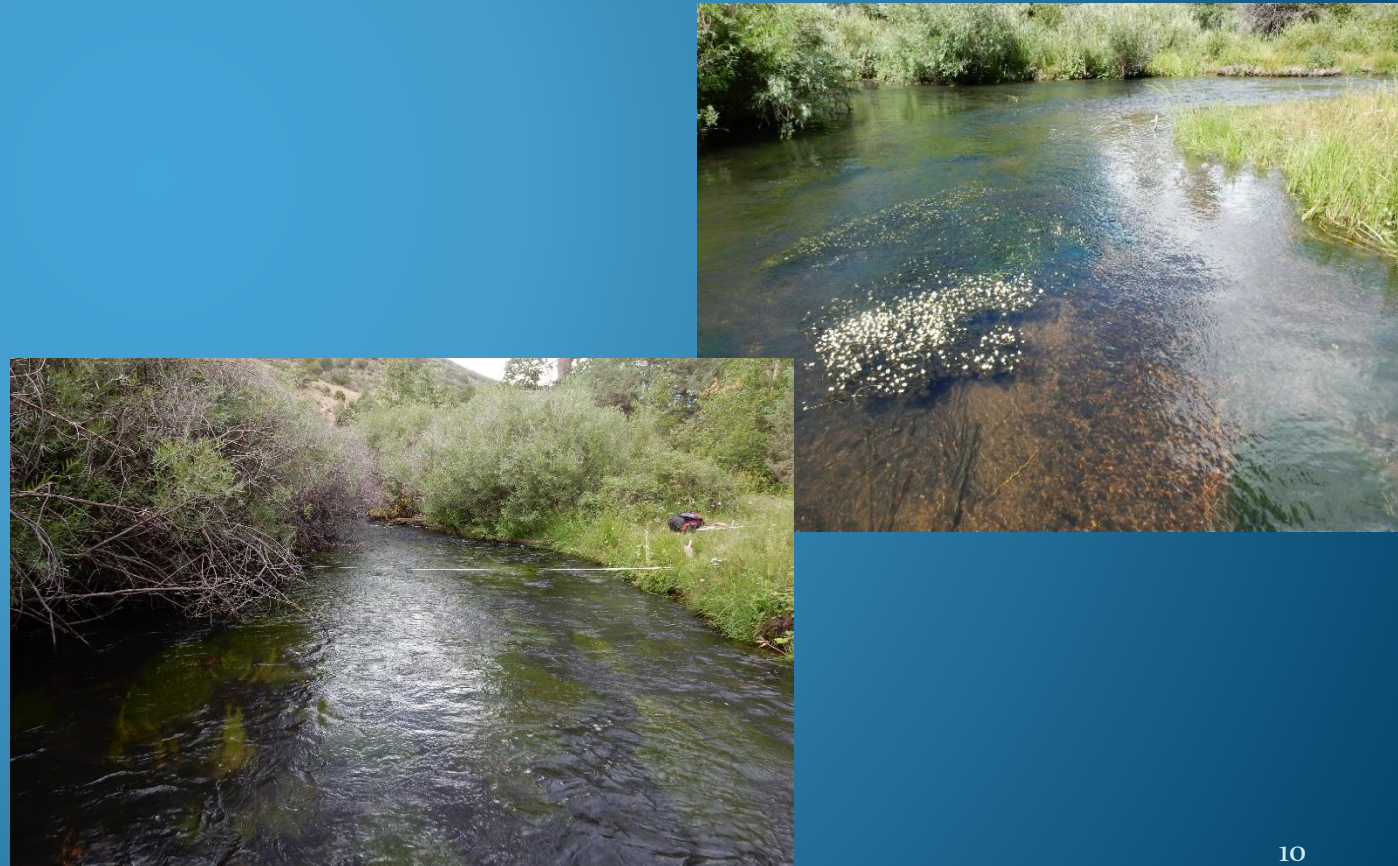
Example of a channel that is not in equilibrium from an SA inside of a livestock pen.
