Abandoned Uranium Mine Assessment for the Red Head Site (NM0183)

FINAL REPORT

November 05, 2010

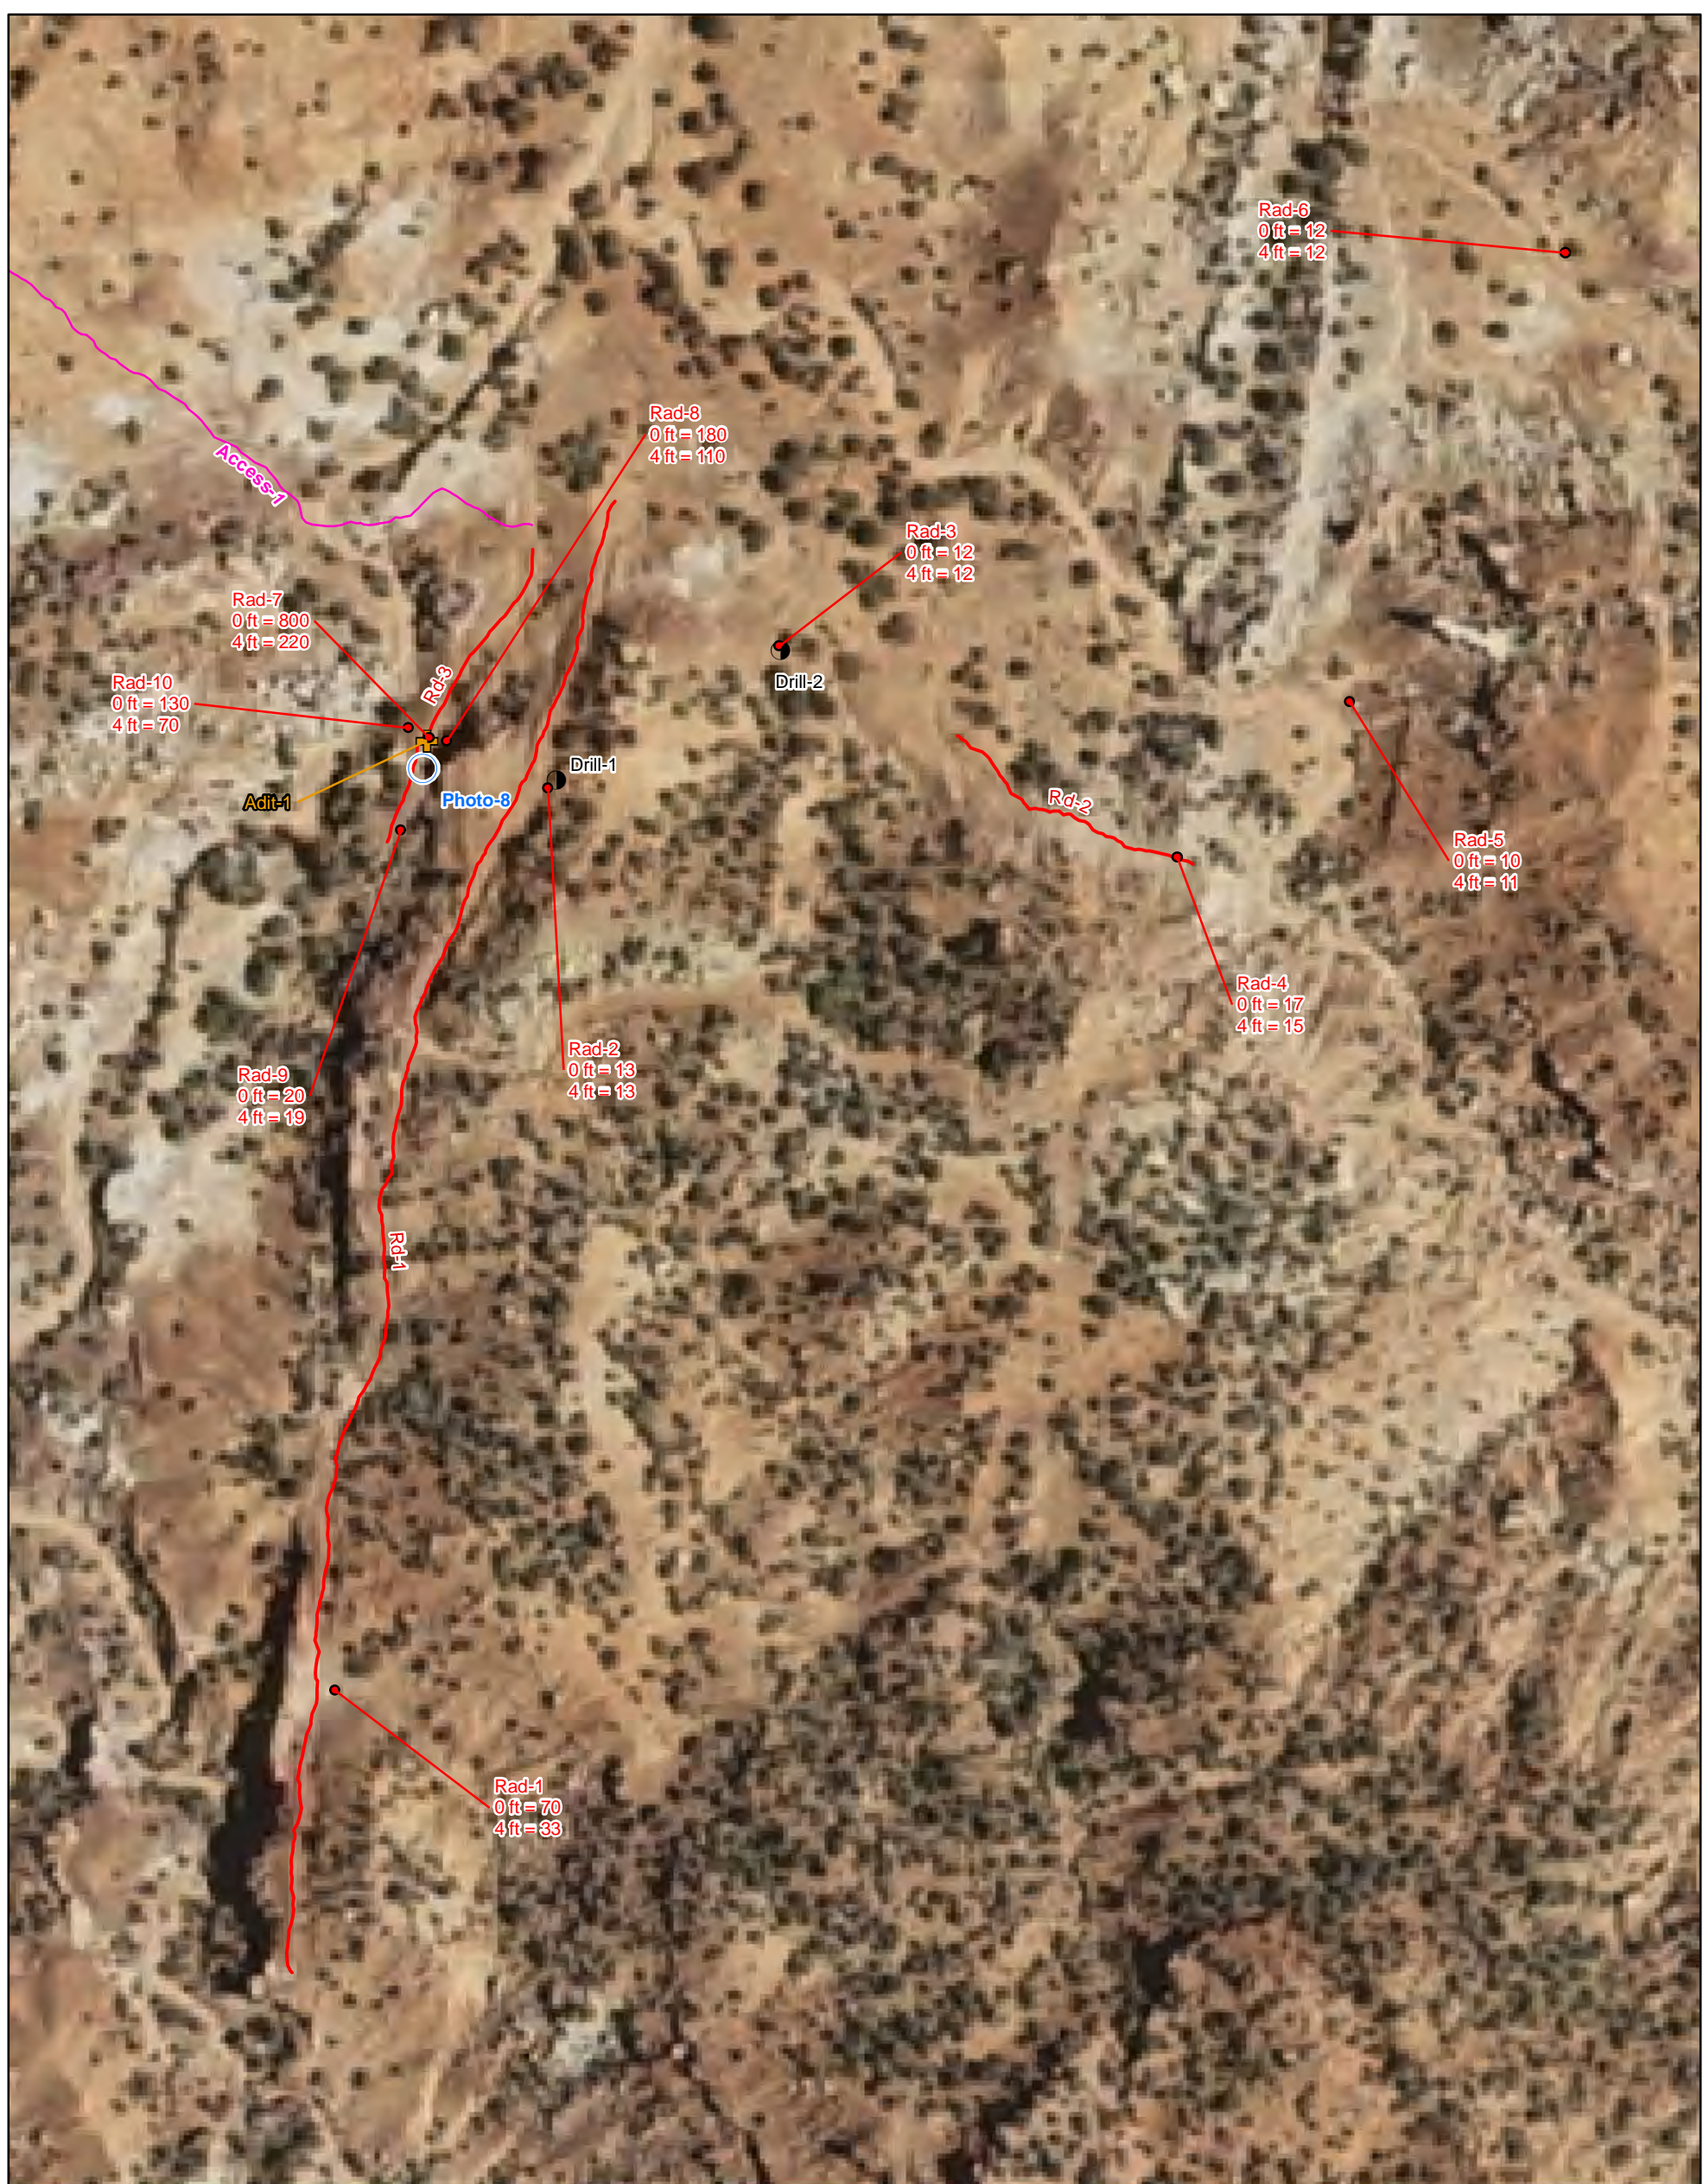
Figure 4a
Site Map on
Aerial Photo
NM0183-Red Head
 Abandoned Uranium
 Mine Assessment

The mine features described below are based on the features provided to INTERA by MMD in the GIS Data Dictionary (MMD, 2009). INTERA marked the locations of the AUM Site features using a Trimble Global Positioning System (GPS) and entered details about the features into the GPS using the MMD data dictionary. Two drillholes, one adit and three mine roads were found onsite. Please see the Photo Log in Appendix A for photos of the AUM Site features, Table 1 for a list of the AUM Site features, and Figures 4a and 4b for the locations of the AUM Site features.

Three mine roads (Rd-1, Rd-2 and Rd-3) were found onsite. Rd-3 is adjacent to Adit-1 and extends approximately 250 ft north of the adit. Rd-1 is located upslope to the east of Rd-3 and extends approximately 1,200 ft north-south along the eastern rim of the canyon. Rd-2 runs northwest to southeast and is located approximately 500 ft east of Adit-1 (please see Figures 4a and 4b).

One background gamma radiation reading was taken near the AUM Site, recording 16 $\mu\text{R/hr}$ at 0 ft above ground and 15 $\mu\text{R/hr}$ at 4 ft above ground. Please see Table 2 for all of the gamma radiation readings taken at the AUM Site and Figures 4a and 4b for the locations of the radiation readings.

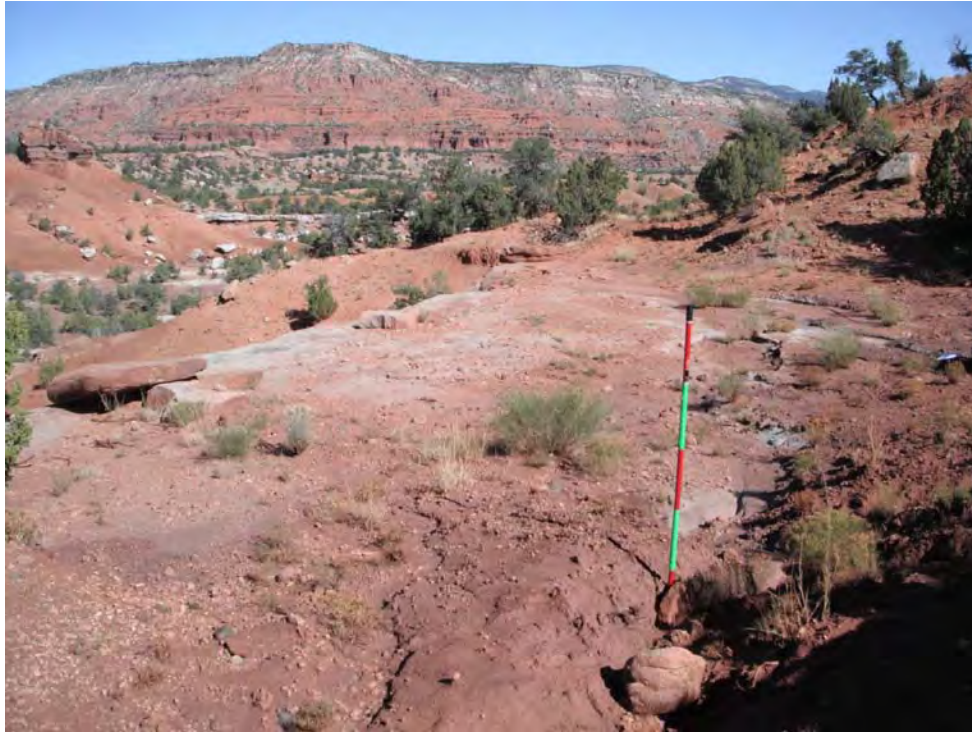
Photo 1-Looking north at Rd-1.

Mine Rd-1 - extending north-south up the canyon

Rad-1 - along Mine Rd-1; 0m - 70 uR/h; 1m - 33 uR/h

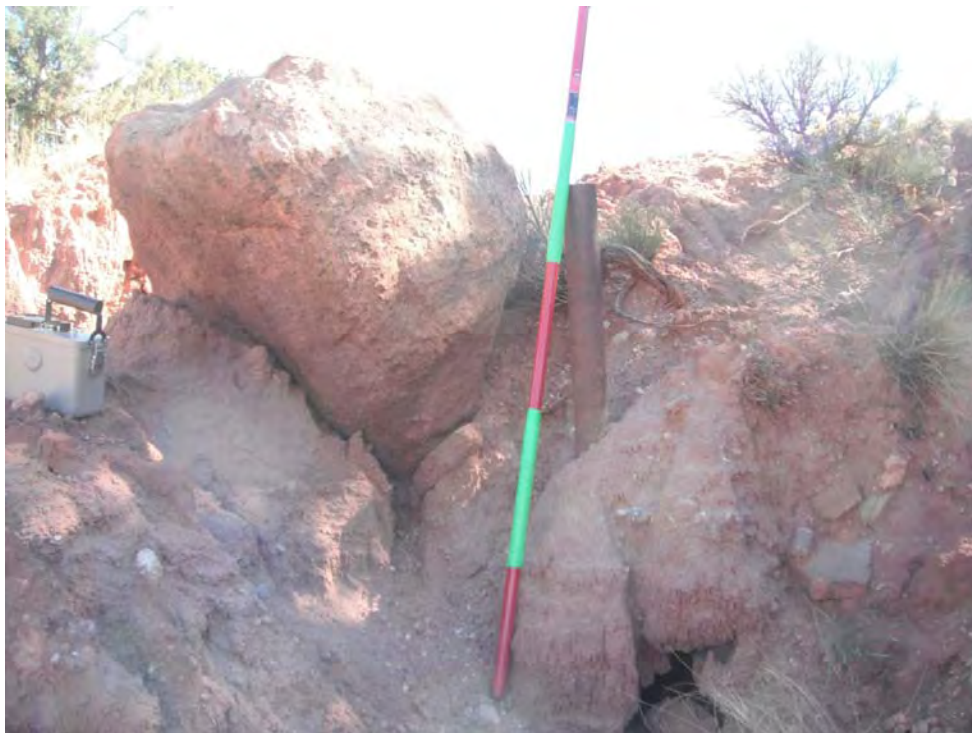
Two drillholes (Drill-1 and Drill-2) were found onsite. Drill-1 contains a 2 inch diameter metal pipe extending approximately 2 ft above the ground surface and located along Rd-1 (see Photo 2 in Appendix A). Drill-2 was found approximately 250 ft northeast of Adit-1. It has a diameter of approximately 3 inches and also contains a metal pipe extending approximately 0.5 ft above the ground surface (see Photo 3 in Appendix A). The depth of the drillings could not be determined.

Photo 2-Looking east at Drill-1.

Drill-1 - 2" diameter metal pipe, along Mine Rd-1

Rad-2 - Drill-1; 0m - 13 uR/h; 1m - 13 uR/h

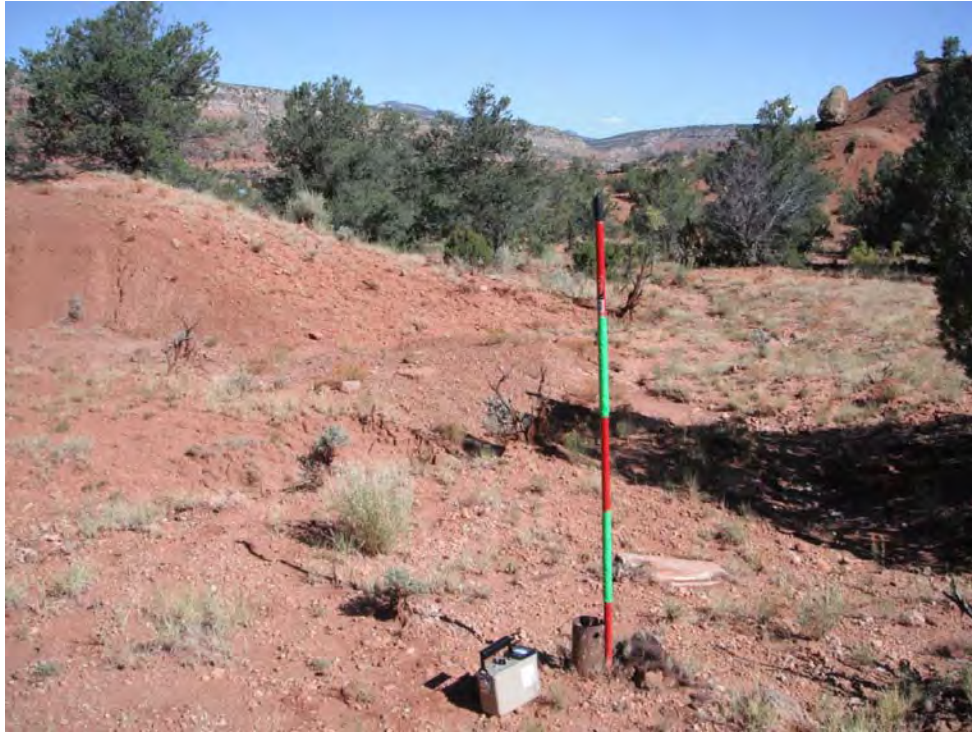
Photo 3-Looking north at Drill-2.

Drill-2 - 3" diameter metal pipe

Rad-3 - Drill-2; 0m - 12 uR/h; 1m - 12 uR/h

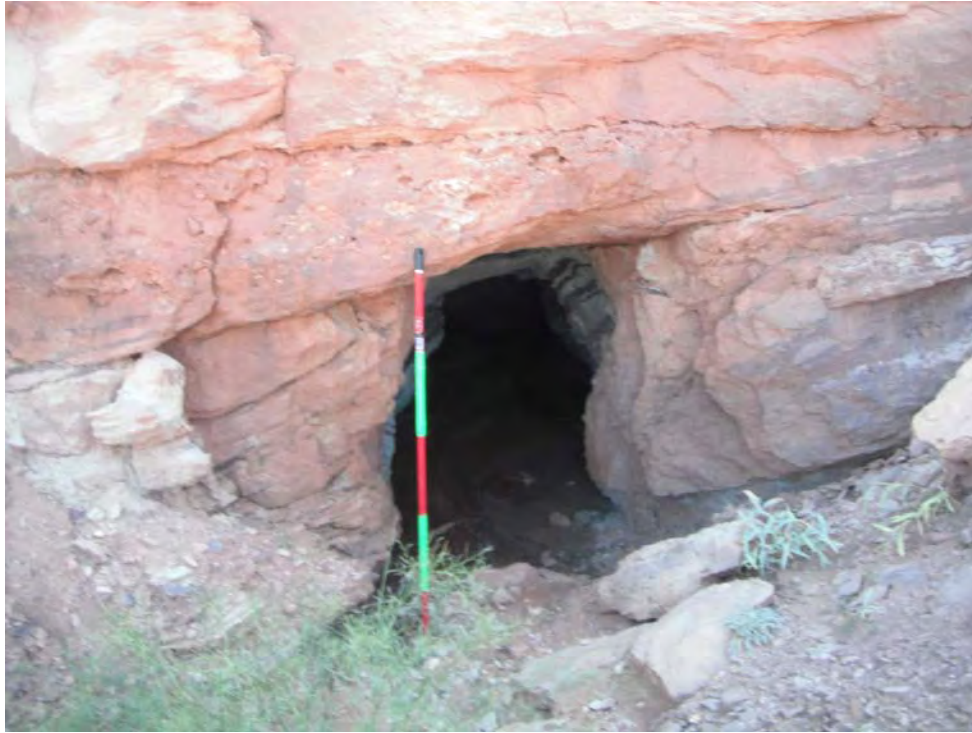
An open adit (Adit-1) was identified at the AUM Site. The adit extends east into an exposure of Permian Cutler Formation sandstone just below the contact with the overlying Triassic Chinle Formation (see Photos 5, 6, and 7 in Appendix A). The opening of the adit is approximately 5 ft tall and 4 ft wide. The depth of the adit could not be determined. Gamma radiation at the entrance to the adit measured 800 $\mu\text{R/hr}$ (microroentgens per hour) at 0 ft above ground at radiation survey point Rad-7 (see Table 2).

Photo 5-Looking east at Adit-1.

Adit-1 - 5' tall, 4' wide, unknown - filling in with sand and mud

Rad 7 - Adit-1; 0m - 800 uR/h; 1m - 220 uR/h - entrance to adit

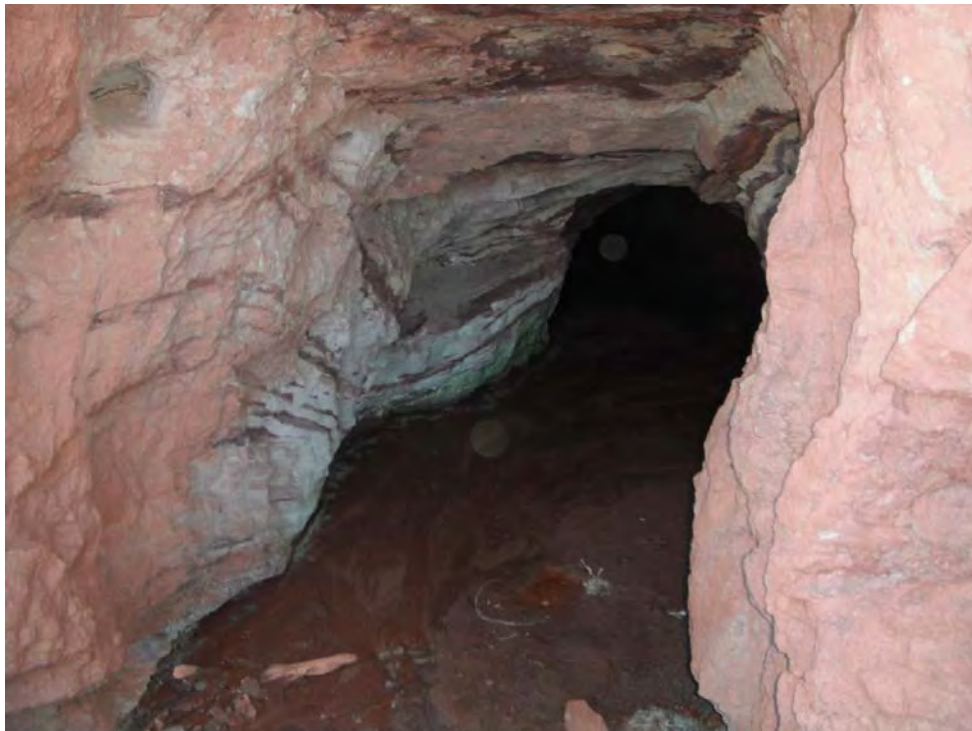
Photo 6-Looking east at wall of Adit-1.

Rad 8 - Adit-1 rock outcrop; 0m - 180 uR/h; 1m - 110 uR/h

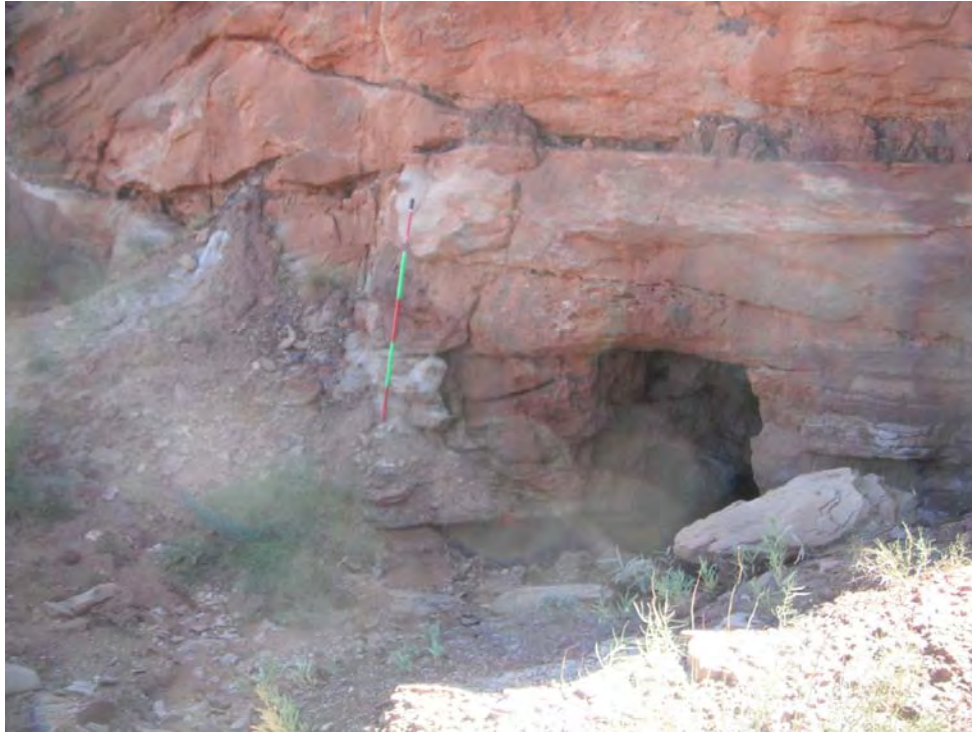
According to Anderson (1980) workings at the site consist of drill roads and an adit. The drilling activity encompasses several hundred square feet and the adit is 5 ft high, 5 ft wide and 50 ft deep (Anderson, 1980). The adit is driven into sandstone and conglomerate of the Permian Cutler Formation (Anderson, 1980). Anderson (1980) reported that 67 tons of ore with an average grade of 0.14% U_3O_8 were mined from the site in 1954 and 1955. According to McLemore (1983) 39 tons of ore yielding 121 pounds of 0.16% U_3O_8 were produced from the site in 1955.

Photo 7-Looking northeast at Adit-1, replicating Anderson photo B.

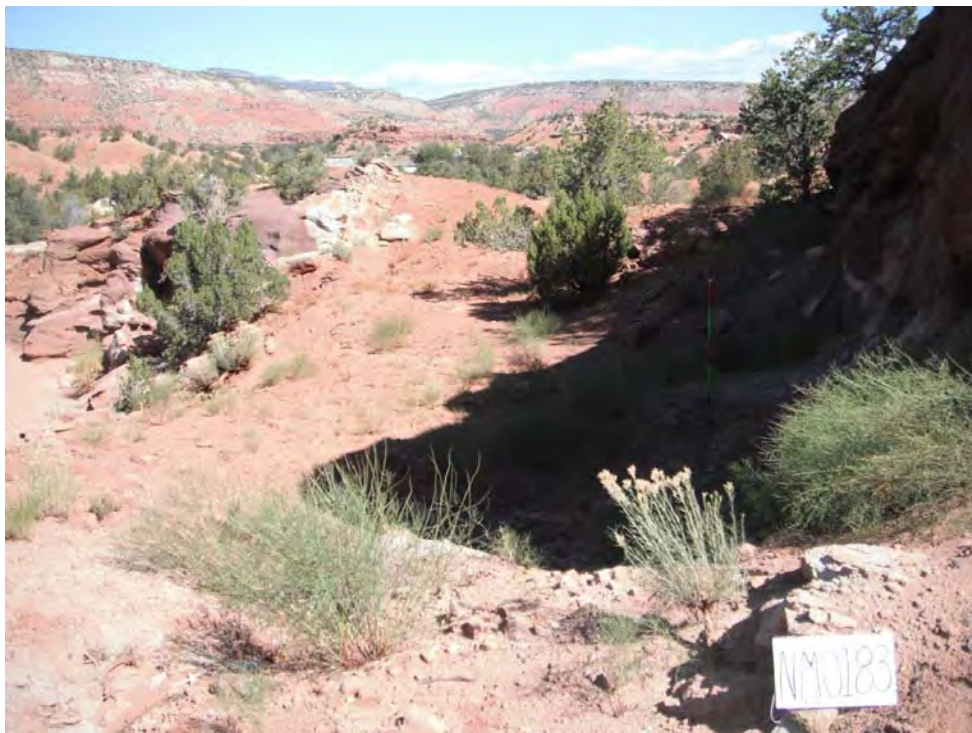
Photo 8-Looking north at Rd-3, replicating Anderson photo A.

Rad 9 - Mine Rd-3 - 0m - 20 uR/h; 1m - 19 uR/h

Rad 10 - west of Mine Rd-3 and Adit-1; 0m - 130 uR/h; 1m - 70 uR/h

Mine Rd-3 - extends north-south along canyon below Mine Rd-1, runs in front of Adit-1
