<b>Inspection Date:</b> December 28, 2017	<b>DP #:</b> 465
	<b>Facility Name:</b> S&R Septic

**Waste Type:** Dom - WW

**Reason for Inspection:** permit compliance assessment

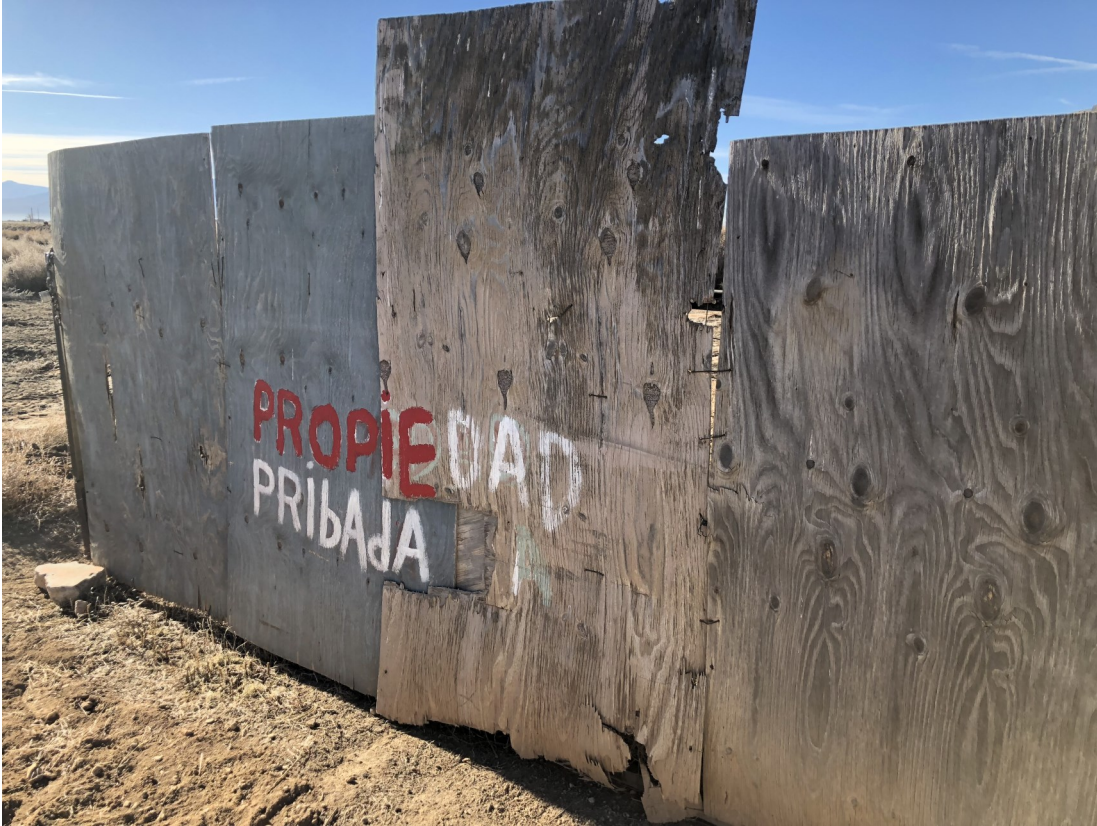
**Photo -1**

**Facility Signage:**  
Signs at the entrance of the facility do not comply with the permits requirements (Photo-1) and the permittee was informed that the proper wording and additional signs were required that contain the contact information and location of the facility. Each cell was identified with a number spray painted on wood. The waste type in each is not designated on the cell signs as the permit requires (Designated with a blue arrow in Photo-3, 6, 7,

Signage at the entrance to the facility

8, 11, 12 and 13). Signs surrounding the facility every 500 ft appeared faded and unreadable. All of these deficiencies were communicated to Mr. Rael and Mansker who agreed to correct them.

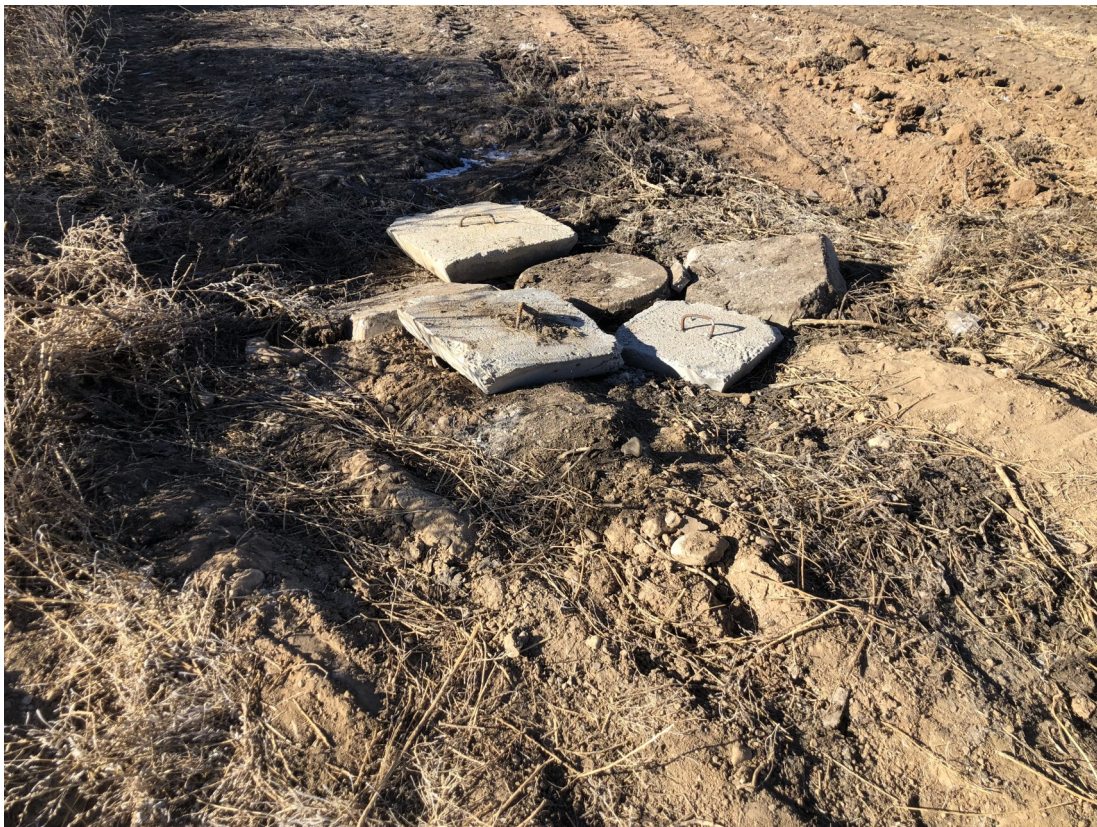
**Photo -2**

The most recent permit requires that concrete splash pads be installed for each cell to prevent erosion and to aid in dispersal within the cells. Each cell contained a collection of concrete pieces that ranged in size and shape (Photo-2, 3, 4 and 10). Mr. Rael mentioned that he had installed large pads of concrete which are now covered by a layer of dirt. He indicated that one of these pads could be seen above the surface in cell 2 (Blue arrow in Photo-4).

Concrete splash guards in Cell 1
