FEDERAL ON-SCENE COORDINATOR REPORT

**Comprehensive Environmental Response Compensation and Liability Act
CERCLA Removal Action
San Mateo Uranium Mine**

**Mt. Taylor Ranger District
Cibola National Forest, New Mexico**

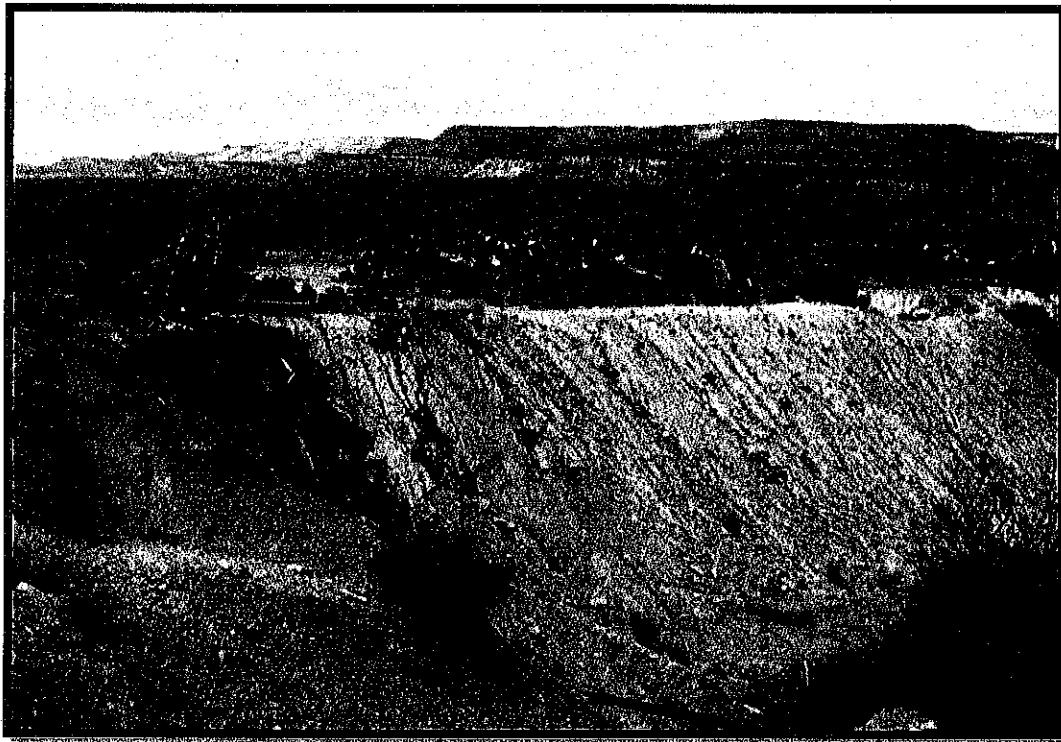
Waste Rock Piles at San Mateo Mine before Removal

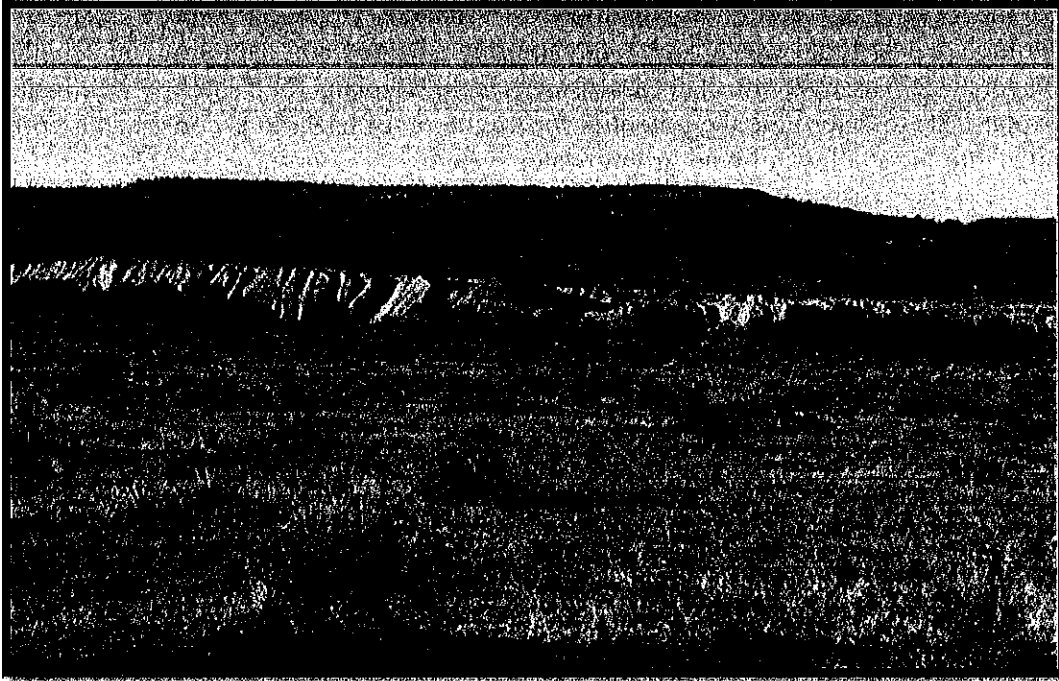
View of Waste Rock Pile at San Mateo Uranium Mine

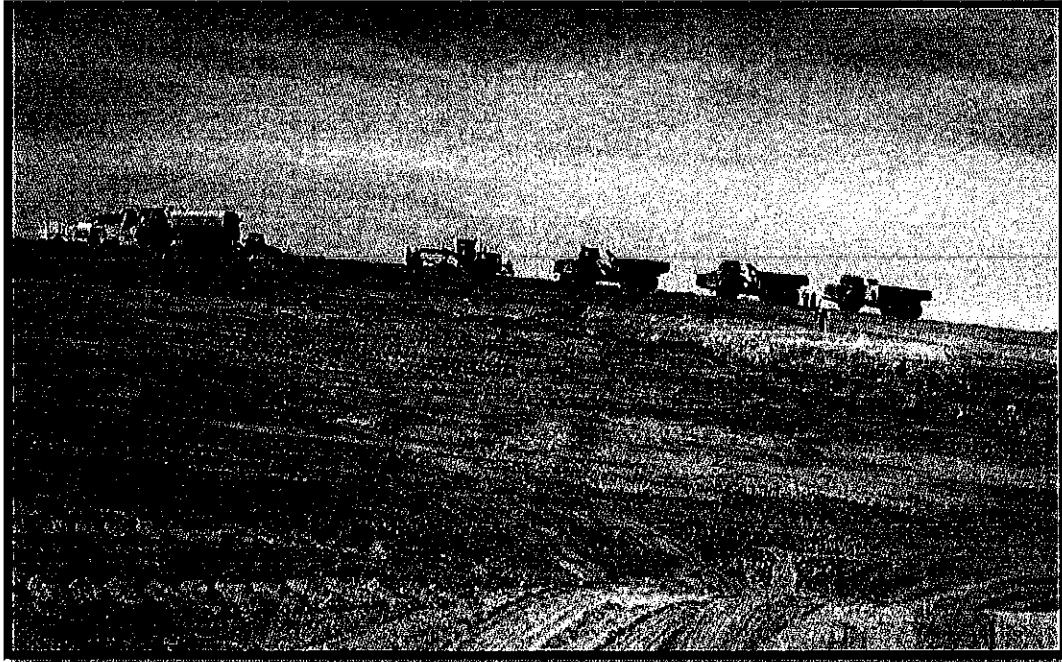
Repository Construction in October 2012

In October, all of remaining contaminated material was removed to the repository. MWH calculated volumes of excavated material from the topographic survey conducted by Envirocon after the removal excavations. The calculated excavated volume of contaminated soil was approximately 136,307 cubic yards from the Site and neighboring properties. This material was placed in the repository. The volume included approximately 112,251 cubic yards of material that was excavated from the area around the mine site, approximately 17,067 cubic yards that was excavated from the neighboring property to the north, and approximately 6,989 cubic yards that was excavated from the neighboring property to the west. The contaminated soil was generally placed in locations on the repository nearest to its point of origin and then spread to accomplish the grading objectives.

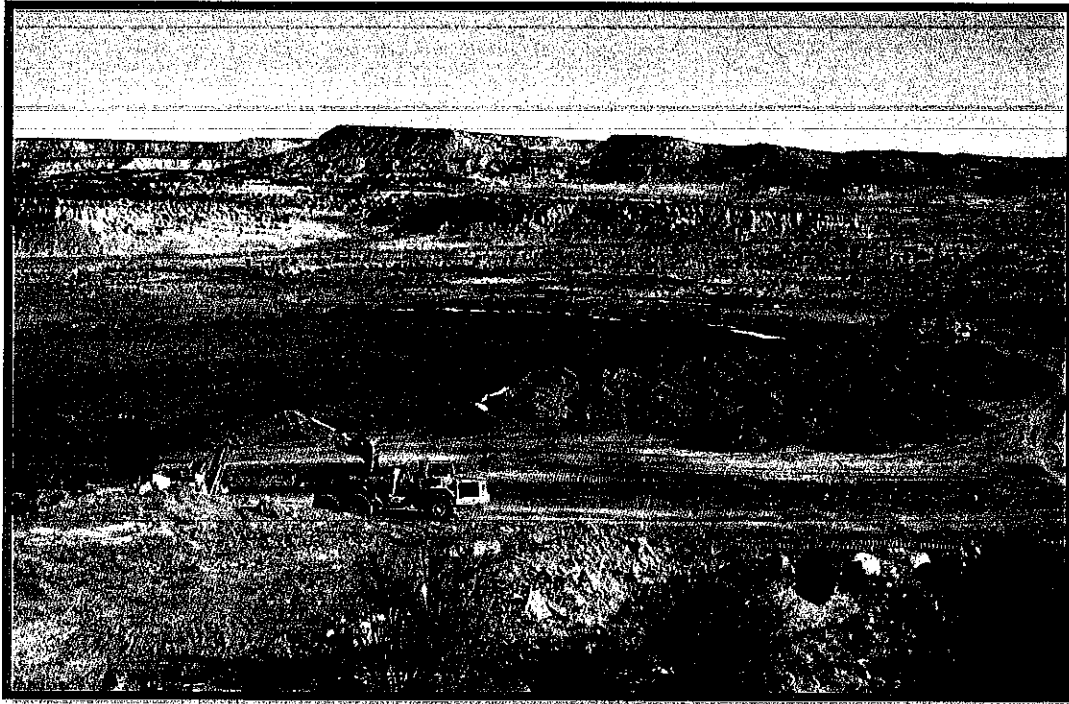
Placement of Cover Material on Repository in November 2012

The construction of the lower layers of the evapotranspiration cover continued in November. The first twelve-inch-thick layer of the evapotranspiration (ET) cover for the repository was completed using clay loam borrow obtained from the Schmitt Ranch. Construction of Diversion Channels 1 and 2 was also begun. Initial sampling and gradation testing of cover sand in the sheet wash area indicated that the fines content of the sand in the area was less consistent than the design report indicated. MWH conducted additional test pit sampling in November and delineated two new borrow areas where the sandy loam met project specifications. The design was modified to use these borrow areas as detention ponds, and to terminate Diversion Channel 2 in the south retention pond rather than extend the channel to the east arroyo as originally designed.

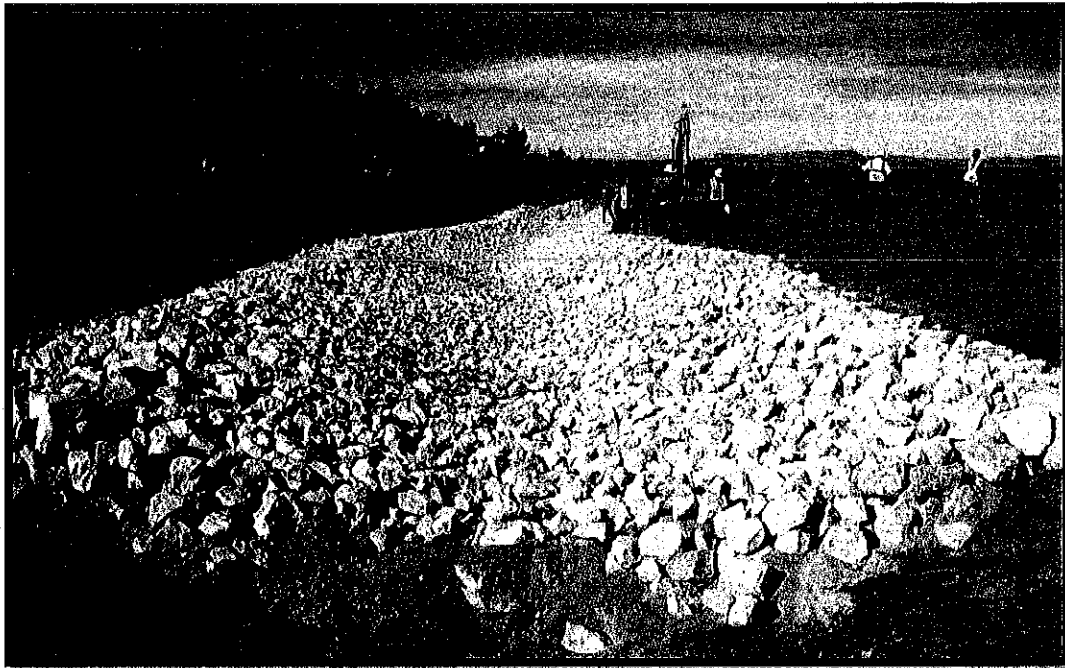
Construction of Diversion Channel #2 in December 2012

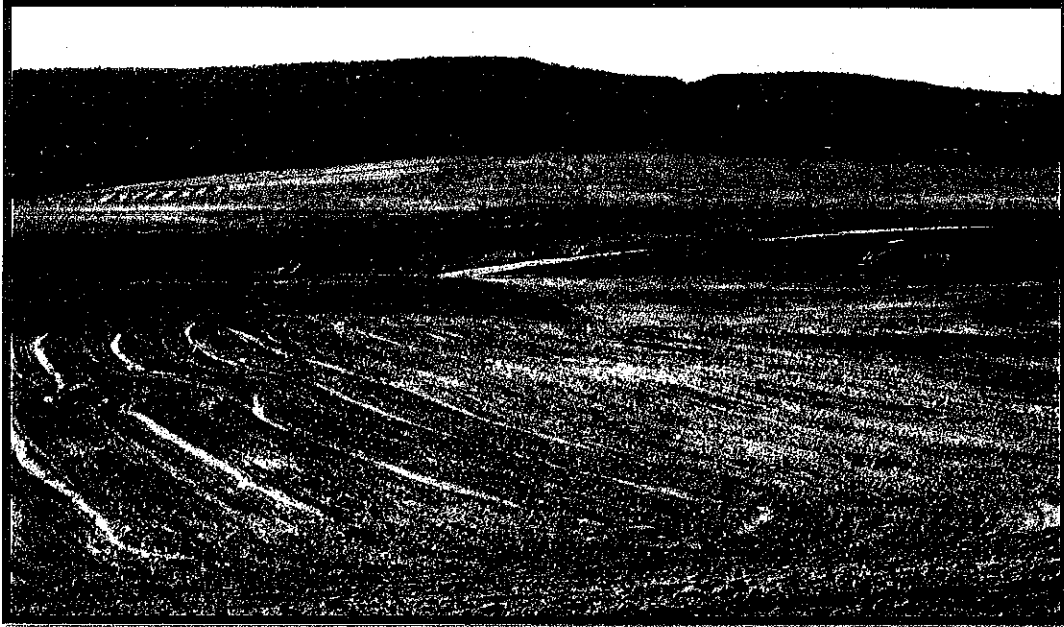
Applying Seed to Repository with Seed Drill in February 2013

Work in February included construction of temporary range fence and permanent chain link fence by Liberty Fencing. Organic material was added to the revegetated areas using composted green mulch on Forest Service lands and sterile cow manure on adjacent private lands. Seed was applied using seed drills on the majority of the site with hydro seeding methods on steeper slopes. Silt fence was installed along the diversion channels. All construction work was completed, and a final inspection was held on March 8, 2013. The revised Construction Completion Report was approved by the Forest Service on June 27, 2013.

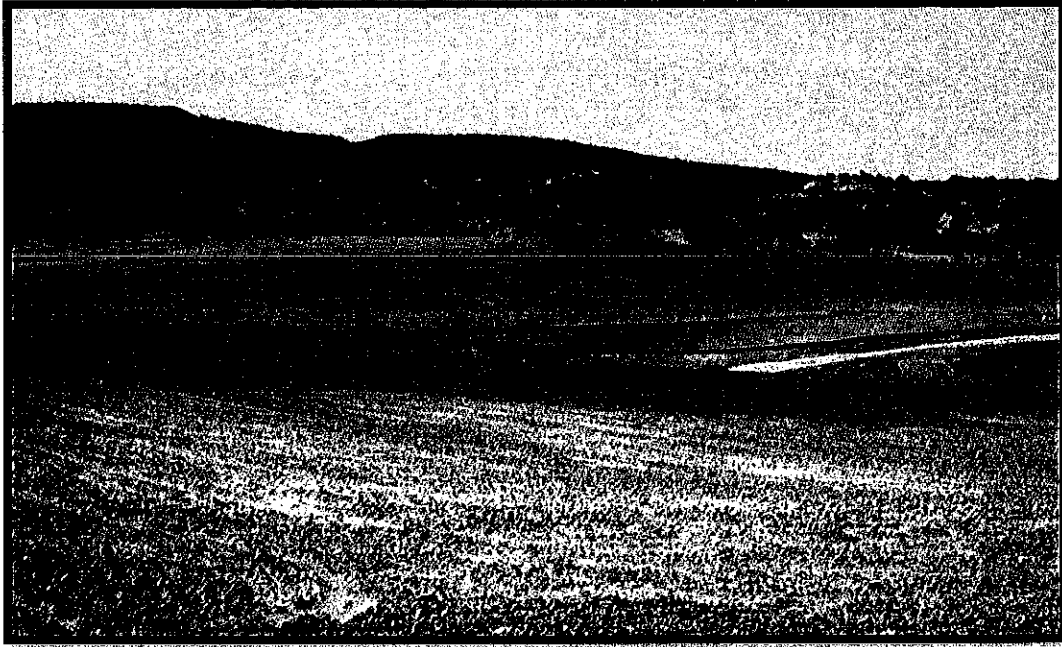
Completed Repository in March 2013

Work in January of 2013 included the placement of the third and final eighteen-inch-thick layer of the ET cover for the waste repository. This final layer is comprised of a rock admixture that is blended with the sandy loam that will resist erosion and provide a good growth medium for plant life. The plant roots will also aid in preventing erosion and providing transpiration. The flatter top of the repository was constructed with a 2-inch rock gradation. The sides of the repository were at a 20 percent slope and a 3-inch rock mixture was used. MWH computed the in-place volumes of the repository cover soils. The volume of the clay loam layer was 37,944 cubic yards, the sandy loam layer volume was 36,768 cubic yards, and the sandy loam and rock admixture layer was 72,684 cubic yards.

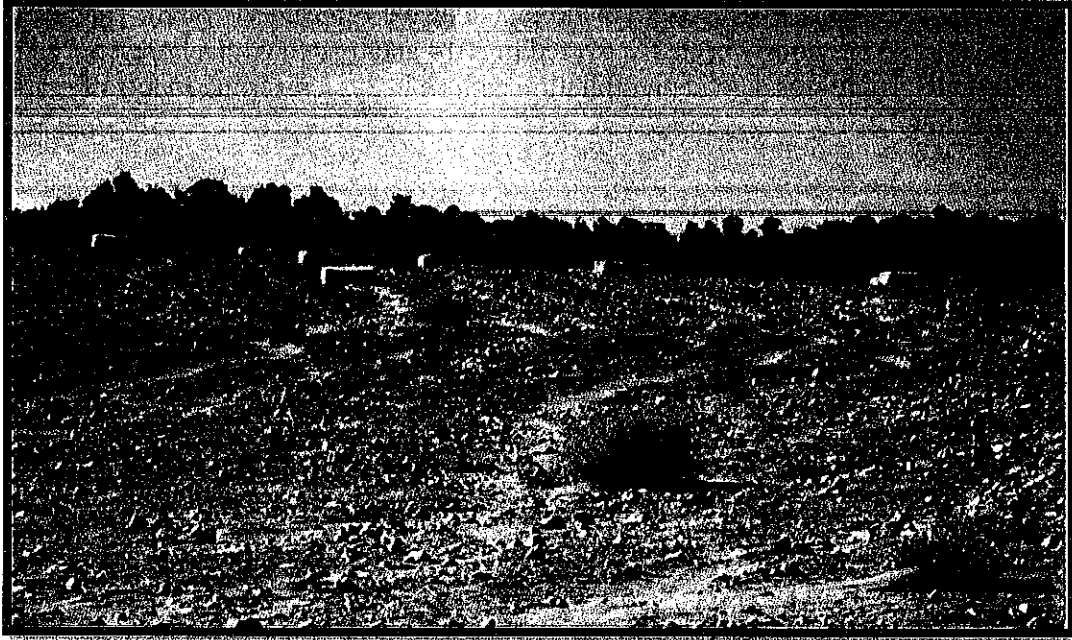
The Forest Service inspected the Site on February 19, 2014, to check on the progress of revegetation and the status of erosion repairs that had been reported previously. The fencing was intact and was in excellent condition. The grass growth was sparse due to a drought. Envirocon had recently repaired a small gulley that had developed the previous September in the borrow area. They had also installed straw bales on several minor erosion rills on the repository itself. In general, site conditions were very good, with the exception of the vegetation, which was very sparse due to drought.

Minor Erosion on North face of Repository in February 2014

The next Forest Service inspection was on May 14, 2015. MWH and Envirocon, hired by the companies, were making erosion repairs to the site on the east side of the repository. Riprap was placed in the gully that had formed along the edge of the repository and coconut matting was also laid to combat further erosion. The chain link fence furnished and installed by Liberty Fencing was being shifted slightly to the east to accommodate this repair work. Disturbed areas were reseeded with native grass.

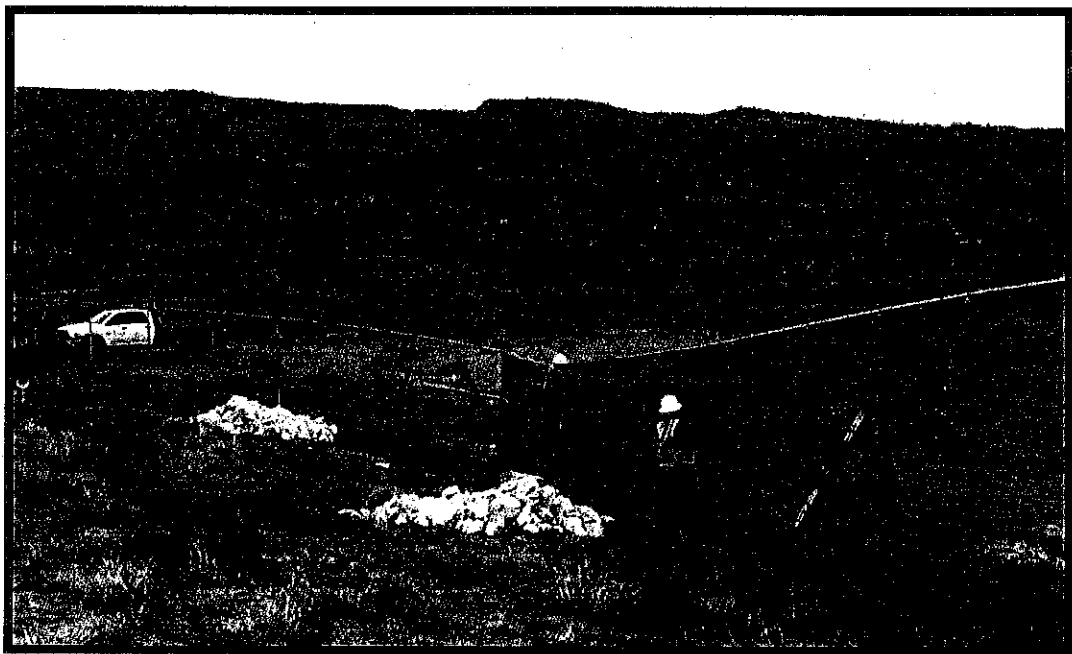
Moving Chain link Fence in May 2015

The chain link fence also unexpectedly caused windblown dirt to accumulate in a several foot high drift at the eastern edge of the repository. This problem was initially solved by moving the fence to a less susceptible location and ultimately by an increased density of vegetation that anchored the soil.

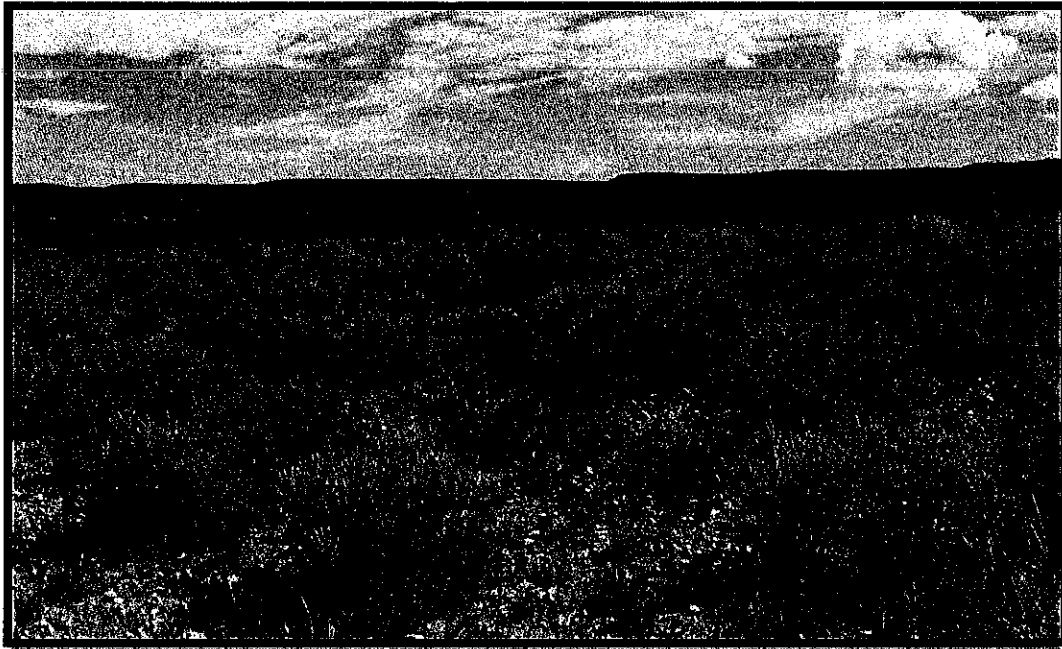
There were a large number of Russian Thistle plants at the repository. Small patches of Russian Knapweed plants had previously been discovered in 2014 and treated with a Forest Service approved herbicide that fall. There was a good precipitation pattern in 2015 resulting in lots of grass seedlings throughout the Site.

Repository Vegetation in September 2016

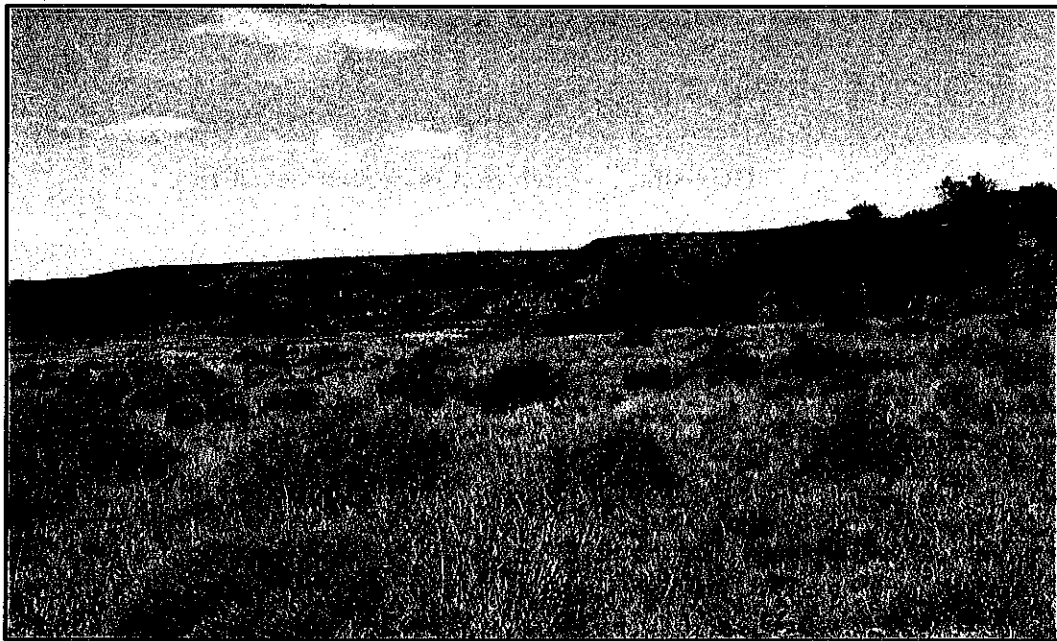
A followup site inspection was conducted five years later on June 22, 2023 to determine if the remedy continued to be protective of human health and the environment. Revegetated areas had improved in size and density to a completely natural appearance. All prior erosion repairs were still in excellent condition. Storm water channels were all in good condition and functioning well. Fencing and gates were all in excellent condition with no signs of vandalism or unauthorized access. The 25 acre repository area will always remain closed to grazing to maximize transpiration and the chain link fence and gates will be kept in perpetuity to exclude cattle and vehicles.

Repository Vegetation in June 2023

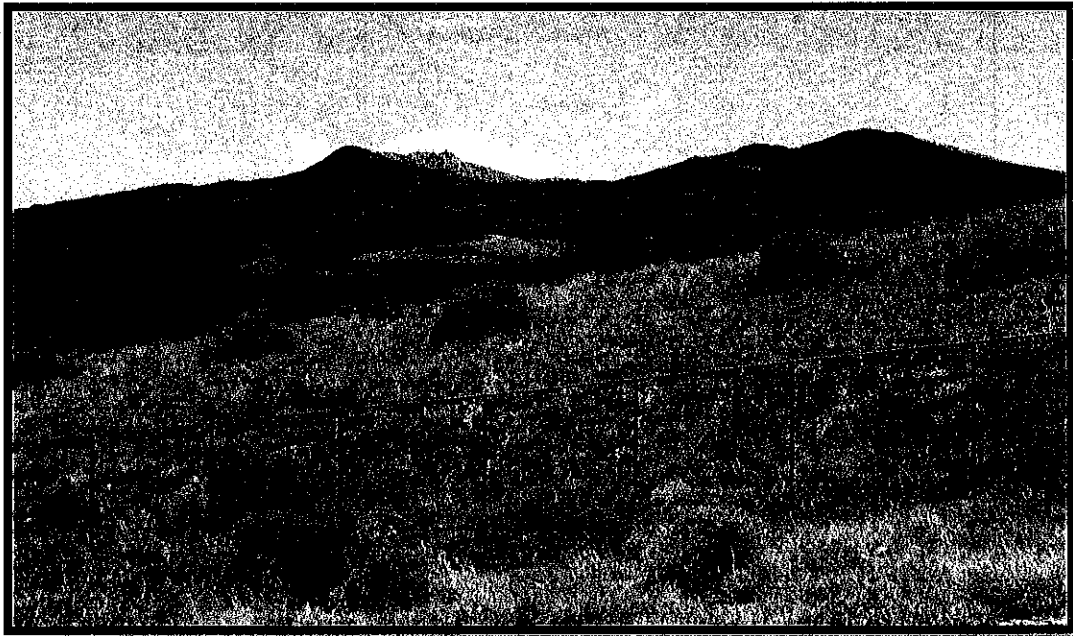
San Mateo Repository has Natural Appearance in 2023
