# Abandoned Uranium Mine Assessment for the Sparks-Stone Site (NM0236)

**FINAL REPORT**

NM0236

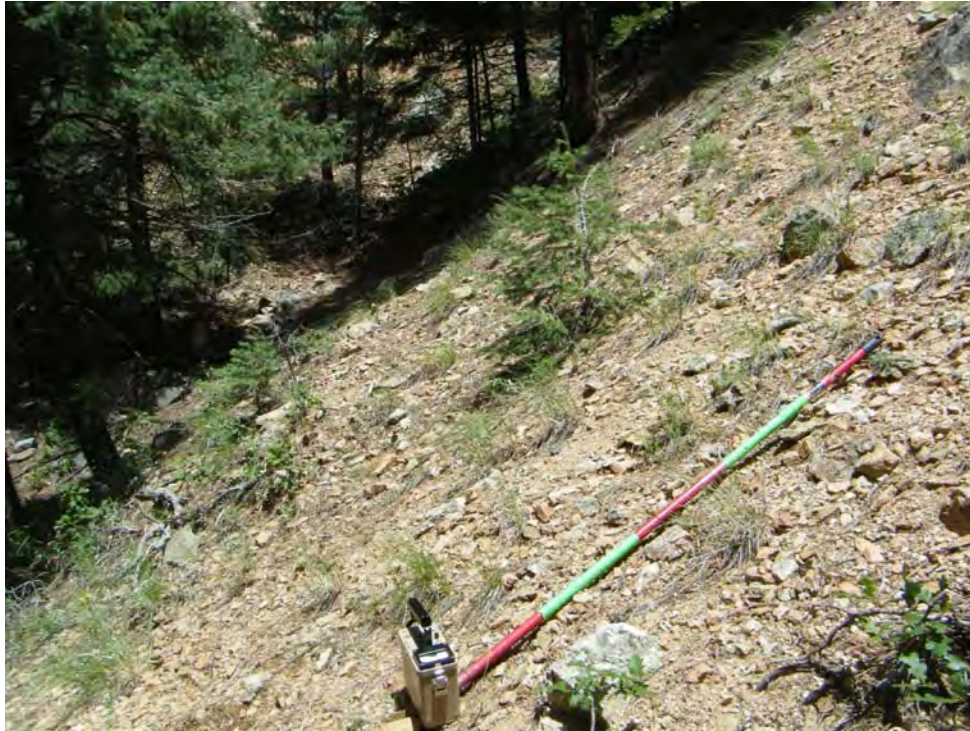
Photo 1-Looking northwest at southern end of MMD polygon boundary.

1237 At southern end of polygon. No mine features visible.

Rad 1 - southern end of polygon, offsite Om - 16 mR/h; 1m - 16 mR/h

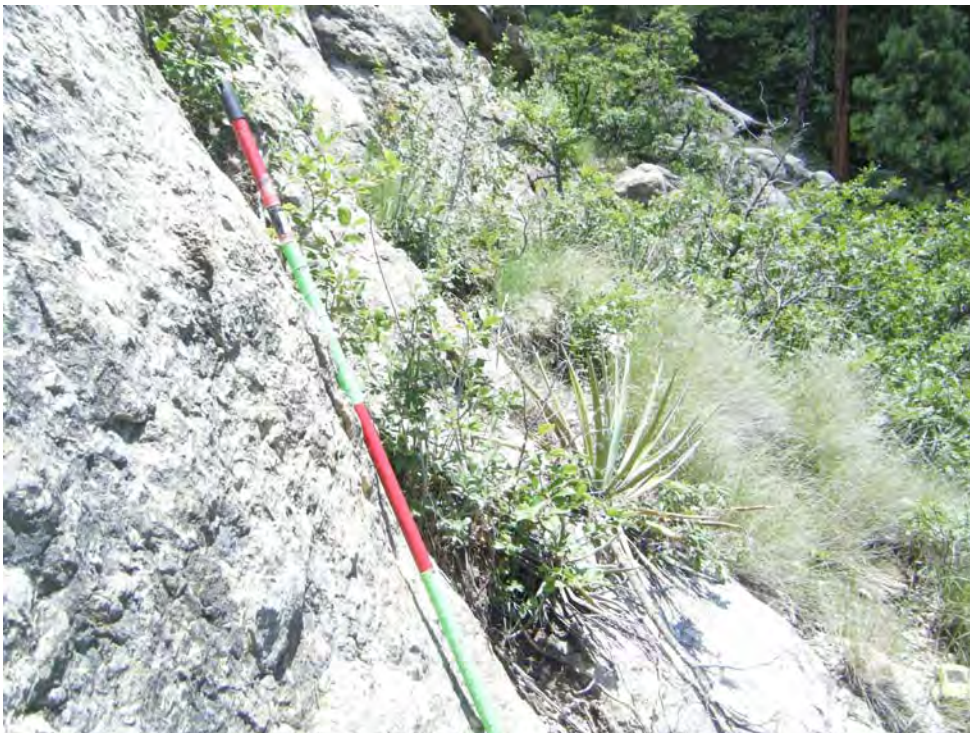
Photo 2-At Rad-2, looking north.

Rad 2 - at western end of polygon, offsite Om - 7 mR/h; 1m - 8 mR/h

Photo 2 - looking north at Rad 2; no visible mine features

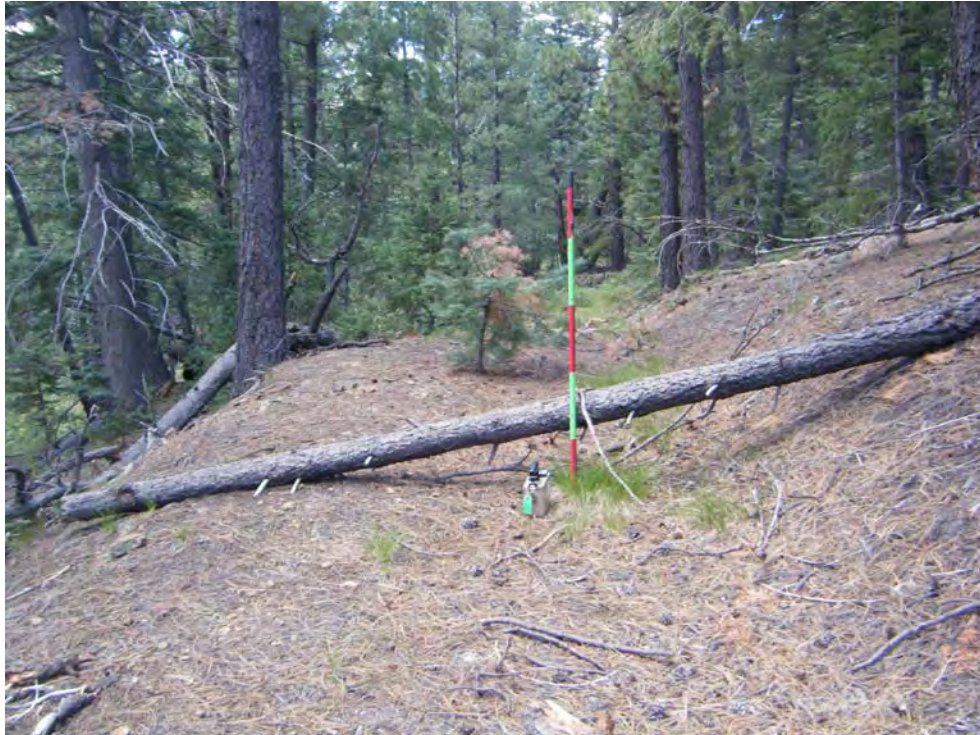
Photo 3-Looking west at Rd-1.

mine road through polygon; Photo 3 & 4 at center looking west then east

Photo 3 - looking west at mineroad 1

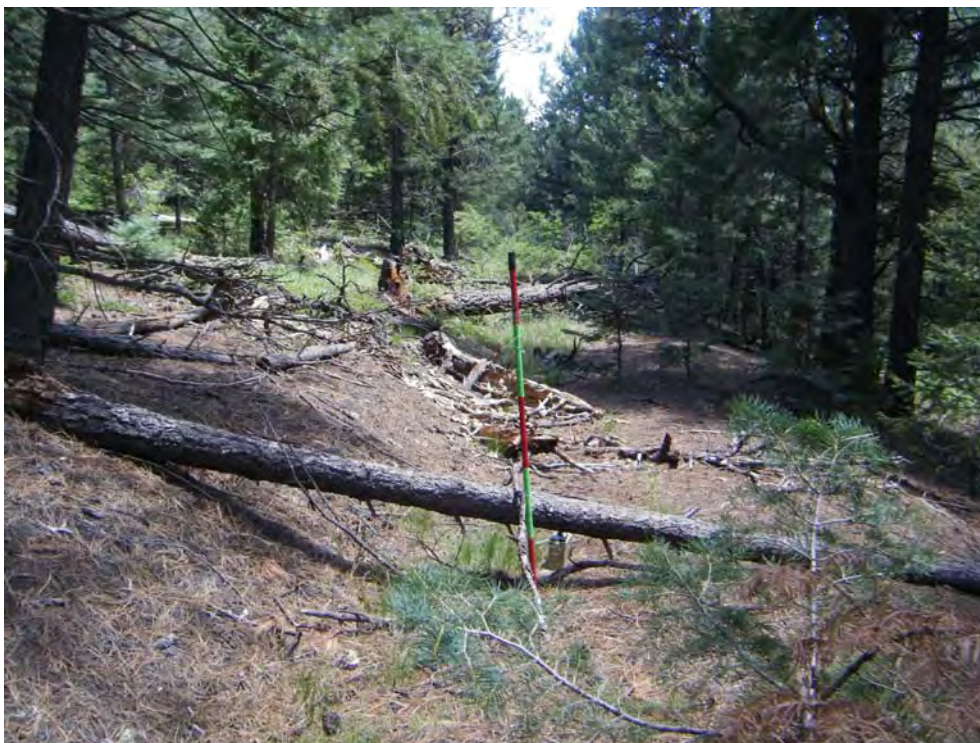
Photo 4-Looking east at Rd-1.

Photo 4 - looking east at mineroad 1

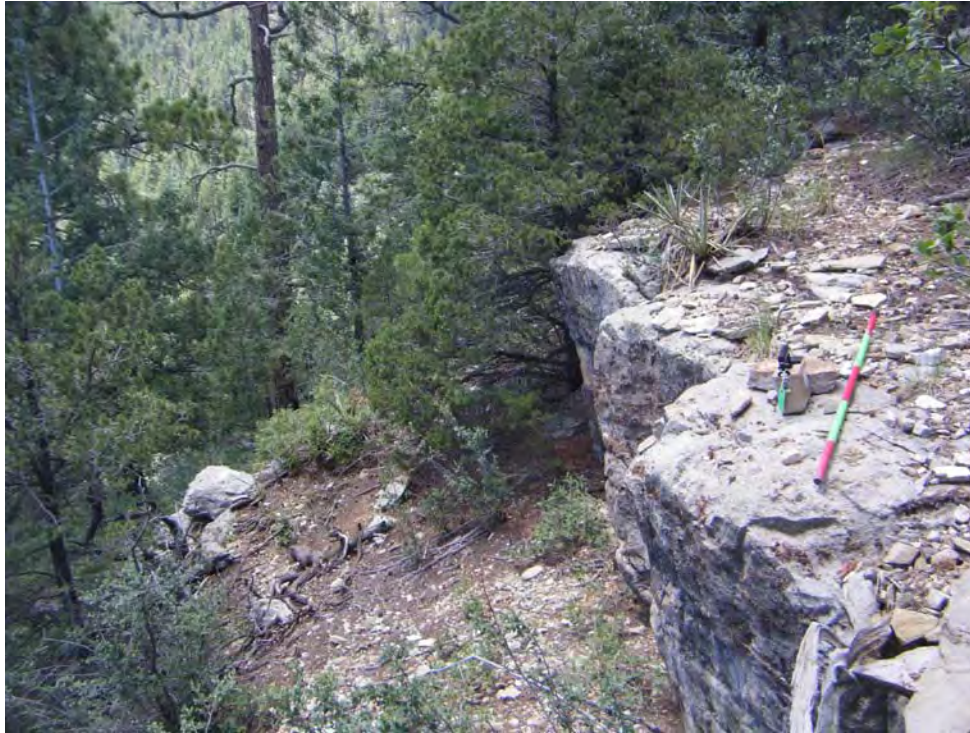
Photo 5-At Rad-4, looking west from eastern edge of MMD polygon boundary.

Rad 4 - eastern end of polygon - Om - 6 mR/h; 1m - 6 mR/h

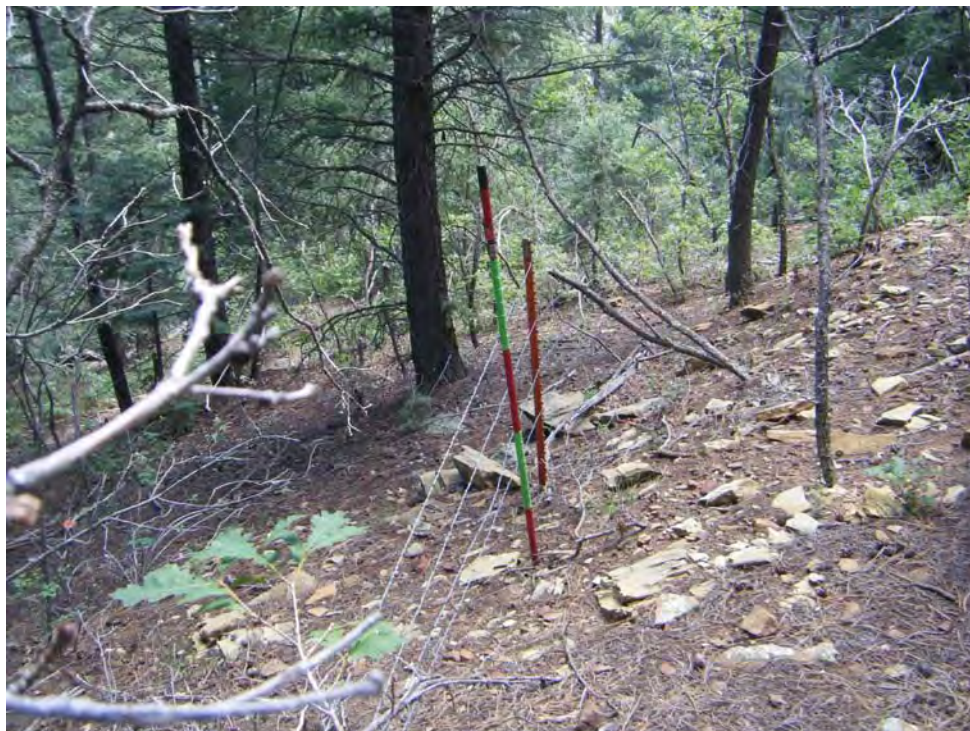
Photo 6-Looking south at Fenc-1.

FenceLn-1 - fence, barbed wire along road - Private ~~road~~<sup>ALT</sup> property beyond.

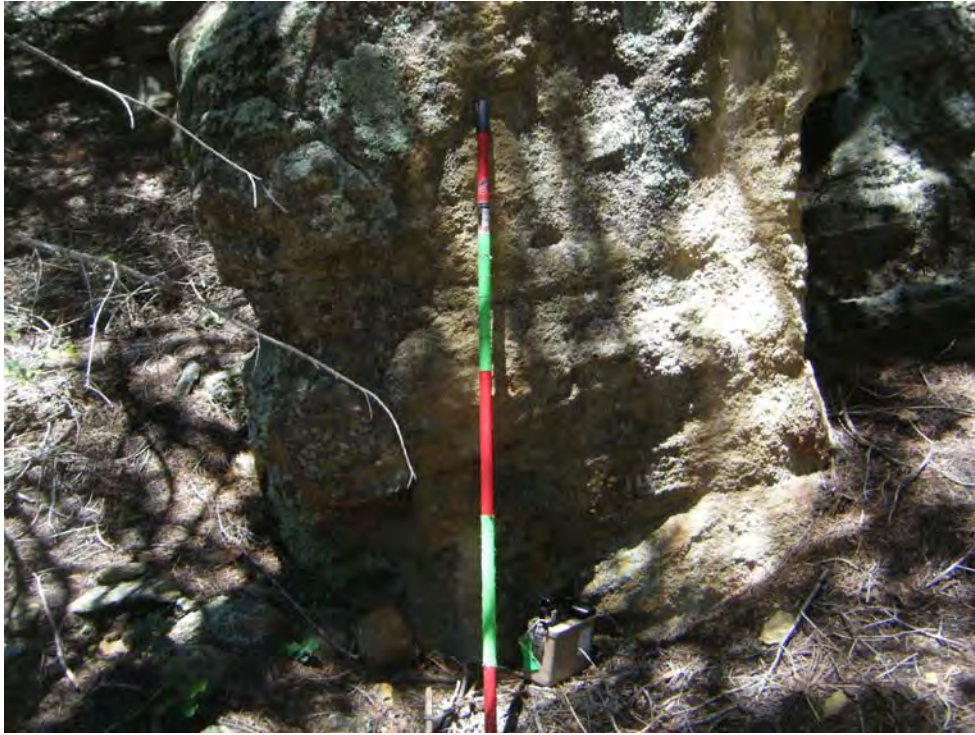
Photo 7- At Rad-5, looking north at northeastern end of MMD polygon boundary.

Rad 5 - northeastern end of polygon; Om - 9 mR/h; 1m - 7 mR/h

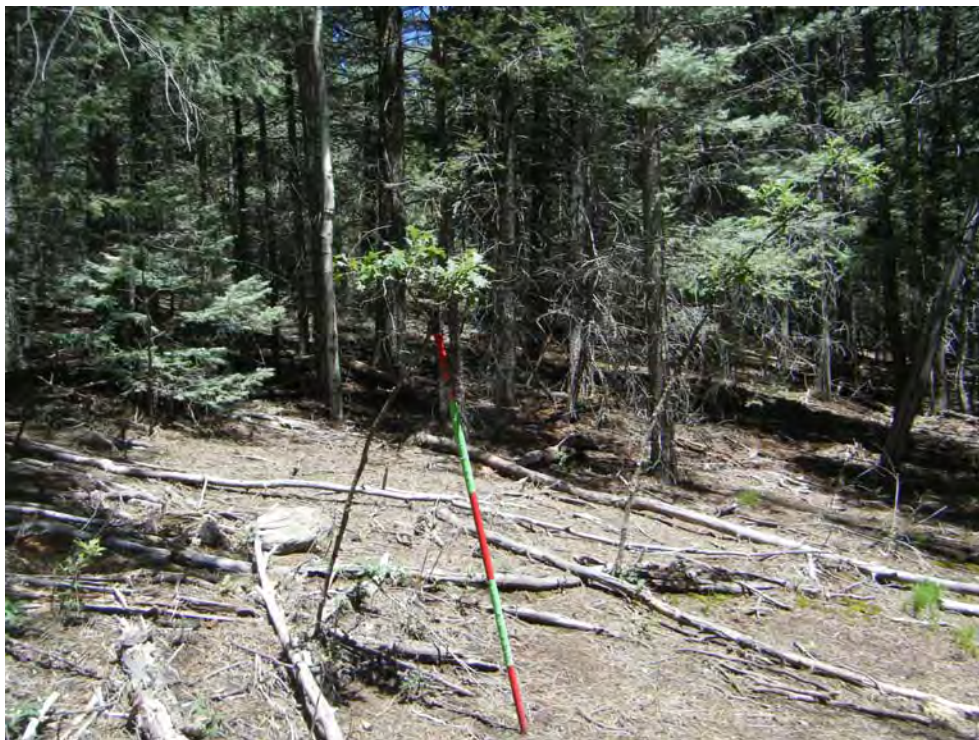
Photo 8- At Rad-6, looking northeast.

Rad 6 - northern part of polygon; Om - 8 mR/h; 1m - 8 mR/h

Photo 8 - looking north east at Rad 6; no visible features

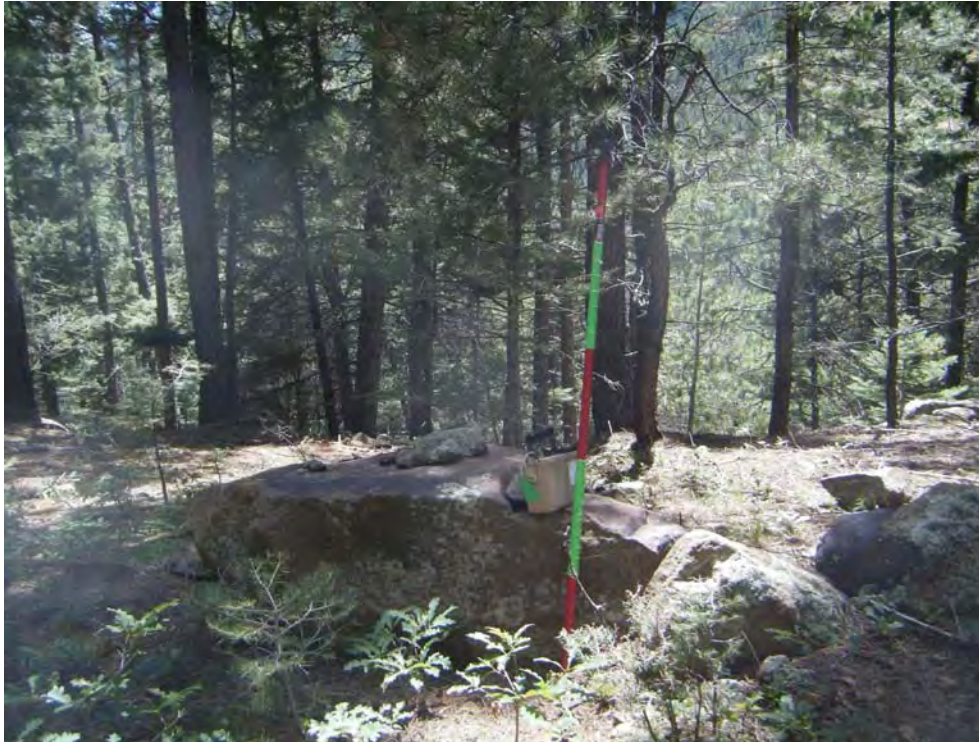
Photo 9- At Rad-7, looking southwest.

Rad 7 - northwest part of polygon; Om - 6 mR/h; 1m - 7 mR/h<sup>ALT</sup>

Photo 9 - looking southwest at Rad 7, no visible mine features

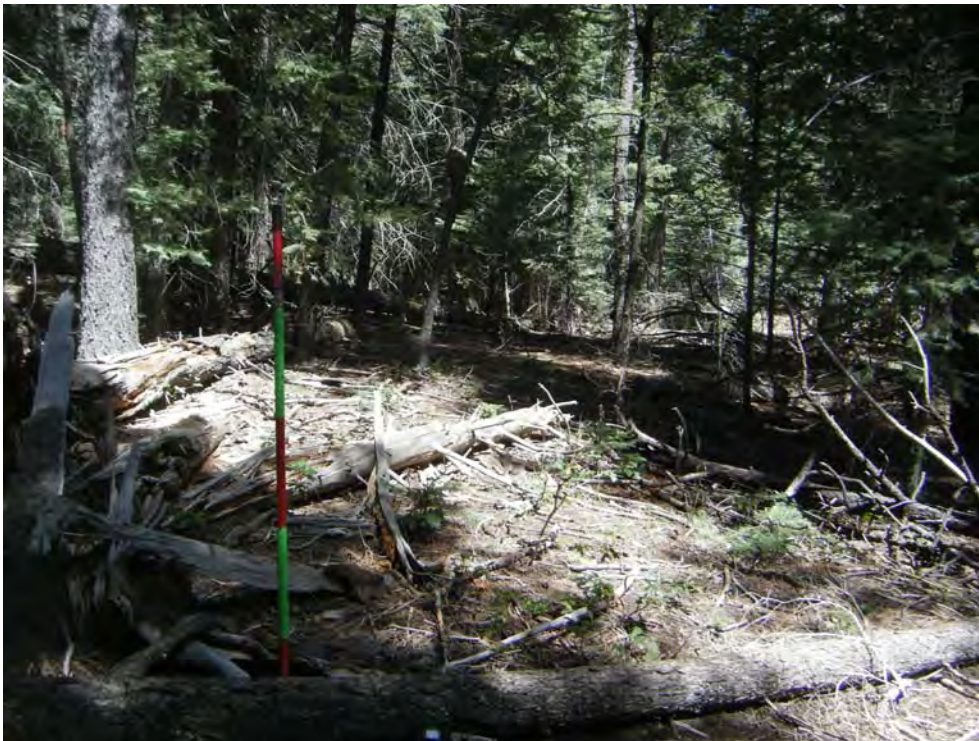
Photo 10-At Rad-8, looking east.

Rad 8 - middle of northern part of polygon; Om - 6 mR/h; 1m - 8 mR/h

Photo 10 - looking east at Rad 8, no visible mine features

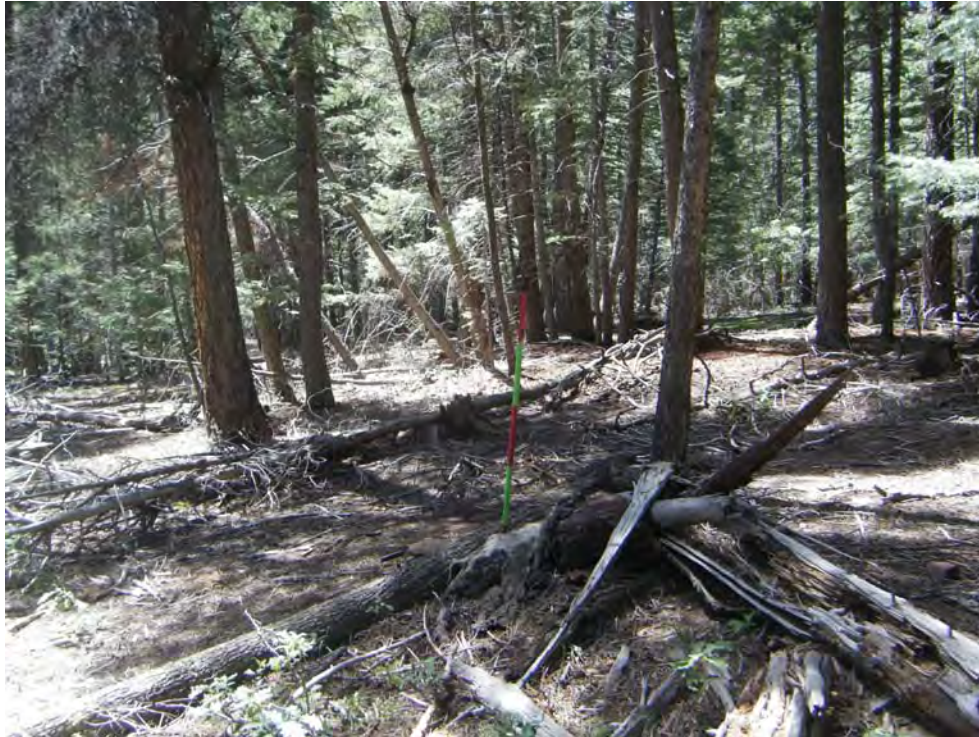
Photo 11-At Rad-8, looking west.

Photo 11 - looking west at Rad 8, no visible mine features

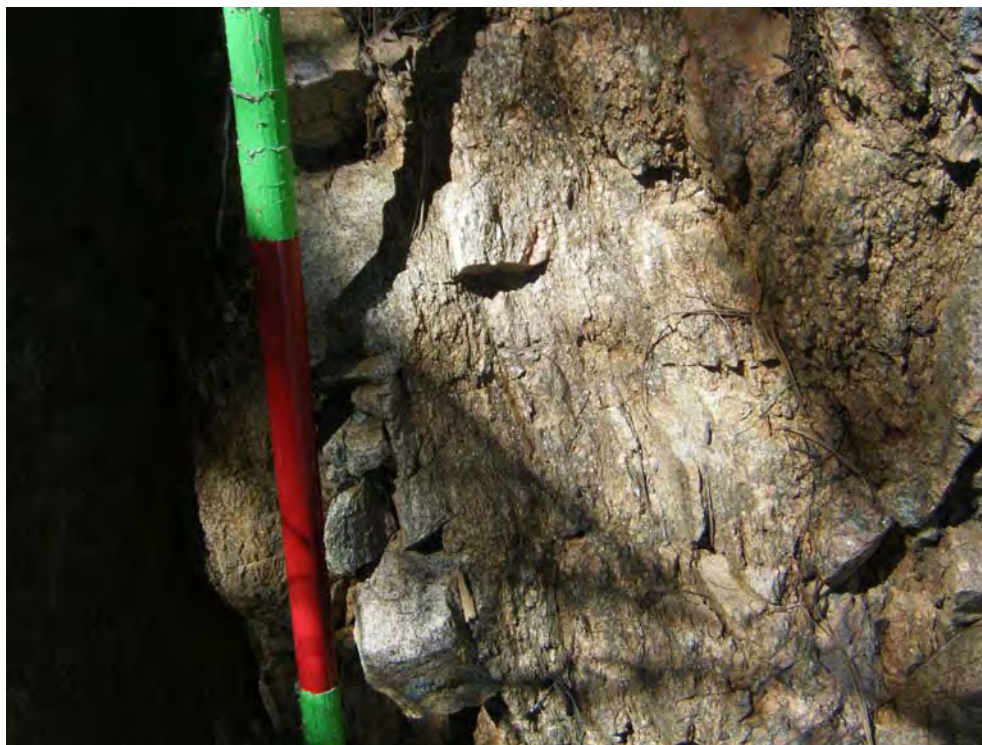
The gamma radiation readings at the AUM Site did not vary significantly above background levels. The highest radiation reading was at Rad-9, where 23  $\mu\text{R/hr}$  was recorded at contact with an outcrop of metamorphic rock. Please see Table 2 for details.

Photo 12-At Rad-9, metamorphic rock outcrop in western part of MMD Polygon.

Rad 9 - western end of southern part of polygon; Om - 23 mR/h; 1m - 17 mR/h

Photo 12 - metamorphic rock outcrop in <sup>part</sup> western part of polygon at Rad 9

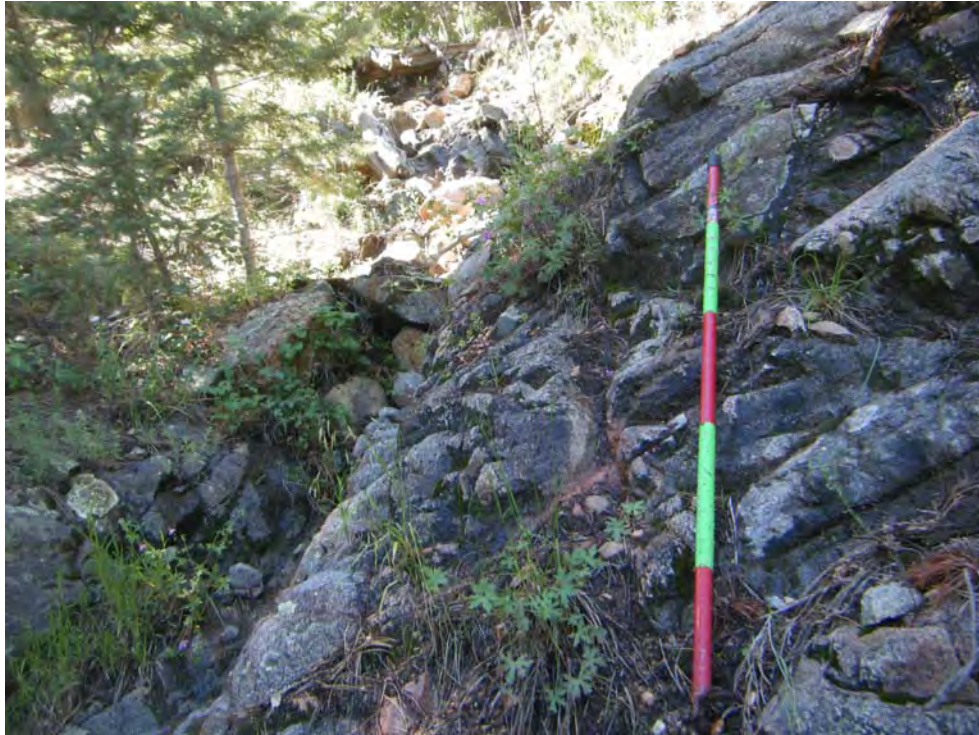
Photo 13-At Rad-10, looking northwest.

Rad 10 - south western end of polygon; Om - 10 mR/h; 1m - 10 mR/h

Photo 13 - looking north west at Rad 10; no visible mine features

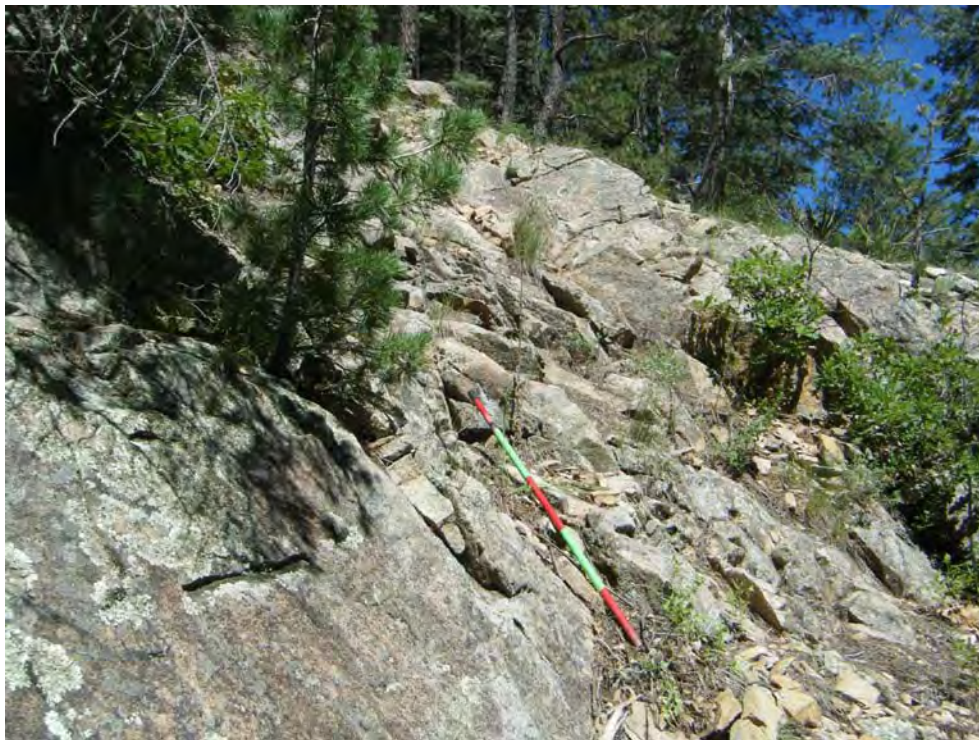
Photo 14-At Rad-11, looking northeast.

Rad 11 - Southeast corner of polygon; 0m-19mR/h; 1m-18mR/h

Photo 14 - looking north east at Rad 11, no visible features
