Abandoned Uranium Mine Assessment for the Vargas-Jarmillo Site (NM0188)

FINAL REPORT

NM0188

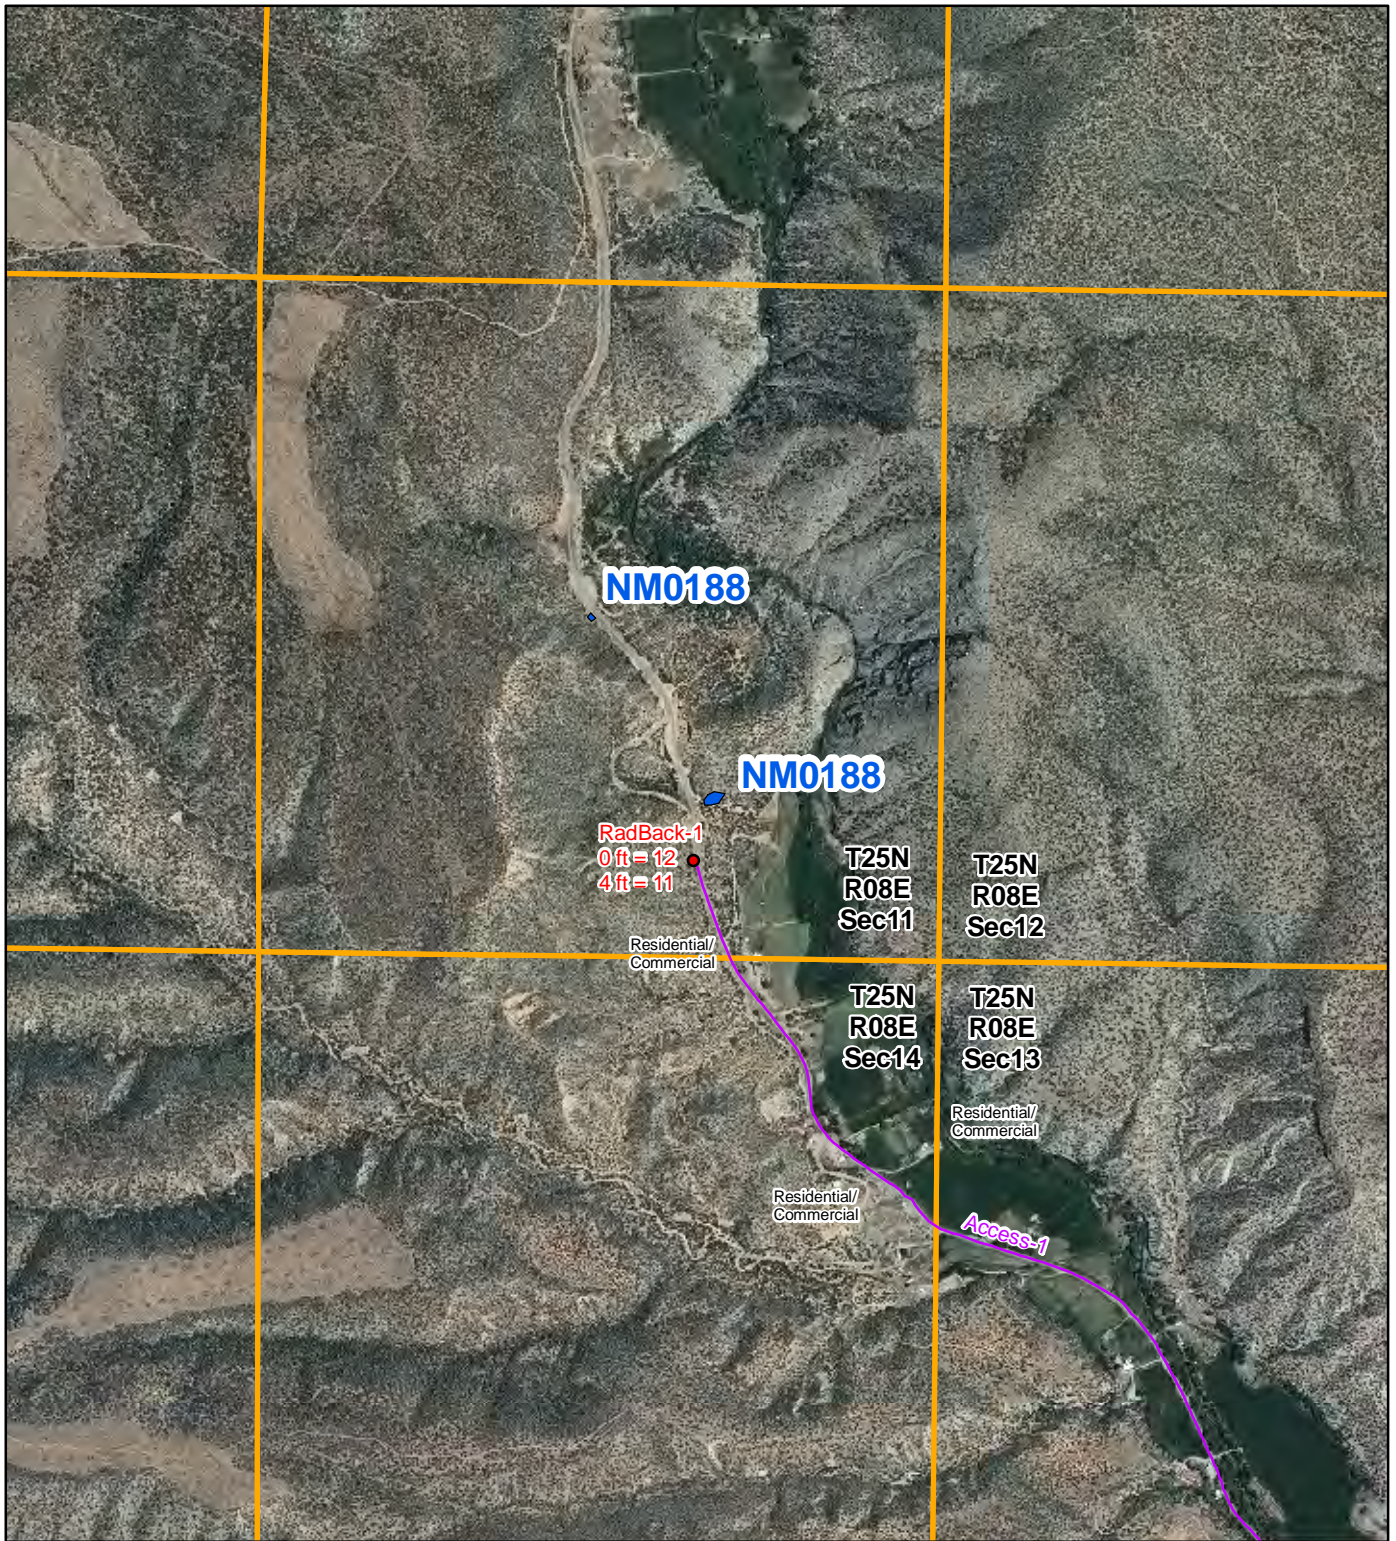
Figure 3
Aerial Photo
NM0188-Vargas-Jarmillo
 Abandoned Uranium
 Mine Assessment

The AUM Site can be found on the La Madera Quadrangle 7.5 minute United States Geological Survey topographic map at an elevation of approximately 6,700 feet above mean sea level (please see Figure 2). The AUM Site is located along the Rio Vallecitos, within a north-south trending canyon formed by the foothills of the Tusas Mountains to the west, and Mesa de la Jabita to the east. Figure 3 shows an aerial photograph of the terrain surrounding the AUM Site.

Several tracts of land used for farming and ranching are located near the site boundary, along State Route 111, and a farmhouse was observed approximately 0.2 miles south of the site (please see Figure 3).

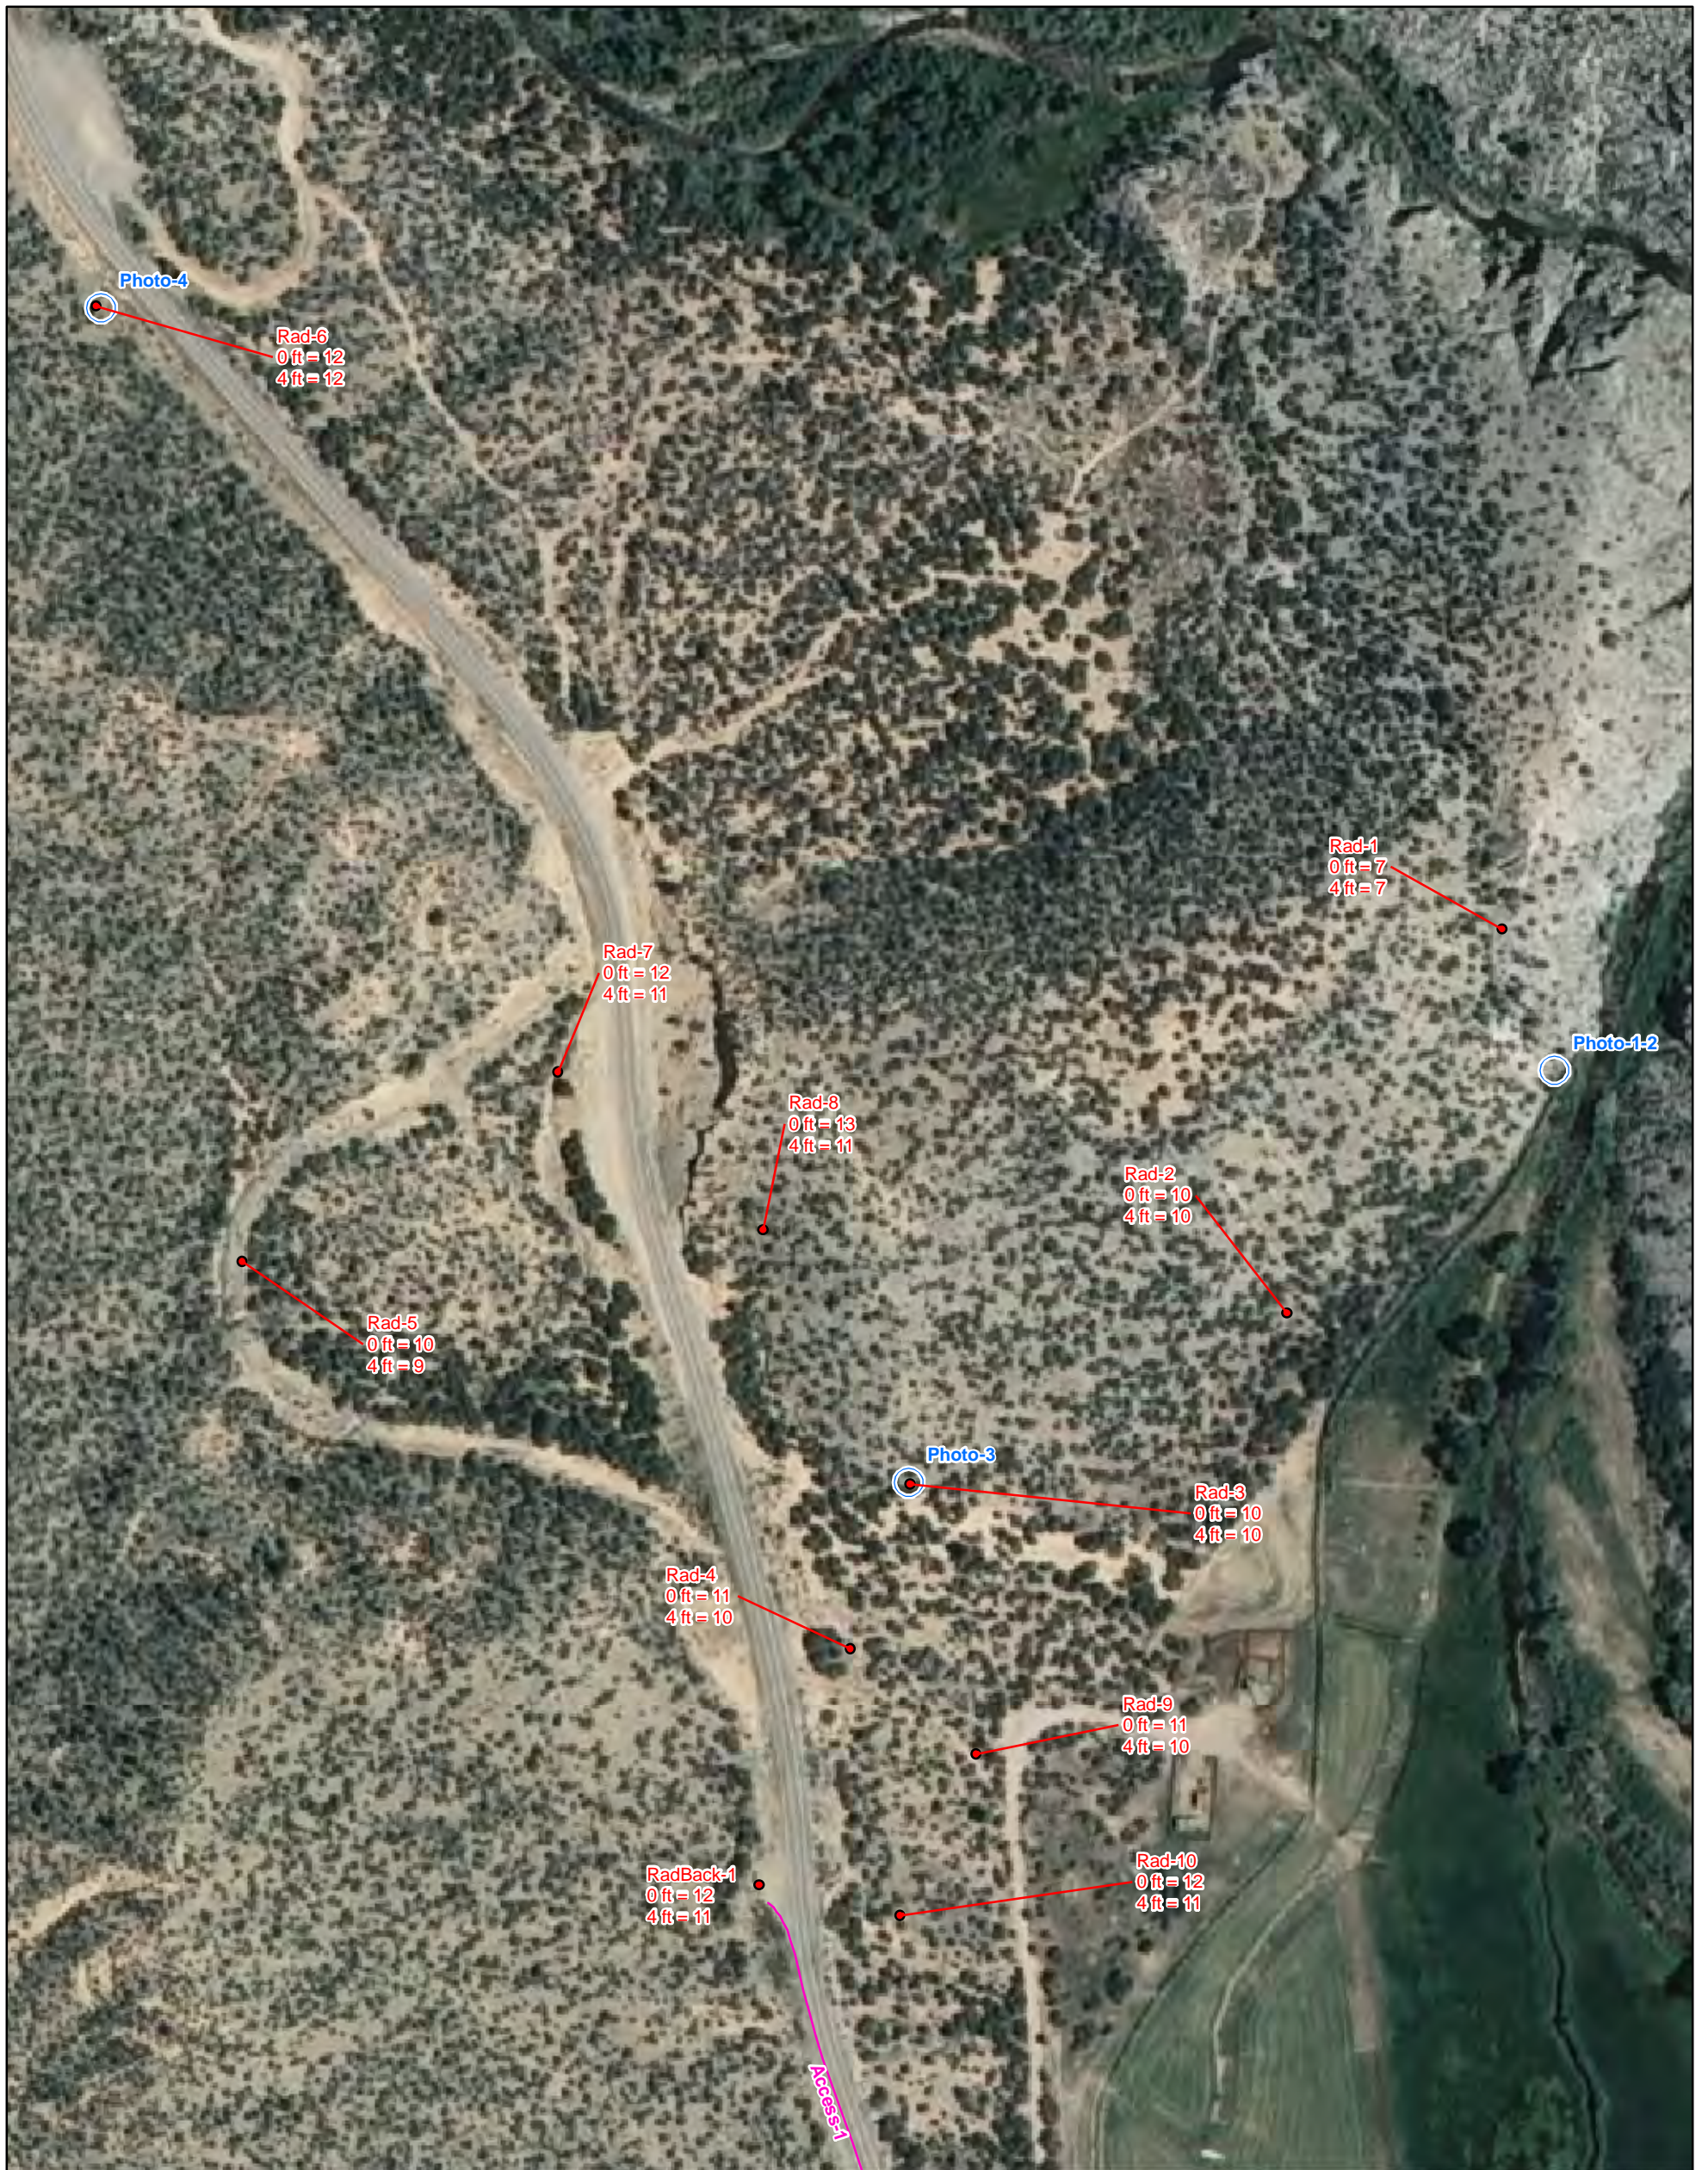
Figure 4a
Site Map on
Aerial Photo
NM0188-Vargas-Jarmillo
 Abandoned Uranium
 Mine Assessment

The mine features described below are based on the features provided to INTERA by MMD in the GIS Data Dictionary (MMD, 2009). INTERA marked the locations of the AUM Site features using a Trimble Global Positioning System (GPS) and entered details about the features into the GPS using the MMD data dictionary. The AUM Site consisted of two MMD-provided polygon areas, neither of which contained any apparent mining related features. Please see the Photo Log in Appendix A for photos, Table 1 for a list of all AUM Site features, and Figures 4a and 4b for the locations of the AUM Site.

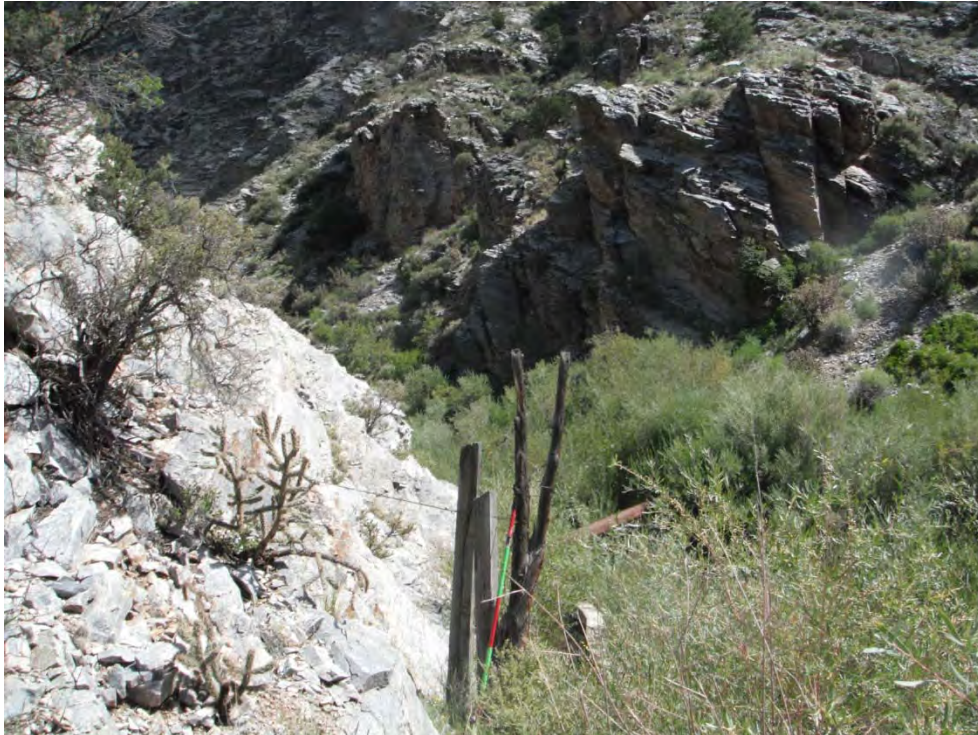
Photo 1-Looking east at eastern extent of accessible area.

Photo 1 - looking east at eastern extent of accessible area. Fence for private land meets steep canyon.

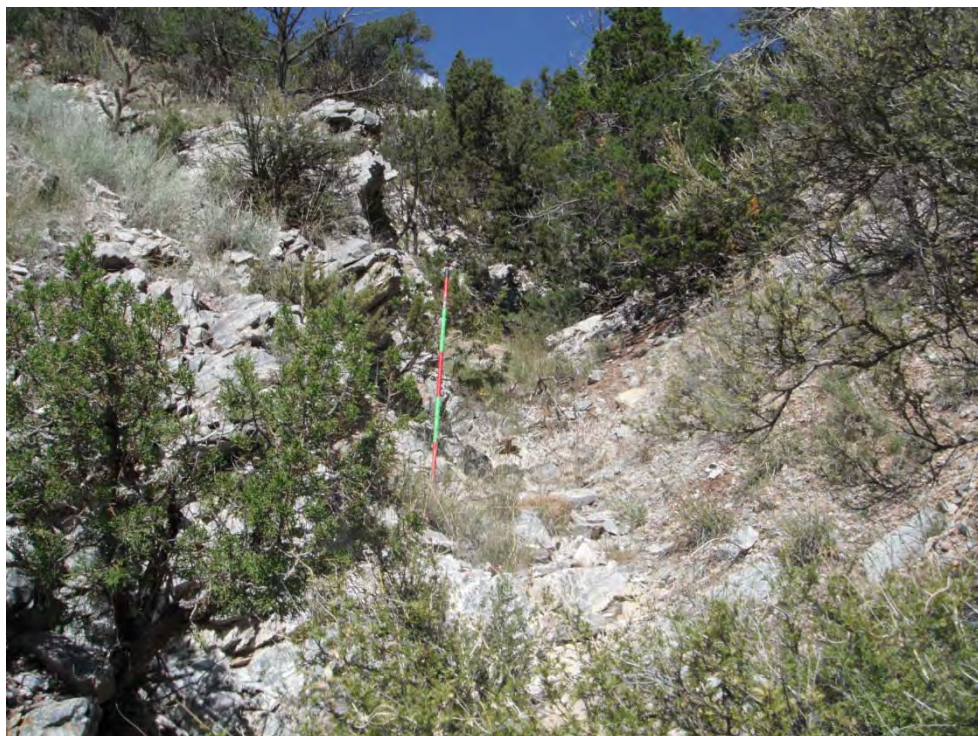
Photo 2-Looking north toward Rad-1.

Rad-1 - 0m - 7 μ R/h; 1m - 7 μ R/h - no visible mine features, rad measurement taken to verify no radiation.

Photo 2 - looking north looking up steep hill; rad-1 taken toward top of hill. No visible mine features.

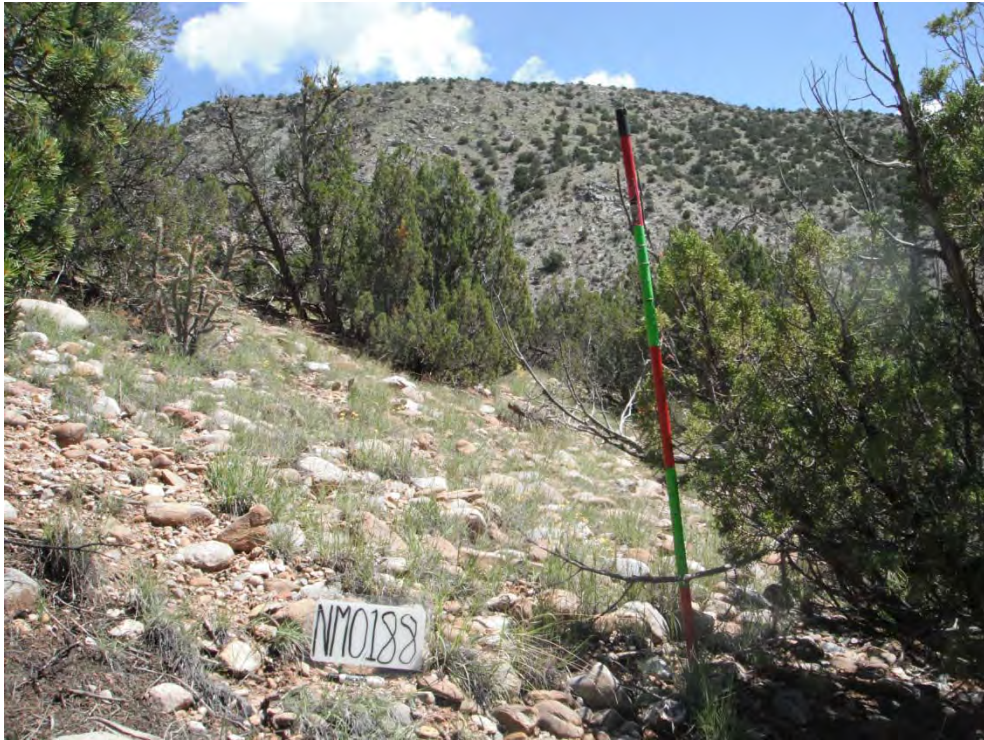
Photo 3-Site location photo looking west at MMD polygon location.

Photo 3 looking east at polygon location, site #0

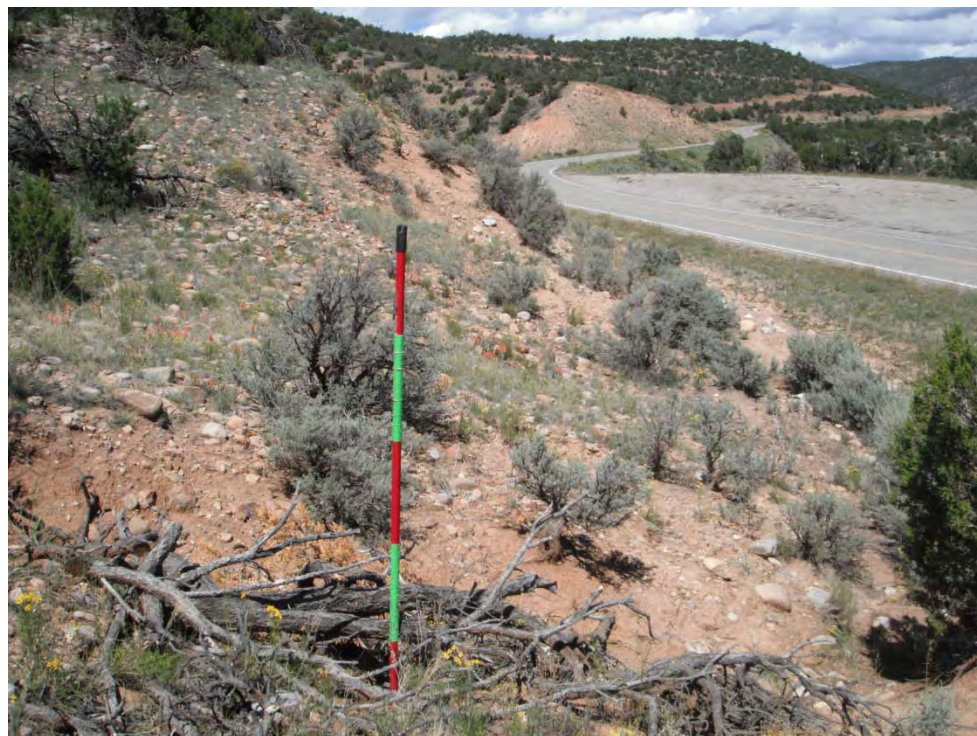
Photo 4-Looking north at second MMD polygon location.

1245 At second ~~poly~~^{ALT} polygon location. No visible mine features:

Photo 4 - looking north at polygon location
