# Abandoned Uranium Mine Field Survey Project

prepared for  
New Mexico Energy, Minerals and Natural Resources Department  
Mining and Minerals Division

**RE: Final Report - Abandoned Uranium Mine Field Survey Project**

## **Moe No. 4 Mine**

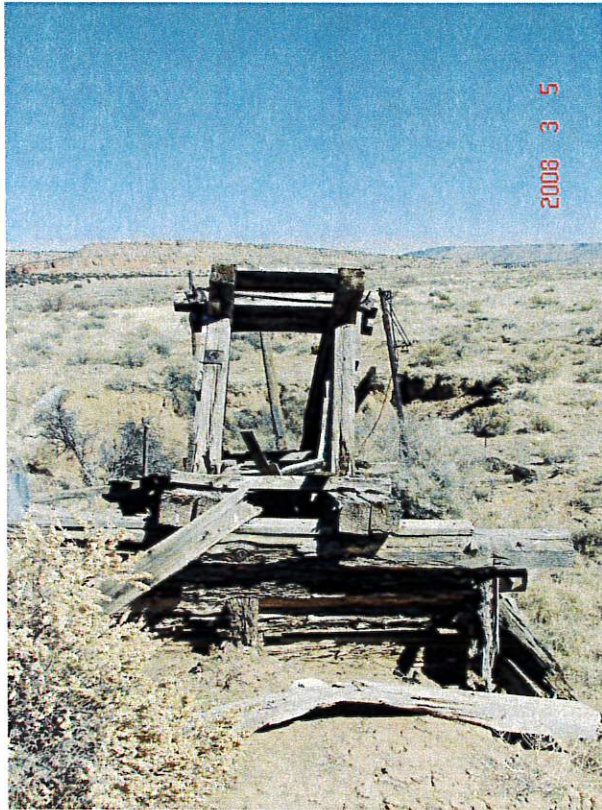
**3. Radiological Survey:** Radiological survey results were as follows: ground surface maximum of 1,100  $\mu$ R/hour and minimum of 12  $\mu$ R/hour. Four-foot elevation maximum was 1,000  $\mu$ R/hour and minimum was 14  $\mu$ R/hour. The ground surface at the headframe displayed readings of 1,100  $\mu$ R/hour. Background radiation level is approximately 15  $\mu$ R/hour.

Headframe, view to north

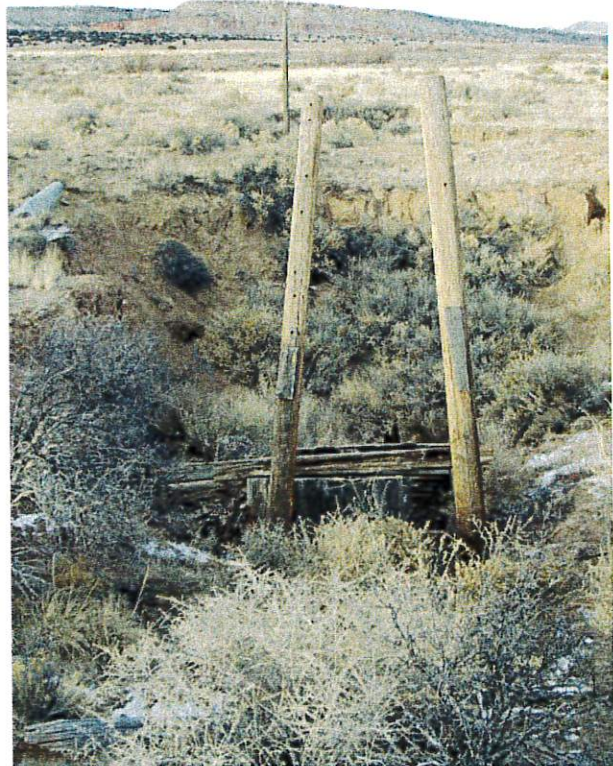
**4. Mine Disturbance:** Moe No. 4 is a small underground mine situated on approximately 3 acres which immediately adjoins an arroyo (ephemeral stream). The mine consists of a 30-degree decline striking north into a collapsed working of approximately 10,000 square-feet by 12 feet deep. The site includes approximately 45 small rock piles having an estimated total volume of approximately 400 cubic-yards.

Decline (adj. to headframe), view to north

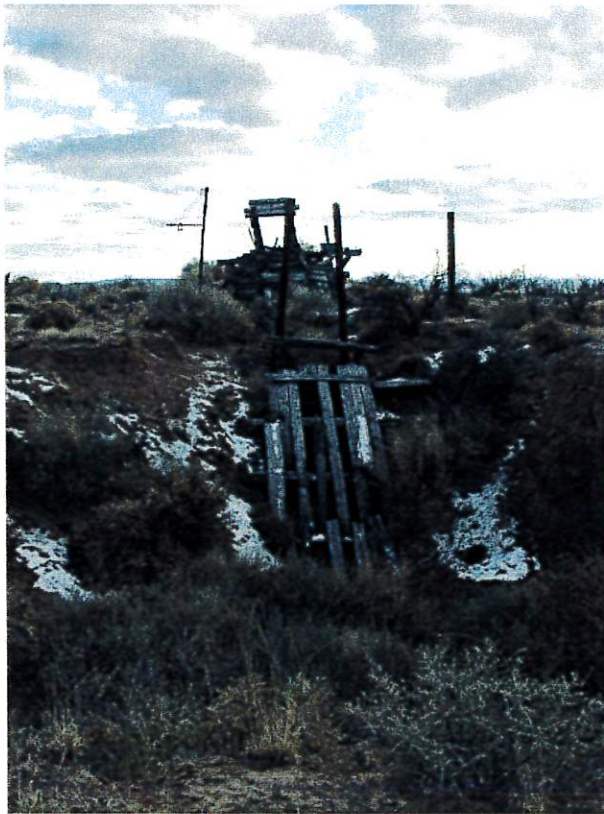
Decline, view to south
