NEW MEXICO ENVIRONMENT DEPARTMENT VOLUNTARY REMEDIATION AGREEMENT

Former MI-SWACO Facility
VRP Site No. 53211003

Voluntary Remediation Program Preliminary Work Plan

Former M-I SWACO Facility

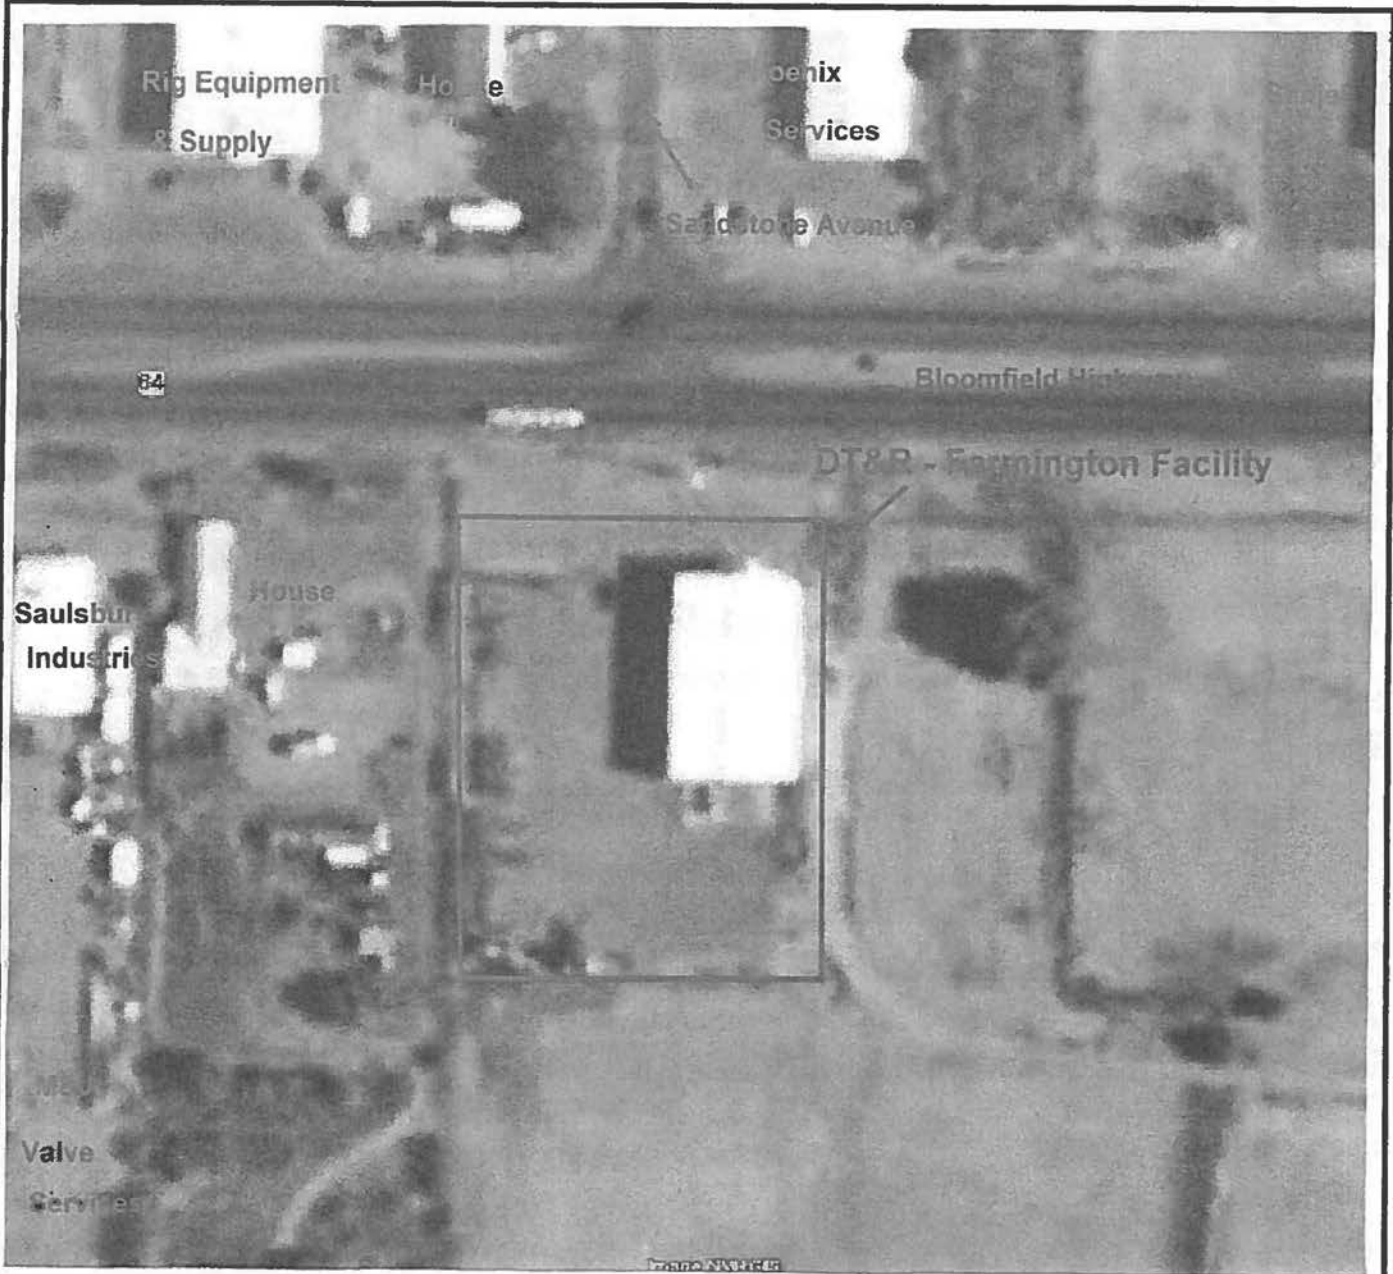
**FIGURE 2
SITE FACILITY PLAN**

DT&R - Bloomfield Highway Facility
 3601 Bloomfield Highway
 Farmington, New Mexico
 3-D Project: 081009

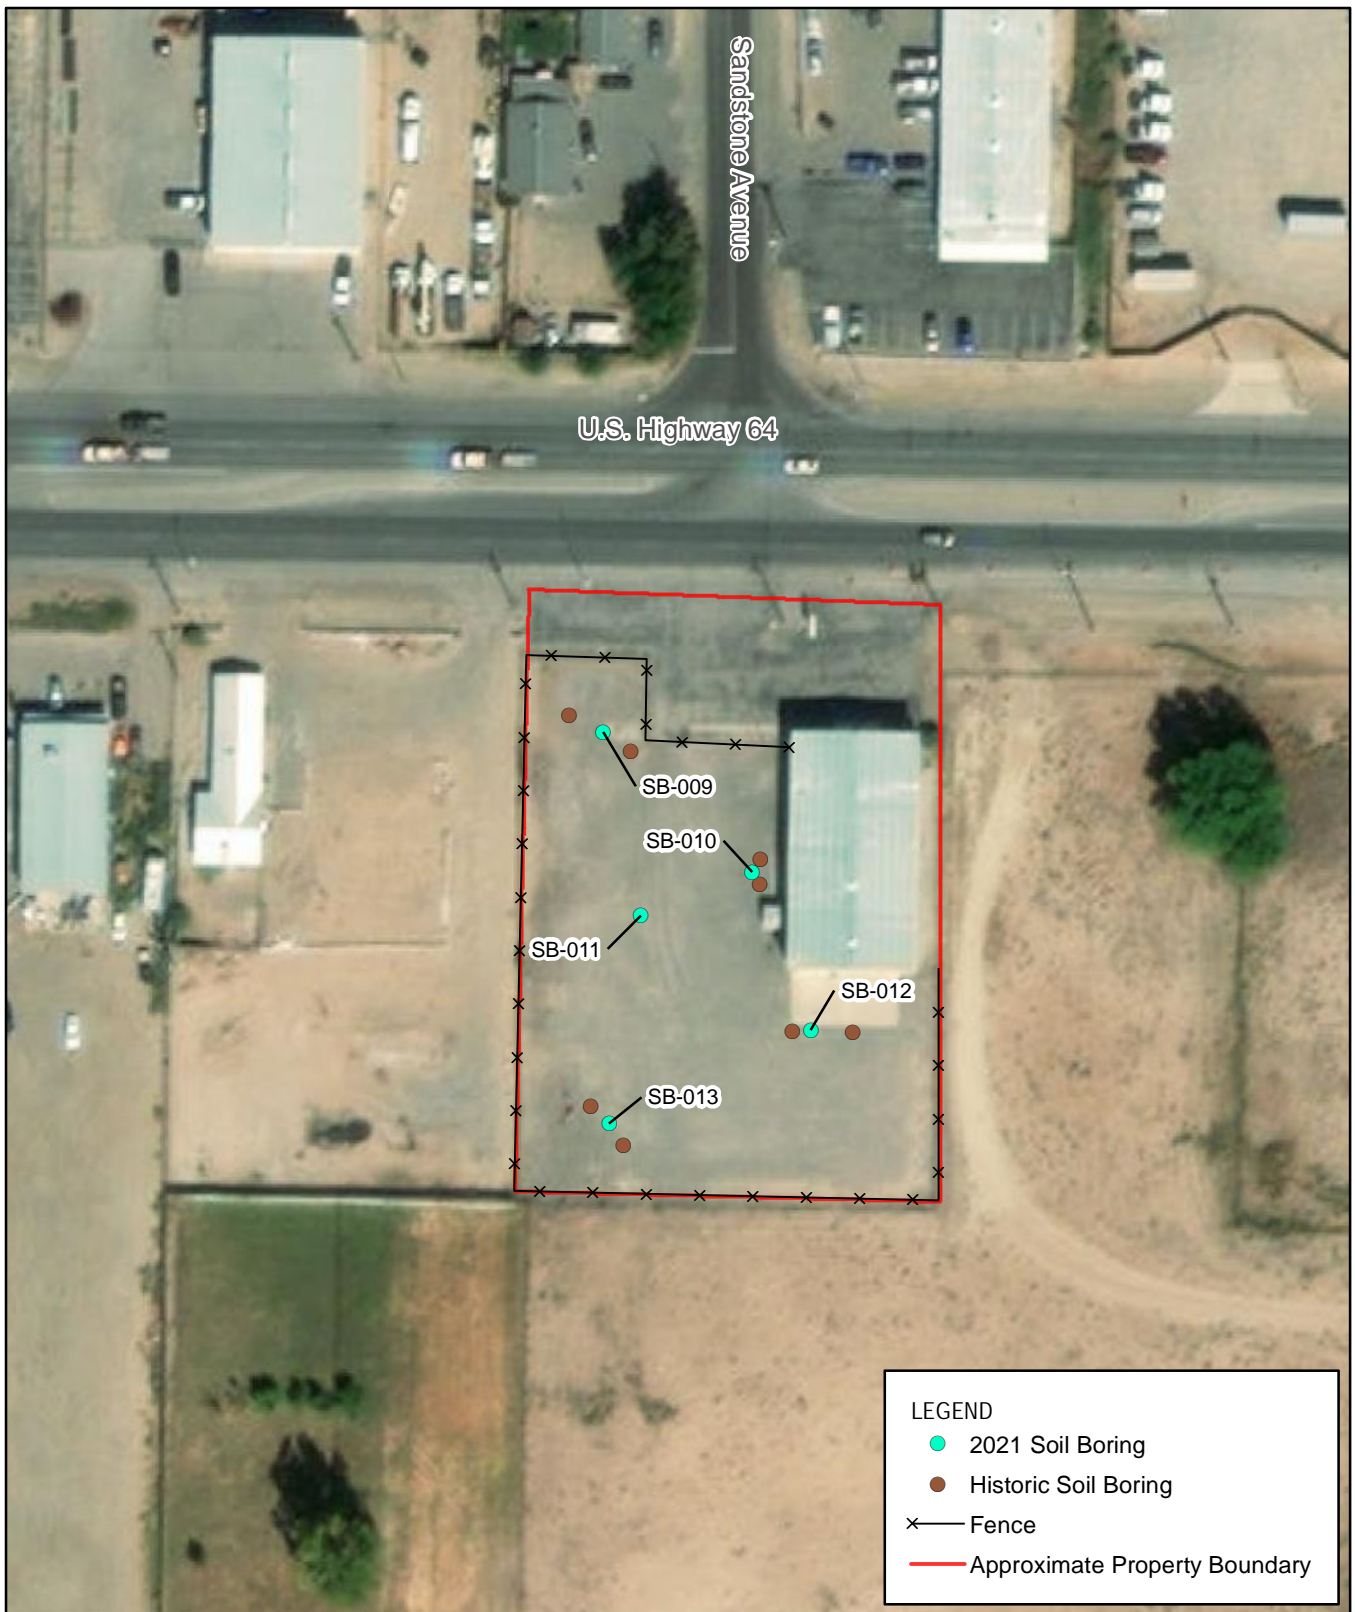
- 2021 Soil Boring
- Historic Soil Boring
- ✕ Fence
- Approximate Property Boundary

The facility consists of a single high-bay metal-clad warehouse and office building, concrete pads, and a gravel-surfaced storage yard (Figure 2-1), with gravel up to 8 inches thick across the entirety of the facility property. A 6-foot-high chain-link perimeter fence topped with barbed wire surrounds the storage yard (3-D Environmental, Inc. 2010).
