Abandoned Uranium Mine Site Assessment for the Little Rattler Site (NM0176)

FINAL REPORT

April 20, 2010

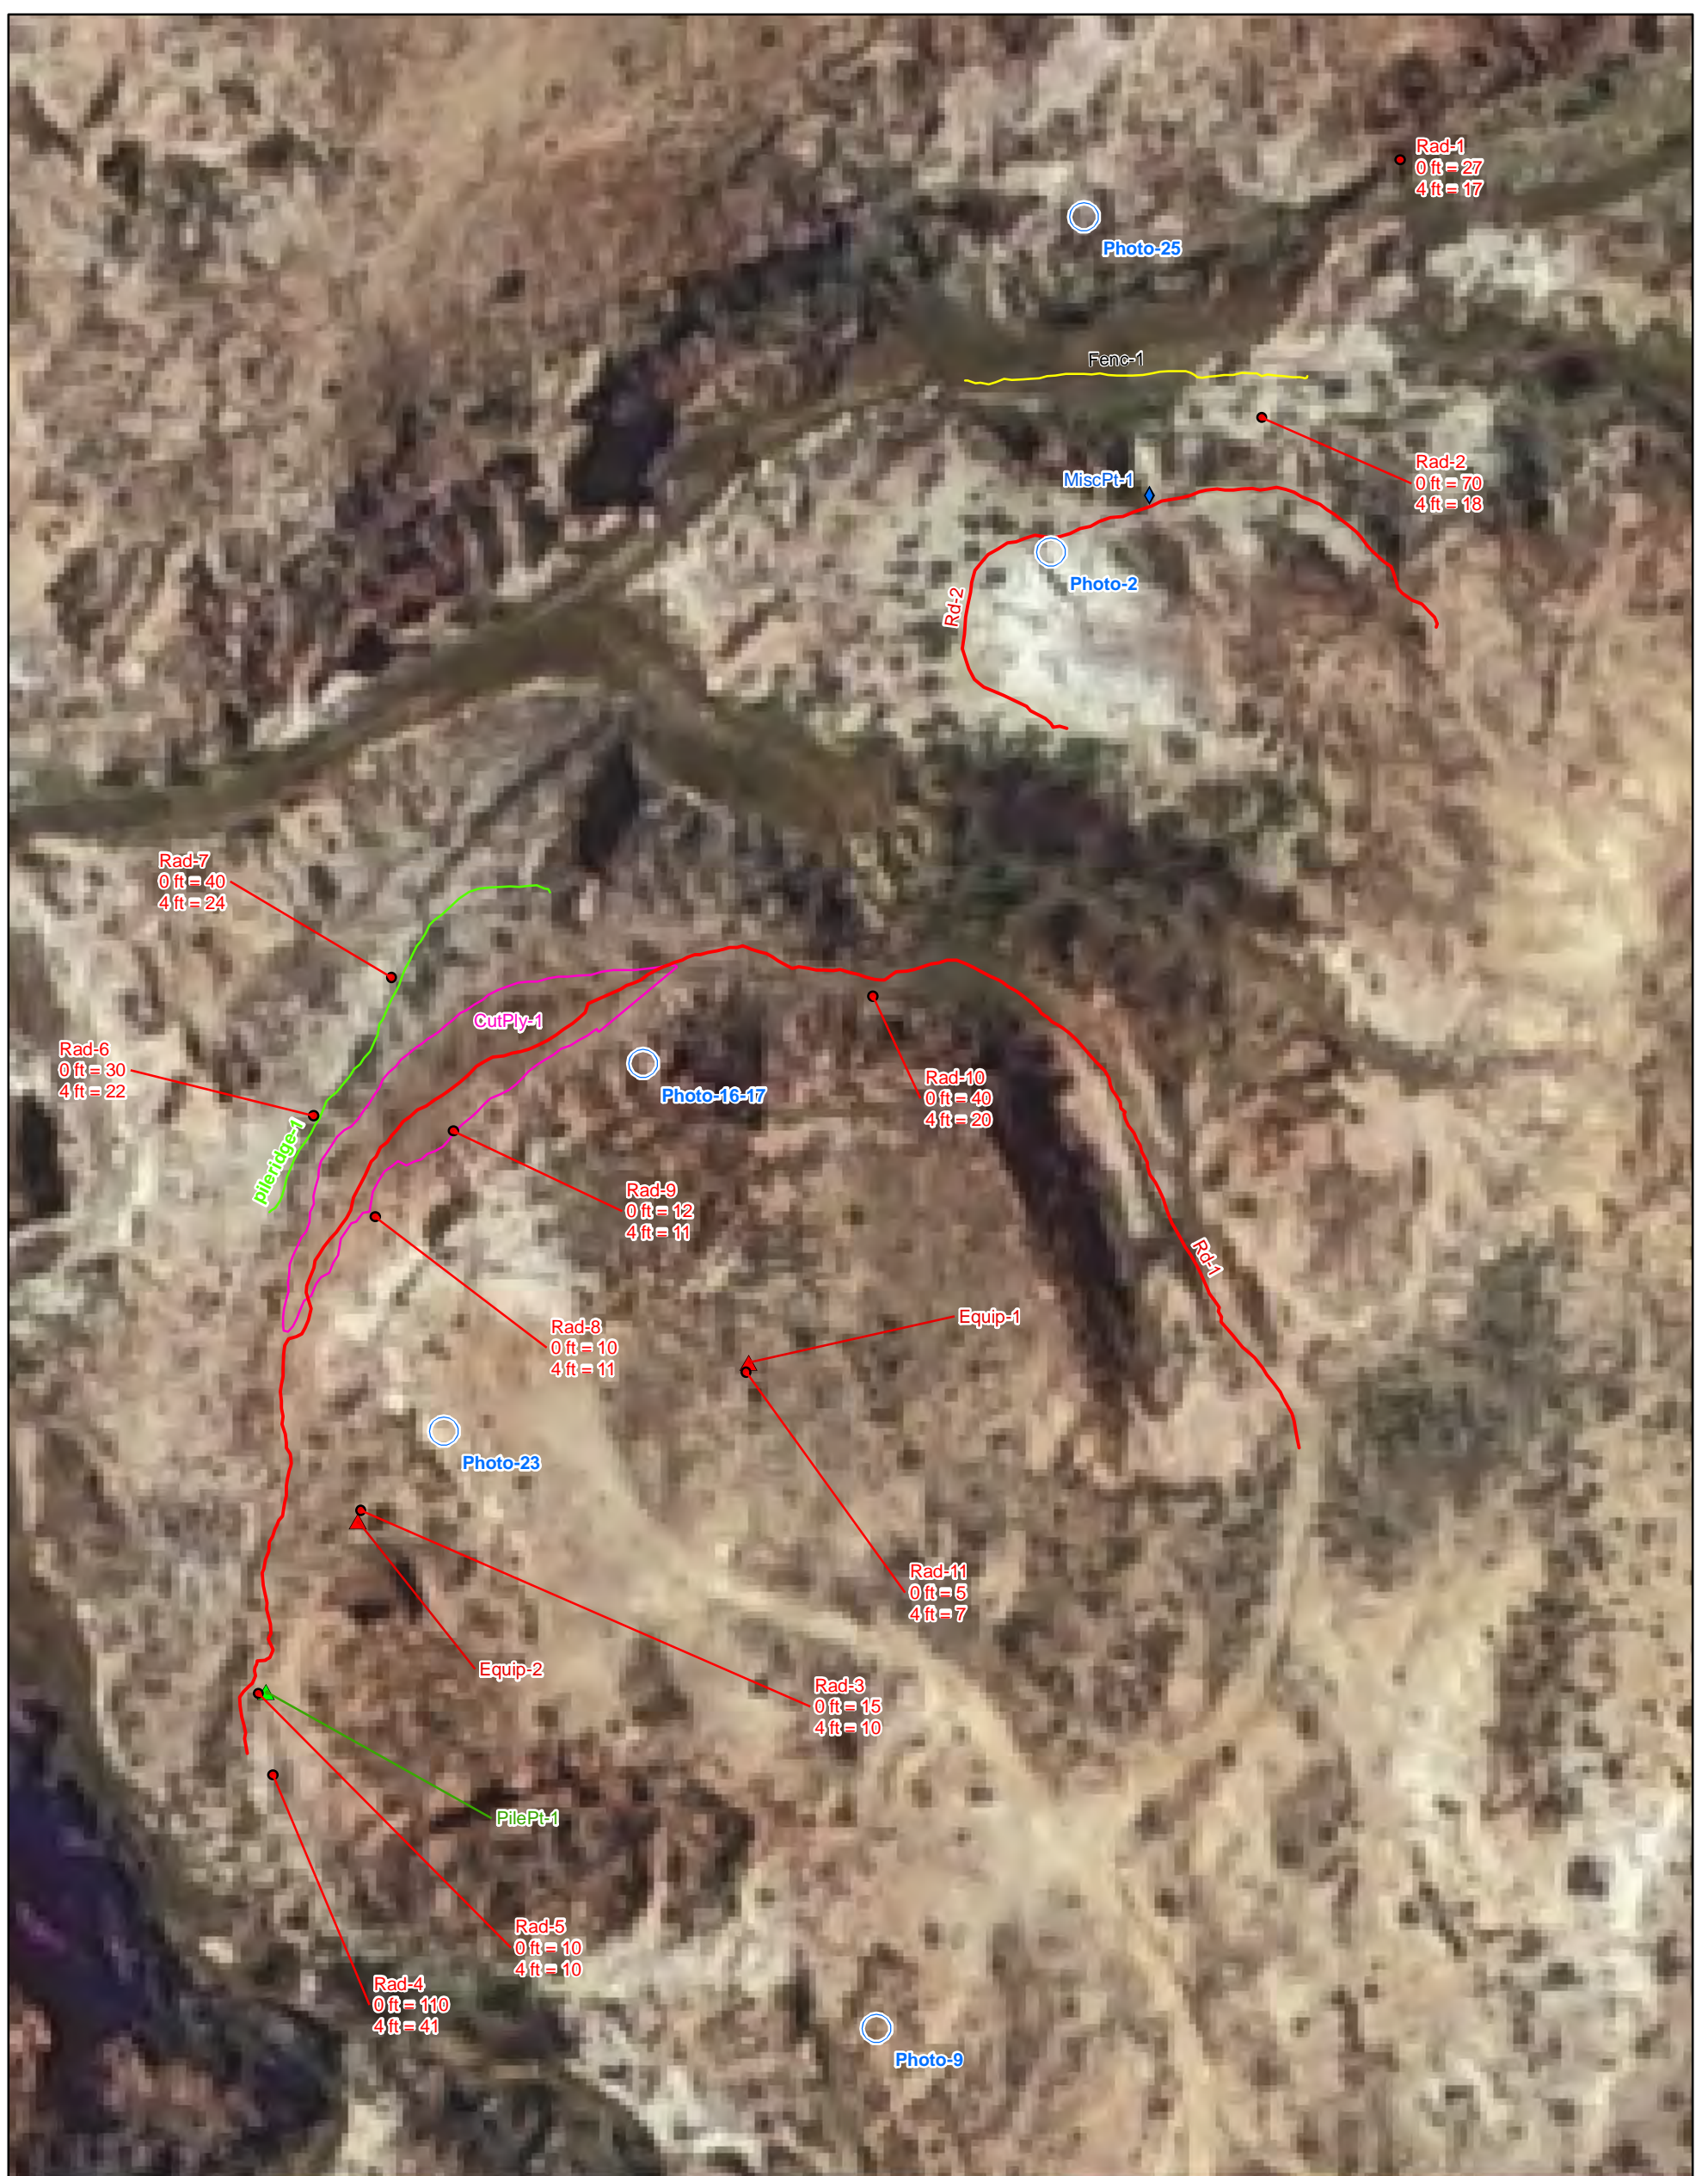
Figure 4a
Site Map on
Aerial Photo
NM0176-Little Rattler
 Abandoned Uranium
 Mine Assessment

The mine features described below are based on the features provided to INTERA by MMD in the GIS Data Dictionary (MMD, 2009). INTERA marked the locations of the AUM Site features using a Trimble Global Positioning System (GPS), and entered details about the features into the GPS using the MMD data dictionary. One open cut, two piles, an ore sorter, and a rock drill were found onsite. In addition, two mine roads (one including a culvert) and a barbed wire boundary fence were located nearby. Please see the Photo Log in Appendix A, Table 1 for a list of AUM Site features, and Figures 4a and 4b for the locations of the AUM Site features.

One background gamma radiation reading was taken at the AUM Site, recording 6 $\mu\text{R/hr}$ at contact and 6 $\mu\text{R/hr}$ at 4 ft above ground. Please see Table 2 for all of the gamma radiation readings taken at the AUM Site and Figures 4a and 4b for the locations of the radiation readings.

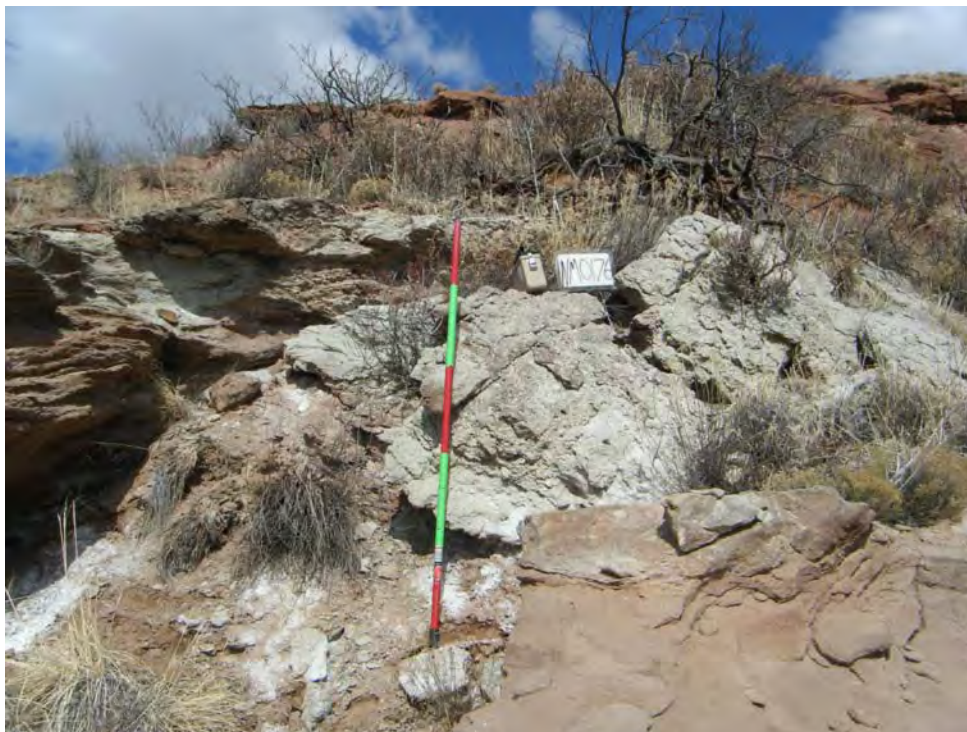
Photo 1-Site photo and gamma radiation survey point Rad-2, looking north.

Rad 1 - $0m = 27 \mu R/hr$; $1m = 17 \mu R/hr$ AEA
Photo 1 - slightly radioactive rock, looking ~~SW~~ N

Group, and previous literature describing the AUM Site refers to it as the “Chinle Formation.” A resistant sandstone layer in the Bull Canyon Formation creates a prominent cliff where it is exposed (see Photo 9 in Appendix A). This layer ranges from white to red in color and has well-defined crossbedding. A lower shale layer is gray-green with occasional yellow staining and sandstone lenses. Petrified wood is locally abundant in this layer at the AUM Site. Radioactive anomalies occur in limestone pebble conglomerate in the middle sandstone layer (see Photo 1 in Appendix A) and at the top of the lower shale layer (see Photo 12 in Appendix A).

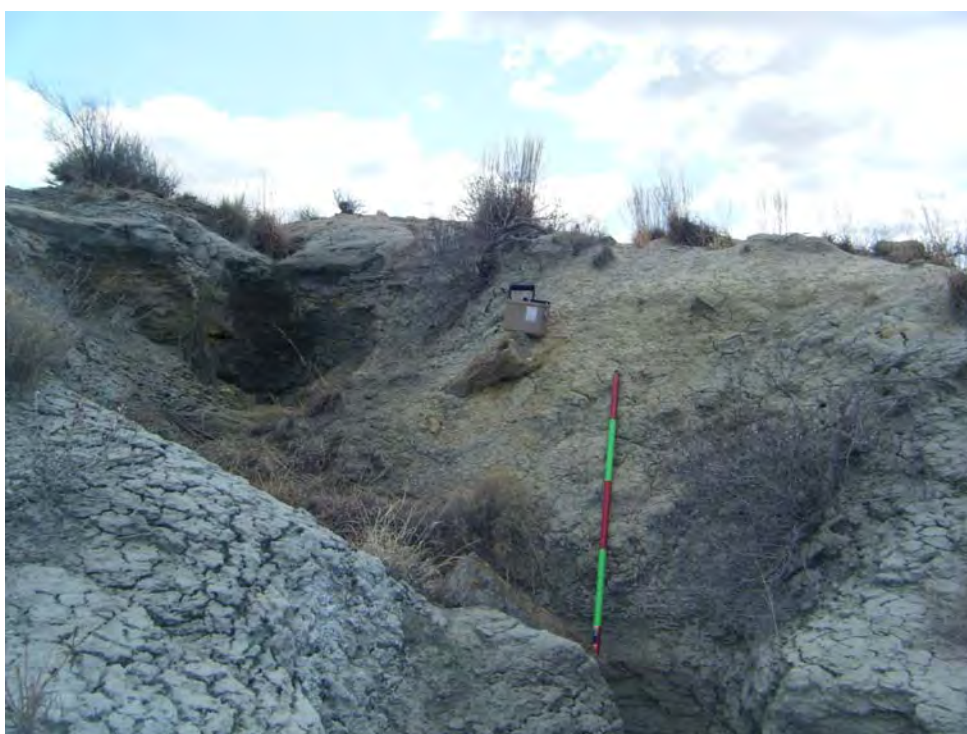
Photo 2-A shale layer in the Bull Canyon Formation, looking southeast. The scintillometer is resting on a piece of petrified wood.

Rad 2 - $0m = 70 \mu R/hr$; $1m = 18 \mu R/hr$
Photo 2 - petrified wood, looking SE

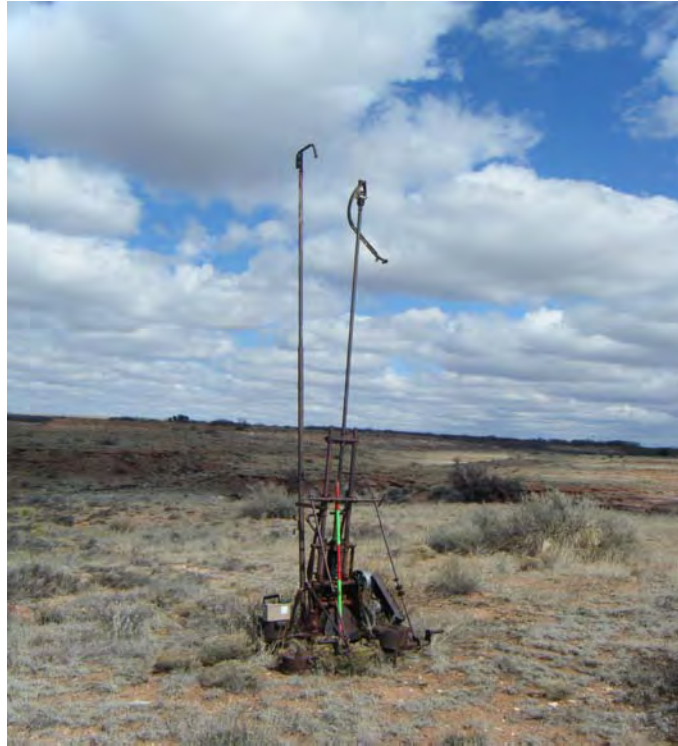
Photo 3-A rock drill found onsite (Equip-1).

Photo 3 - rock drill, looking NE

Two pieces of mine equipment were discovered onsite: a rock drill on the mesa to the east of CutPly-1, and an ore sorter mentioned by Anderson, 1980 (see photo "a" in the Anderson report, compare with Photo 23 in Appendix A of this report). Two mine roads, Rd-1 and Rd-2, provided access to CutPly-1 from above. A culvert was found in Rd-2.

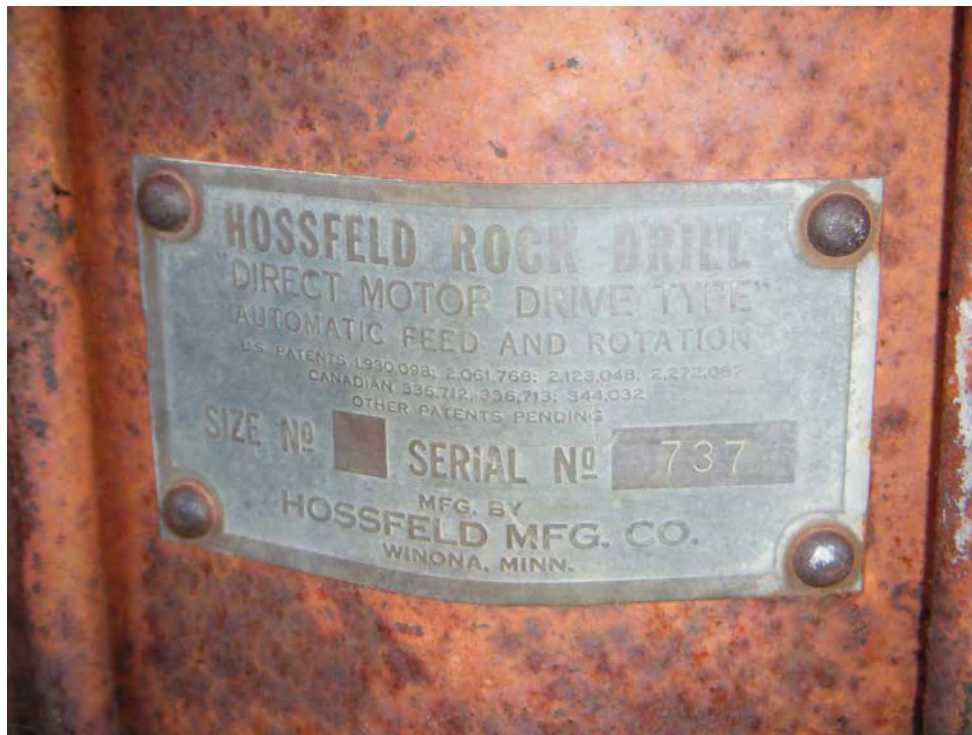
Photo 8-Closeup of serial number on rock drill (Equip-1).

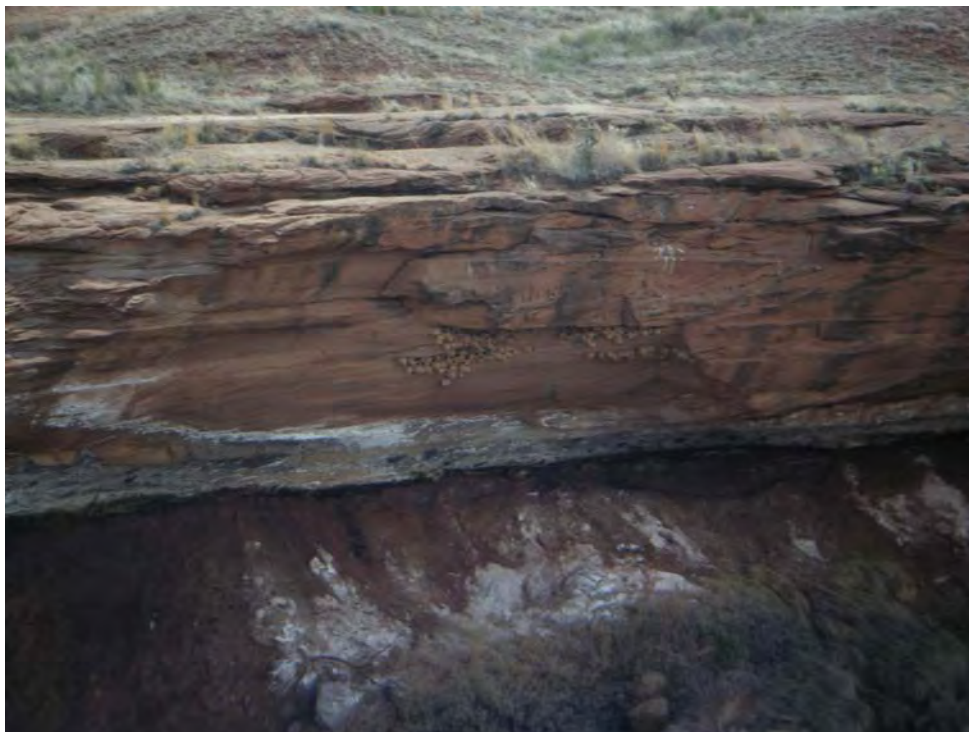
A great horned owl was seen onsite. Swallow nests were present under overhanging cliffs (see Photo 9 in Appendix A).

Photo 9-Swallow nests, looking southeast.

Photo 9 - swallow nests in rock, looking SE

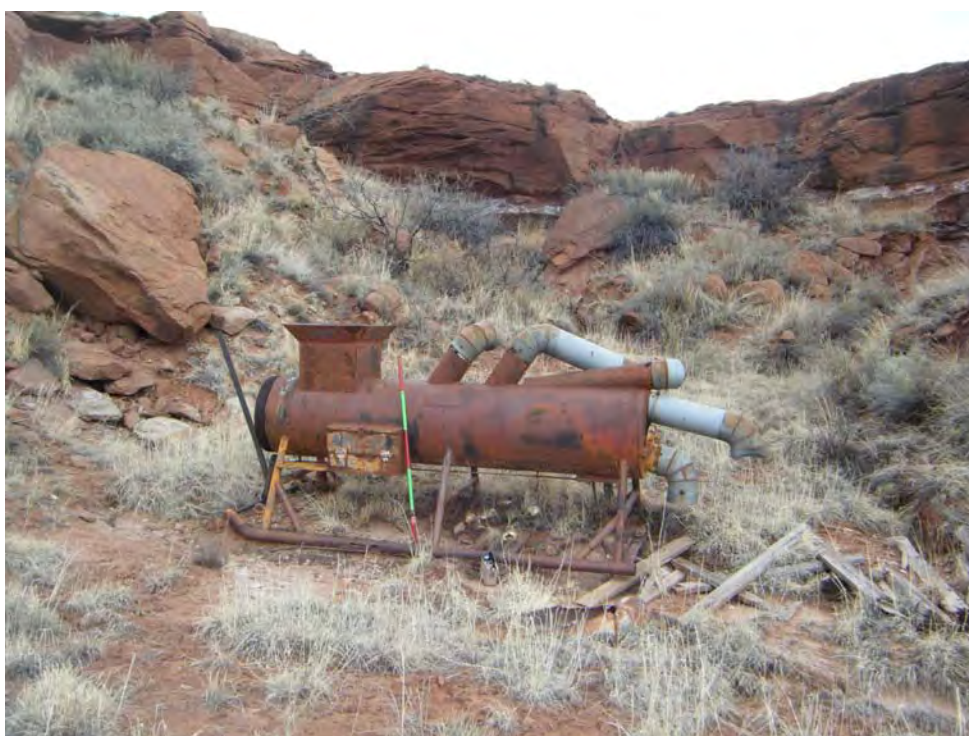
Photo 10-An ore sorter (according to Anderson, 1980) found onsite (Equip-2).

Photo 10 - ore sorter, looking E

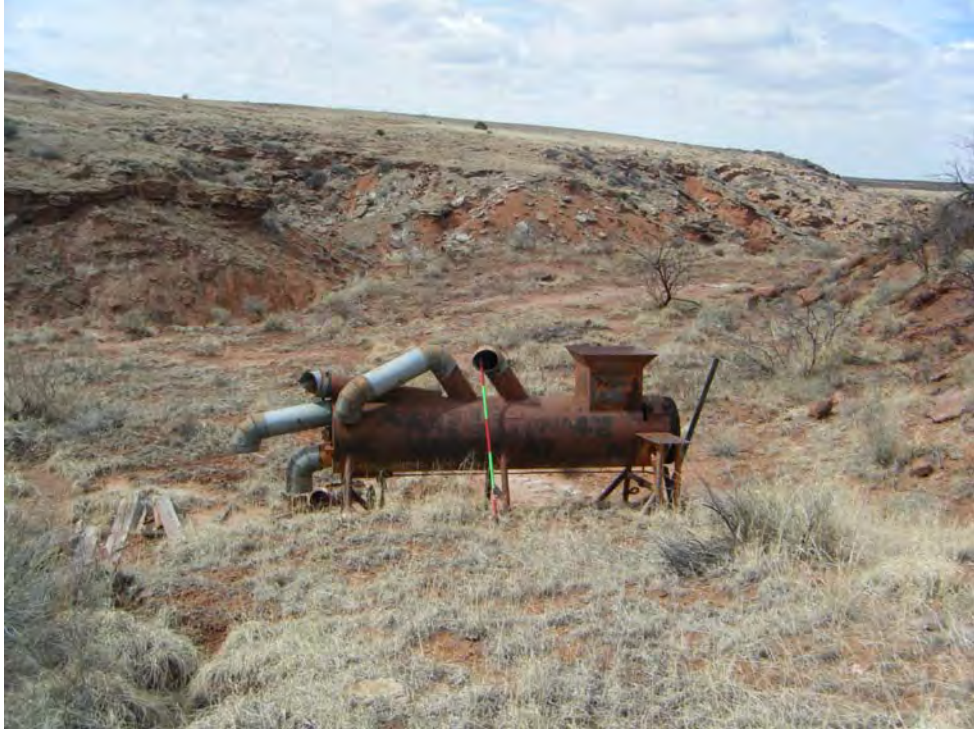
Photo 11-Ore sorter (Equip-2), looking northwest.

Photo 11 - ore sorter, looking NW

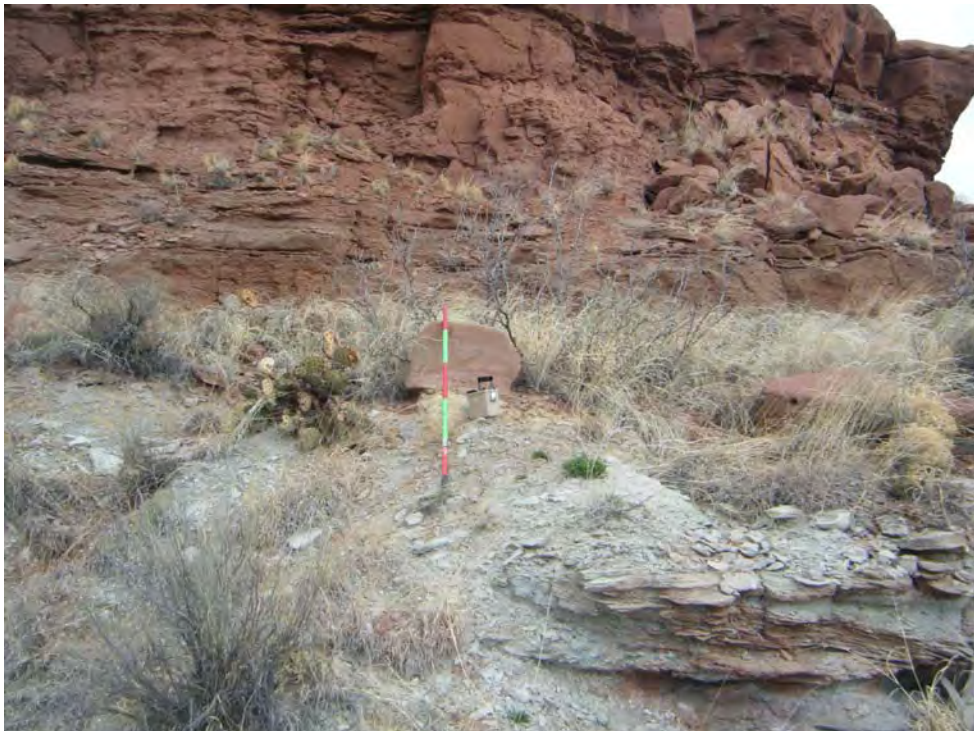
Photo 12-Gamma radiation survey point Rad-4, looking northeast.

Photo 12 - Rad 4, looking NE

The maximum gamma radiation reading for the AUM Site was 110 $\mu\text{R/hr}$ at contact at radiation survey point Rad-4. This reading was taken on yellow staining in a gray-green shale layer in the Bull Canyon Formation (see Photo 12 in Appendix A).

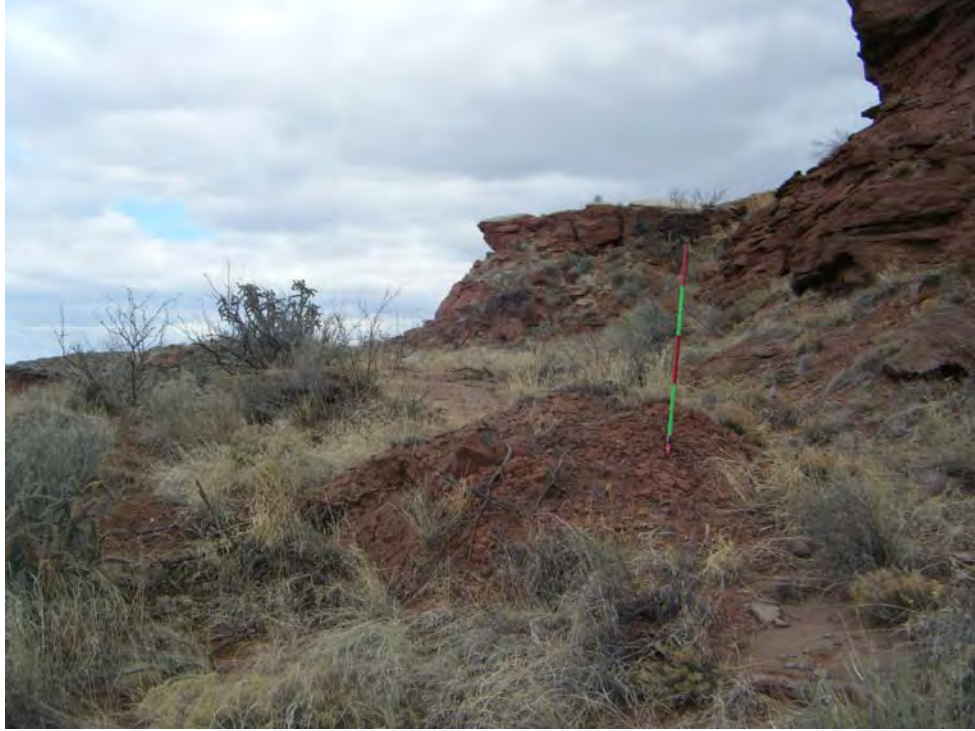
Photo 13-Looking north at PilePt-1.

Pilept 1 - in the middle of a mine road
3 ft high, 4 ft x 6 ft

Photo 13 - pilept 1 ~~looking N~~ ^{NE} looking N
up mine road

Two piles are located on the AUM Site. PilePt-1 is a small pile of soil and rock at the end of a mine road (Rd-1). The maximum gamma ray reading on this pile was 10 $\mu\text{R/hr}$ at contact. Another pile, Pileridge-1, is a linear mound paralleling CutPly-1. The maximum gamma ray reading on this pile was 40 $\mu\text{R/hr}$ at contact.

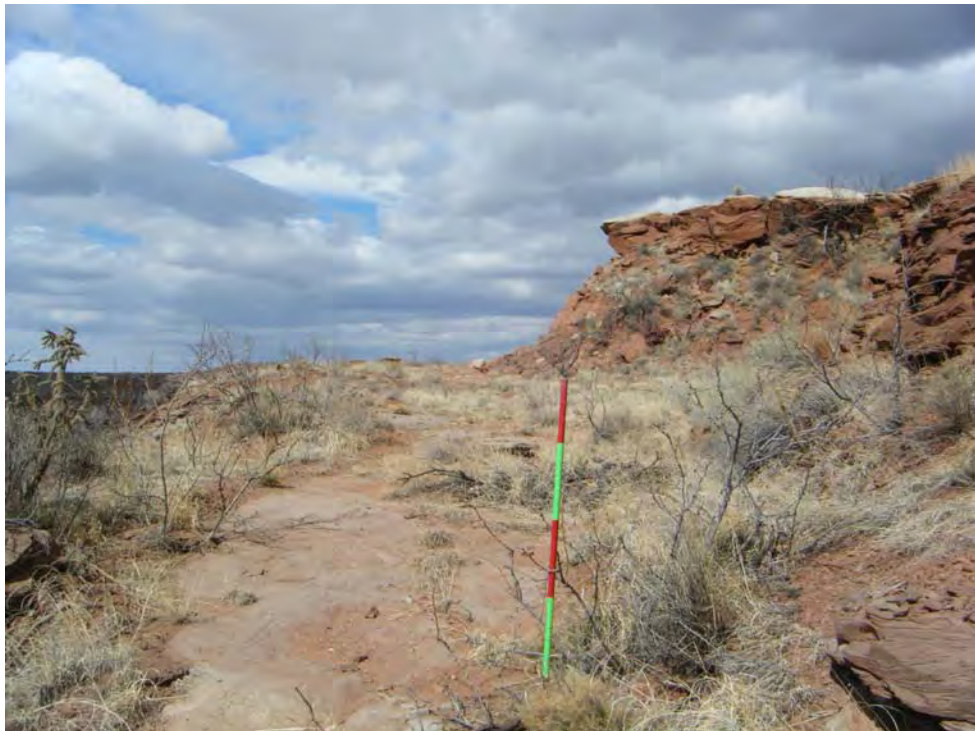
Photo 14-Looking north up Rd-1. The ore sorter (Equip-2) is off the photo to the right.

Rd 1 - runs N-S, 10 ft wide

Photo 14 - rd 1, looking N; ore sorter is off the photo to the right

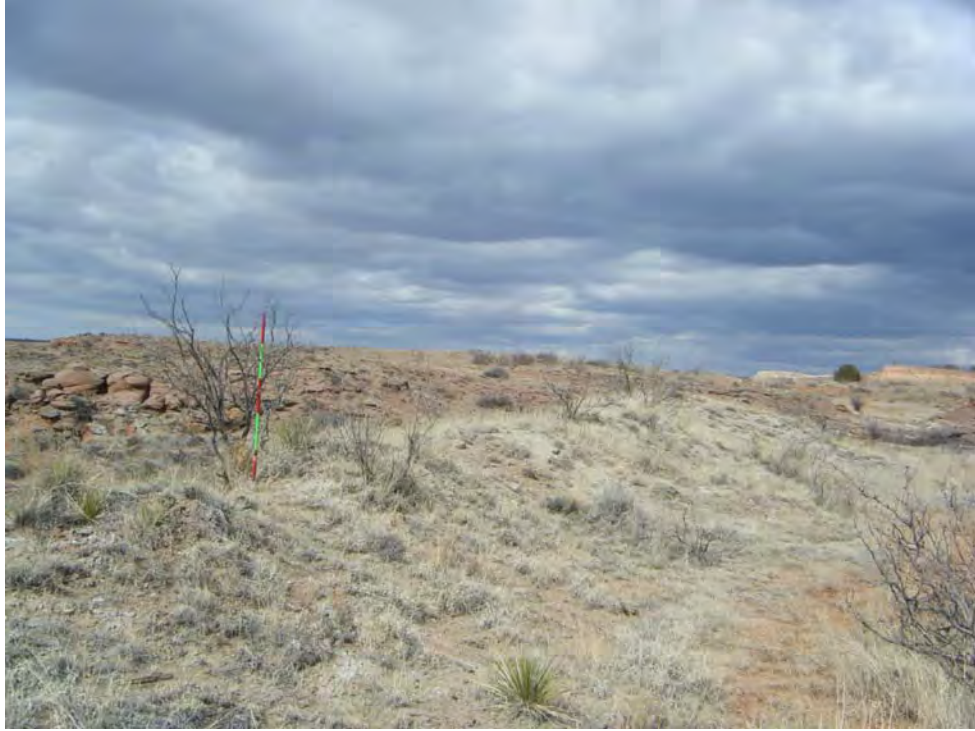
Photo 15-Looking north at Pileridge-1.

Pile Ridge 1 - runs NE-SW, parallel to cut:
4 ft high, 15-20 ft wide

Photo 15 - pile ridge 1

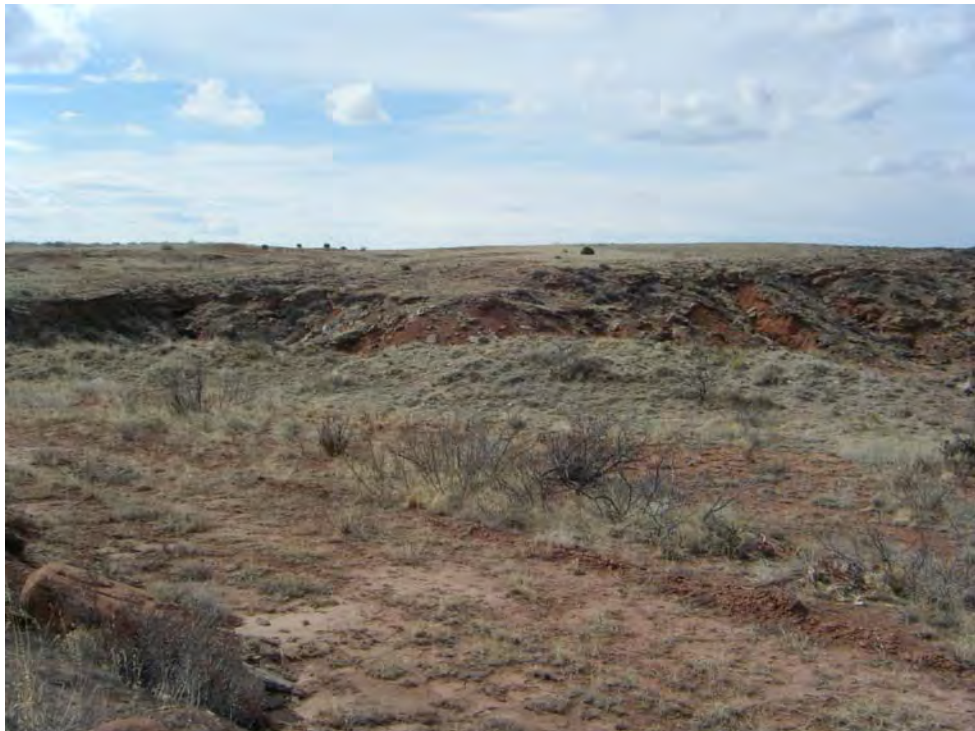
Photo 16-Looking southwest at Pileridge-1.

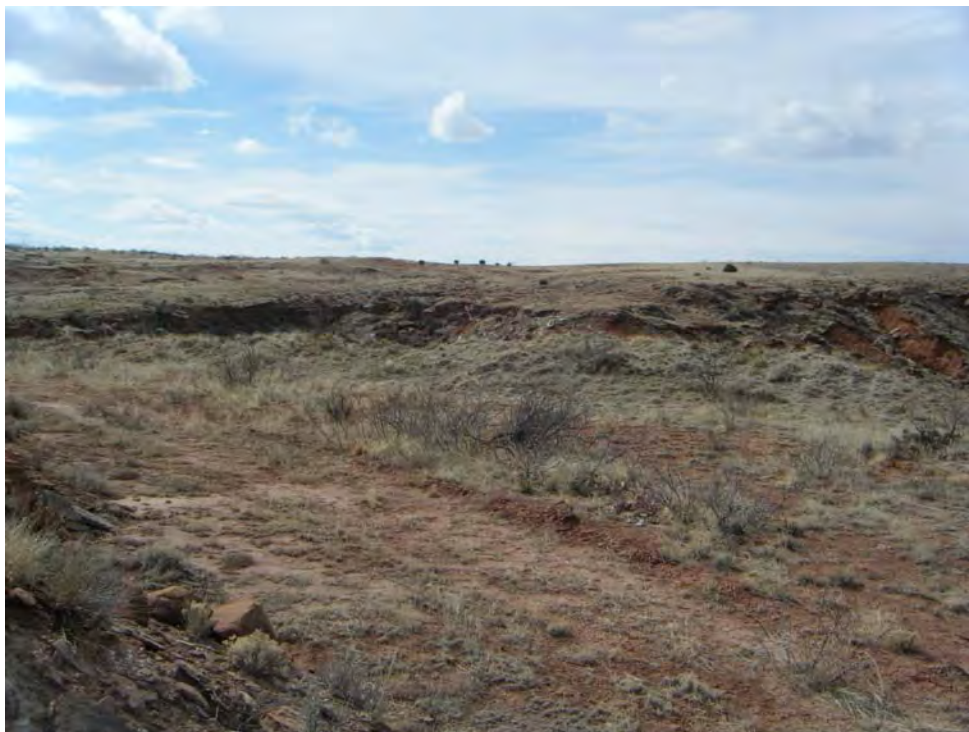
Photo 17-Looking northwest at Pileridge-1, replicating Anderson Report photo "b".

Photos 16+17 - Attempting to replicate Anderson report, looking SW

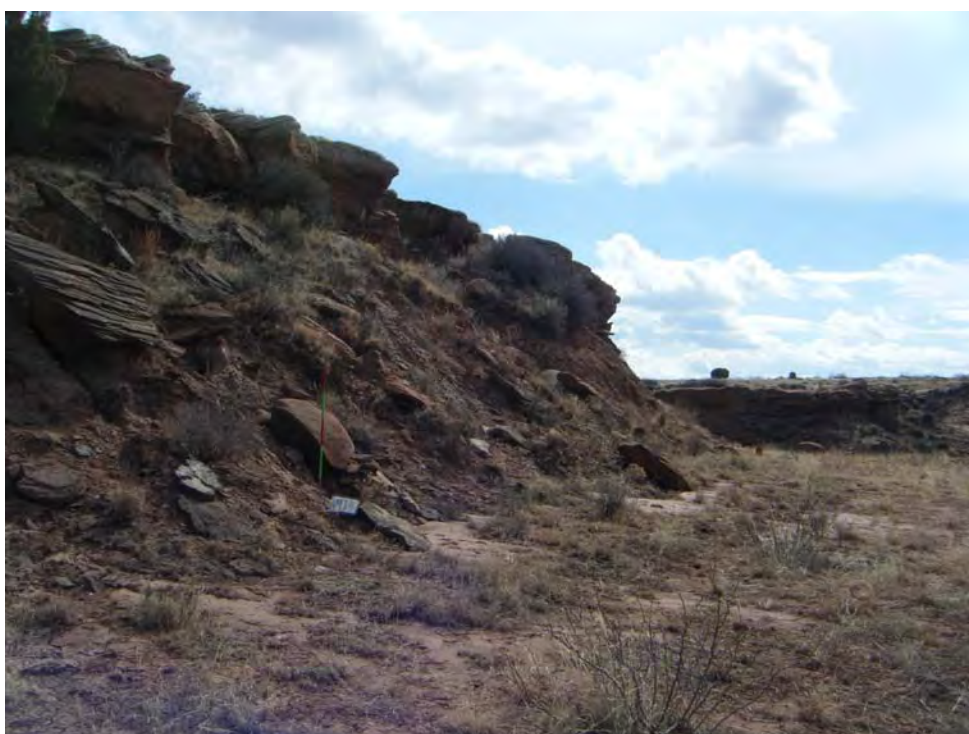
Photo 18-Looking southwest at CutPly-1.

Cutply 1 - cut that is parallel to pile ridge 1
50 ft wide, 30 ft high ^{NE}

Photo 18 - cutply 1 looking SW

One open cut was found at the AUM Site (CutPly-1). This open cut exposed gray-green shale below a sandstone caprock. The maximum gamma ray reading in this cut was 12 $\mu\text{R/hr}$ at contact.

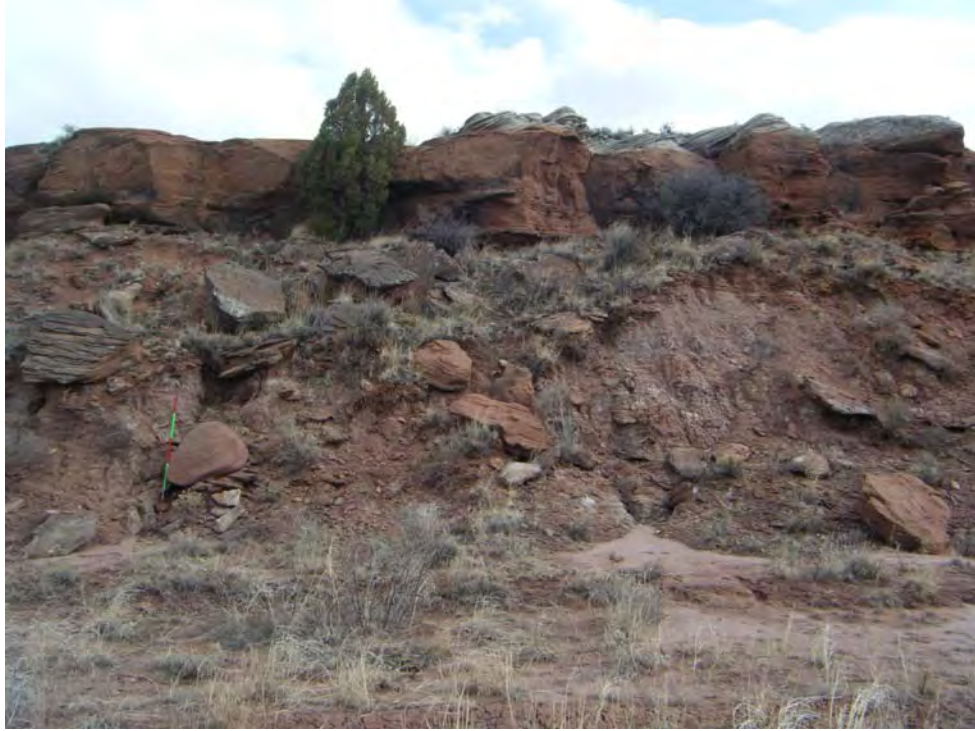
Photo 19-Looking southeast at CutPly-1.

Photo 19 - cutply looking SE ^{NE}

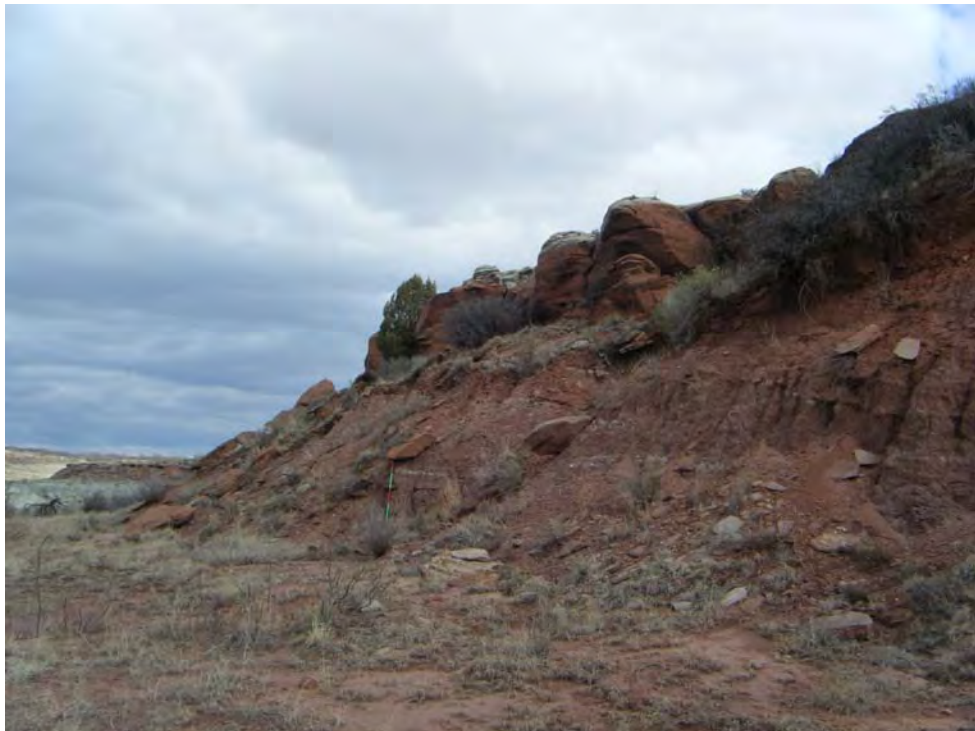
Photo 20-Looking east at CutPly-1.

Photo 20 - cutply looking E

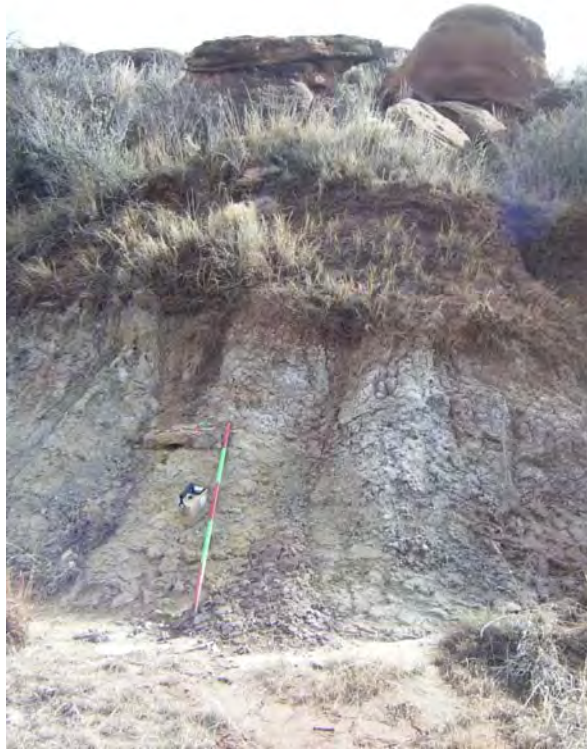
Photo 21-Gamma radiation survey point Rad-10, looking south.

Rad 10 - 0m = 40 μ R/hr; 1m = 20 μ R/hr
Photo 21 - rad 10, looking S
Photo 22 - rad 10 close up

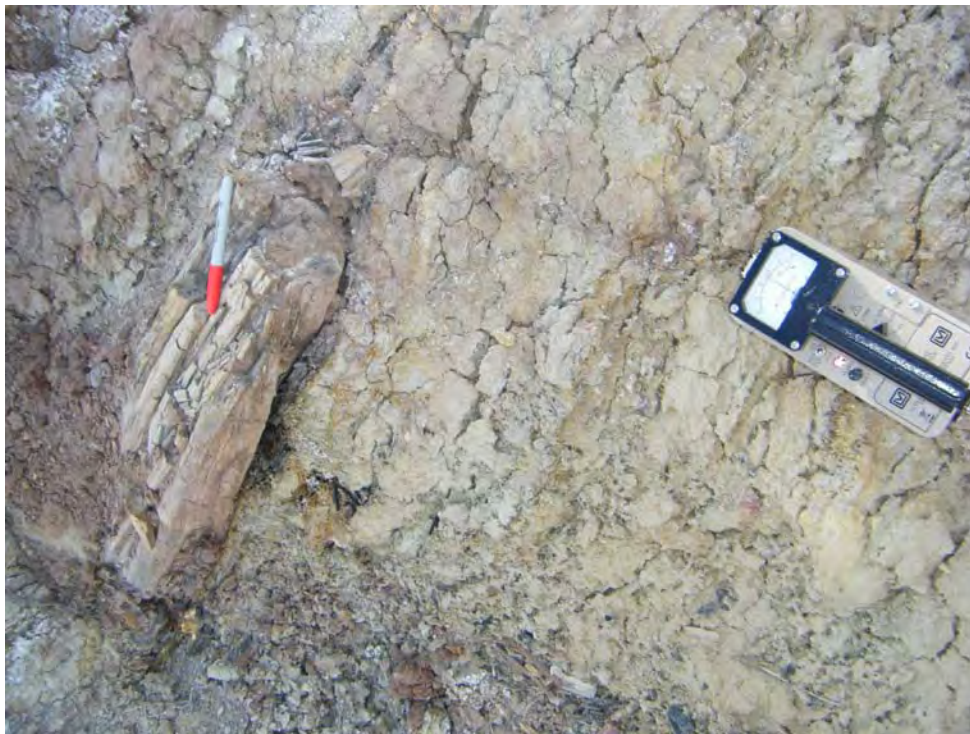
Photo 22-Closeup of gamma radiation survey point Rad-10. The pen is resting on a piece of petrified wood.

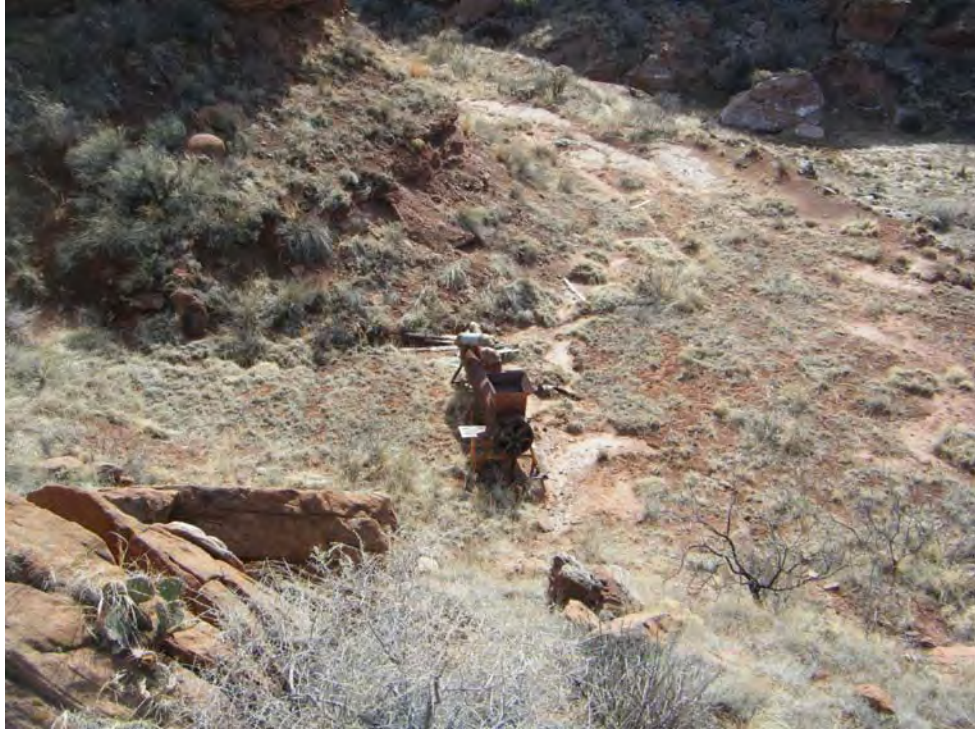
Photo 23-Looking down and to the south at ore sorter (Equip-2) from above, replicating Anderson Report photo "a".

Photo 23 - Replicating Anderson report
photo looking down on ore
sorter, looking S

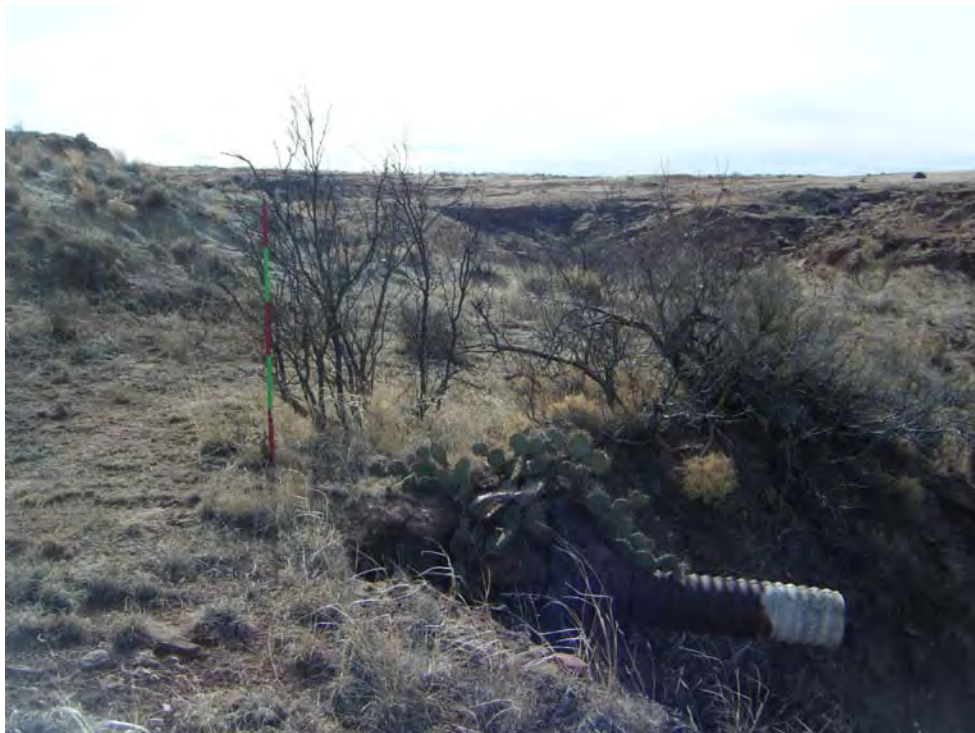
Photo 24-A culvert (MiscPt-1) in mine road Rd-2.

Miscpt 1 - culvert in Rd 2

Photo 24 - Rd 2 + culvert, looking W

A mine road (Rd-2) is being undermined by runoff spilling from a culvert (MiscPt-1).
