Abandoned Uranium Mine Site Assessment for the Gay Eagle Site (NM0121)

FINAL REPORT

NM0121

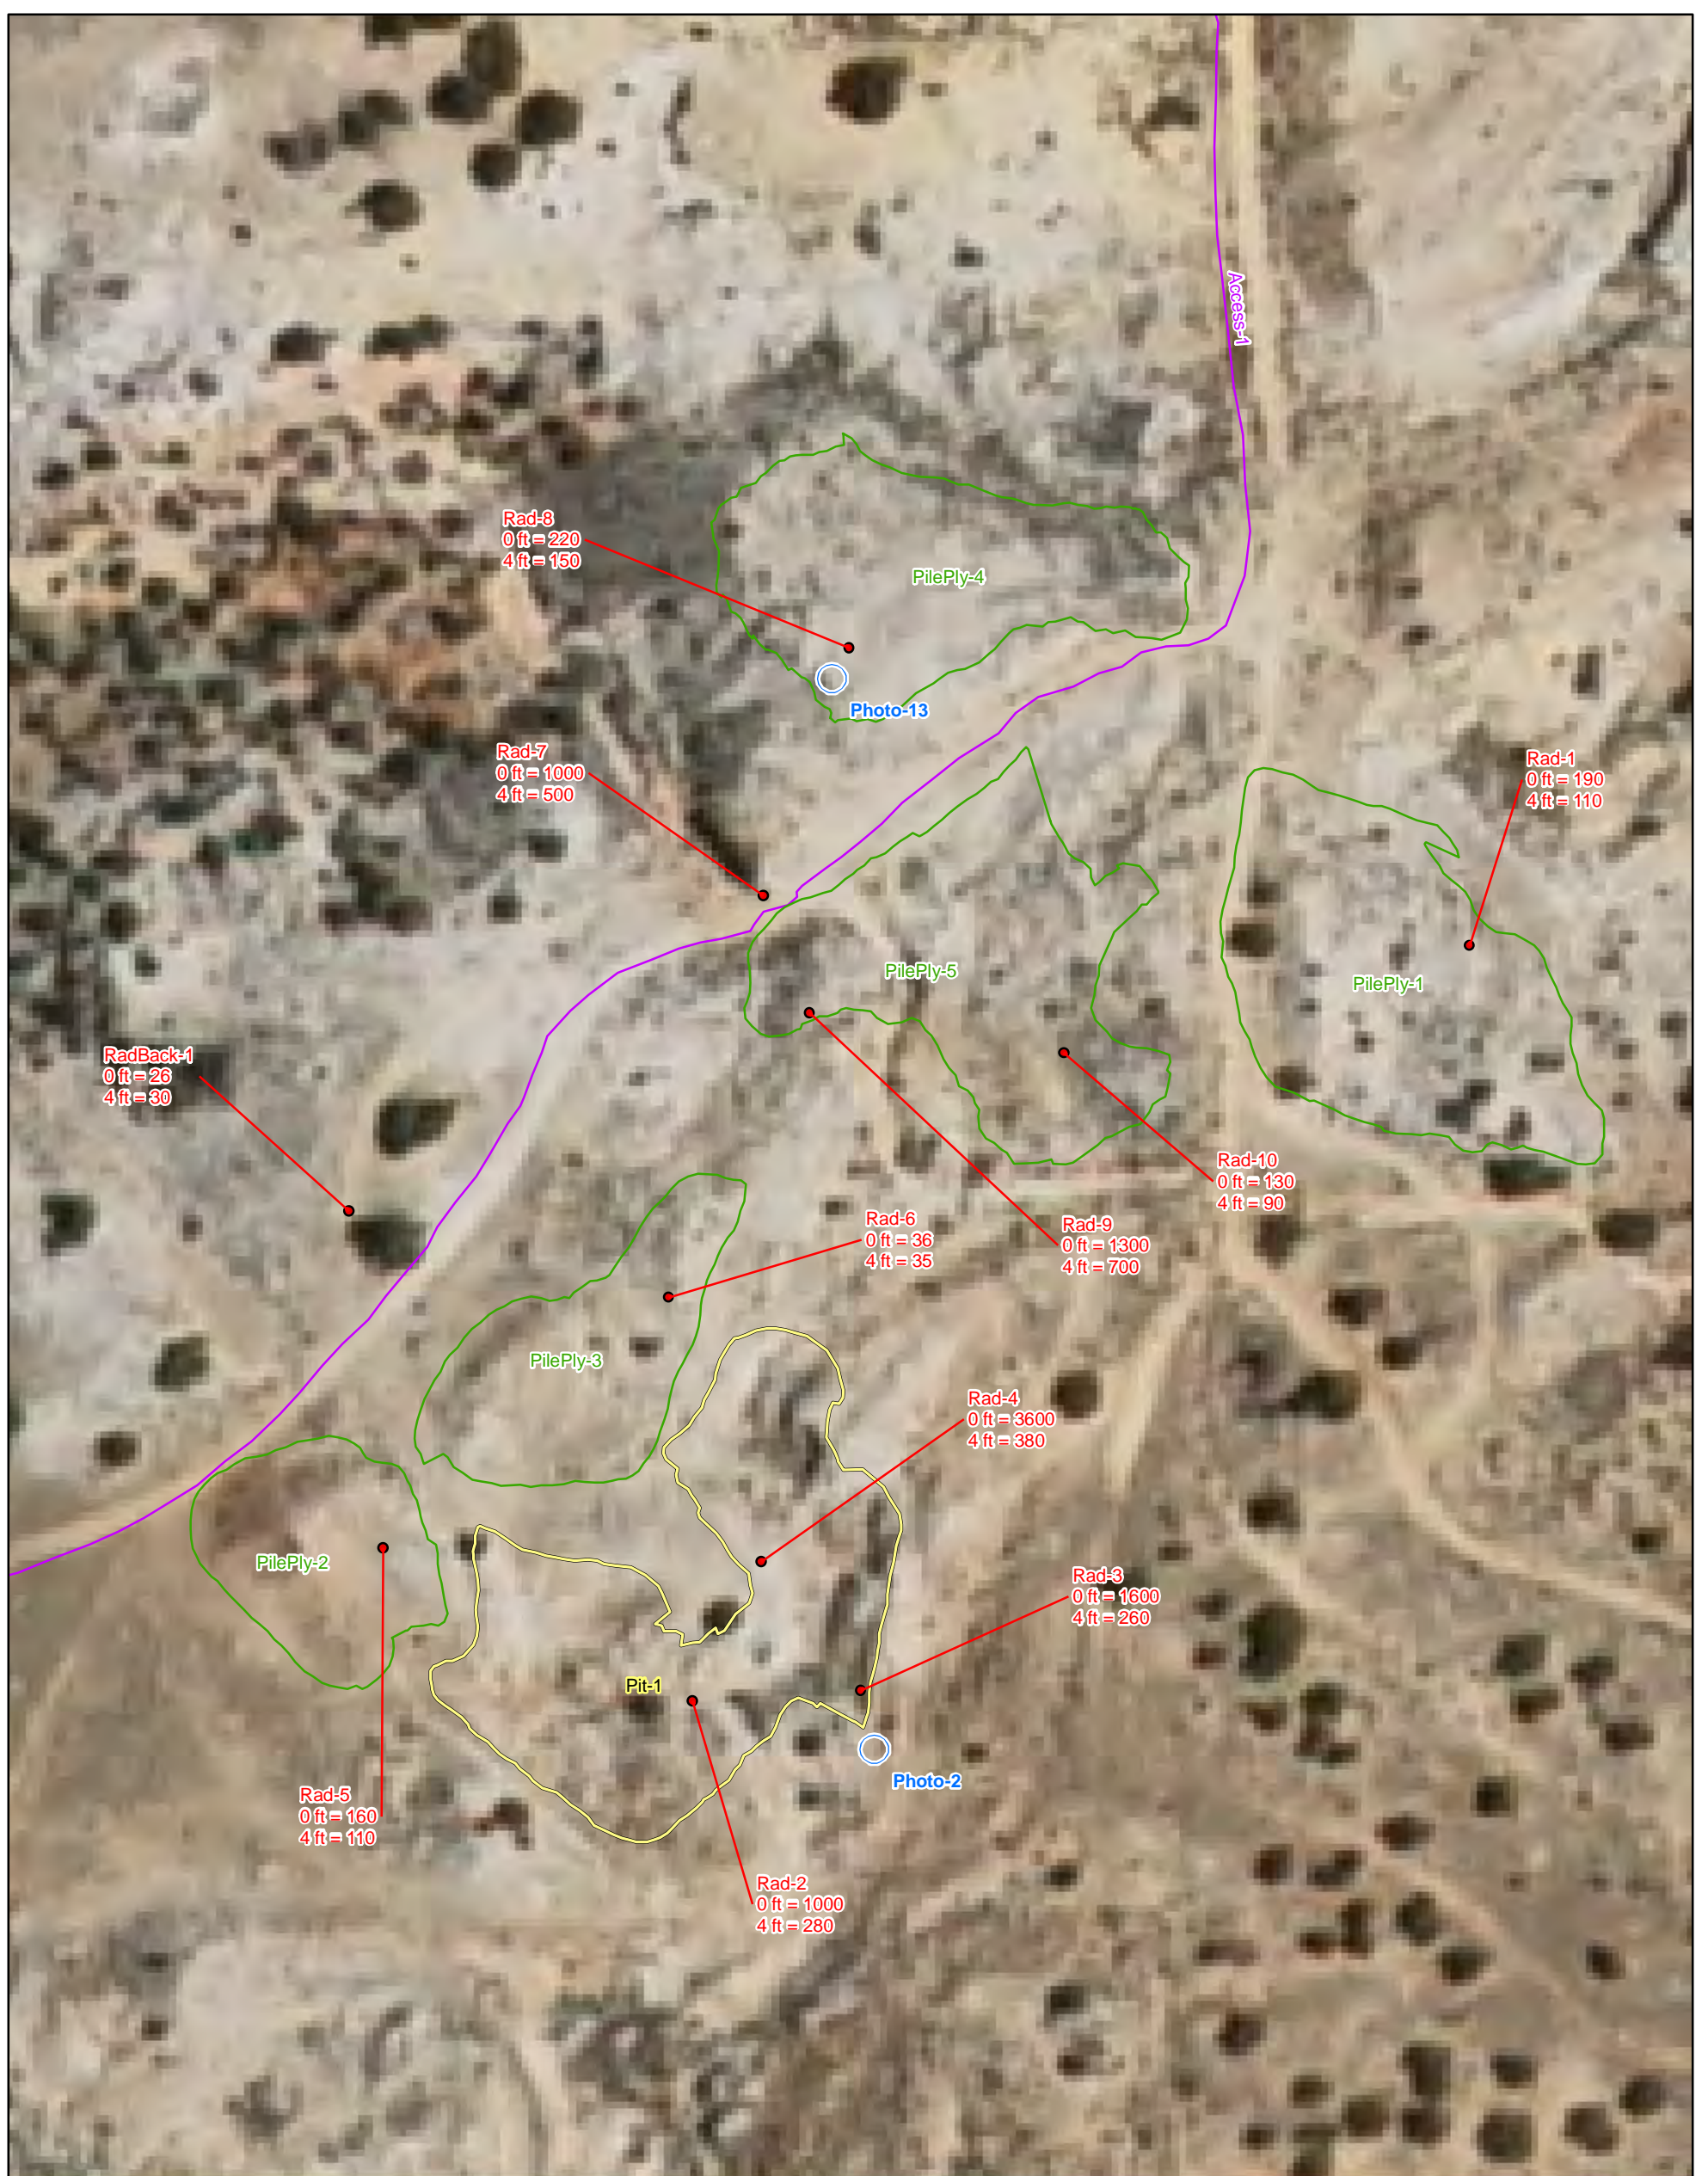
Figure 4a
Site Map on
Aerial Photo
NM0121-Gay Eagle
 Abandoned Uranium
 Mine Assessment

The mine features described below are based on the features provided to INTERA by MMD in the GIS Data Dictionary (MMD, 2009). INTERA marked the locations of the AUM Site features using a Trimble Global Positioning System (GPS), and entered details about the features into the GPS using the MMD data dictionary. One pit and five piles were found onsite. Please see the Photo Log in Appendix A for photos of the AUM Site features, Table 1 for a list of the AUM Site features, and Figures 4a and 4b for the locations of the AUM Site features.

One background gamma radiation reading was taken near the AUM Site, recording 26 $\mu\text{R/hr}$ at 0 ft above ground and 30 $\mu\text{R/hr}$ at 4 ft above ground. Please see Table 2 for all of the gamma radiation readings taken at the AUM Site and Figures 4a and 4b for the locations of the radiation readings.

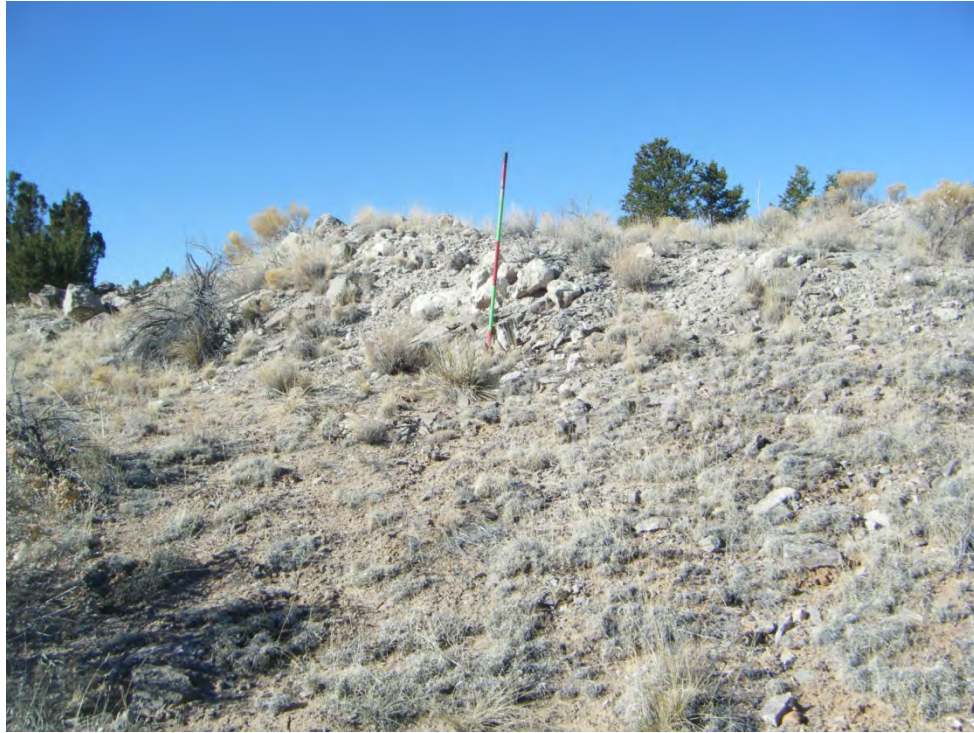
Photo 1-Looking south at PilePly-1.

Pileply-1 - 15' high, 75' wide, 100' long; waste

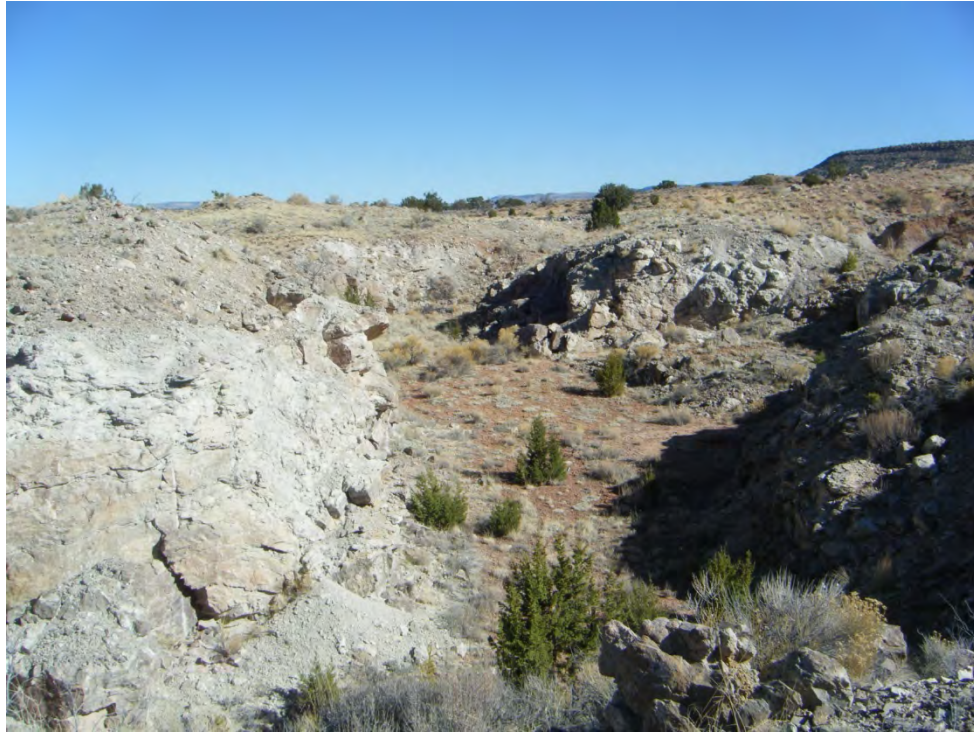
Photo 3-Looking north at the northern arm of Pit-1.

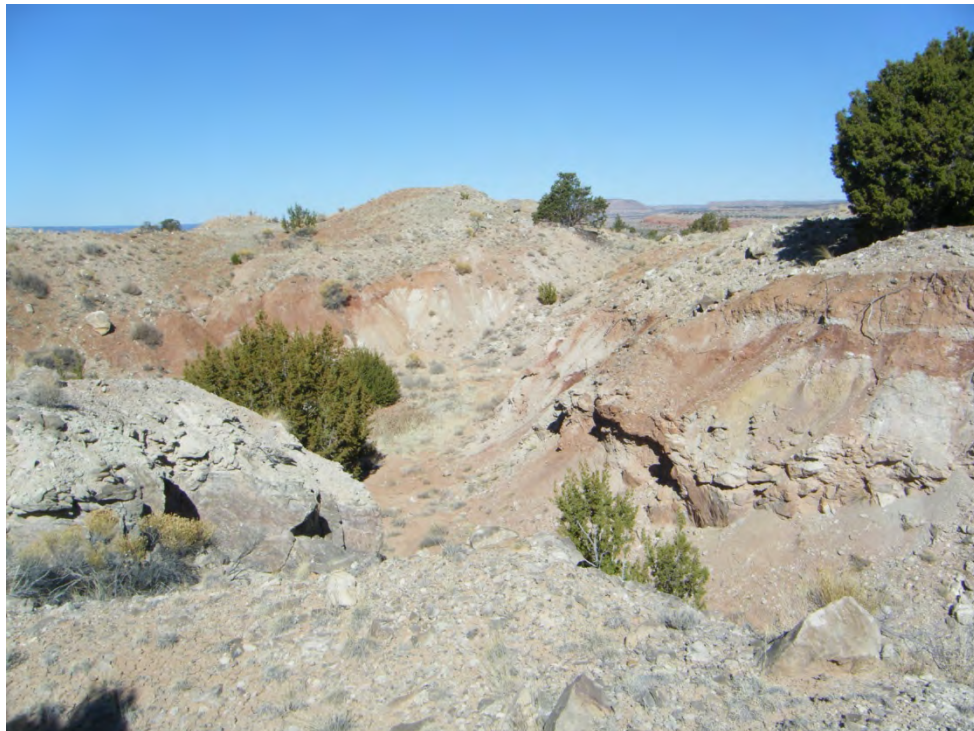
Photo 4-Looking west at Pit-1, western arm.

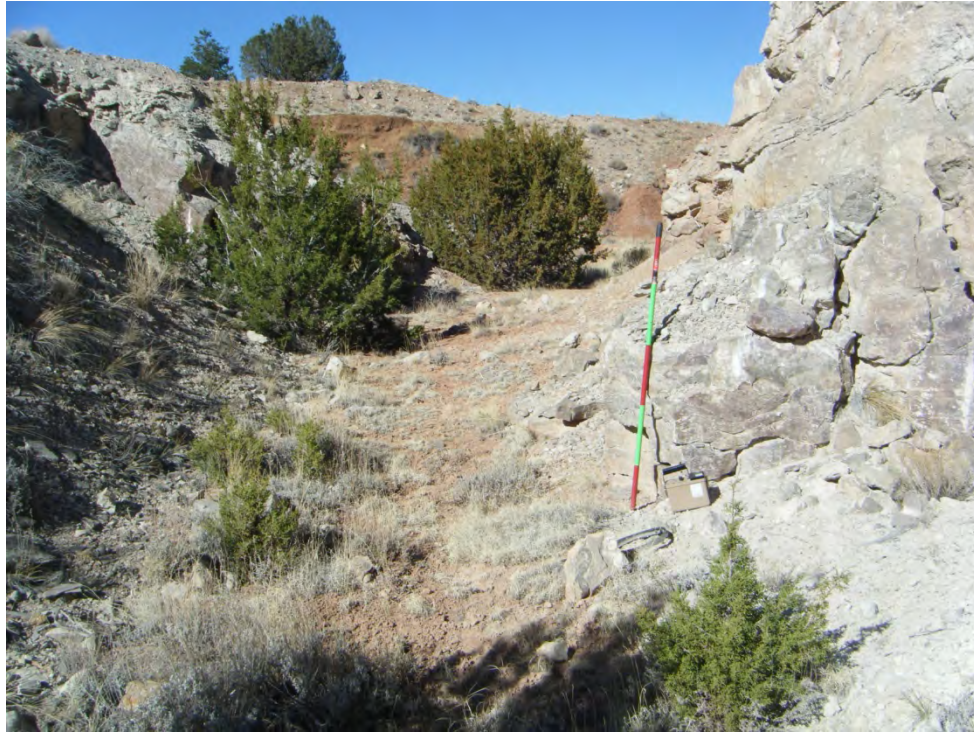
Photo 5-Looking west up the west arm of Pit-1.

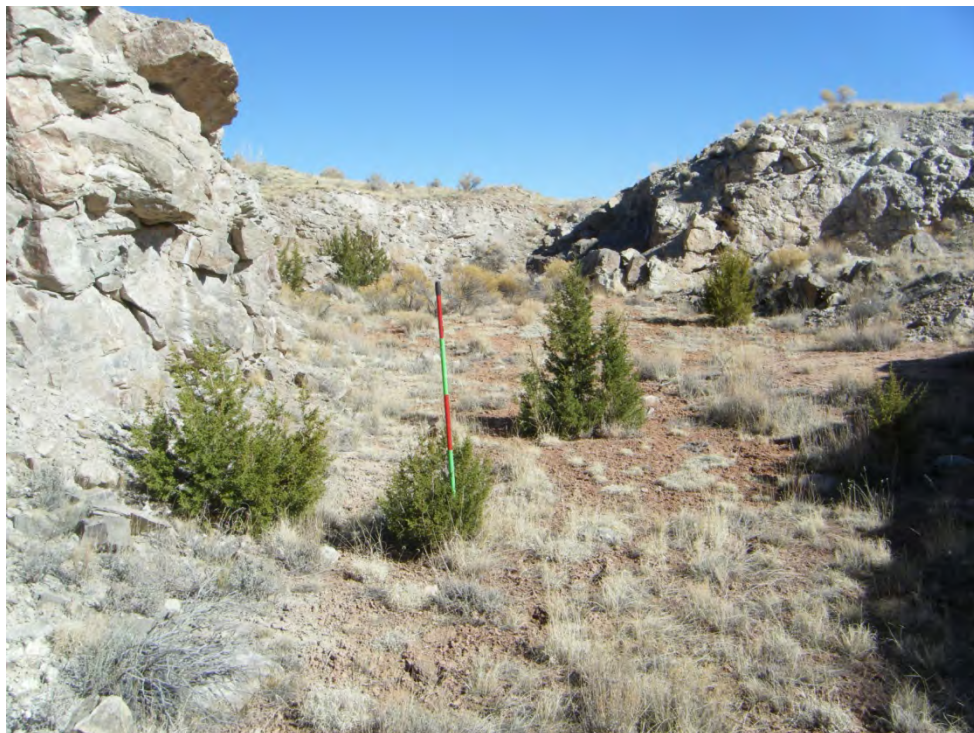
Photo 6-Looking north up the north arm of Pit-1.

Pit-1 - 20' deep, 30' wide, 180' long; "L" shaped

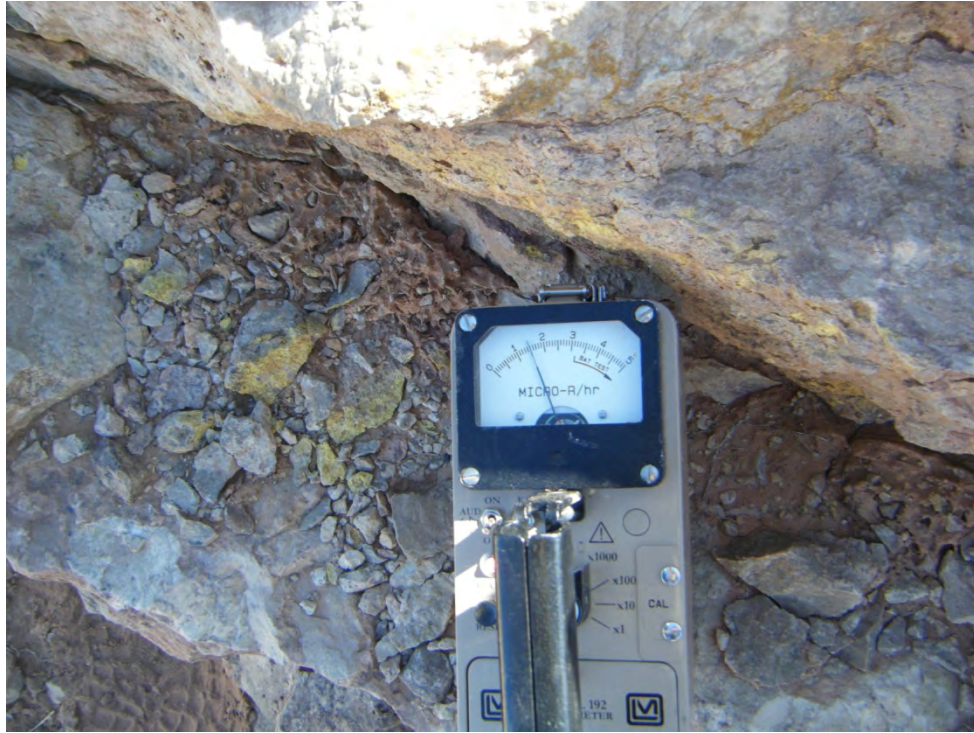
Photo 7-Radiation survey point 3 (1600 μ R/hr at contact).

Rad 3 - entrance to Pit 1, south end; 0m - 1600 uR/h; 1m - 260 uR/h

Photo 7 - looking at Rad 3 and yellow mineralization on Todilto

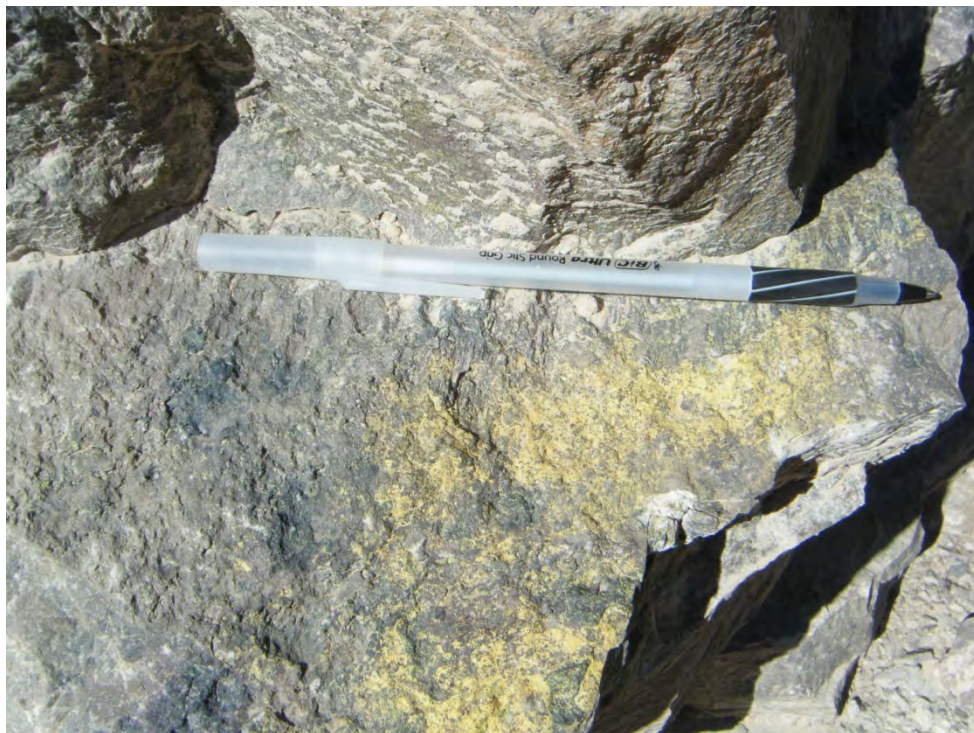
The maximum gamma radiation reading for the AUM Site was 3600 $\mu\text{R/hr}$ at 0 ft above ground at radiation survey point Rad-4 (see Photo 7 and 8 in Appendix A). This reading was taken on a localized area of mineralization on the walls of Pit-1. Other notable radiation readings were taken at radiation survey point Rad-3 (1600 $\mu\text{R/hr}$ at 0 ft above ground) in Pit-1 and radiation survey point Rad-9 (1300 $\mu\text{R/hr}$ at 0 ft above ground) on PilePly-5. An outcrop of Todilto Formation limestone in an arroyo yielded 1000 $\mu\text{R/hr}$ (radiation survey point Rad-7, see Photo 11 in Appendix A).

Photo 8-Secondary uranium minerals at radiation survey point Rad-4 (3600 μ R/hr at contact).

Rad 4 - Pit 1; 0m - 3600 uR/h; 1m - ~~380~~^{380 ALT} uR/h

Photo 8 - yellow mineralization at Rad 4

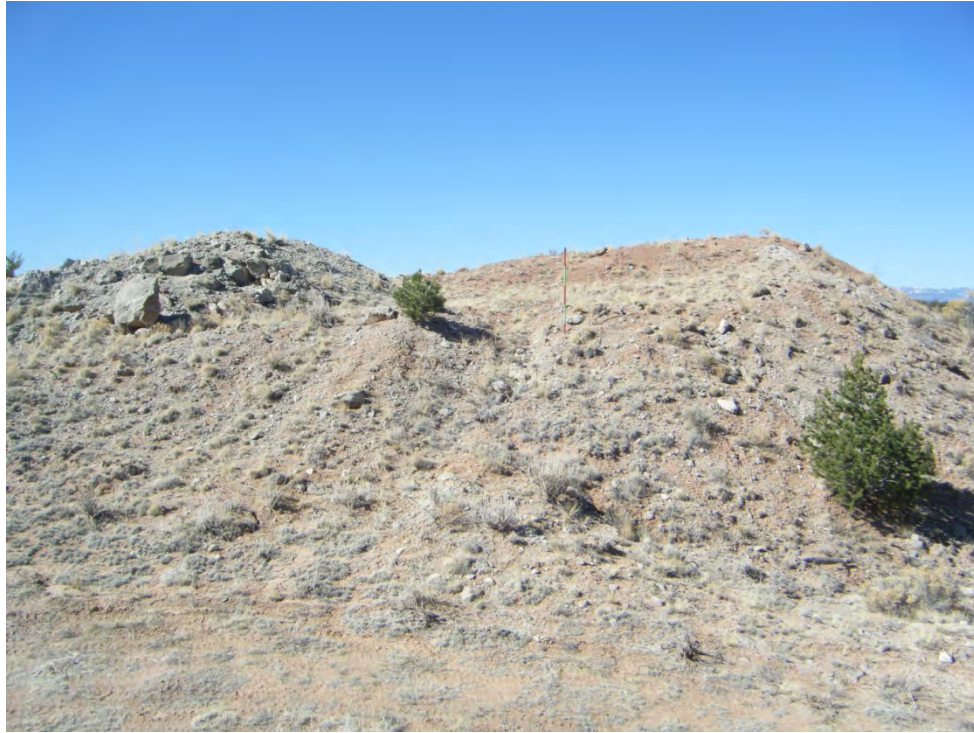
Photo 9-Looking southwest at PilePly-2.

Pile Ply 2 - 25' high; 75' wide; 100' long

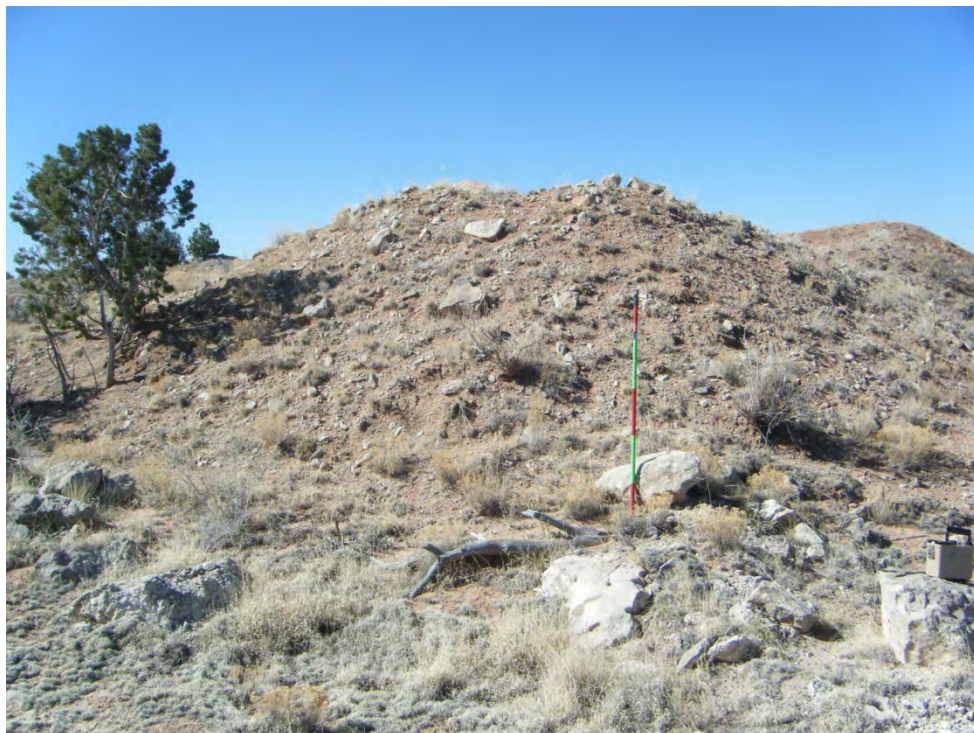
Photo 10-Looking southwest at PilePly-3.

Pile Ply 3 - 20' high; 50' wide; 120' long

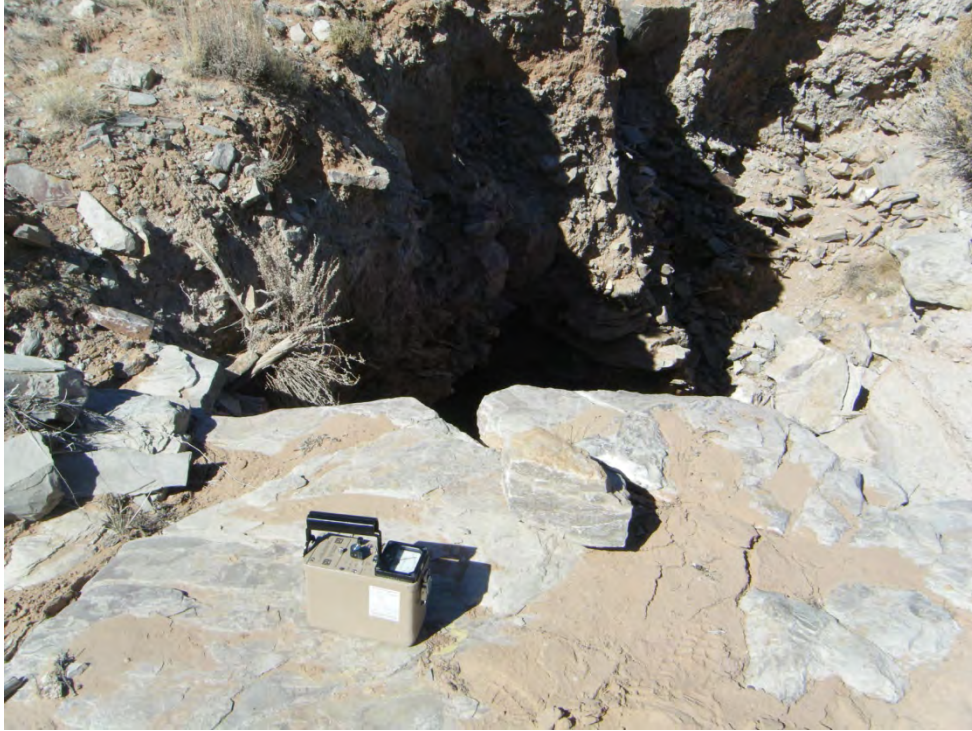
Photo 11-Looking west at radiation survey point Rad-7 (1000 μ R/hr at contact).

Rad 7 - drainage, through site, yellow mineralization on Todilto; 0m - 1000 uR/h; 1m - 500 uR/h

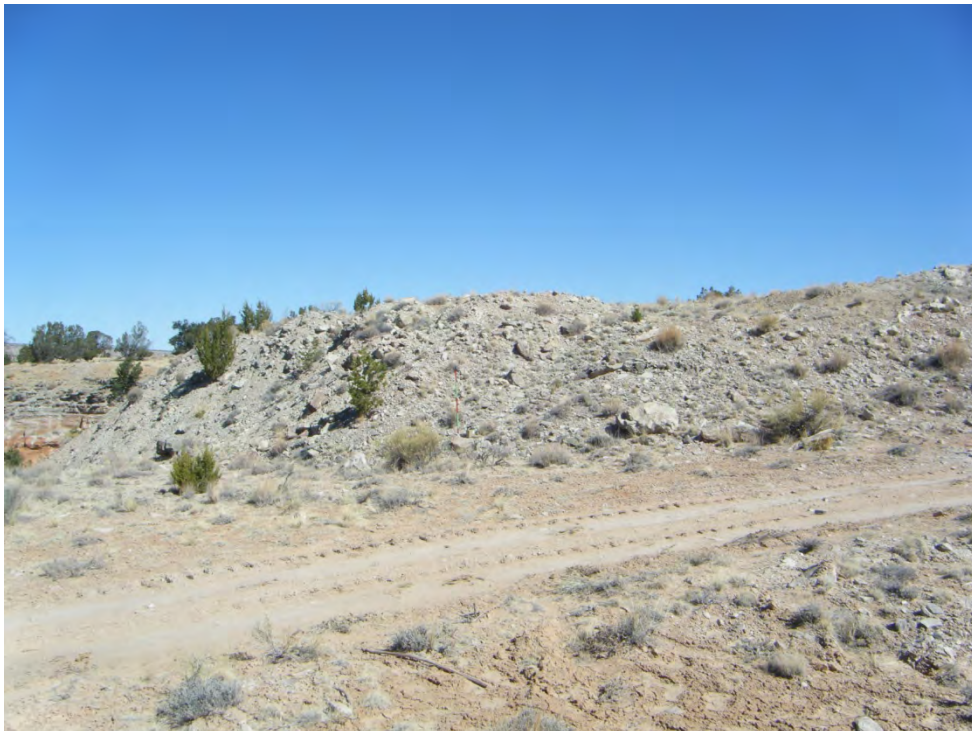
A) contain both waste rock and overburden. PilePly-4 (see Photo 12 in Appendix A) and PilePly-5 (see Photo 14) are mostly waste rock. One gamma reading on PilePly-5 recorded 1000 $\mu\text{R/hr}$ at 0 ft above ground (radiation survey point Rad-7). Material from PilePly-4 is spilling off the edge of the mesa, into a drainage below.

Photo 12-Looking north at PilePly-4.

Pile Ply 4 - 20' high, 100' wide, 200' long

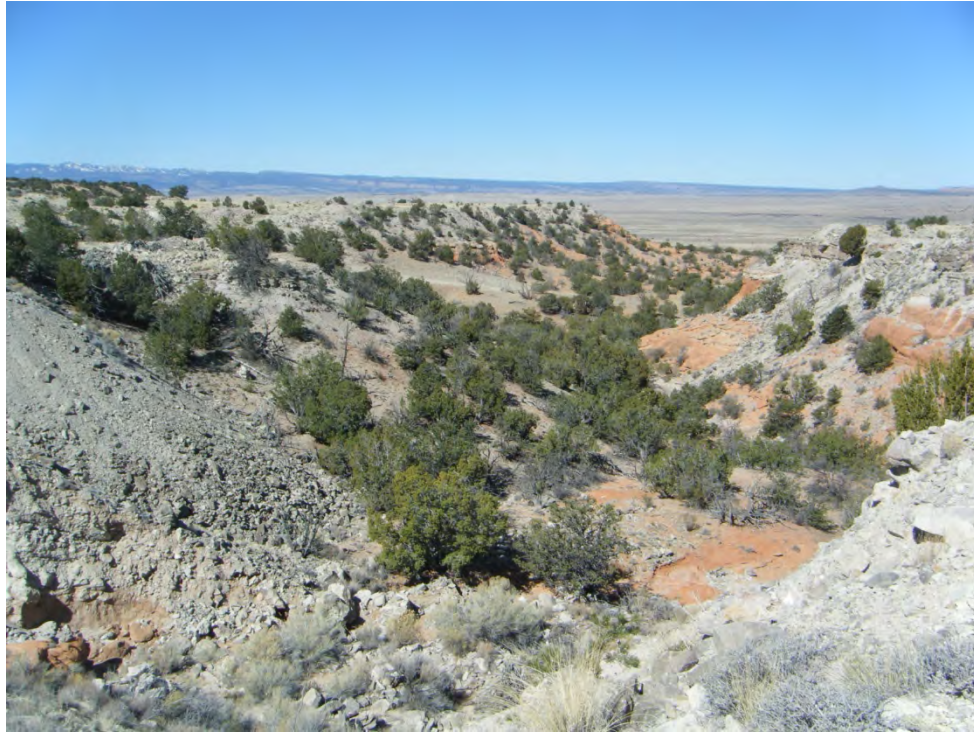
Photo 13-Looking west down a drainage on the edge of the mesa. Note waste rock spilling down the slope to the left.

Photo 13 - looking west down drainage, on west face of mesa; note waste rock spilling into drainage.

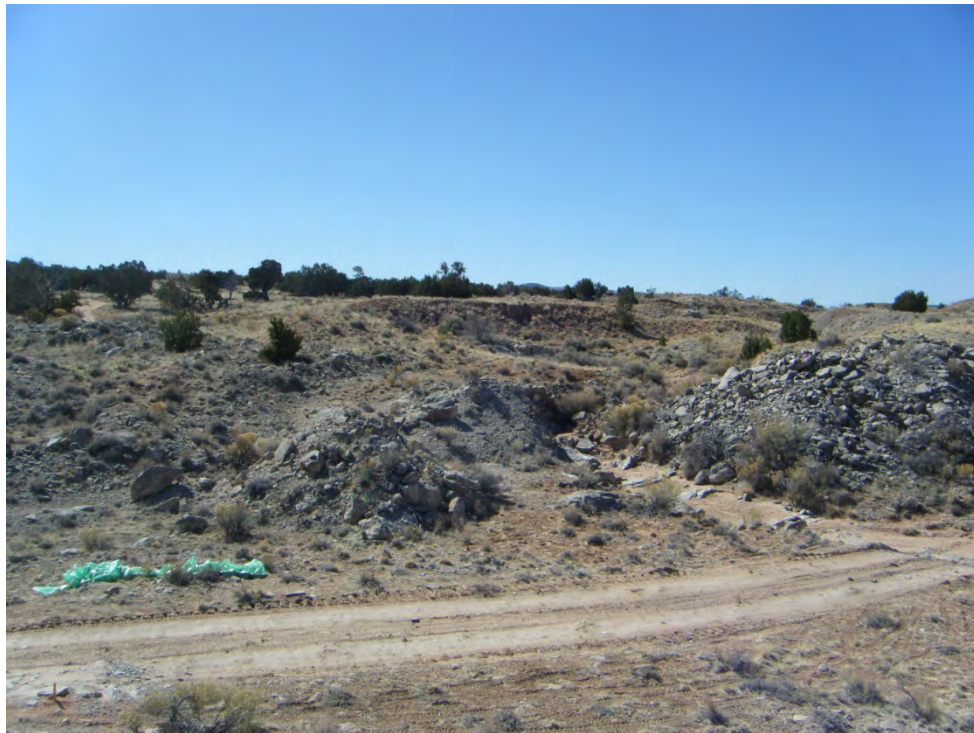
Photo 14-Looking southeast at PilePly-5.

Pile Ply 5 - 15' high, 100' wide, 200' long
piles of small and large waste rock

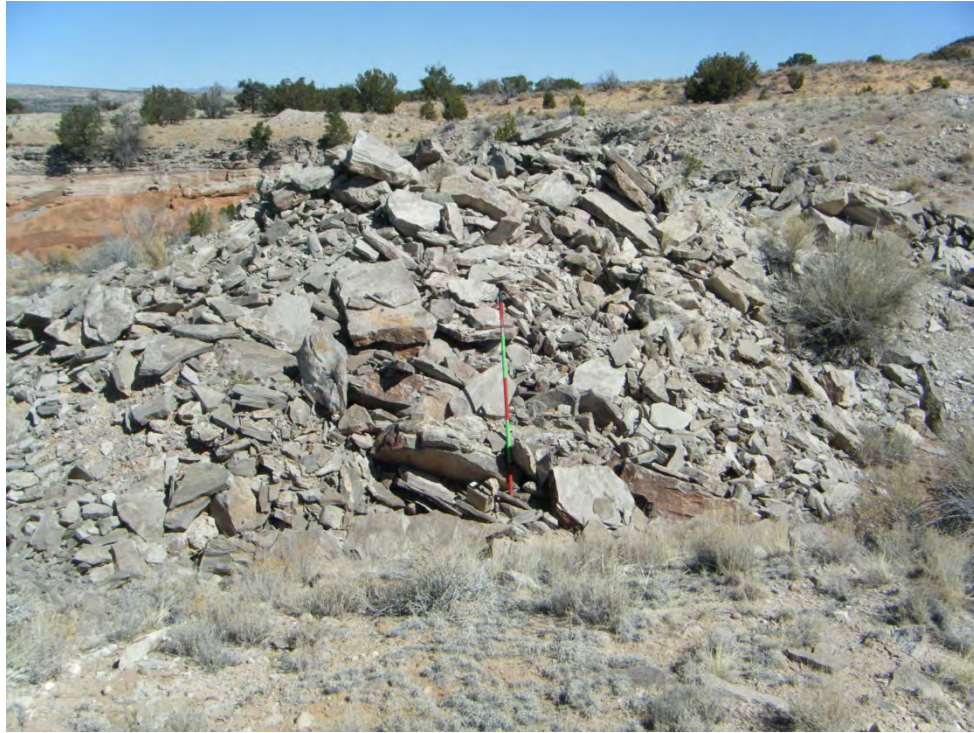
Photo 15-Looking northwest at part of PilePly-5.
