ABANDONED OR INACTIVE URANIUM
MINES IN NEW MEXICO

A report of investigation carried out
between August 1979 and May 1980 under
contract with the New Mexico Energy and
Minerals Department.

New Mexico Bureau of Mines and
Mineral Resources
Open-File Report 148

Mine name(s) La Paloma County Rio Arriba

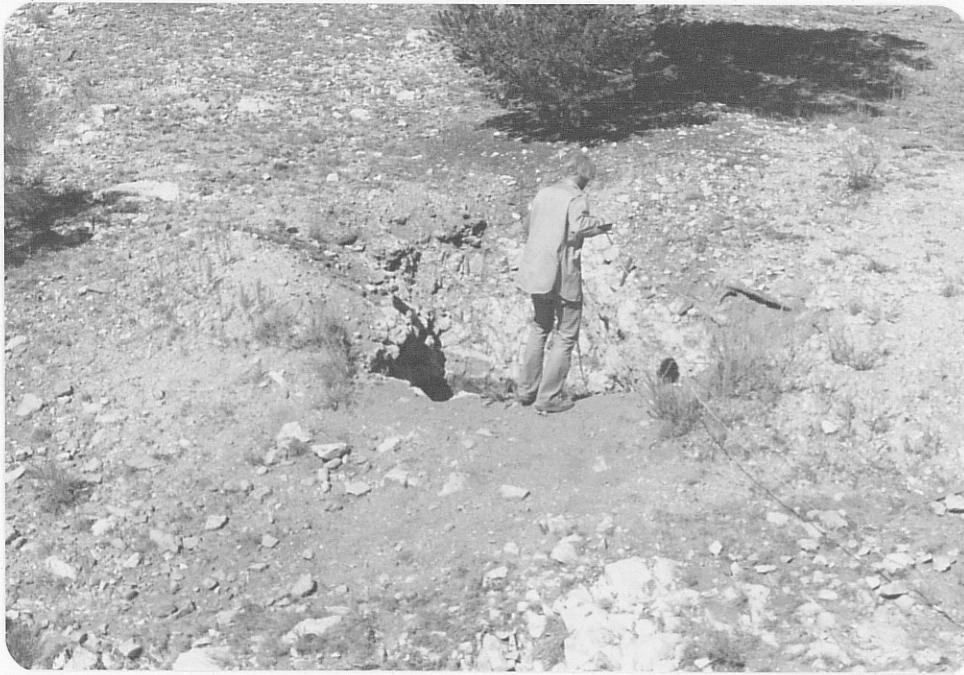
Photo (a) Looking west at surface openings of small pit.
Field geologist is taking a water sample.

The La Paloma consists of a shallow shaft, and several small open pits and bulldozer cuts. The shaft is 6' x 6' at the surface, and water filled. The depth to the water is 4'. The total depth is not known, however, it probably does not exceed 10' (photos a and b). A water sample was taken, and the analysis is attached. The smaller pits and bulldozer cuts are located in a small drainage trending southwest from the main shaft (photo c). The pits are generally shallow, ranging from 1-5' in depth (photo d). The bulldozed areas have removed topsoil and exposed bedrock (photo c). The total disturbed area is 500' northeast/southwest x 100' northwest/southeast.

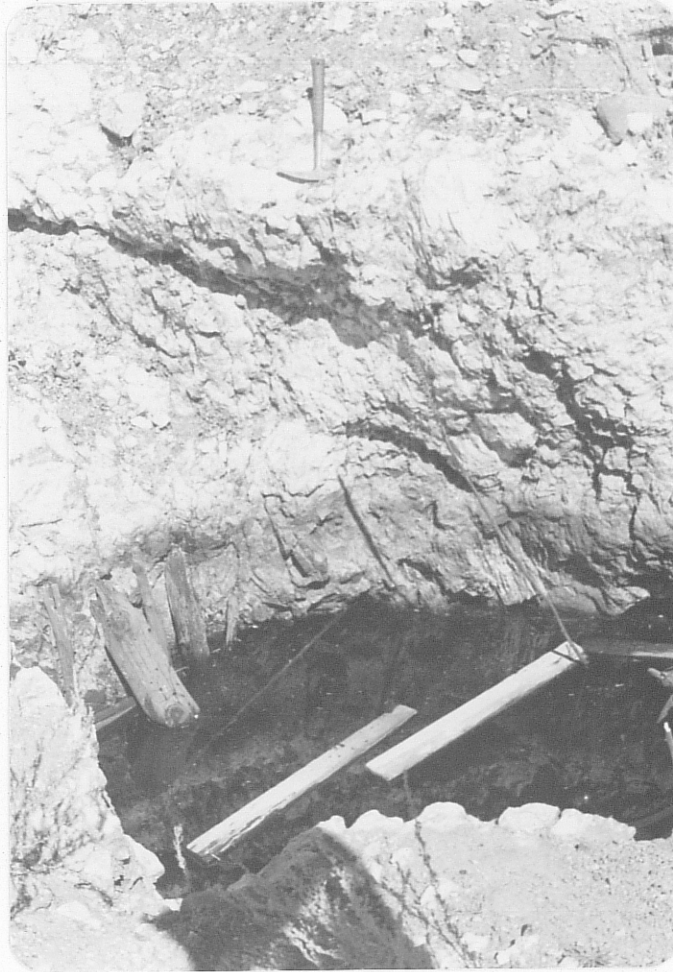
Photo (b) Close up of the small, water filled shaft on the La Paloma workings. Note hammer for scale.

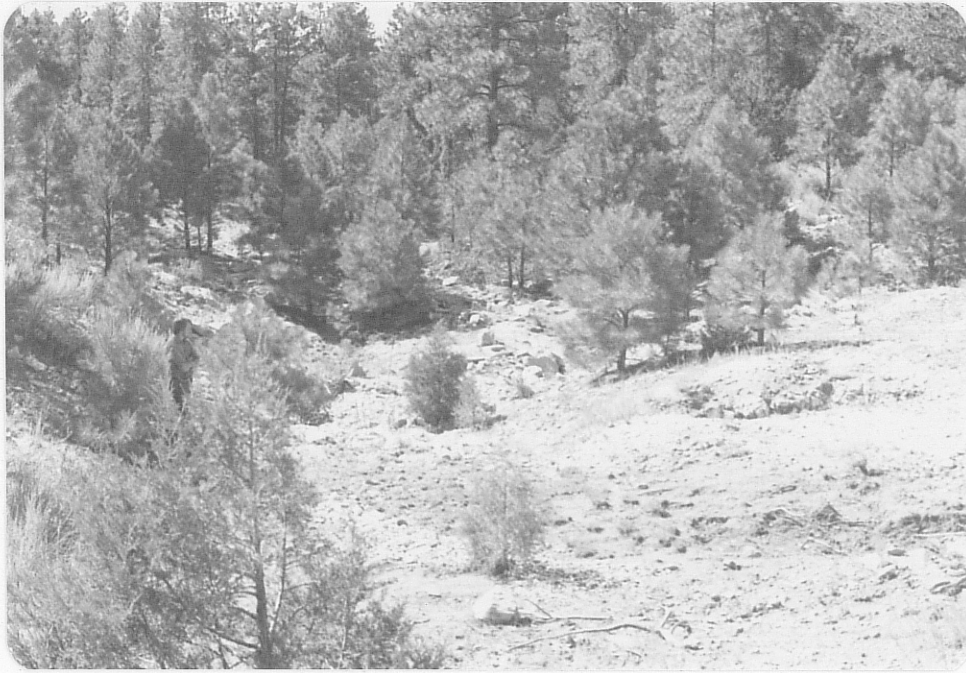
Photo (c) Looking south at typical small pit (arrow) along a drainage on the La Paloma workings. Note the growth of pine along the drainage and on the dump south of the pit.

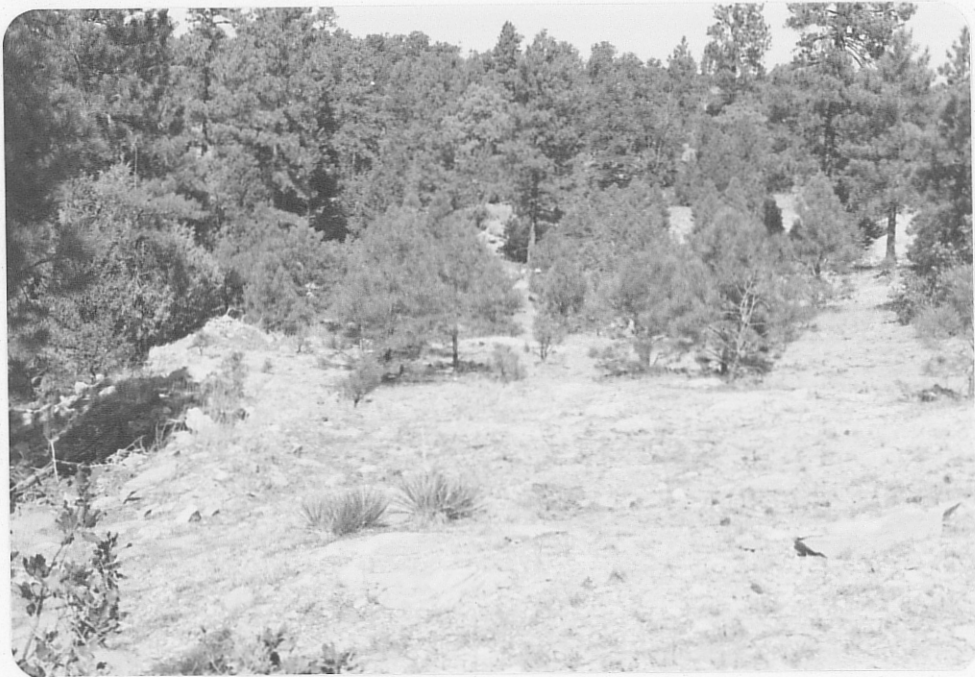
Photo (e) Bulldozed area on the La Paloma workings. Note rejuvination of area by pines and grasses.
