# Abandoned Uranium Mine Site Assessment for the Christmas Day Site (NM0119)

**FINAL REPORT**

NM0119

INTERA Incorporated (INTERA) has prepared this Abandoned Uranium Mine (AUM) Site Assessment Report for the Mining and Minerals Division (MMD) of the New Mexico Energy, Minerals and Natural Resources Department (EMNRD) in compliance with the Professional Service Agreement dated November 2, 2009. INTERA visited the Christmas Day Site (AUM Site), MMD ID: NM0119 on April 7, 2010.

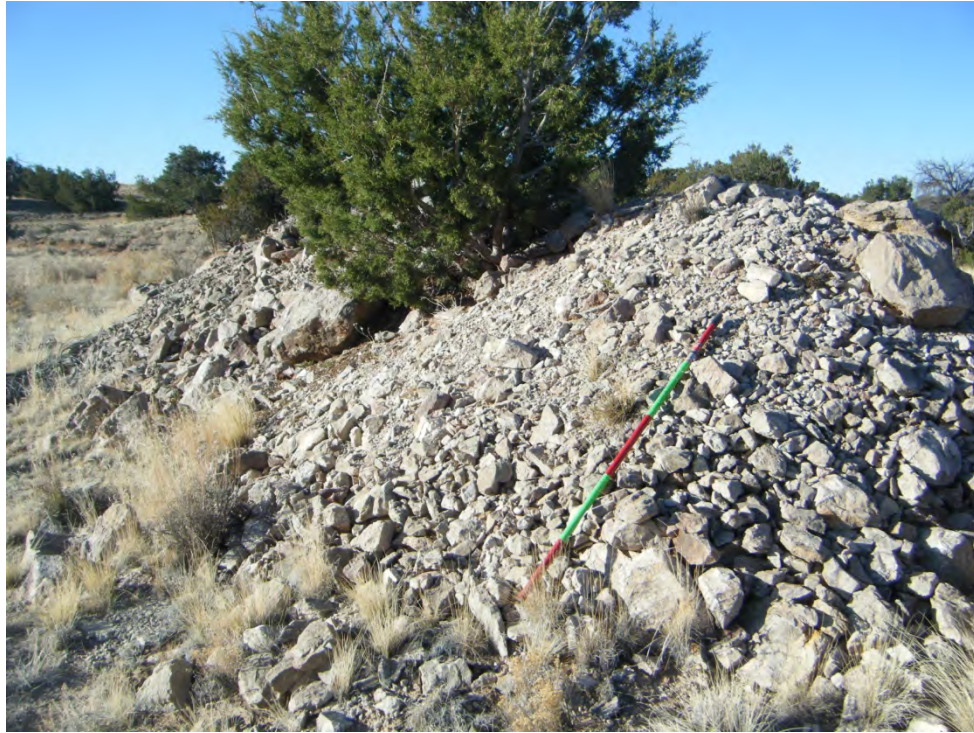
Two piles were found at the AUM Site. PilePly-1 consists of waste rock (see Photo 1 in Appendix A) and PilePly-2 is mostly overburden (see Photo 9). PilePly-1 is likely the pile in Photo (c) of the Anderson report.

Photo 1-Looking south at PilePly-1.

PilePly 1 - 6' high, 10' wide, 30' long; waste rock

Rad 1 - PilePly 1 - 0m - 270  $\mu$ R/h; 1m - 90  $\mu$ R/h

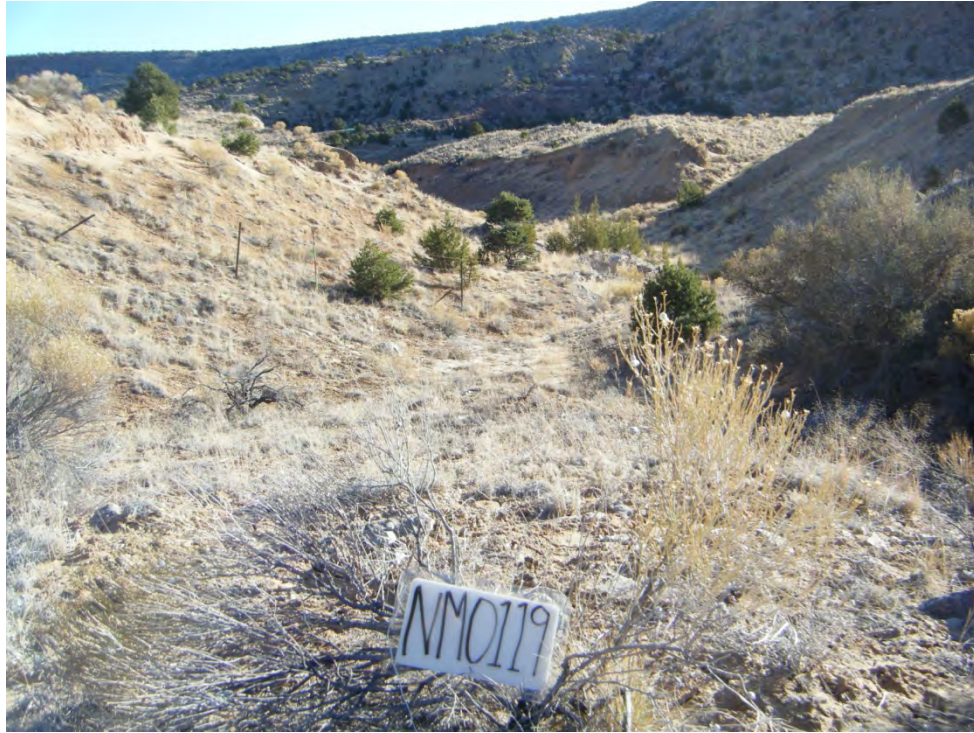
One pit was found onsite (see Photos 3-5, 7, 8 in Appendix A). This pit approximately corresponds with the C-shaped pit mentioned by Anderson (Anderson, 1980). However, thirty years of aeolian and perhaps fluvial activity have completely filled in the eastern limb of the pit. The only exposed bedrock is located in the still-open western limb (see Photo 7 in Appendix A).

Photo 3-Site photo looking north at Pit-1 in the background.

Photo 3 - looking north at Pit 1 with site name  
from south side of Pit

Pit 1 - 50' deep, 100' wide, 300' long; exposed Todilto at  
bottom of pit, filling with sand, overburden is sand

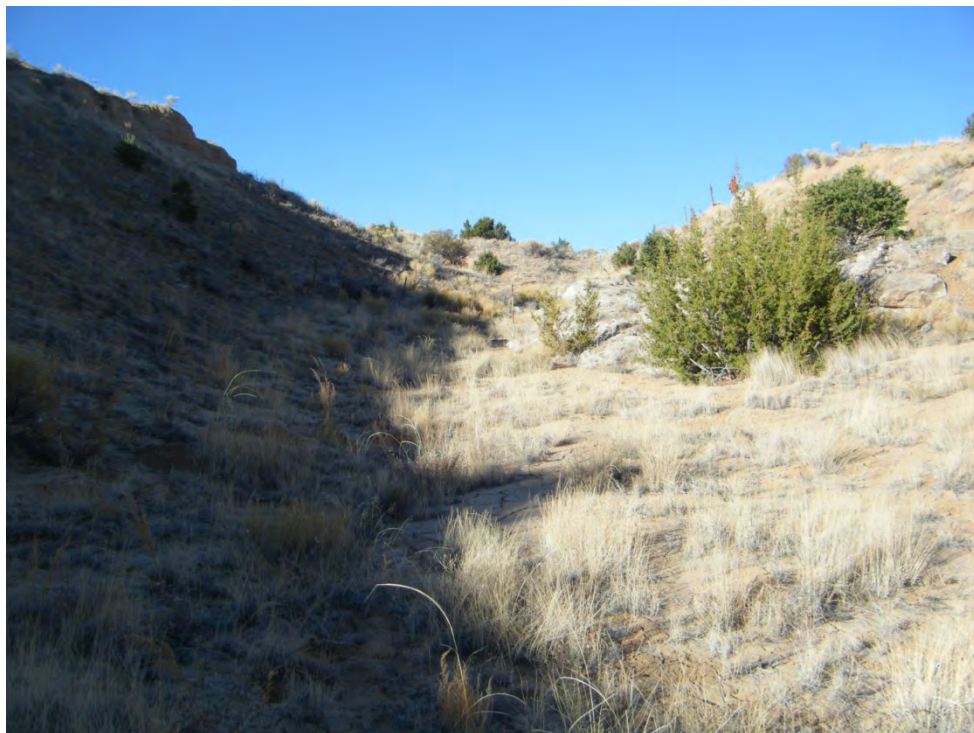
Photo 4-Looking south from the center of Pit-1.

Photo 4 - looking south from center of Pit 1

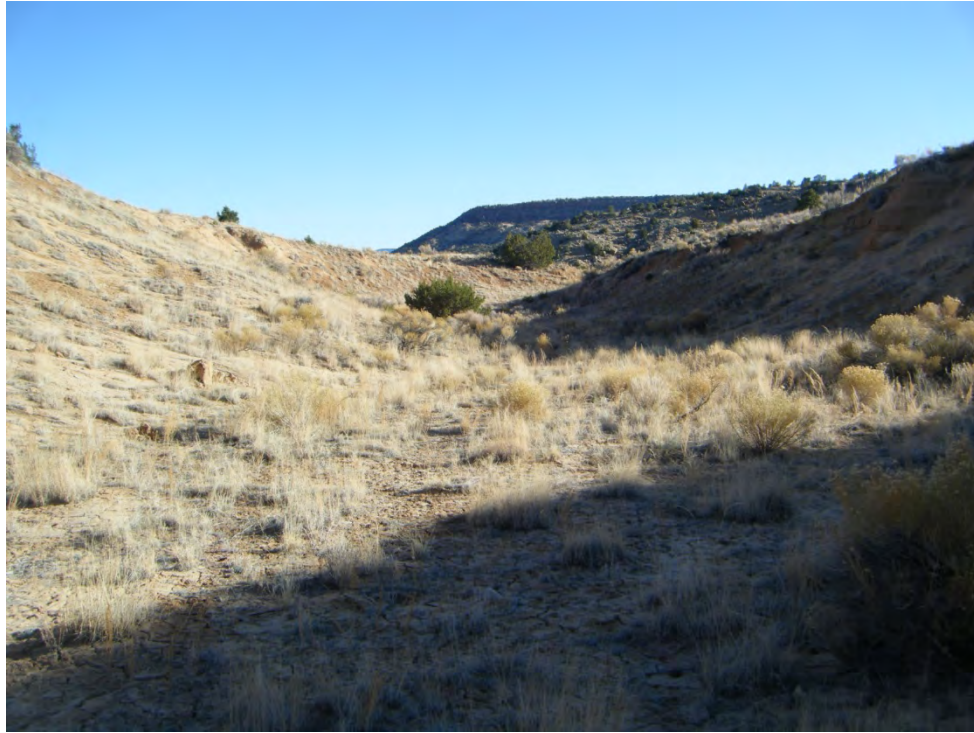
Photo 5-Looking north from the center of Pit-1.

Photo 5 - looking north from center of Pit 1

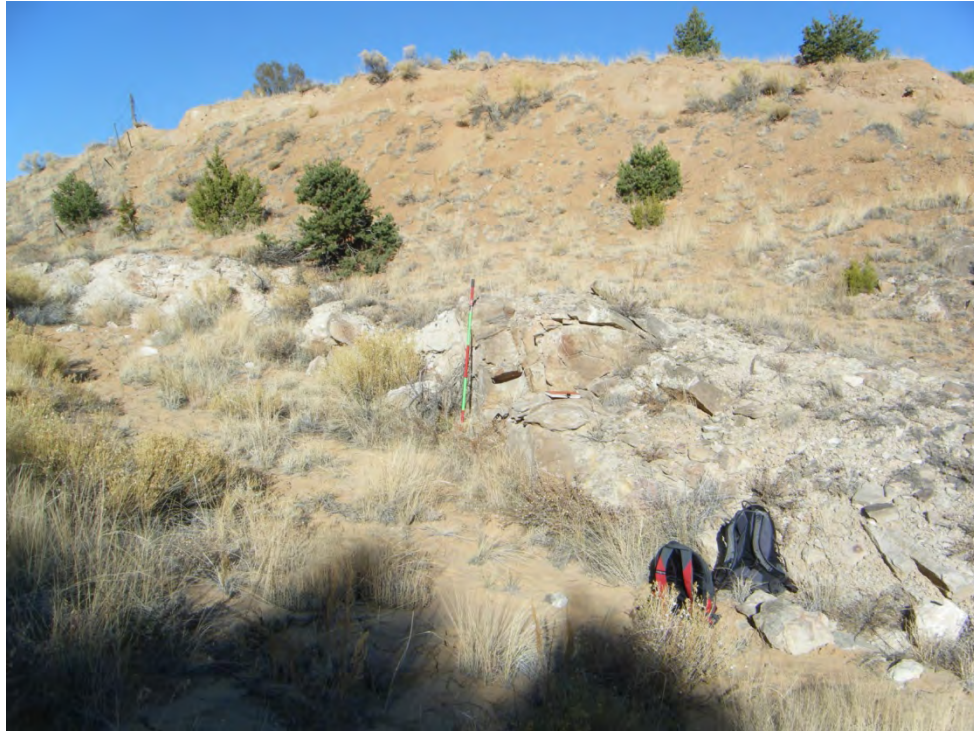
The highest gamma radiation readings were on a shelf of exposed Todilto Formation limestone in Pit-1 (radiation survey point Rad-4), measuring 900  $\mu\text{R/hr}$  at 0 ft above ground.

The maximum gamma radiation reading for the AUM Site was 900  $\mu\text{R/hr}$  at 0 ft above ground at radiation survey point Rad-4 (see Photo 7 in Appendix A). This reading was taken on a shelf of limestone from the Todilto Formation inside Pit-1. Other notable radiation readings were taken at radiation survey point Rad-6 (600  $\mu\text{R/hr}$  at 0 ft above ground) in Pit-1 and radiation survey point Rad-1 (270  $\mu\text{R/hr}$  at 0 ft above ground) on PilePly-1.

Photo 7-Limestone of the Todilto Formation exposed in the bottom of Pit-1. This is the location of radiation survey point Rad-4 (900  $\mu$ R/hr at 0 ft above ground). Note aeolian sand above the Todilto.

Rad 4 - center of exposed Todilto in Pit 1

0m - 900  $\mu$ R/h; 1m - 310  $\mu$ R/h

Photo 7 - Todilto exposure in Pit 1

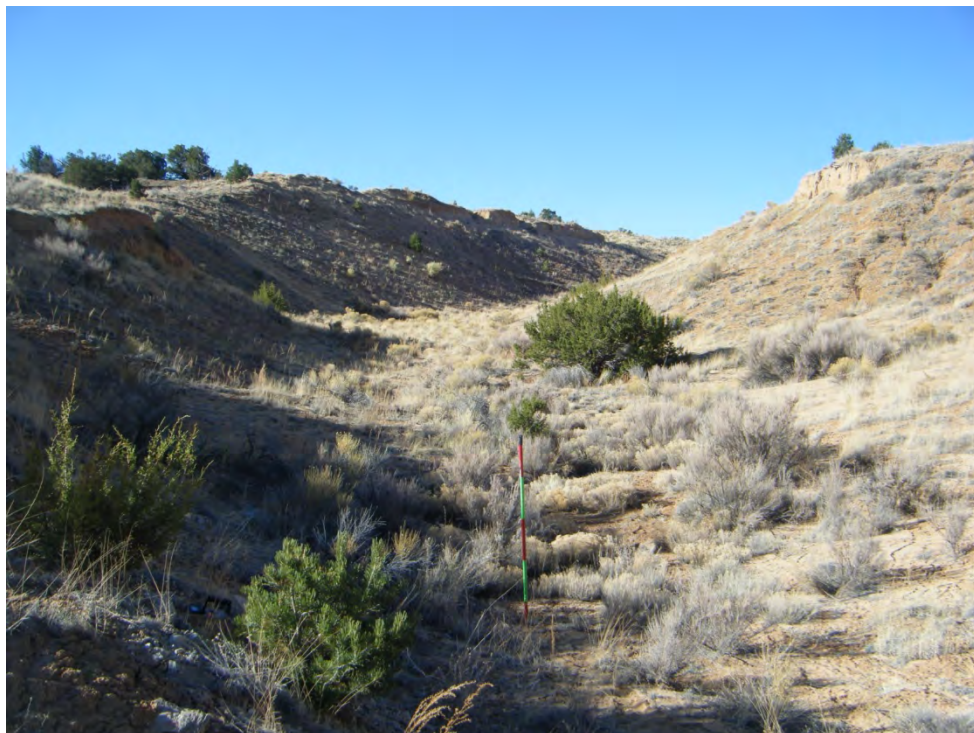
Photo 8-Looking south at Pit-1.

Photo 8 - looking south at Pit 1

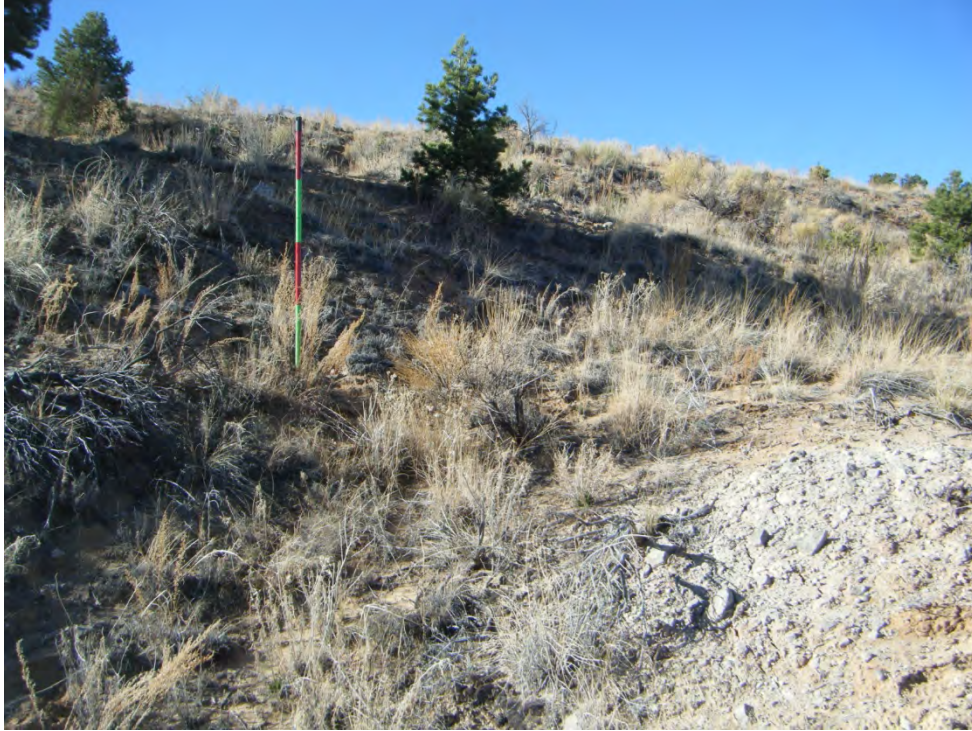
Photo 9-Looking southwest at PilePly-2.

PilePly 2 - 15' high, 20' wide, 30' long; sand and waste  
rock from Pit 1

Photo 9 - looking south west at PilePly 2

Rad 10 - PilePly 2 - 0m - 160  $\mu$ R/h; 1m - 15  $\mu$ R/h
