# Abandoned Uranium Mine Assessment for the Corral No. 3 Site (NM0242)

**FINAL REPORT**

**October 19, 2010**

NM0242

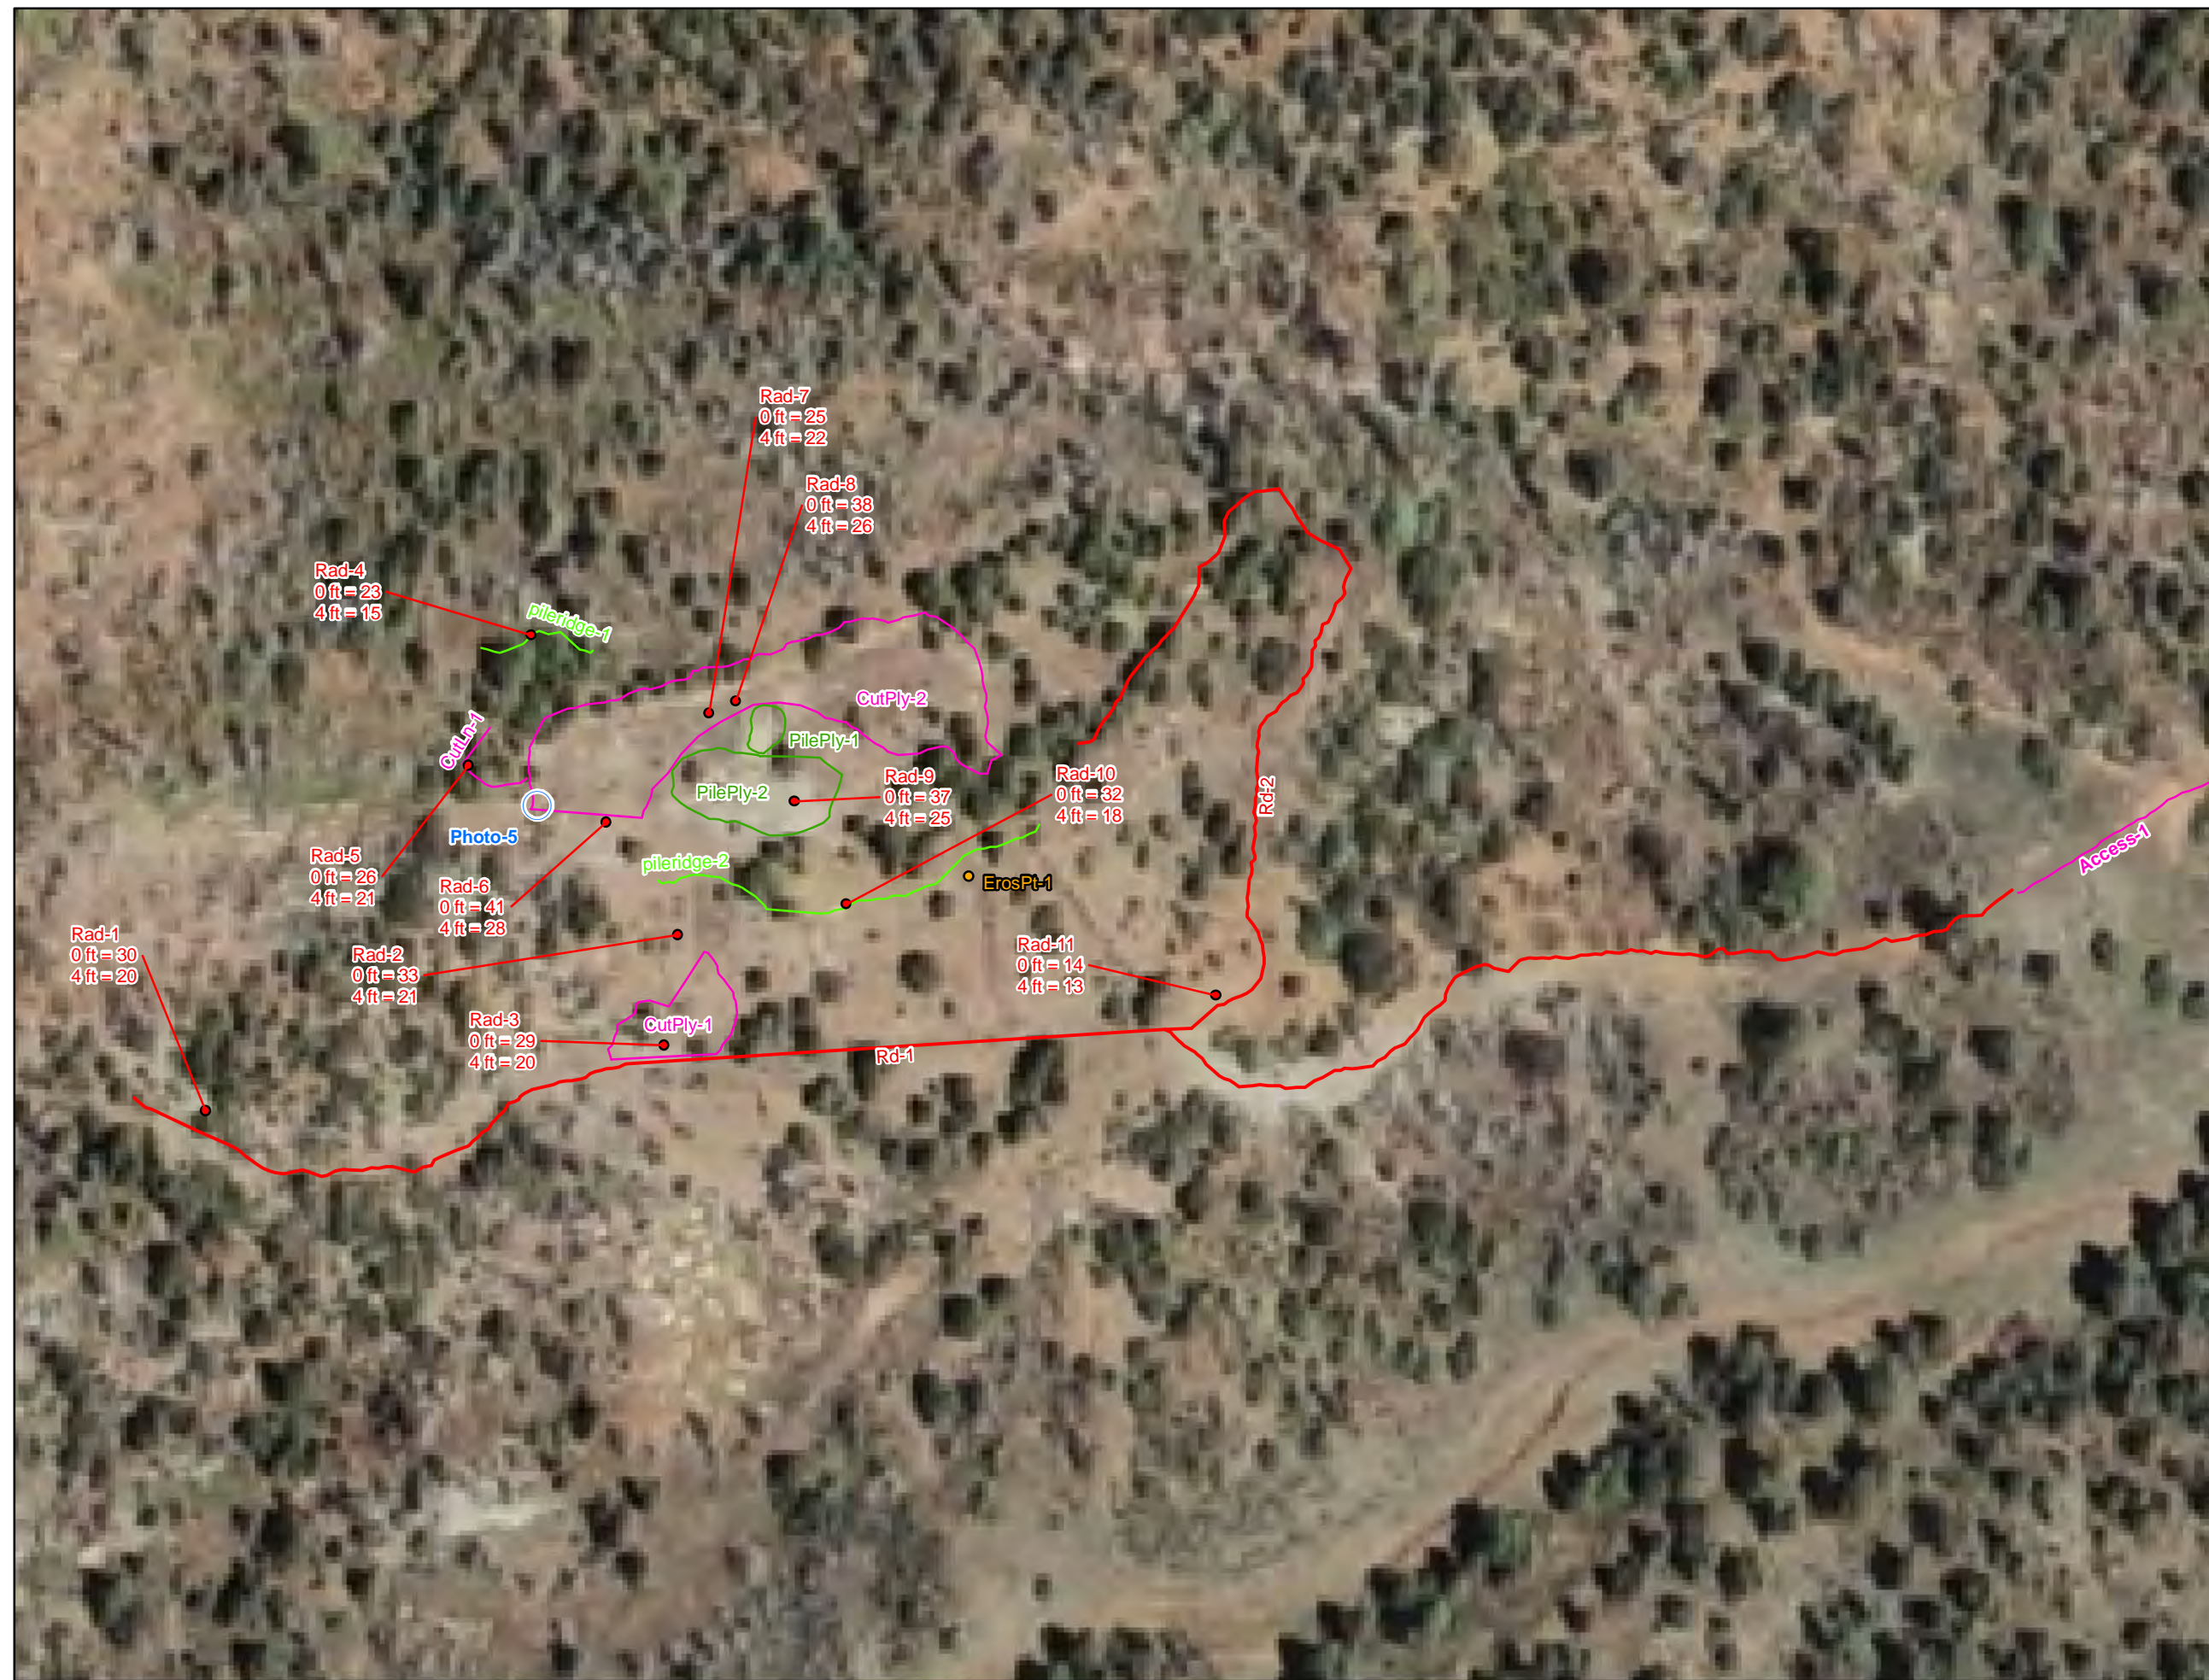
**Figure 4a**  
**Site Map on**  
**Aerial Photo**  
**NM0242-Corral No. 3**  
 Abandoned Uranium  
 Mine Assessment

The mine features described below are based on the features provided to INTERA by MMD in the GIS Data Dictionary (MMD, 2009). INTERA marked the locations of the AUM Site features using a Trimble Global Positioning System (GPS) and entered details about the features into the GPS using the MMD data dictionary. Four piles, three cuts, two mine roads, and an erosional feature were identified onsite. Please see the Photo Log in Appendix A for photos of the AUM Site features, Table 1 for a list of the AUM Site features, and Figures 4a and 4b for the locations of the AUM Site features.

One background gamma radiation reading was taken near the AUM Site, recording 11  $\mu\text{R/hr}$  at 0 ft above ground and 11  $\mu\text{R/hr}$  at 4 ft above ground. Please see Table 2 for all of the gamma radiation readings taken at the AUM Site and Figures 4a and 4b for the locations of the radiation readings.

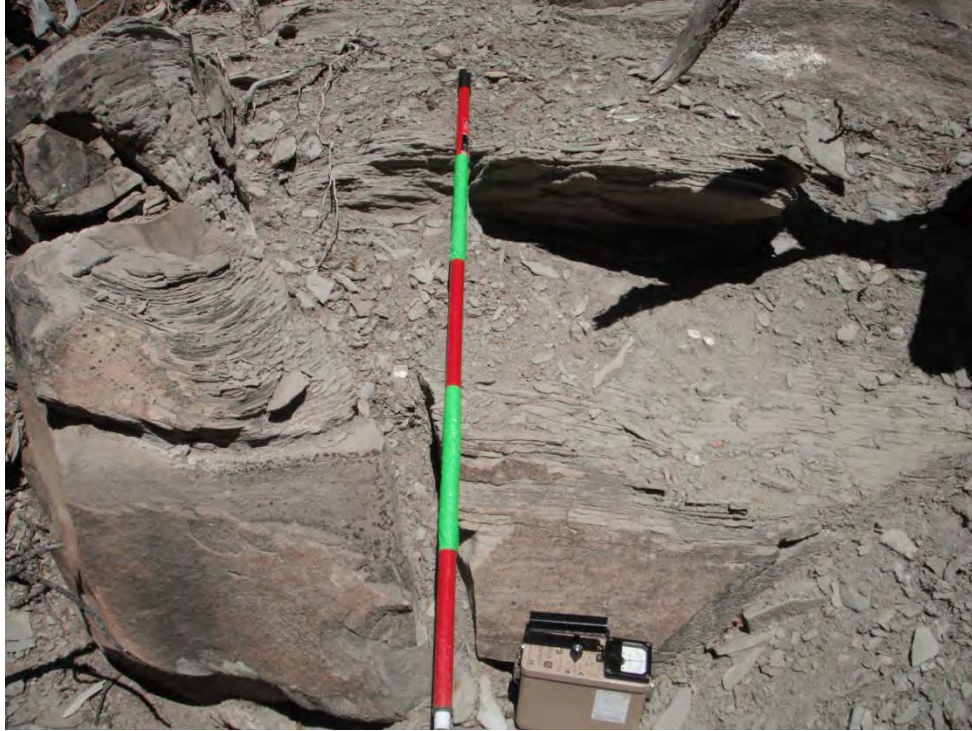
Photo 1-Looking northeast at Rad-1.

Rad-1 - mine Rd-1; 0m - 30 uR/h; 1m - 20 uR/h

Photo 1 - looking northeast at Rad-1

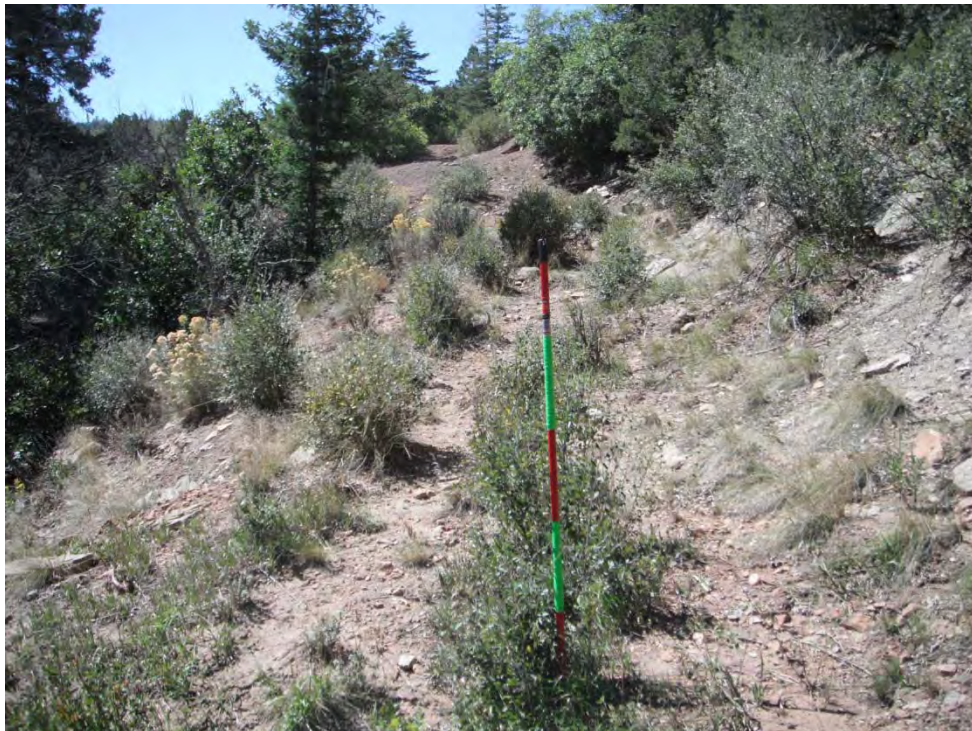
Photo 2-Looking west at Rd-1.

Two mine roads (Rd-1 and Rd-2) were identified onsite. Rd-1 is adjacent to CutPly-1 and runs east-west along the bottom of PileRidge-2 (see Figures 4a and 4b). Rd-2 leads east down from CutPly-2 and then curves to the south and joins Rd-1 below (see Figures 4a and 4b).

Mine Rd-1 - 5' wide; dirt non-maintained

Photo 2 - mine Rd-1 looking west

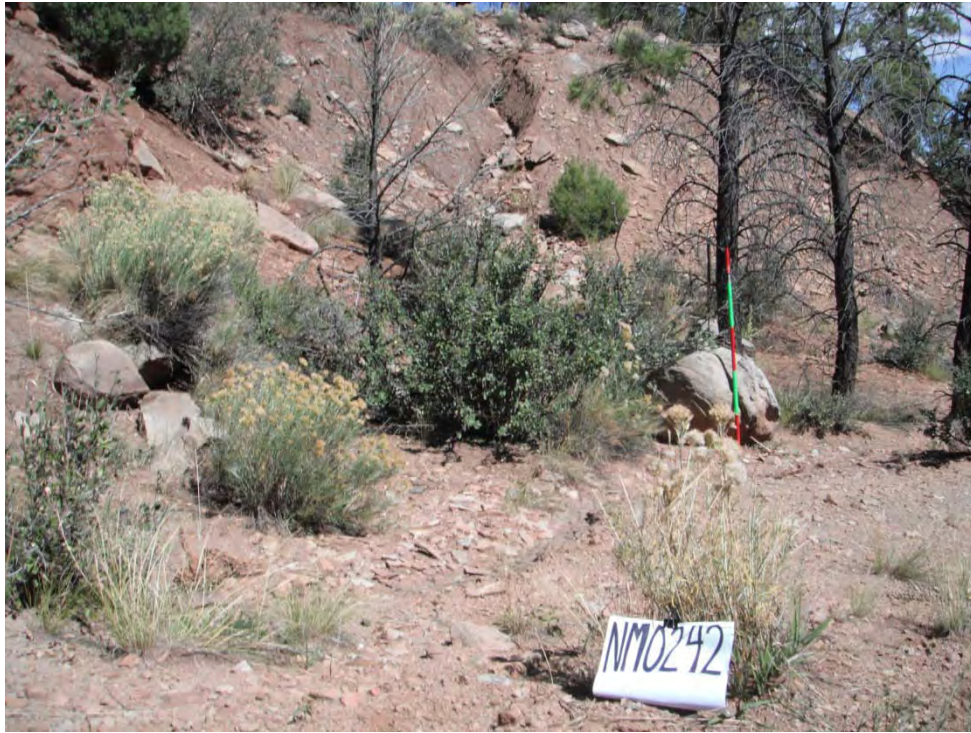
Photo 3-Site location photo, looking northeast at CutPly-1.

CutPly-1 - 20' high, 80' long, 20' wide

Photo 3 - cutPly-1 looking northeast, site ID photo.

Rad-2 - CutPly-1; 0m - 33 uR/h; 1m - 21 uR/h

Rad-3 - CutPly-1; 0m - 29 uR/h; 1m - 20 uR/h

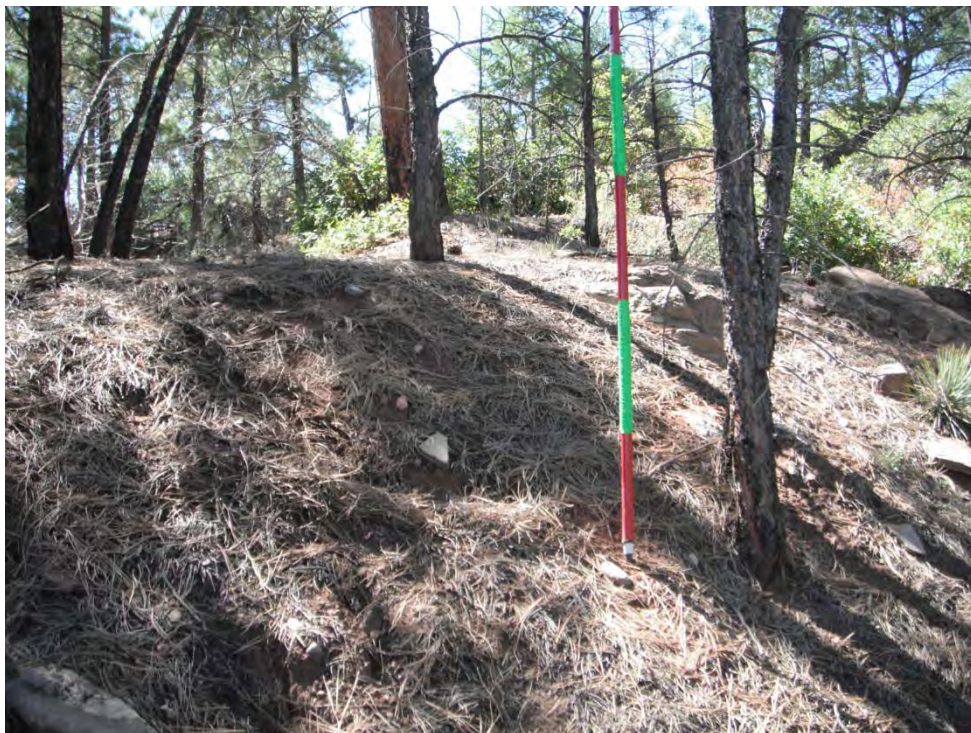
Photo 4-Looking west at PileRidge-1.

Four waste piles (PileRidge-1, PileRidge-2, PilePly-1, and PilePly-2) were found onsite. PileRidge-1 is located above the main pit (CutPly-2) and is associated with CutLn-1 (see Figures 4a and 4b). This pile is approximately 5 ft high, 5 ft wide, and 90 ft long. PileRidge-2 extends down the slope below the main pit (CutPly-2) (see Figures 4a and 4b). It is approximately 20 ft

PileRidge-1 - 5' tall, 5' wide, 90' long

Photo 4 - PileRidge-1 looking west

Rad-4 - PileRidge-1; 0m - 23 uR/h; 1m - 15 uR/h

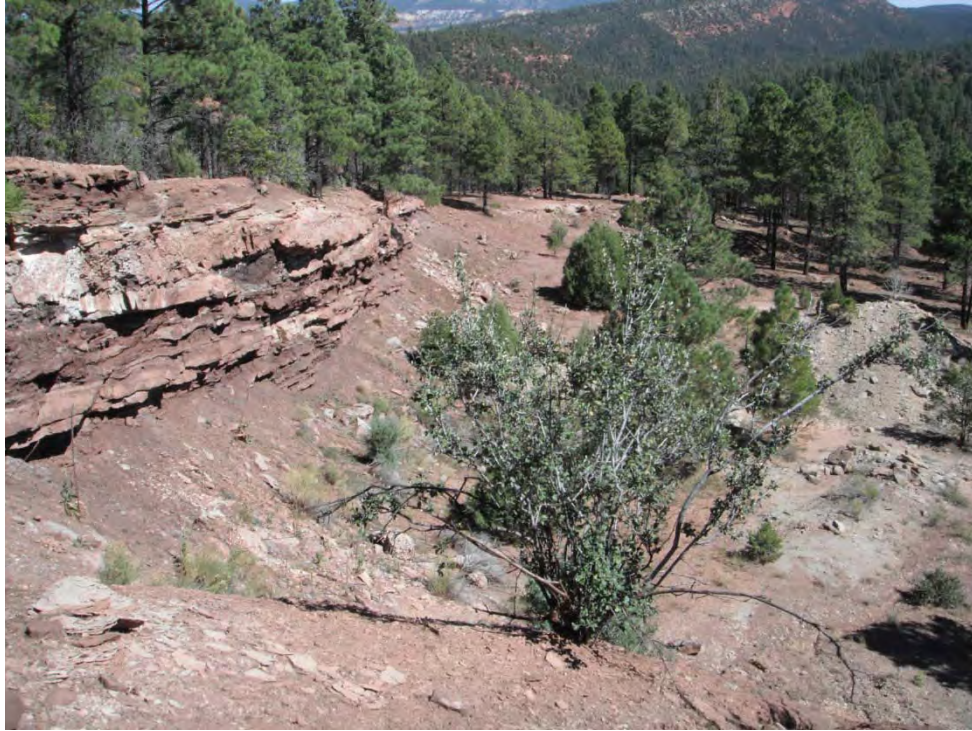
Photo 5-Looking east at CutPly-2, replicating Anderson photo C.

Three open cuts (CutLn-1, CutPly-1, and CutPly-2) were found onsite. CutPly-2 represents the main open pit referred to by Anderson (1980) and exposes an approximately 400 ft long and 30 ft tall cliff of sandstone, mudstone, and conglomerate strata (See photos 5, 7, and 8 in Appendix A). CutLn-1 is a smaller surface excavation above the main pit (CutPly-2) measuring approximately 50 ft long and 10 ft tall (see Figures 4a and 4b). CutPly-1 is an excavation along the hillside below the main pit (CutPly-2) and is approximately 80 ft long and 20 ft deep (see Figures 4a and 4b). The maximum gamma radiation measurement for these features was 41  $\mu\text{R/hr}$  (microroentgens per hour) at 0 ft above ground at radiation survey point Rad-6 along CutPly-2 (see Table 2).

Photo Pt-1; Photo 5 looking east at CutPly

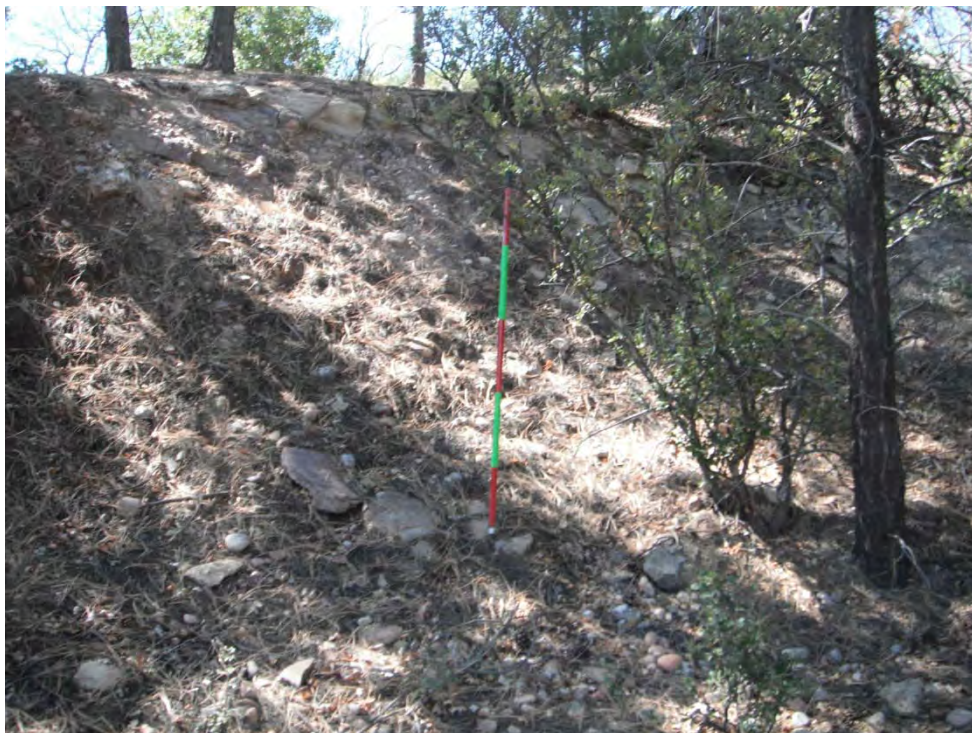
Photo 6-Looking west at CutLn-1.

CutIn-1 - 10' tall, 5' wide, 50' long

Photo 6 - CutIn-1 looking west

Rad 5 - CutIn-1; 0m - 26 uR/h; 1m - 21 uR/h

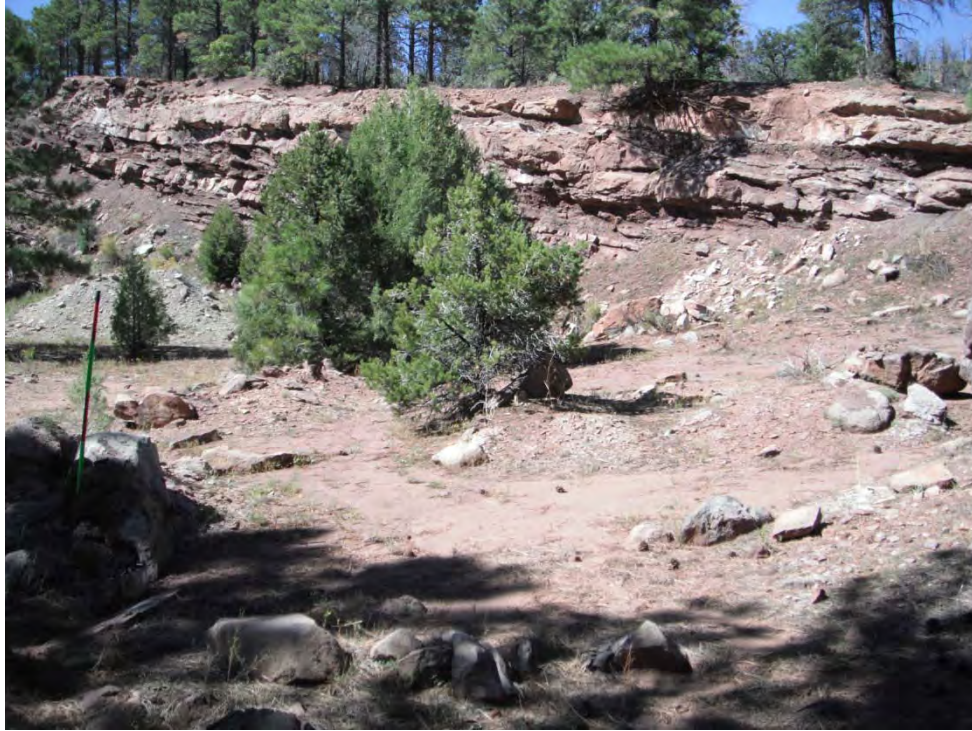
Photo 7-Looking northwest at CutPly-2.

CutPly-2 - 30' high, 50' wide, 400' long

Photo 7 - CutPly 2 looking northwest

Rad 6 - CutPly-2; 0m - 41 uR/h; 1m - 28 uR/h

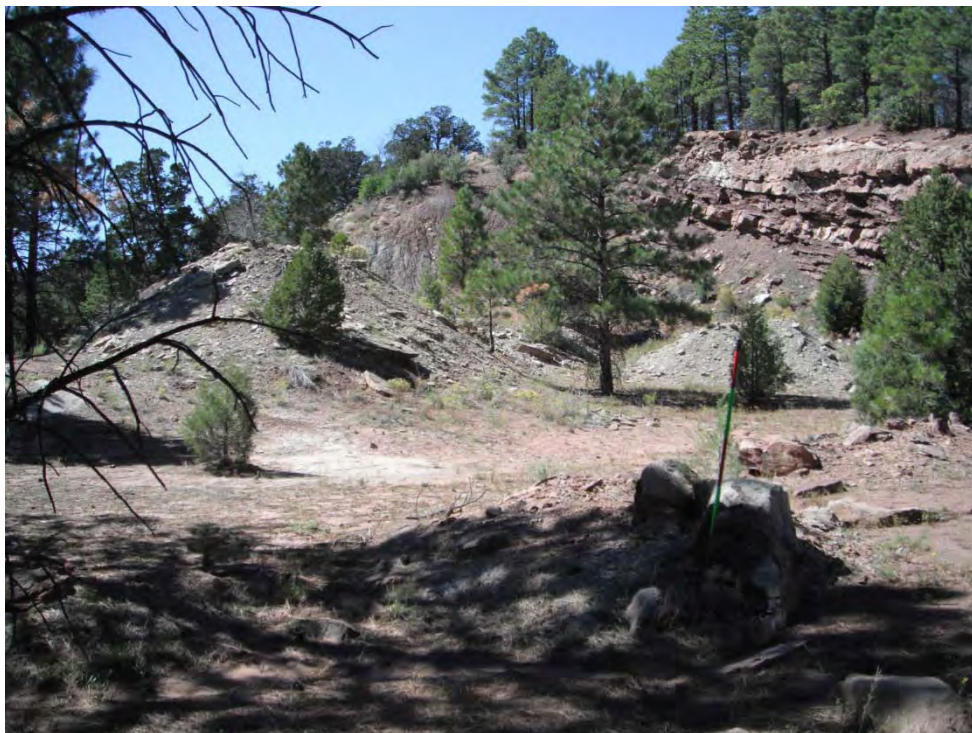
Photo 8-Looking west at CutPly-2, replicating Anderson photo A.

Photo 8 - CutPly 2 looking west

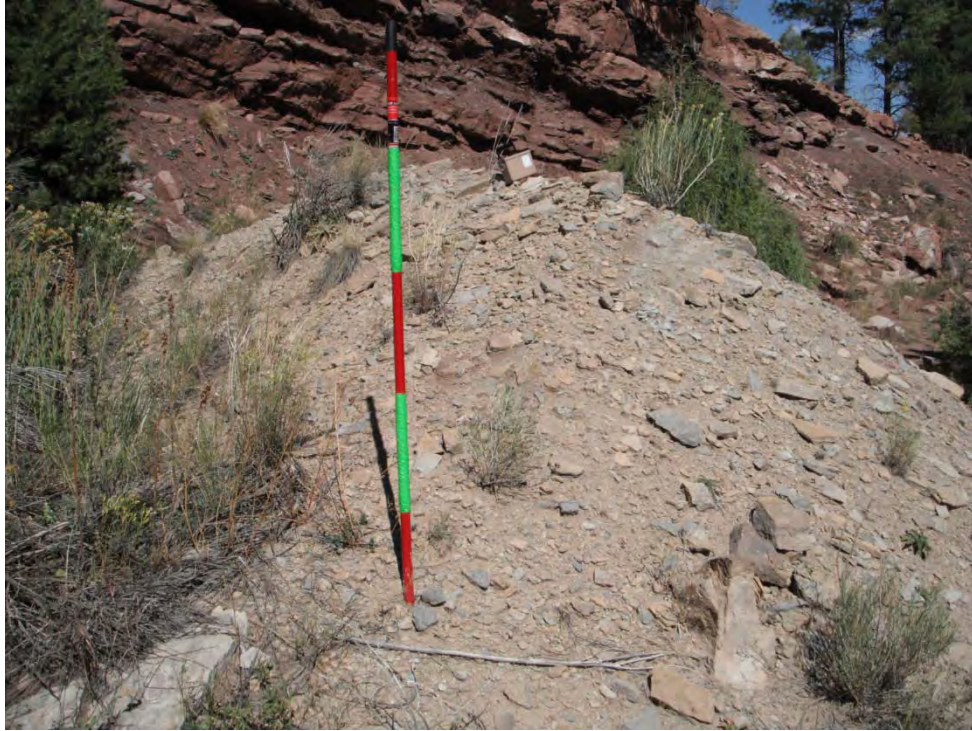
Photo 9-Looking north at PilePly-1.

wide, 200 ft long, and 30 ft high. PilePly-1 and PilePly-2 consist of waste rock and are located next to CutPly-2 (see Photos 5, 8, 9 and 10 in Appendix A and Figures 4a and 4b). The maximum gamma radiation measurement for these features was 38  $\mu\text{R/hr}$  at 0 ft above ground at radiation survey point Rad-8 on PilePly-1 (see Table 2).

PilePly-1 - 8' tall, 15' wide, 25' long, 35% slope

Photo 9 - PilePly-1 looking north

Rad 8 - PilePly-1 - 0m - 38 uR/h; 1m - 26 uR/h

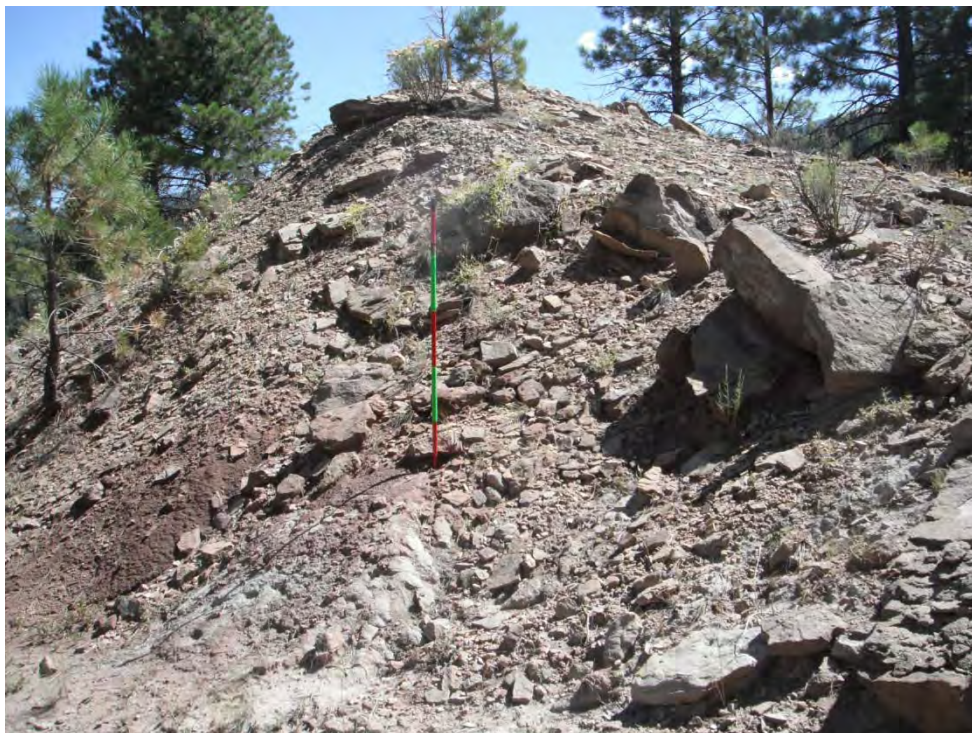
Photo 10-Looking south at PilePly-2.

PilePly-2 - 15' tall, 30' wide, 80' long, 45% slope

Photo 10 - PilePly 2 looking south;

Rad 9 - PilePly 2; 0m - 37 uR/h; 1m - 25 uR/h

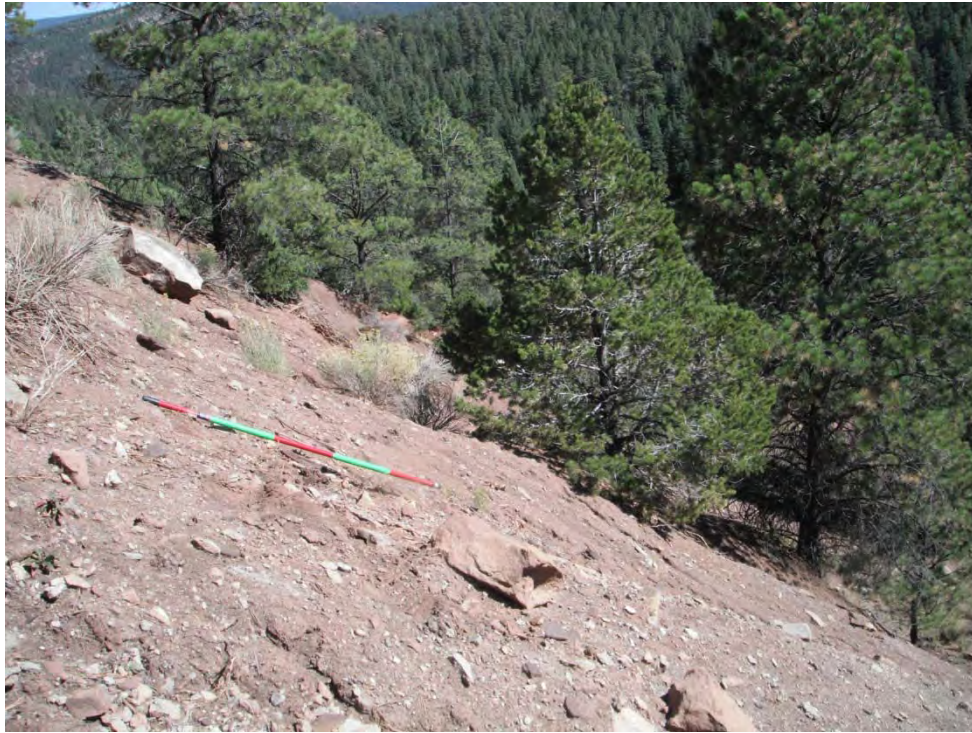
Photo 11-Looking east at PileRidge-2.

PileRidge 2 - 30' tall, 20' wide, 200' long; 50% slope; <sup>ALT</sup> end

Photo 11 - PileRidge-2 looking east; edge of slope runs down hill

Rad-10 - PileRidge-2; 0m - 32 uR/h; 1m - 18 uR/h

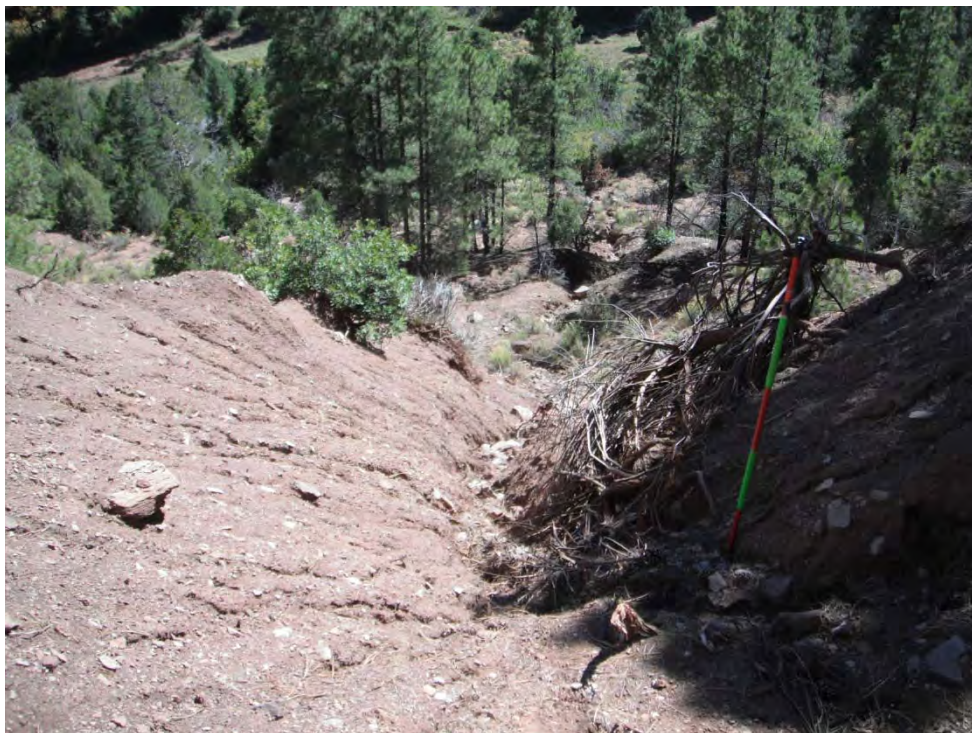
Photo 12-Looking south at ErosPt-1.

One erosional feature (ErosPt-1) was observed onsite. This erosional feature has formed from runoff cutting through the top of PileRidge-2 and draining down the steep slope of the pile (See photo 12 in Appendix A).

ErosPt-1 - 5' deep, 10' wide, 50' long; in PileRidge-2

Photo 12 - ErosPt-1 looking south

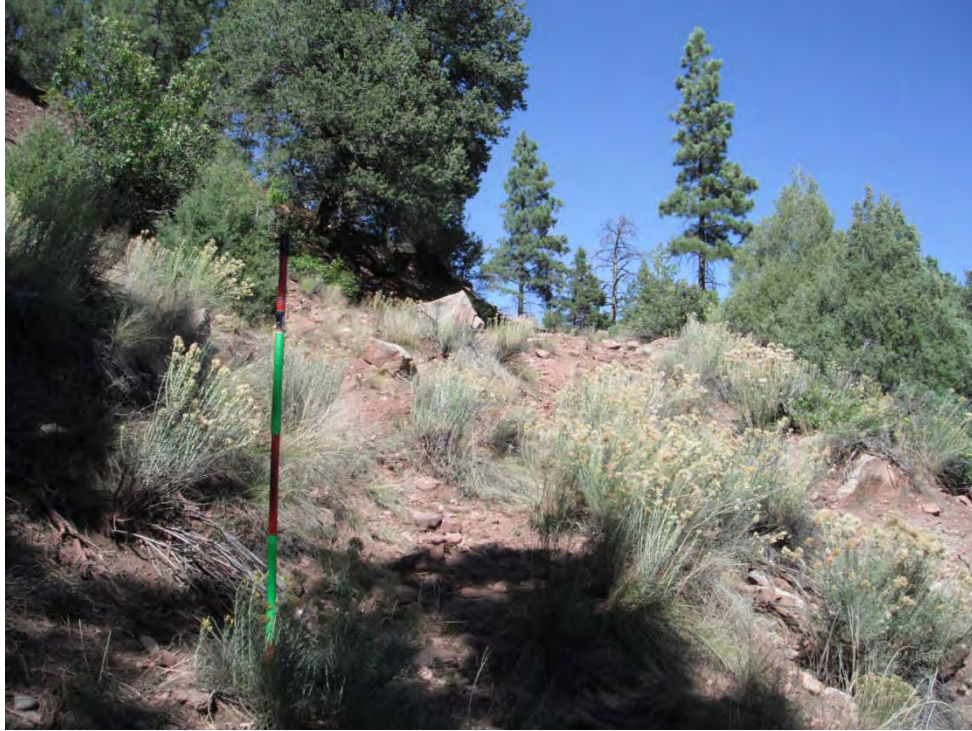
Photo 13-Looking northeast at Rd-2.

Mine Rd-2 - leading east from CutPly 2 and then south to mine Rd-1

Photo 13 - Mine Rd-2 looking northeast

Rad 11 - Mine Rd-2 & mine Rd-1 junction; 0m - 14 uR/h; 1m - 13 uR/h
