Abandoned Uranium Mine Assessment for the Coyote Hill Site (NM0180)

FINAL REPORT

November 05, 2010

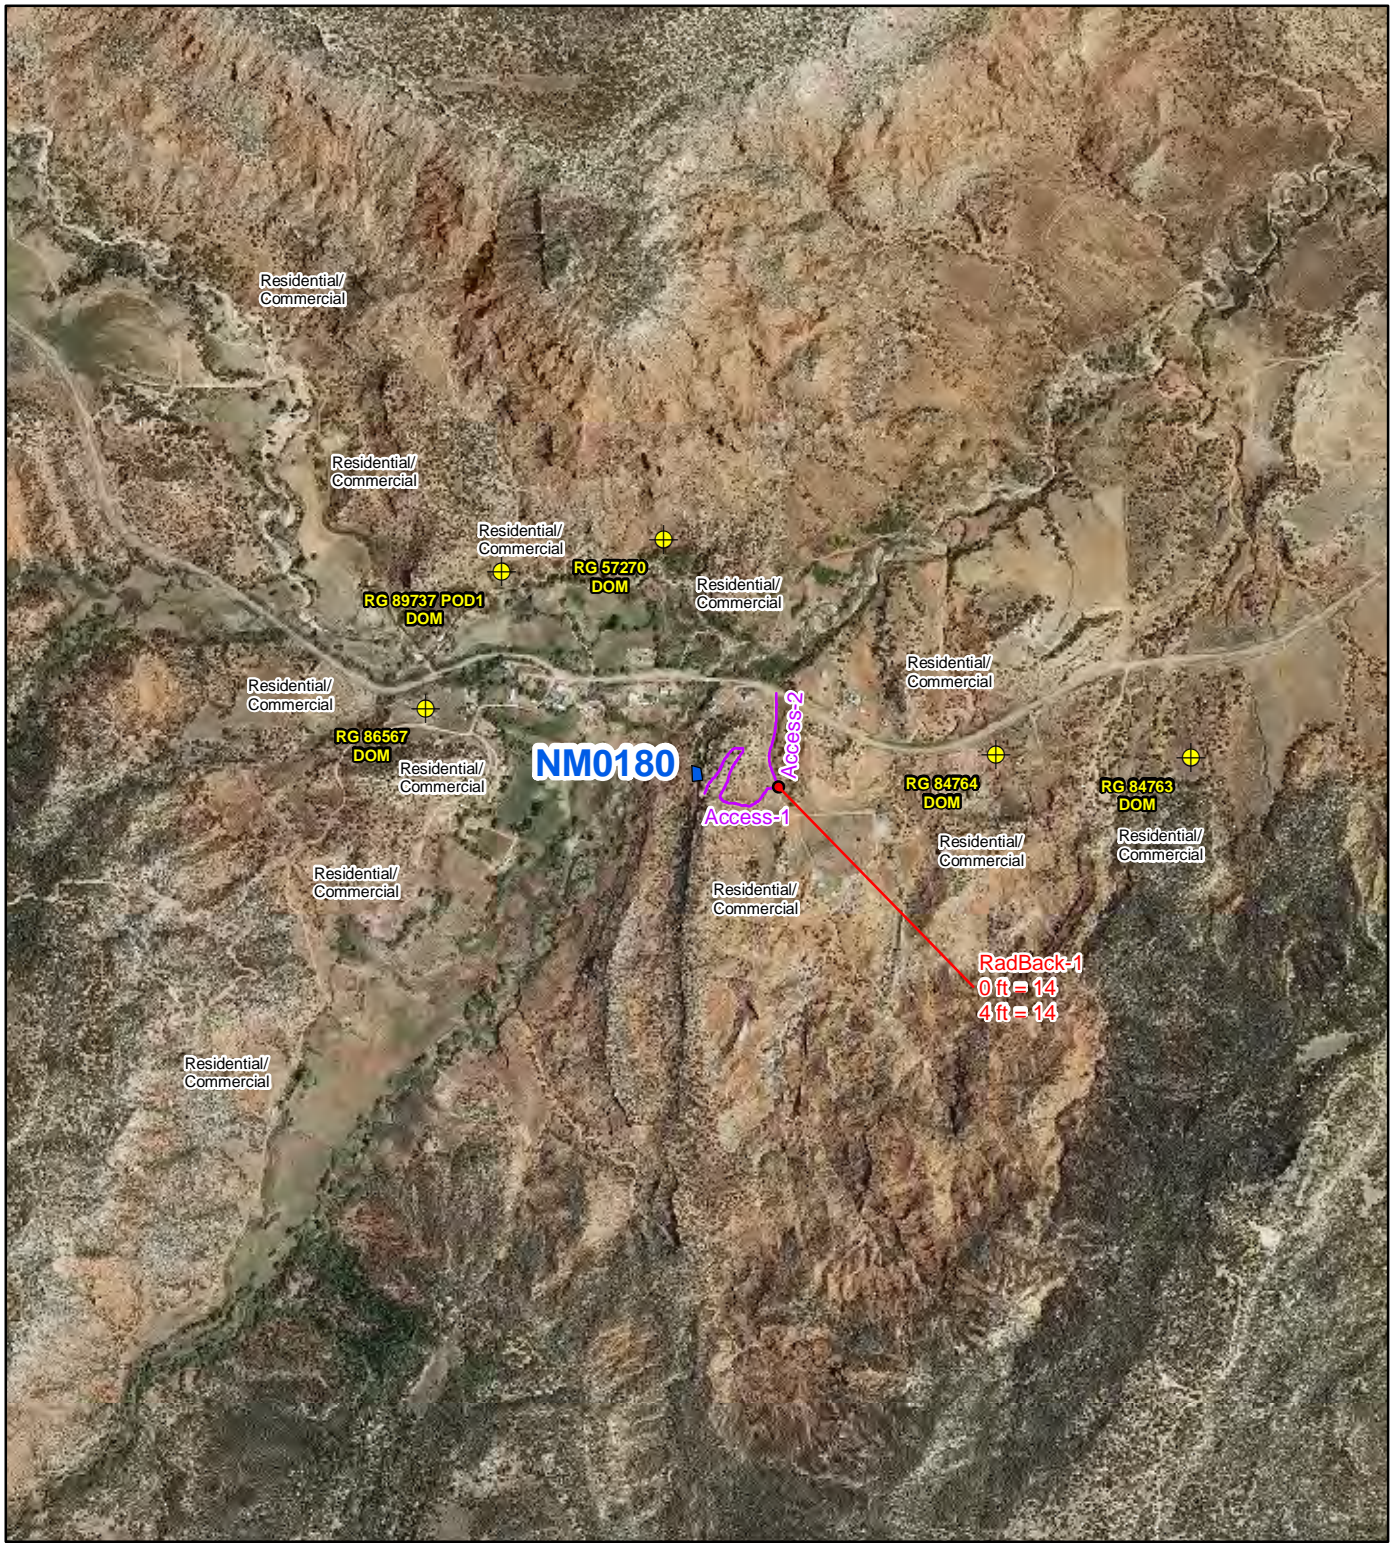
Figure 3
Aerial Photo
NM0180-Coyote Hill
 Abandoned Uranium
 Mine Assessment

The AUM Site is found on the Arroyo del Agua 7.5 minute United States Geological Survey topographic map at an elevation of approximately 6,800 ft above mean sea level (please see Figure 2). The AUM Site is located along the eastern slope a north-south trending drainage within the foothills at the northern end of Mesa Ojitos. Figure 3 shows an aerial photograph of the terrain surrounding the AUM Site.

Human activity at the AUM Site and in the surrounding area included grazing and domestic dwellings within a 1 mile radius of the site (please see Figure 3).

Three private residences are located 0.25 miles southeast of the AUM Site along the gravel road that leads to the area from NM-96. Several other homes and farms are located within 0.25 miles to the north and northwest of the AUM Site along NM-96 (please see Figure 3).

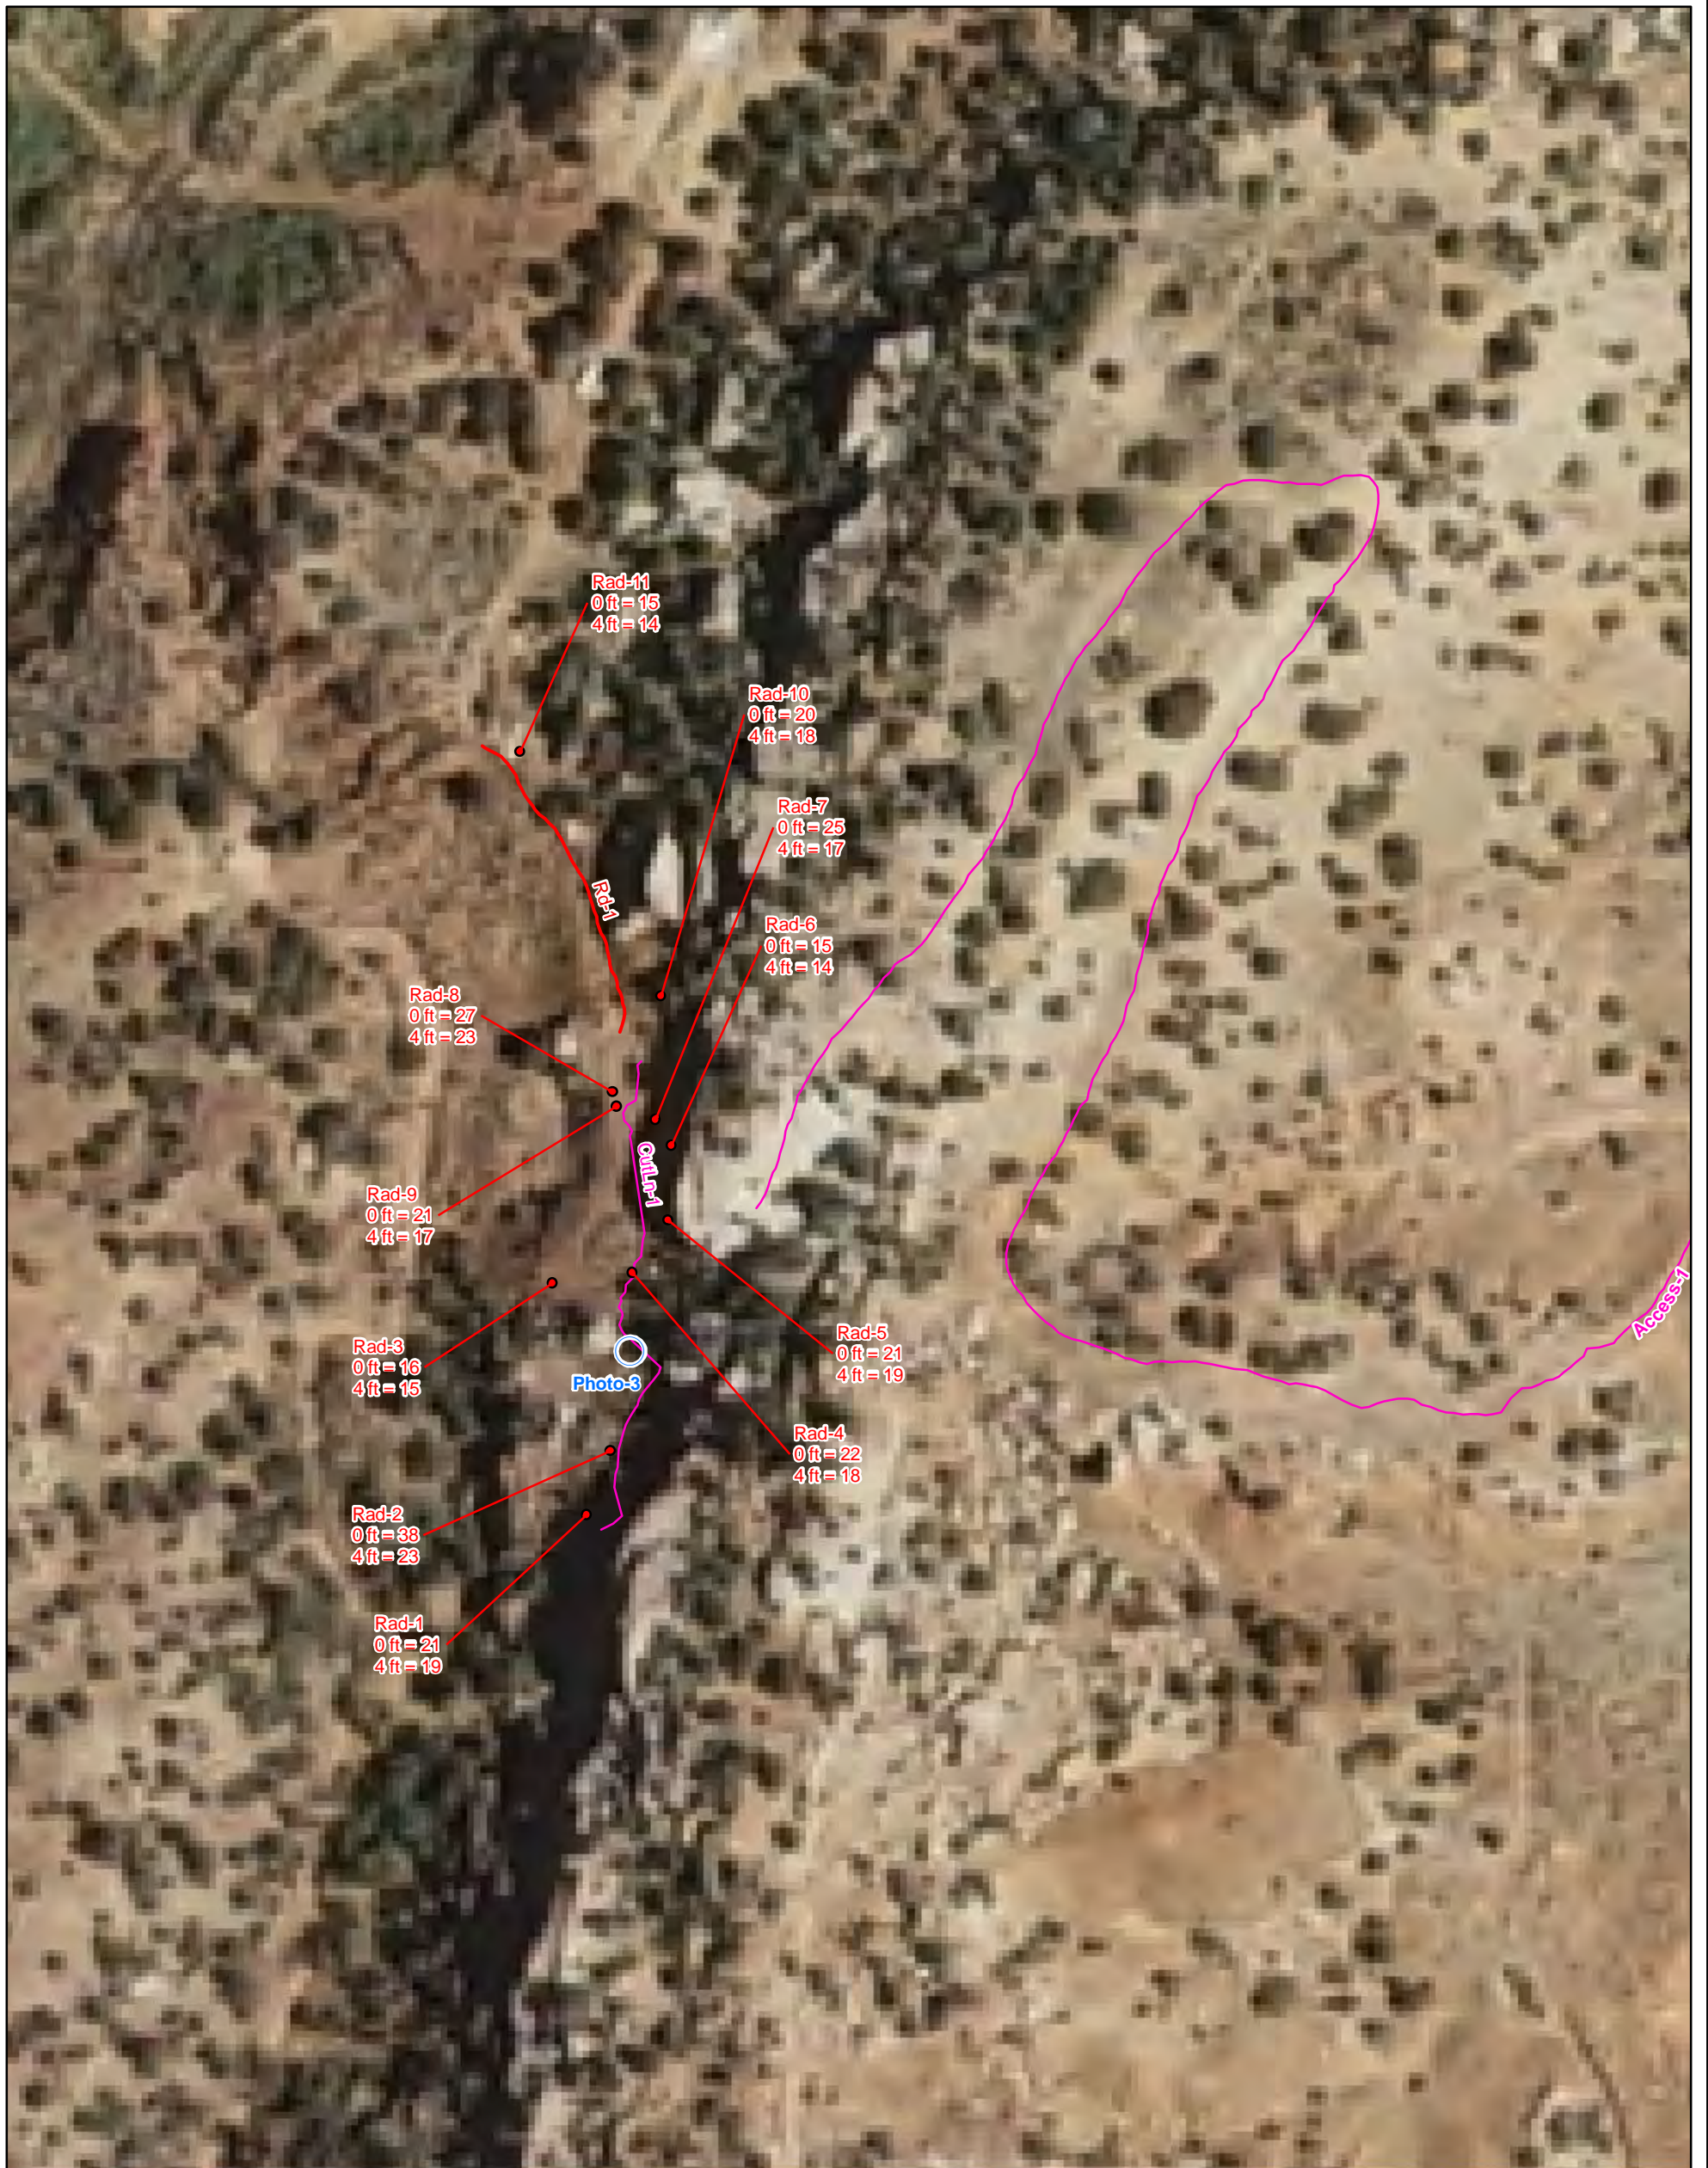
Figure 4a
Site Map on
Aerial Photo
NM0180-Coyote Hill
 Abandoned Uranium
 Mine Assessment

The mine features described below are based on the features provided to INTERA by MMD in the GIS Data Dictionary (MMD, 2009). INTERA marked the locations of the AUM Site features using a Trimble Global Positioning System (GPS) and entered details about the features into the GPS using the MMD data dictionary. One open cut and one mine road were found onsite. Please see the Photo Log in Appendix A for photos of the AUM Site features, Table 1 for a list of the AUM Site features, and Figures 4a and 4b for the locations of the AUM Site features.

One mine road (Rd-1) was identified onsite. Rd-1 is a ramp that leads north from the north end of the bench into the drainage below (see Figures 4a and 4b).

One background gamma radiation reading was taken near the AUM Site, recording 14 $\mu\text{R/hr}$ at 0 ft above ground and 14 $\mu\text{R/hr}$ at 4 ft above ground. Please see Table 2 for all of the gamma radiation readings taken at the AUM Site and Figures 4a and 4b for the locations of the radiation readings.

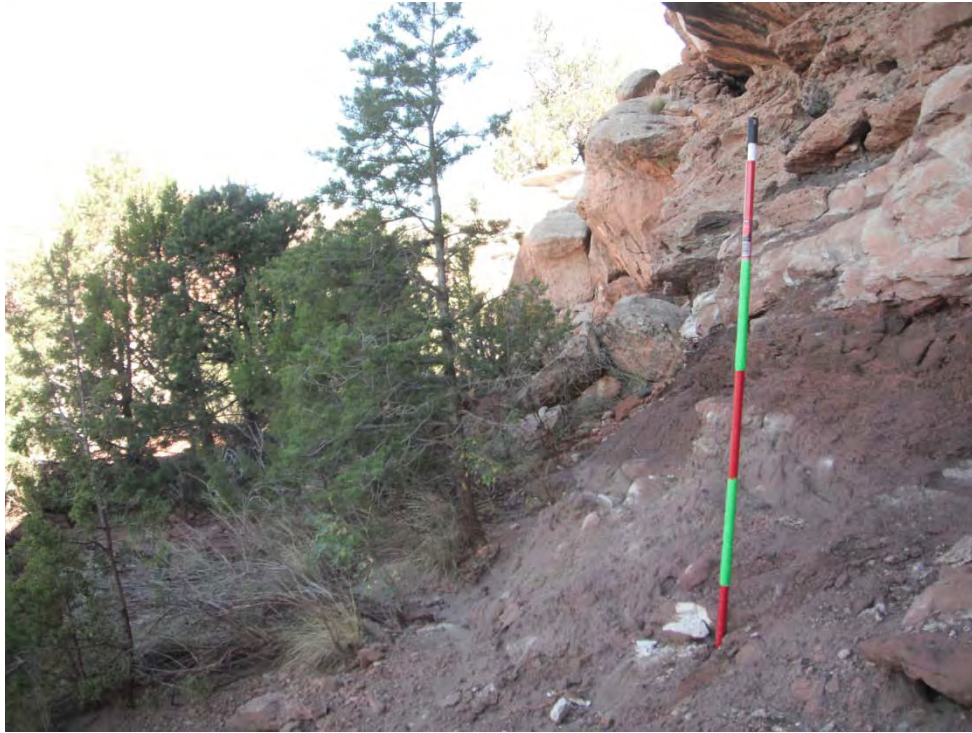
One open cut (CutLn-1) was identified at the AUM Site. This feature is a 20 ft-high, 250 ft-long bench cut that exposes the Permian and Triassic sediments forming the hillside. The bench of the cut is approximately 25 ft wide (see Photos 1, 3, 4 and 5 in Appendix A). Several gamma radiation measurements were taken along the surface of the cut but none of the readings varied significantly above background level. The maximum gamma radiation measurement along CutLn-1 was 38 $\mu\text{R/hr}$ (microroentgens per hour) at 0 ft above ground at radiation survey point Rad-2 (see Table 2).

Photo 1-Looking north at northern end of CutLn-1.

Photo-1 - north end of cutln-1 looking north

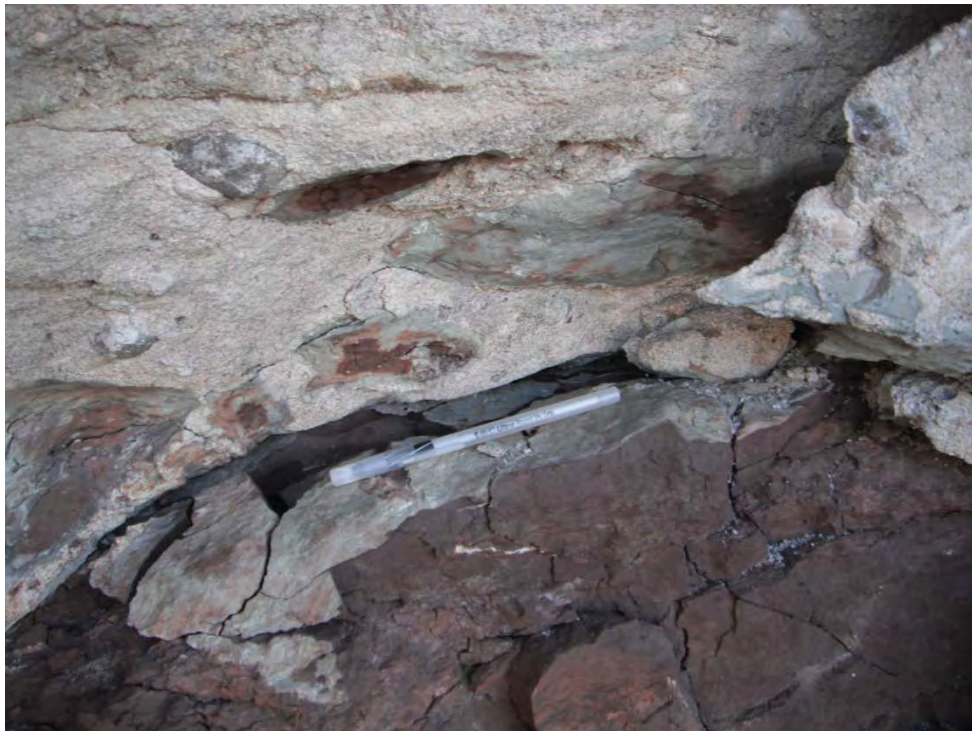
The gamma radiation readings at the AUM Site did not vary significantly above background levels. The highest radiation reading was at Rad-2, where 38 $\mu\text{R/hr}$ was recorded along the contact between a reddish-brown shale layer and overlying coarse-grained sandstone. Please see Table 2 for details.

Photo 2-Looking east, closeup of contact at Rad-2.

Rad-2 - cutln-1, contact between Permian Cutler and overlying sandstone; Om - 38 μ R/h; Im - 23 μ R/h

Photo-2 - Rad-2 close up of contact looking east

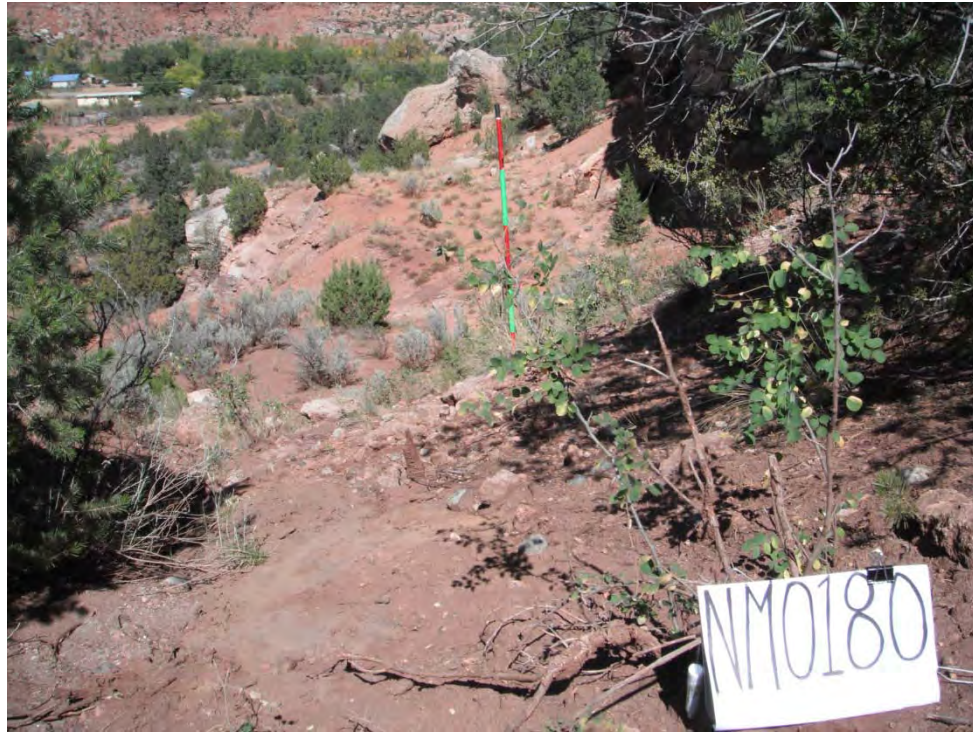
Photo 3-Site location photo, looking north at CutLn-1.

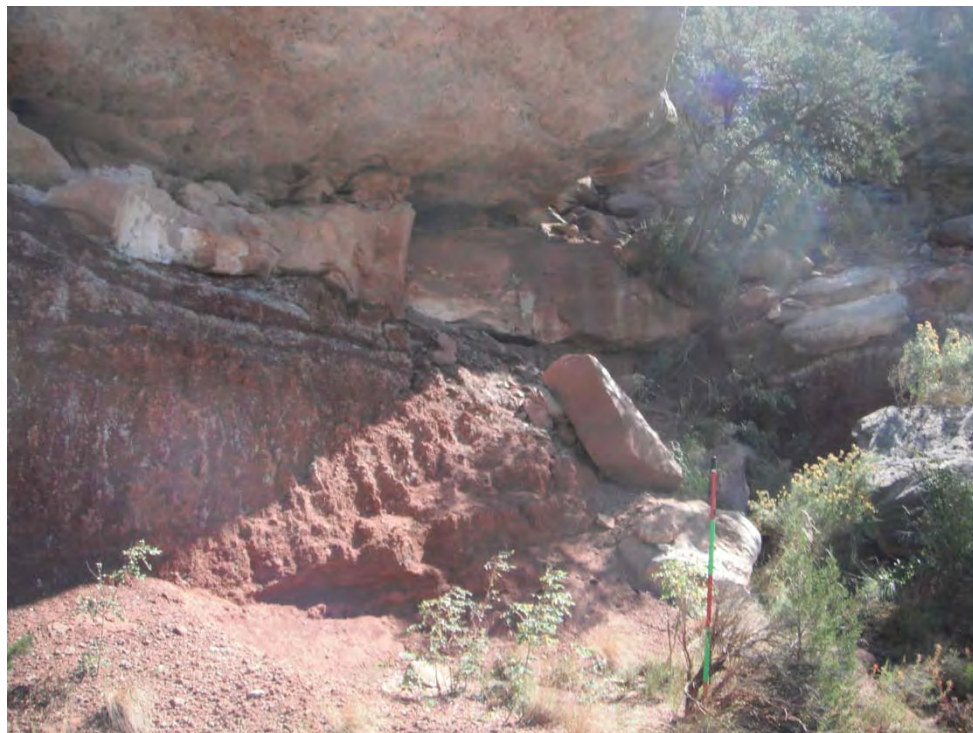
Photo 4-Looking southeast at CutLn-1.

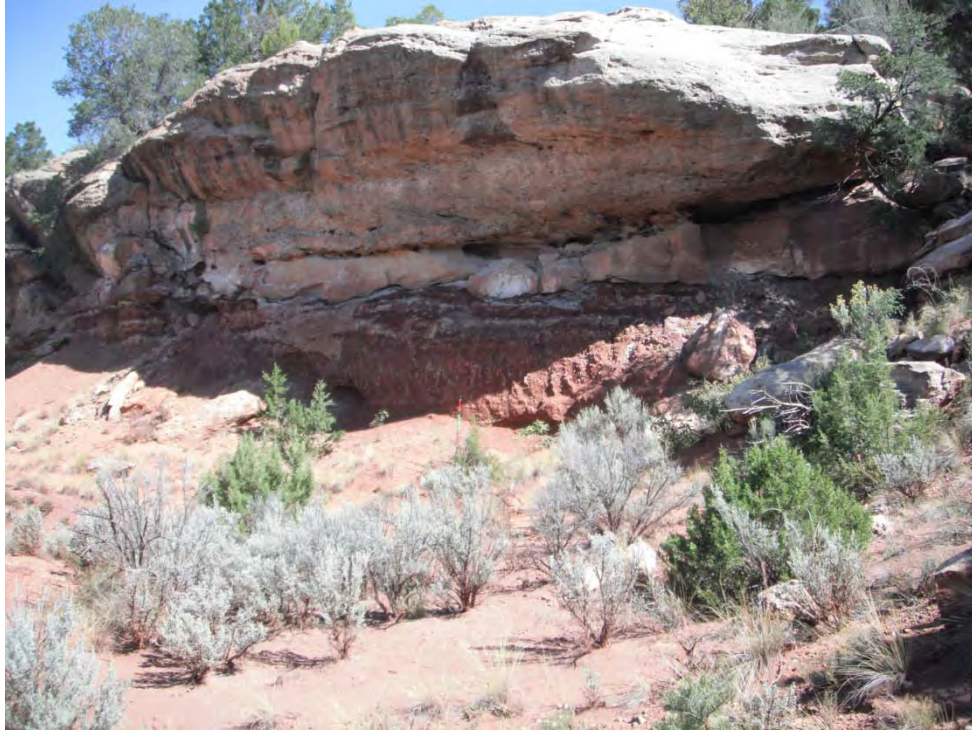
Photo 5-Looking east at CutLn-1.

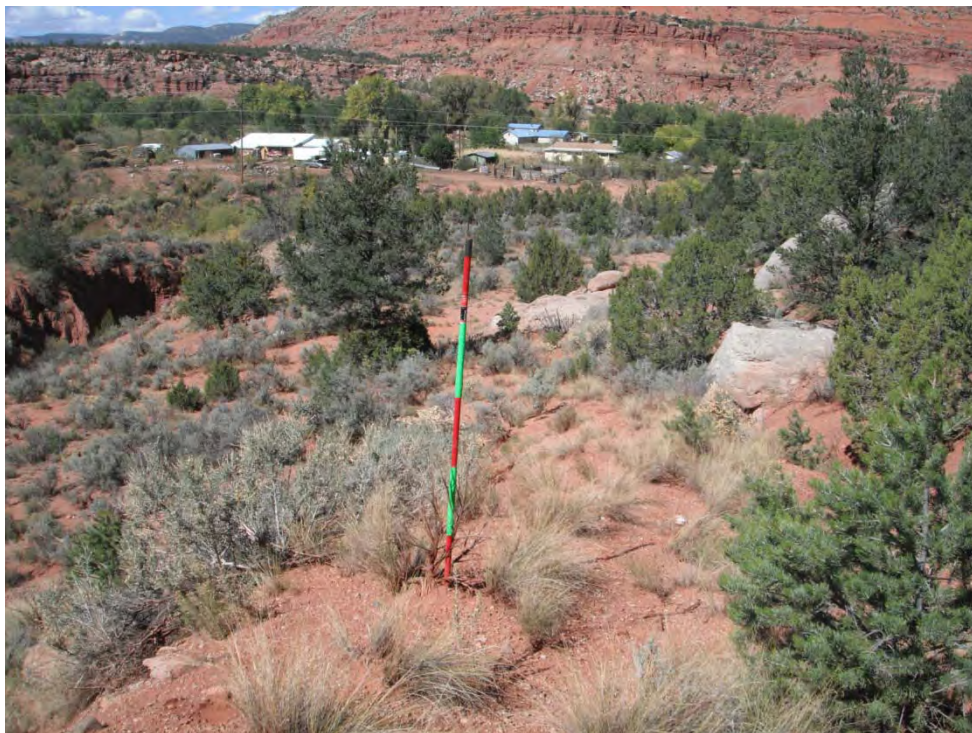
Photo 6-Looking north at Rd-1.

Photo 6 - mine Rd-1 looking north
