# Abandoned Uranium Mine Site Assessment for the Blackhawk, Bunney, Red Bluff Nos. 7, 8, 10, & UDC No. 1 Site (NM0074)

**FINAL REPORT**

**May 28, 2010**

NM0074

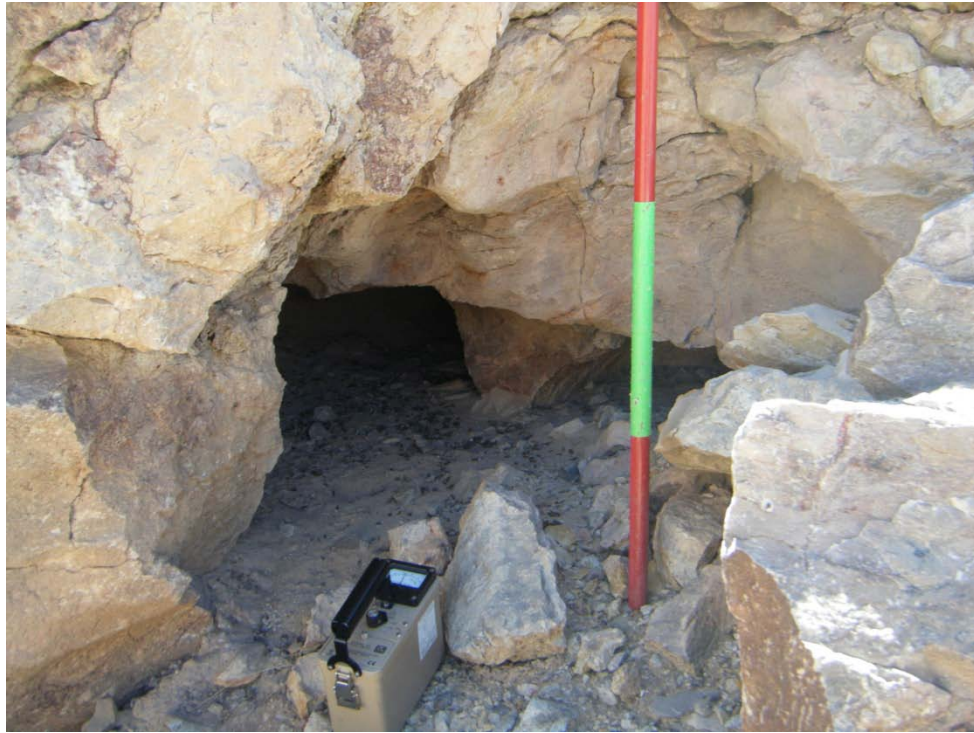
Photo 9-Looking southeast into Adit-1 (Blackhawk/Bunney claims).

Nine adits were found at the AUM Site. The first eight adits were found on the Blackhawk/Bunney claims, and the ninth adit was found on the Red Bluff No. 8 claim. Adit-1, Adit-2, and Adit-3 are small holes in the wall of Pit-2 (see Photos 9-11 in Appendix A). Adit-4 is accessed through a vertical entrance at the north end of Pit-2. Adit-5, Adit-6, Adit-7, and Adit-8 are located in the walls of Pit-3. Adit-5 has a timbered entrance and two passageways (see Photos 20 and 21 in Appendix A). Adit-6 parallels the axis of an anticline in the Todilto Formation (see Photos 22 and 23 in Appendix A). Adit-7 is partially infilled with sand (see Photo 26 in Appendix A). Adit-8 also parallels the axis of an anticline in the Todilto Formation (see Photos 30 and 31 in Appendix A). Adit-9 is located in the southwestern end of Pit-16 and is almost completely filled with mud (see Photo 77 in Appendix A). Although this adit appears to run underneath the fence between Section 4 and Section 9, there is no corresponding entrance in the pit immediately to the south on the Section 9 claims. The highest gamma ray readings at the entrance to these adits was 1000  $\mu\text{R/hr}$  at 0 ft above ground at radiation survey point Rad-11, associated with Adit-6.

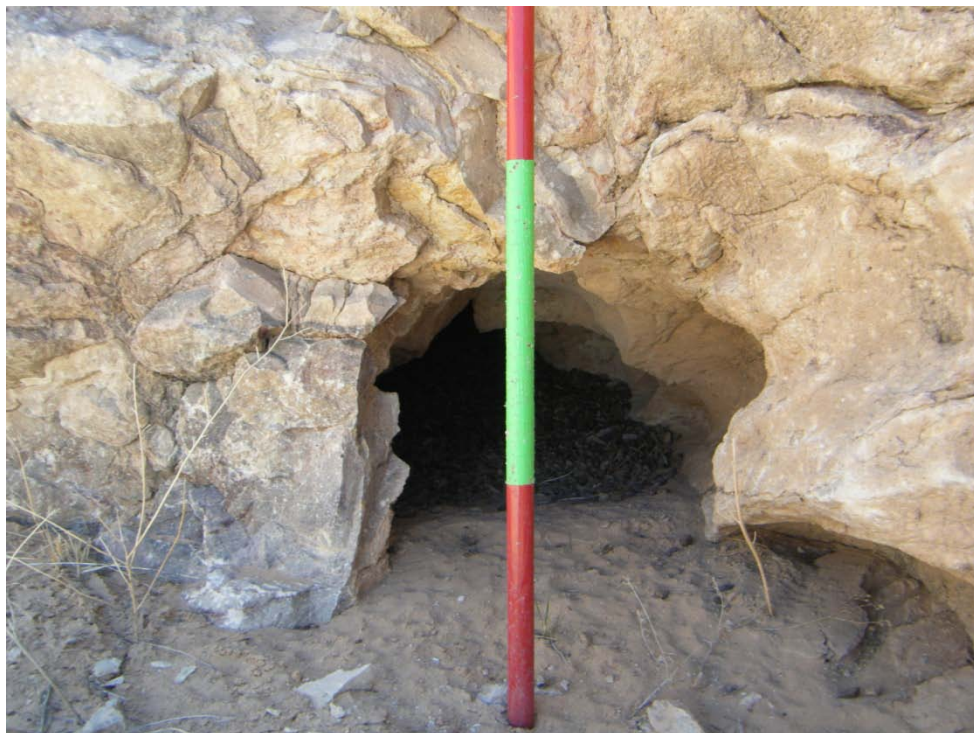
Photo 10-Looking east into Adit-2 (Blackhawk/Bunney claims).

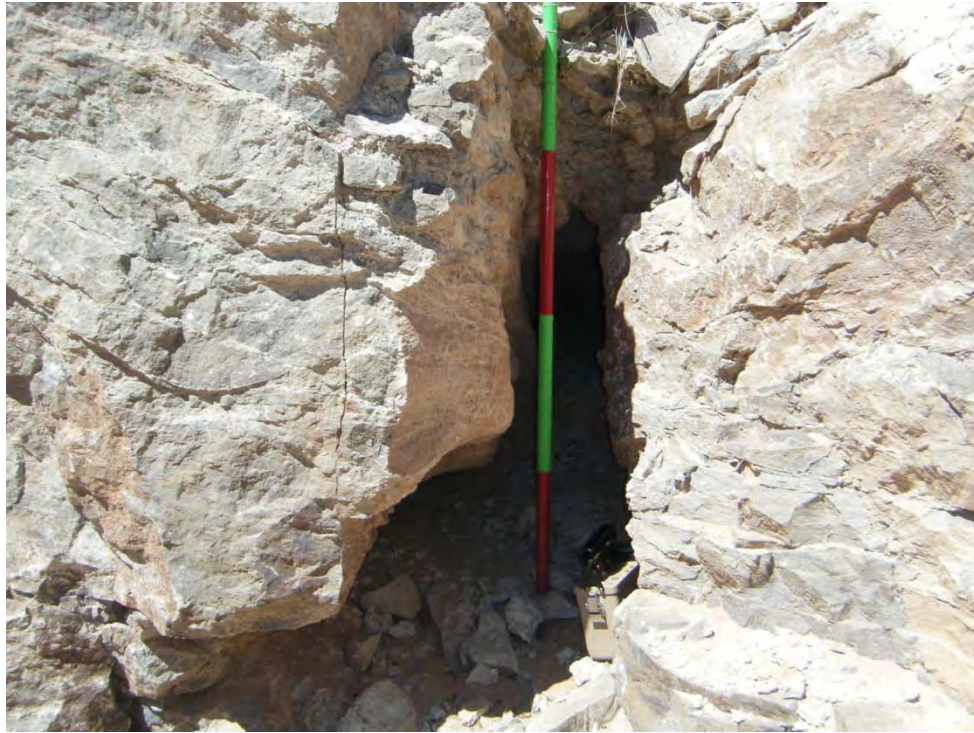
Photo 11-Looking west into Adit-3 (Blackhawk/Bunney claims).

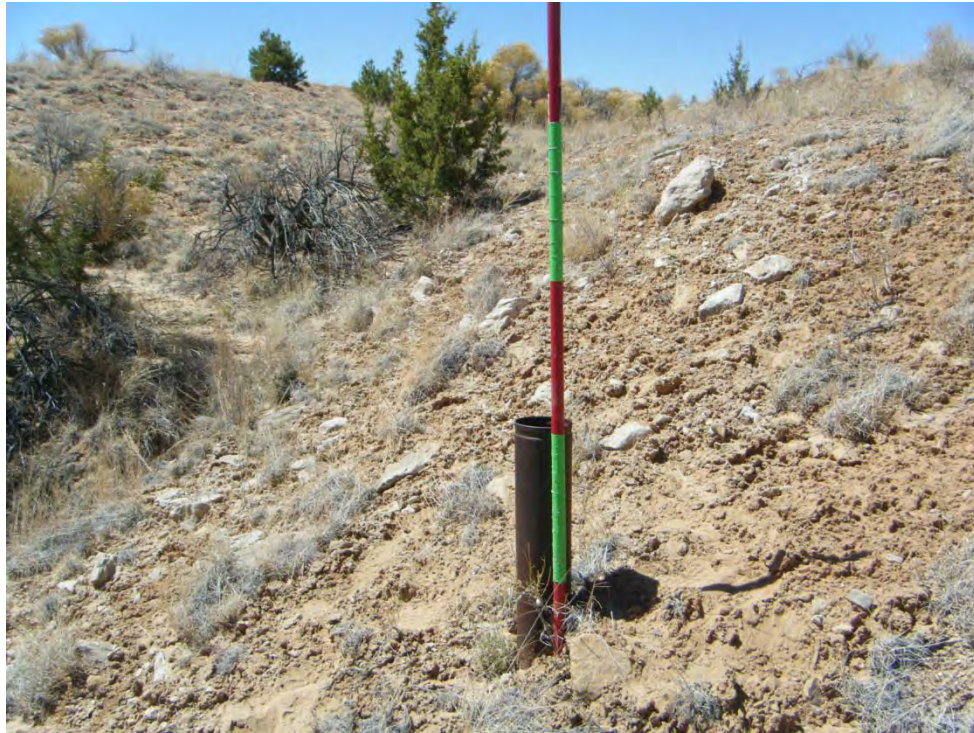
Photo 15-Looking south at a vent pipe (MiscPt-1; Blackhawk/Bunney claims).

Three barbed wire fences (Fenc-1, Fenc-2, and Fenc-3) were located on the AUM Site. A vent hole (MiscPt-1) was found on the Blackhawk/Bunney claims (see Photo 16 in Appendix A). This vent hole may have provided ventilation to the underground workings associated with nearby adits. A pile of wooden beams and metal (Equip-1) was found near Pit-3 on the Blackhawk/Bunney claims (see Photo 18 and 19 in Appendix A).

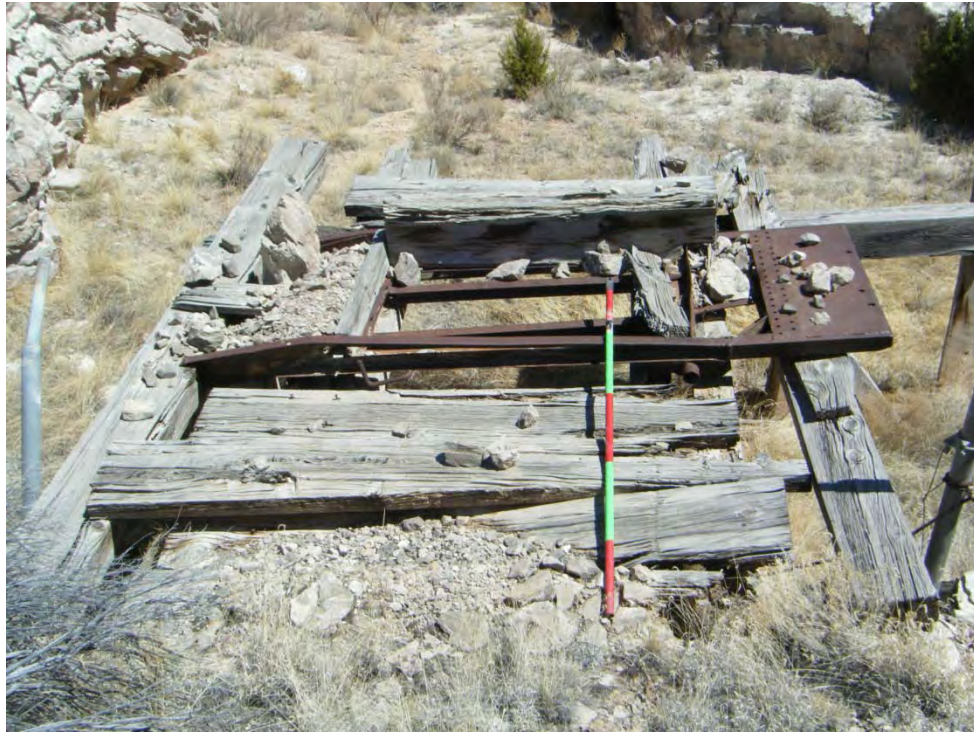
Photo 25-Looking east at StrucPly-1 (Blackhawk/Bunney claims).

Two structures were found onsite. StrucPly-1 is a wooden structure located inside Pit-3 on the Blackhawk/Bunney claims (see Photos 24, 25, and 28 in Appendix A). StrucPly-2 is a wooden structure sunk into the ground on the Red Bluff No. 7 claim (see Photo 68 in Appendix A).

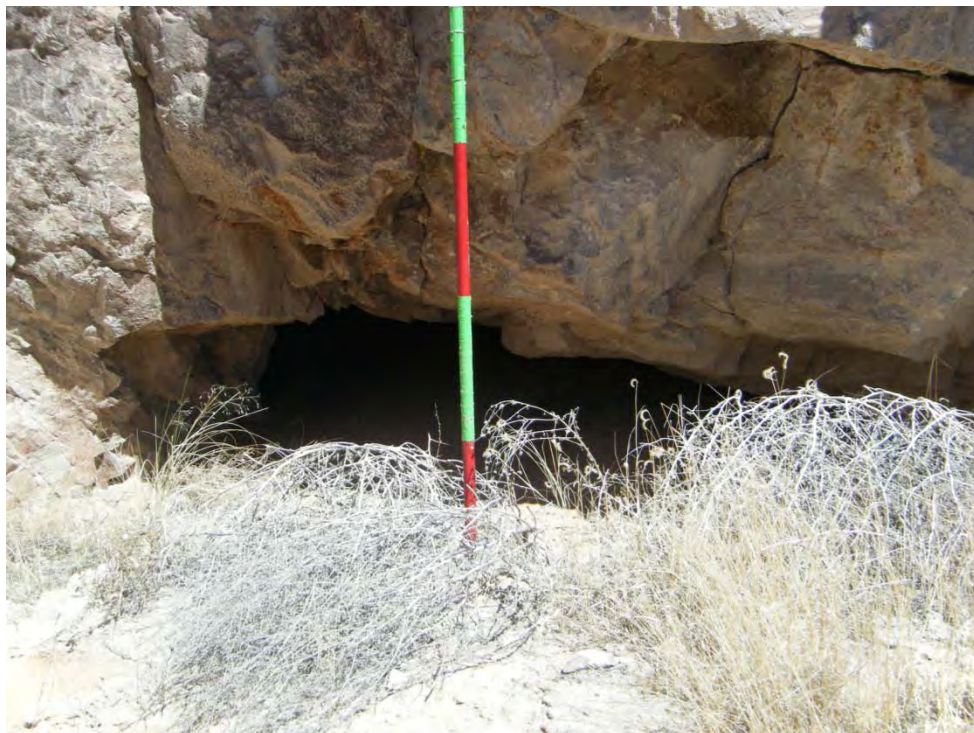
Photo 26-Looking east into Adit-7 (Blackhawk/Bunney claims). The adit appears half full of sand eroded from the walls of Pit-3.

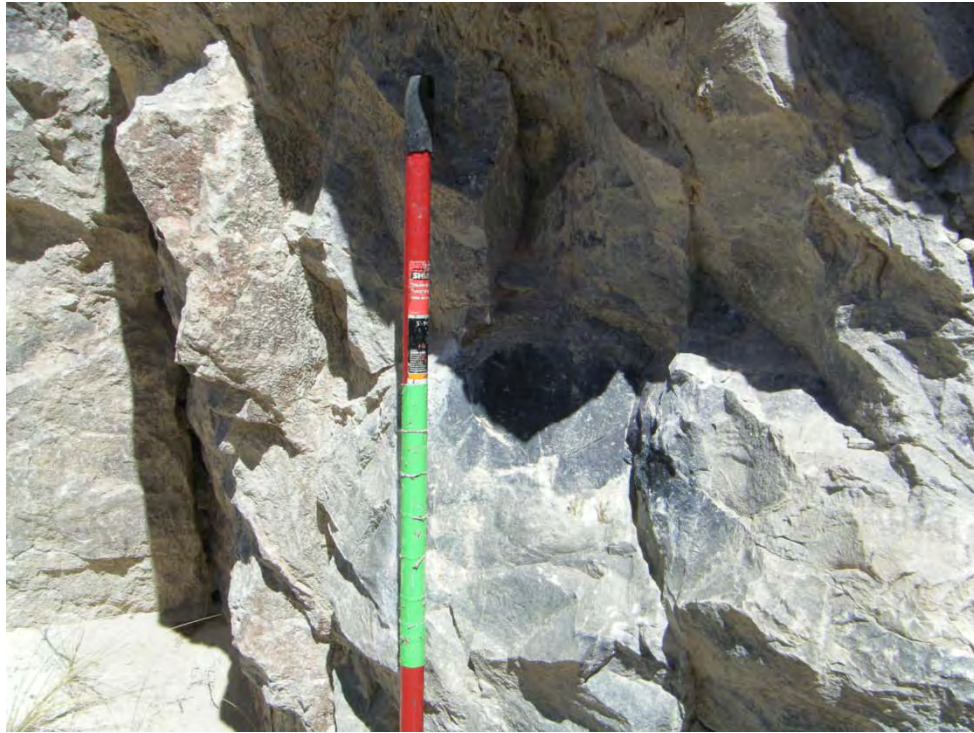
Photo 29-Radiation survey point Rad-14 (2800  $\mu$ R/hr at 0 meters; Blackhawk/Bunney Claims).

Eight pits were located in the Blackhawk/Bunney claims. Two of the three pits on the eastern end of the claims (Pit-2 and Pit-3) contained adits. Pit-3 also had a mining structure (StrucPly-1) in the bottom (see Photo 23 in Appendix A). The three eastern pits (Pit-1, Pit-2, and Pit-3) tend to be narrow (15-30 ft wide), with several arms (see Photo 32 in Appendix A). The maximum gamma radiation measured in these pits was 2800  $\mu\text{R/hr}$  at 0 ft above ground at radiation survey

point Rad-14 (see Photo 29 in Appendix A). The five western pits in the Blackhawk/Bunney claims of the AUM Site tend to be linear. No adits, structures, or other mine features were found within these pits. The highest gamma radiation measured in these pits was 2400  $\mu\text{R/hr}$  at 0 ft above ground at radiation survey point Rad-21 in Pit-5. Another reading of 1300  $\mu\text{R/hr}$  at 0 ft above ground was taken at radiation survey point Rad-17 in Pit-4. Pit-6, Pit-7, and Pit-8 had gamma radiation levels below 1000  $\mu\text{R/hr}$  at 0 ft above ground. See Photo 44 in Appendix A for an example of these pits.

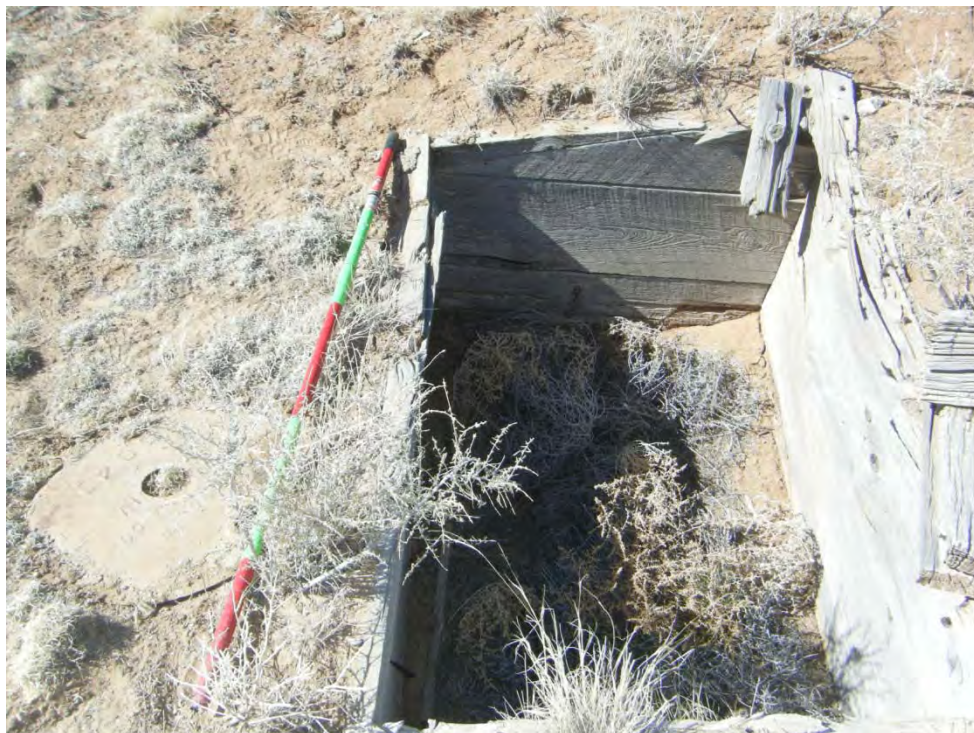
Photo 68-A wooden structure sunk into the ground (StrucPly-2; Red Bluff No. 7 claim).

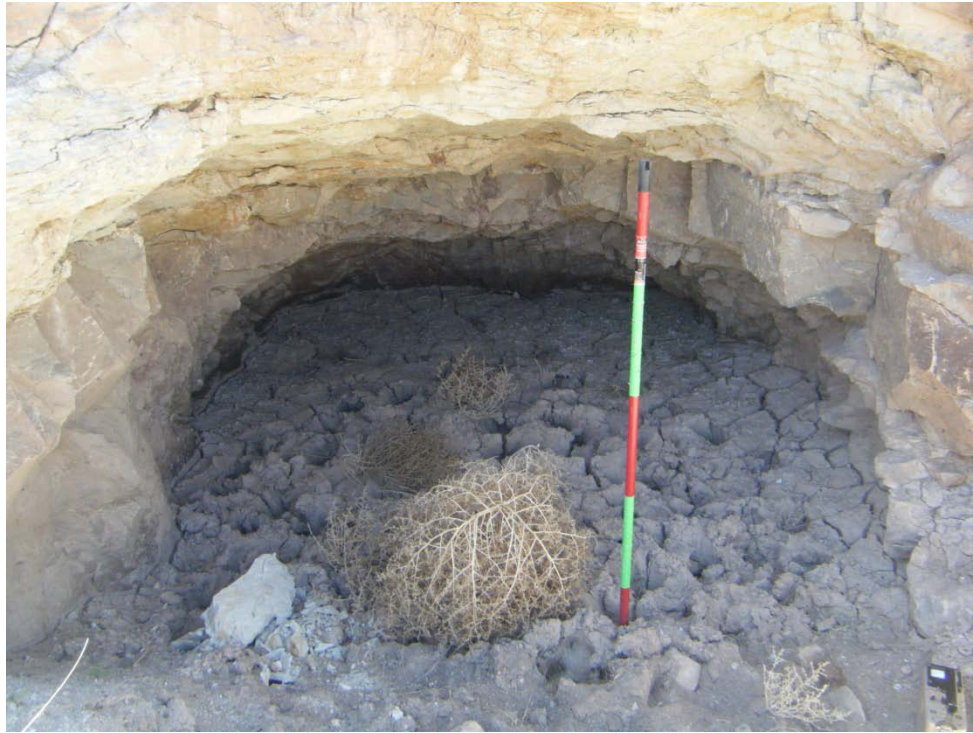
Photo 77-Looking south at Adit-9 (Red Bluff No. 8 claim).
