Use Attainability Analysis for Unclassified Non-Perennial Watercourses with NPDES Permitted Facilities

New Mexico Environment Department
June 2012

Cover Sheet
Hydrology Protocol Use Attainability Analysis
for an Ephemeral Stream¹

Stream Name:	Basin:	8-digit HUC:
Mulatto Canyon	Middle Rio Grande	13020205
Reach Description:	Upstream lat/long:	Downstream lat/long:
Unlined, unclassified, ephemeral arroyo	35.4852/-107.6796	35.5372/-107.5738
Current WQS		Assessment Unit ID:
<input checked="" type="checkbox"/> Unclassified 20.6.4.98 or 99 NMAC <input type="checkbox"/> Classified 20.6.4. ____ NMAC		Lee Ranch Mine

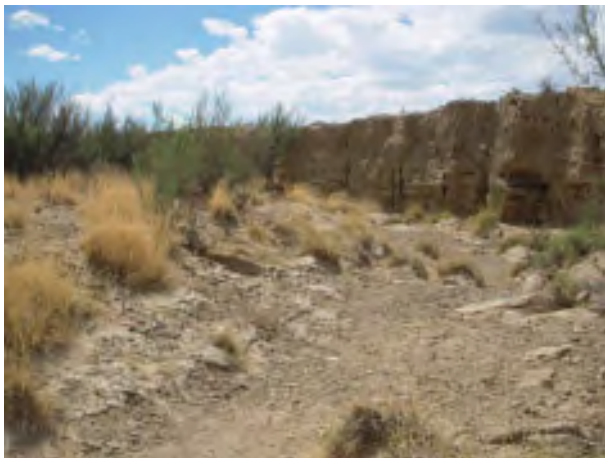
Lee Ranch-7

Photo #	Description (US, DS, LB, RB, etc.)	Notes
Lee Ranch 7	Upstream	WP-23
8	downstream	
9	Upstream, channel splits	WP-24
10	Right bank
