ABANDONED OR INACTIVE URANIUM

MINES IN NEW MEXICO

New Mexico Bureau of Mines and
Mineral Resources
Open-File Report 148

Mine name(s) Blackjack #1 County McKinley

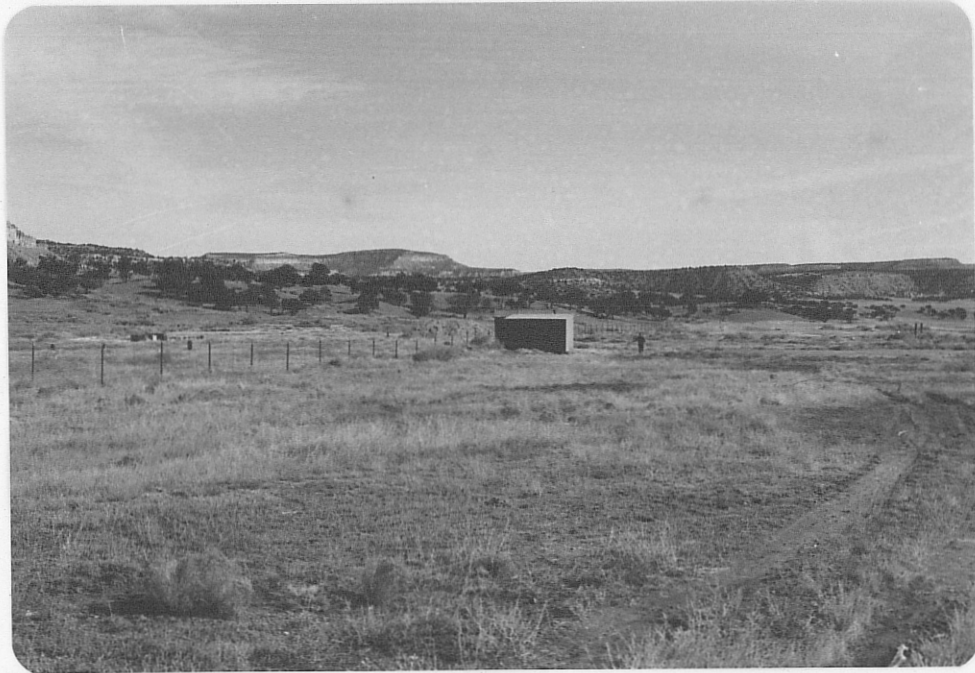
Photo (a) Looking eastward toward the Blackjack #1 site; headframe foundation at left indicated by arrow.

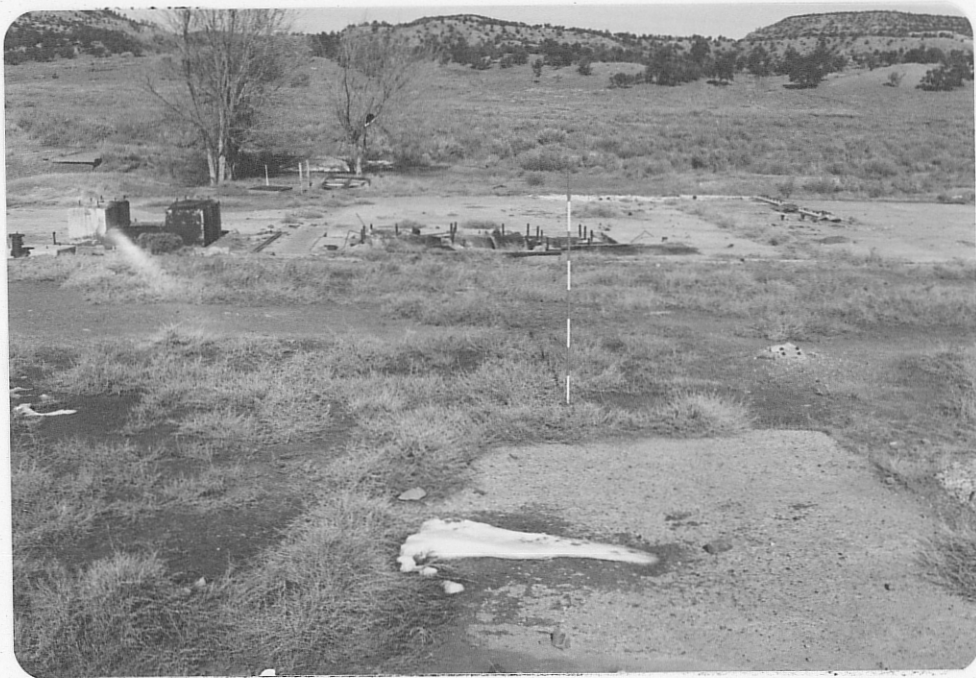
Photo (b) Looking north at shaft site immediately in front of range pole, and one corner of headframe foundation (arrow). Hoist foundation lies behind range pole.

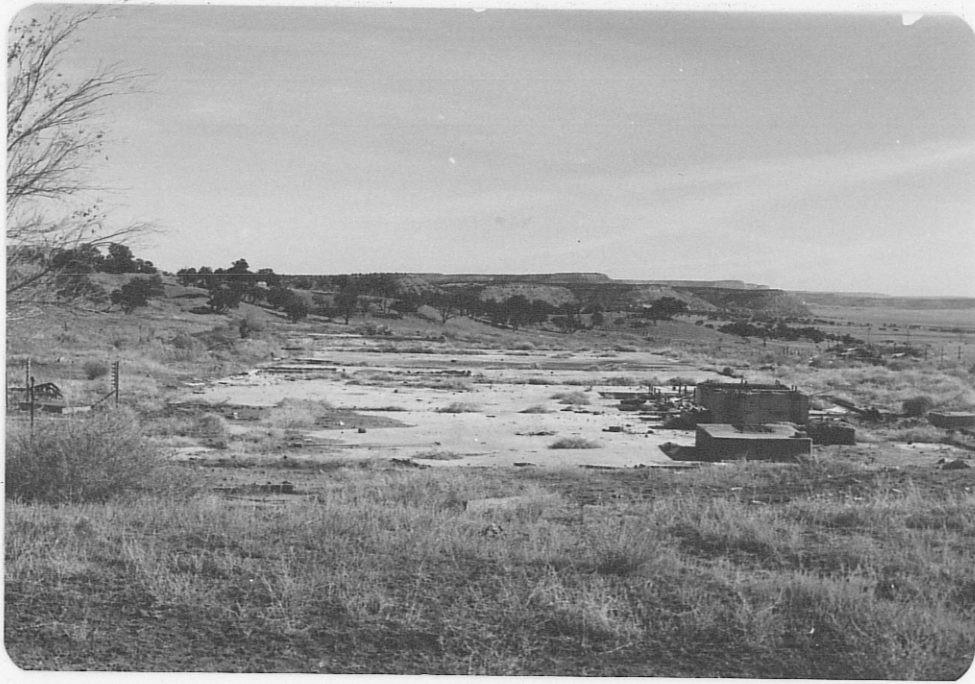
Photo (c) Looking east at 190' long concrete slab; hoist and drum foundation at right.

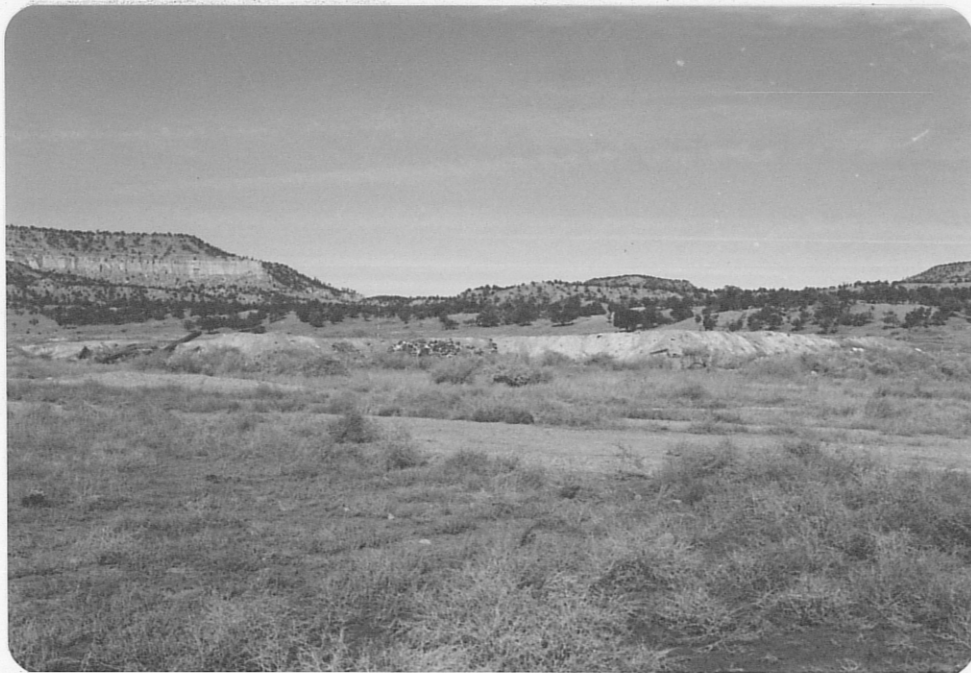
Photo (d) Looking northwestward at tailings dump; note range pole (circled) for scale.

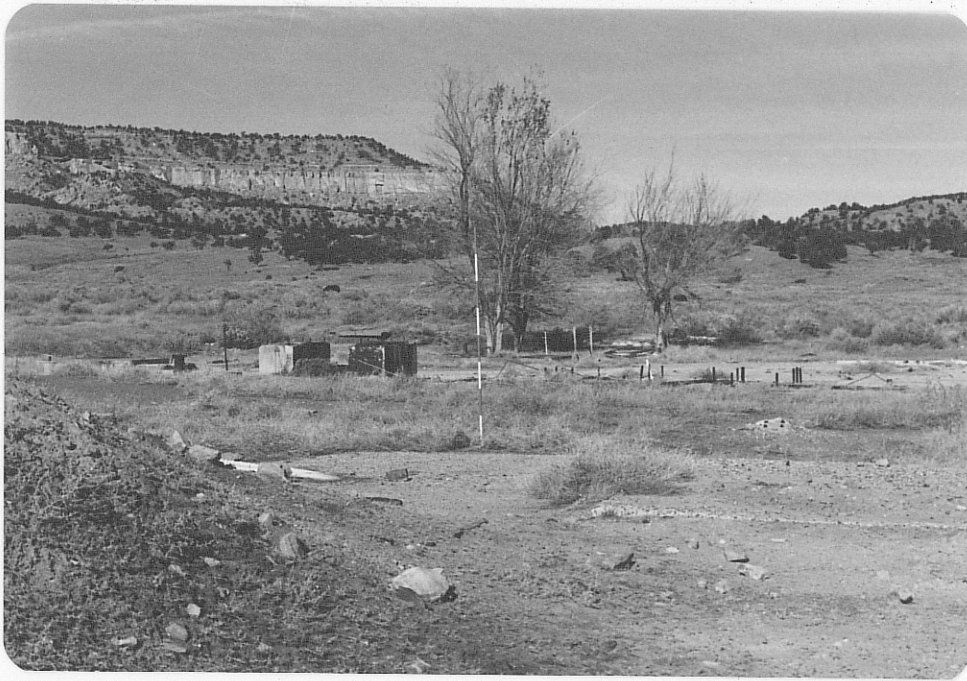
Scintillometer readings on the tailings dump were in the 900-1000 range in a "waist high traverse," or about 12x background. The only other area that produced readings of 1,000 cps or more was the small waste dump immediately south of the shaft site (see photo e).

Photo (e) Looking northwestward at shaft site with 5' high tailings dump showing at lower left; dump produced scintillometer readings up to 1,200 cps.

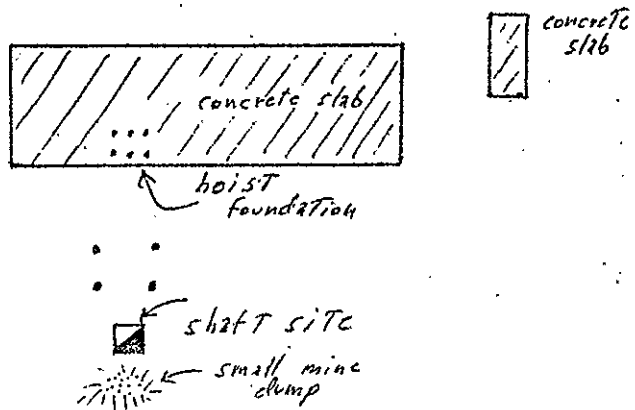
Fig. 1 Sketch map of Blackjack #1 Mine site.

The shaft has since been sealed, the headframe removed, and most buildings razed. All that remains is the headframe foundation and concrete slabs, a few small buildings, the mine tailings, and a considerable amount of general debris-cans, tires, scrap metal, sheet metal, lumber, and cable. Photo (a) is a view of the mine site as it is approached from the west; the most prominent features are the buildings and the mine tailings. Photo (b) is a close-up of the shaft site and the headframe foundation. No evidence of subsidence has appeared around the shaft thus far. Photo (c) is a view eastward of the largest remaining concrete slab, 190' long, on the site. Photo (d) is a view of the tailings dump which measures 260' long (E-W), by 180' wide, and generally 5' to 6' high. A sketch of the area is shown in Fig. 1.
