Abandoned Uranium Mine Assessment for the High Peak Site (NM0237)

FINAL REPORT

NM0237

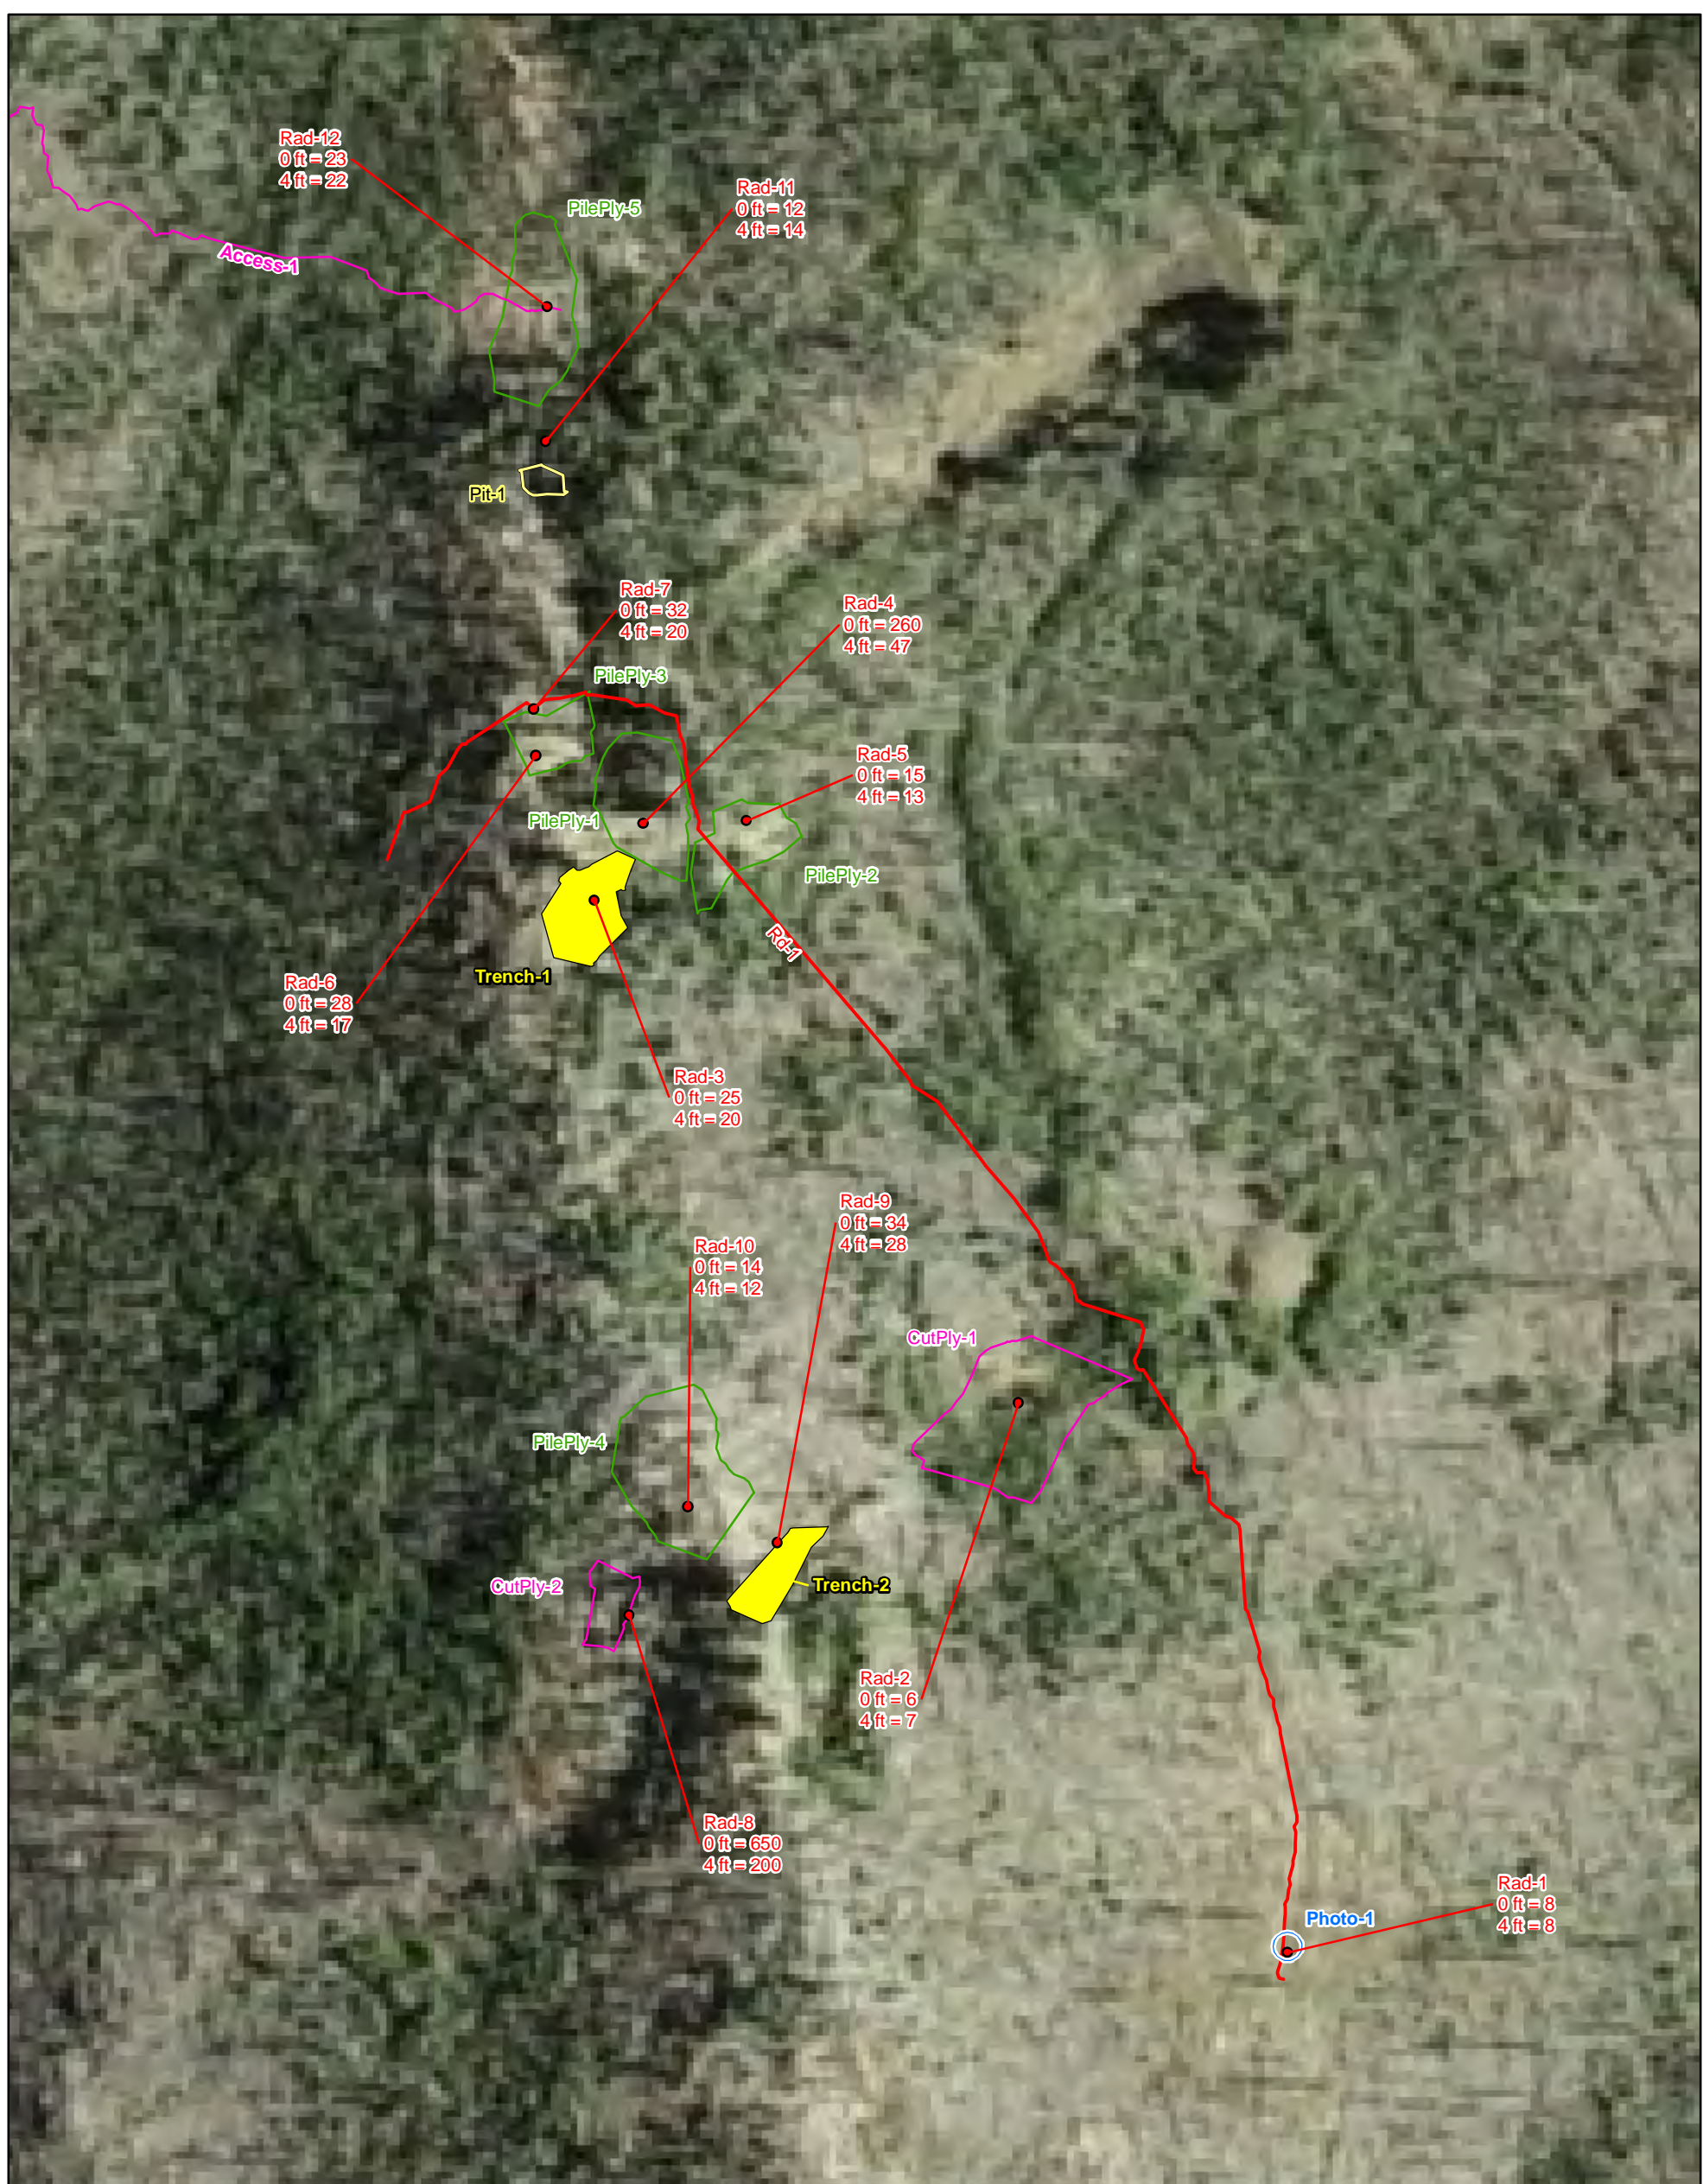
Figure 4a
Site Map on
Aerial Photo
NM0237-High Peak
 Abandoned Uranium
 Mine Assessment

The mine features described below are based on the features provided to INTERA by MMD in the GIS Data Dictionary (MMD, 2009). INTERA marked the locations of the AUM Site features using a Trimble Global Positioning System (GPS), and entered details about the features into the GPS using the MMD data dictionary. Two open cuts, two trenches, five waste piles, and one pit were found on site. Please see the Photo Log in Appendix A for photos of the AUM Site features, Table 1 for a list of the AUM Site features, and Figures 4a and 4b for the locations of the AUM Site features.

The background gamma radiation readings were measured approximately 0.8 miles north of the AUM Site boundary. The background gamma level was 17 $\mu\text{R/hr}$ (microrentgens per hour) at 0 ft above ground and 18 $\mu\text{R/hr}$ at 4 ft above ground. Please see Table 2 for all of the gamma radiation readings taken at the AUM Site and Figures 4a and 4b for the locations of the radiation readings.

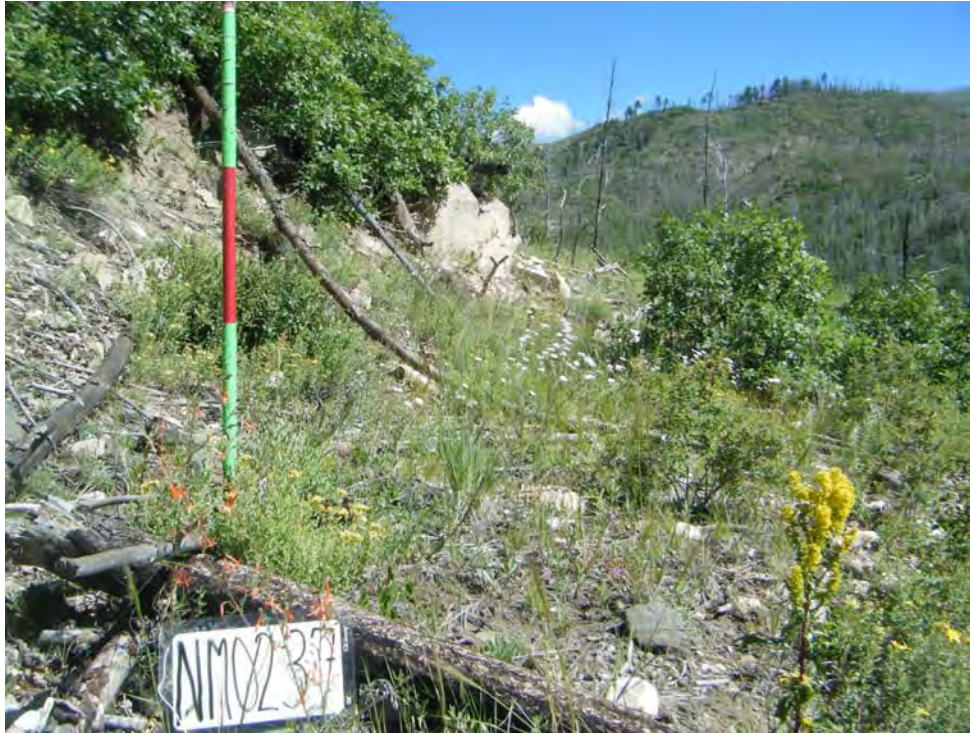
Photo 1-Site location photo, looking north along Rd-1.

Photo - 1 - Photo ID - 1 site location photo looking north

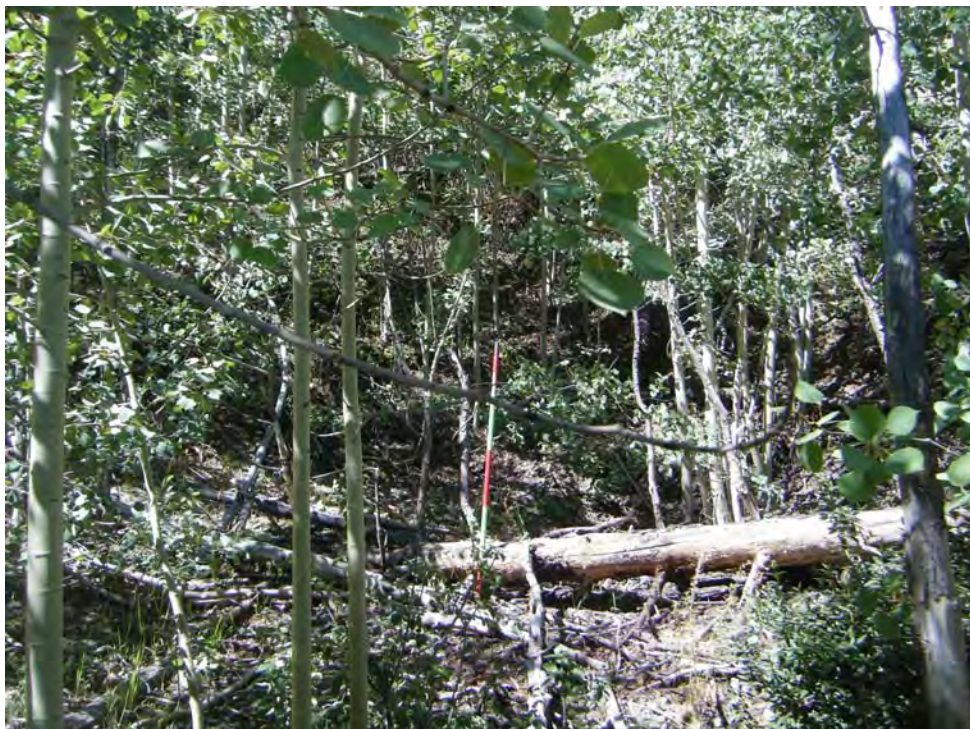
Photo 2-Looking west at CutPly-1.

Photo - 2 looking west at cut Ply - 1

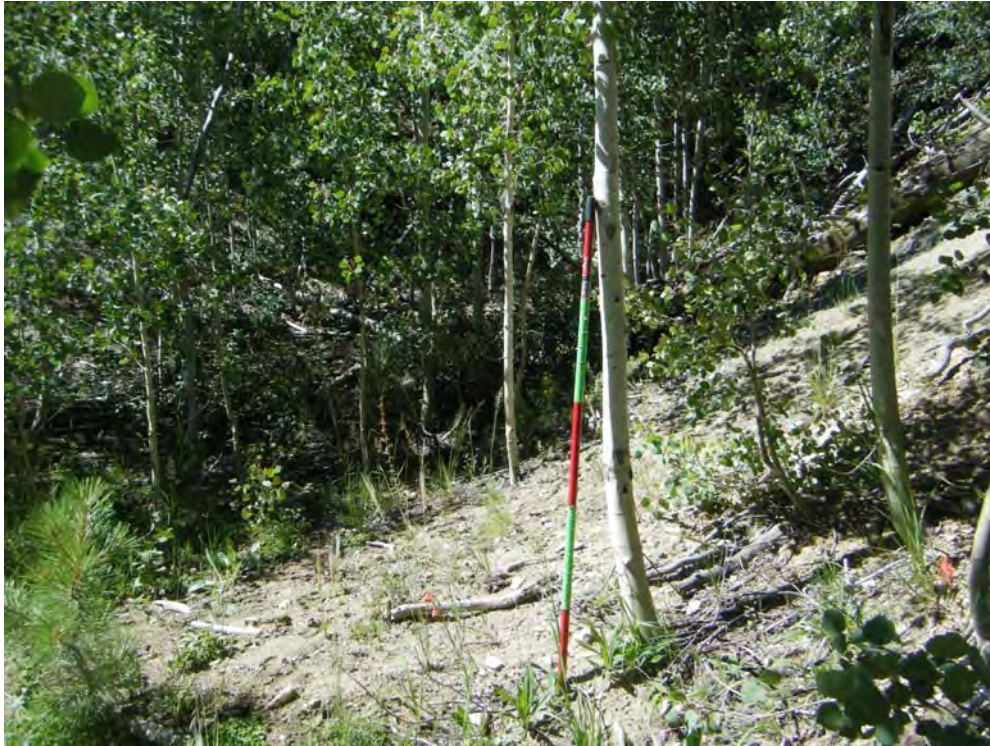
Photo 3-Looking southwest at CutPly-1.

Photo - 3 looking southwest at cut Ply - 1

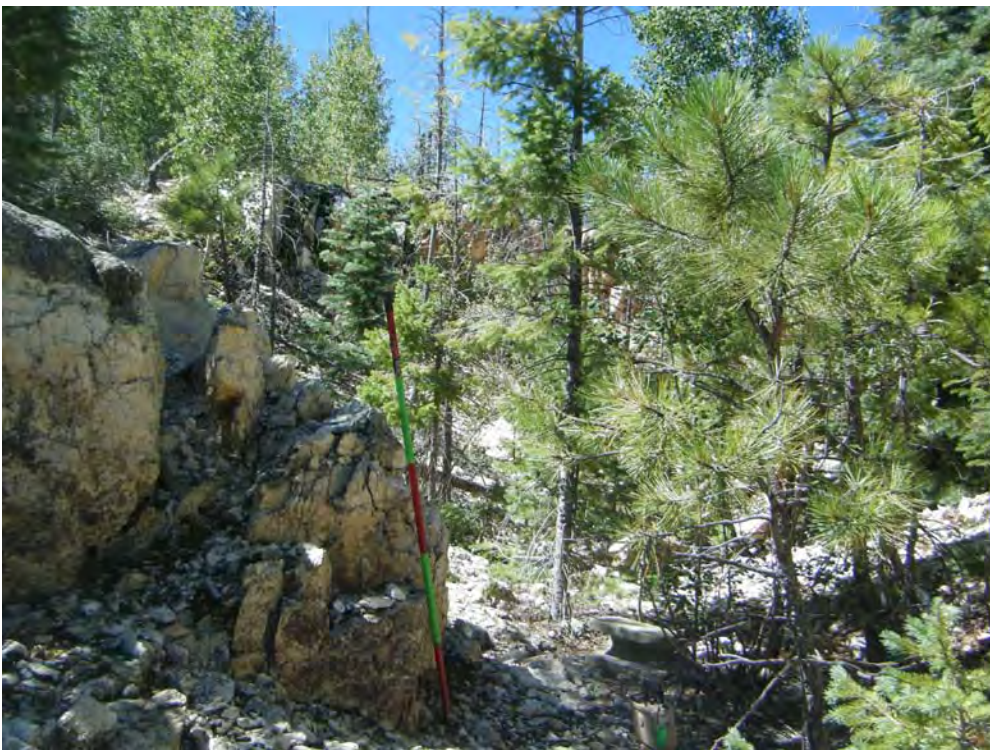
Photo 4-Looking south at Trench-1.

Trench Ply - 1 - 15' wide, ^{30' ALT}~~25'~~ long; 10' deep

Photo 4 - looking south at Trench - 1

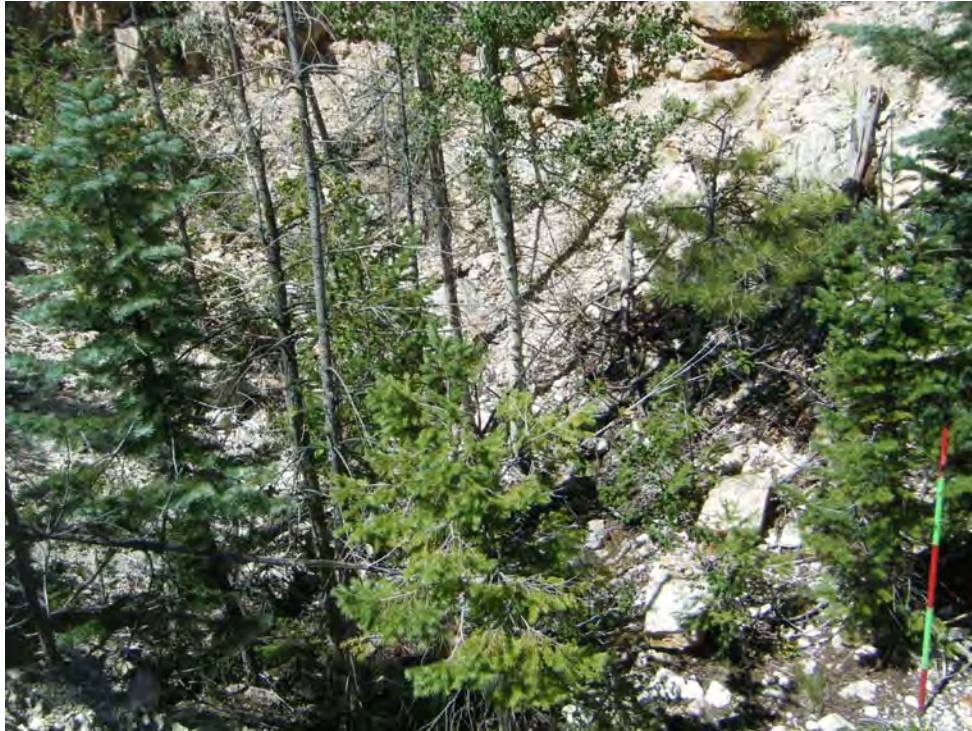
Photo 5-Looking west down at Trench-1.

Photo 5 - looking west down at Trench - 1

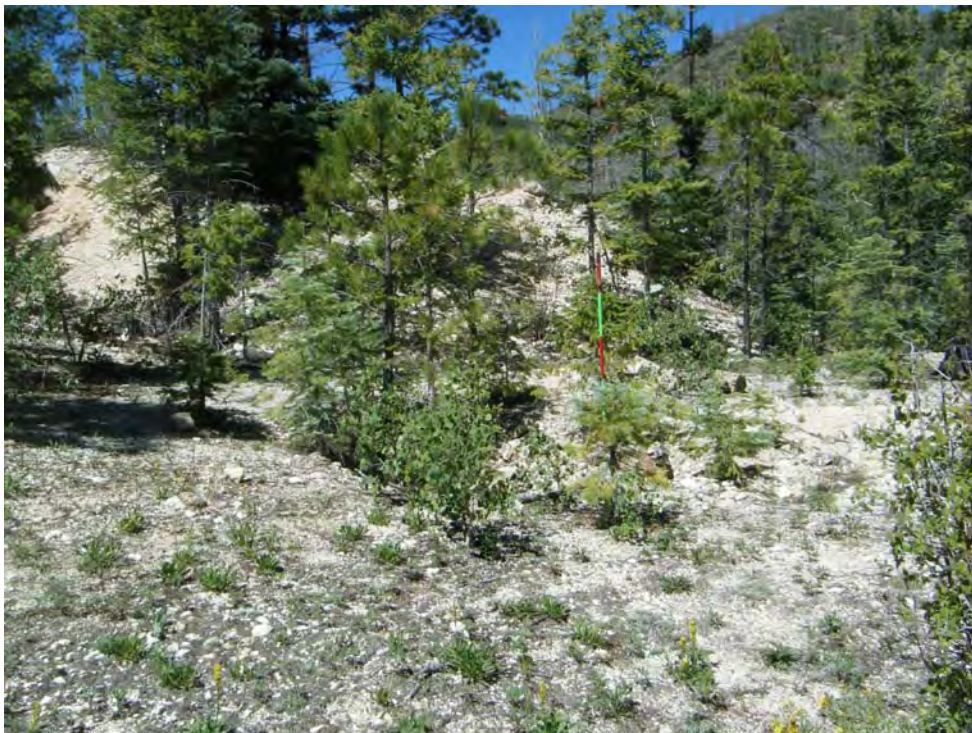
The maximum gamma radiation measured on site was 650 $\mu\text{R/hr}$ at 0 ft above ground and 200 $\mu\text{R/hr}$ at 4 ft above ground at radiation survey point Rad-8 in CutPly-2 (see Photos 9-11 in Appendix A). A gamma radiation measurement taken on top of PilePly-1 (radiation survey point Rad-4, see Photo 6 in Appendix A) recorded 260 $\mu\text{R/hr}$ at 0 ft above ground.

Photo 6-Looking west at PilePly-1.

Pile Ply-1 - 25' wide, 30' long, 5' tall; north of Trench-1, 40% slope

Photo 6 - looking west at Pile Ply-1, waste rock

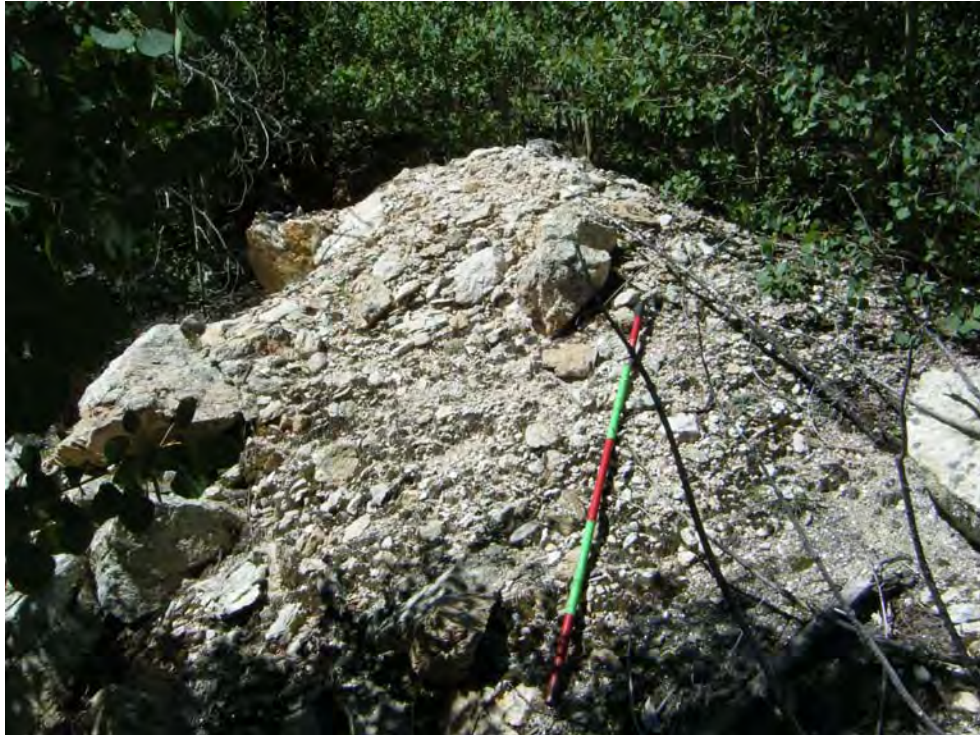
Photo 7- Looking south at PilePly-2.

Pile 2 - 25' wide, 20' long, 10' tall, 35% slope, east of Pile Ply-1

Photo 7 - looking south at Pile Ply 2

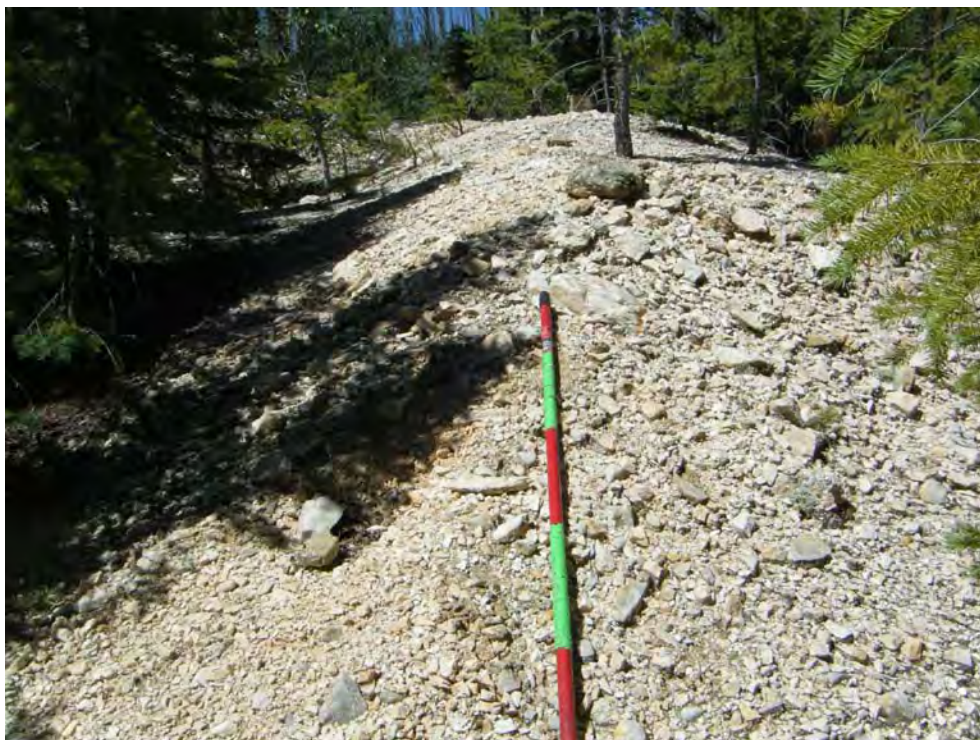
Photo 8- Looking west at PilePly-3.

Pile Ply-3 - 15' wide, 30' long, 10' tall, 40% slope, west of Pile Ply-1

Photo 8 - looking west at Pile Ply-3

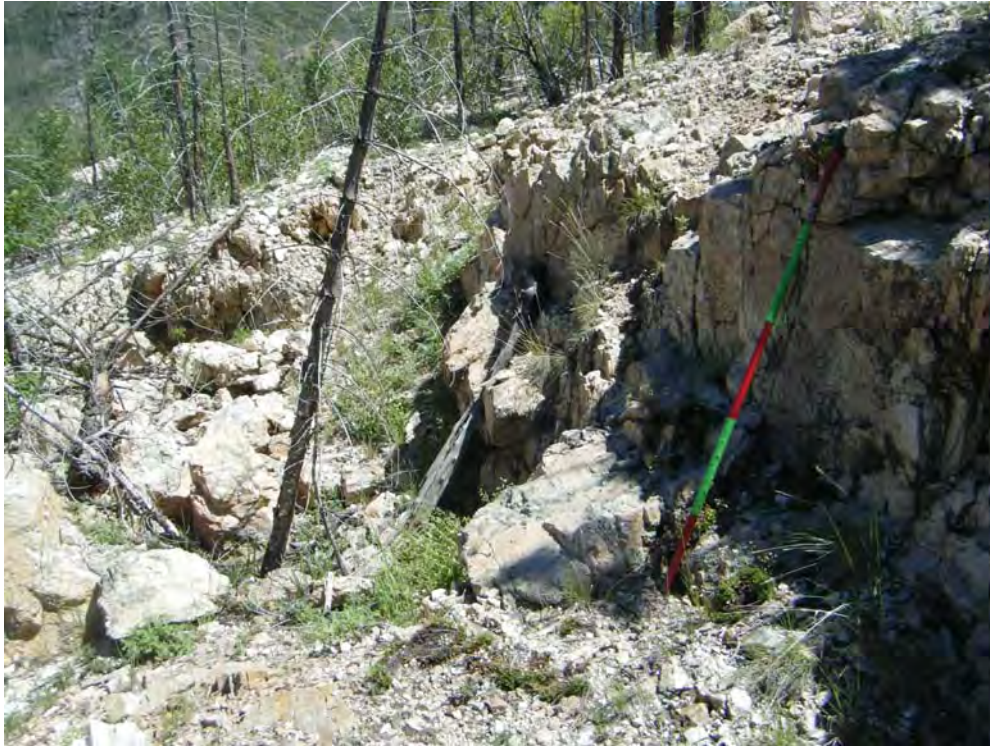
Photo 9- Looking north at CutPly-2.

Cut Ply 2 - 15' wide, 30' long, 5' deep; in Pegmatite

Photo 9 - north at cut Ply 2

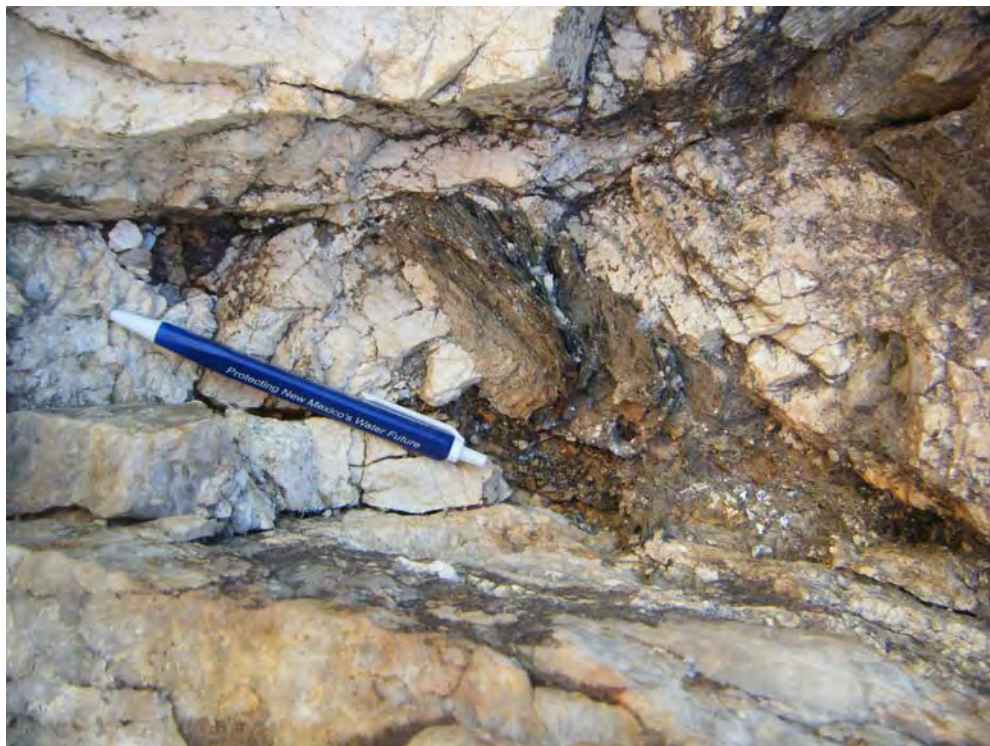
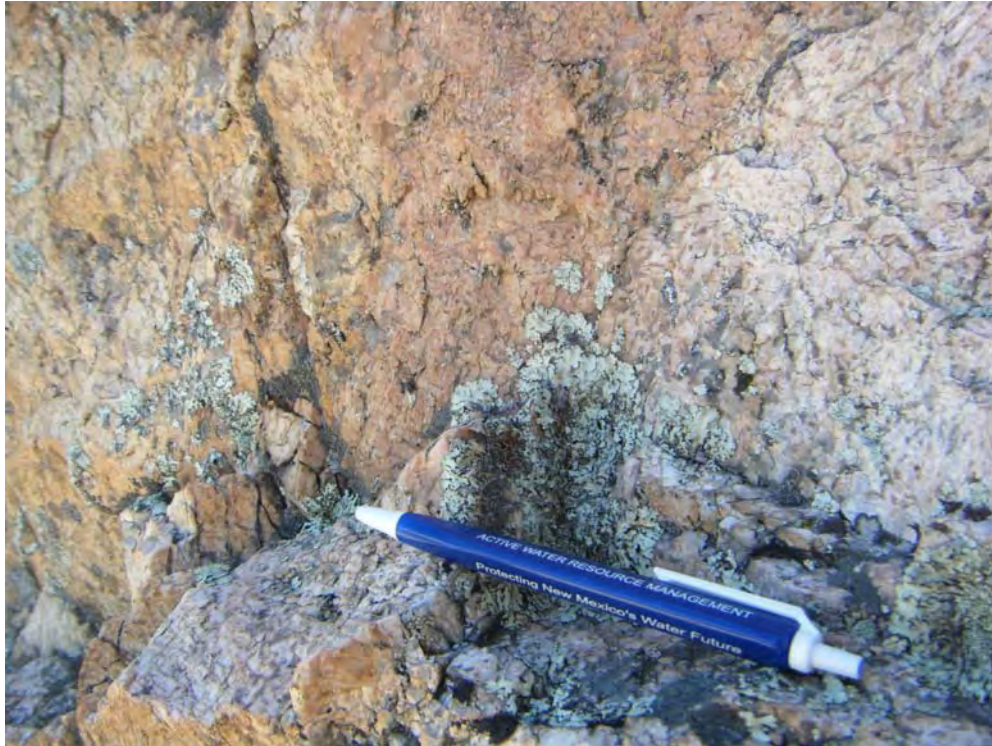
Photo 10-Close-up of rock face in CutPly-2, looking east.

Photo 11- Close-up of rock face in CutPly-2, looking east

Photo 10 & 11 - closeup of rock face, east

Rad 8 - cut Ply 2 - Om - 650 uR/h; 1m - 200 uR/h

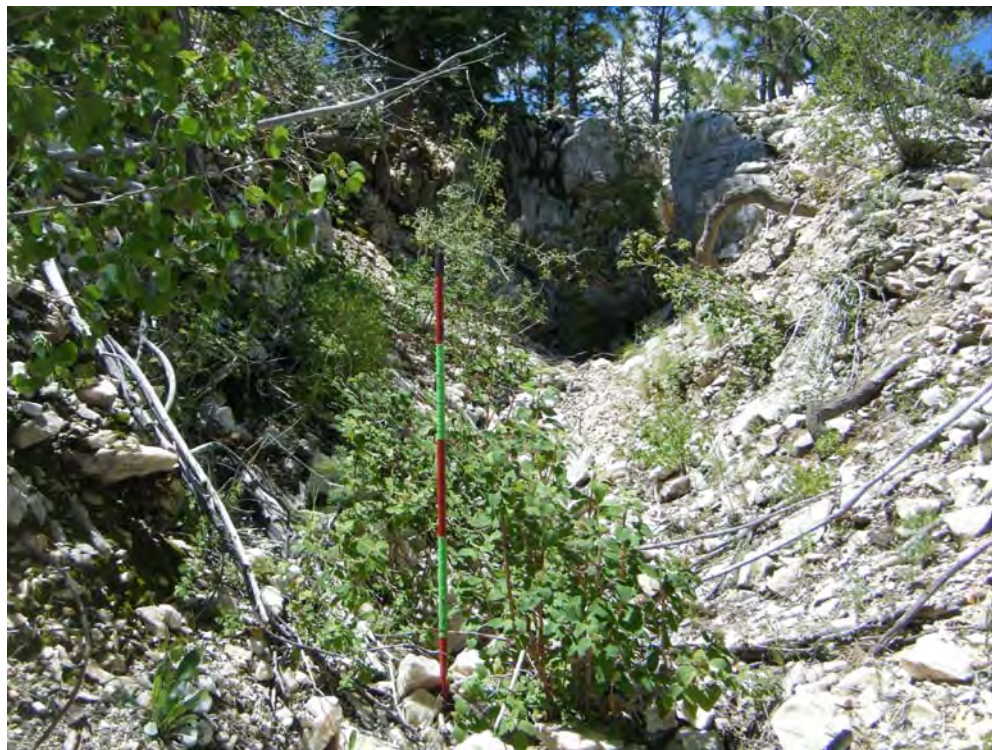
Photo 12-Looking southwest at Trench-2.

Trench-2 - 10' wide, 40' long, 10' deep

Photo 12 - looking southwest at Trench-2

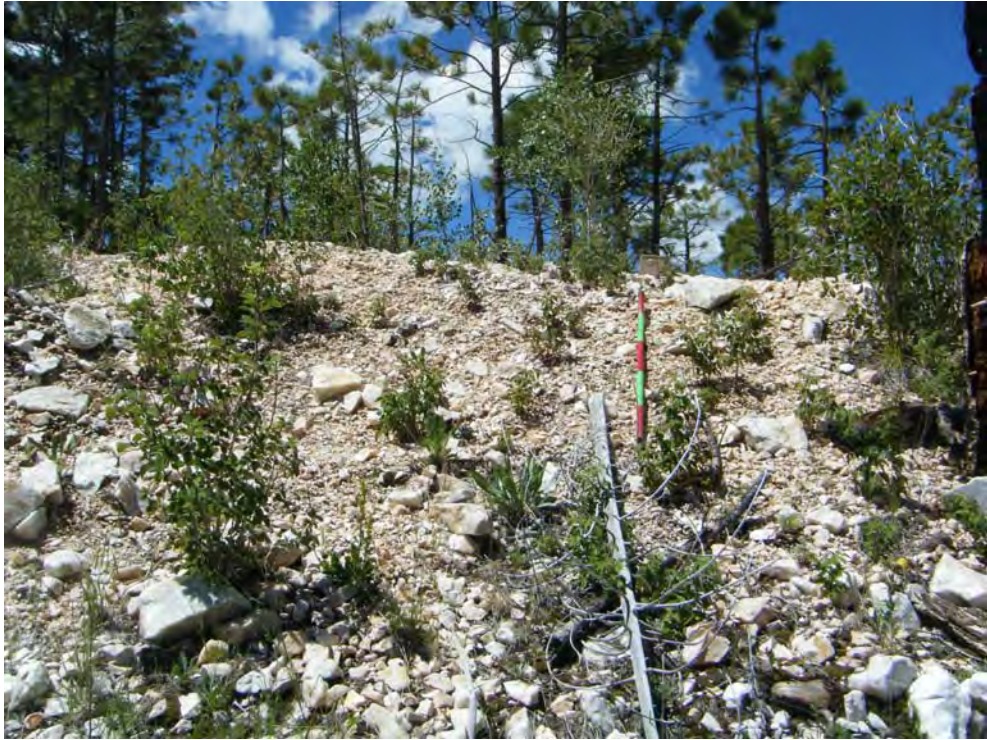
Photo 13-Looking west at PilePly-4.

Pile Ply-4 - 25' wide, 40' long, 5' tall waste rock; 25% slope

Photo 13 - looking west at Pile Ply-4

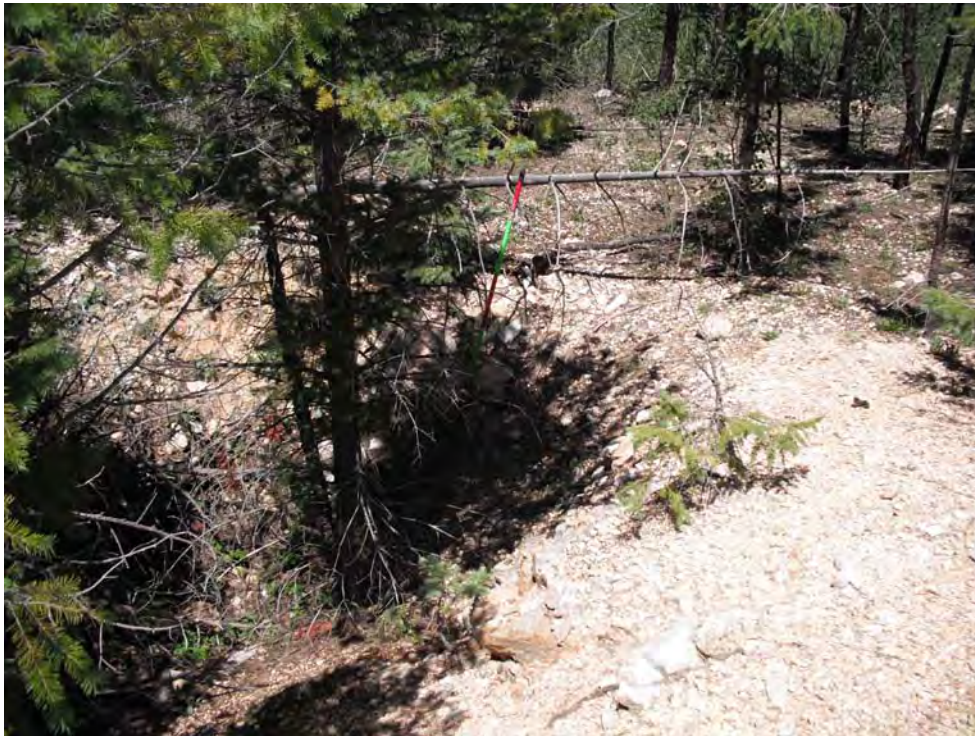
Photo 14-Looking north at Pit-1.

Pit-1 - 15' wide; 20' long, 5' deep; 45%

Photo 14 - looking north at Pit-1

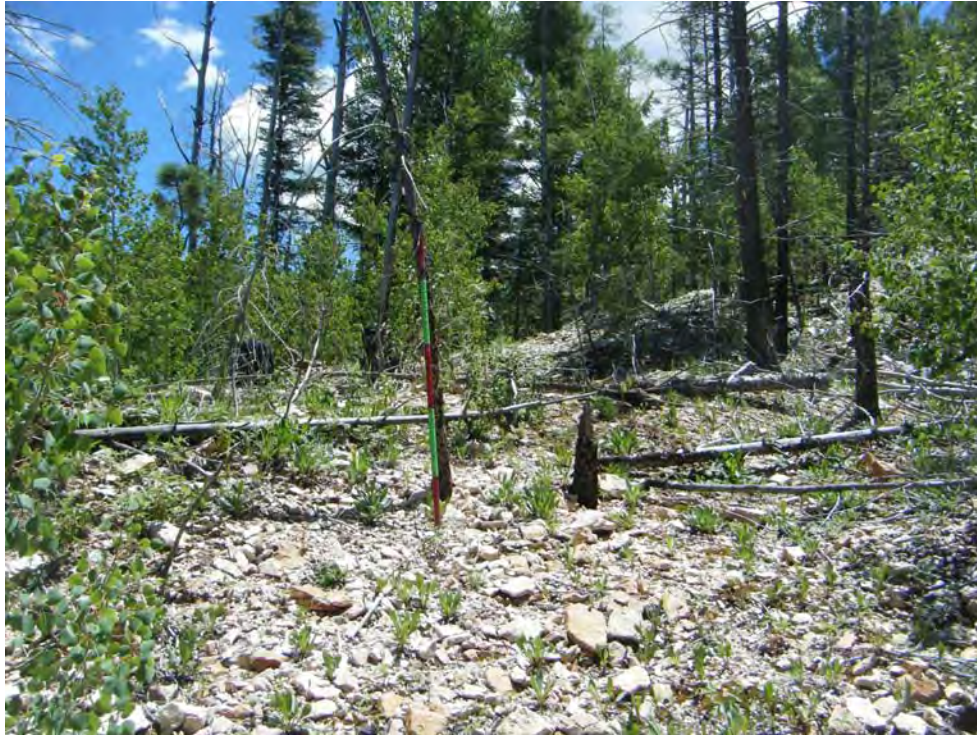
Five waste piles were found onsite. All of the piles consisted of waste rock. The largest pile, PilePly-5 is 15 ft high, 30 ft wide and 50 ft long and was found down slope from the excavation features. PilePly-1, near Trench-1, contained the highest radiation reading found on the waste piles; the gamma radiation measurement was 260 $\mu\text{R/hr}$ at 0 ft above ground at radiation survey point Rad-4 (see Table 2).

Photo 15-Looking southeast at PilePly-5.

Pile Ply 5 - 30' wide; 50' long, 15' tall waste rock

Photo 15 - looking south east at Pile 5
