**RE: NMED SWQB Comments August 24, 2018 and EPA Comments September 26, 2018**

Enclosed you will find one (1) electronic copy of the revised Lee Ranch Mine (LRM) Use Attainability Analysis (UAA) report for the streams located in the vicinity of the LRM. The UAA report has been revised to address the technical review comments provided by New Mexico Environmental Department (NMED) Surface Water Quality Bureau (SWQB) on 8/24/2018 and Environmental Protection Agency (EPA) on 9/26/2018. Peabody Natural Resources Company (PNRC) believes that this UAA provides substantial evidence to support the modification of the designated use of the San Isidro Arroyo and its tributaries. Also accompanying this letter is PNRC's response to the technical review comments from NMED SWQB and EPA.

**Figure 1: Lee Ranch Mine UAA - Location Map**

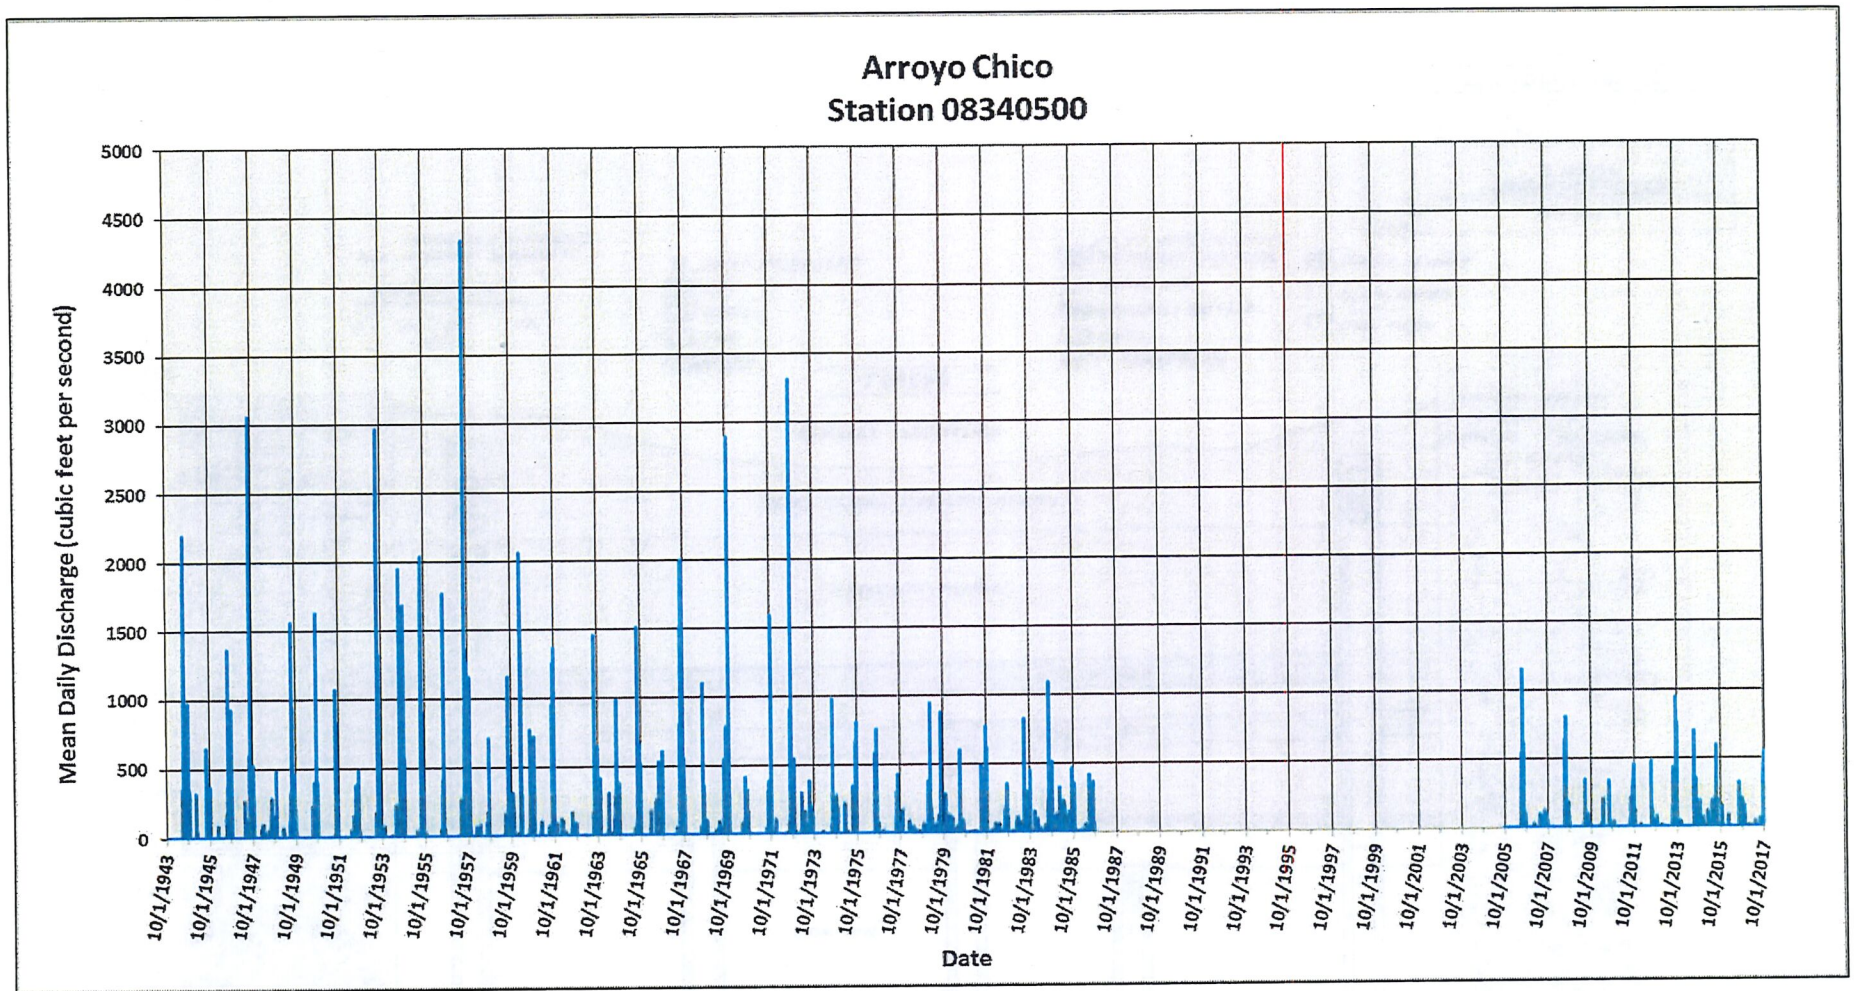
Figure 4. Mean daily discharge (cubic feet per second) at the USGS Arroyo Chico Gaging Station (08340500) located downstream of the San Isidro drainage basin.

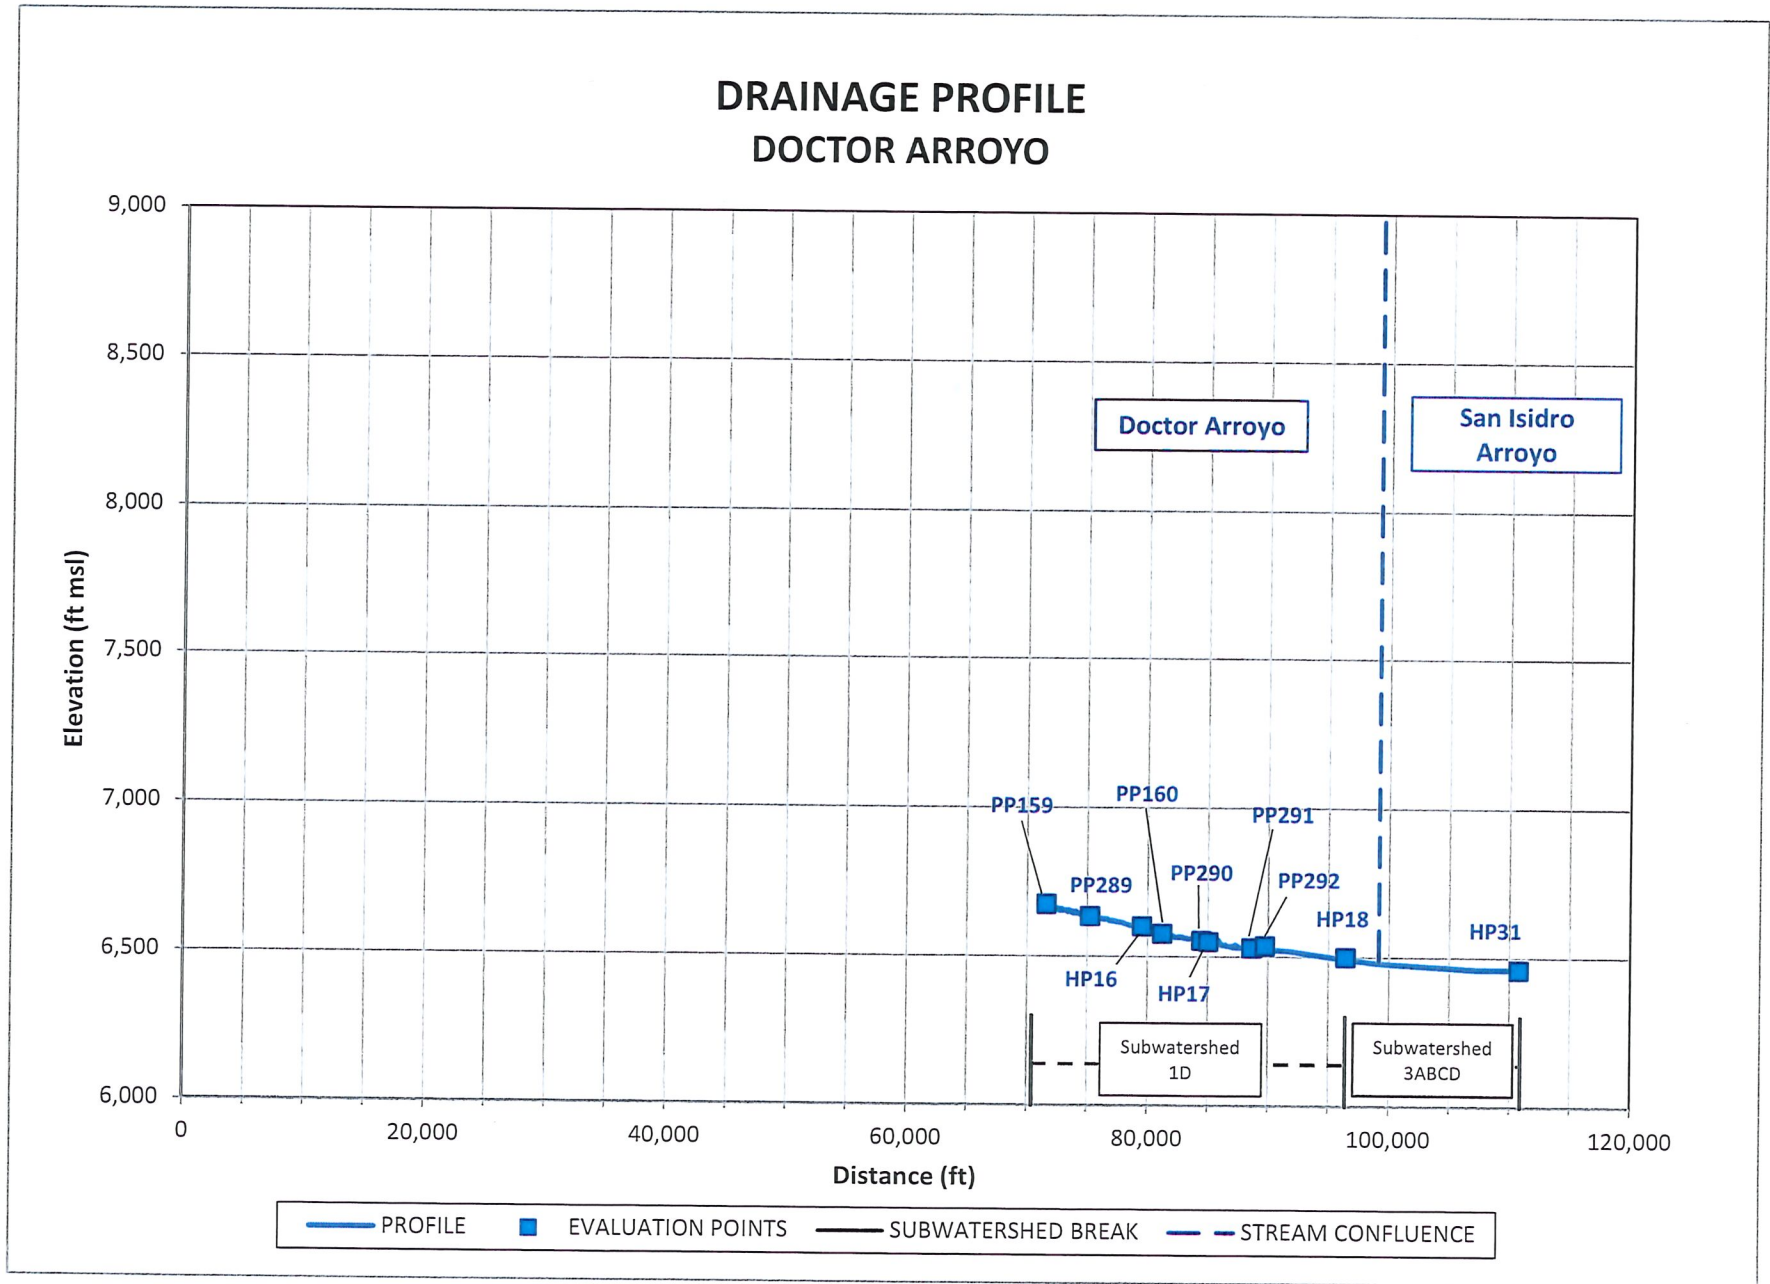
Figure 15. Doctor Arroyo drainage profile.

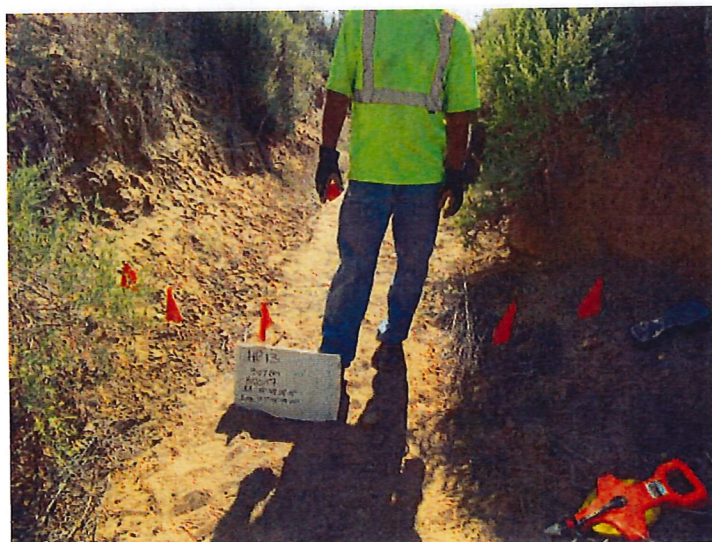
6 - HP13 bankfull width

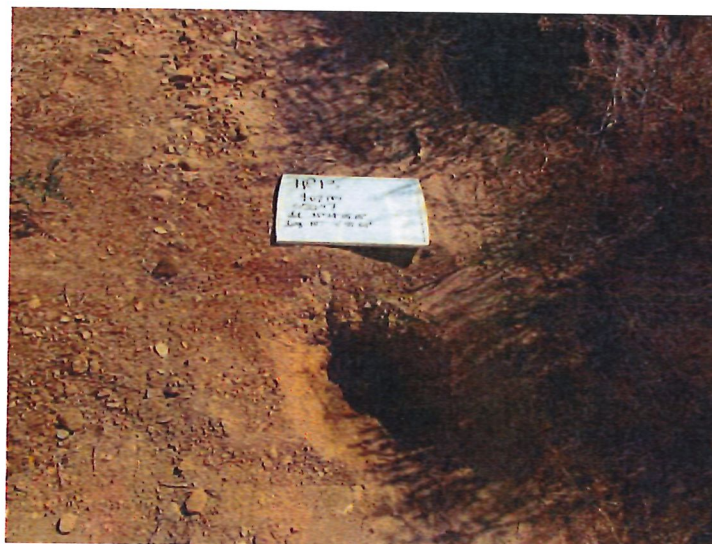
9 - HP13 soil profile (1)

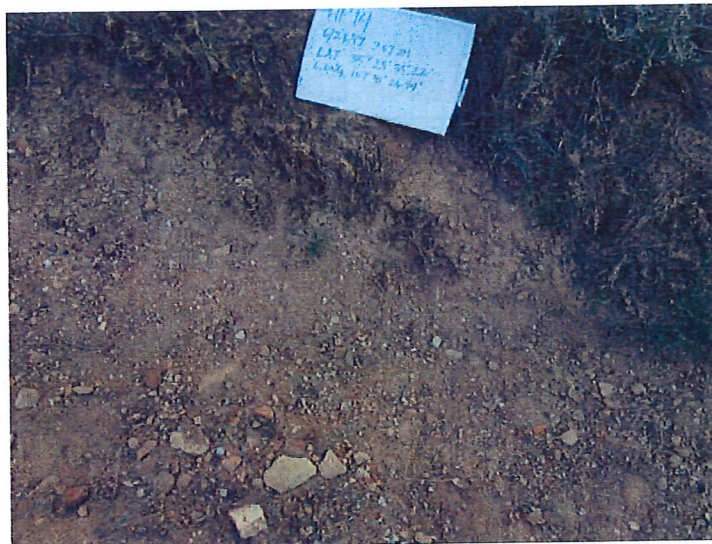
15 - HP14 example of debris at base of channel

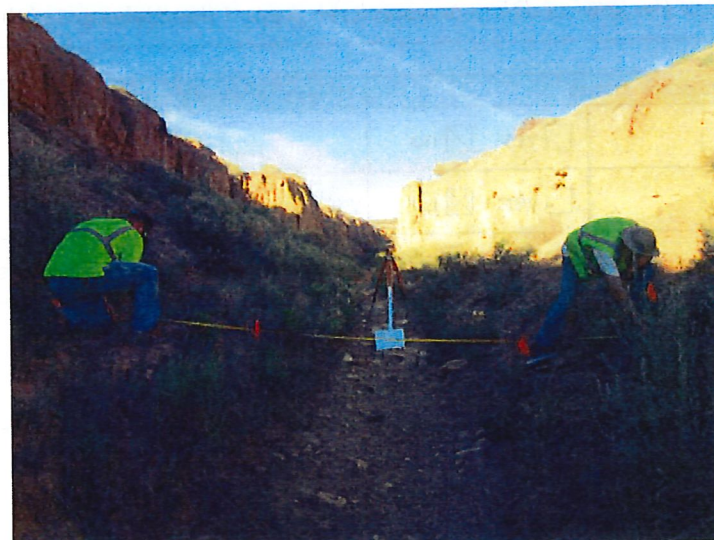
16 - measuring HP14 flood plain width

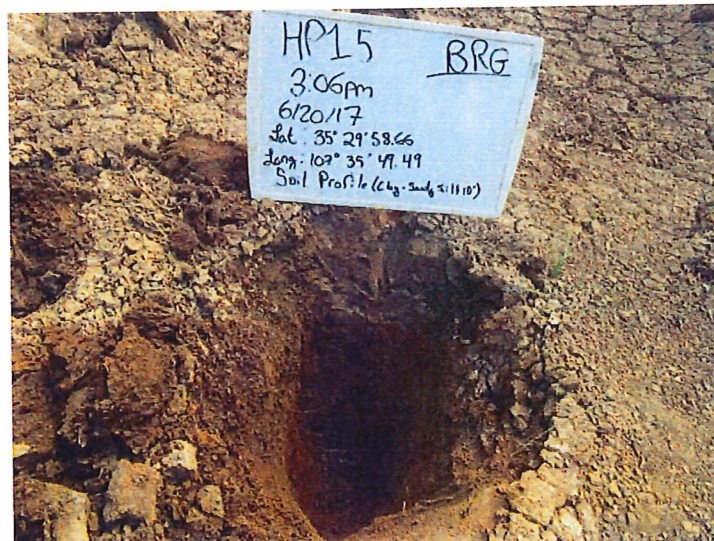
19 - HP15 soil profile (1)

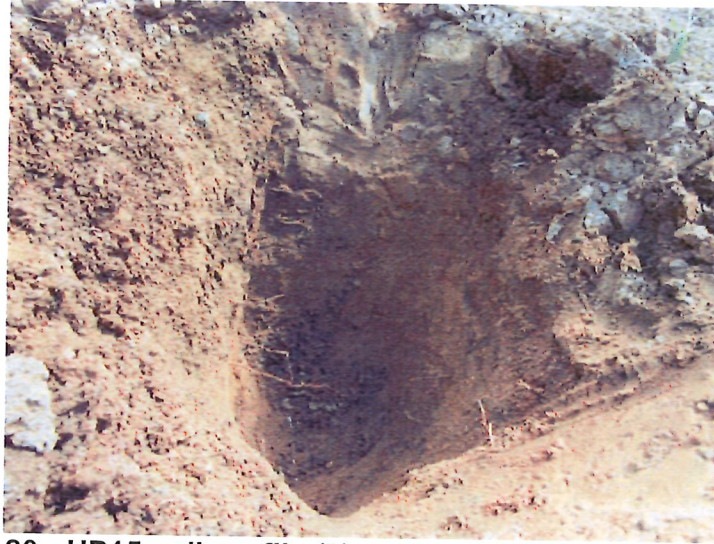
20 - HP15 soil profile (2)

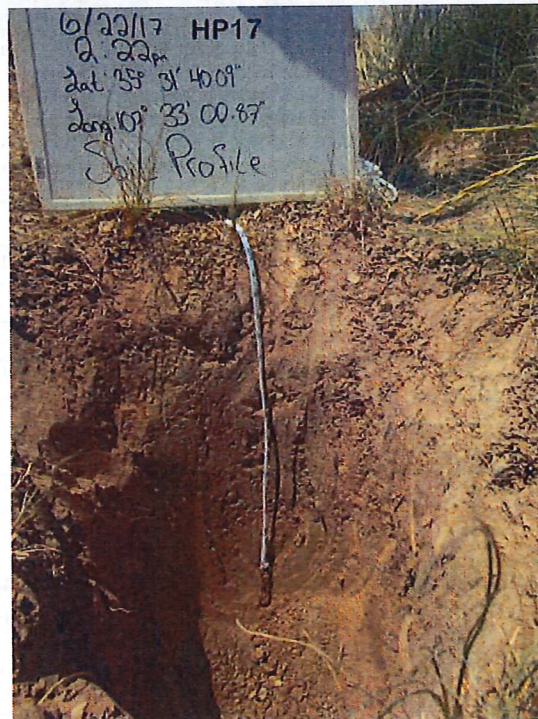
29 - HP17 soil profile

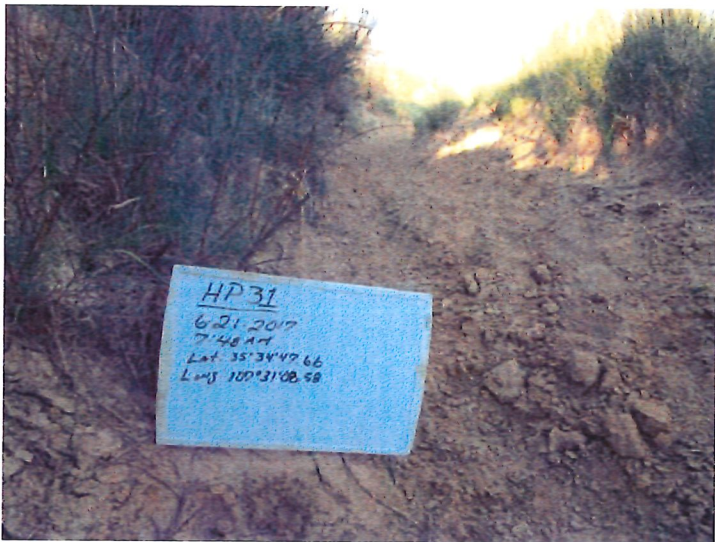
38 - HP31 channel bottom
