**Application of the Hydrology
Protocol to STSIU Drainages**

Chino Mines, Vanadium, New Mexico

October 2014

**Application of Hydrology
Protocol to STSIU Drainages**

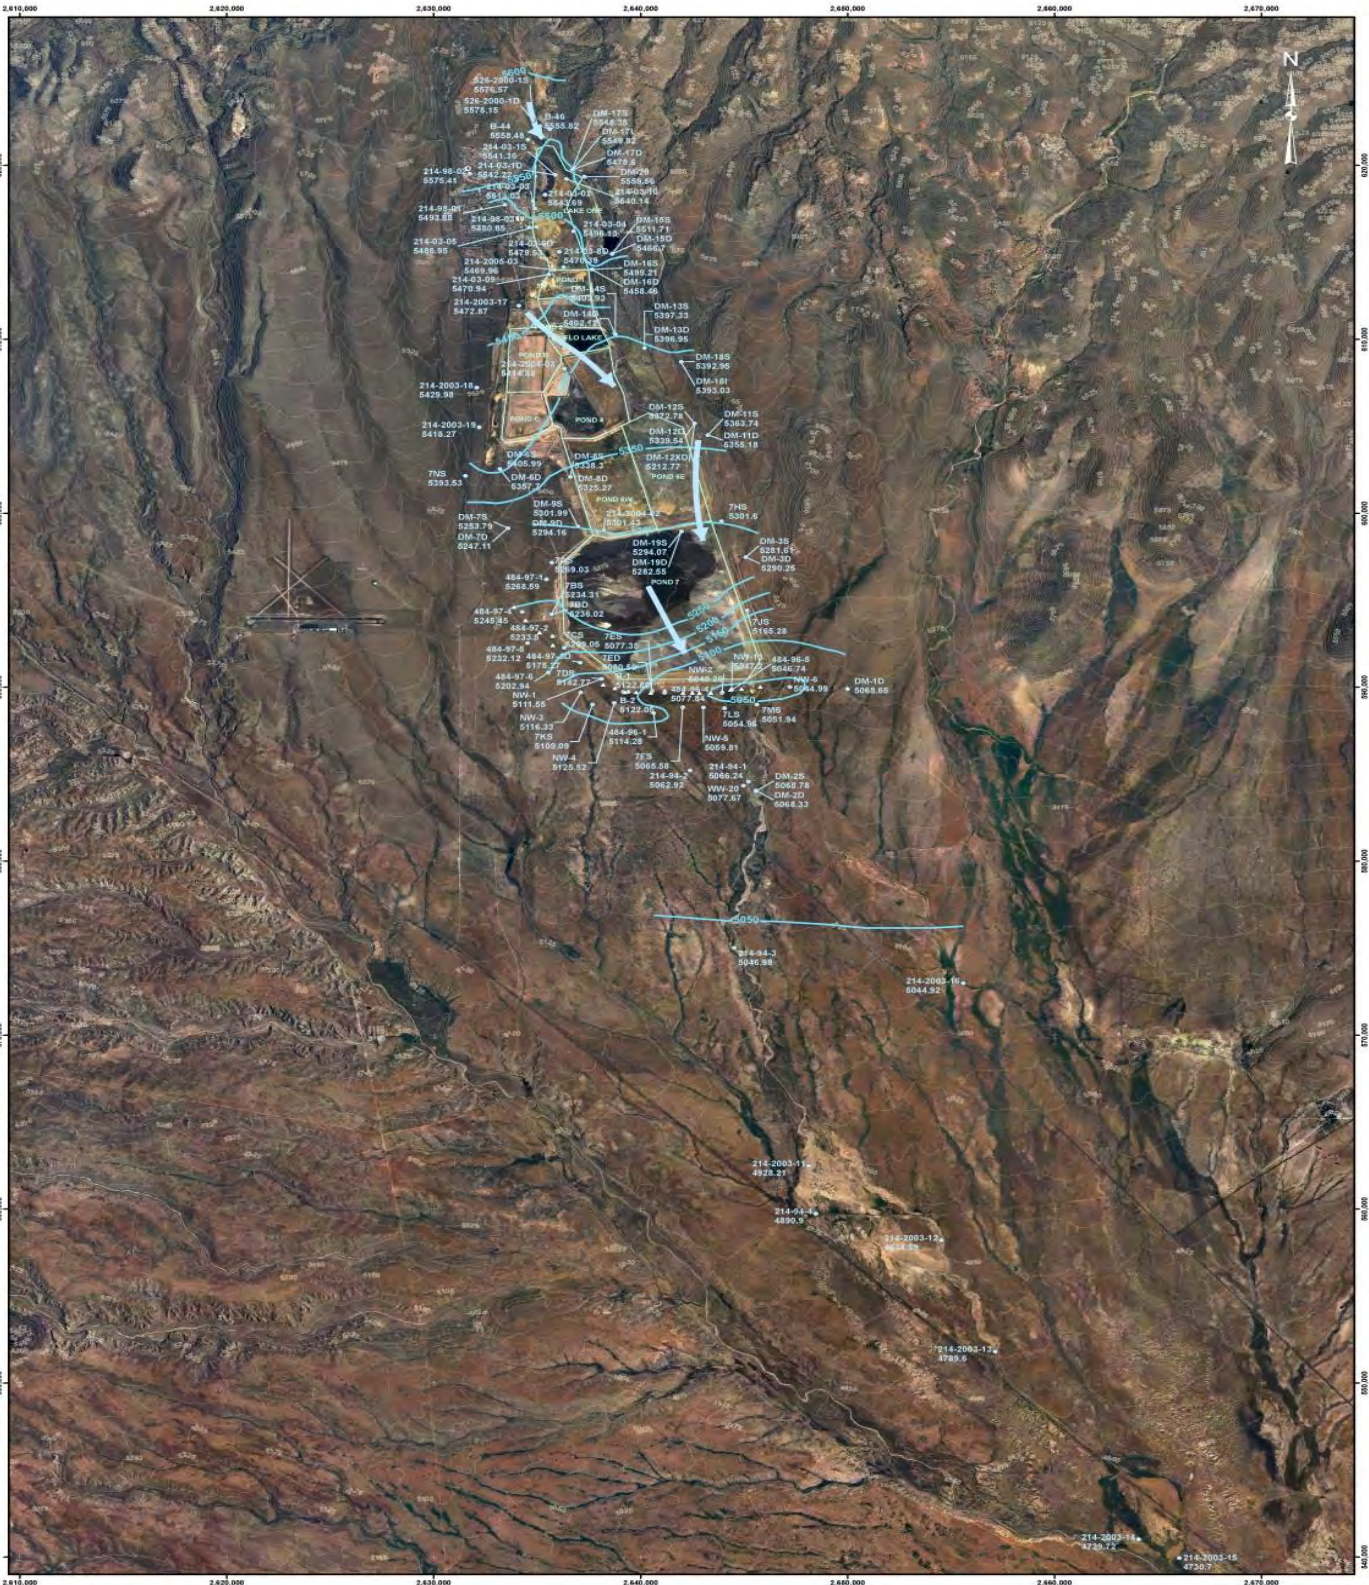
Figure 7-1 from Golder (2007)

PROJECT		CHINO MINES COMPANY DP-1340 CONDITION 83 - HYDROLOGIC STUDY	
TITLE			
GROUNDWATER ELEVATIONS AND FLOW DIRECTIONS MIDDLE WHITWATER CREEK AREA			
<p>Golder Associates Tucson, Arizona</p>	PROJECT No. 043-2980.004	SCALE AS SHOWN	REV. 0
	DESIGN ---		
	GIS MCM 6/15/2007		
	CHECK MB 6/15/2007		
	REVIEW DB 6/25/2007		
			FIGURE: 7-1

For further reference, maps depicting groundwater flow directions from Golder (2007) are attached to this document (Figures 6-1, 7-1, and 8-1 from Golder 2007). Additionally, Figure 7-1 from Golder (2005) depicts surface-water and groundwater divides. Of note, the STSIU Subwatersheds A, B, C, D and E that are proposed for ephemeral classifications are separated hydrologically from the pit area, and therefore are not impacted by pit drawdown (or by potentially impacted groundwater).

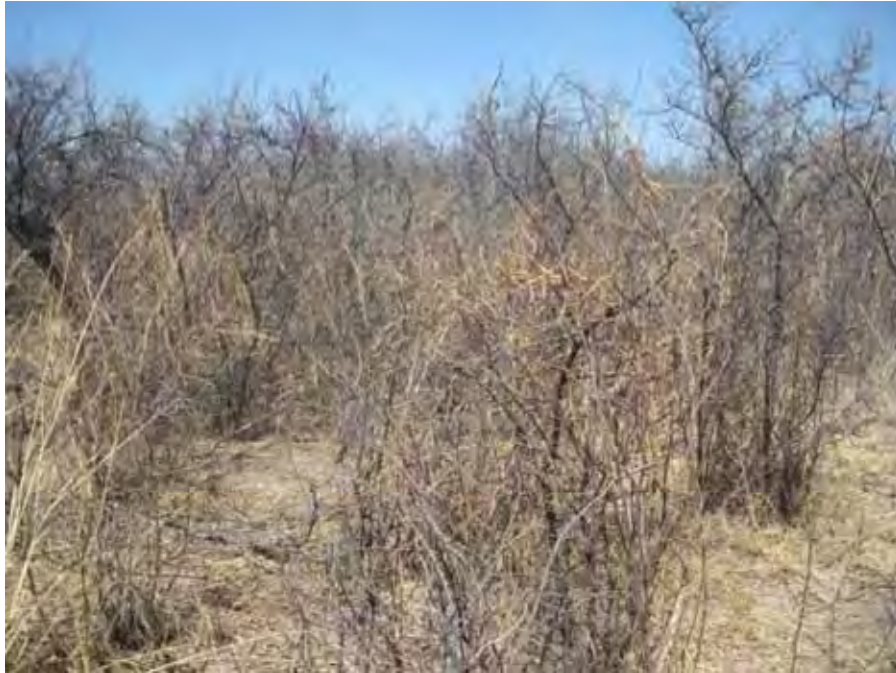
A9-1: Photographic reference for indicators 1.1 through 1.6. Photograph of channel area. Typical densely rooted vegetation within the channel. No water or biotic indicators of water observed along survey reach. Indicator 1.6 scored as 0 - rooted upland plants prevalent in streambed.

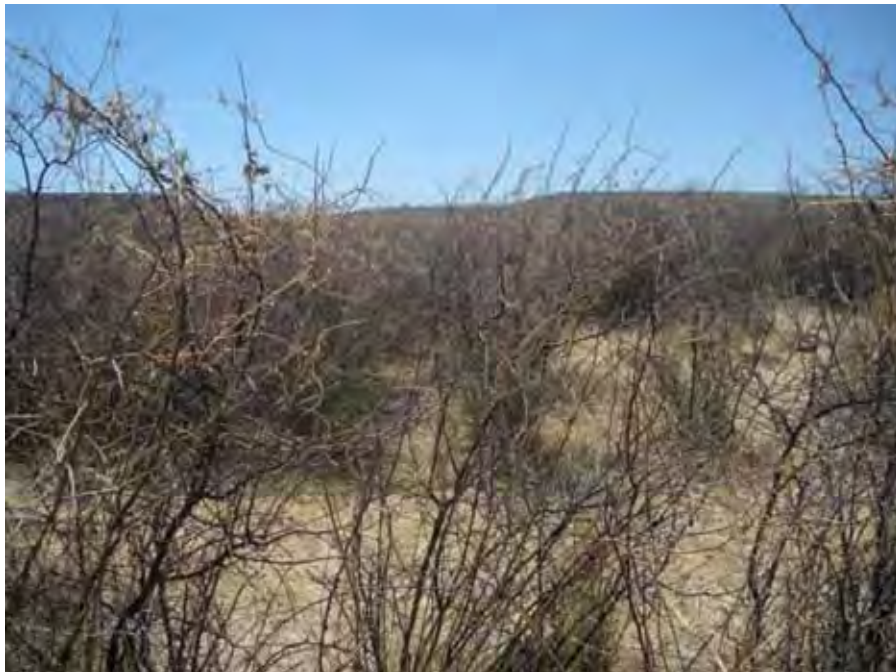
A9-2: Photographic reference for indicator 1.5. Photograph of upslope and overbank area. Vegetation within, and adjacent to channel, occurred at slightly greater densities but was consistent with vegetation growing in adjacent upland areas (mostly bunch grass and cat claw).

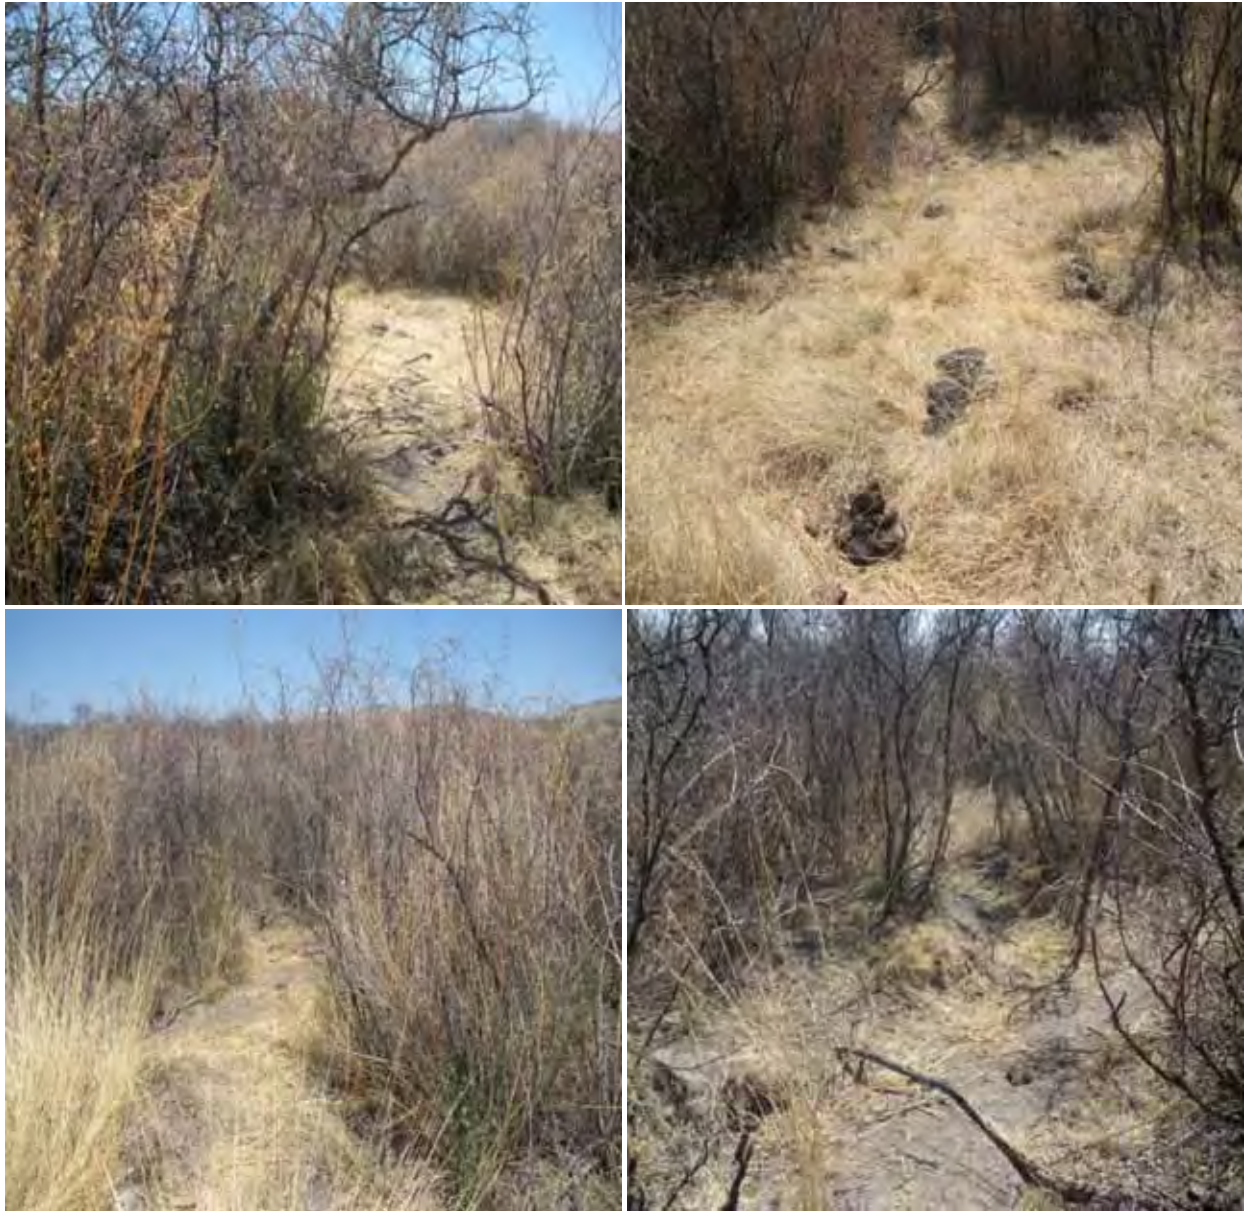
A9-3: Photographic reference for indicators 1.5 and 1.6. Photographs of vegetation. Typical densely rooted vegetation within the channel. No compositional differences were observed between vegetation growing around the channel and adjacent uplands, but upland species did occur at greater densities within and around the channel.

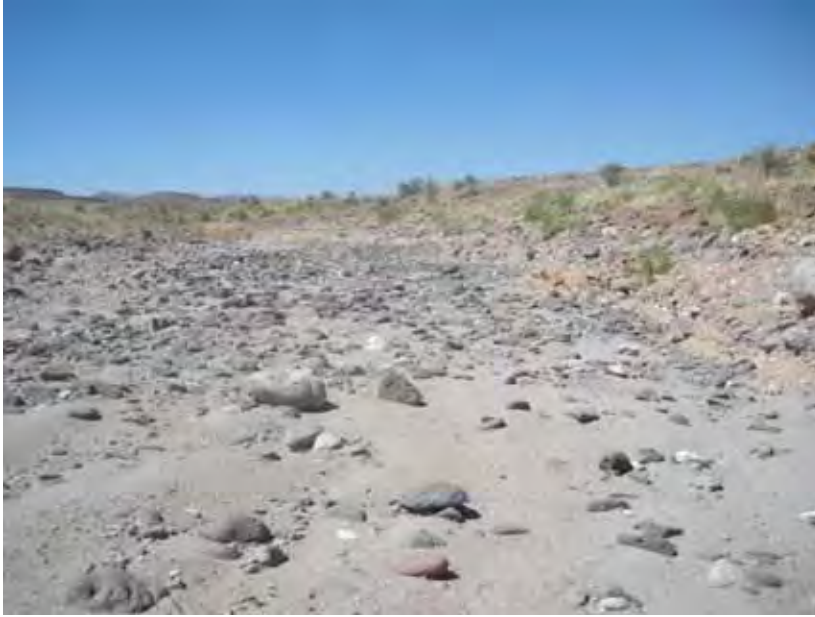
A10-1: Photographic reference for indicators 1.1 through 1.6. Typical view of stream bed and banks. Indicators 1.1 through 1.4 scores of 0 - no water or biotic indicators of water observed along survey reach.

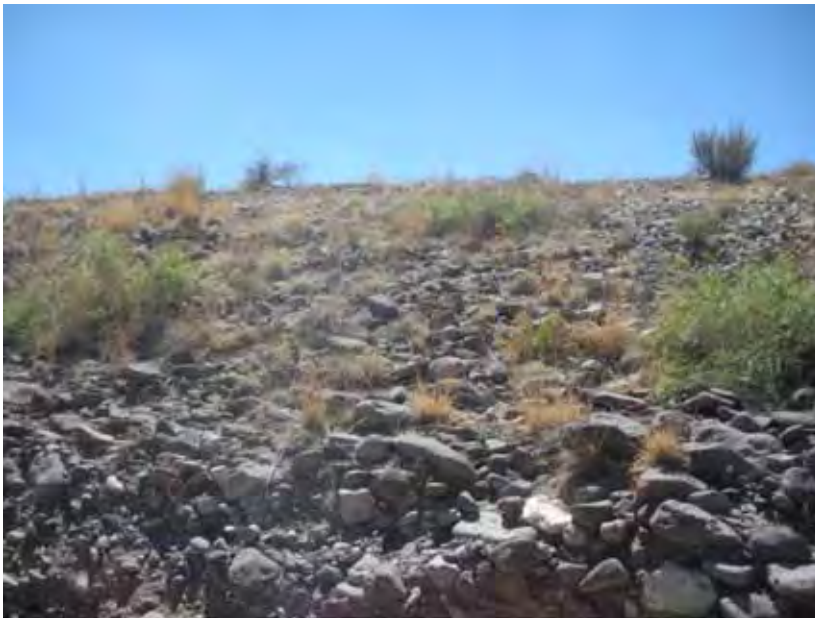
A10-2: Photographic reference for indicator 1.5. Photograph of typical stream bank and over bank vegetation (also observed in other photos provided). No significant compositional or density differences between bank and adjacent uplands and no riparian zone present. Indicator 1.5 score of 0 - no vegetative differences between banks and uplands.

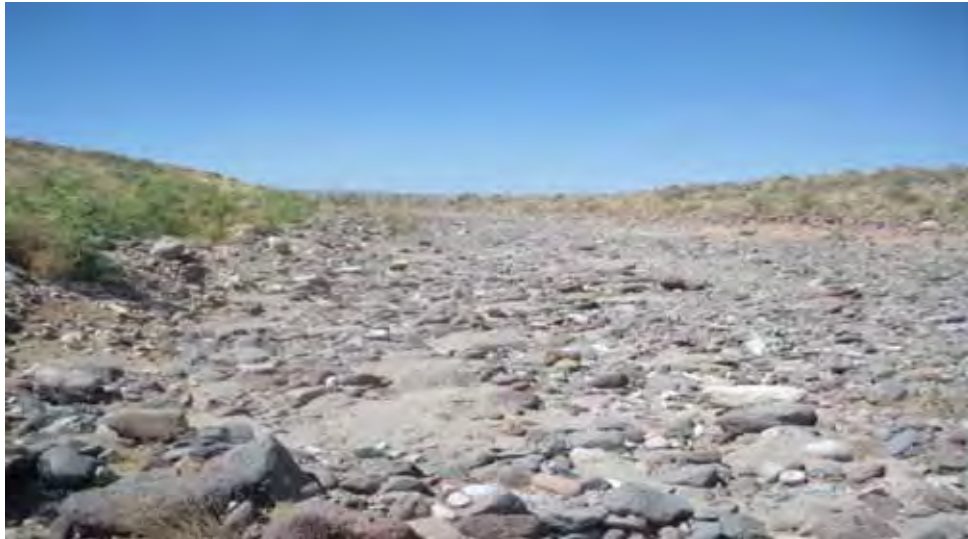
A10-3: Photographic reference for indicator 1.6. Most of the streambed is relatively devoid of vegetation most likely as a result of flow regime and bed material (course sands, gravel and boulders). Indicator 1.6 scored as 2 -- a few upland rooted plants were observed growing within the channel (see below pictures), although they were mostly (but not entirely) absent presumably as a result of substrate limitations.

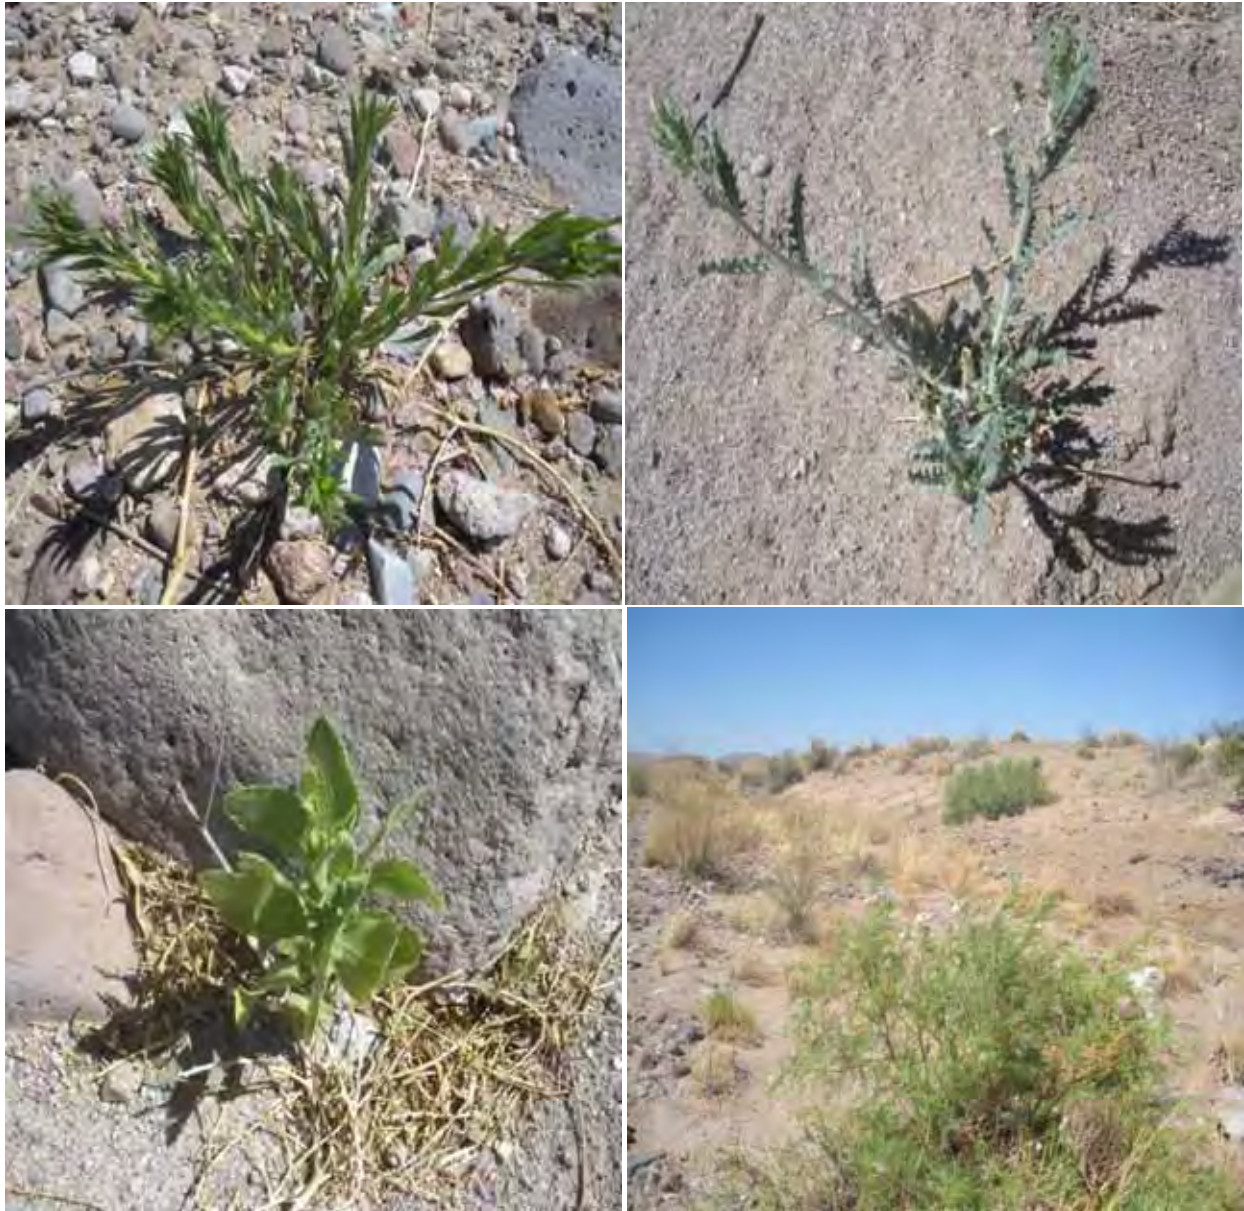
A10-4: Photographic reference for indicators 1.5 and 1.6. Photographs of in stream rooted plants and overbank/upland areas. Typical rooted vegetation noted within the channel. No significant compositional or density differences between bank and adjacent uplands.

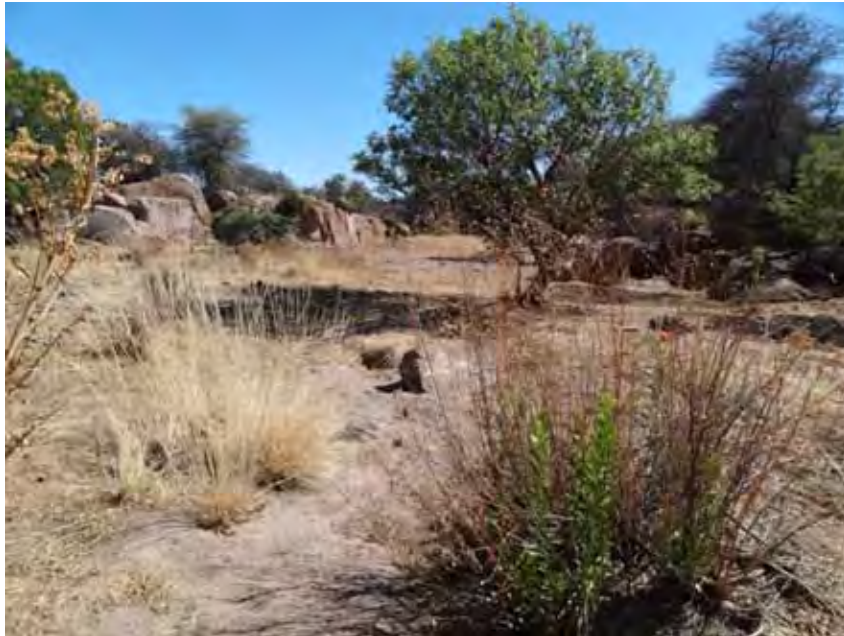
B7-1: Photographic reference for indicators 1.1 through 1.6. Photograph of stream bed. Typical rooted vegetation across channel and banks relatively consistently dispersed throughout channel length. Indicator 1.6 scored as 1 - rooted upland plants consistently dispersed in streambed. No water or biotic indicators of water observed along survey reach.

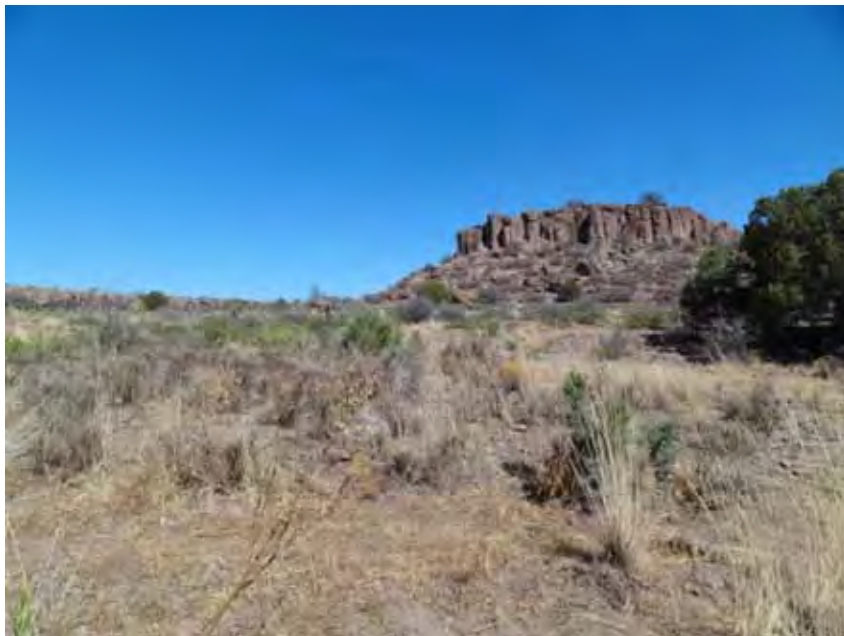
B7-2: Photographic reference for indicator 1.5. Photograph of bank and upland area. Indicator 1.5 scored as 1 - evident variation in vegetative density but no dramatic difference in composition. No distinct riparian zone observed.

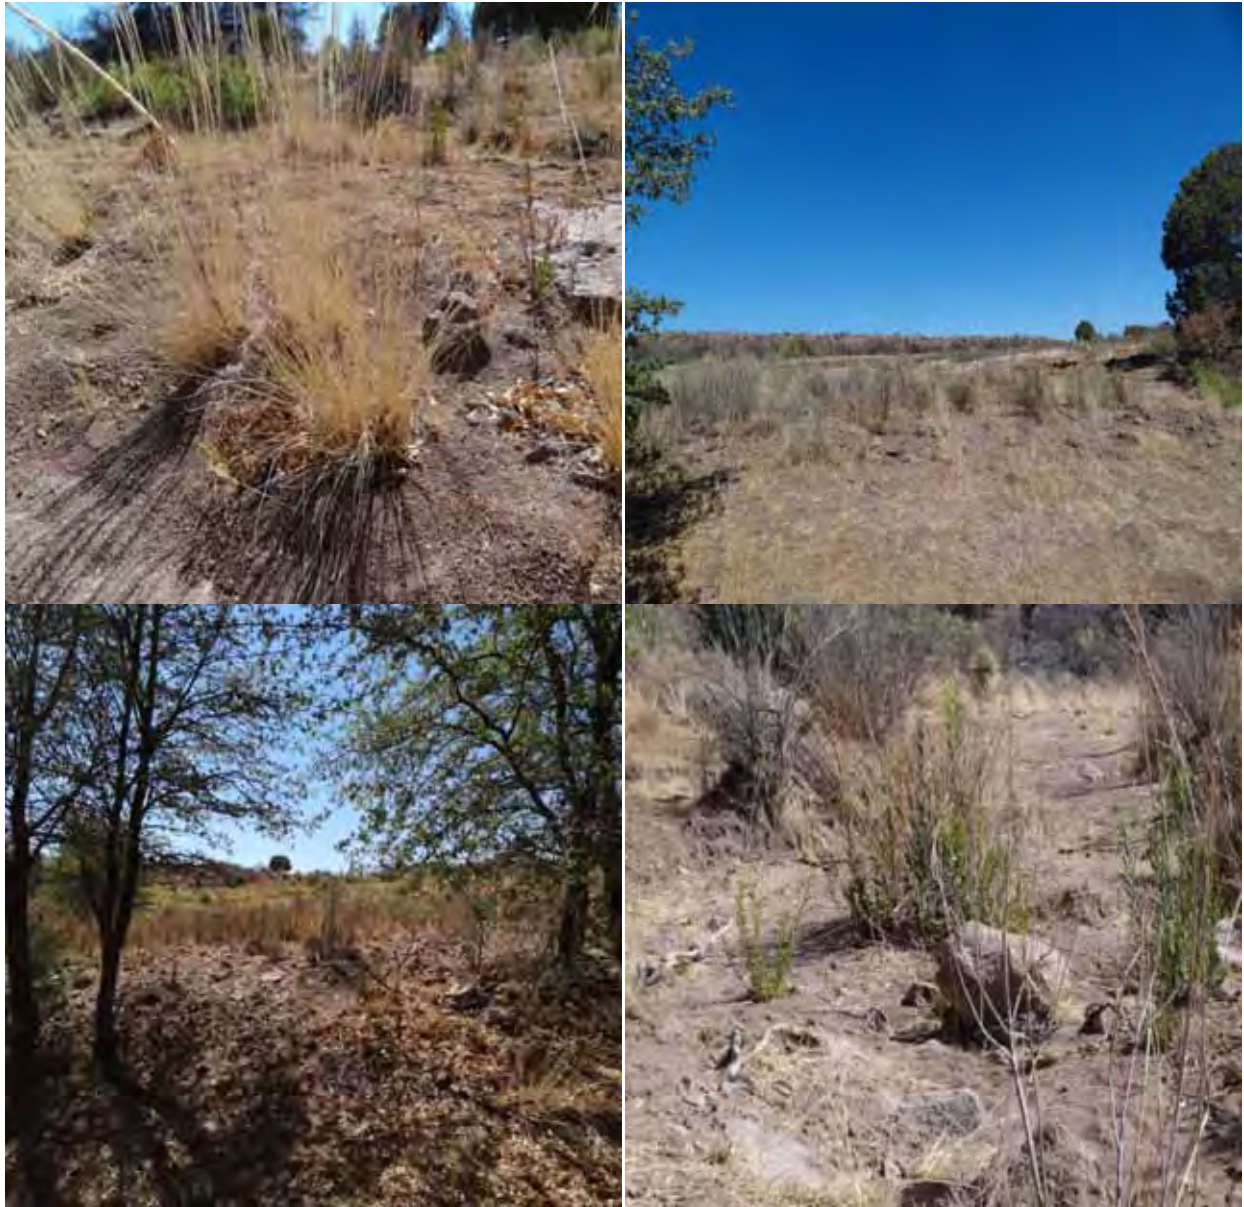
B7-3: Photographic reference for indicators 1.5 and 1.6. Photographs of bank/upland area and rooted in channel vegetation. There is a variation in vegetative density but no dramatic difference in composition. Rooted vegetation consistent across channel and banks.

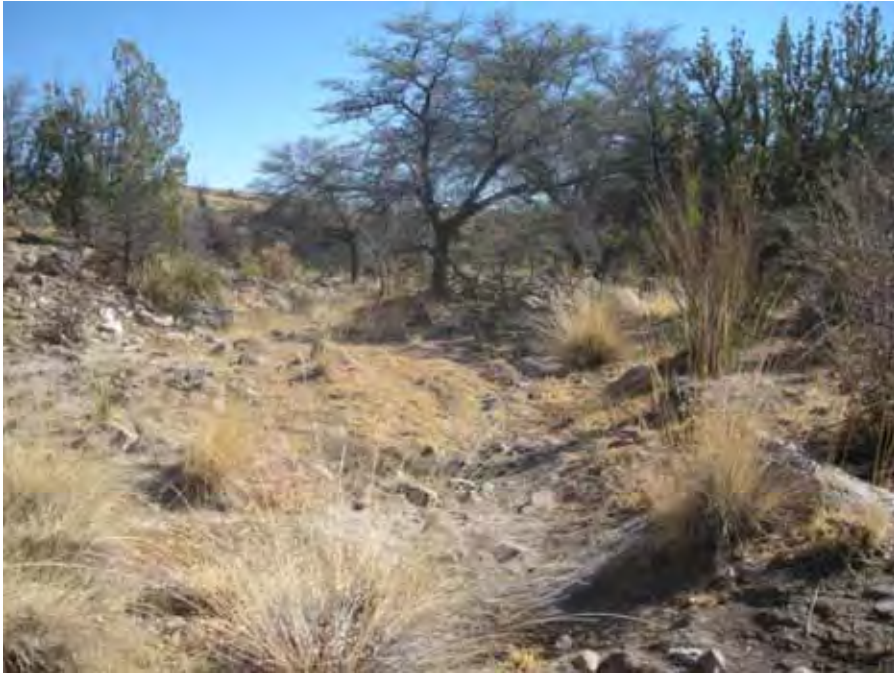
B7 DS-1: Photographic reference for indicator 1.1 through 1.6. Indicator 1.6 scored as 1 - rooted vegetation along the stream bed is consistently dispersed. No water or biotic indicators of water observed along survey reach.

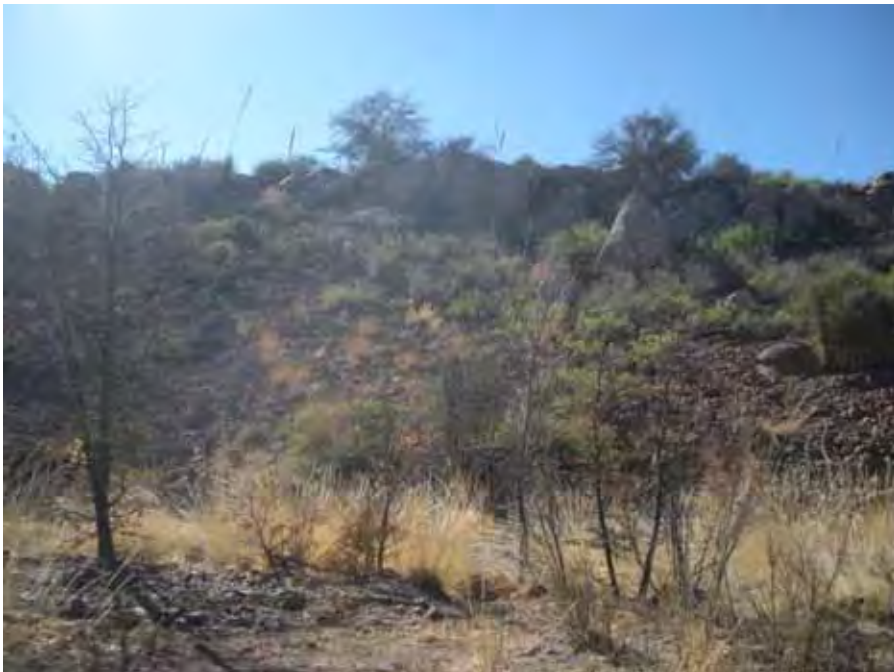
B7 DS-2: Photographic reference for indicator 1.5. Photograph of the overbank area and uplands. Indicator 1.5 scored as 1 - evident variation in vegetative density but no dramatic difference in composition. No distinct riparian zone observed.

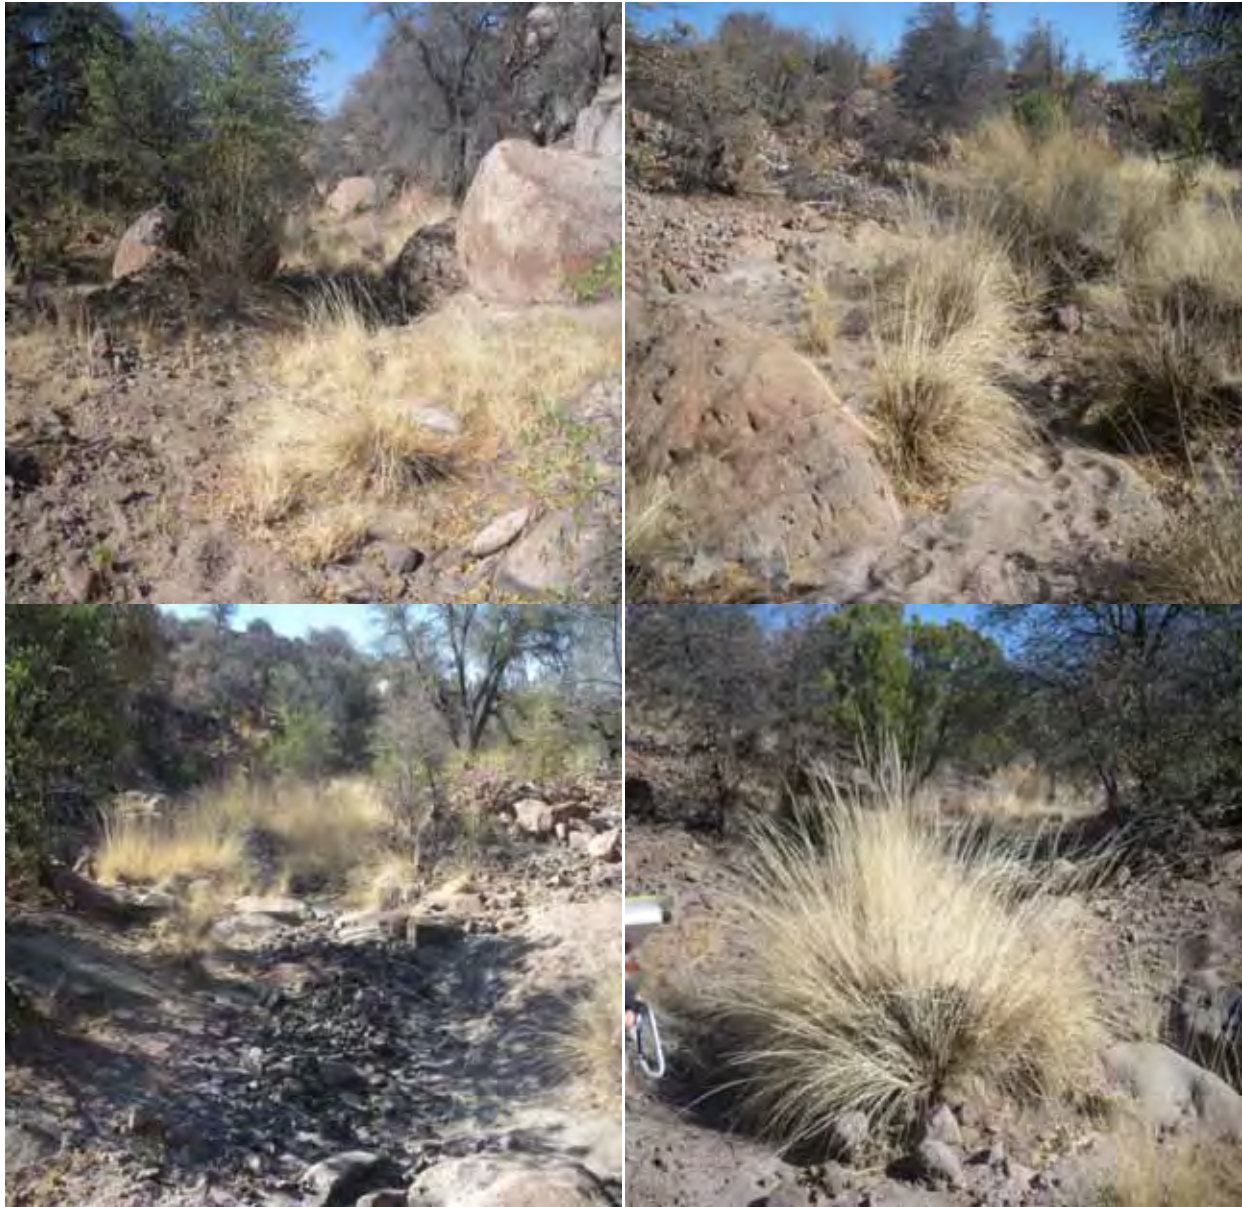
B7 DS-3: Photographic reference for indicators 1.5 and 1.6. Photographs of in stream rooted plants and overbank/upland areas. Evident variation in vegetative density but no dramatic difference in composition and rooted vegetation along the stream bed is consistently dispersed.

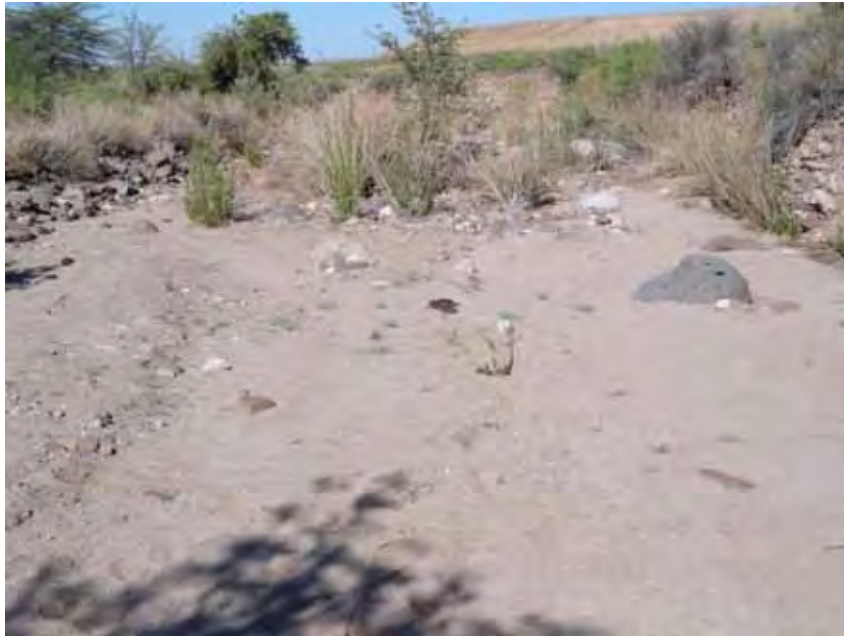
B8-1: Photographic reference for indicator 1.1 through 1.6. Photograph of typical channel bed and channel banks. Indicator 1.6 scored as 2 - rooted vegetation inconsistently present in stream bed. No water or biotic indicators of water observed along survey reach.

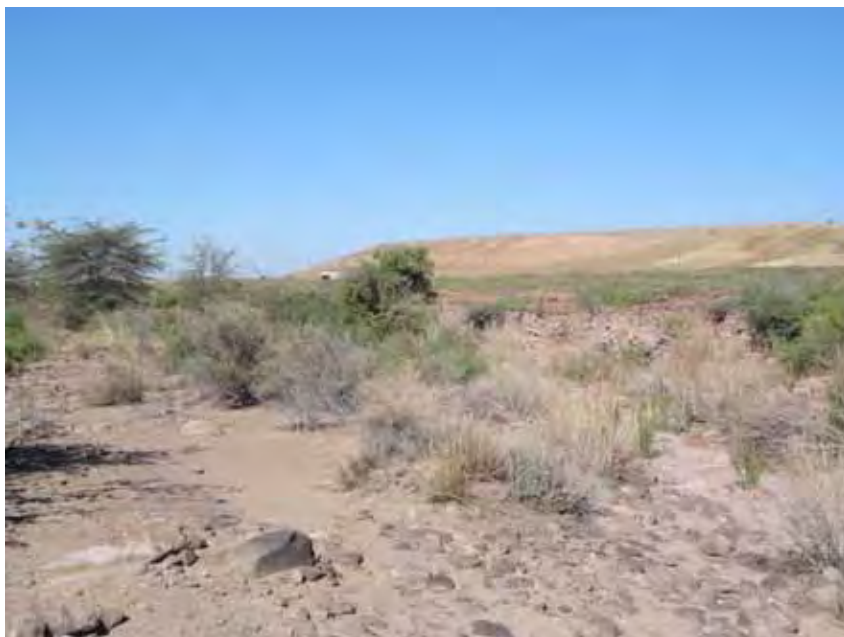
B8-2: Photographic reference for indicator 1.5. Photograph of bank and upland area. No dramatic differences between channel bank vegetation and upland vegetation. Indicator 1.5 scored as 1 - evident variation in vegetative density but no dramatic difference in composition. No distinct riparian zone present.

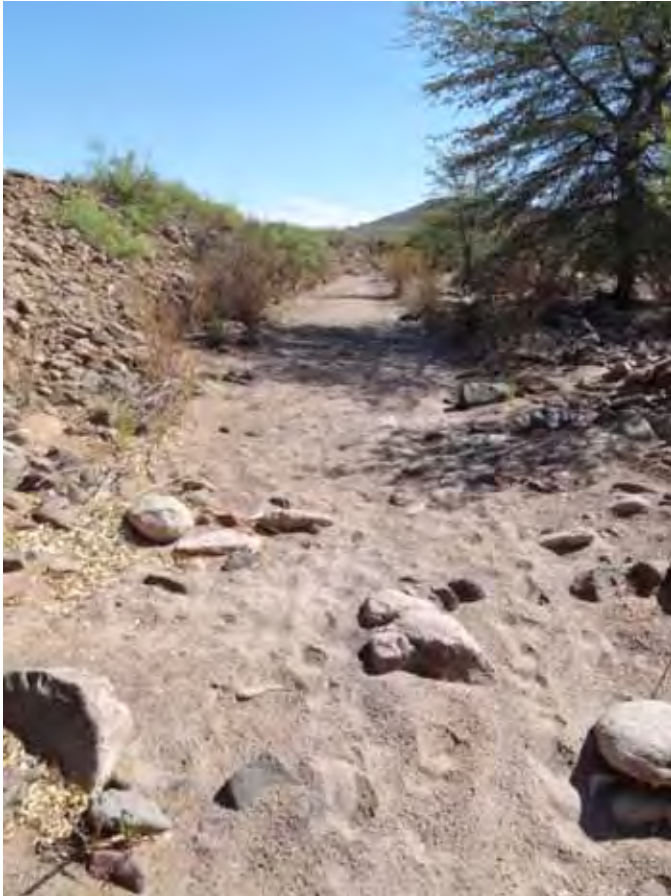
B8-3: Photographic reference for indicator 1.6 and 1.9. Portions of the stream bed along the reach are devoid of vegetation while other portions are vegetated (see previous photograph). Lack of vegetation is likely the result of the flow regime and the bed material rather than an indicator of water persistence. Indicator 1.6 scored as 2 - few rooted upland plants present along streambed.

Indicator 1.9 scored as 0 - no riffle-pool sequence observable.

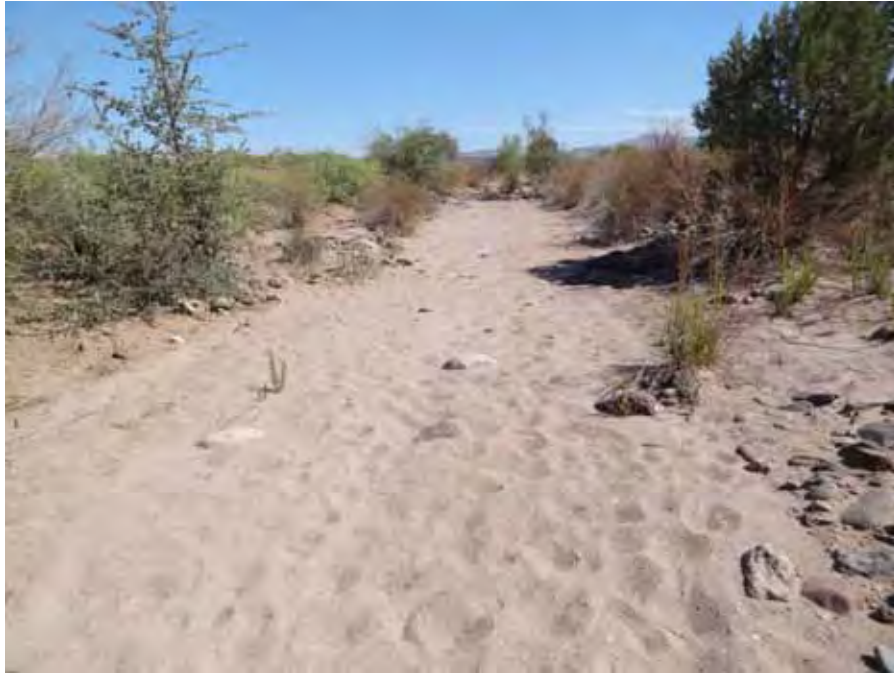
B8-4: Photographic reference for indicator 1.8 and 1.10. Photograph of the cross-section for measurement of the floodplain and channel dimensions. Indicator 1.8 scored 1.5 based on measurements taken - moderate confinement and presence of inactive floodplain.

Indicator 1.10 scored as 1.5. Channel bed material is medium to coarse sand, which is consistent but noticeably courser than the bank and over bank area. Little to no substrate sorting is observable.

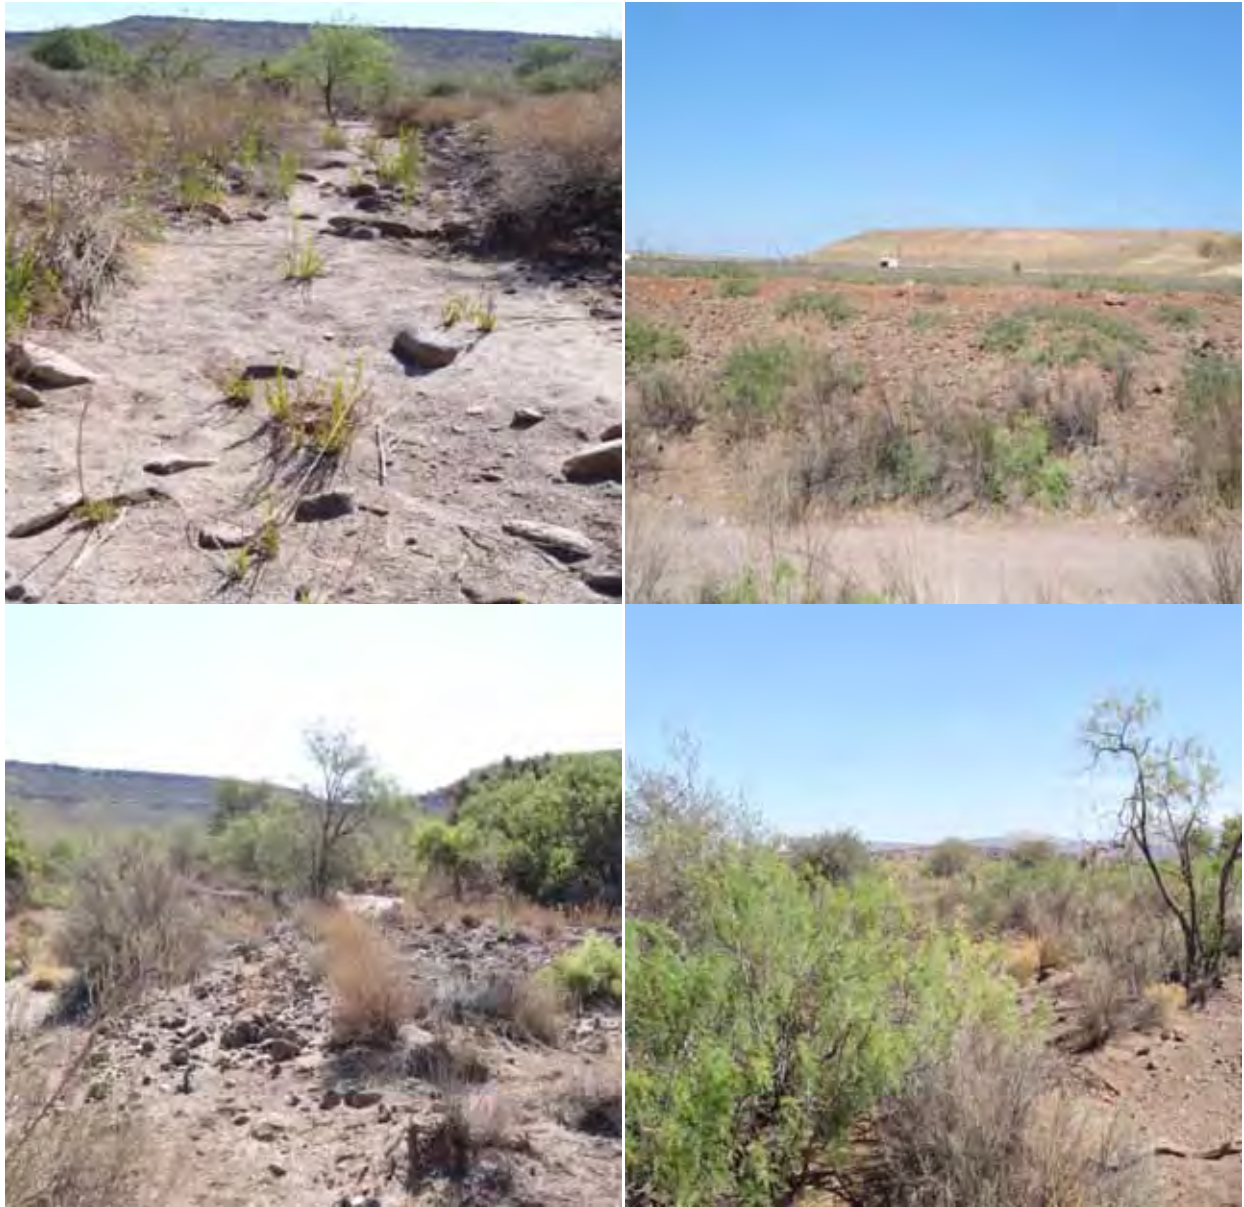
B8-5: Photographic reference for indicators 1.5 and 1.6. Photographs of bank/upland area and rooted in channel vegetation. There is a variation in vegetative density but no dramatic difference in composition. Rooted vegetation inconsistent across channel and banks.

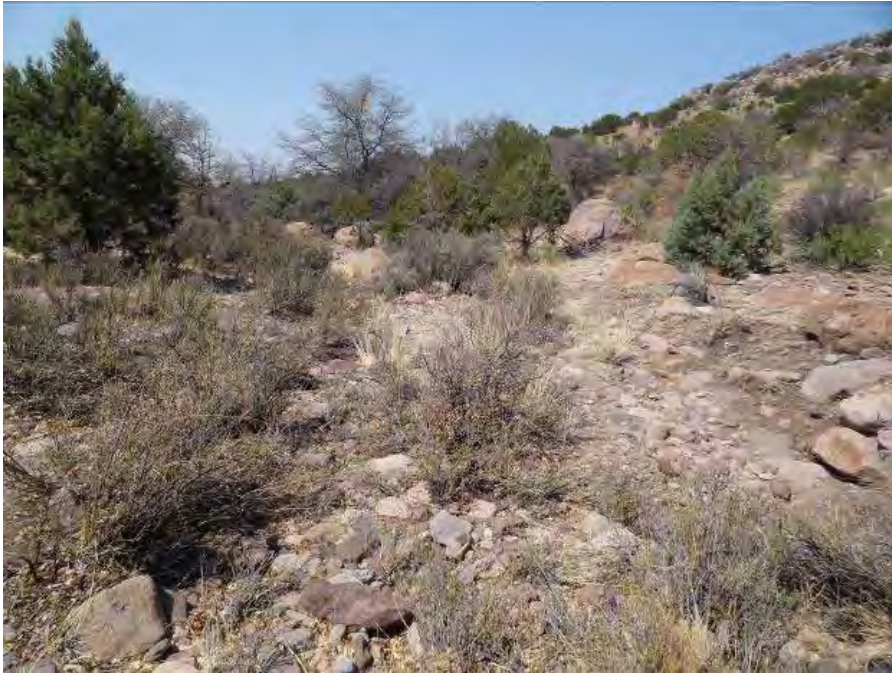
C19-1: Photographic reference to representative channel bottom characteristics.

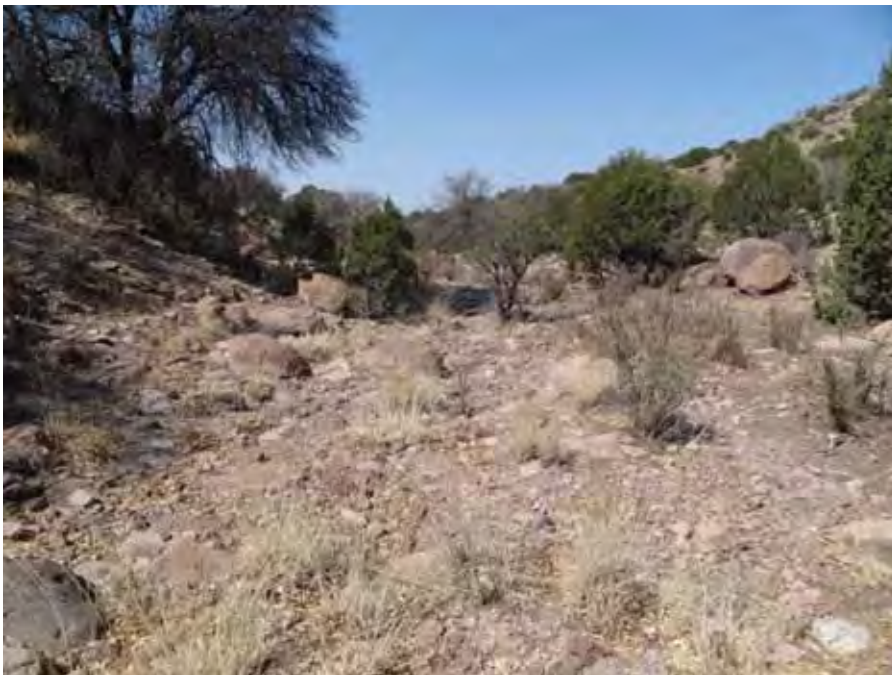
C19-2: Photographic reference for indicators 1.1 through 1.6. Photograph from upper extent of survey reach facing downstream. Rooted vegetation present in channel is present but inconsistent (see subsequent photograph). No water or biotic indicators of water observed along survey reach.

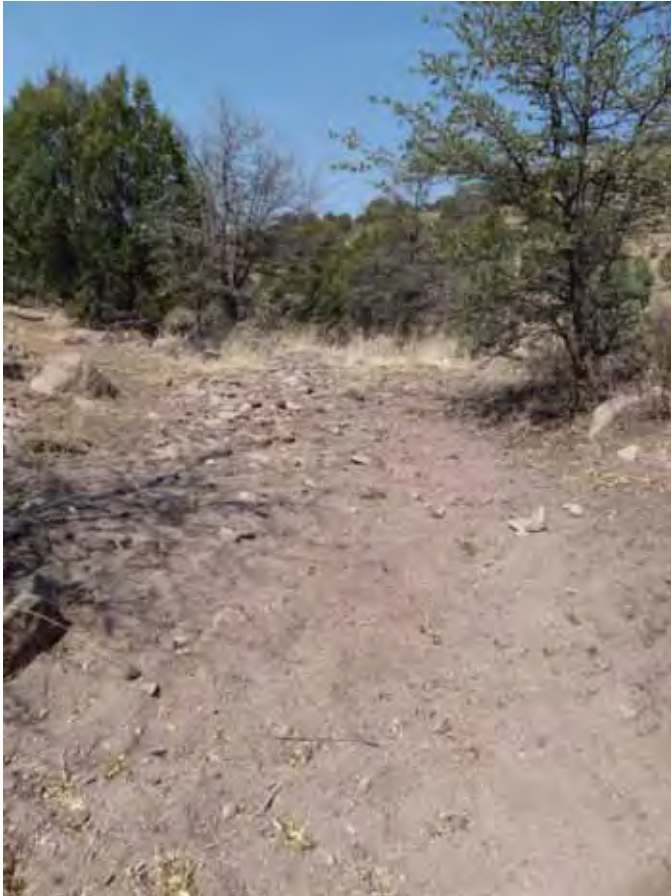
C19-3: Photographic reference for indicator 1.6. Portions of the survey reach devoid of vegetation as a result of bed material and lack of moisture rather than an indicator of persistence of flow. Indicator 1.6 scored as 1 – few rooted plants present in streambed.

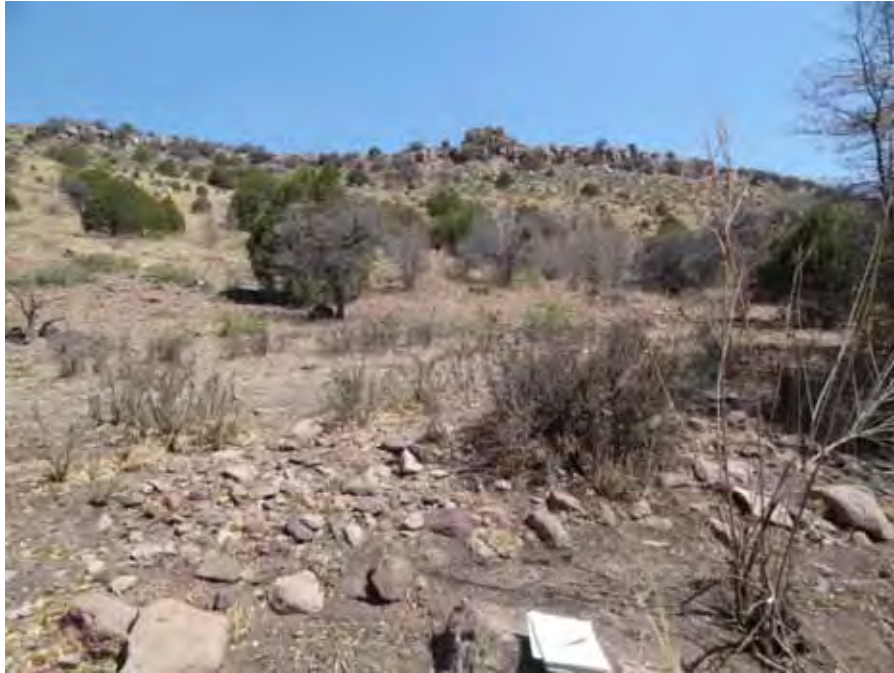
C19-4: Photographic reference for indicator 1.5. Photograph of upland area and upland vegetation. Indicator 1.5 scored as 1 - evident variation in vegetative density but no dramatic difference in composition. No distinct riparian zone observed.

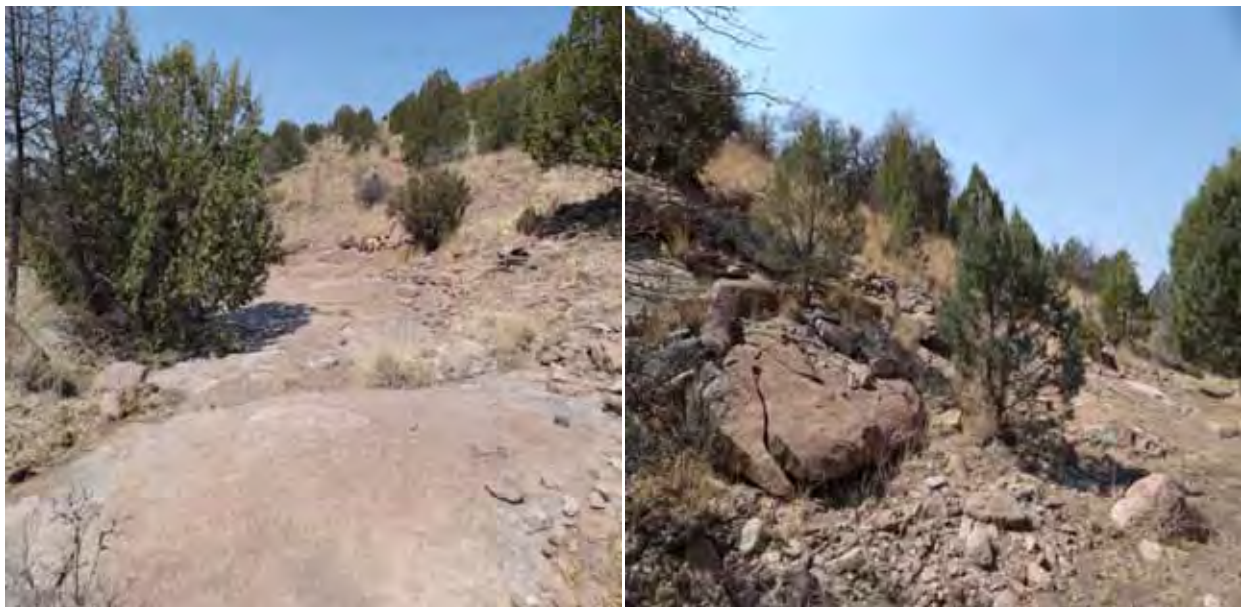
C19-5: Photographic reference for indicators 1.5 and 1.6. There is a variation in vegetative density but no dramatic difference in composition. Portions of the survey reach few rooted plants present in streambed as a result of bed rock in channel.

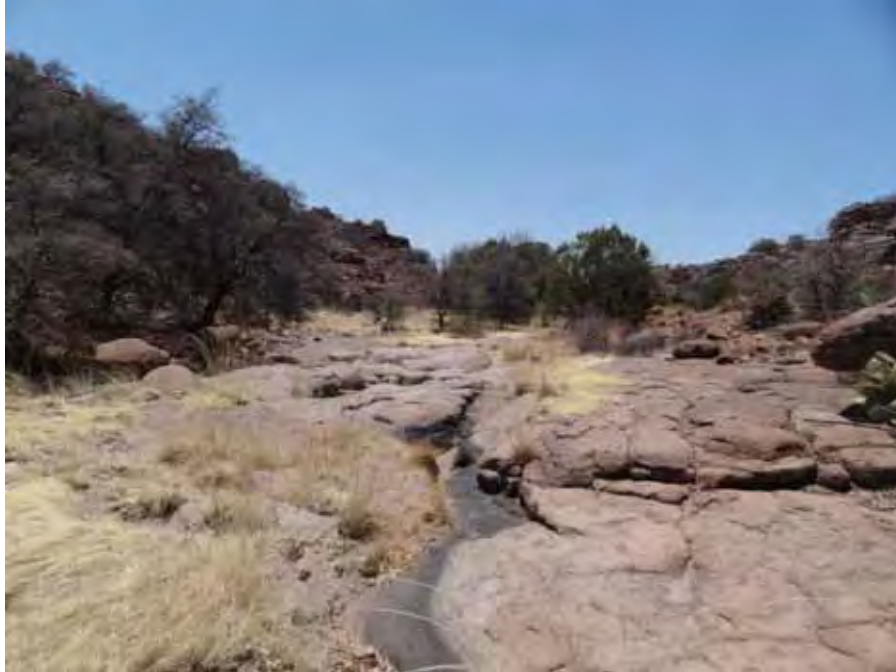
C4-1: Photographic reference for indicator 1.1 to 1.6. Streambed is predominantly bedrock. Vegetation present where deposition has occurred. No water or biotic indicators of water observed along survey reach.
