**Application of the Hydrology
Protocol to STSIU Drainages**

Chino Mines, Vanadium, New Mexico

October 2014

**Application of Hydrology
Protocol to STSIU Drainages**

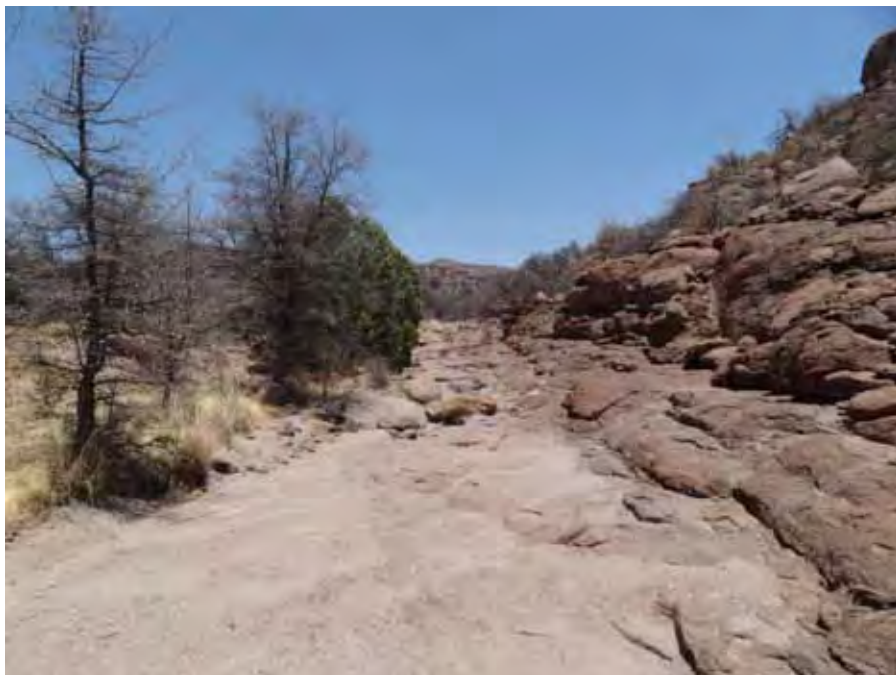
C4-2: Photographic reference for indicator 1.6. Indicator 1.6 scored as 2 – few rooted upland plants present in streambed. Lack of vegetation present in streambed likely result of flow regime and presence of bedrock rather than result of persistent water.

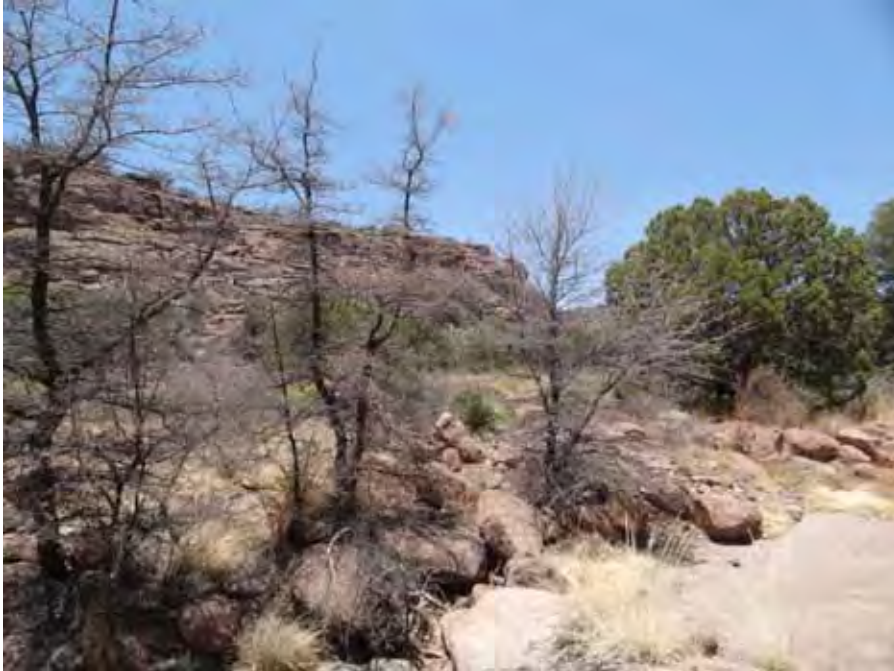
C4-3: Photographic reference for indicator 1.5. Photograph of bank and upland vegetation. Indicator 1.5 scored as 1 - evident variation in vegetative density but no dramatic difference in composition. No distinct riparian zone observed.

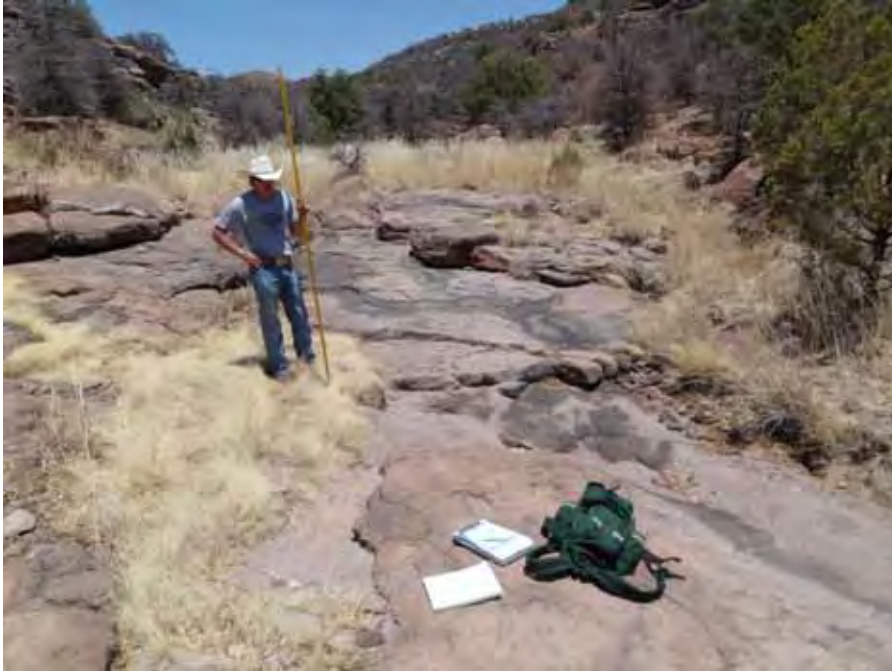
C4-4: Photographic reference for indicators 1.8 through 1.10. Photograph of the entrenchment transect location. Indicator 1.8 scored as 1.5 - stream is somewhat confined with an inactive floodplain.

Indicator 1.9 scored as 0 - no riffle-pool sequence observed (also refer to other photos).

Indicator 1.10 scored as 1.5 - particle sizes within the channel are similar to upland material but are noticeably larger (primarily sands and gravels where bedrock is not present).

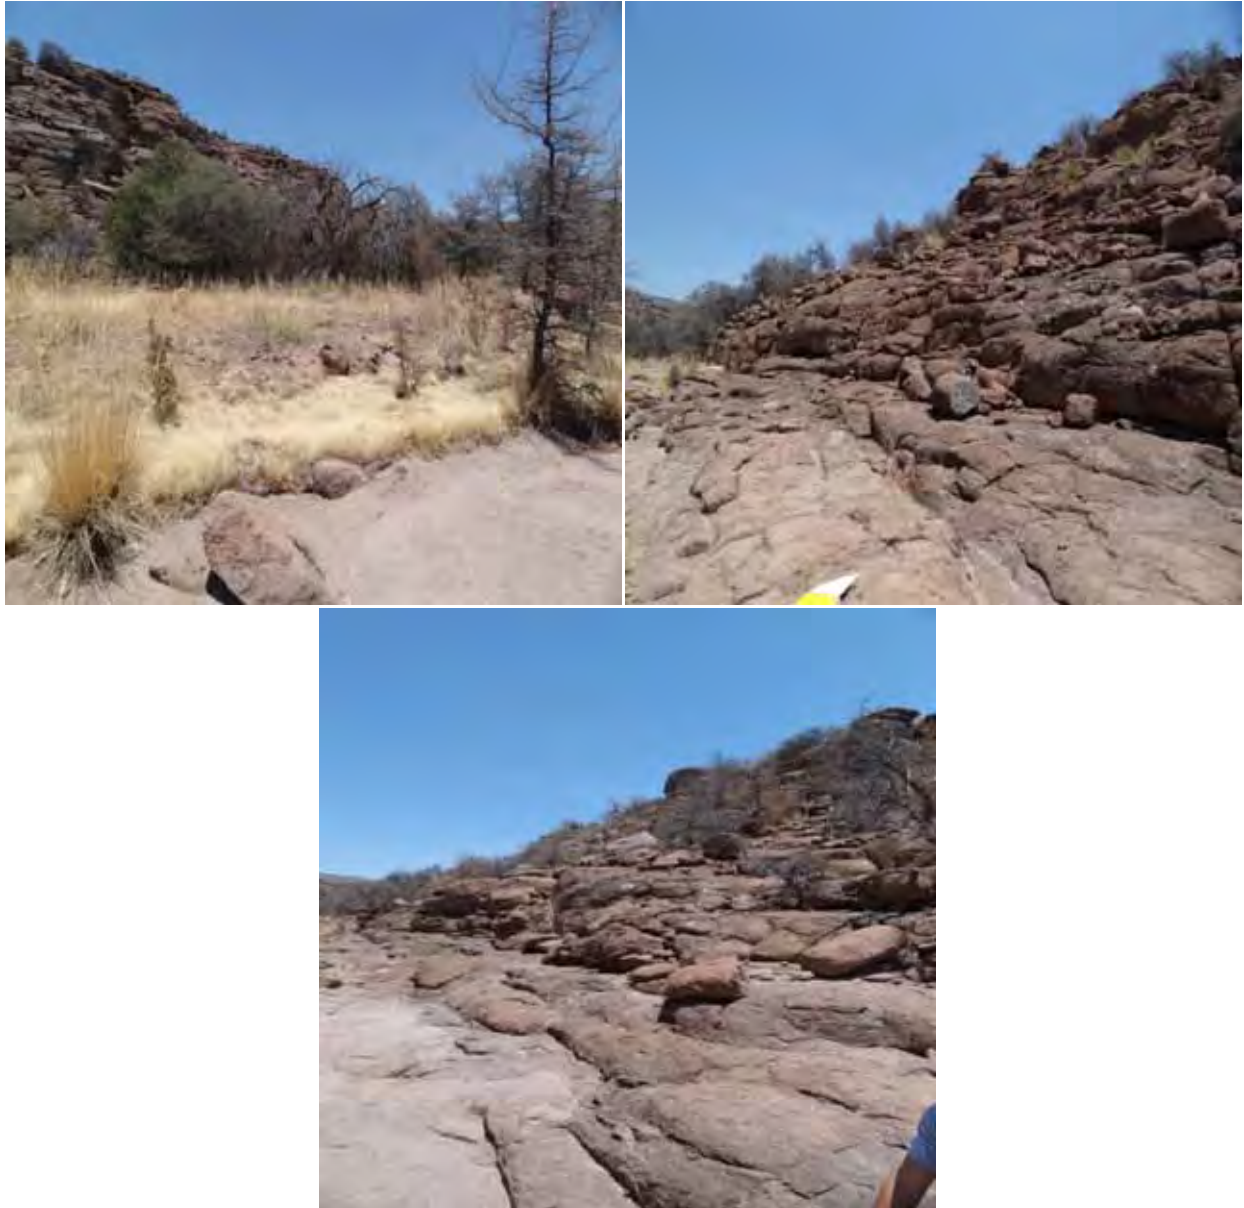
C4-5: Photographic reference for indicator 1.5. Photographs of bank and upland vegetation. Evident variation in vegetative density but no dramatic difference in composition. There is no distinct riparian vegetation corridor.

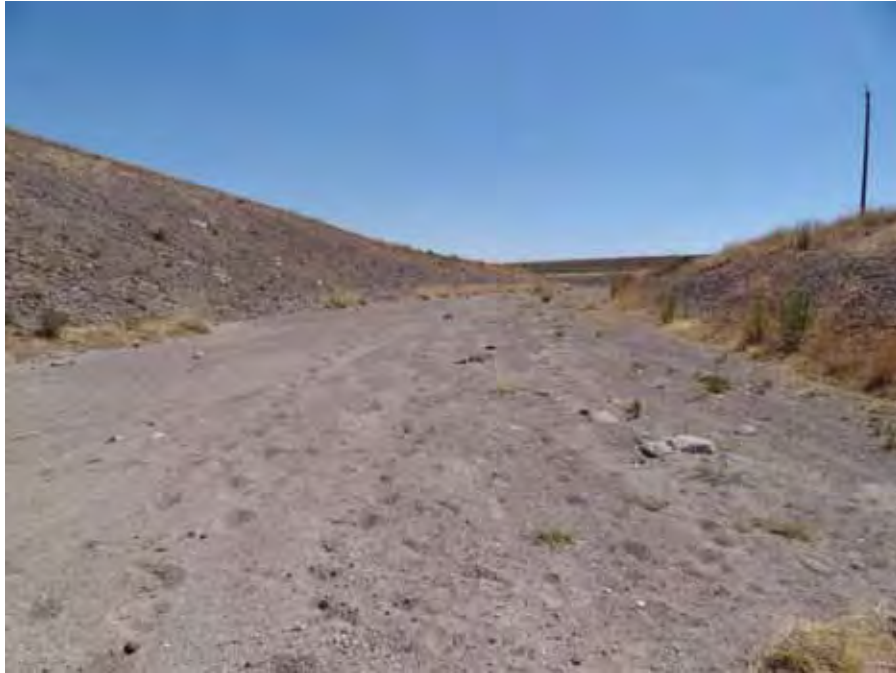
C5-1: Photographic reference for indicators 1.1 through 1.6. Indicator 1.6 scored as 2 – few rooted plants in the streambed. Lack of rooted plants is likely the result of the flow regime and granular bed material present rather than persistence of flow. No water or biotic indicators of water observed.

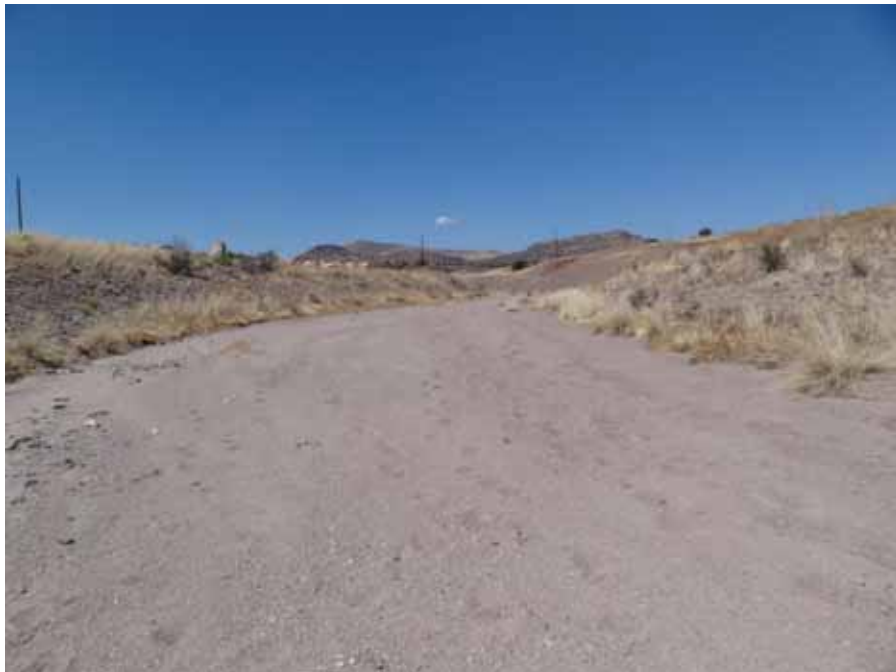
C5-2: Photographic reference for indicator 1.5. Indicator 1.5 scored as 0. Vegetation along streambank and uplands is sparse but consistent with no compositional or density differences between the two areas observed. Also refer to previous photograph.

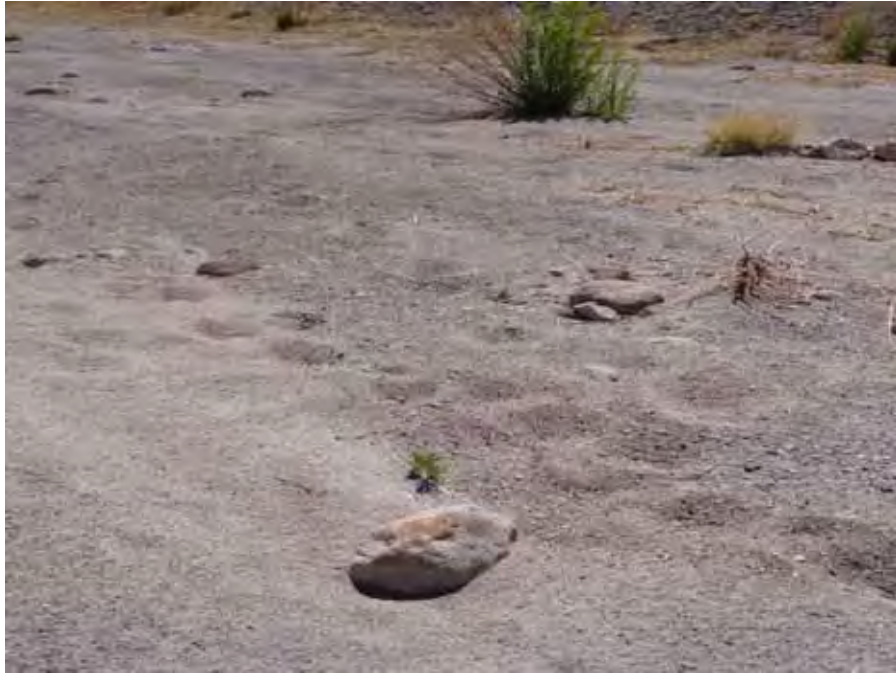
C5-3: Photographic reference for indicator 1.6. Few rooted plants in the streambed. Lack of rooted plants is likely the result of granular bed material present.

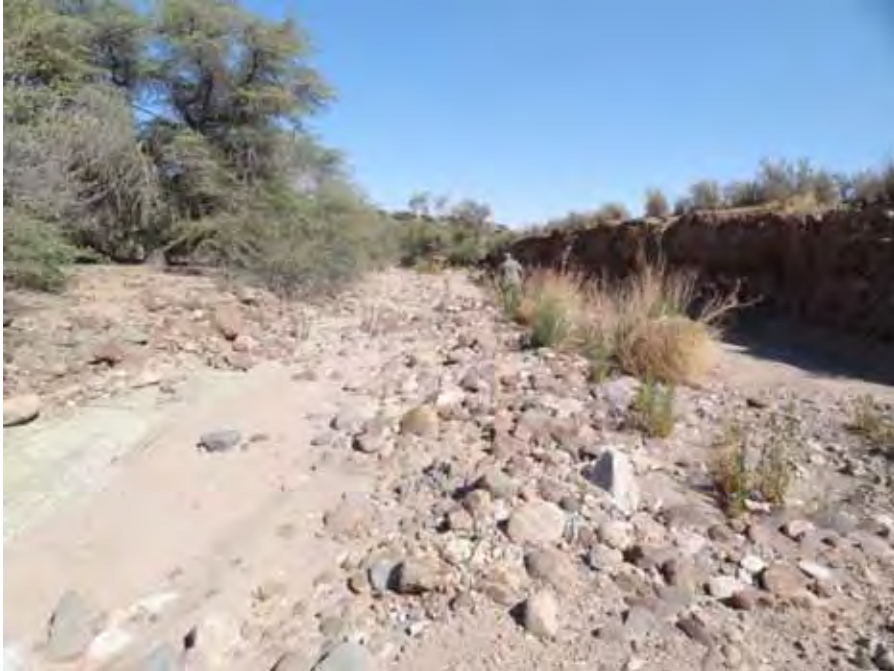
C6-1: Photographic reference for indicators 1.1 through 1.6. Indicator 1.6 scored as 2. Few rooted plants present in the streambed but inconsistently present. Lack of rooted plants is likely the result of the flow regime and granular bed material present rather than persistence of flow. No water or biotic indicators of water observed along survey reach.

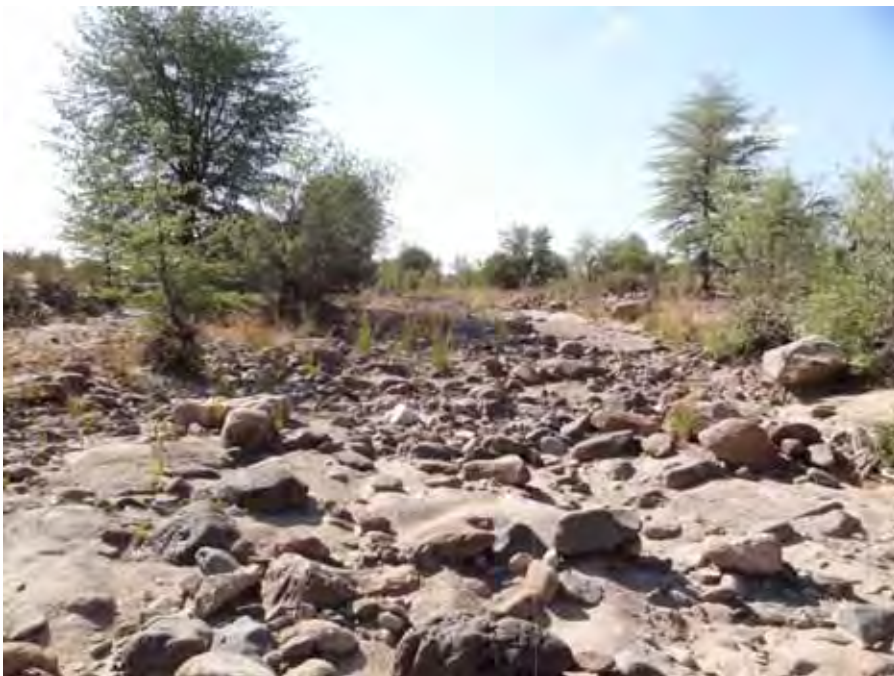
C6-2: Photographic reference for indicator 1.5. Indicator 1.5 scored as 1 - evident variation in vegetative density but no dramatic difference in composition. No distinct riparian zone observed.

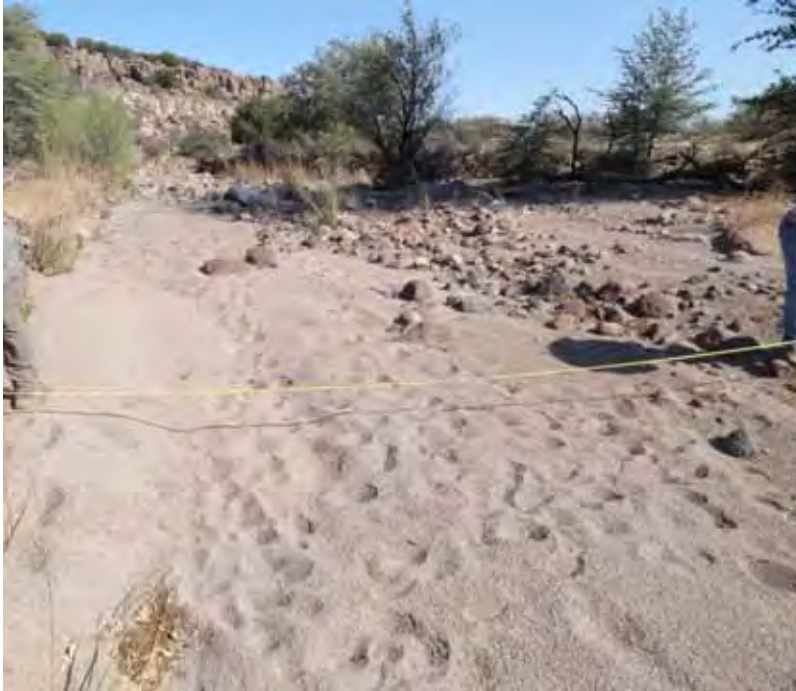
C6-3: Photographic reference for indicator 1.8. Location of transect shown. Indicator 1.8 scored as 1.5. Stream is somewhat confined with an inactive floodplain.

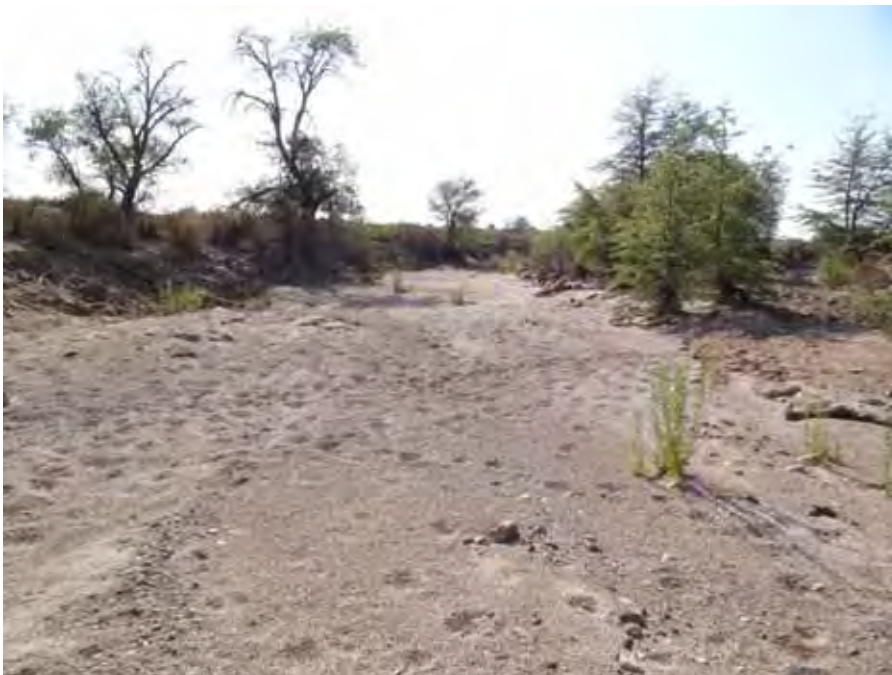
C6-4: Photographic reference for indicator 1.9 and 1.10. Indicator 1.9 scored as 0 - riffle-pool sequence not observable along survey reach. Indicator 1.10 scored as 1.5 - particle sizes of the channel bed material is primarily coarse sand and gravel which is similar to but coarser than the material of the upland area. Substrate sorting not evident.

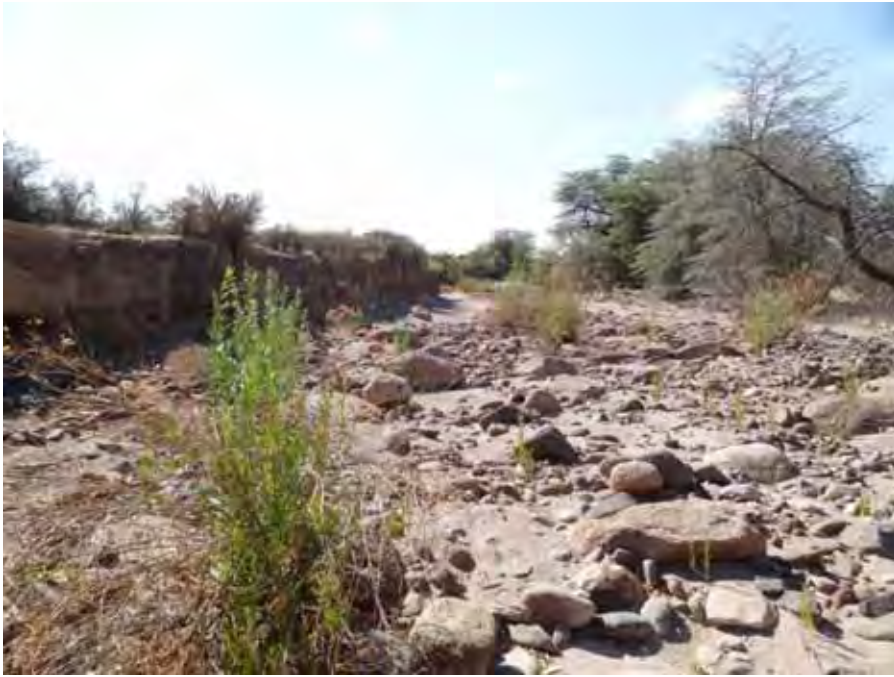
C6-5: Photographic reference for indicator 1.6. Few rooted plants present in the streambed but inconsistently present. Lack of rooted plants is likely the result of granular bed material present.

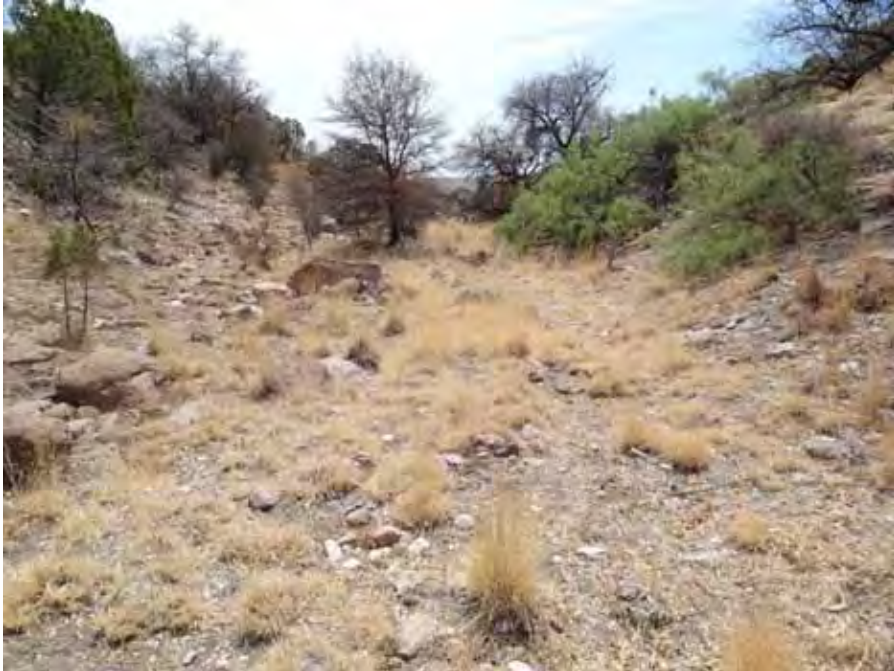
D1-1: Photographic reference of representative channel bottom characteristics. Note large boulders and cobbles in stream channel, similar to those observed on hillside.

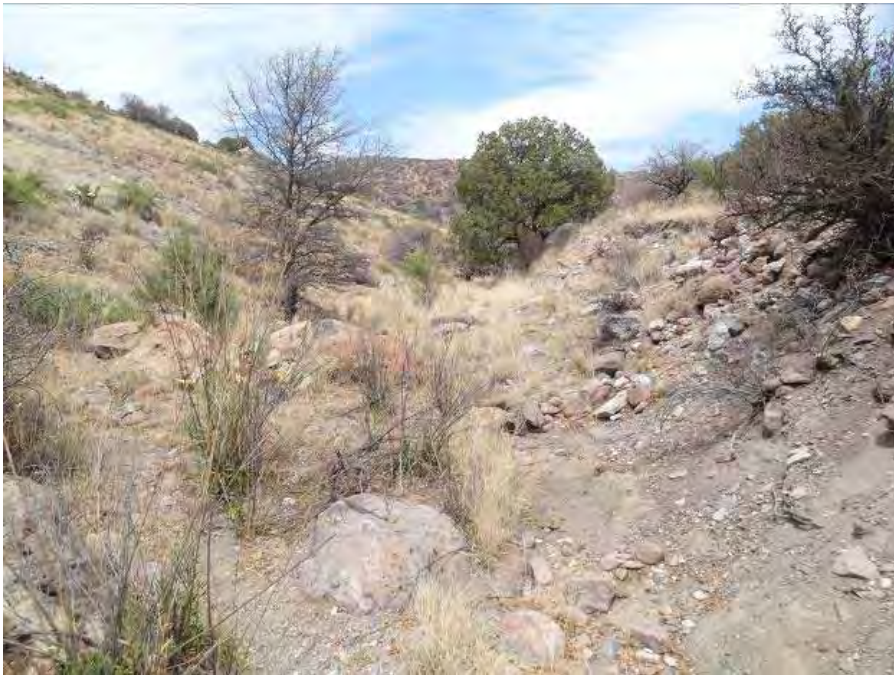
D1-2: Photographic reference of representative channel bottom characteristics. Note large boulders and cobbles in stream channel, similar to those observed on hillside.

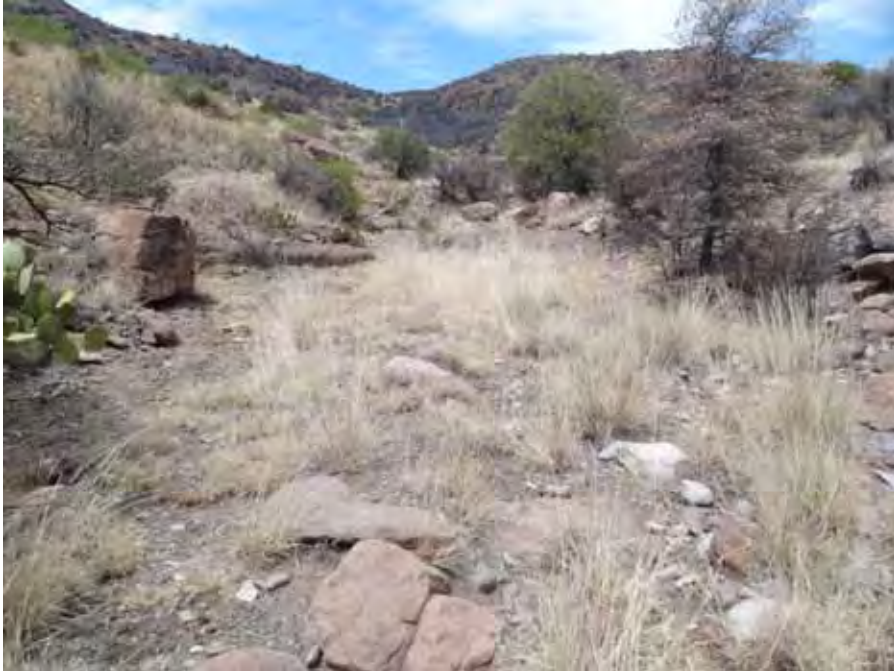
D1-3 Photographic reference for indicator 1.1 through 1.6. Typical view of stream bed and banks. Indicator 1.6 scored as 1 - rooted plants are prevalent and consistently dispersed in the streambed. No water or biotic indicators of water observed along survey reach.

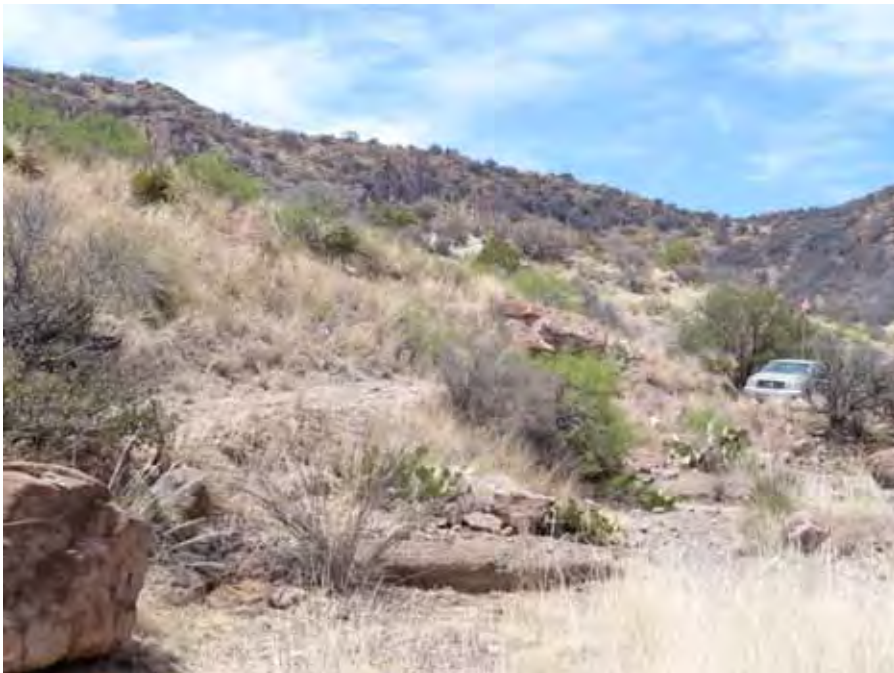
D1-4: Photographic reference for indicator 1.5. Photograph of typical vegetation in the upland region of the survey reach. Indicator 1.5 scored as 0. Upland vegetation composition and density similar to stream and stream banks shown in previous photograph.

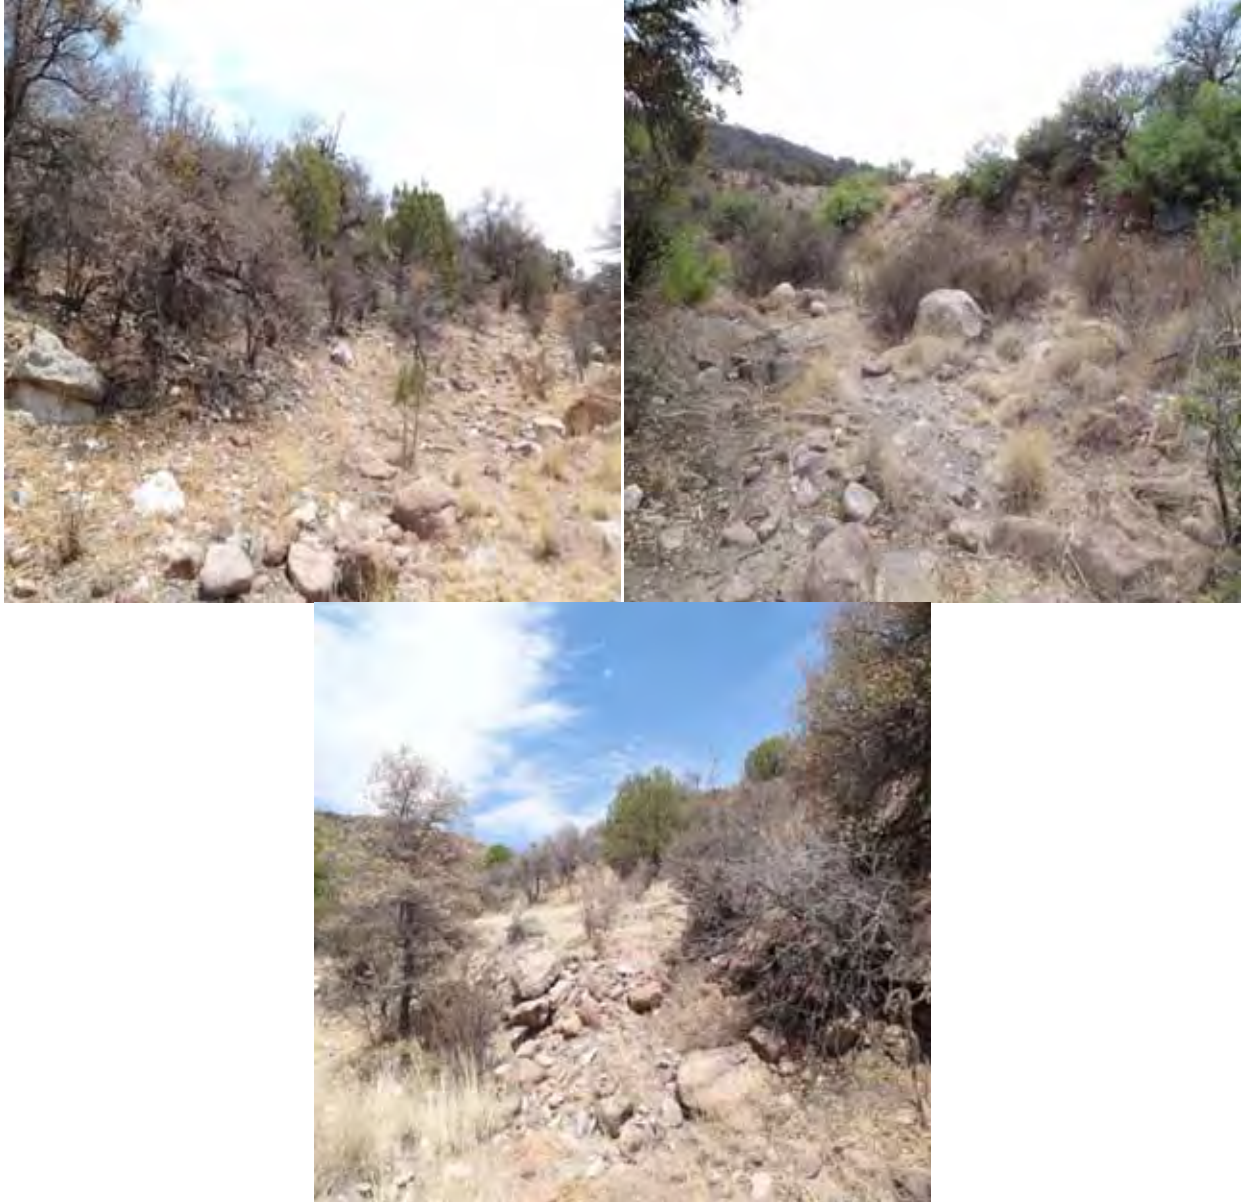
D1-5: Photographic reference for indicators 1.5 and 1.6. Photographs of stream bed, the bank/upland area and rooted in channel vegetation. Upland vegetation composition and density similar to stream and stream banks. Rooted plants are prevalent and consistently dispersed in the streambed.

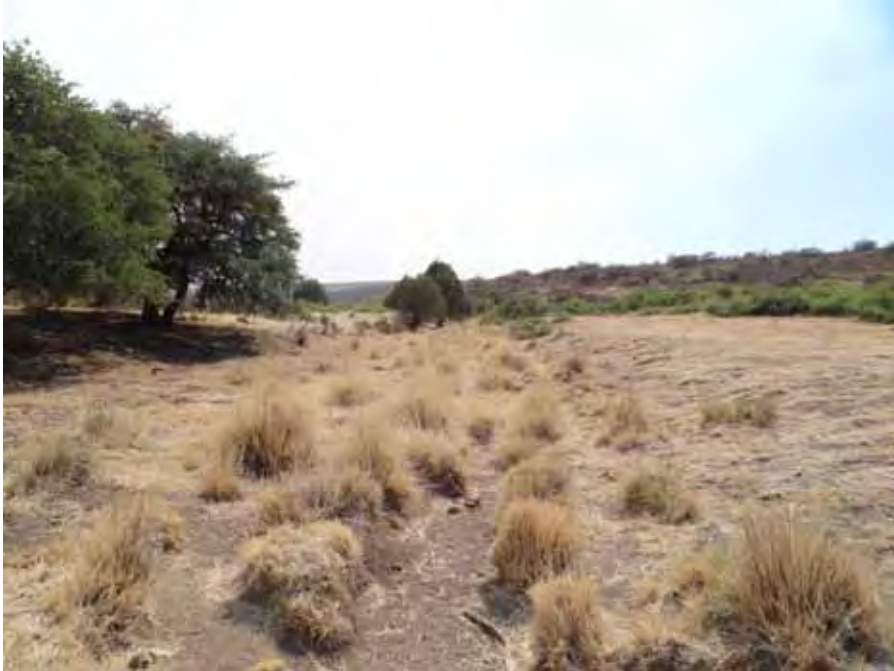
D1-2-1: Photographic reference for indicator 1.1 through 1.6. Indicator 1.6 scored as 0. Rooted plants present in the channel bed and are prevalent at similar density as the upslope area. No water or biotic indicators of water observed along survey reach.

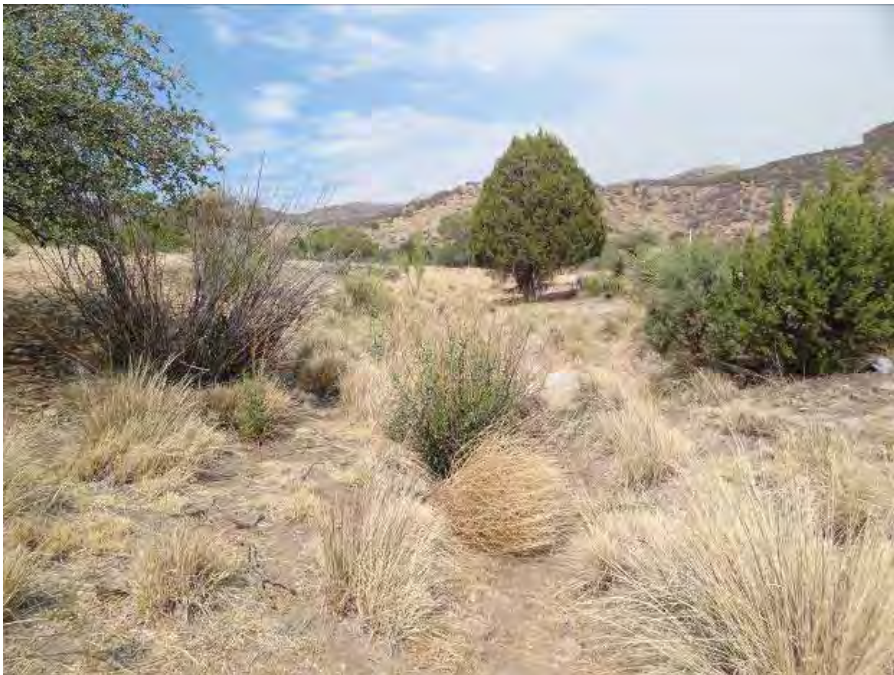
D1-2-2: Photographic reference of representative channel bottom characteristics. Note sand/gravel channel bottom with prevalent rooted upland plants throughout.

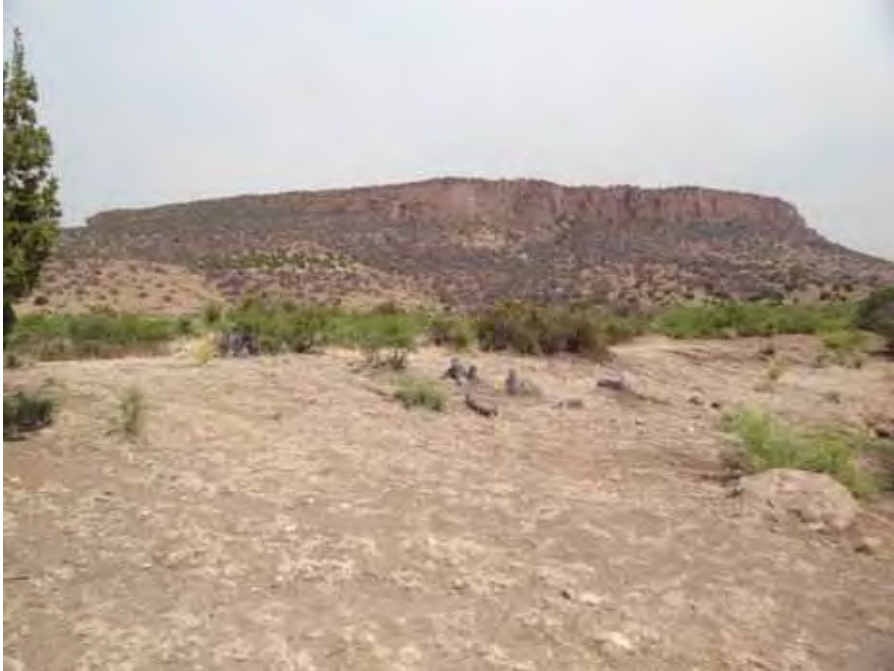
D1-2-3: Photographic reference for indicator 1.5. Photograph of the overbank and upland area. Indicator 1.5 scored as 1 - evident variation in vegetative density but no dramatic difference in composition. No distinct riparian zone observed.

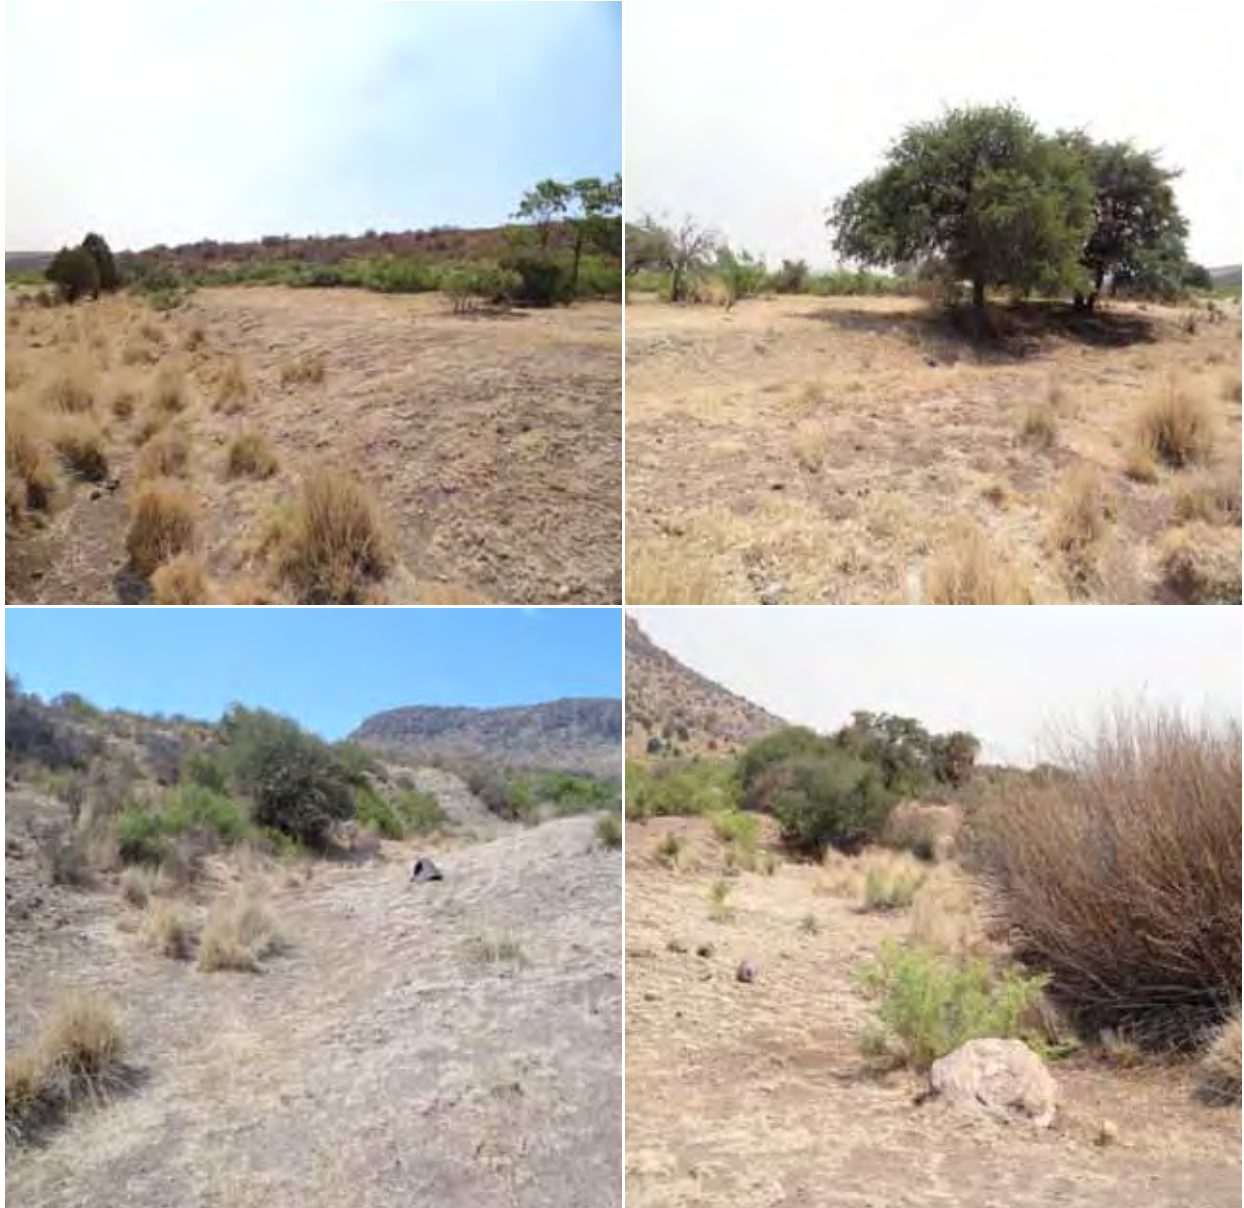
D1-2-4: Photographic reference for indicators 1.5 and 1.6. Photographs of stream bed, the bank/upland area and rooted in channel vegetation. There is an evident variation in vegetative density but no dramatic difference in composition. Rooted plants present in the channel bed and are prevalent at similar density as the upslope area.

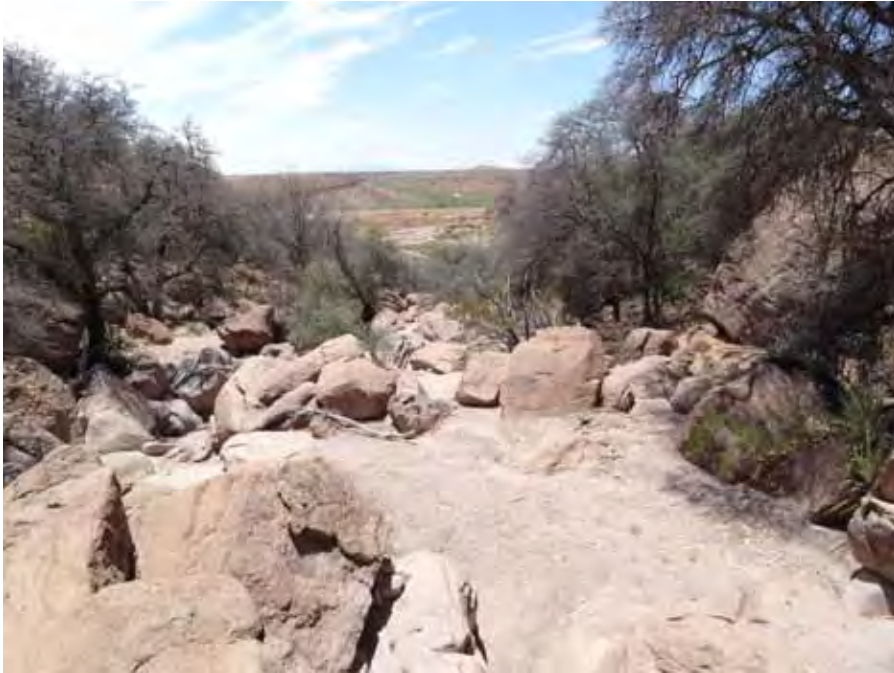
D2-1: Photographic reference of representative channel bottom characteristics. Note large boulders and cobbles in stream channel, similar to those observed on hillside. Note confining nature of hillsides.

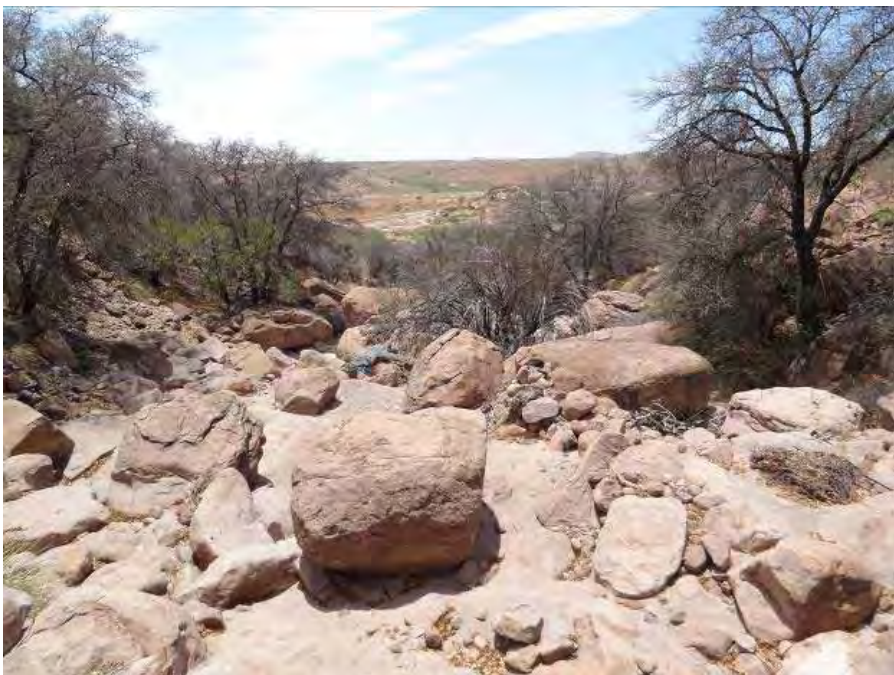
D2-2: Photographic reference of representative channel bottom characteristics. Note large boulders and cobbles in stream channel, similar to those observed on hillside. Note confining nature of hillsides.

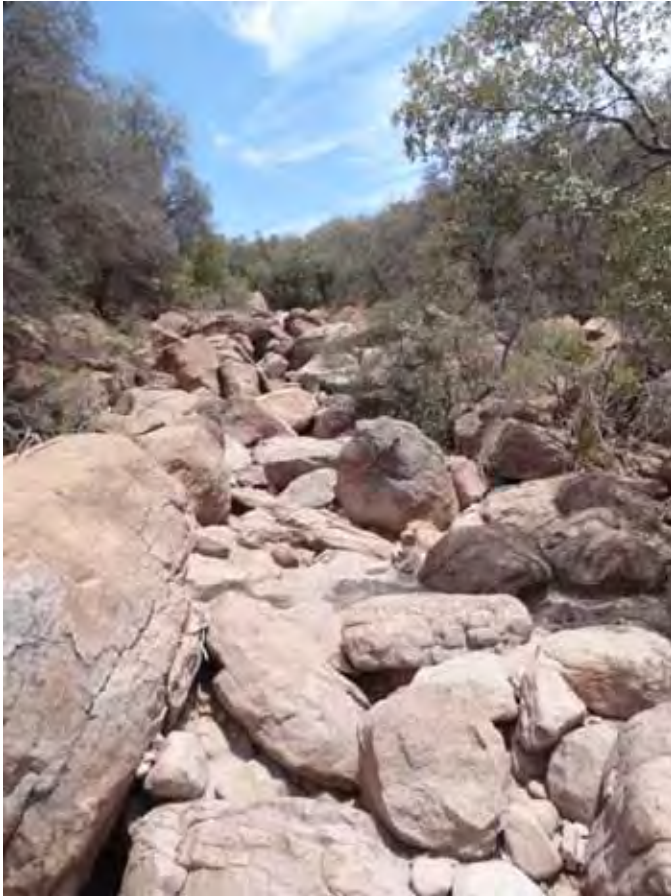
D2-3: Photographic reference for indicators 1.1 through 1.6. Indicator 1.6 scored as 2 – few rooted plants present in the streambed. Lack of instream vegetation most likely a result of the bed material present (boulders) rather than an indicator of flow persistence. No water or biotic indicators of water observed along survey reach.

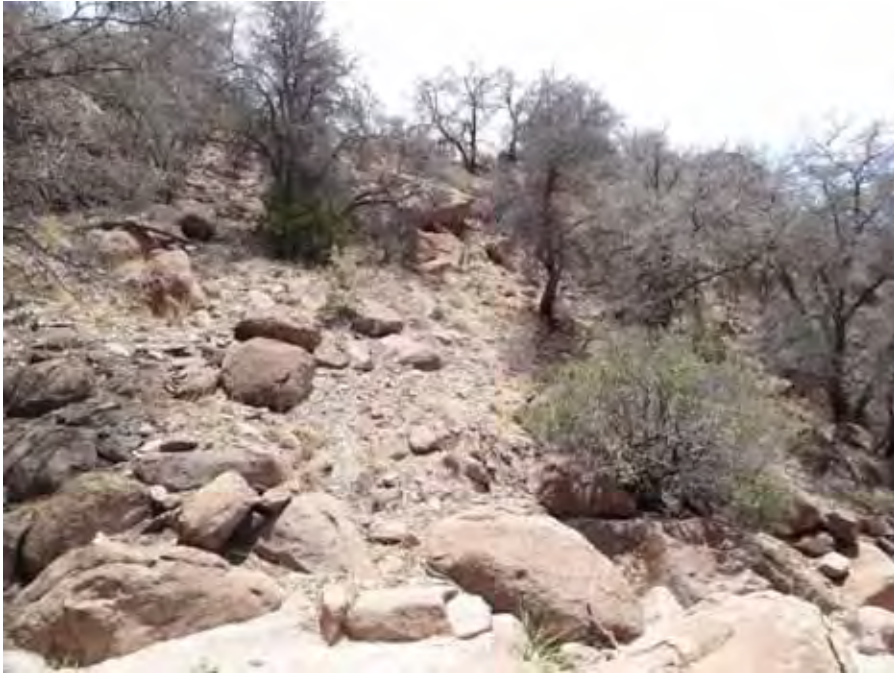
D2-4: Photographic reference for indicator 1.5. Photograph of bank vegetation (also observable in previous photograph) and the upland vegetation. Indicator 1.5 scored as 0. No vegetative compositional or density differences observed between the banks and the upland area.

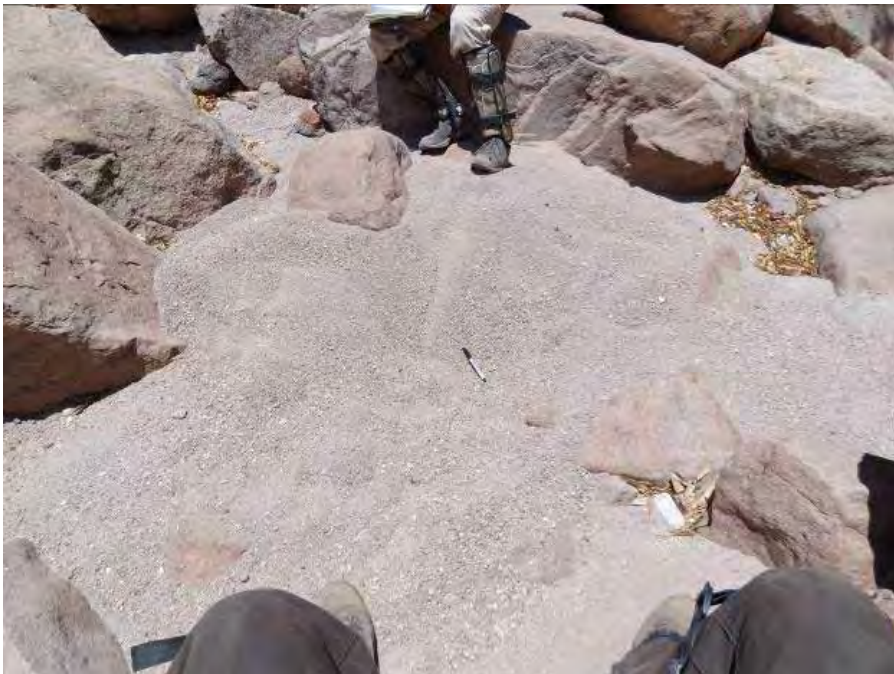
D2-5: Photographic reference for indicator 1.6. Lack of instream vegetation indicative of coarse mineral sediments and complete lack of moisture. Assessment unit representative of channel bottom characteristics. Note dry material sand sediments within channel.

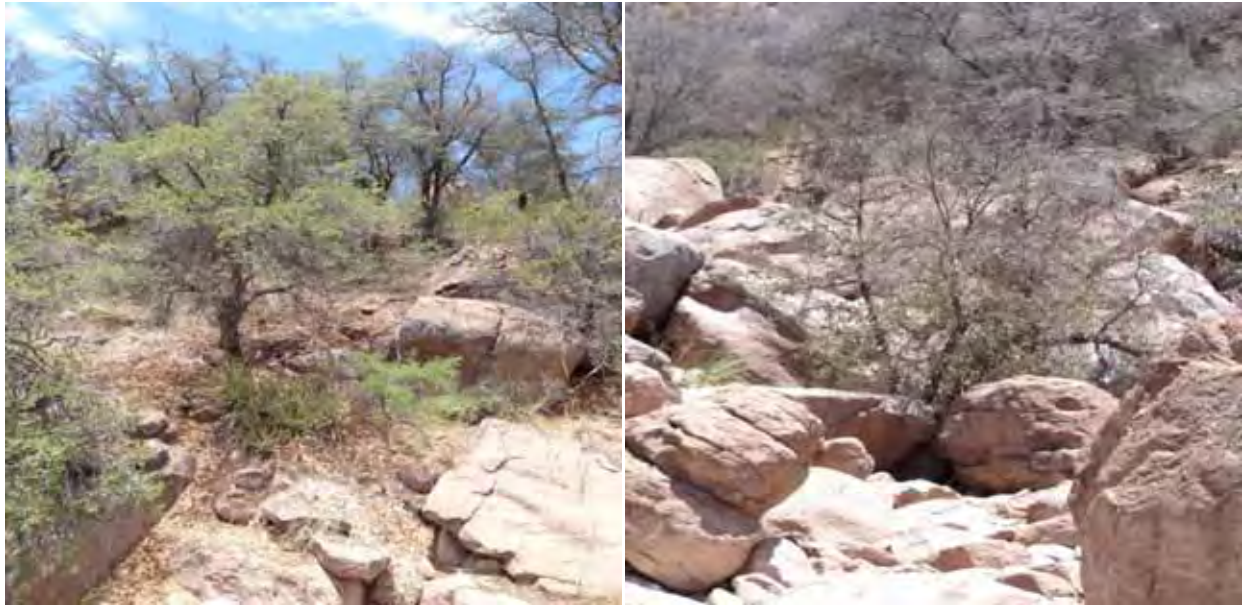
D2-6: Photographic reference for indicator 1.5. Photographs of stream bed, the bank/upland area and rooted in channel vegetation. There is no composition difference in vegetation between the bank and the upland area.

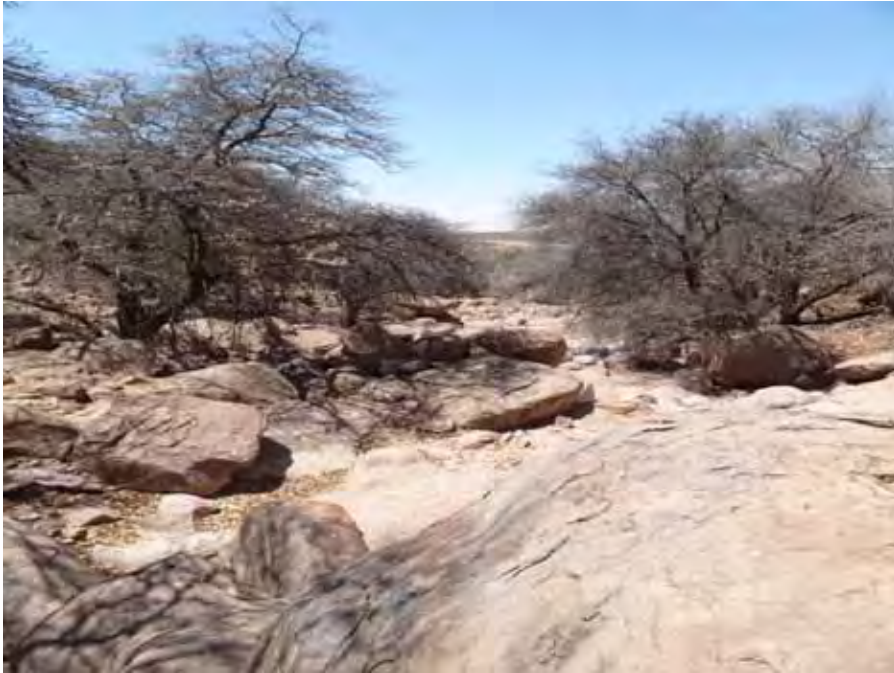
D3-1: Photographic reference of representative channel bottom characteristics. Note large boulders and cobbles in stream channel, similar to those observed on hillside. Note confining nature of hillside.

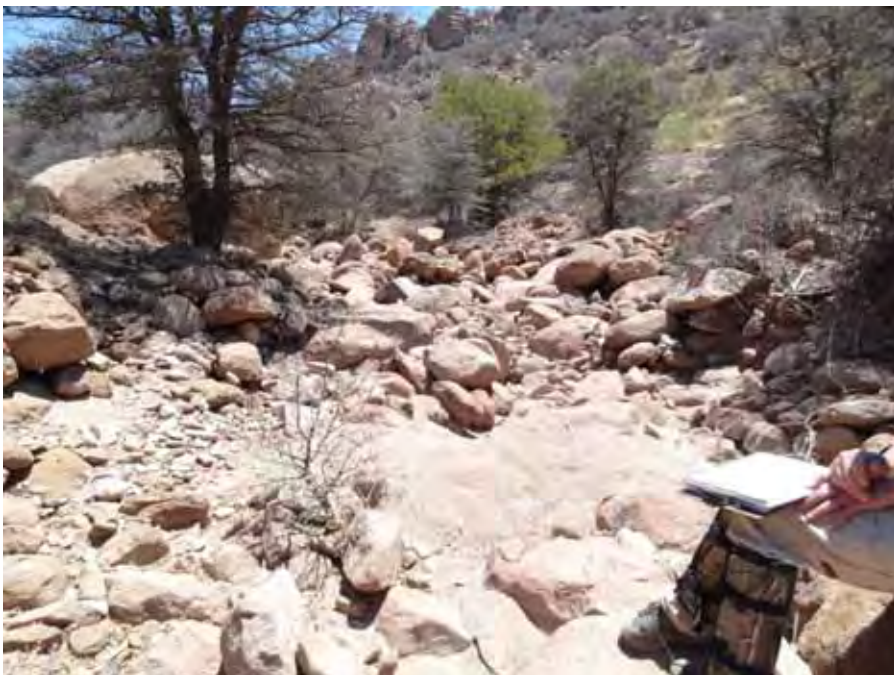
D3-2: Photographic reference for indicator 1.1 through 1.6. Photograph of stream bed. Indicator 1.6 scored as 2 – few rooted plants present in the streambed. Lack of instream vegetation most likely a result of the bed material present (boulders) rather than an indicator of flow persistence. No water or biotic indicators of water observed along survey reach.

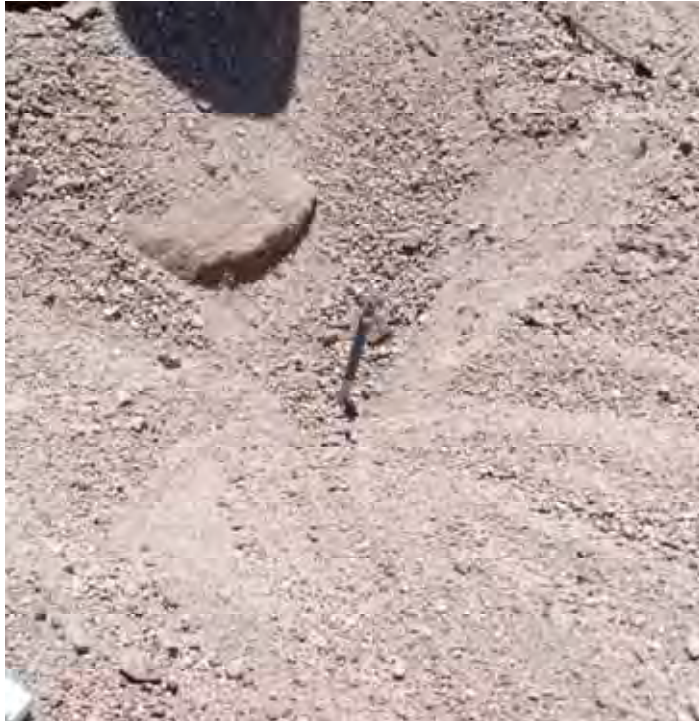
D3-3: Photographic reference for indicator 1.6. Photograph of 7 inch hole excavated in-channel. There is a complete lack of soil structure and moisture. Assessment unit is representative of channel bottom characteristics. Note dry mineral, sand sediments within channel.
