**Application of the Hydrology
Protocol to STSIU Drainages**

Chino Mines, Vanadium, New Mexico

October 2014

**Application of Hydrology
Protocol to STSIU Drainages**

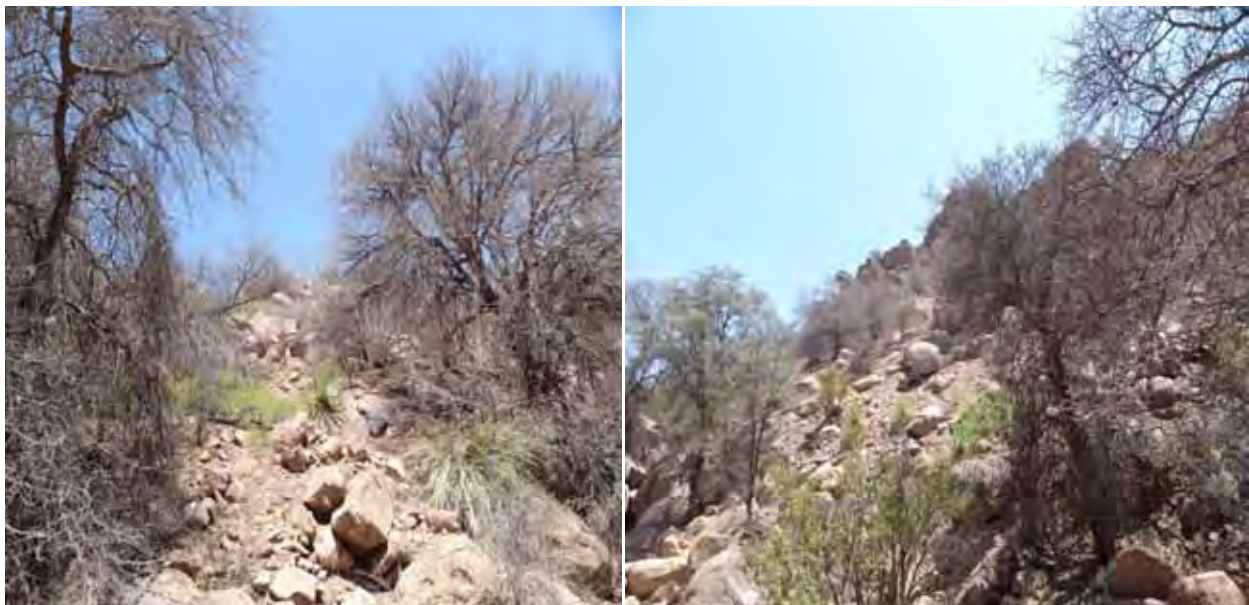
D3-4: Photographic reference for indicator 1.5. Photographs of stream bank and upland vegetation. Indicator 1.5 scored as 0. No vegetative compositional or density differences observed between the banks and the upland area.

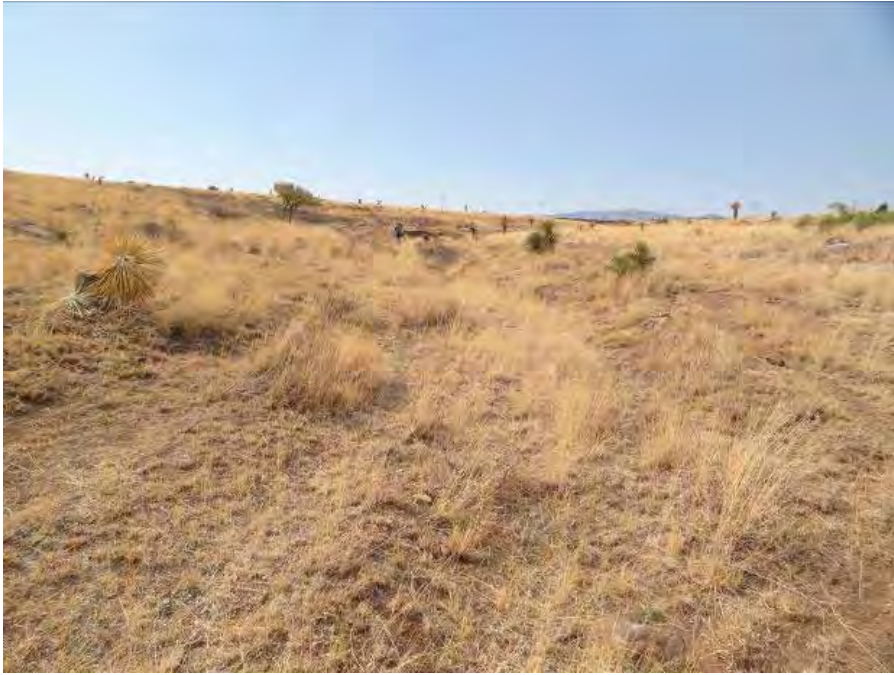
E1-1: Photographic reference of representative channel bottom and vegetation characteristics.

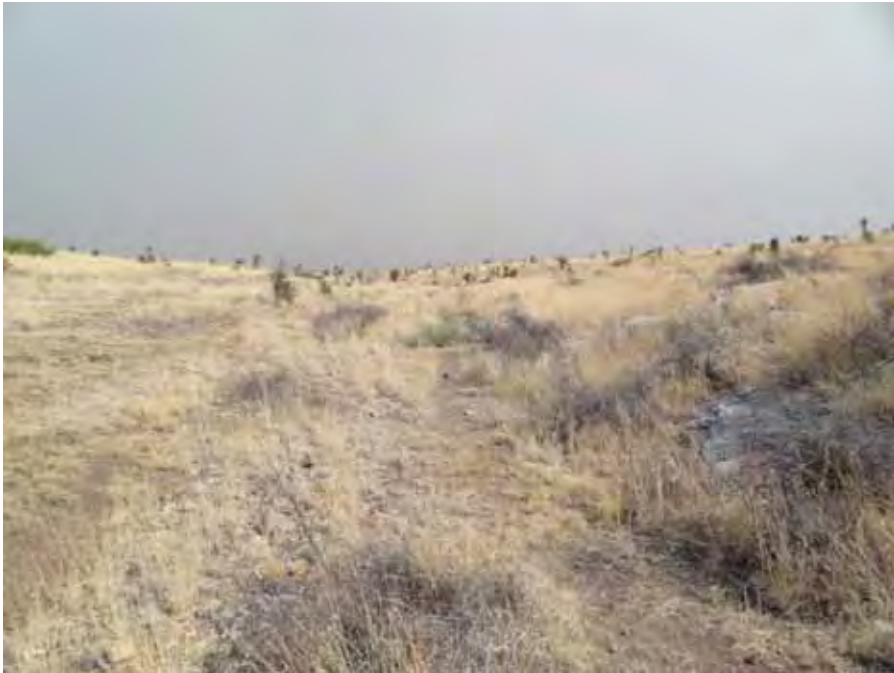
E1-2: Photographic reference for indicators 1.1 through 1.6. Photograph of stream bed. Indicator 1.6 scored as 0 - vegetation in stream bed is prevalent and consistent with bank and upslope areas. No water or biotic indicators of water observed along survey reach.

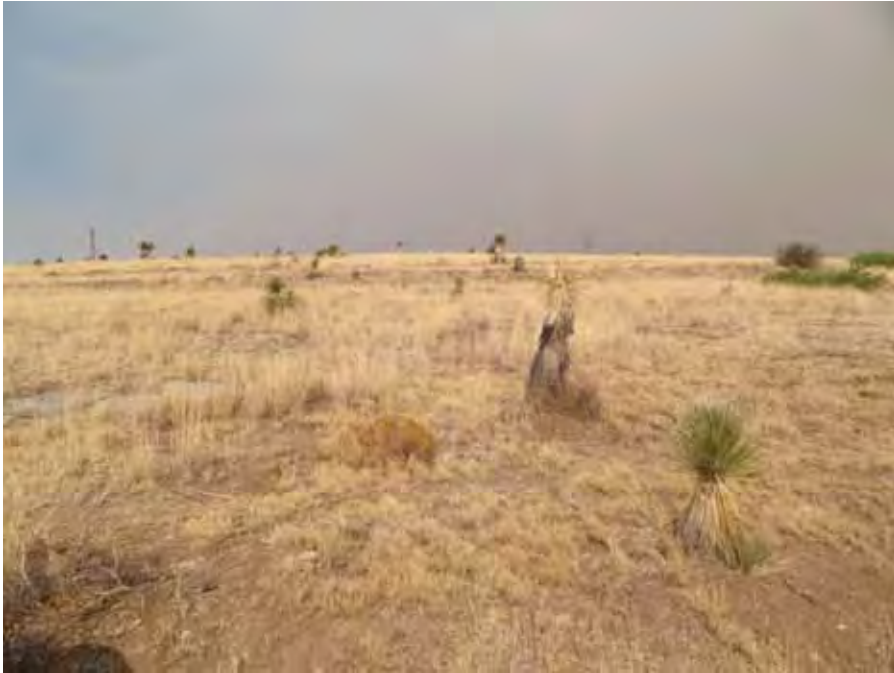
E1-3: Photographic reference for indicator 1.5. Photograph of the stream bank and upland areas. Indicator 1.5 scored as 0 - no vegetative compositional or density differences observed between the banks and the upland area.

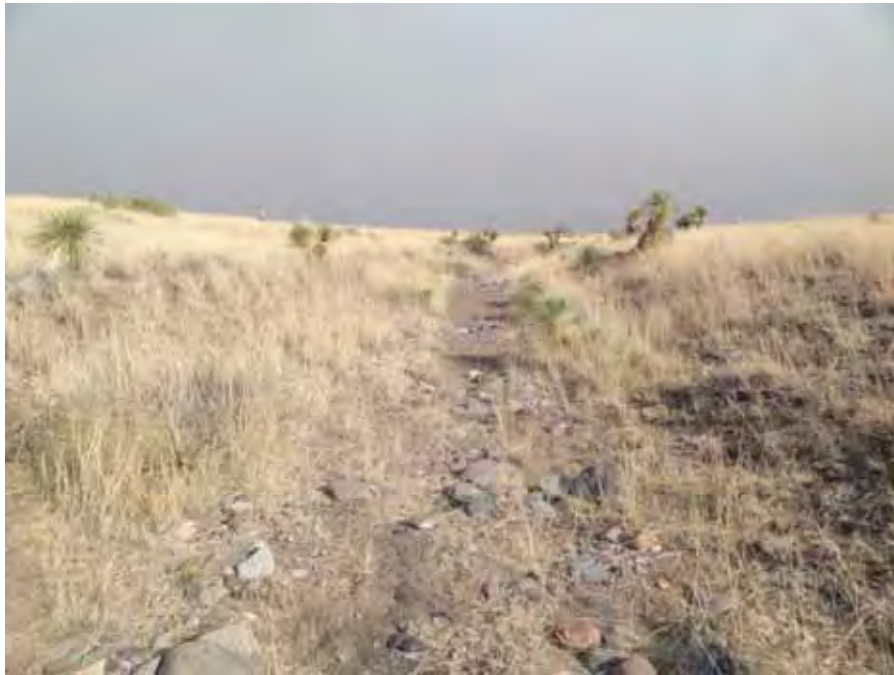
E2-1: Photographic reference for indicator 1.1 through 1.6. Photograph of the stream channel and the bank and upland areas. Indicator 1.5 scored as 0 - no vegetative compositional or density differences observed between the banks and the upland area. No water or biotic indicators of water observed along survey reach.

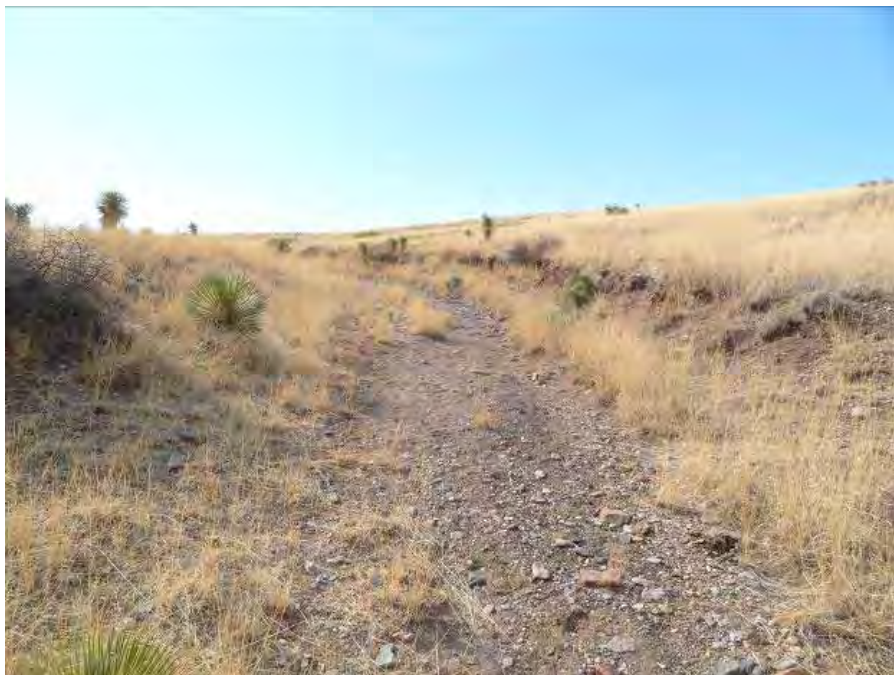
E2-2: Photographic reference of channel bed and bank.

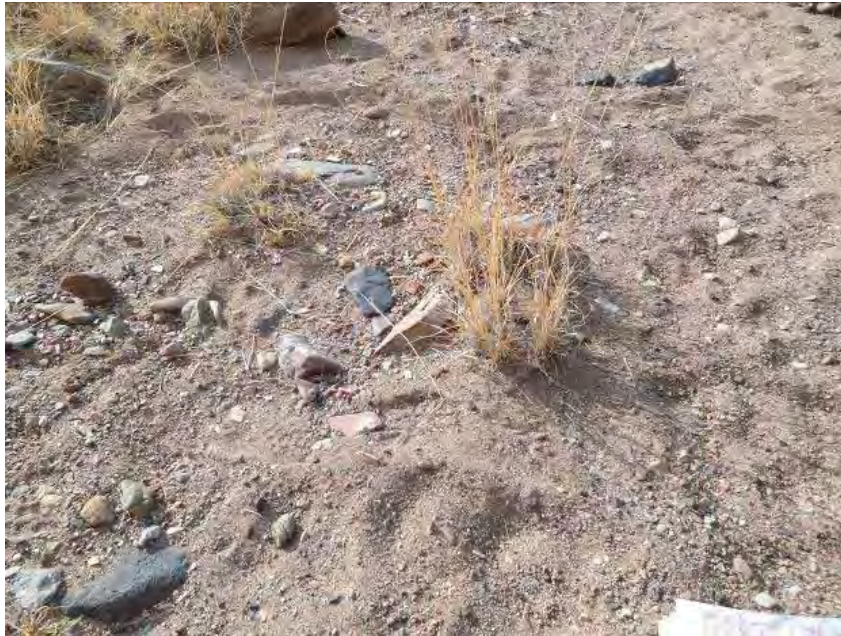
E2-3: Photographic reference of in-channel vegetation.

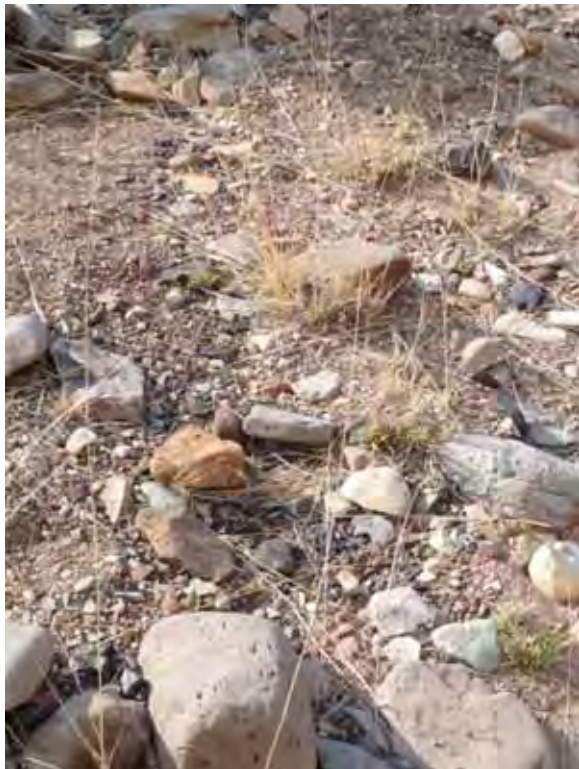
E2-4: Photographic reference for indicator 1.6. Indicator 1.6 scored as 1. Rooted upland plants (grasses) are present in the streambed and consistently dispersed but are not prevalent throughout the channel.

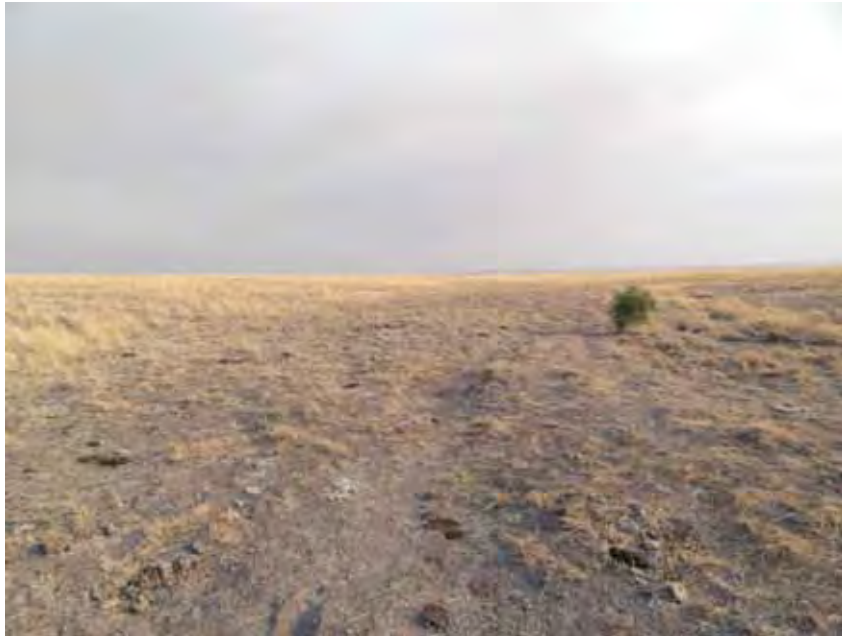
E3-1: Photographic reference for indicator 1.1 through 1.6. Photograph of the stream channel/lowland area and the bank and upland areas. Indicator 1.5 scored as 0 - no vegetative compositional or density differences observed between the banks and the upland area. No water or biotic indicators of water observed along survey reach.

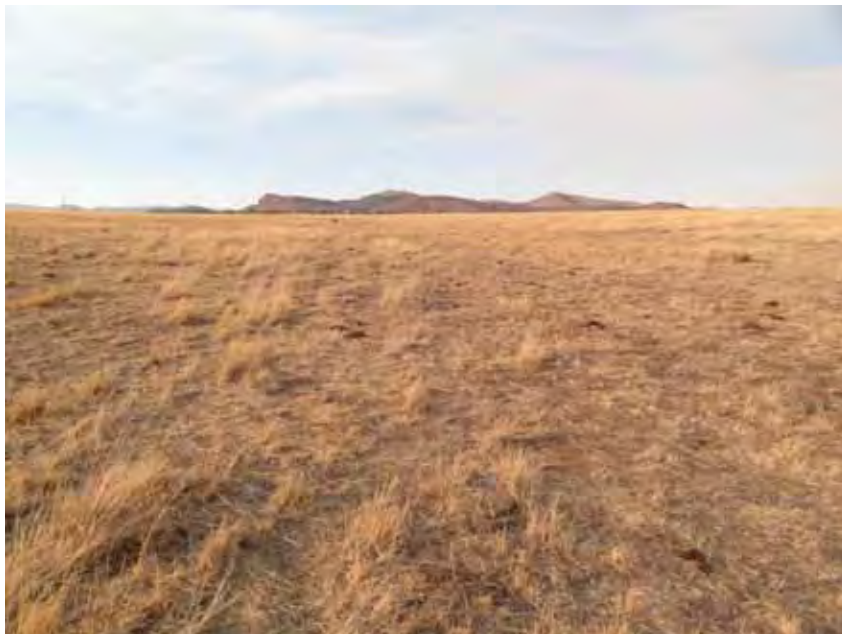
E3-2: Photographic reference for indicator 1.5. Photograph of the stream bank and upland area. Indicator 1.6 scored as 0 - vegetation in stream bed is prevalent and consistent with bank and upslope areas.

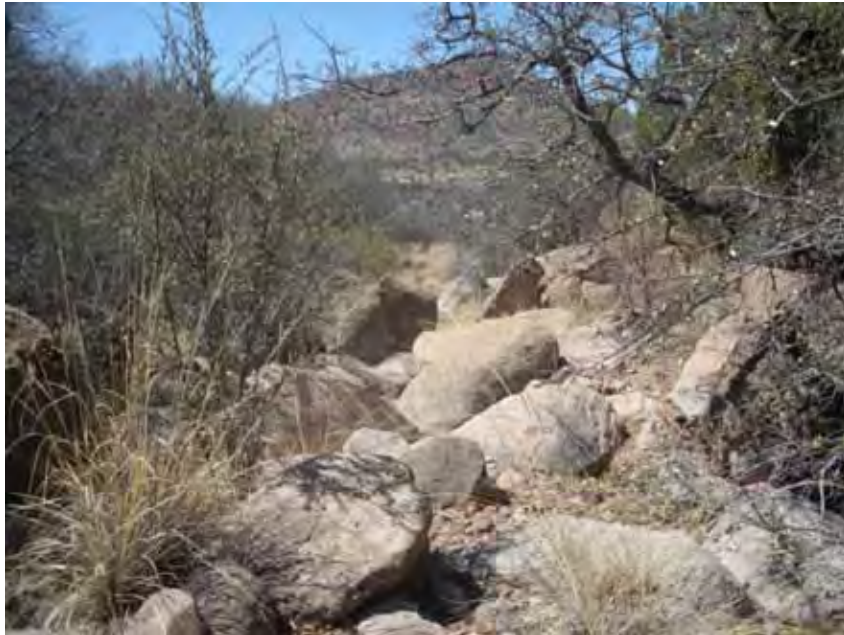
MC11-1: Photographic reference for indicators 1.1 through 1.6. Indicator 1.6 scored as 1. Vegetation in the channel bed is consistently dispersed throughout the streambed between the boulders and where deposition of finer grained material has occurred. No water or biotic indicators of water observed along survey reach.

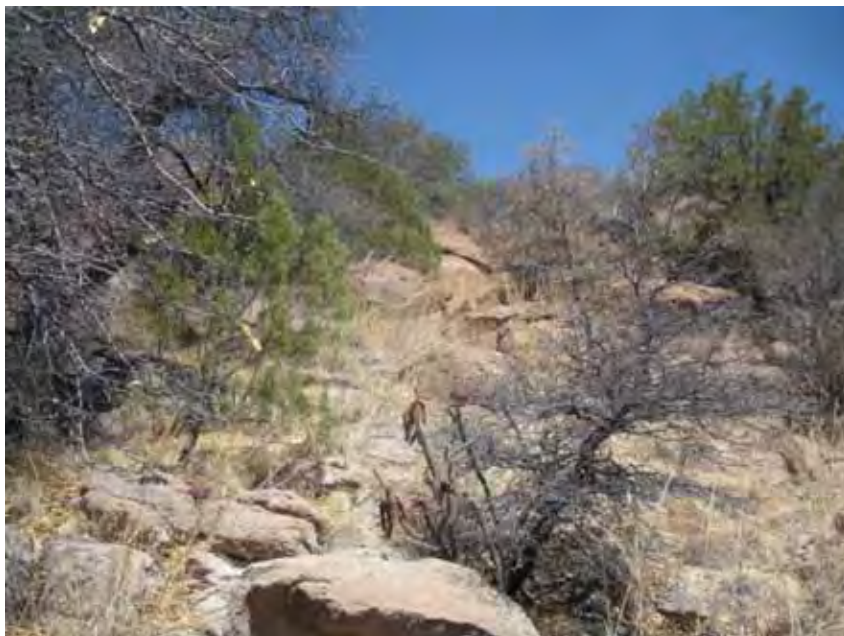
MC11-2: Photographic reference for indicator 1.5. Photograph of the bank and upland area. Indicator 1.5 scored as 1. Vegetation is similar in composition with some slight variation in density between the bank and the upland area.

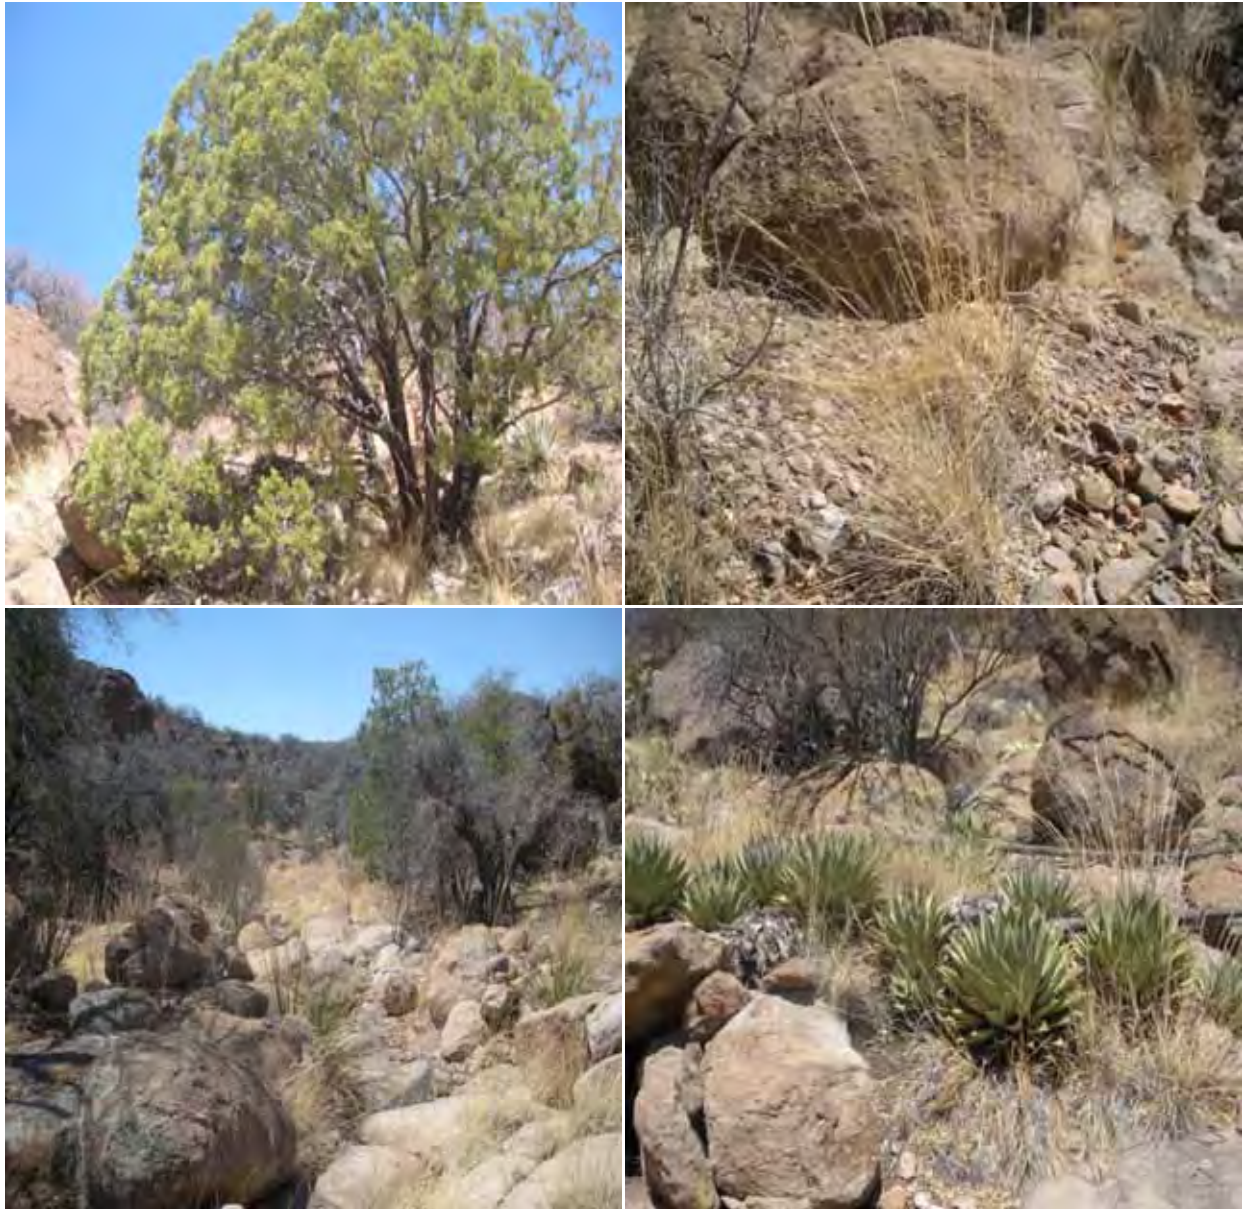
MC11-3: Photographic reference for indicators 1.5 and 1.6. Photographs of the bank/upland area and rooted in channel vegetation. Vegetation is similar in composition between the bank and the upland area. Vegetation is consistently dispersed throughout the channel.

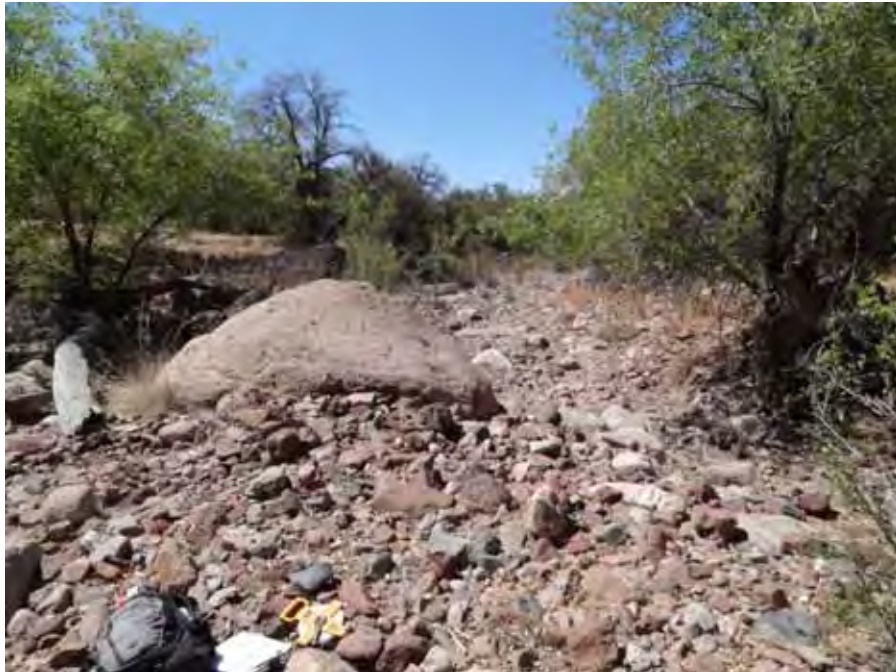
MC12-1: Photographic reference for indicators 1.1 through 1.6. No water or biotic indicators of water observed along survey reach. Channel bed material is predominantly boulders and sand and gravel.

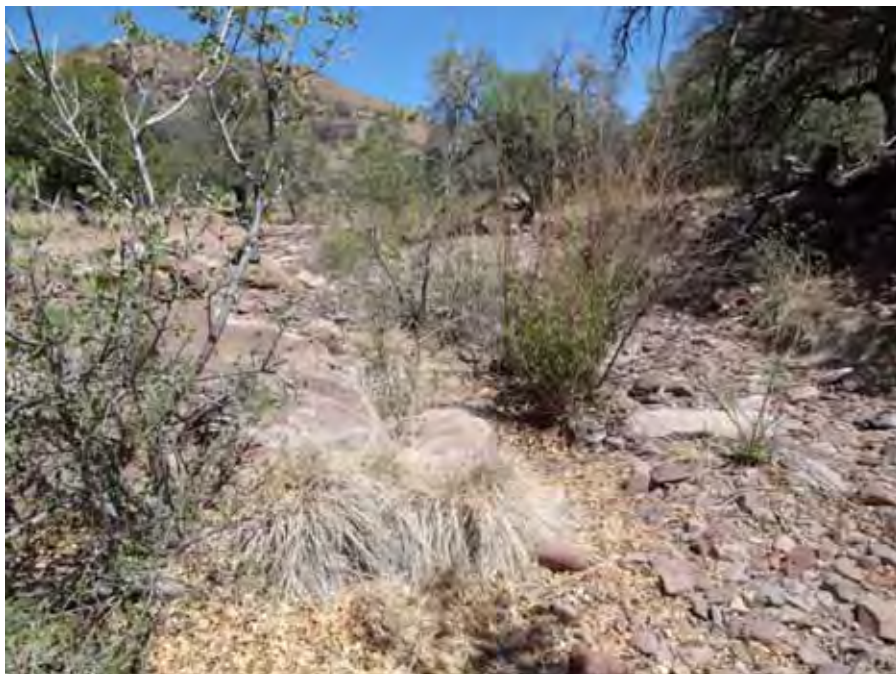
MC12-2: Photographic reference for indicator 1.6. Instream and bank vegetation shown. Indicator 1.6 scored as 1. Vegetation in channel is predominantly grasses and shrub species and are consistently dispersed throughout the channel.

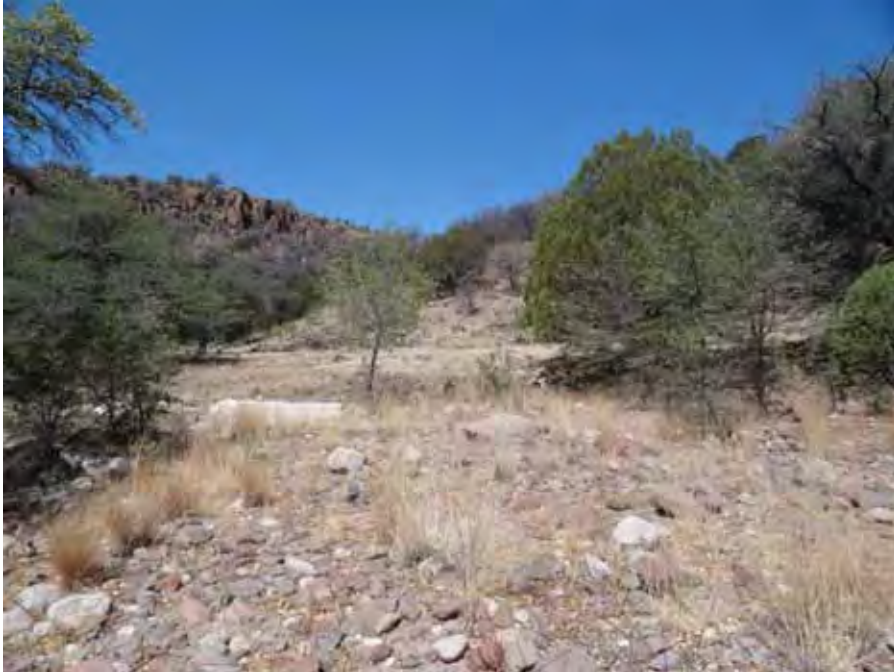
MC12-3: Photographic reference for indicator 1.5. Indicator 1.5 scored as 1. Upland vegetation is similar to what is observable along the banks and within the streambed (previous photograph). Density decrease slightly with distance from the stream but composition is similar.

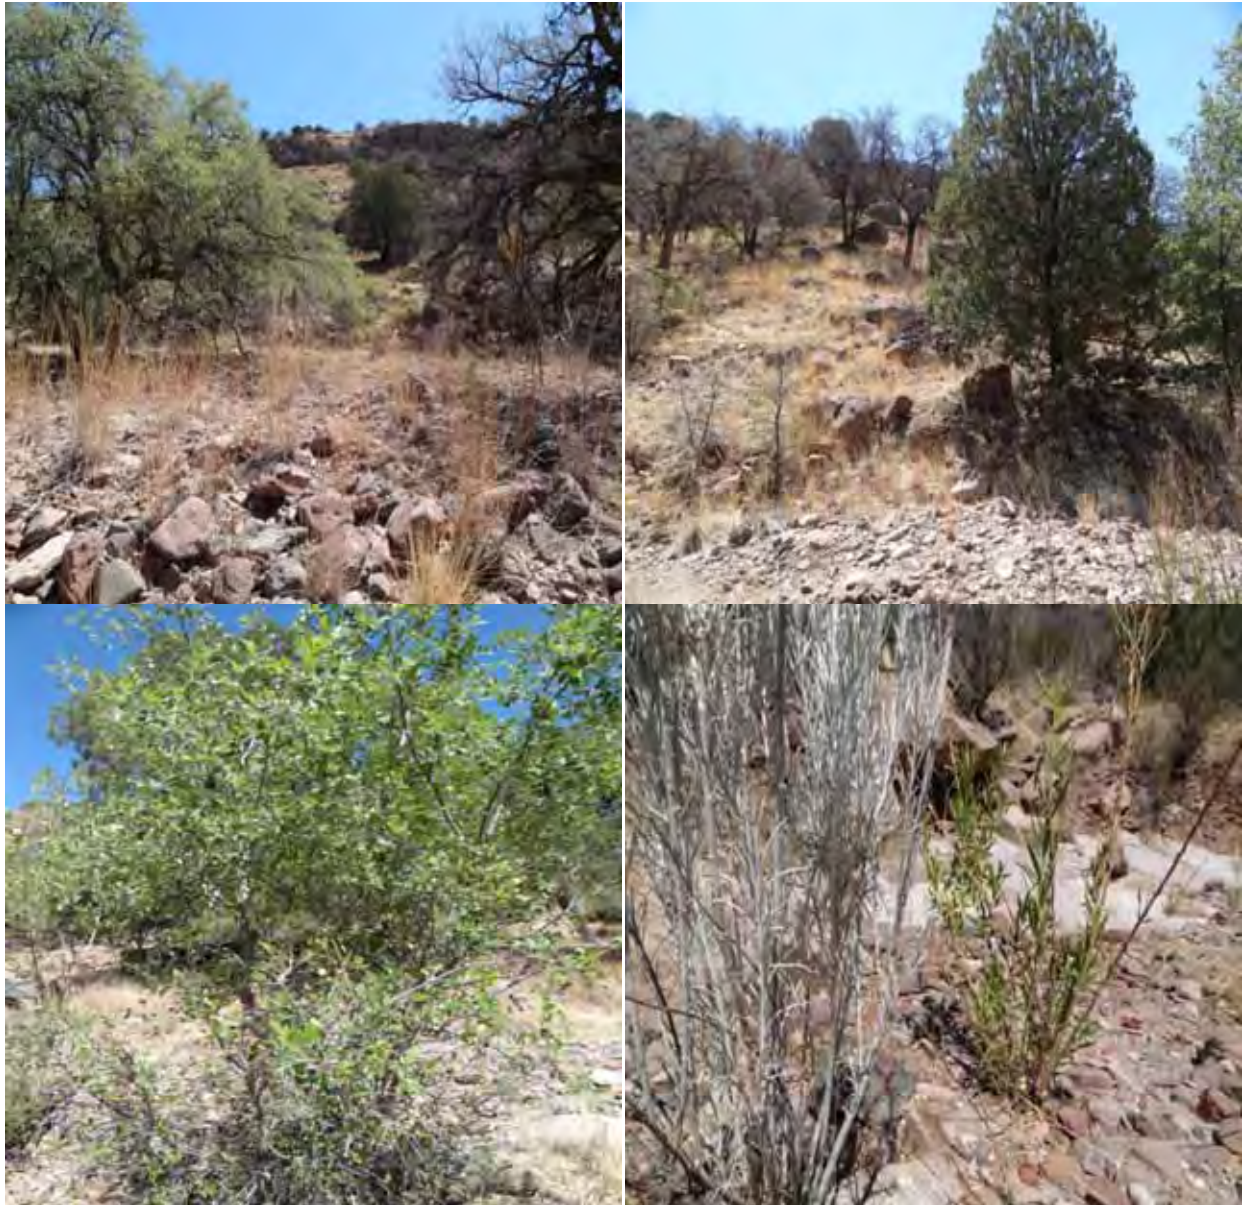
MC12-4: Photographic reference for indicators 1.5 and 1.6. Photographs of the bank/upland area and rooted in channel vegetation. Vegetation is similar in composition between the bank and the upland area. Vegetation is consistently dispersed throughout the channel.

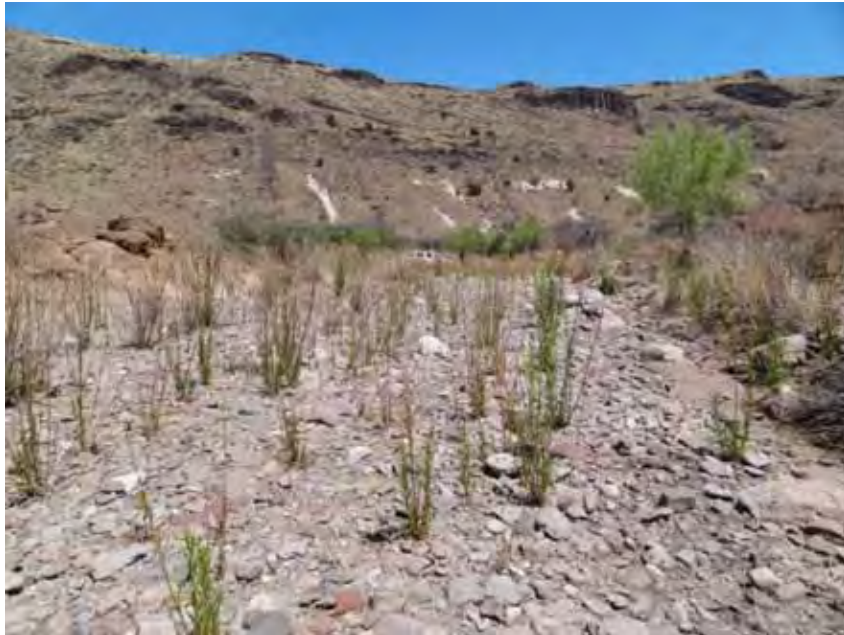
MC13-1: Photographic reference for indicator 1.1 through 1.6. Indicator 1.6 scored as 1. Rooted vegetation within the channel consists of grasses which are dispersed throughout the streambed. No water or biotic indicators of water observed along survey reach.

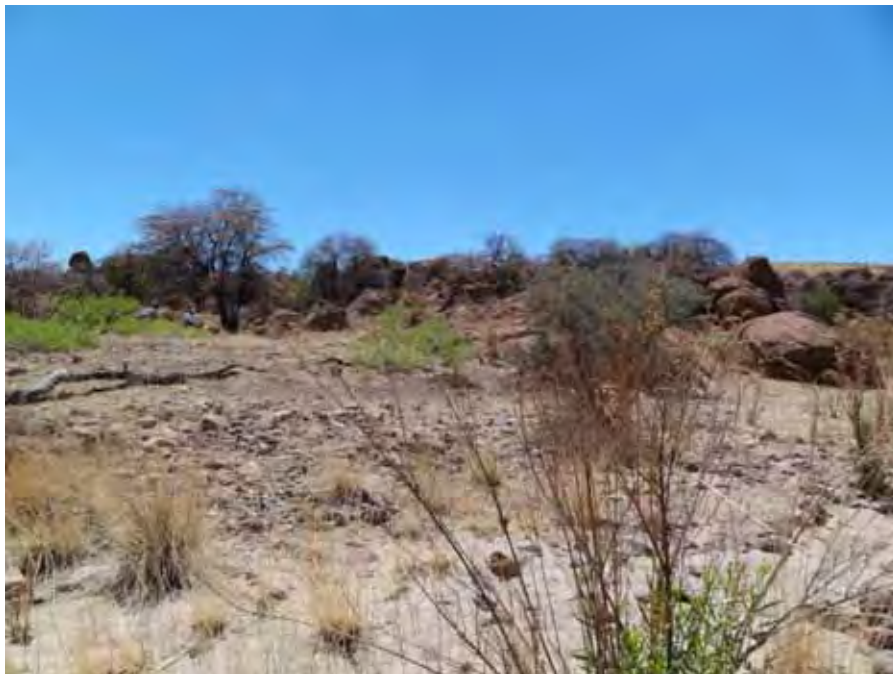
MC13-2: Photographic reference for indicator 1.5. Photograph of the overbank and upslope area. Indicator 1.5 scored as 1. Vegetation in the upslope area is similar to the vegetation along the banks and within the channel observed in the previous photograph. Minimal differences in density are observable. No distinct riparian zone exists.

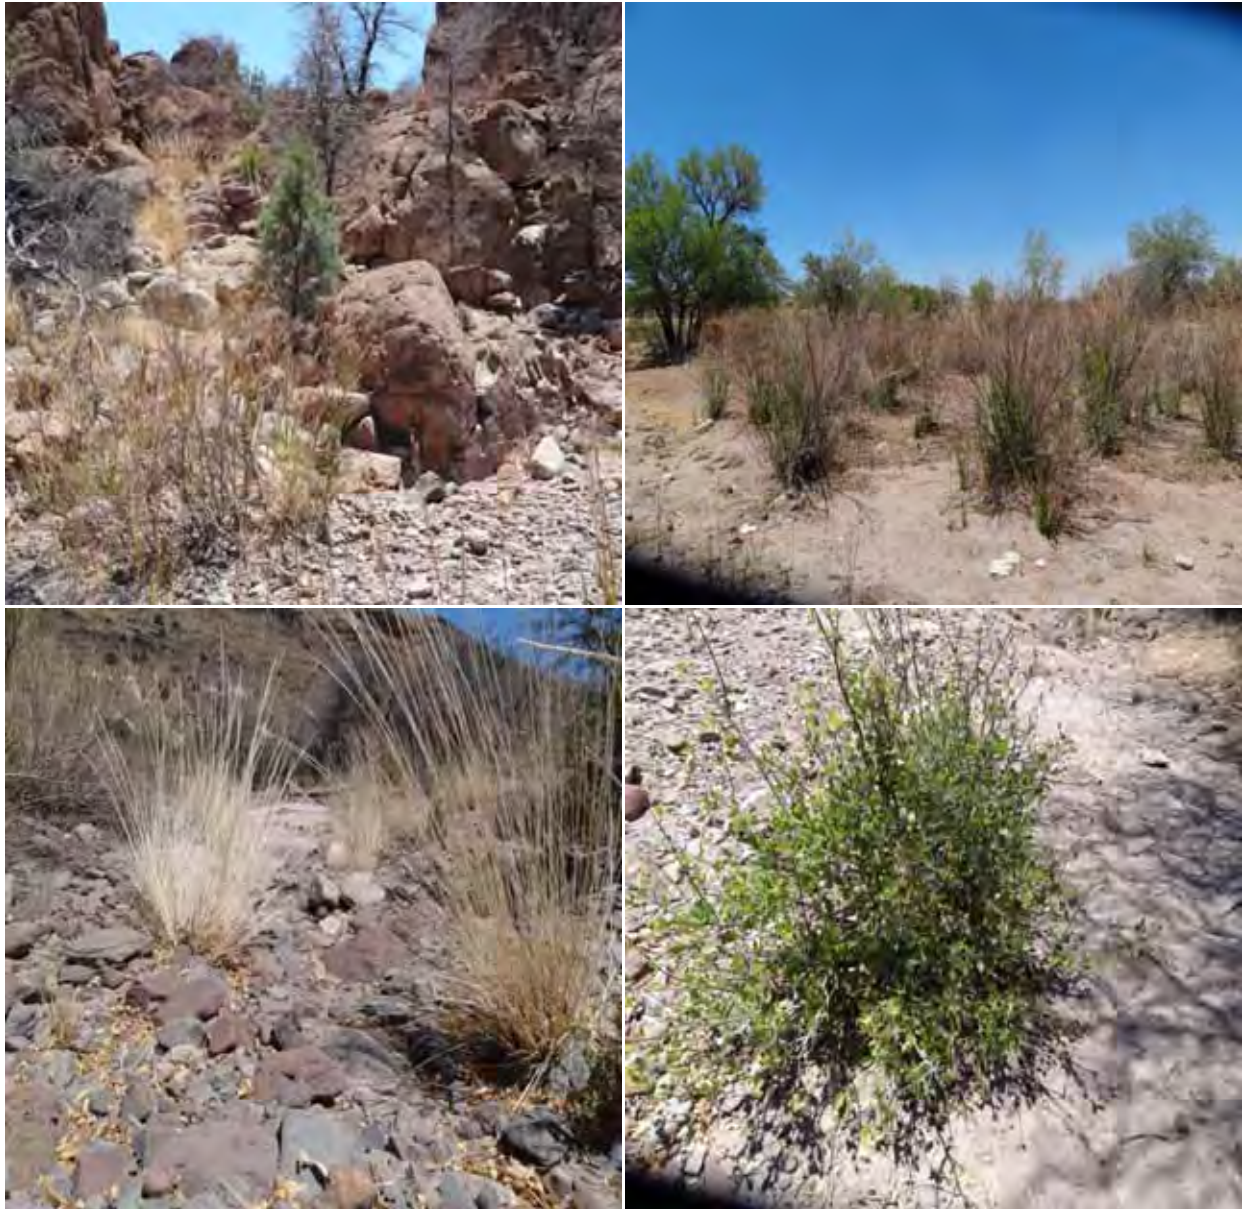
MC13-3: Photographic reference for indicators 1.5 and 1.6. Photographs of the bank/upland area and rooted in channel vegetation. Vegetation is similar in composition between the bank and the upland area. Vegetation is consistently dispersed throughout the channel.

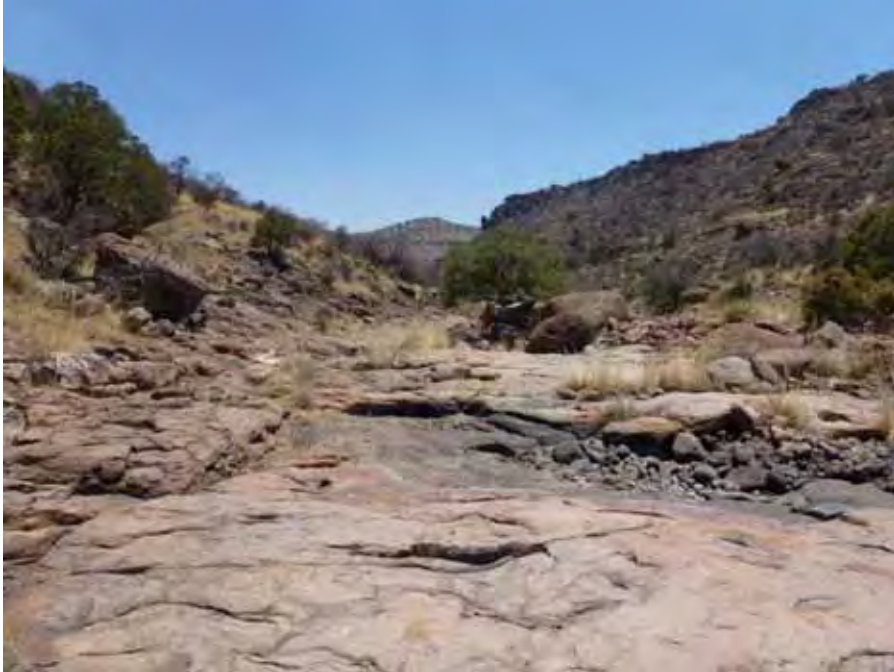
RC14A-1: Photographic reference for indicators 1.1 through 1.6 and 1.9. Water and biotic indicators of water were observed along the reach (see subsequent photos). Channel bed is predominantly bedrock. Note the small dry pool area located in the center right of photograph.

Indicator 1.9 scored as 1 - channel is partially confined with an inactive floodplain.

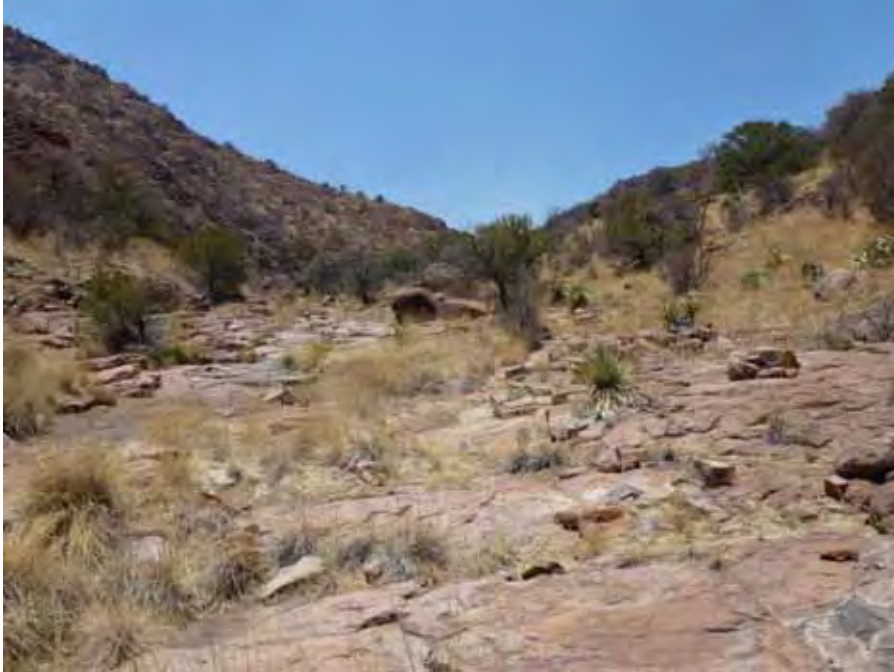
RC14A-2: Photographic reference for indicator 1.5. Indicator 1.5 scored as 1. Vegetation along the reach is compositionally consistent between the bank and the upland area with some differences in density observed. Distinct riparian zone not present.

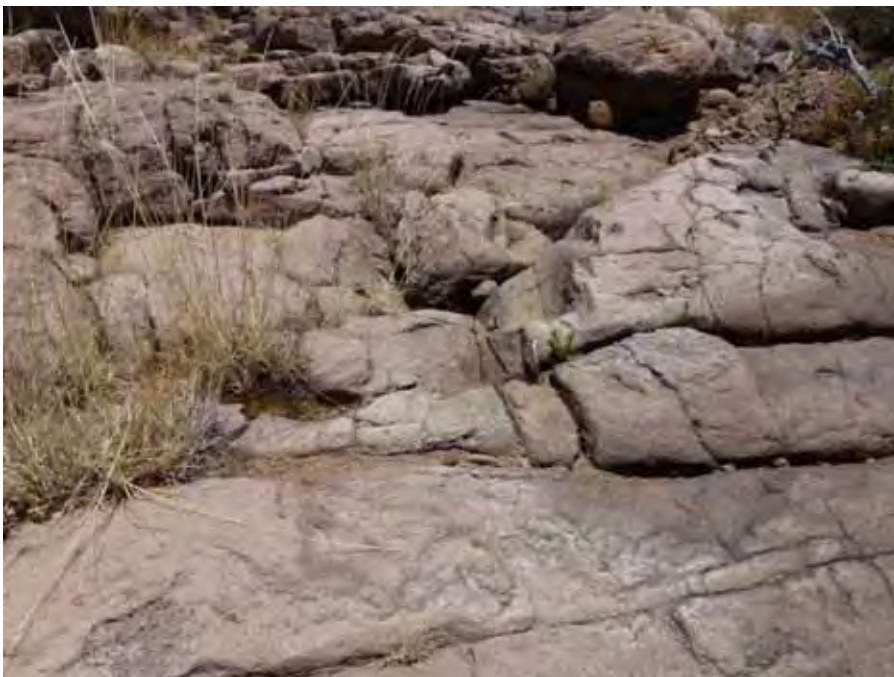
RC14A-3: Photographic reference for indicator 1.6. Indicator 1.6 scored as 2. A few rooted grasses are present in the streambed but are generally not present because of the bedrock present.

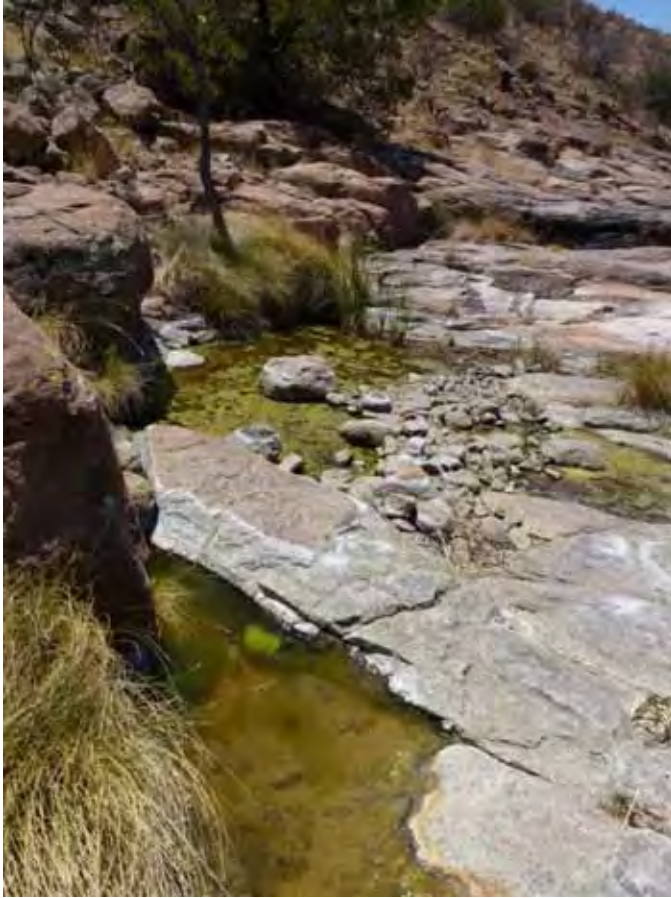
RC14A-4: Channel is primarily dry with small pools and standing water observed along the stream stretch. Indicator 1.1 scored as 2. No fish were present in the pools but benthic macroinvertebrates and filamentous algae/periphyton were observed after extensive searching. Both indicators 1.3 and 1.4 scored as 1. Seeps were observed to feed the pools; however, the pools are isolated.

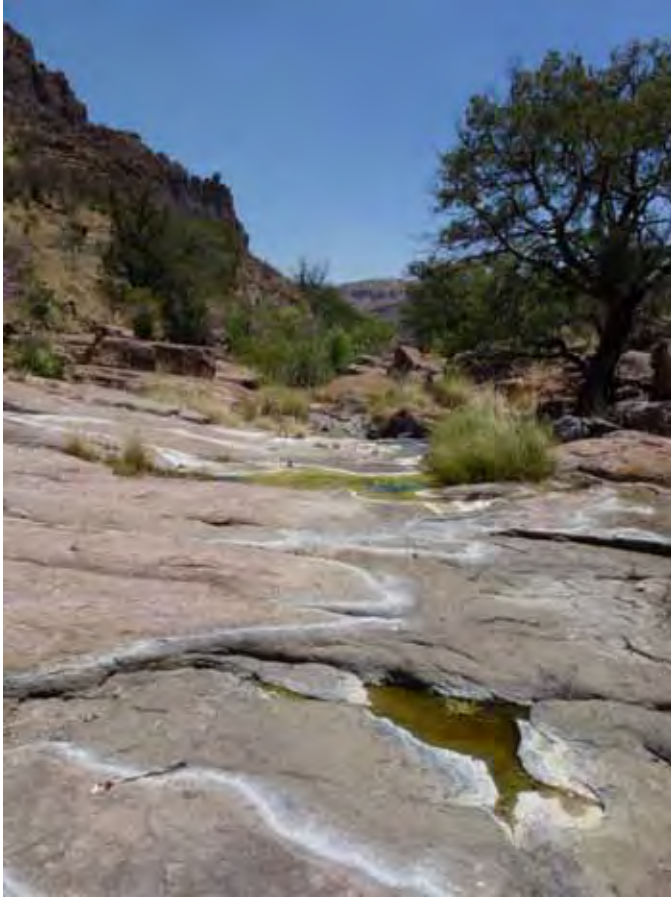
RC14A-5: Channel is primarily dry with small pools and standing water observed along the stream stretch. Filamentous algae/periphyton were observed after extensive searching.

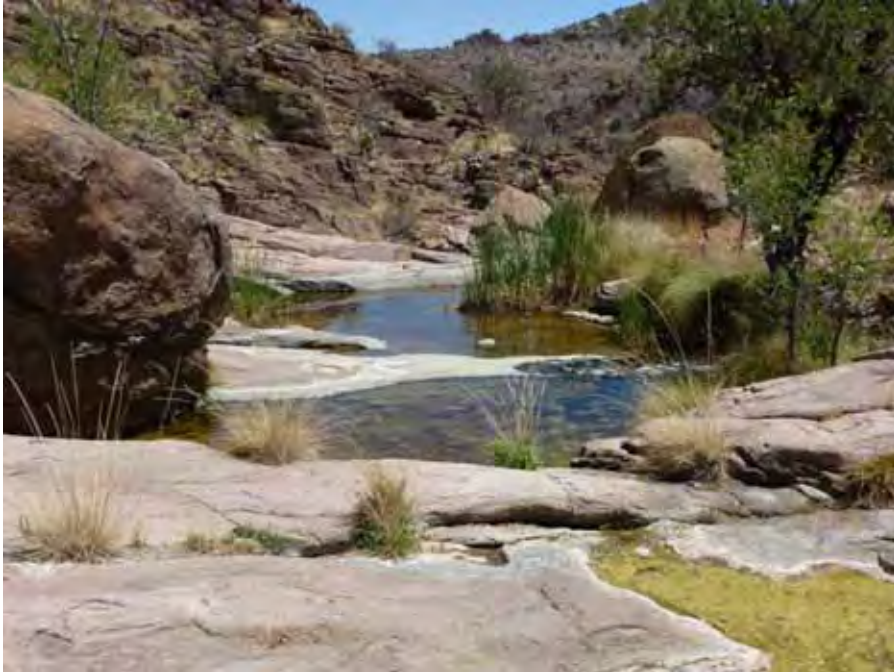
RC14B-1: Photographic reference for indicators 1.1 through 1.6 and 1.9. Biotic indicators of water and water were observed along the reach (see subsequent photos). Multiple isolated pools present along the stretch and springs/seeps observed. Biotic indicators of water found with little difficulty.

Indicator 1.5 scored as 2 - distinct riparian corridor present for parts of the stretch near pools as bank and upland vegetation is noticeably lush.

Indicator 1.9 scored as 1 – pool sequences likely but difficult to discern. Stream morphology is dominated by bedrock features.

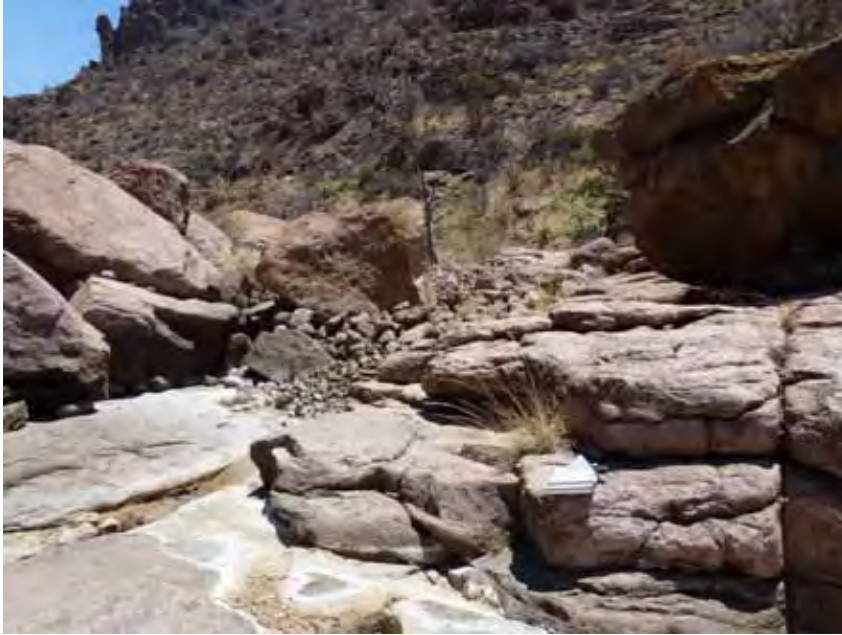
RC14B-2: Photographic reference for indicator 1.5. Photograph is of channel, bank, and upland area. Indicator 1.5 scored as 2 - distinct riparian zone not evident along portions of stream where pools are not present. Area shown in photograph is noticeably lacking riparian vegetation. Indicates that water is only persistent in areas where pools are maintained by bedrock springs.

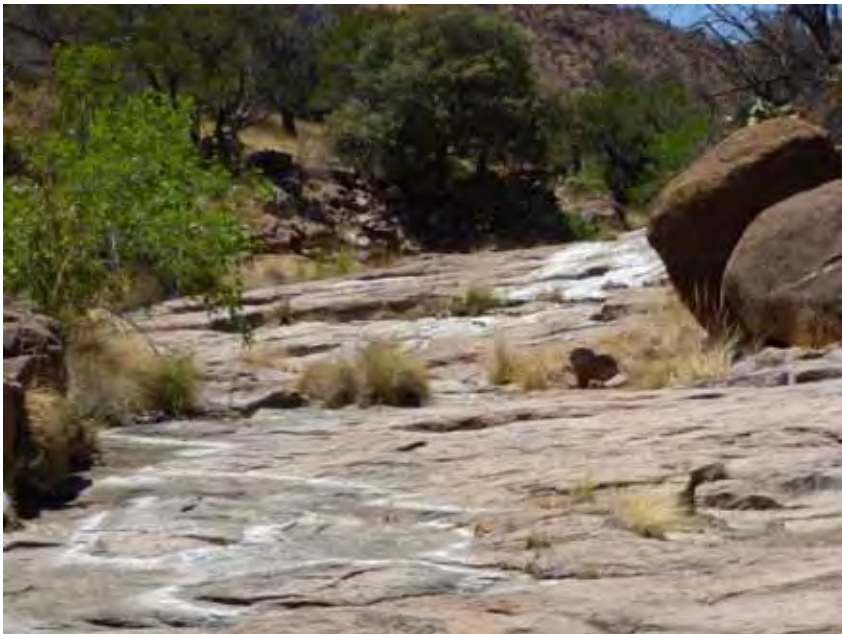
RC14B-3: Photographic reference for indicator 1.6. Indicator 1.6 scored as 2. Rooted vegetation present in the streambed, but limited by bedrock rather than persistence of flow.

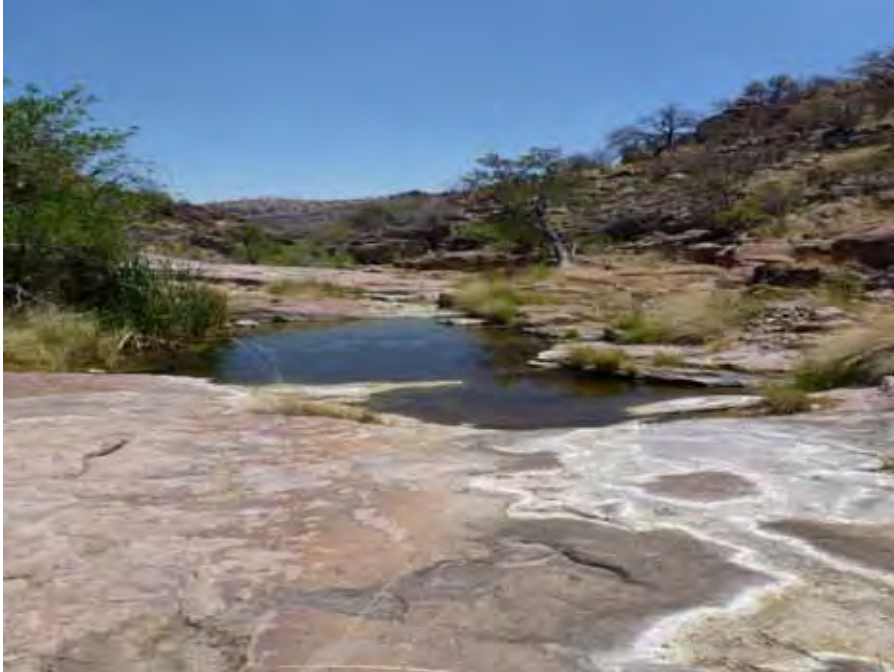
RC14B-4: Photographic reference of representative channel bottom characteristics.

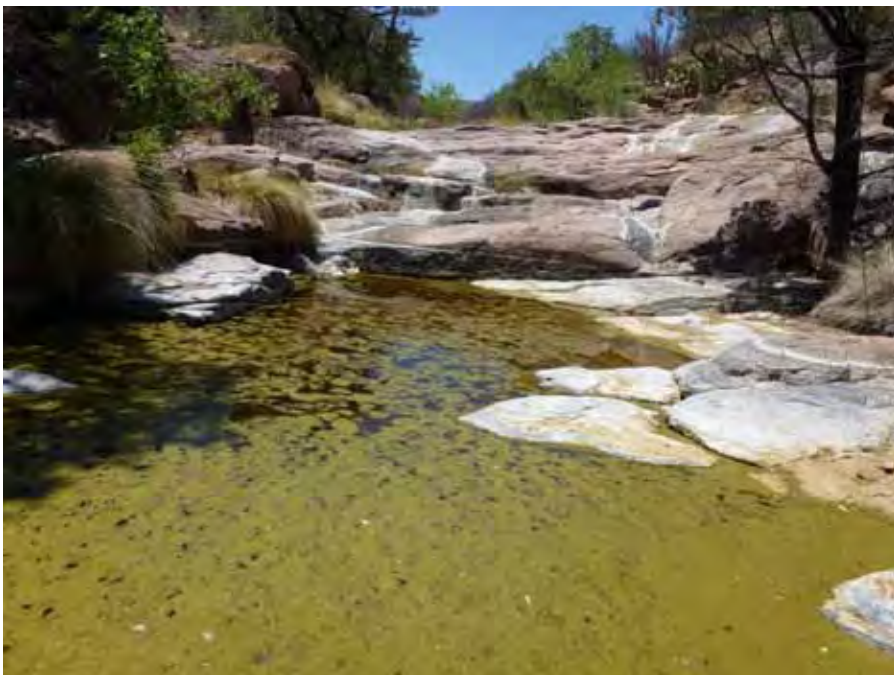
RC14B-5: Photographic reference of algae and benthic macro-invertebrates located near standing water.

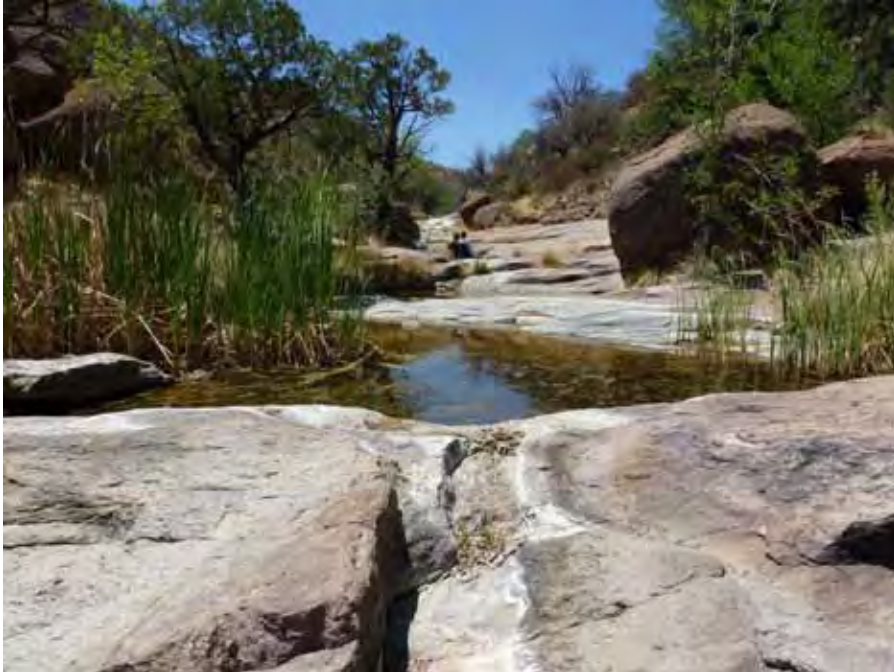
RC14B-6: Photographic reference for indicators 1.1 through 1.6. Filamentous algae/periphyton was observed along the reach. Multiple isolated pools present along the stretch. Biotic indicators of water found with little difficulty.
