**Application of the Hydrology
Protocol to STSIU Drainages**

Chino Mines, Vanadium, New Mexico

October 2014

**Application of Hydrology
Protocol to STSIU Drainages**

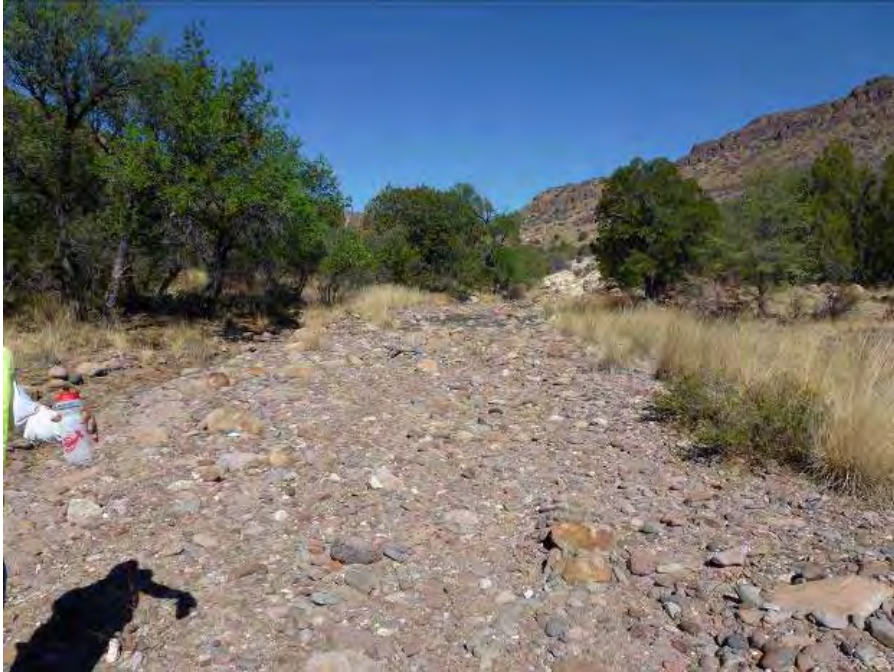
RC15-1: Photographic reference of representative channel bottom characteristics.

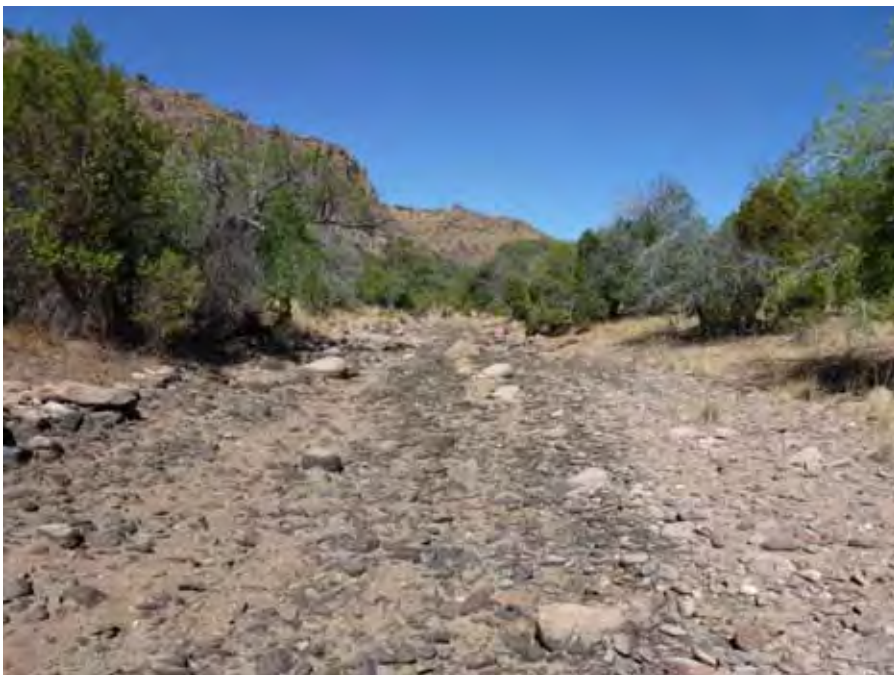
RC15-2: Photographic reference for indicators 1.1 through 1.6. No water observed over survey reach. Indicator 1.6 scored as 2 - few rooted plants along streambed. Vegetation limited by streambed material which is primarily coarse grain material and boulders.

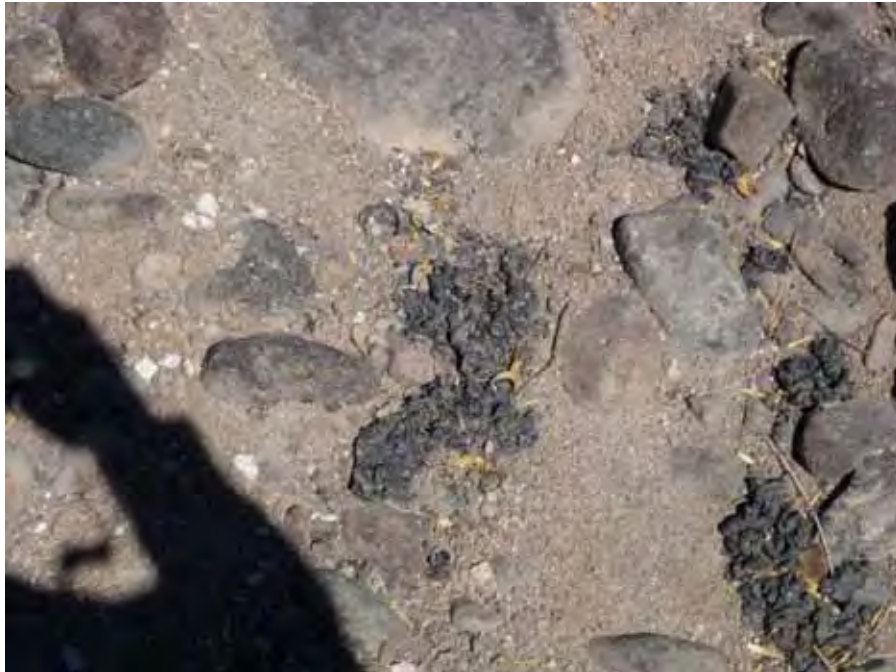
RC15-3: Photographic reference for indicator 1.4. Indicator 1.4 scored as 1. Algae is present in stream but is very isolated.

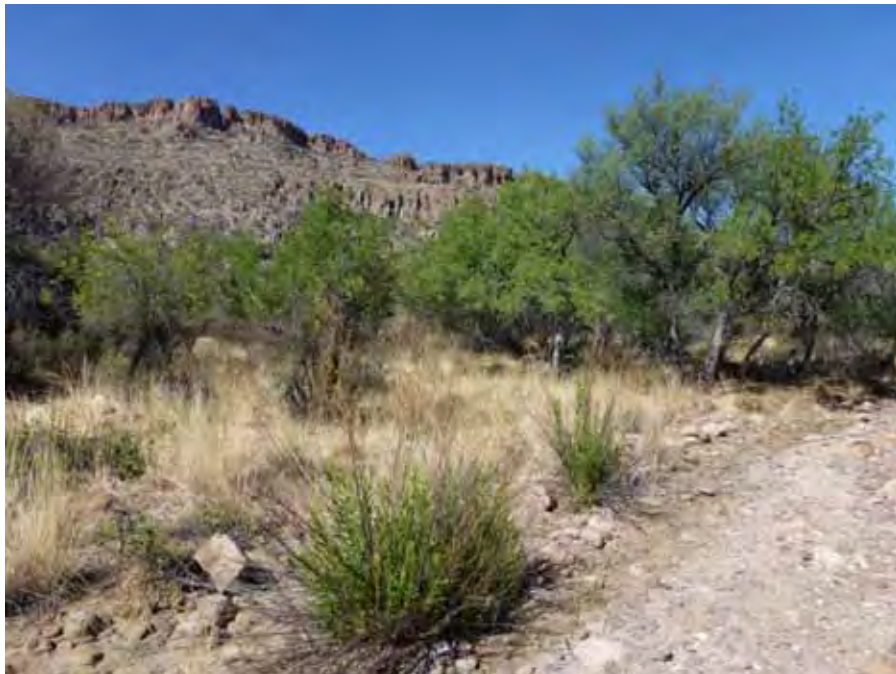
RC15-4: Photographic reference for indicator 1.5. Photograph of stream bank and upland area. Indicator 1.5 scored as 2. Distinct riparian corridor exists over portions of the reach but are not consistent over the entirety of the reach.

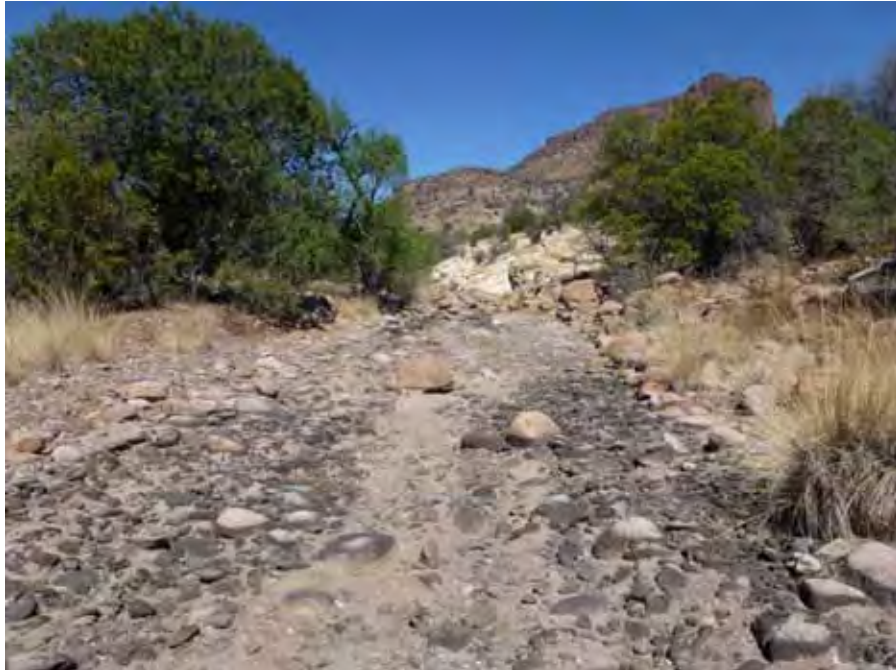
RC15-5: Photographic reference for indicator 1.8. Photograph of the general proximity of the stream cross-section transect. Indicator 1.8 scored as 1.5. Stream is moderately confined with an inactive flood plain based on vegetative growth.

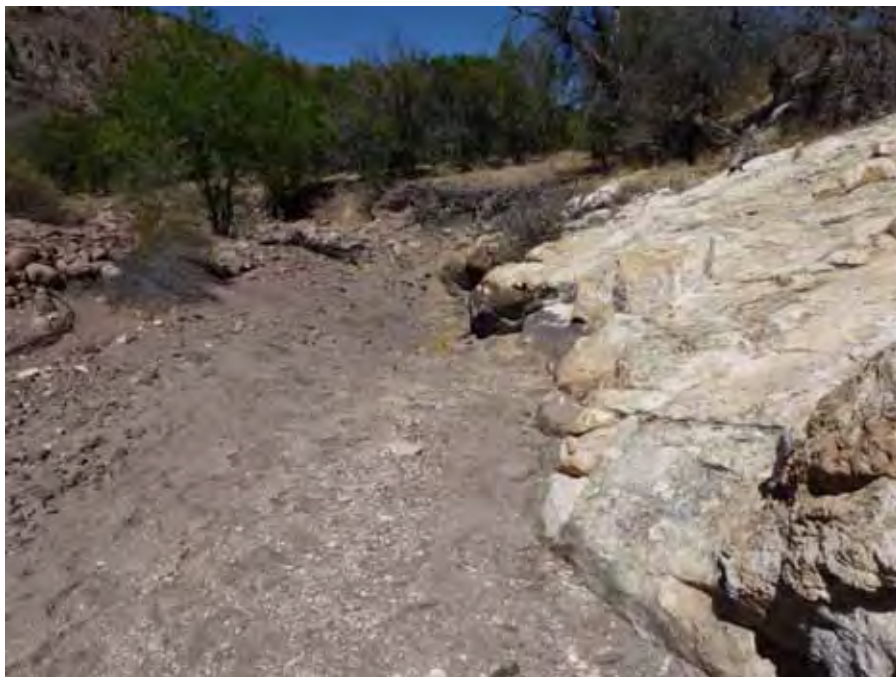
RC15-6: Photographic reference for indicator 1.9. Relatively deep pool shown in photograph. Indicator 1.9 scored as 1. Some pools are observable over the extent of the survey reach, but a riffle pool sequence is not evident.

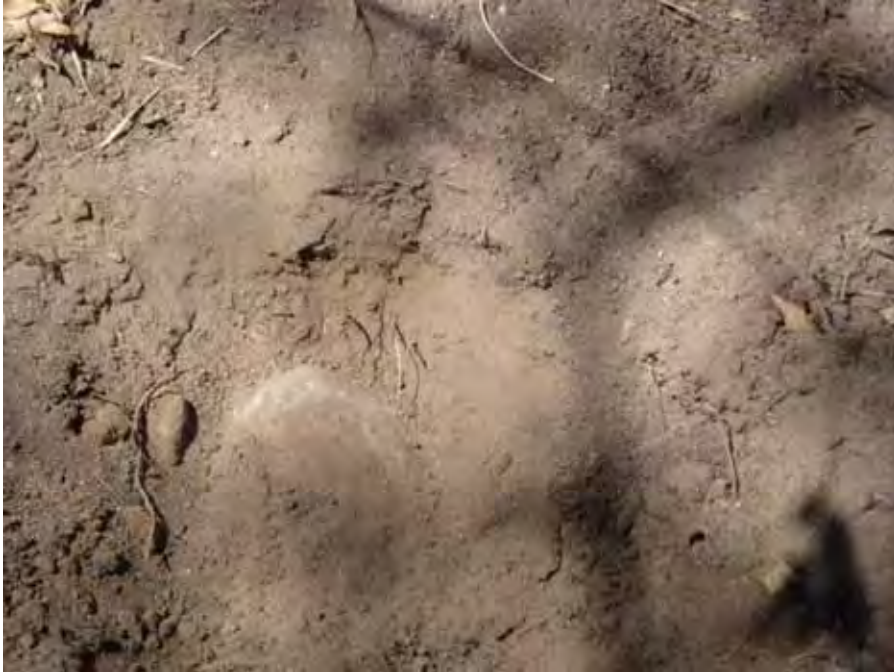
RC15-7: Photographic reference for indicator 1.10. Photograph is example of soil in the floodplain. Indicator 1.10 scored as 3. Distinct differences observed between soil outside of the streambed and the soil within the streambed. Streambed distribution of substrate material evident where finer material drops in pools and areas of lower velocity flow, while other portions of the stream bed are coarser materials.

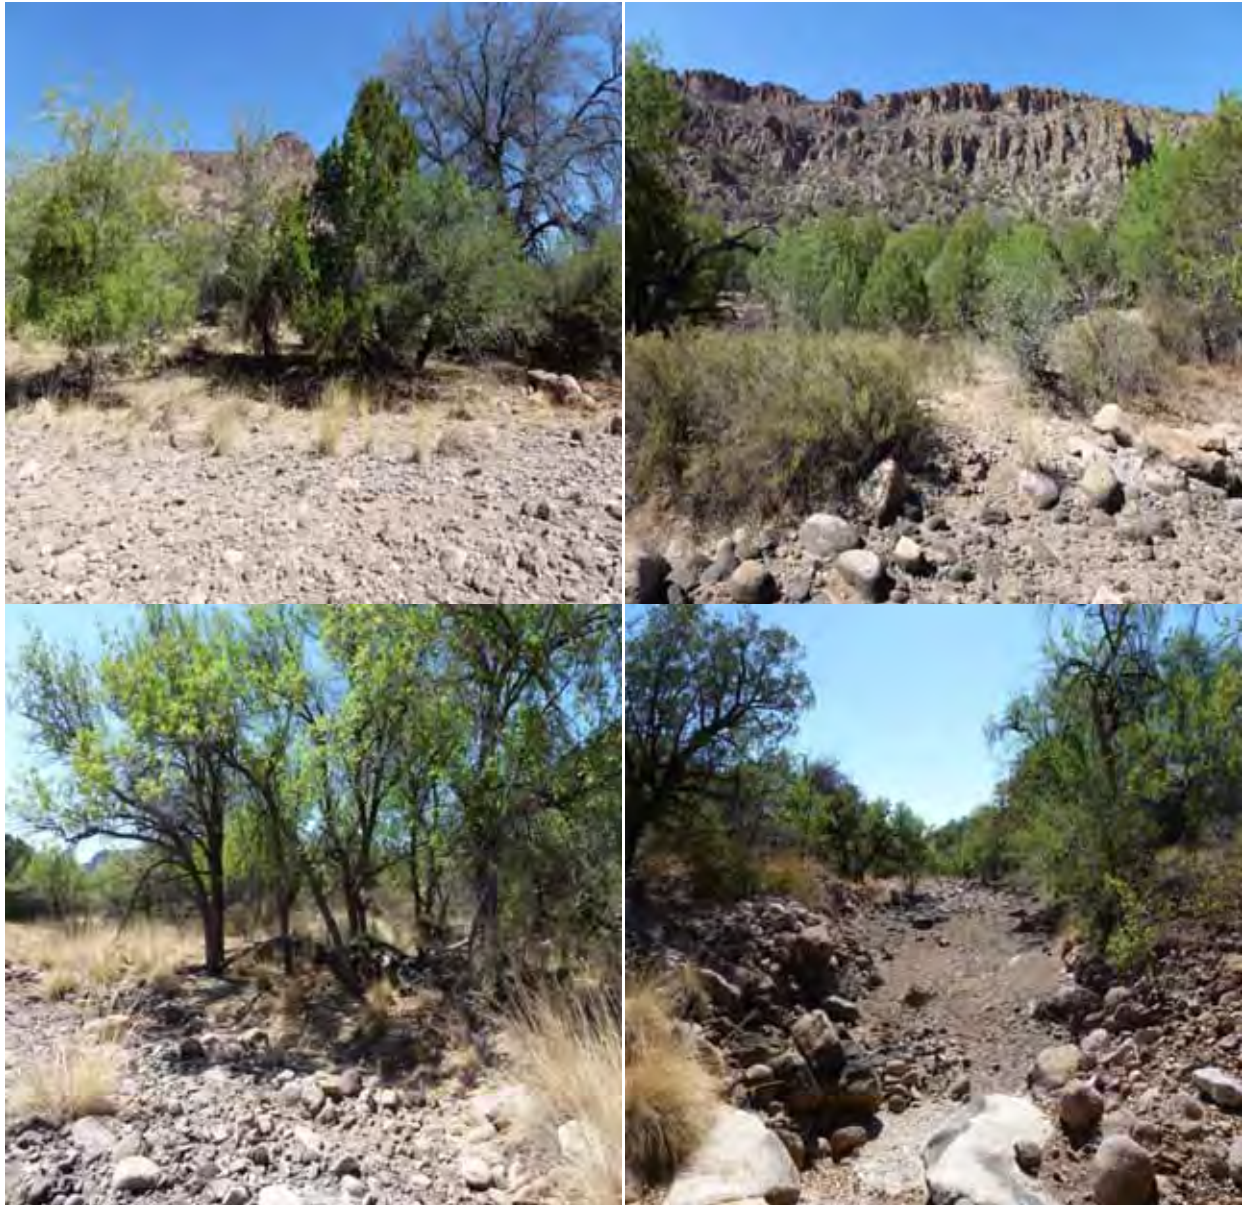
RC15-8: Photographic reference for indicators 1.5 and 1.6. Photographs of the bank/upland area and rooted in channel vegetation. Distinct riparian corridor exists over portions of the reach. Vegetation is inconsistently dispersed throughout the channel.

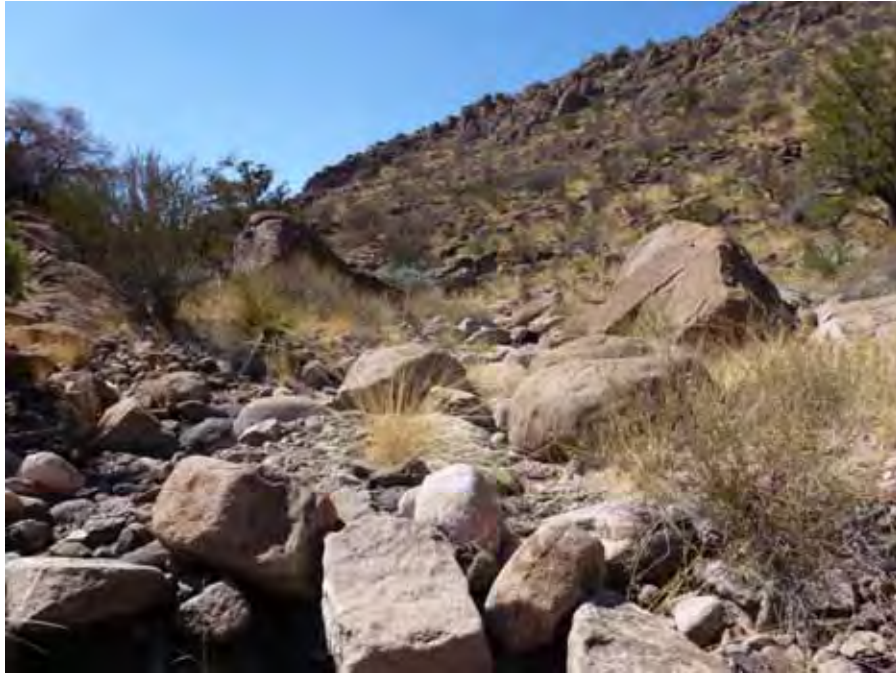
RC2-22-1: Photographic reference for indicators 1.1 through 1.6. Indicator 1.6 scored as 1 – rooted upland plants consistently dispersed throughout streambed. Channel bed is primarily gravel and boulders. No water or biotic indicators of water observed along survey reach.

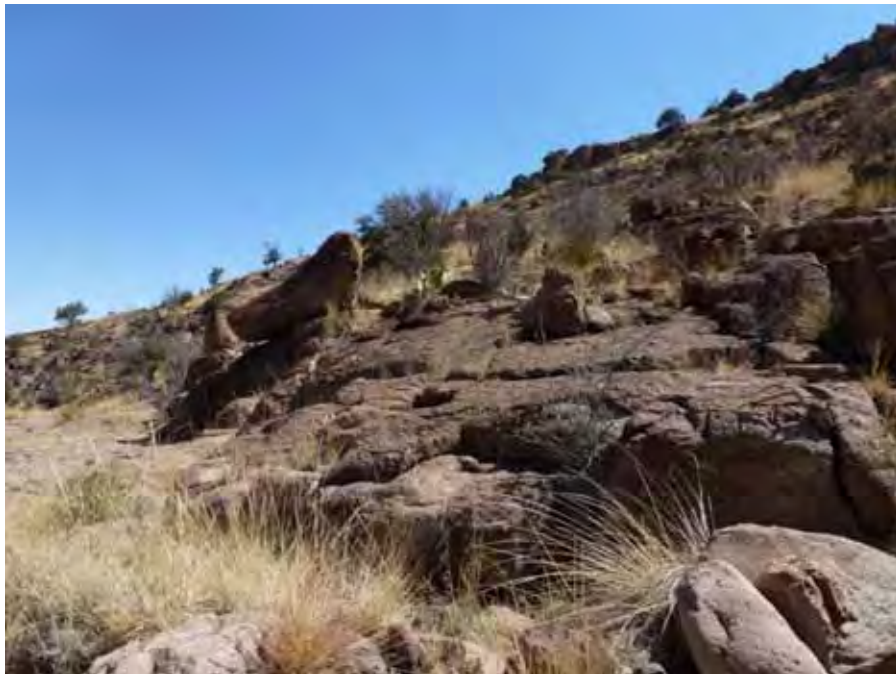
RC2-22-2: Photographic reference for indicator 1.5. Indicator 1.5 scored as 1. Vegetation along banks of the reach is similar in composition as vegetation in the upland areas. Some density differences were evident.

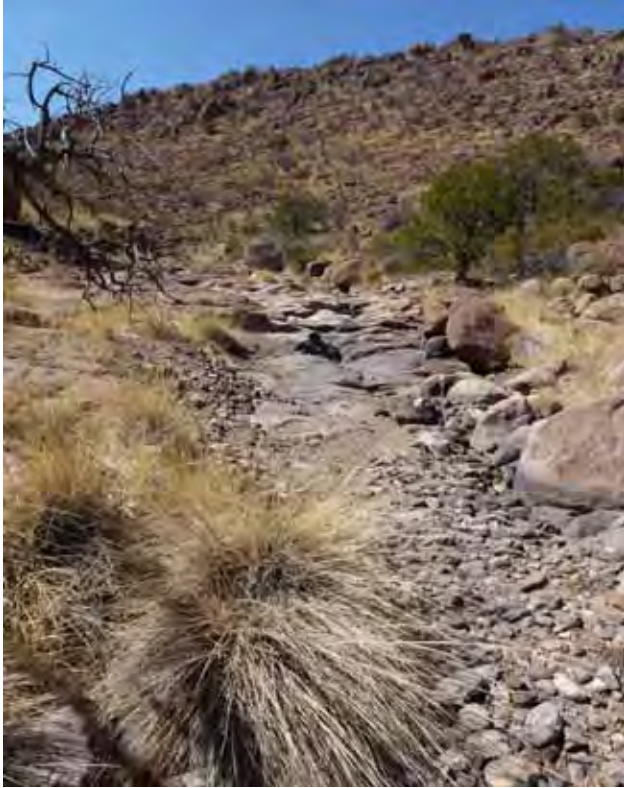
RC2-22-3: Photographic reference of bedrock controlled channel.

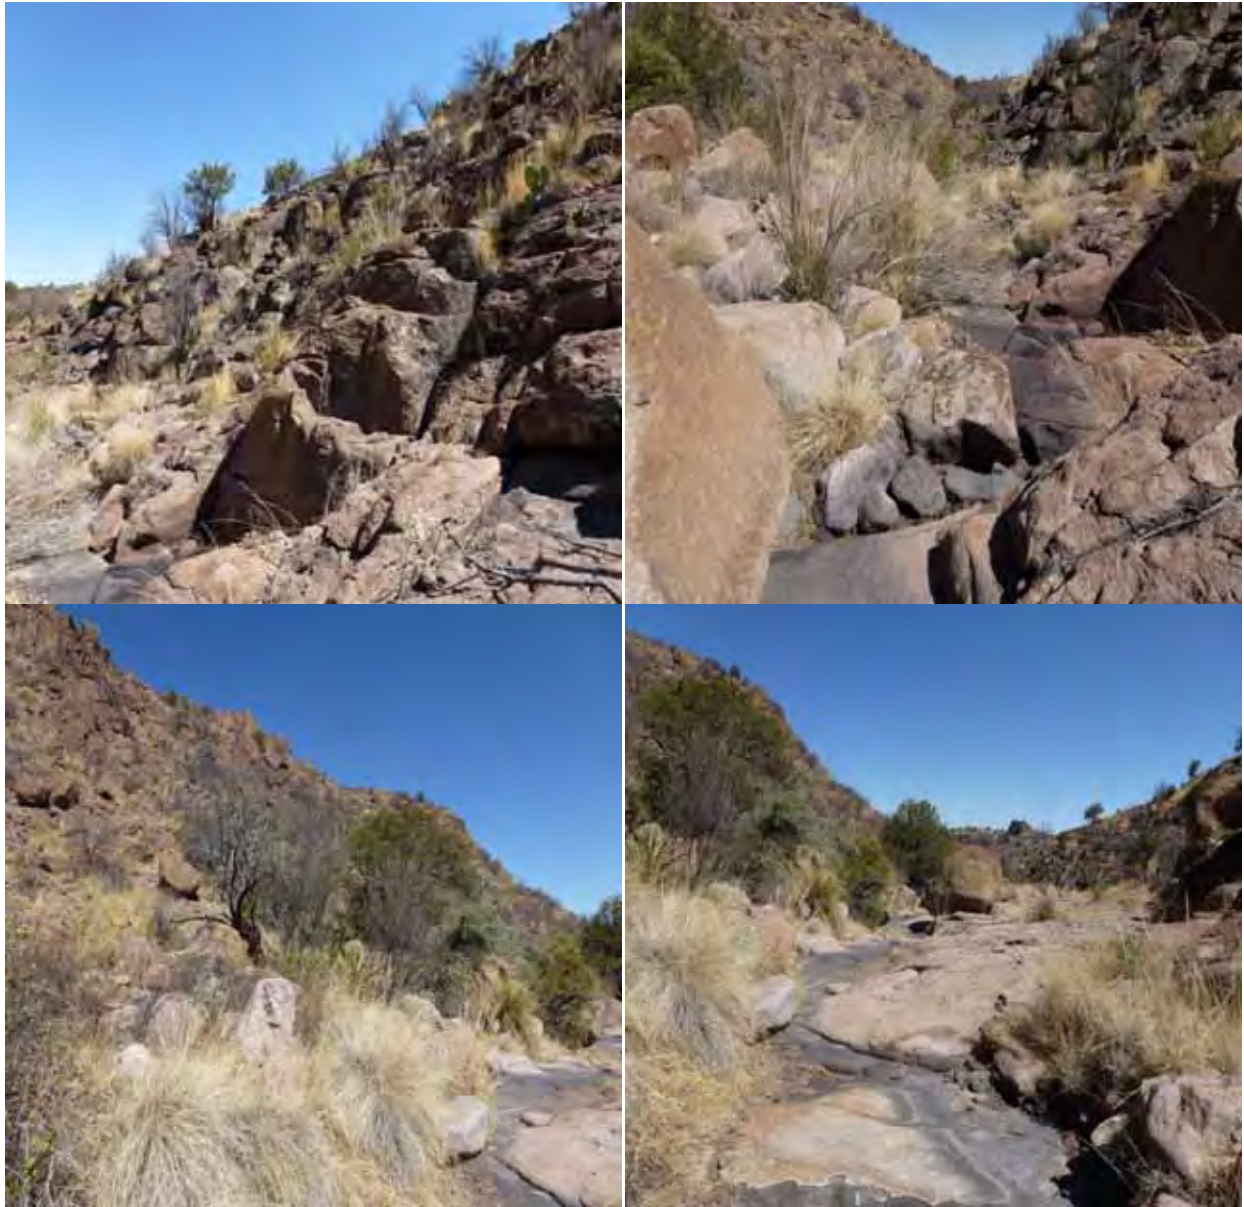
RC2-22-4: Photographic reference for indicators 1.5 and 1.6. Photographs of the bank/upland area and rooted in channel vegetation. Vegetation is similar in composition between the bank and the upland area. Vegetation is consistently dispersed throughout the channel.

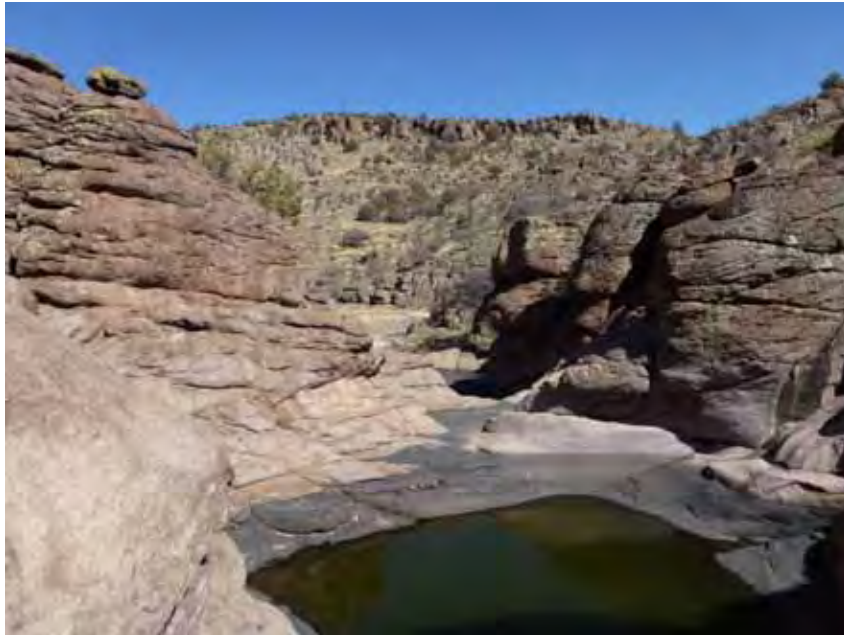
RC2-22B-1: Photographic reference for indicator 1.1 through 1.5. Small isolated pools are located along the sample reach. Seeps or springs were not observed along the reach. Biotic indicators of persistent water located with little effort but are not consistent throughout the reach. Indicators 1.1, 1.3, and 1.4 scored as 2.

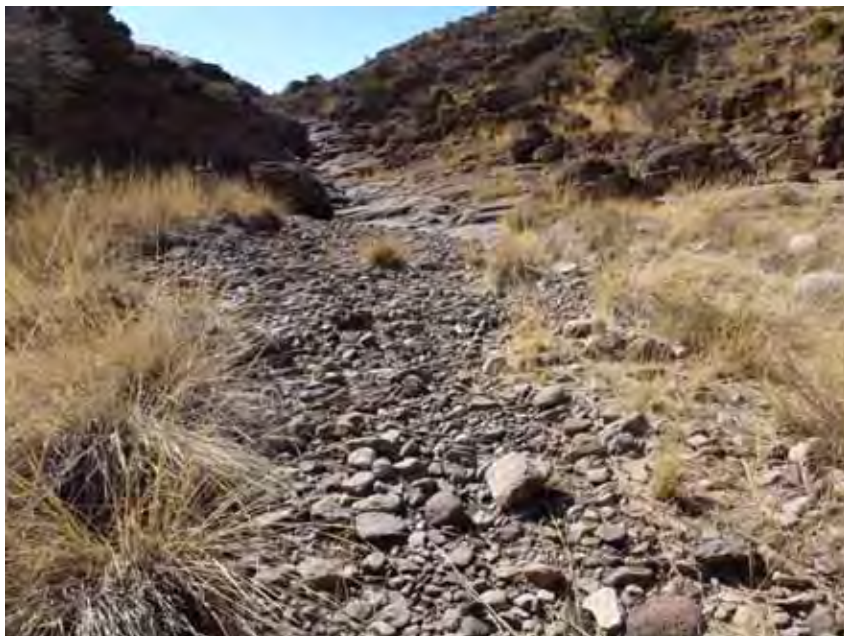
RC2-22B-2: Photographic reference for indicator 1.6. Streambed and geomorphology is dominated by bedrock. Indicator 1.6 scored as 2. Rooted vegetation is present along some portions of the stream reach, but is inconsistent.

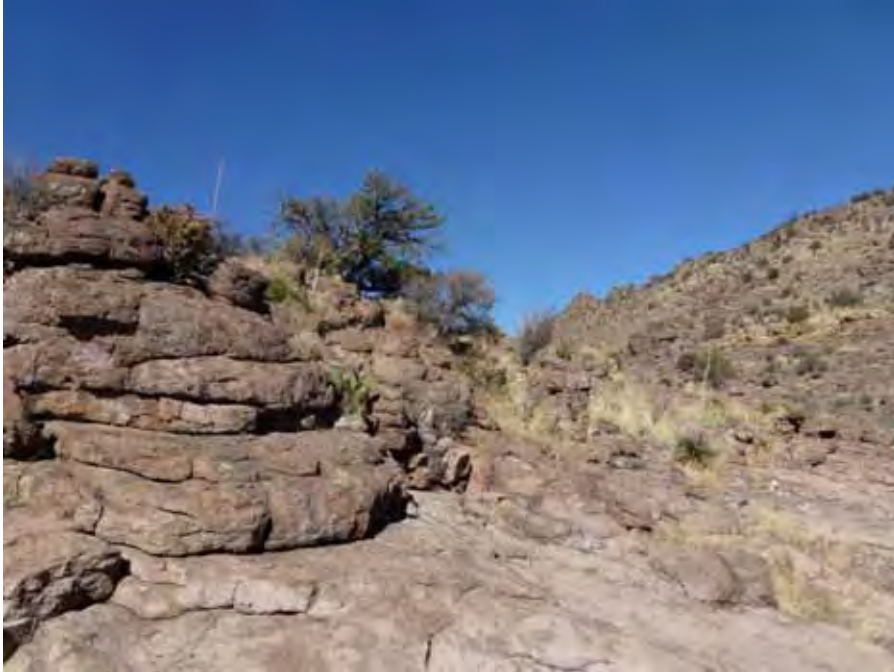
RC2-22B-3: Photographic reference for indicator 1.5. Indicator 1.5 scored as 0 - compositional and density differences in vegetation between stream bank and upland area not evident. No distinct riparian zone present.

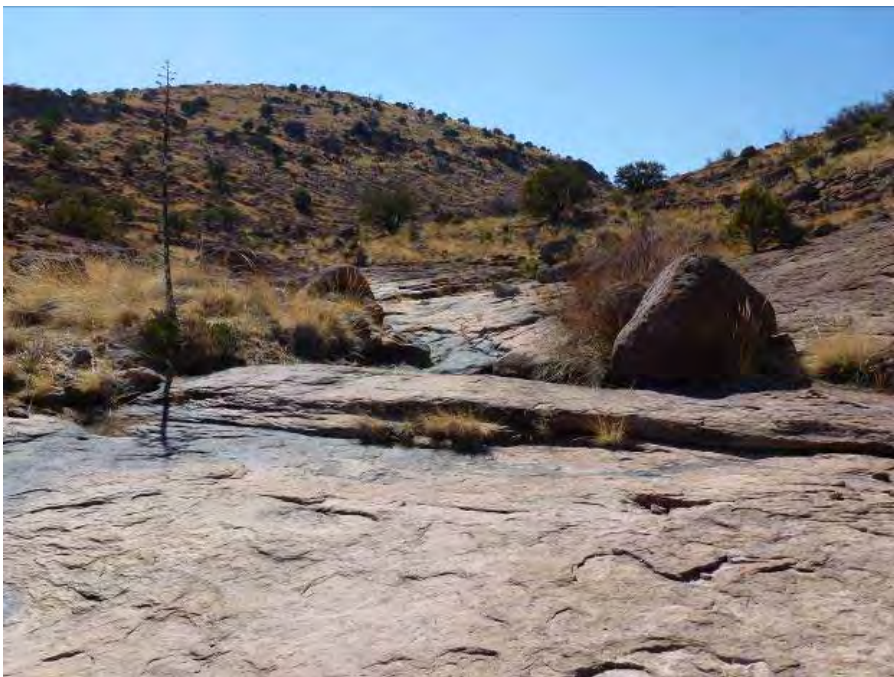
RC2-22B-4: Photographic reference of bedrock controlled channel.

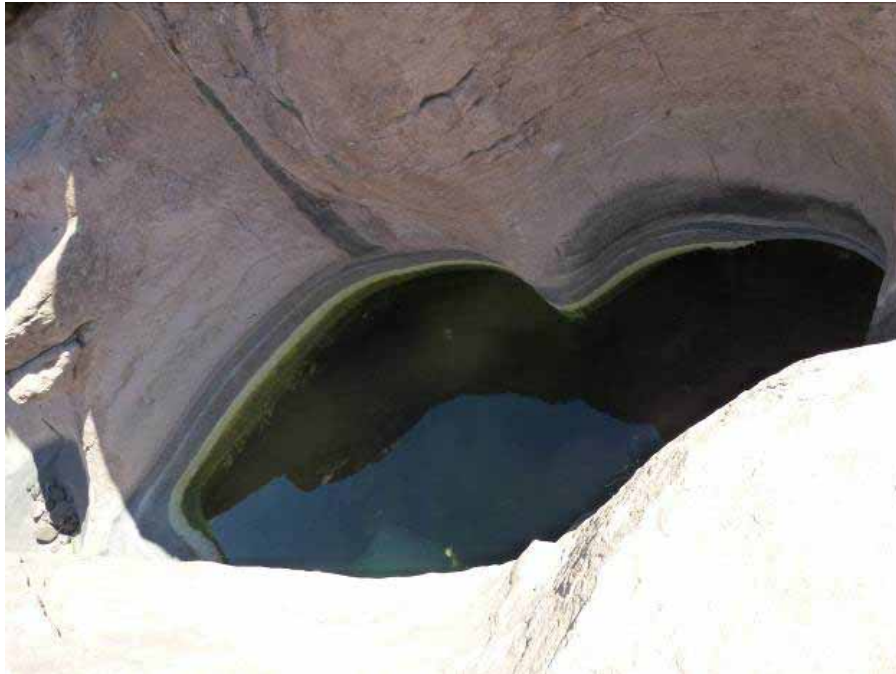
RC2-22B-5: Photographic reference of standing pool within downstream West Branch Rustler Canyon assessment unit.

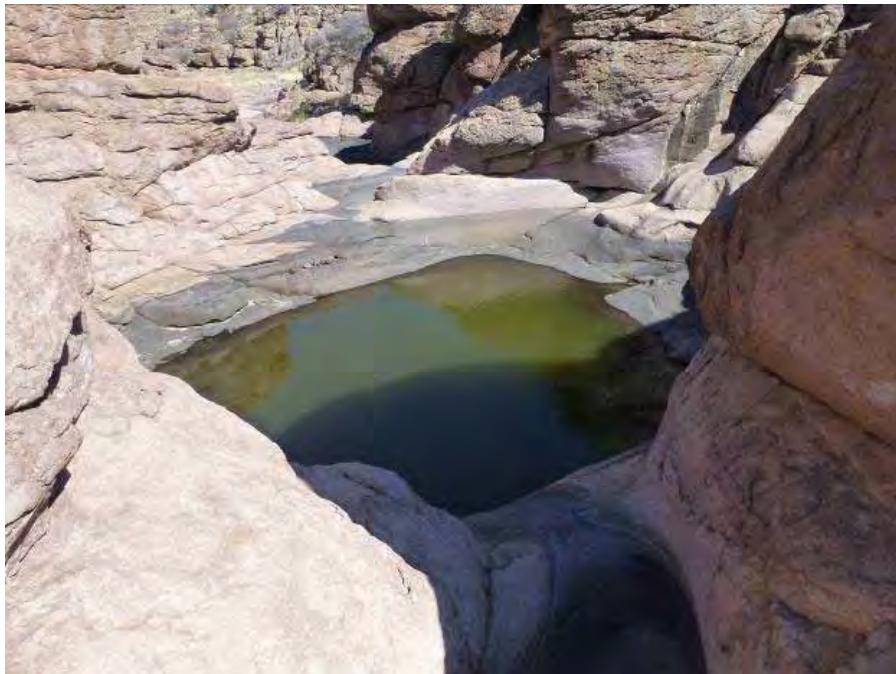
RC2-22B-6: Photographic reference of standing pool within downstream West Branch Rustler Canyon assessment unit.

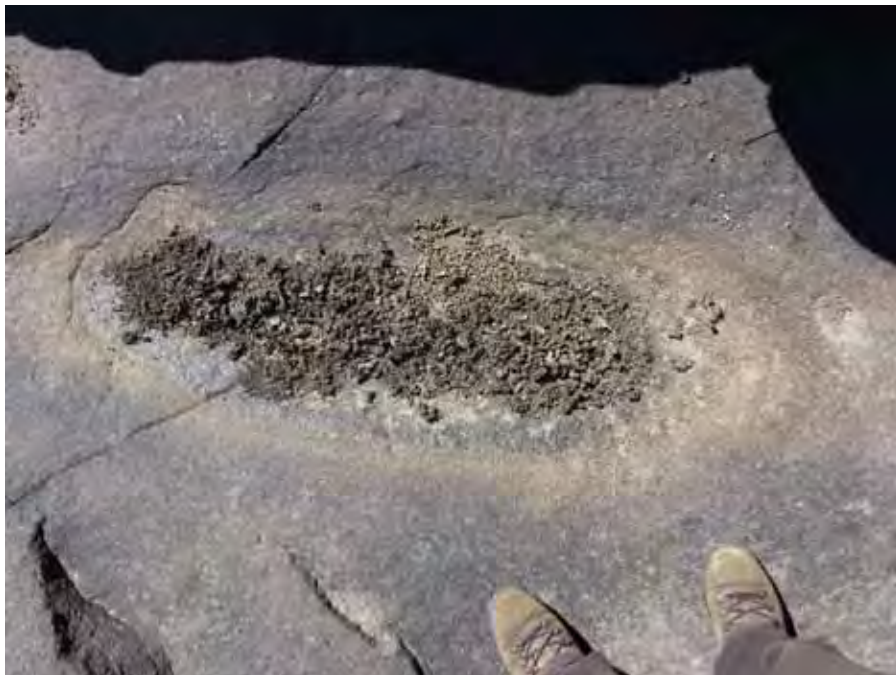
RC2-22B-7: Photographic reference of algae and benthic macro-invertebrates within downstream West Branch Rustler Canyon assessment unit.

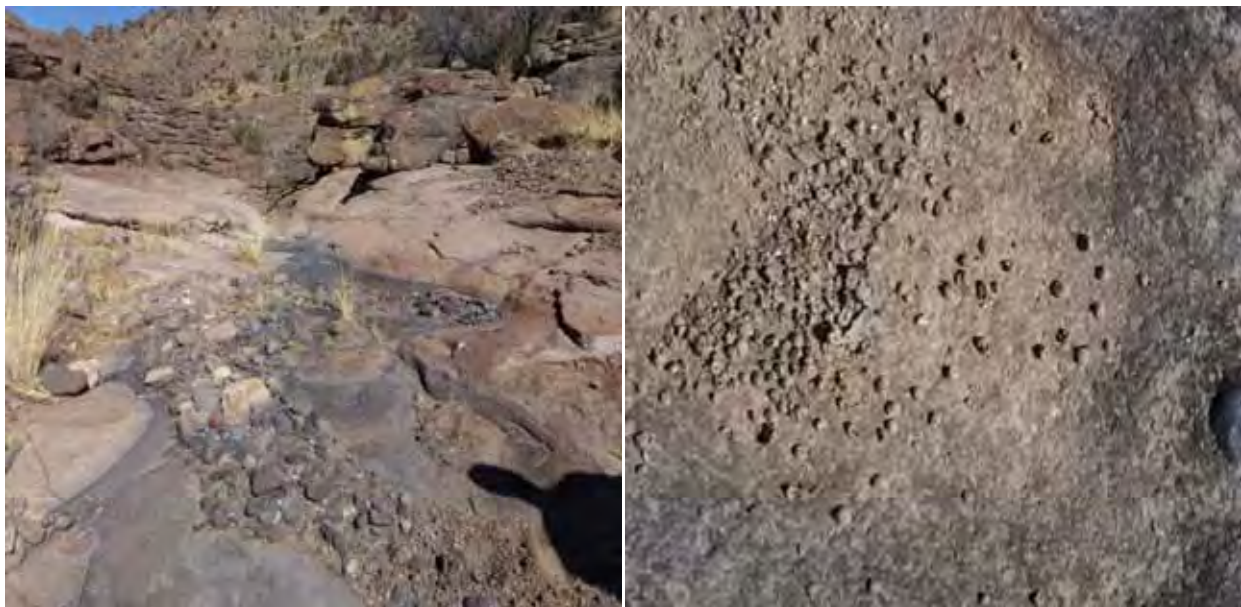
RC2-22B-8: Photographic reference for indicators 1.1 through 1.6. Filamentous algae/periphyton was observed along the reach. Multiple isolated pools present along the stretch. Biotic indicators of water found with little difficulty. Vegetation is inconsistently dispersed throughout the channel.

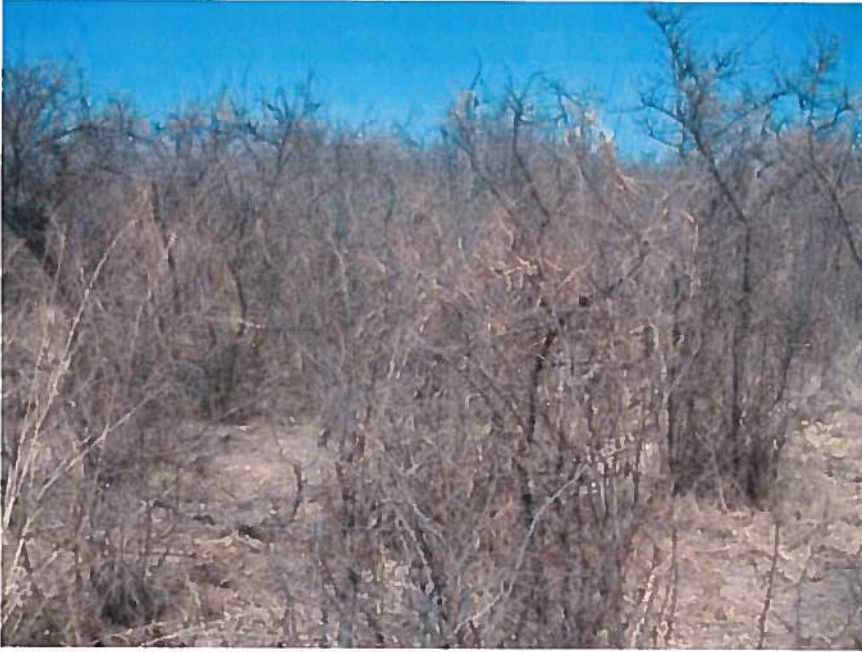
A9-1: Photographic reference for indicators 1.1 through 1.6. Photograph of channel area. Typical densely rooted vegetation within the channel. No water or biotic indicators of water observed along survey reach. Indicator 1.6 scored as 0 - rooted upland plants prevalent in streambed.

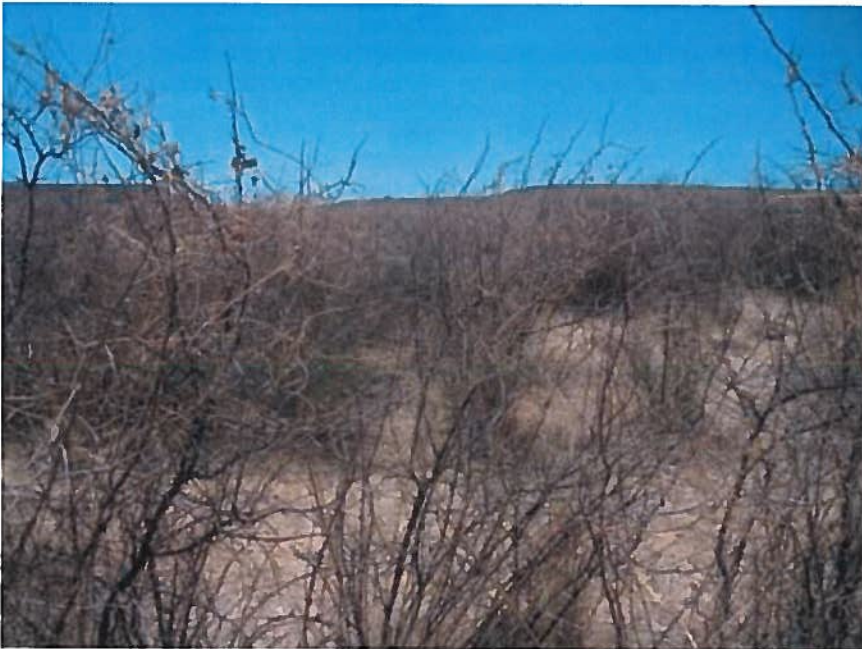
A9-2: Photographic reference for indicator 1.5. Photograph of upslope and overbank area. Vegetation within, and adjacent to channel, occurred at slightly greater densities but was consistent with vegetation growing in adjacent upland areas (mostly bunch grass and cat claw).

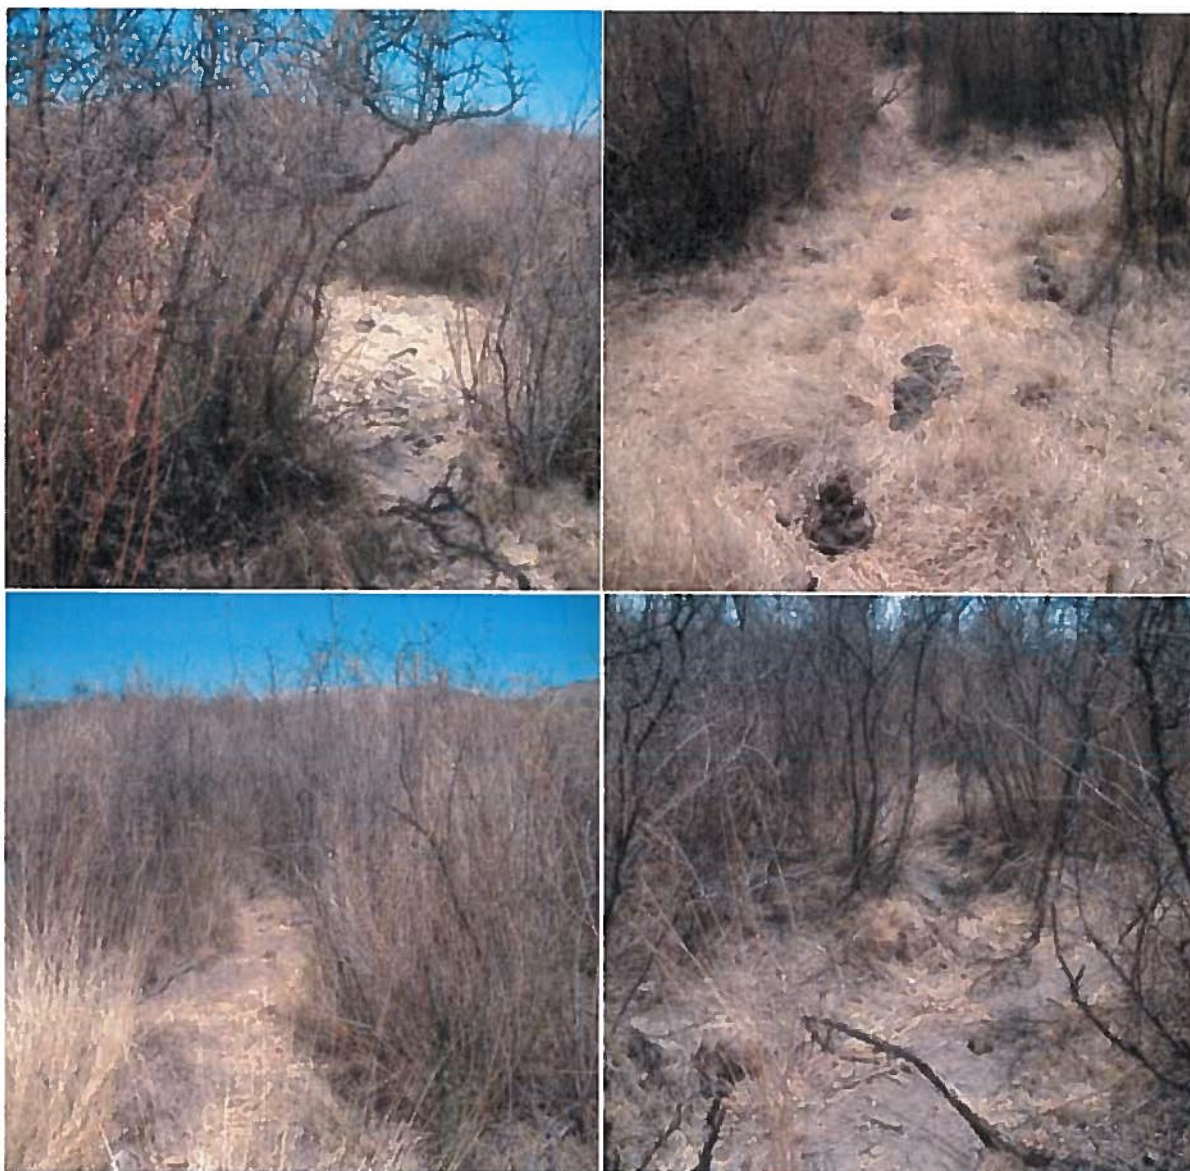
A9-3: Photographic reference for indicators 1.5 and 1.6. Photographs of vegetation. Typical densely rooted vegetation within the channel. No compositional differences were observed between vegetation growing around the channel and adjacent uplands, but upland species did occur at greater densities within and around the channel.

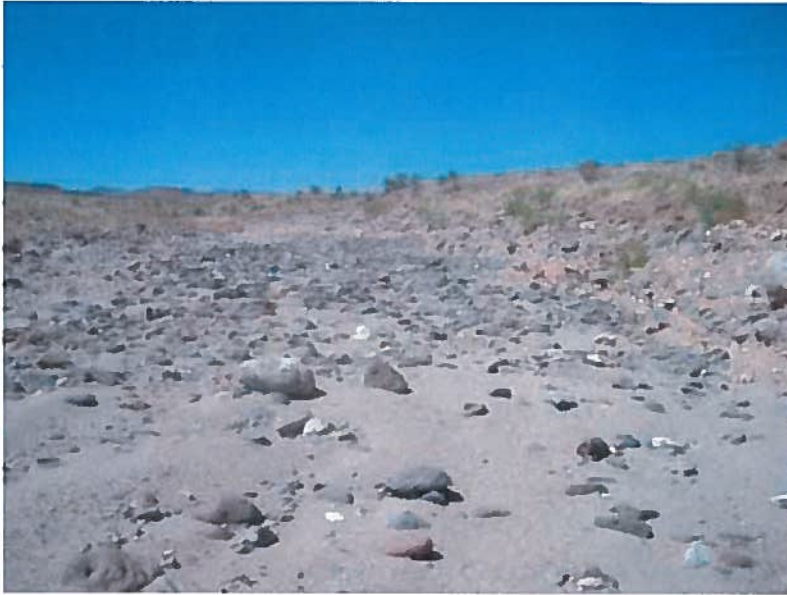
A10-1: Photographic reference for indicators 1.1 through 1.6. Typical view of stream bed and banks. Indicators 1.1 through 1.4 scores of 0 - no water or biotic indicators of water observed along survey reach.

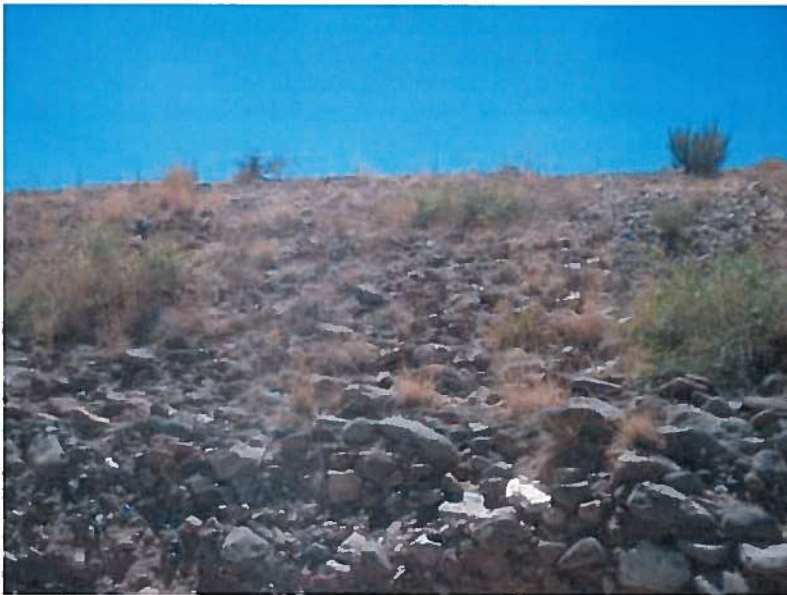
A10-2: Photographic reference for indicator 1.5. Photograph of typical stream bank and over bank vegetation (also observed in other photos provided). No significant compositional or density differences between bank and adjacent uplands and no riparian zone present. Indicator 1.5 score of 0 - no vegetative differences between banks and uplands.

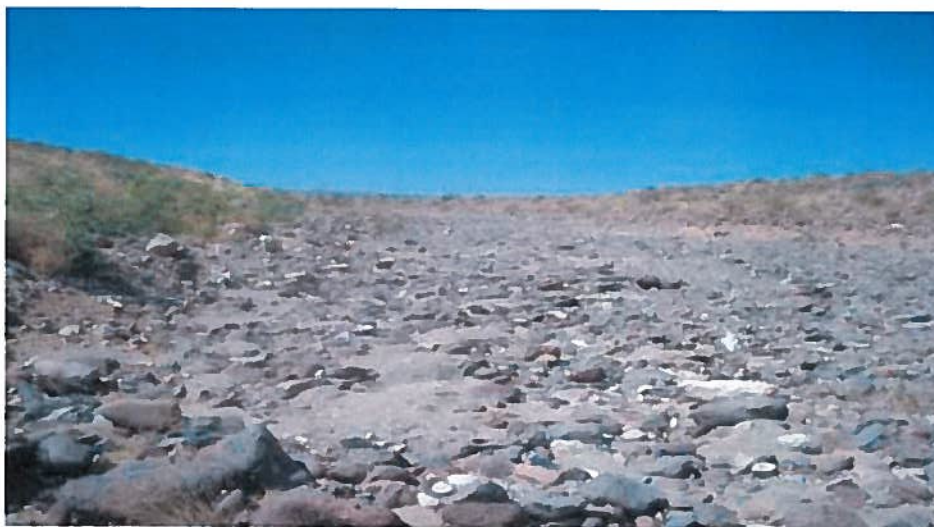
A10-3: Photographic reference for indicator 1.6. Most of the streambed is relatively devoid of vegetation most likely as a result of flow regime and bed material (course sands, gravel and boulders). Indicator 1.6 scored as 2 -- a few upland rooted plants were observed growing within the channel (see below pictures), although they were mostly (but not entirely) absent presumably as a result of substrate limitations.

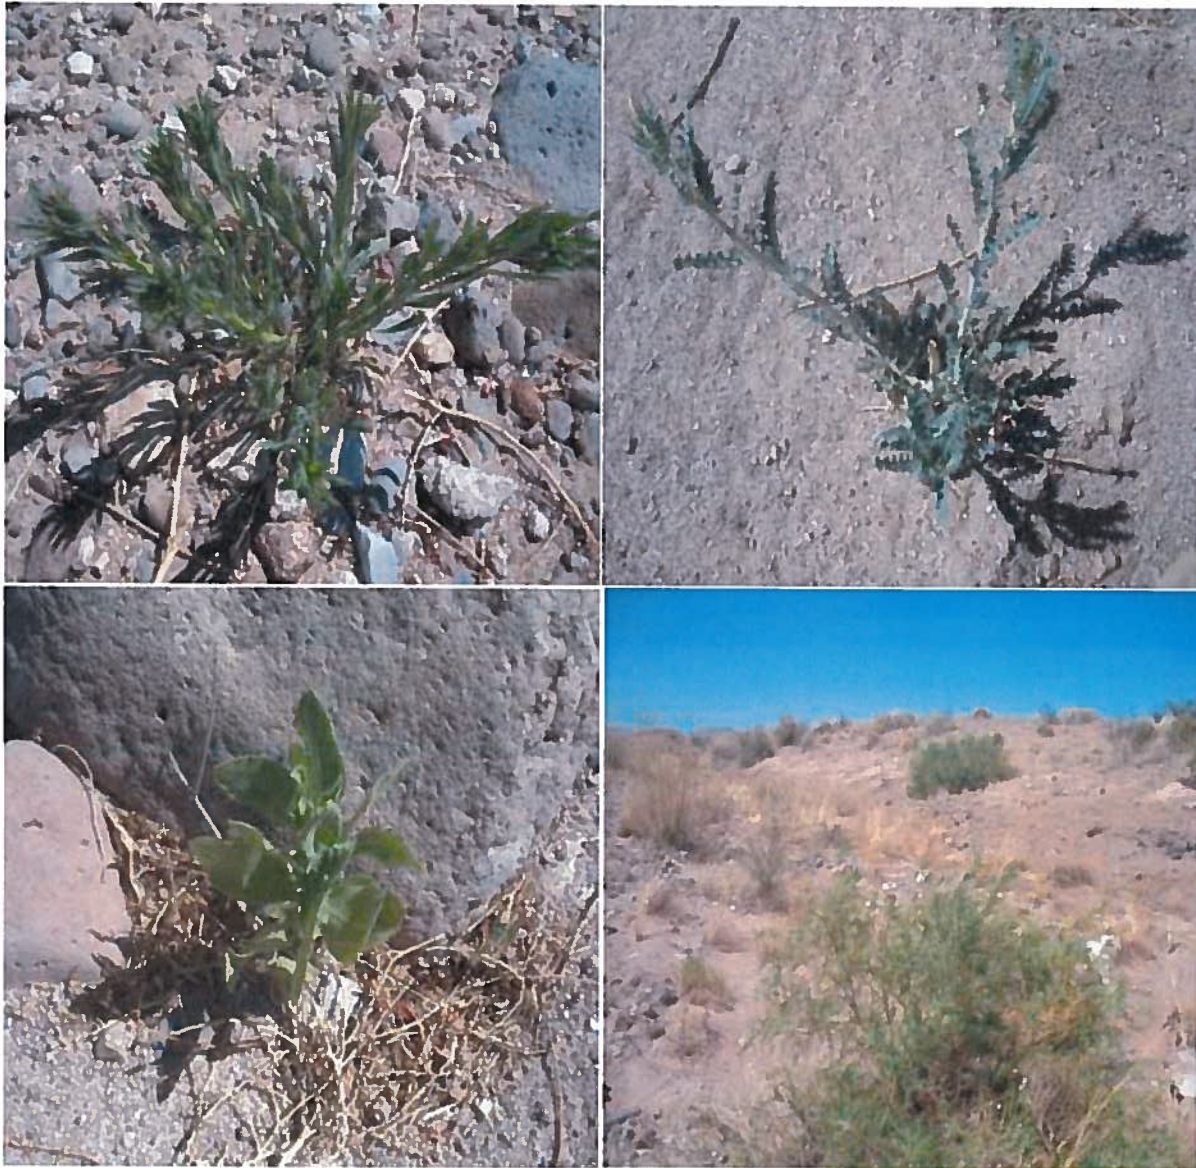
A10-4: Photographic reference for indicators 1.5 and 1.6. Photographs of in stream rooted plants and overbank/upland areas. Typical rooted vegetation noted within the channel. No significant compositional or density differences between bank and adjacent uplands.

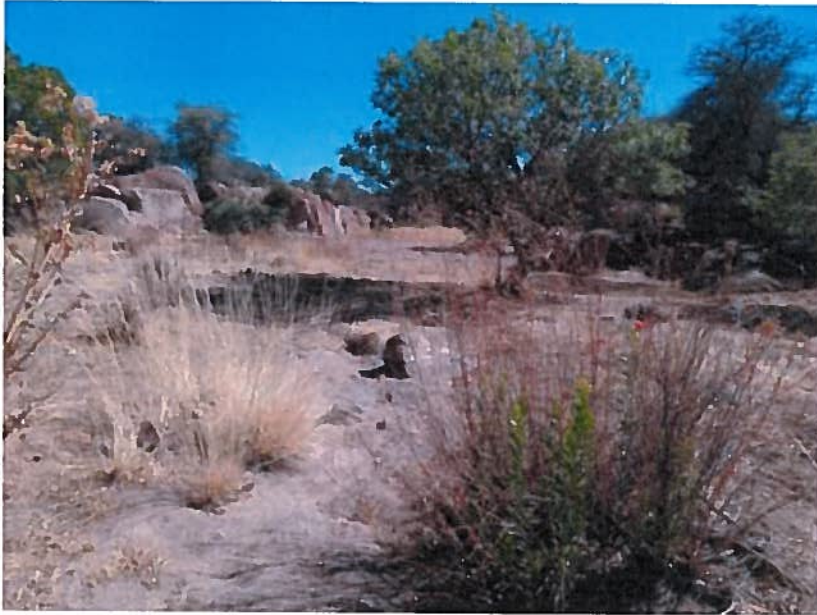
B7-1: Photographic reference for indicators 1.1 through 1.6. Photograph of stream bed. Typical rooted vegetation across channel and banks relatively consistently dispersed throughout channel length. Indicator 1.6 scored as 1 - rooted upland plants consistently dispersed in streambed. No water or biotic indicators of water observed along survey reach.

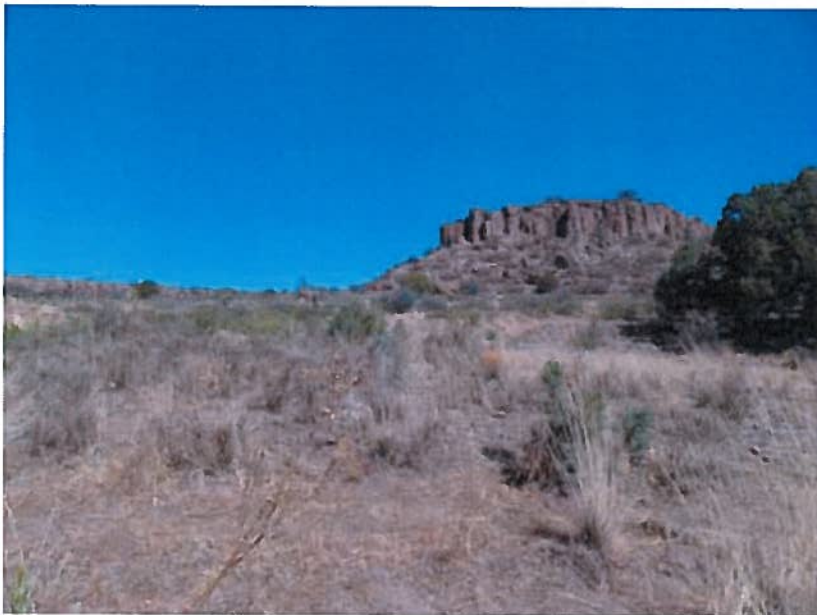
B7-2: Photographic reference for indicator 1.5. Photograph of bank and upland area. Indicator 1.5 scored as 1 - evident variation in vegetative density but no dramatic difference in composition. No distinct riparian zone observed.
