**Application of the Hydrology
Protocol to STSIU Drainages**

Chino Mines, Vanadium, New Mexico

October 2014

**Application of Hydrology
Protocol to STSIU Drainages**

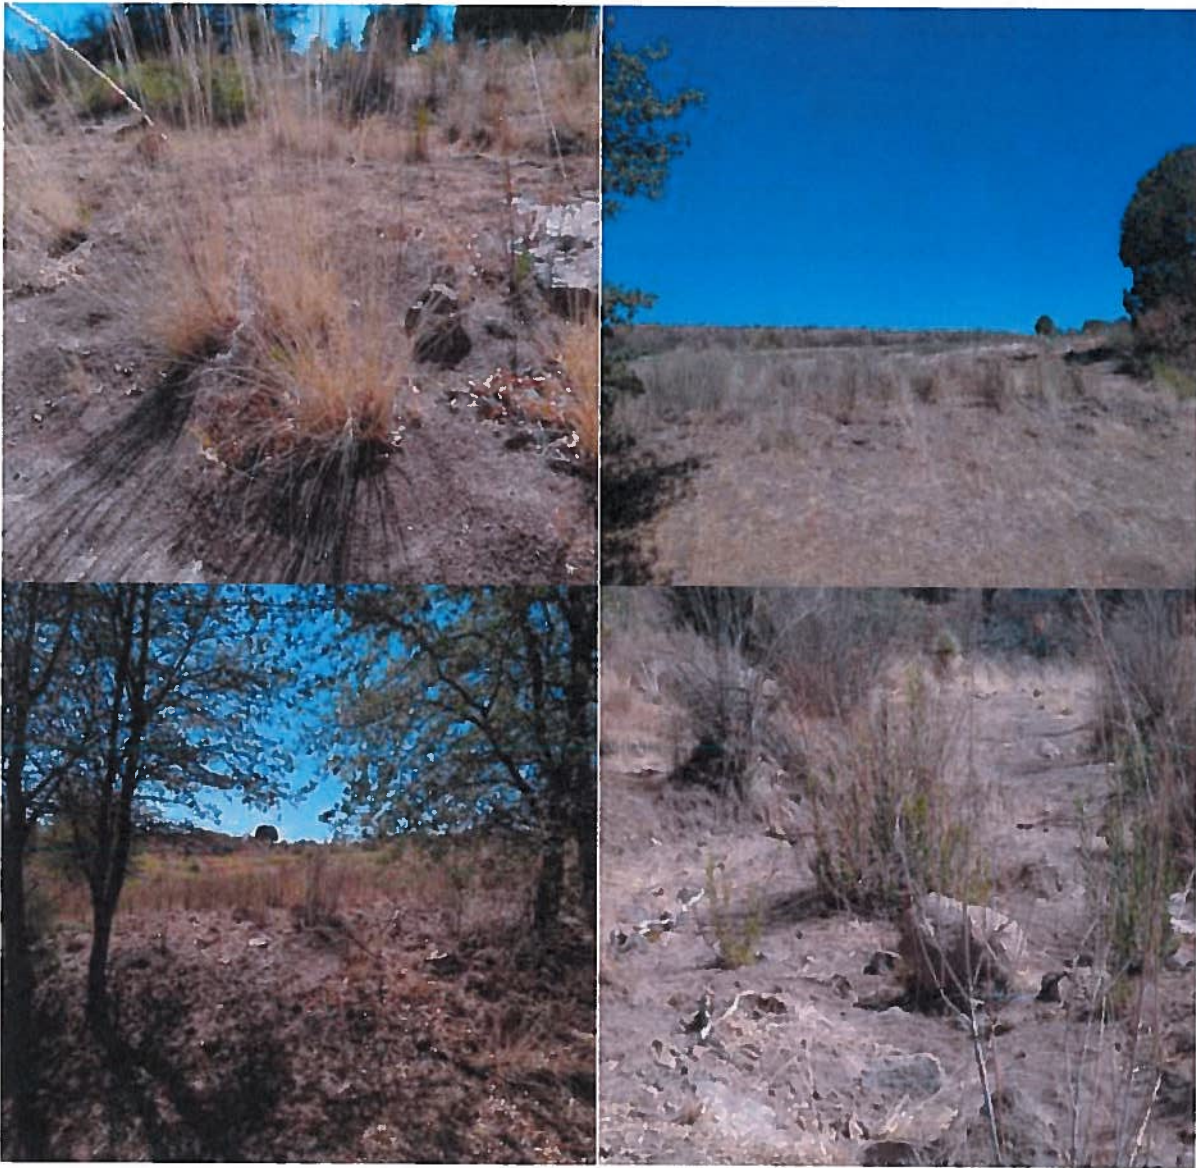
B7-3: Photographic reference for indicators 1.5 and 1.6. Photographs of bank/upland area and rooted in channel vegetation. There is a variation in vegetative density but no dramatic difference in composition. Rooted vegetation consistent across channel and banks.

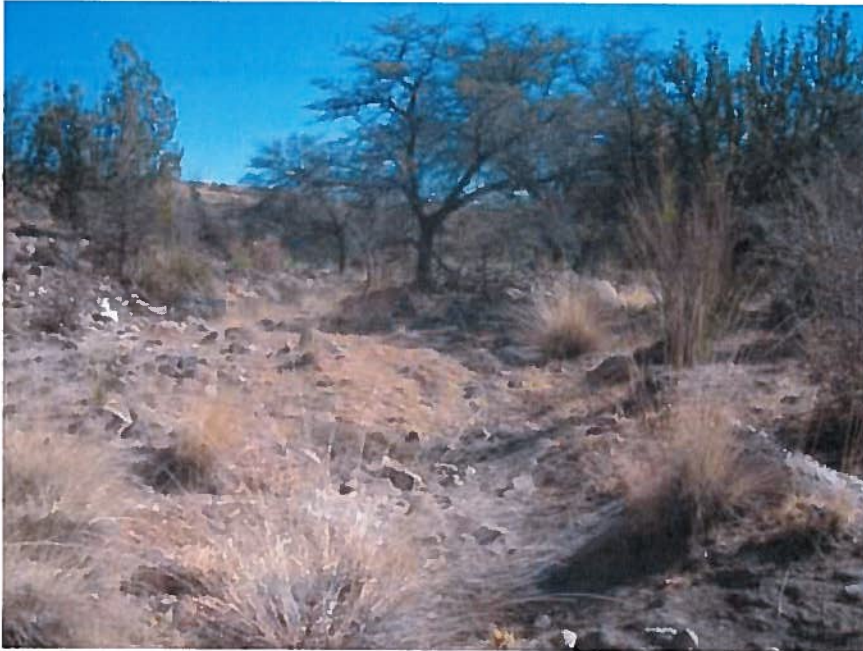
B7 DS-1: Photographic reference for indicator 1.1 through 1.6. Indicator 1.6 scored as 1 - rooted vegetation along the stream bed is consistently dispersed. No water or biotic indicators of water observed along survey reach.

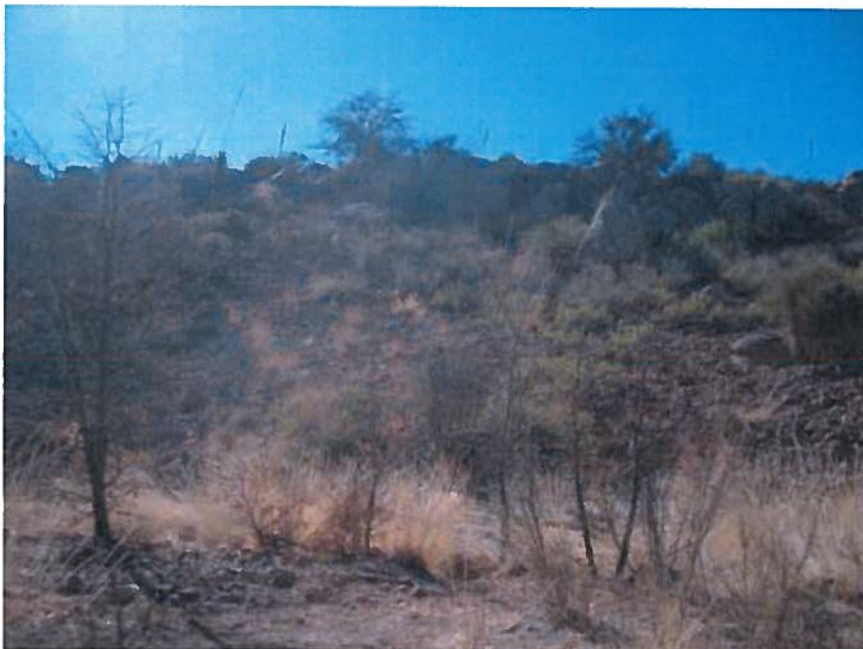
B7 DS-2: Photographic reference for indicator 1.5. Photograph of the overbank area and uplands. Indicator 1.5 scored as 1 - evident variation in vegetative density but no dramatic difference in composition. No distinct riparian zone observed.

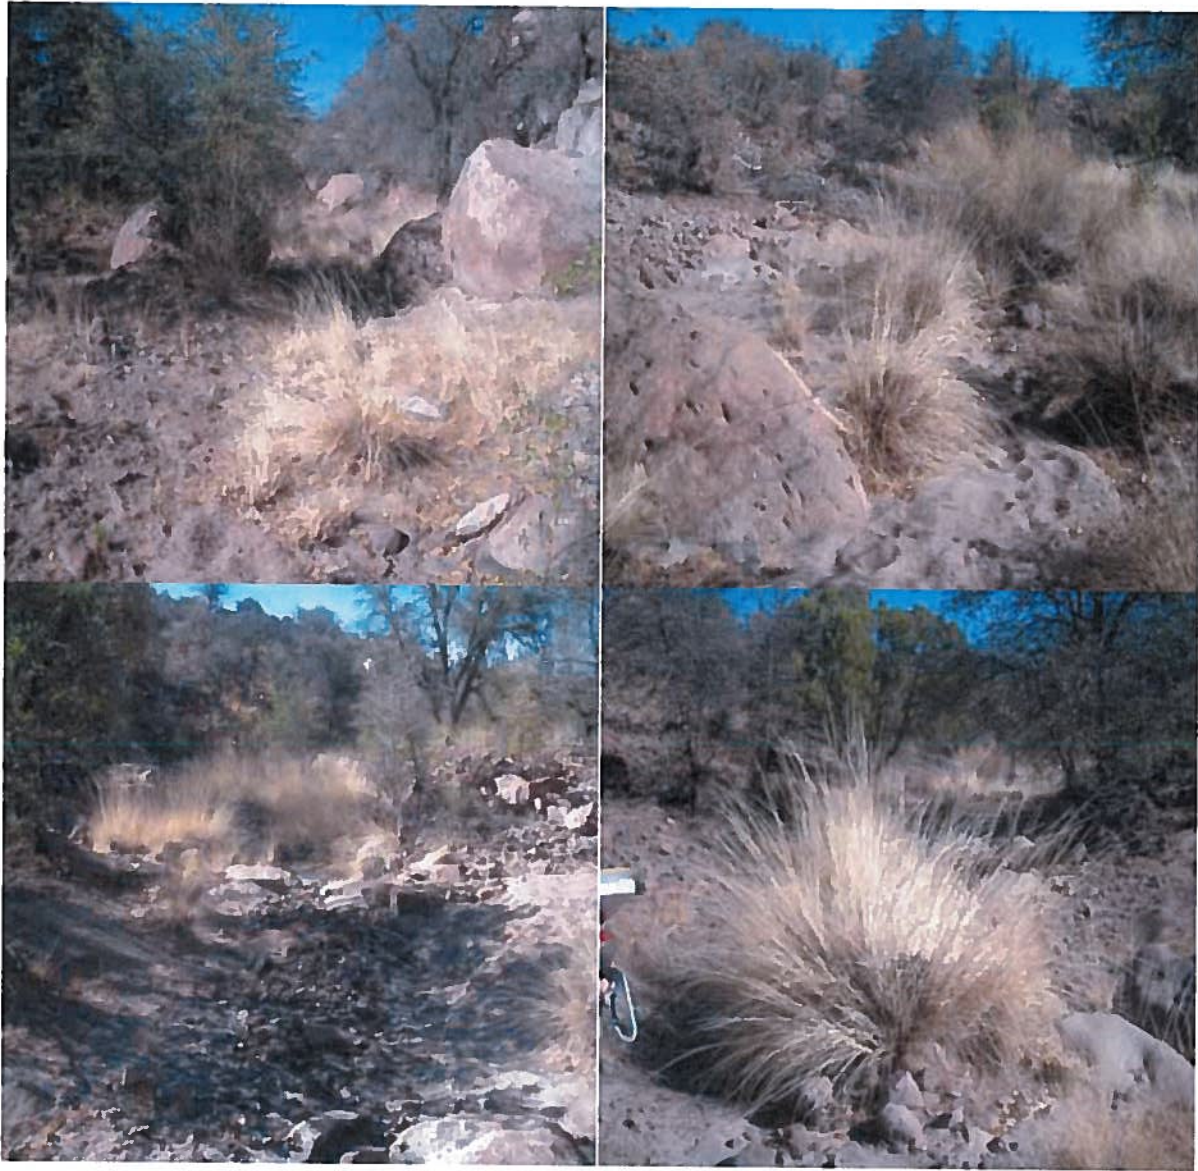
B7 DS-3: Photographic reference for indicators 1.5 and 1.6. Photographs of in stream rooted plants and overbank/upland areas. Evident variation in vegetative density but no dramatic difference in composition and rooted vegetation along the stream bed is consistently dispersed.

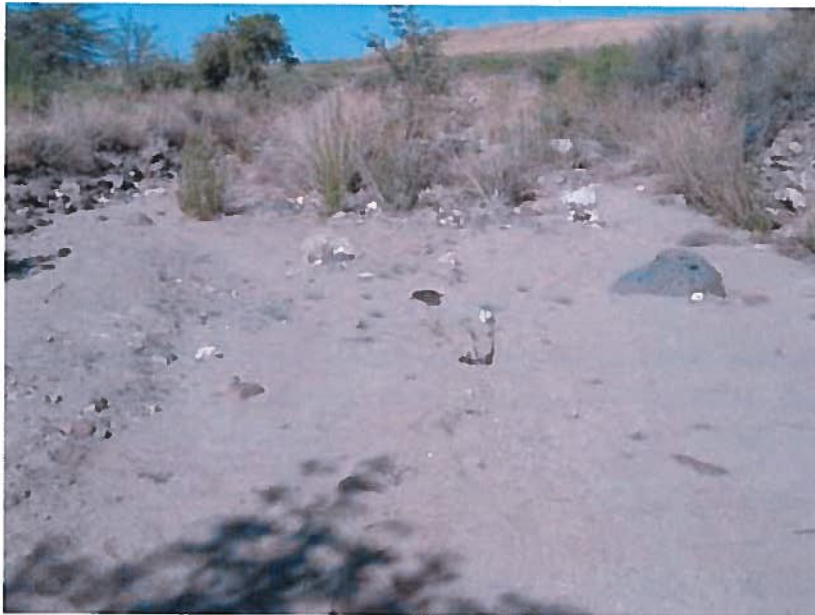
B8-1: Photographic reference for indicator 1.1 through 1.6. Photograph of typical channel bed and channel banks. Indicator 1.6 scored as 2 - rooted vegetation inconsistently present in stream bed. No water or biotic indicators of water observed along survey reach.

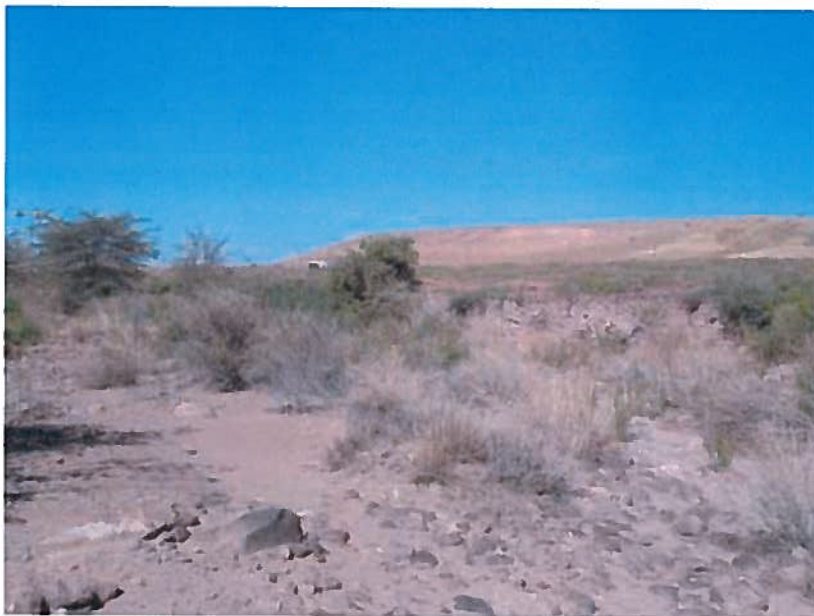
B8-2: Photographic reference for indicator 1.5. Photograph of bank and upland area. No dramatic differences between channel bank vegetation and upland vegetation. Indicator 1.5 scored as 1 - evident variation in vegetative density but no dramatic difference in composition. No distinct riparian zone present.

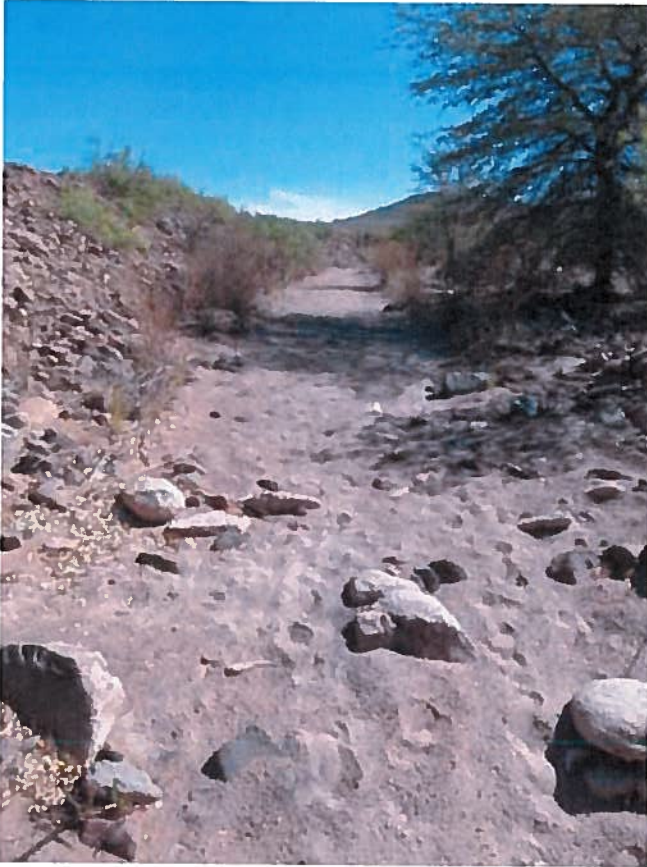
B8-3: Photographic reference for indicator 1.6 and 1.9. Portions of the stream bed along the reach are devoid of vegetation while other portions are vegetated (see previous photograph). Lack of vegetation is likely the result of the flow regime and the bed material rather than an indicator of water persistence. Indicator 1.6 scored as 2 - few rooted upland plants present along streambed.

Indicator 1.9 scored as 0 - no riffle-pool sequence observable.

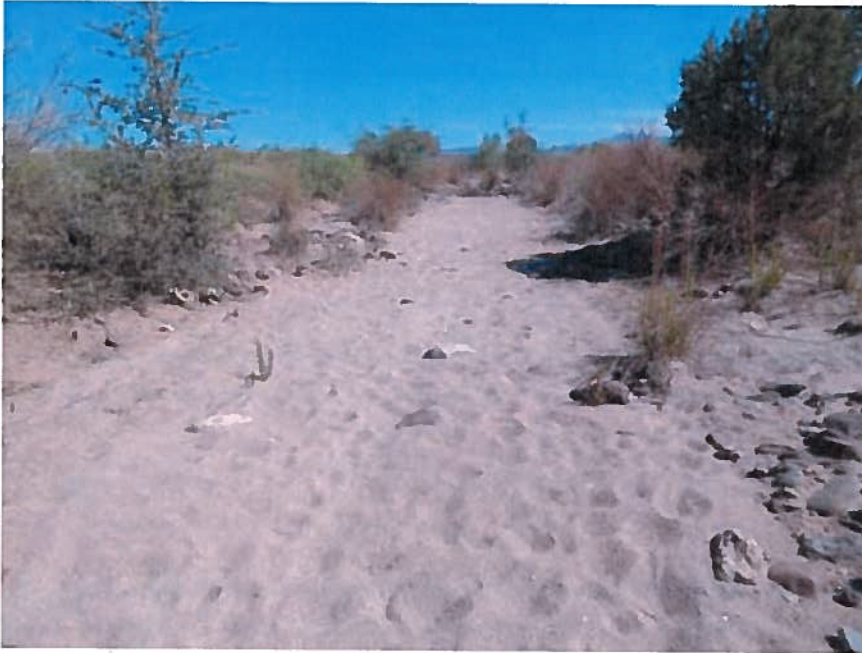
B8-4: Photographic reference for indicator 1.8 and 1.10. Photograph of the cross-section for measurement of the floodplain and channel dimensions. Indicator 1.8 scored 1.5 based on measurements taken - moderate confinement and presence of inactive floodplain.

Indicator 1.10 scored as 1.5. Channel bed material is medium to coarse sand, which is consistent but noticeably courser than the bank and over bank area. Little to no substrate sorting is observable.

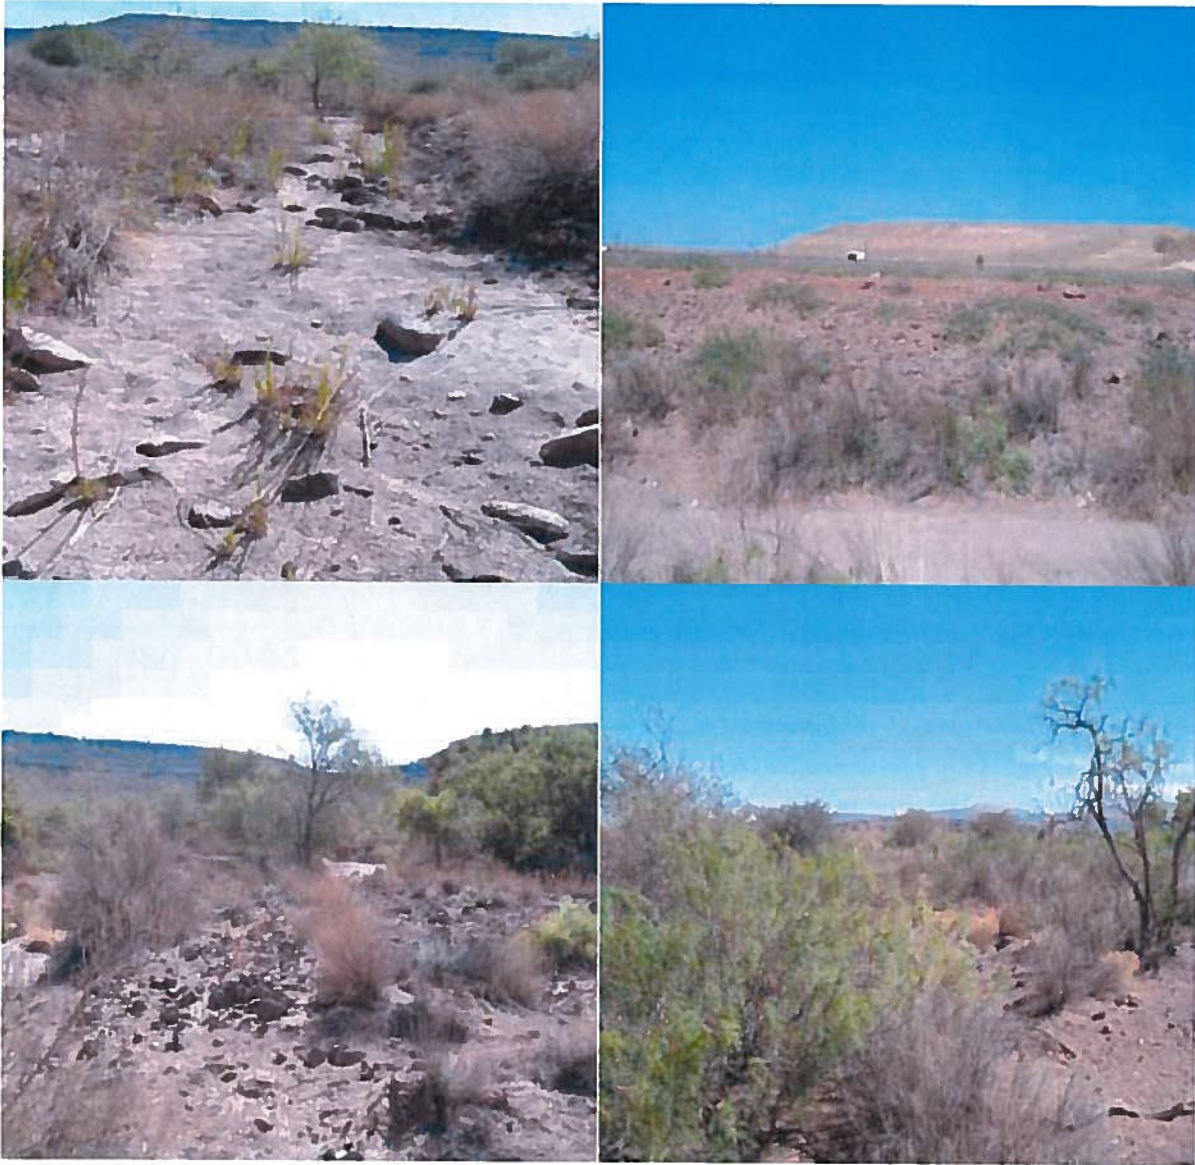
B8-5: Photographic reference for indicators 1.5 and 1.6. Photographs of bank/upland area and rooted in channel vegetation. There is a variation in vegetative density but no dramatic difference in composition. Rooted vegetation inconsistent across channel and banks.

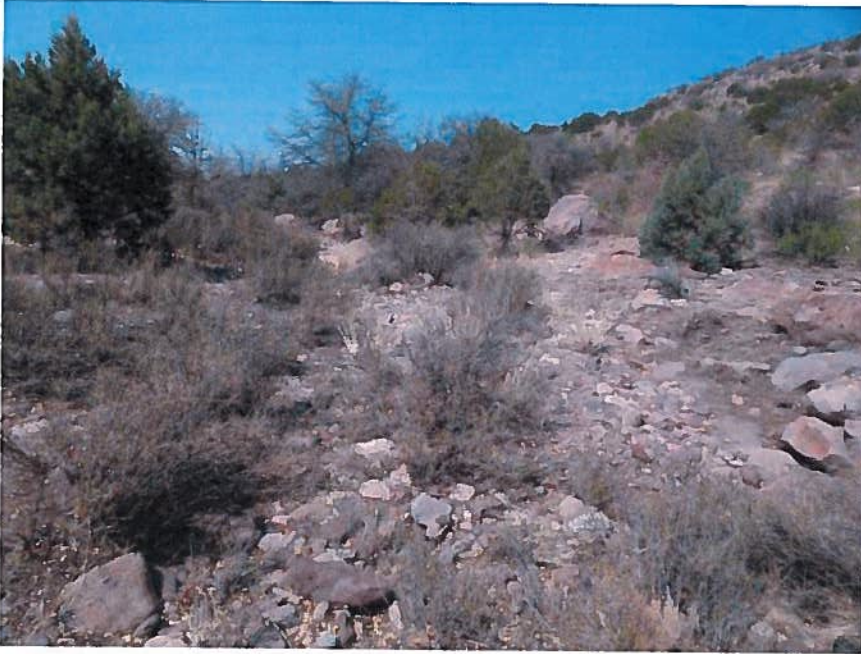
C19-1: Photographic reference to representative channel bottom characteristics.

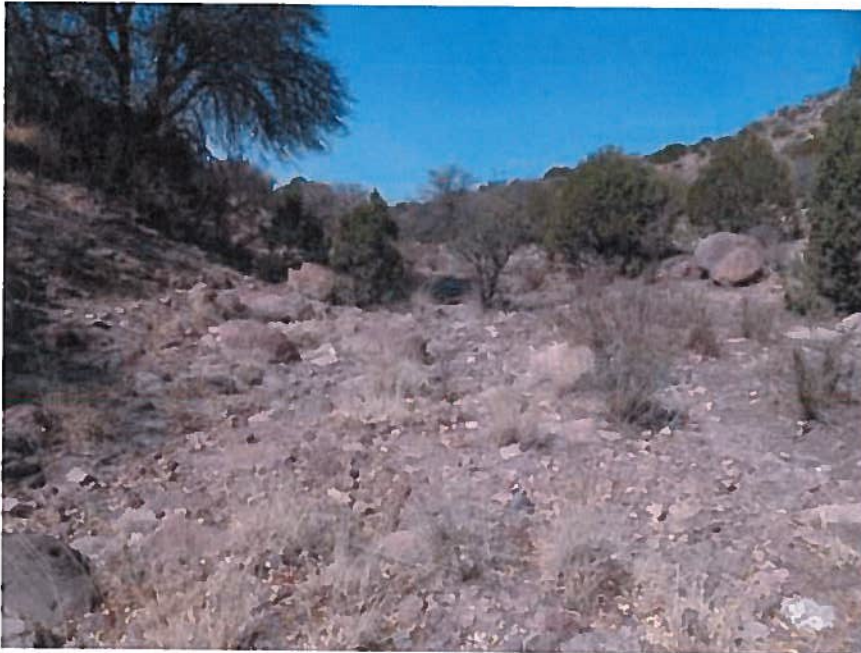
C19-2: Photographic reference for indicators 1.1 through 1.6. Photograph from upper extent of survey reach facing downstream. Rooted vegetation present in channel is present but inconsistent (see subsequent photograph). No water or biotic indicators of water observed along survey reach.

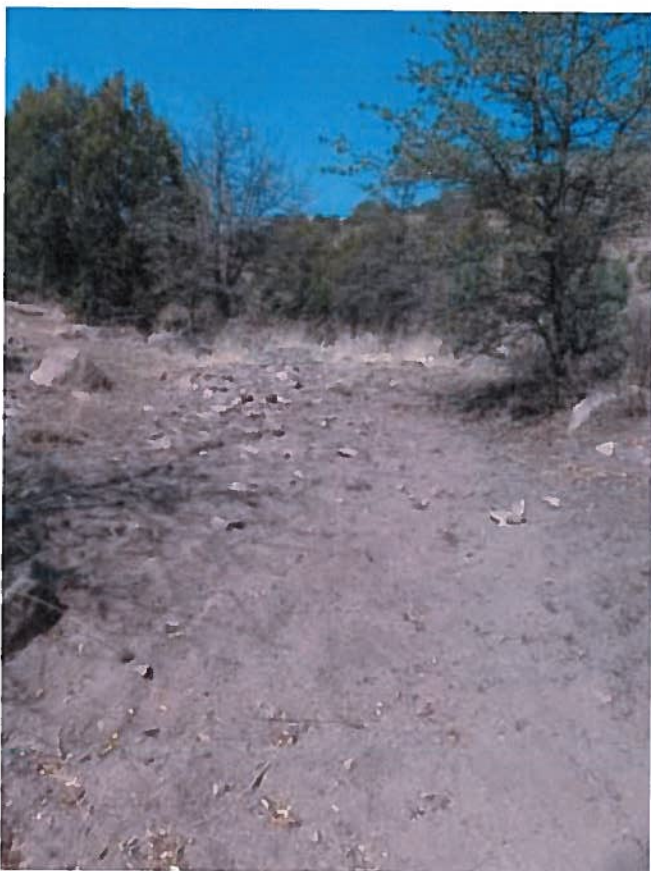
C19-3: Photographic reference for indicator 1.6. Portions of the survey reach devoid of vegetation as a result of bed material and lack of moisture rather than an indicator of persistence of flow. Indicator 1.6 scored as 1 – few rooted plants present in streambed.

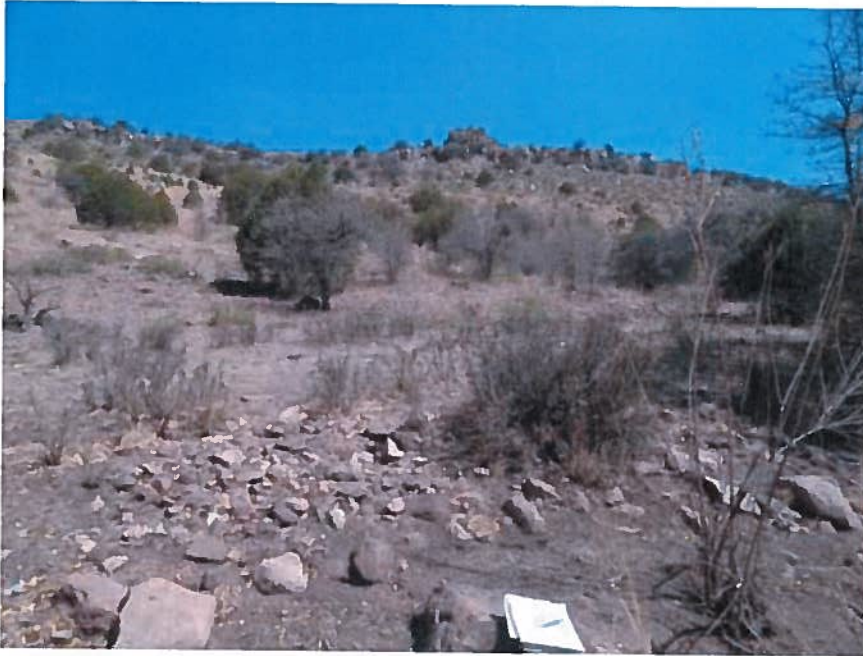
C19-4: Photographic reference for indicator 1.5. Photograph of upland area and upland vegetation. Indicator 1.5 scored as 1 - evident variation in vegetative density but no dramatic difference in composition. No distinct riparian zone observed.

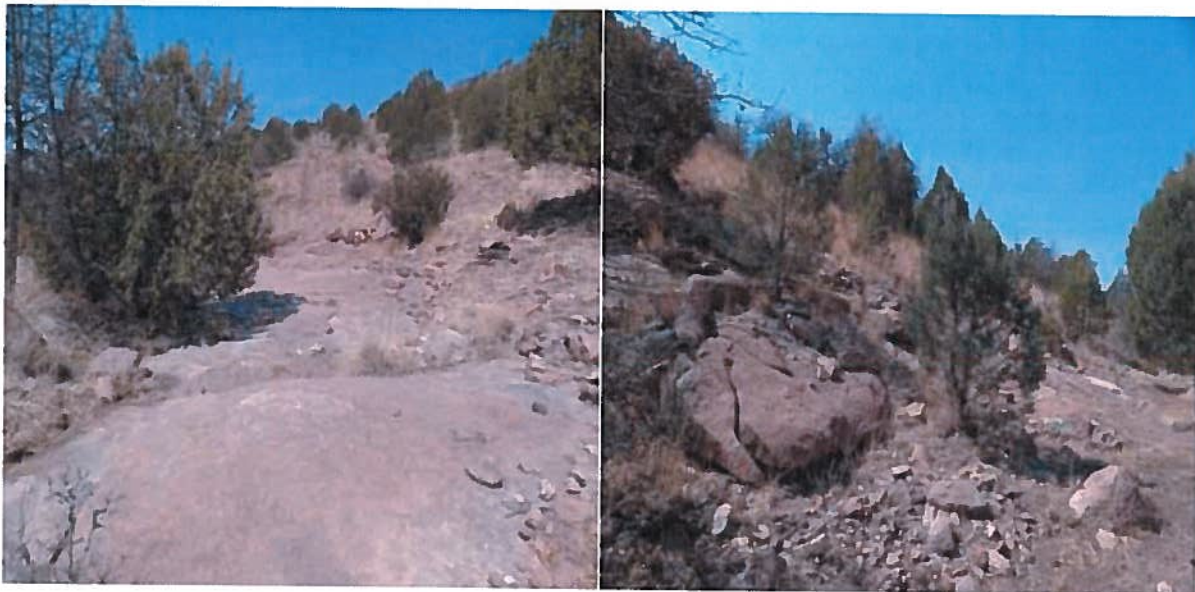
C19-5: Photographic reference for indicators 1.5 and 1.6. There is a variation in vegetative density but no dramatic difference in composition. Portions of the survey reach few rooted plants present in streambed as a result of bed rock in channel.

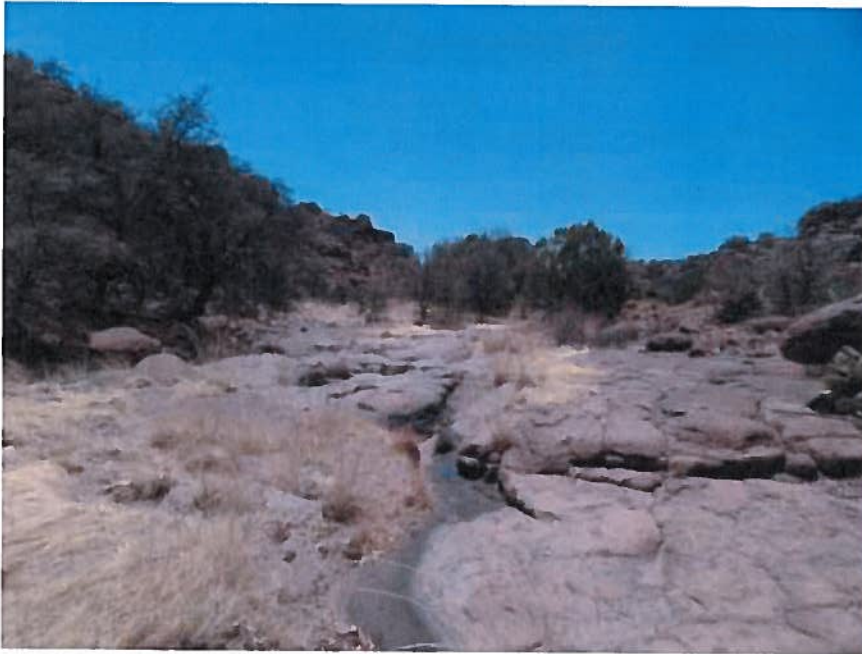
C4-1: Photographic reference for indicator 1.1 to 1.6. Streambed is predominantly bedrock. Vegetation present where deposition has occurred. No water or biotic indicators of water observed along survey reach.

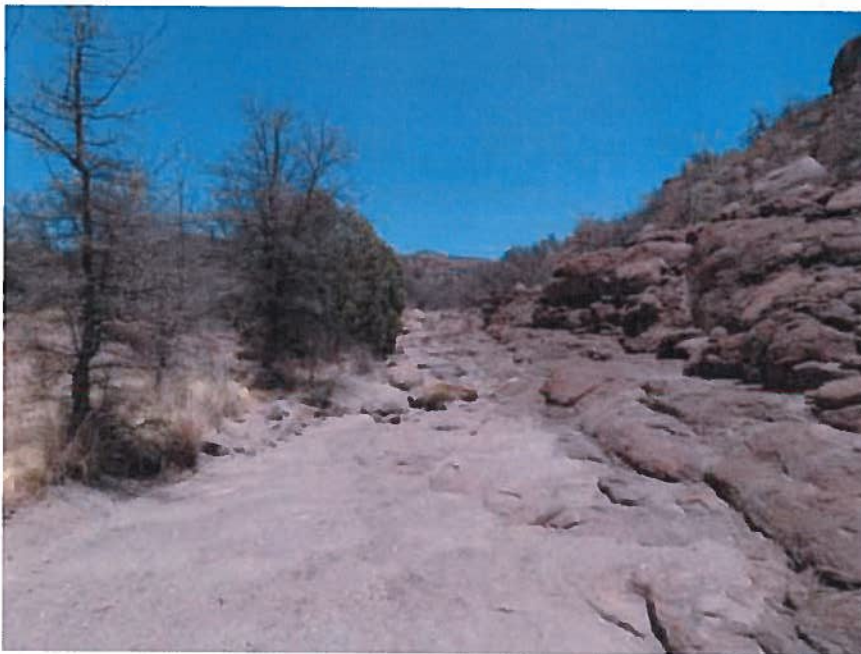
C4-2: Photographic reference for indicator 1.6. Indicator 1.6 scored as 2 – few rooted upland plants present in streambed. Lack of vegetation present in streambed likely result of flow regime and presence of bedrock rather than result of persistent water.

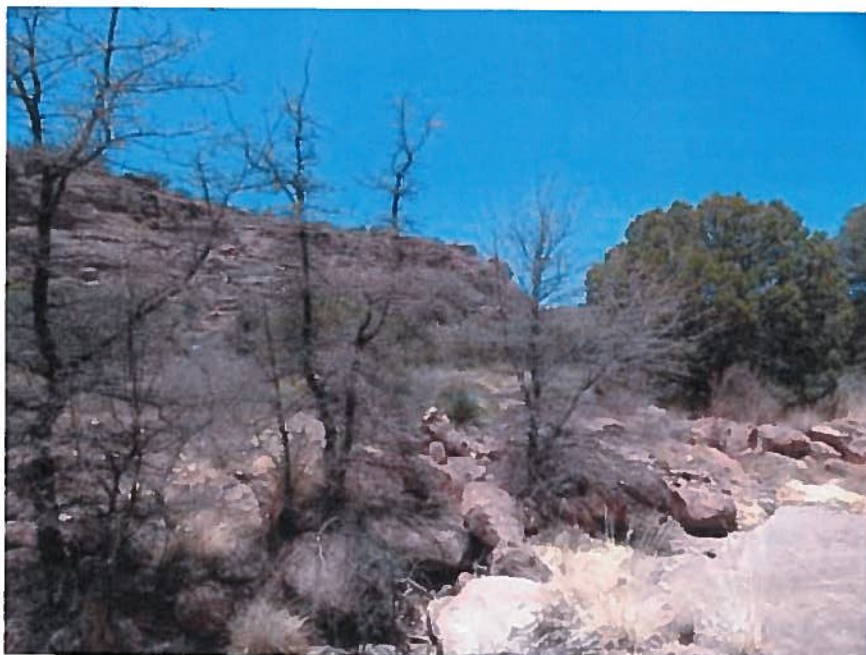
C4-3: Photographic reference for indicator 1.5. Photograph of bank and upland vegetation. Indicator 1.5 scored as 1 - evident variation in vegetative density but no dramatic difference in composition. No distinct riparian zone observed.

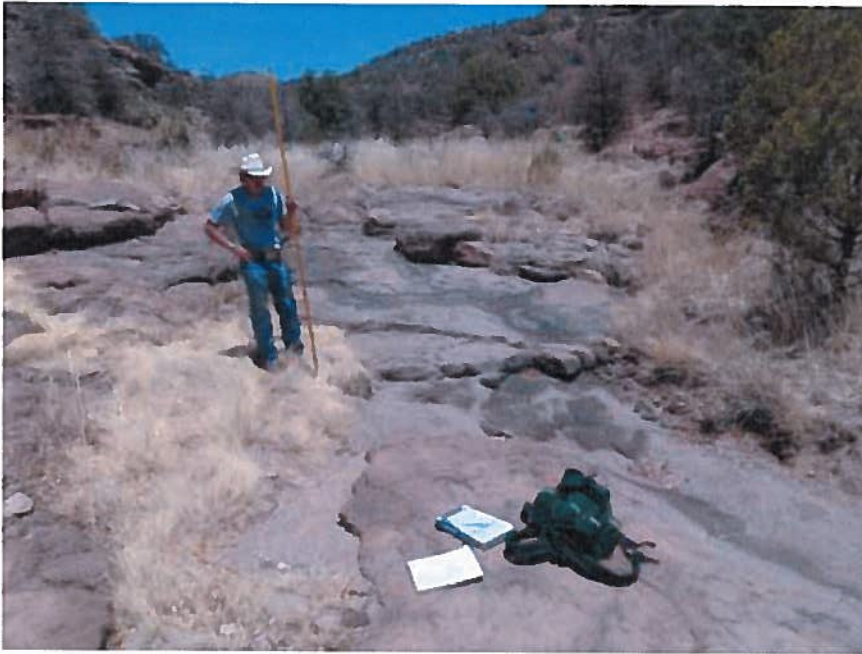
C4-4: Photographic reference for indicators 1.8 through 1.10. Photograph of the entrenchment transect location. Indicator 1.8 scored as 1.5 - stream is somewhat confined with an inactive floodplain.

Indicator 1.9 scored as 0 - no riffle-pool sequence observed (also refer to other photos).

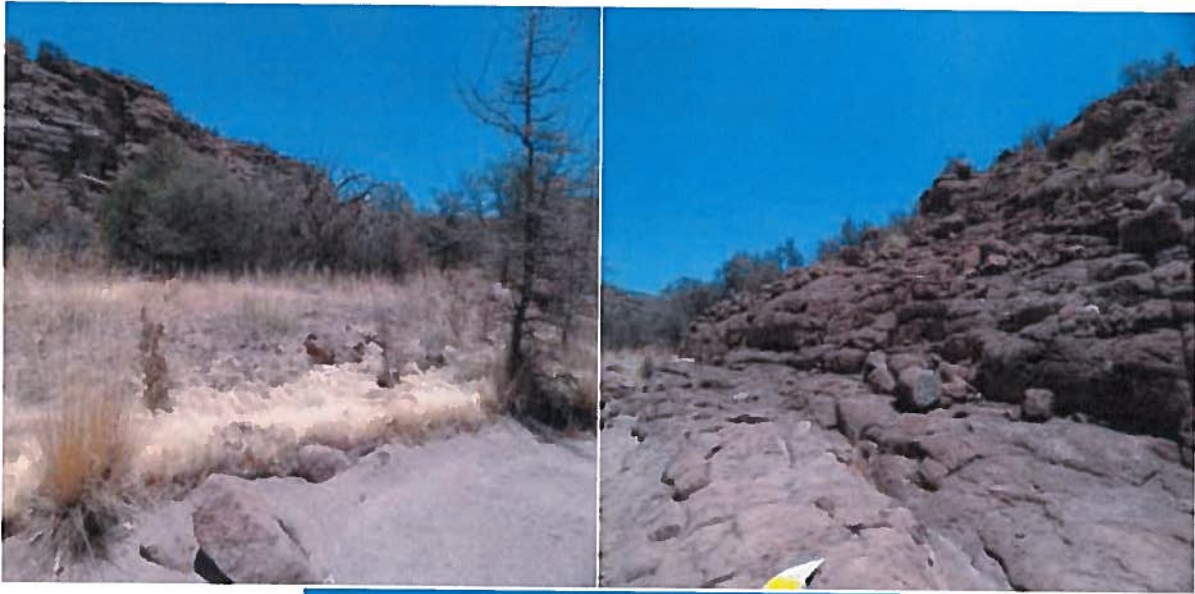
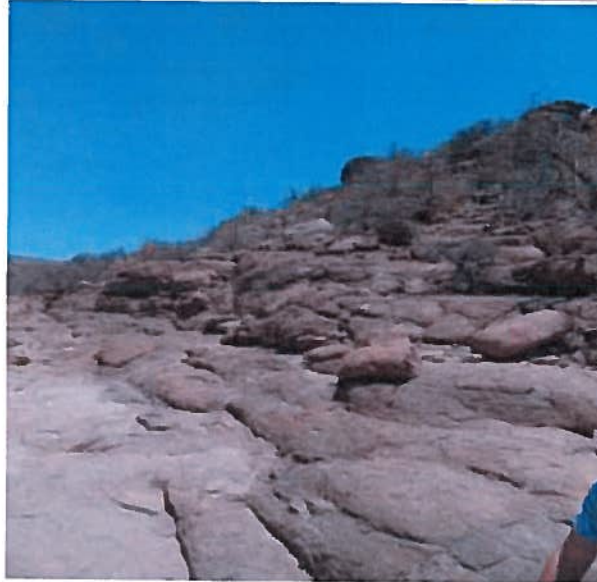
C4-5: Photographic reference for indicator 1.5. Photographs of bank and upland vegetation. Evident variation in vegetative density but no dramatic difference in composition. There is no distinct riparian vegetation corridor.

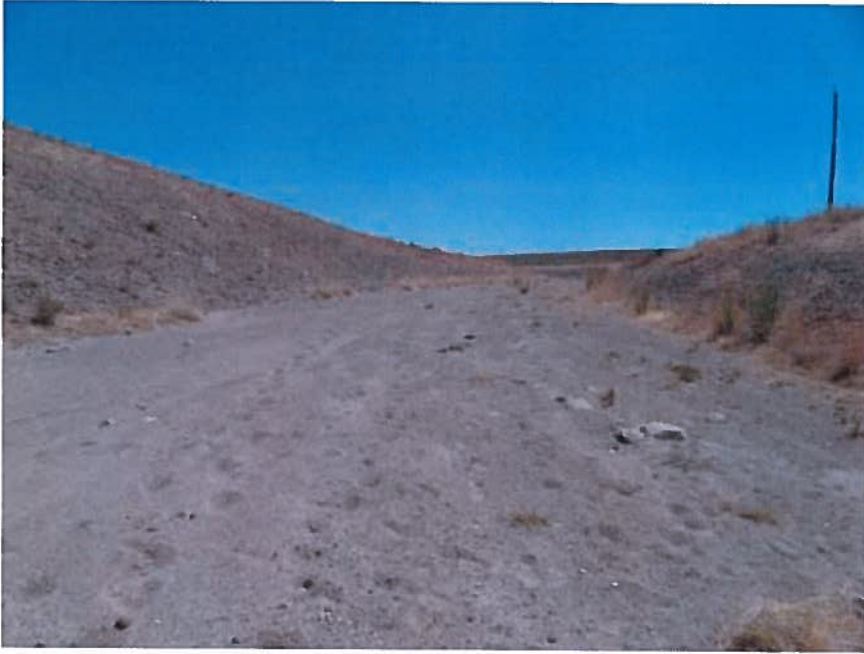
C5-1: Photographic reference for indicators 1.1 through 1.6. Indicator 1.6 scored as 2 – few rooted plants in the streambed. Lack of rooted plants is likely the result of the flow regime and granular bed material present rather than persistence of flow. No water or biotic indicators of water observed.

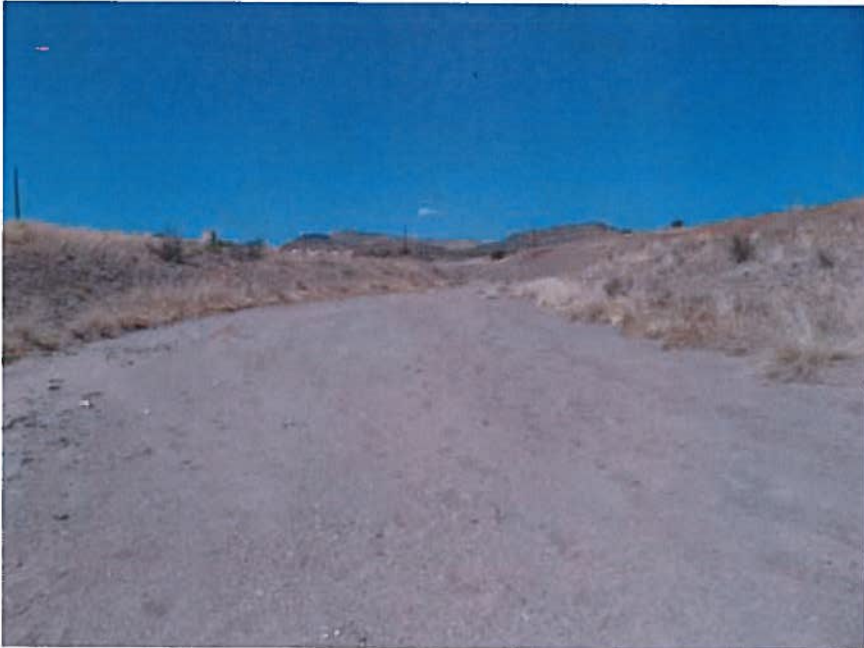
C5-2: Photographic reference for indicator 1.5. Indicator 1.5 scored as 0. Vegetation along streambank and uplands is sparse but consistent with no compositional or density differences between the two areas observed. Also refer to previous photograph.

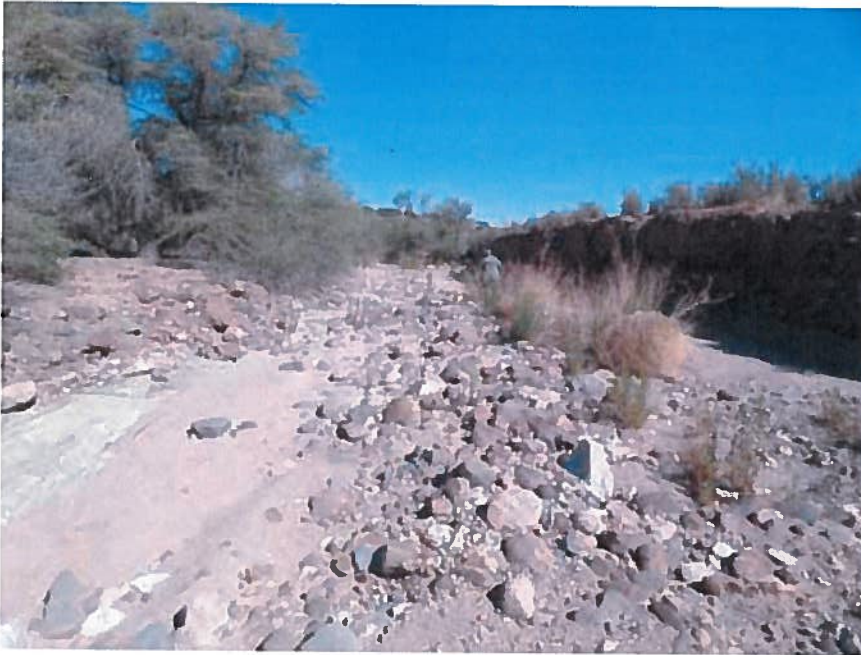
C6-1: Photographic reference for indicators 1.1 through 1.6. Indicator 1.6 scored as 2. Few rooted plants present in the streambed but inconsistently present. Lack of rooted plants is likely the result of the flow regime and granular bed material present rather than persistence of flow. No water or biotic indicators of water observed along survey reach.

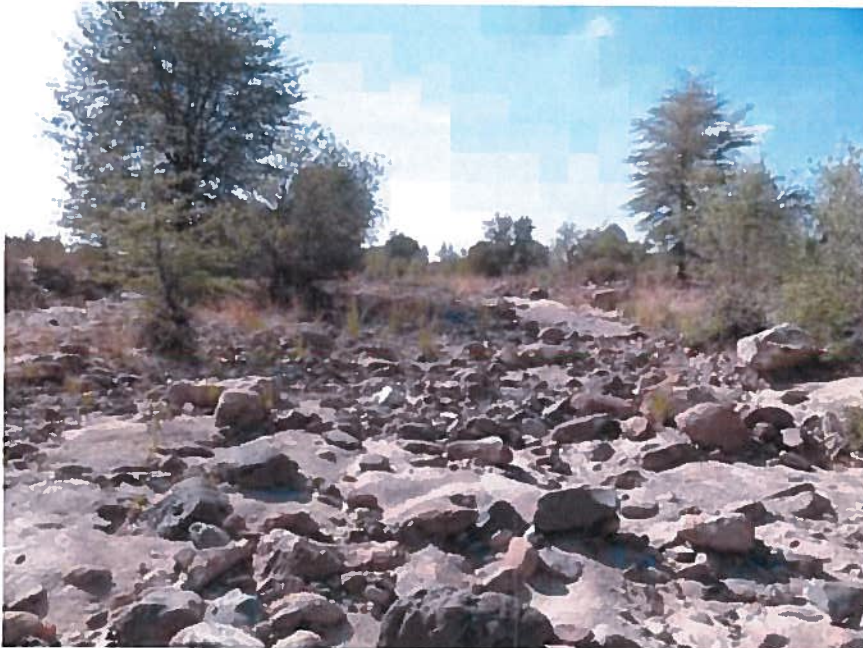
C6-2: Photographic reference for indicator 1.5. Indicator 1.5 scored as 1 - evident variation in vegetative density but no dramatic difference in composition. No distinct riparian zone observed.

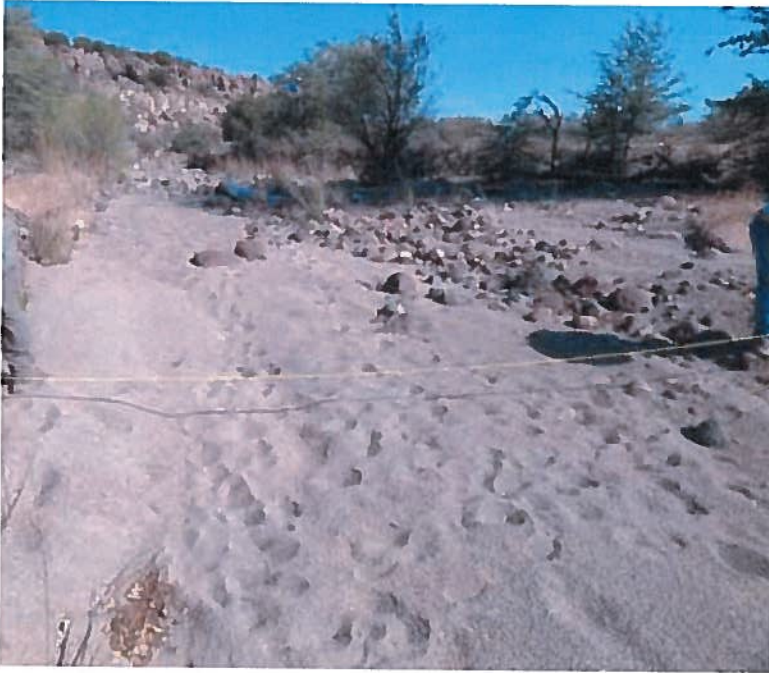
C6-3: Photographic reference for indicator 1.8. Location of transect shown. Indicator 1.8 scored as 1.5. Stream is somewhat confined with an inactive floodplain.

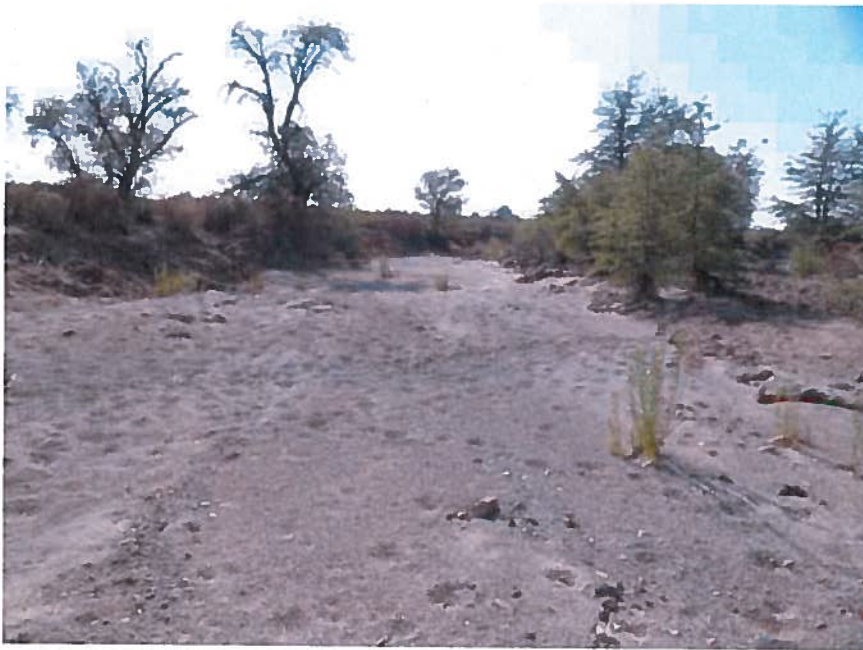
C6-4: Photographic reference for indicator 1.9 and 1.10. Indicator 1.9 scored as 0 - riffle-pool sequence not observable along survey reach. Indicator 1.10 scored as 1.5 - particle sizes of the channel bed material is primarily coarse sand and gravel which is similar to but coarser than the material of the upland area. Substrate sorting not evident.

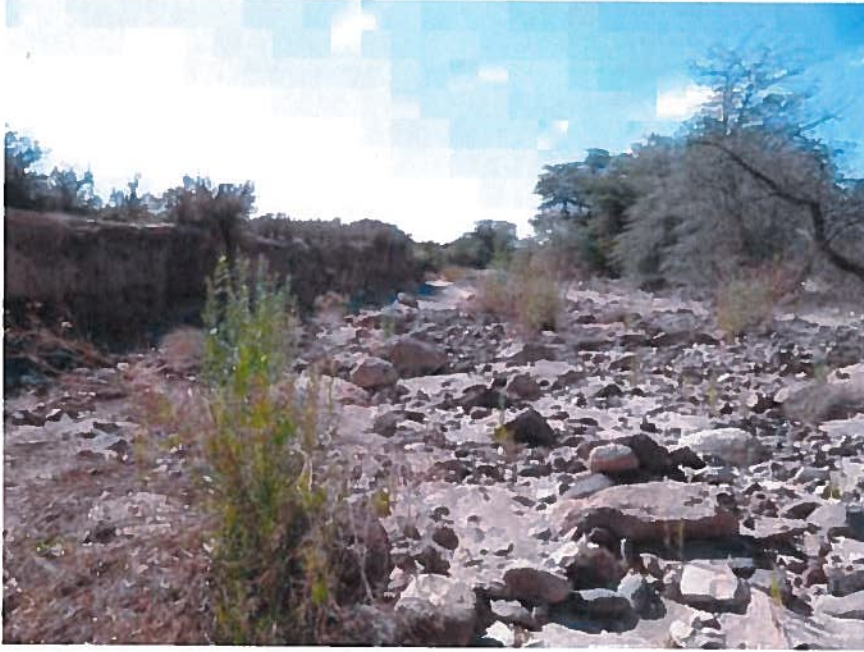
C6-5: Photographic reference for indicator 1.6. Few rooted plants present in the streambed but inconsistently present. Lack of rooted plants is likely the result of granular bed material present.
