ABANDONED OR INACTIVE URANIUM
MINES IN NEW MEXICO

A report of investigation carried out
between August 1979 and May 1980 under
contract with the New Mexico Energy and
Minerals Department.

New Mexico Bureau of Mines and
Mineral Resources
Open-File Report 148

Mine name(s) VCA Plot #7 (Lower Oak Creek) County San JuanSection (Unsurveyed) Twنش. 29 N R. 21 WQuadrangle sheet Red Rock Valley 15'Mining district East CarrizoElevation 5700'Nearest city and/or dwelling Oak Springs, 1 mi. NW

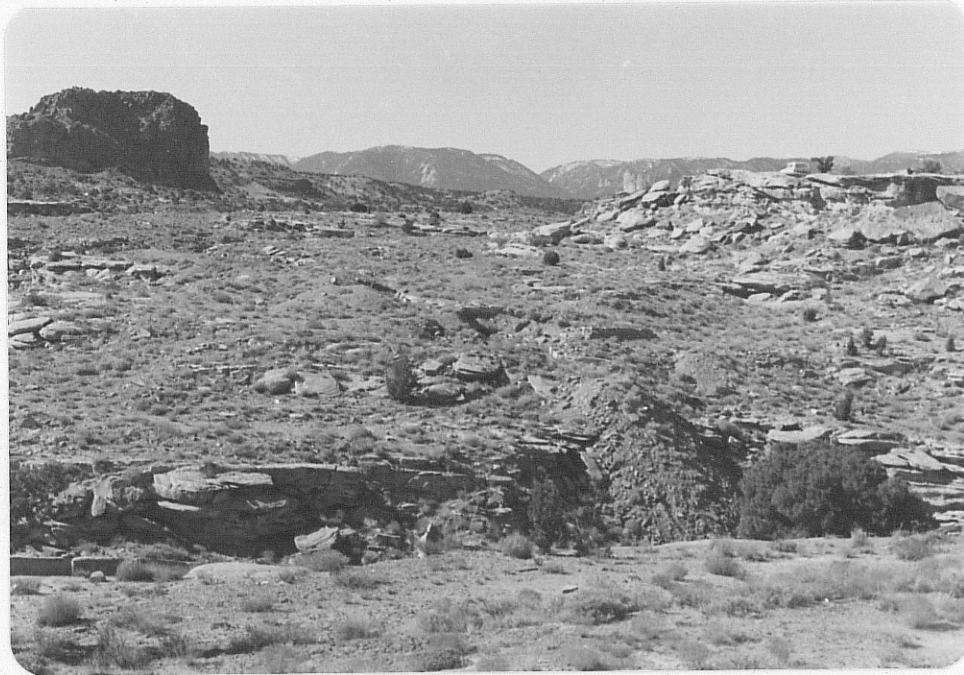
Photograph (a) offers a representative view of the southeastern edge of the plot, looking due west with the Carrizo Mtns. in the background. At right is upper Terrace level with vehicle for scale; at center is a lower Terrace level (both surfaces in Salt Wash Member) into which Oak Springs Wash is cut; at left is an exhumed volcanic neck which is shown topographically in the $SW\frac{1}{4} SW\frac{1}{4}$ Sec. 11, T. 29 N., R. 21 W., on the Red-rock Valley 15' sheet; and in the foreground is an inclined adit with mine tailings partially spilled over into an arroyo which is tributary to Oak Spring Wash. Photo (b) is a close-up shot of this inclined adit, the portal visible at the end of an 11' deep trench. The remainder of the photographs carry their own descriptions and attempt to show the small and discrete nature of each working along with the unique manner in which waste rock was sometimes stacked by hand labor along small trenches, passageways, or outside small underground workings.

Photo (a) On VCA Plot #7, south side, looking west into valley of Oak Spring Wash; small inclined adit and tailings dump in foreground.

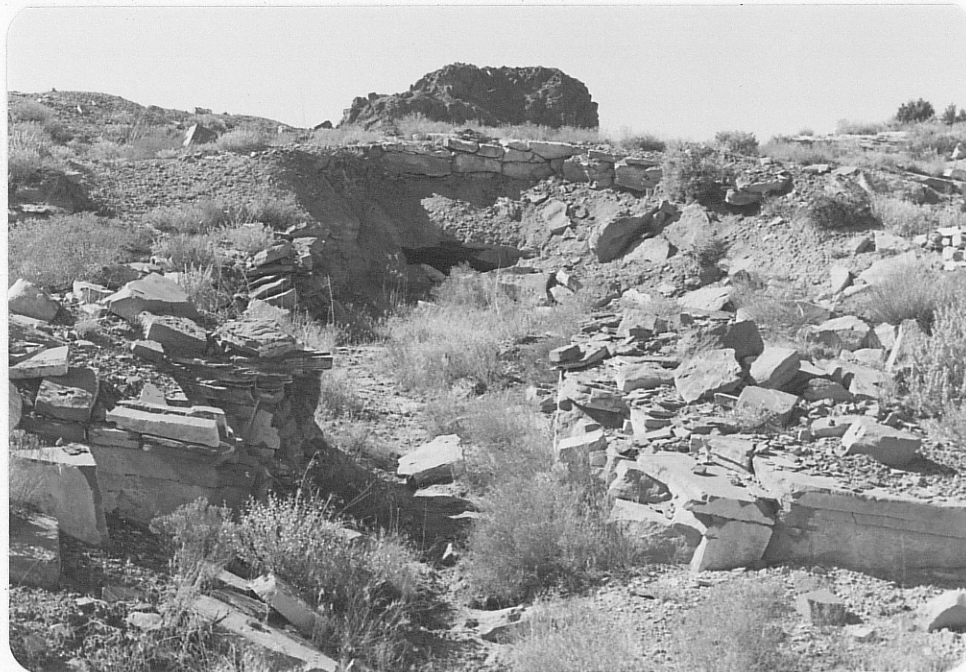
Photo (b) VCA Plot #7, close-up of inclined adit shown in photo (a); looking west.

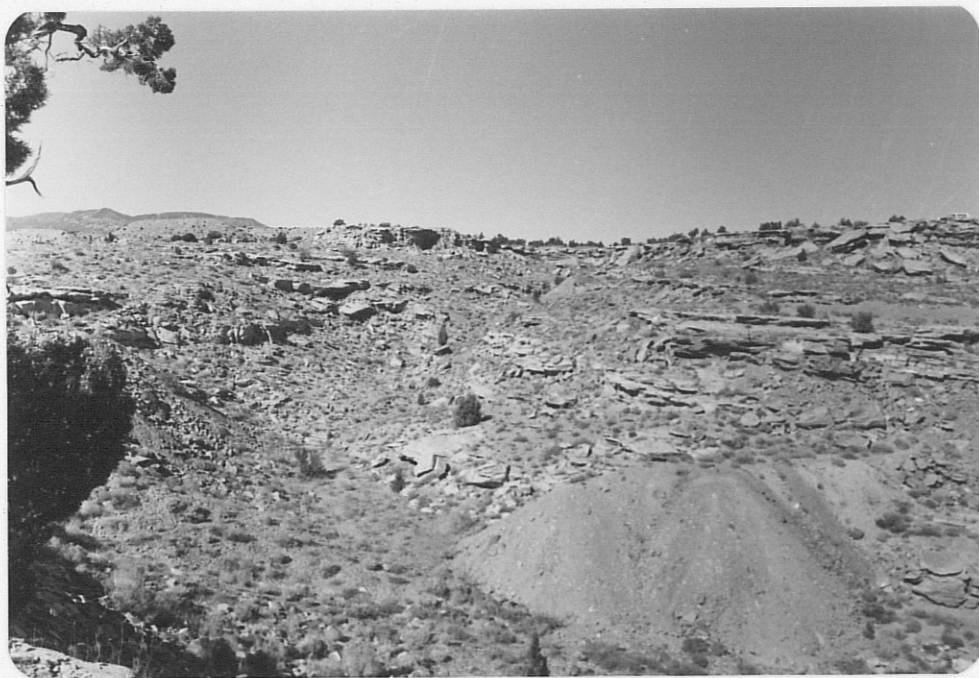
Photo (c) Looking north at mines and dumps in north-south trending tributary near the corner of VCA Plot #7. Arrow indicates position of adit shown in photo (e).

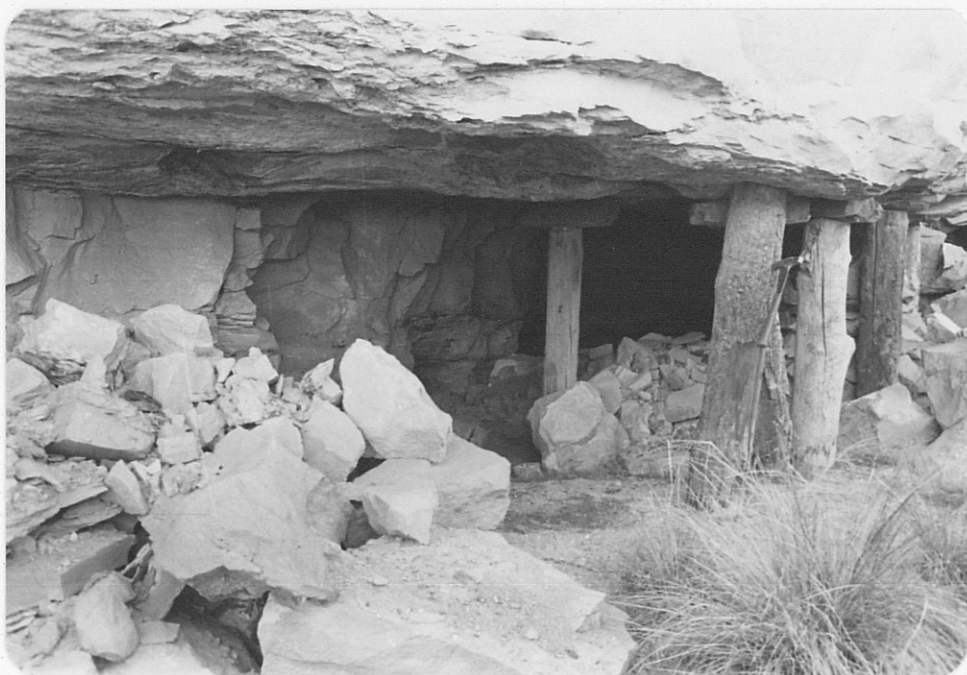
Photo (d) Looking west at small adit in lower left hand corner of photo (c) Rock pick in post for scale. Near the SE corner of VCA Plot #7.

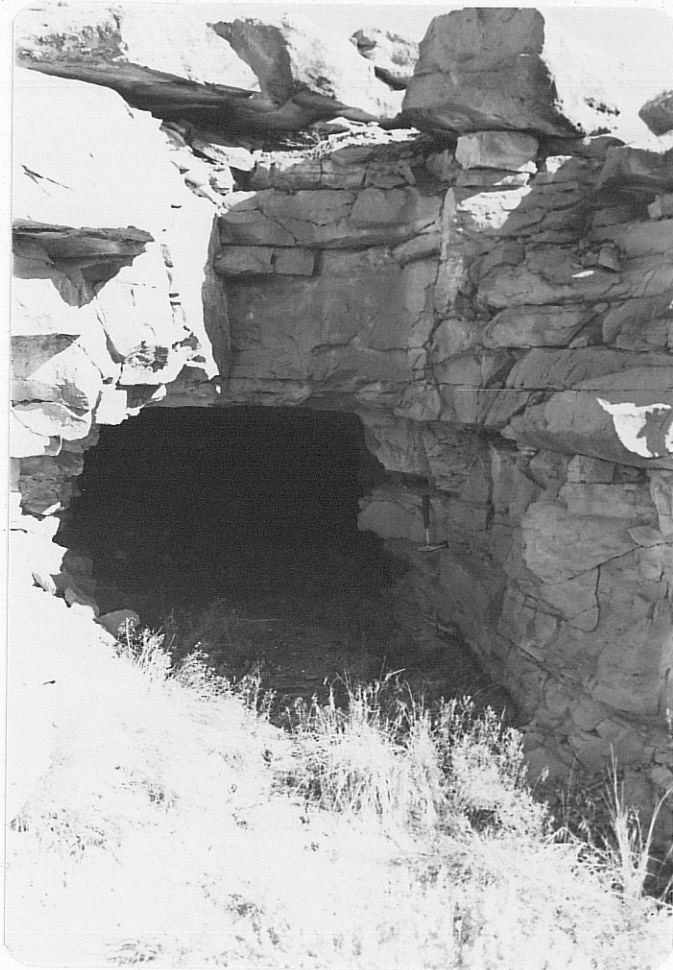
Photo (e) Looking east at small adit in right center of photo (c) near the SE corner of VCA Plot #7. Hammer on right wall for scale.

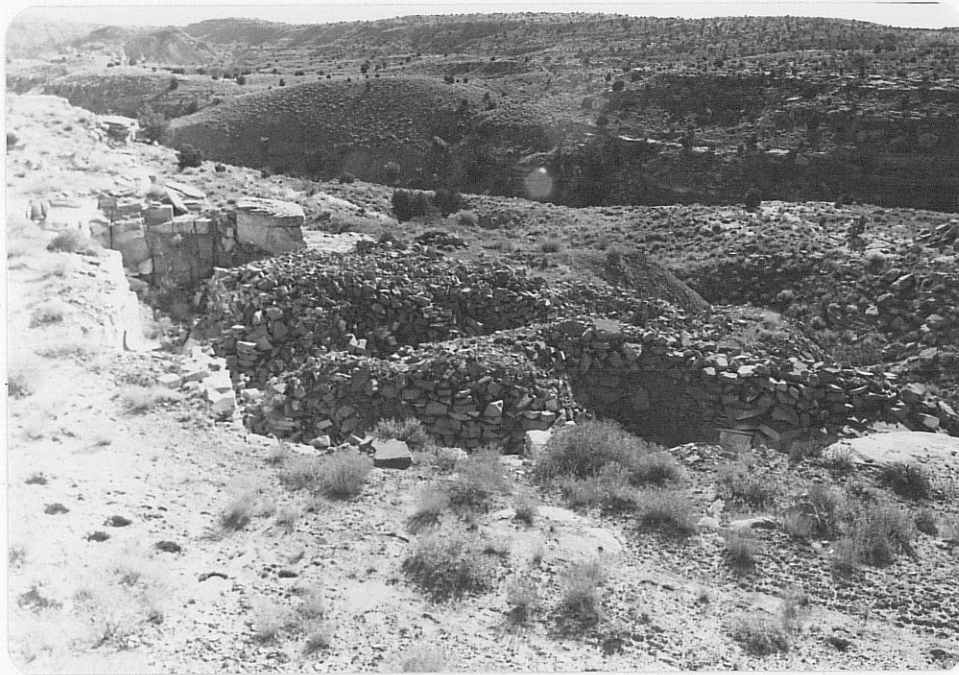
Photo (f) Looking SW at pit to the west of the workings in photo (c). Location is still in the S-SE corner of the VCA Plot #7. Note stacking of waste rock. Depth of trenching is 5' on left side of photo.

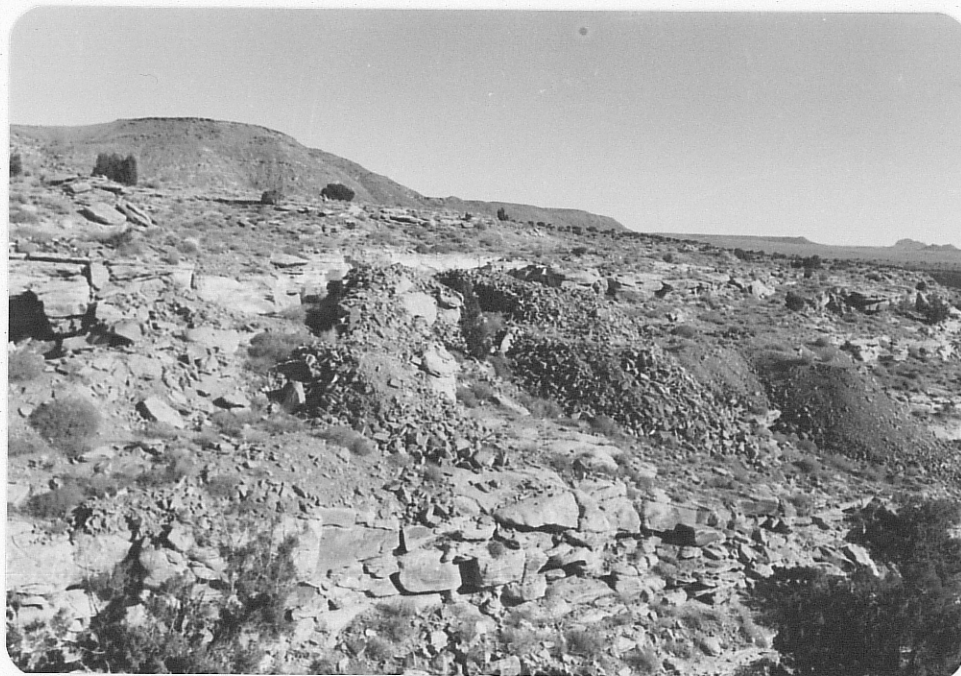
Photo (g) Looking east at workings in photo (f), near the SE corner of VCA Plot #7.

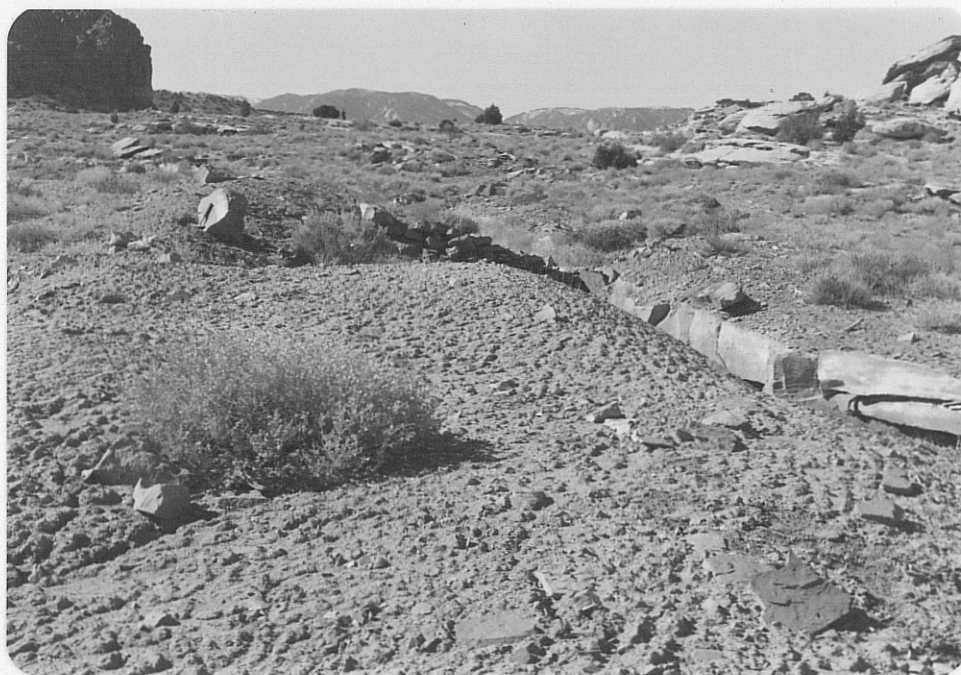
Photo (h) VCA Plot #7, SE side looking W at a small prospecting trench 3' deep, 150' S of adit shown in photo (b); note hammer at upper left for scale.

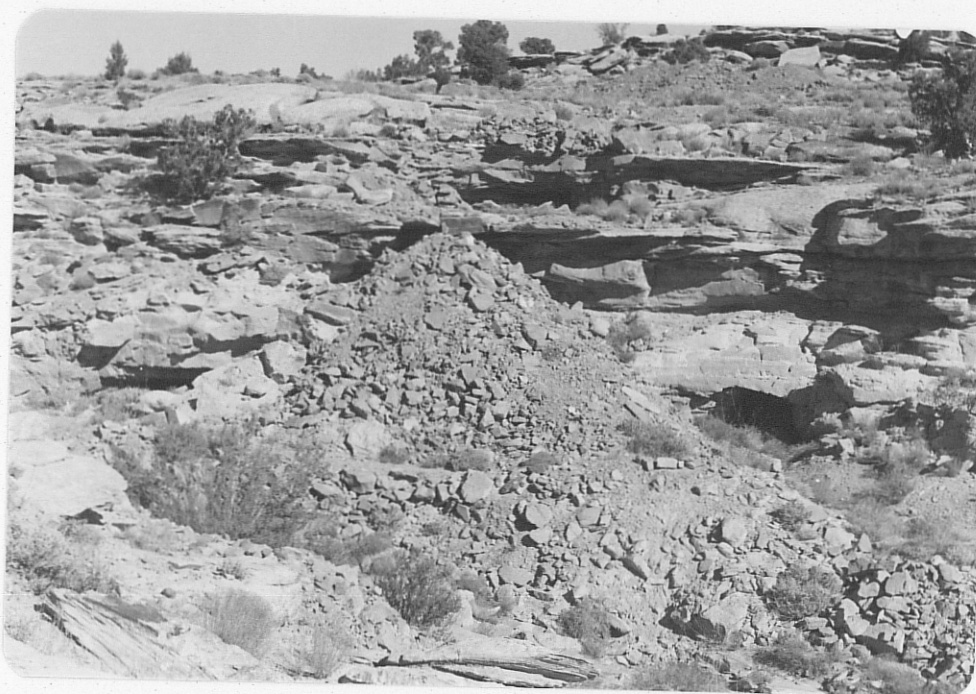
Photo (i) VCA Plot #7, SE side, looking E at two stub adits (upper one partially concealed by tailings from open cut above); on east side of small N-S tributary to Oak Spring Wash. Adit at lower right is approx. 5' high, 6' W, 12' long; see also photo (j).

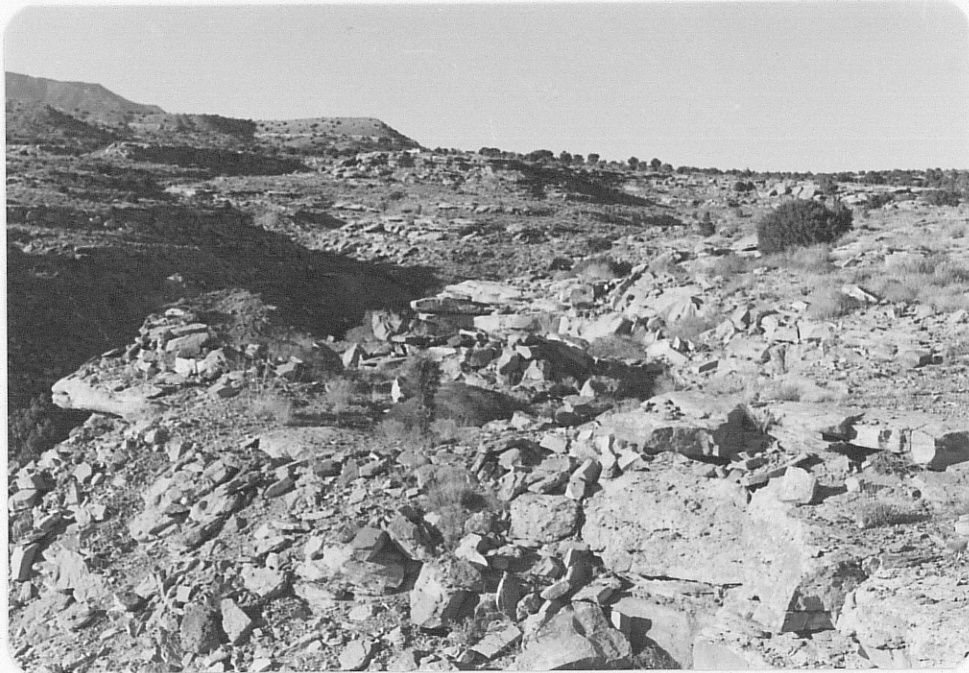
Photo (j) VCA Plot #7, SE side, looking N at typical terrain of southside plot #7; tributary to right of vehicle is one referred to in photo (i).

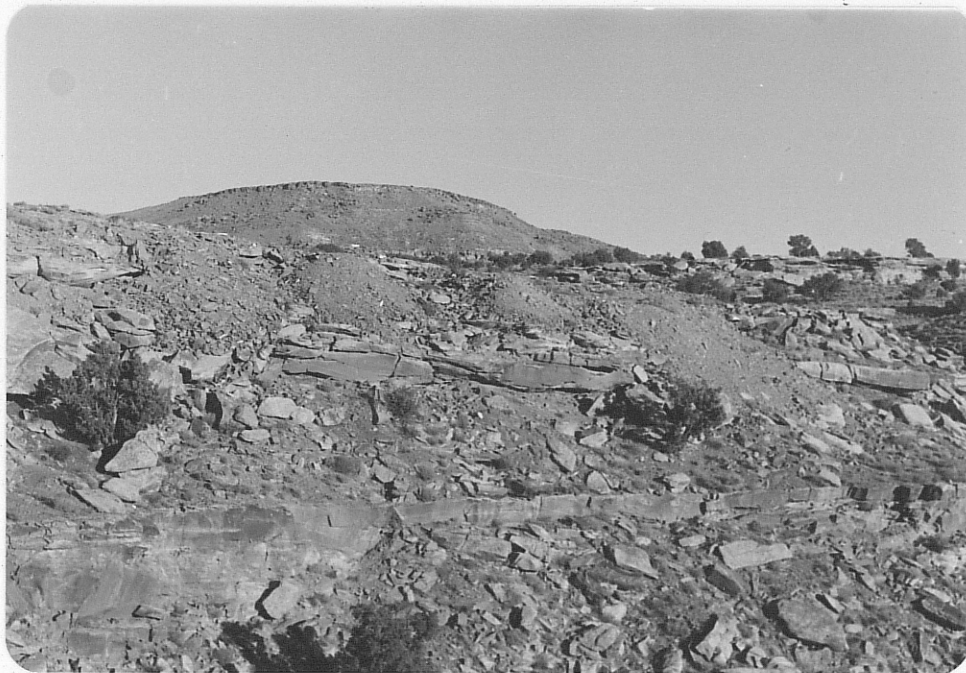
Photo (k) VCA Plot #7, SE side; looking east at tailings pile from rim cuts 300-400' south of photo (i) area. Workings are easily spotted by fan shaped dumps on moderate to steep slopes; note 3'-5' thick lenticular ss beds typical of Salt Wash member.

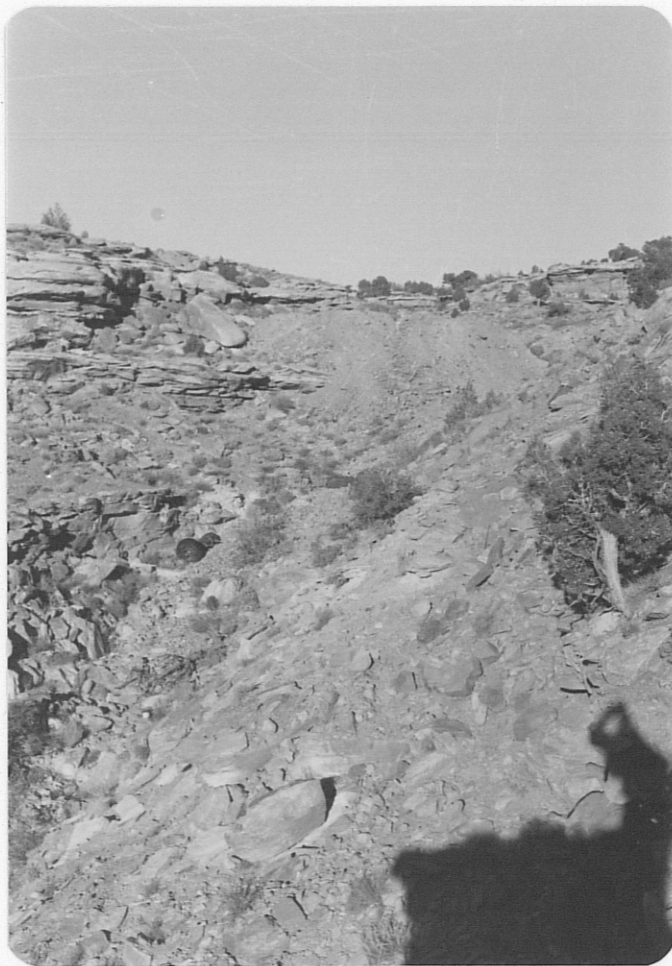
Photo (L) VCA Plot #7, SE side, looking NE at dump in small re-entrant just visible at right center in photo (k). Dump is over 100' wide, 70' in downslope direction; note truck tire and axle for scale. Scintillometer readings at this site reached 2500 cps. See photo (m) for view from distance.

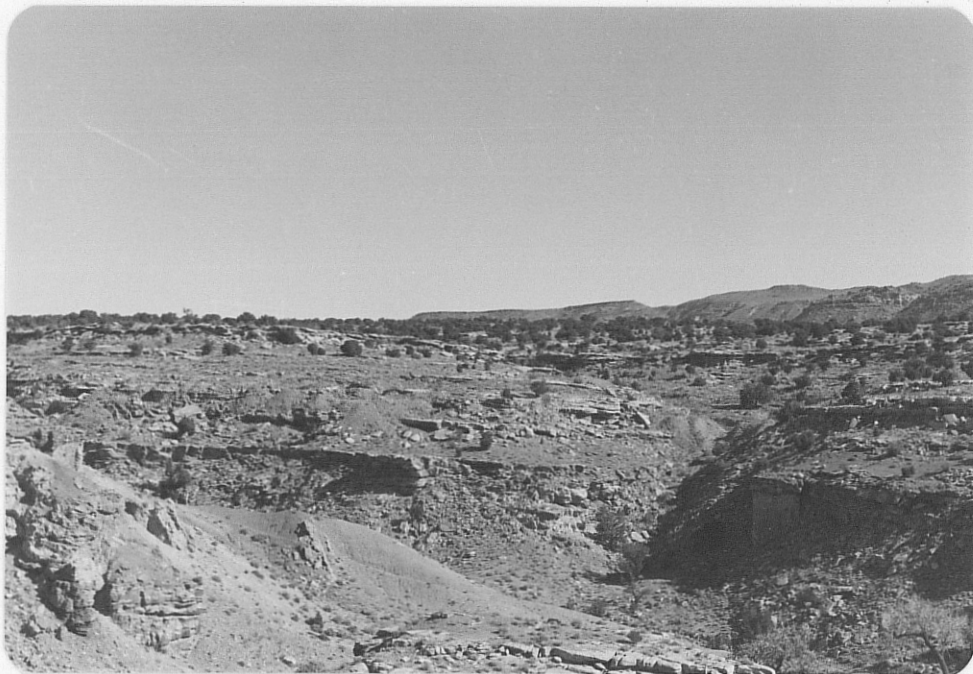
Photo (m) VCA Plot #7, SE side, looking E; arrow points to tailings dump shown in photo (L). Dumps visible to left correspond to those shown in photo (k).

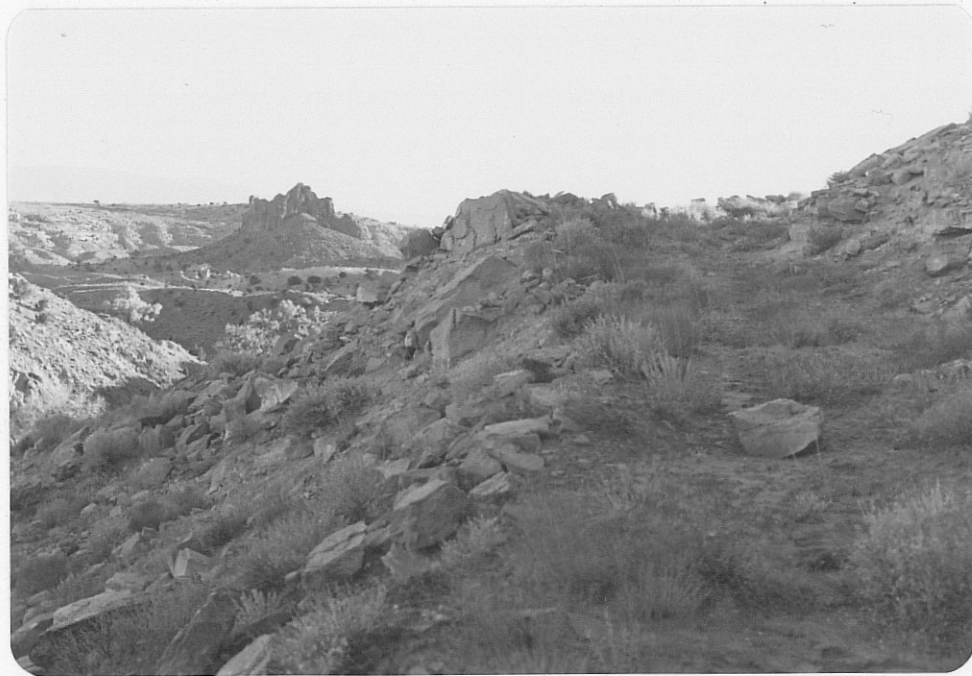
Photo (n) VCA Plot #7, SE side; looking S toward King Tutt plug in middle distance; drill road on right, Beautiful Mountain in distance just to left of King Tutt plug.

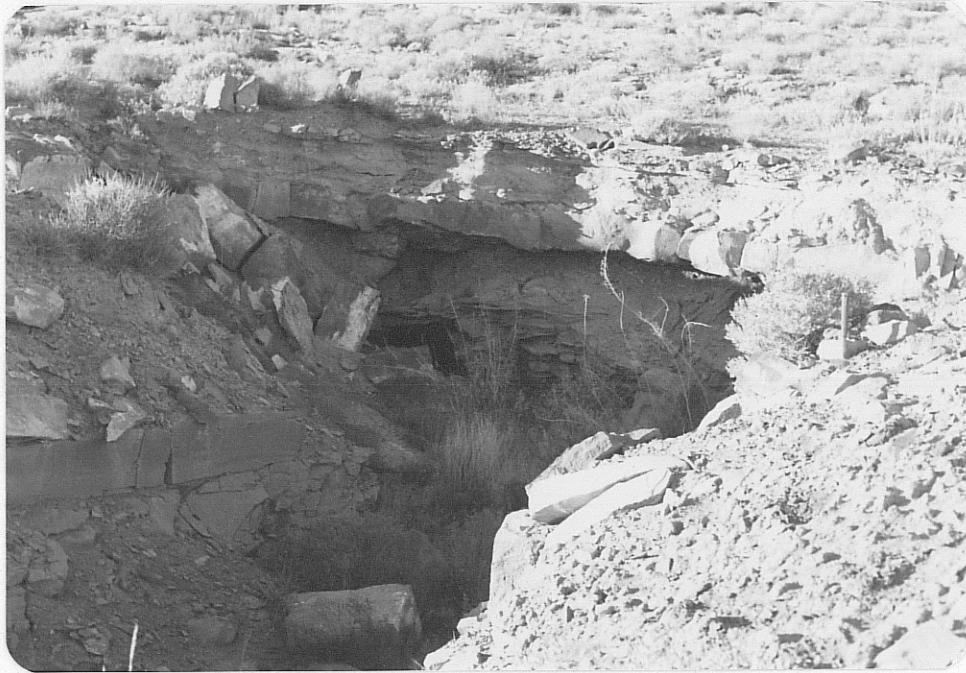
Photo (o) VCA Plot #7, looking N; typical of small scale prospecting near central portion of plot; note hammer at right for scale.

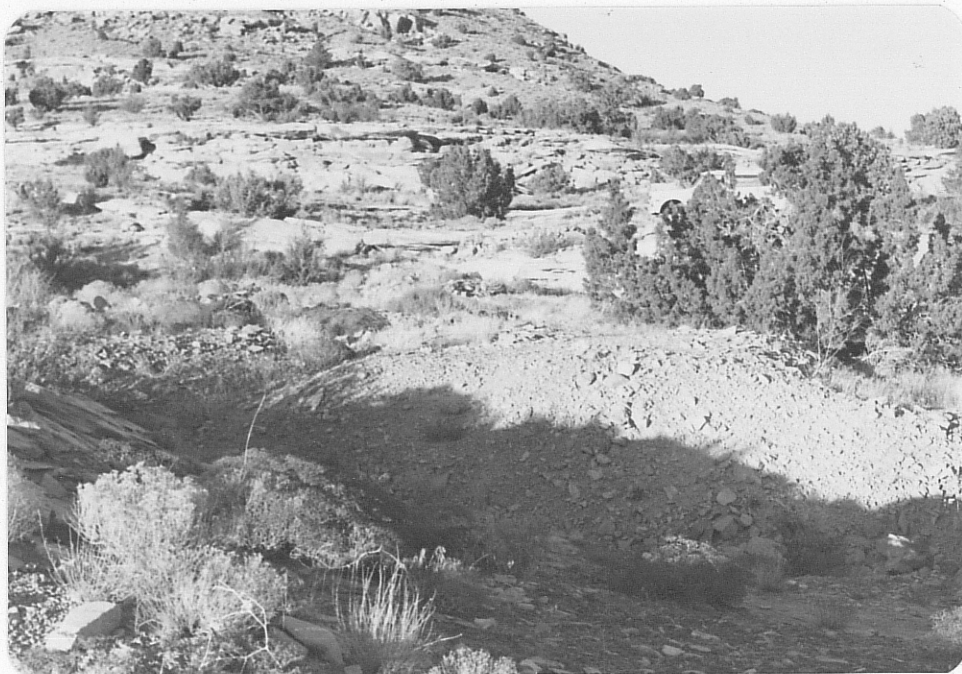
Photo (p) VCA Plot #7, looking NE; typical of small surface prospecting near north central portion of plot #7, just south of access road that leads SE from Oak Spring.
