**RE: In-situ BOS 200<sup>®</sup> Post Injection Implementation Letter Report Chevron Isleta  
(FID #30681, RID #314), Deliverable 3999-2**

## **Vista GeoScience Injection Report No: 18069.01**

### **Application of RPI BOS-200® for the In-Situ Remediation of Petroleum Contaminants at: Former Chevron Isleta 3401 Isleta Boulevard SW, Albuquerque, NM**

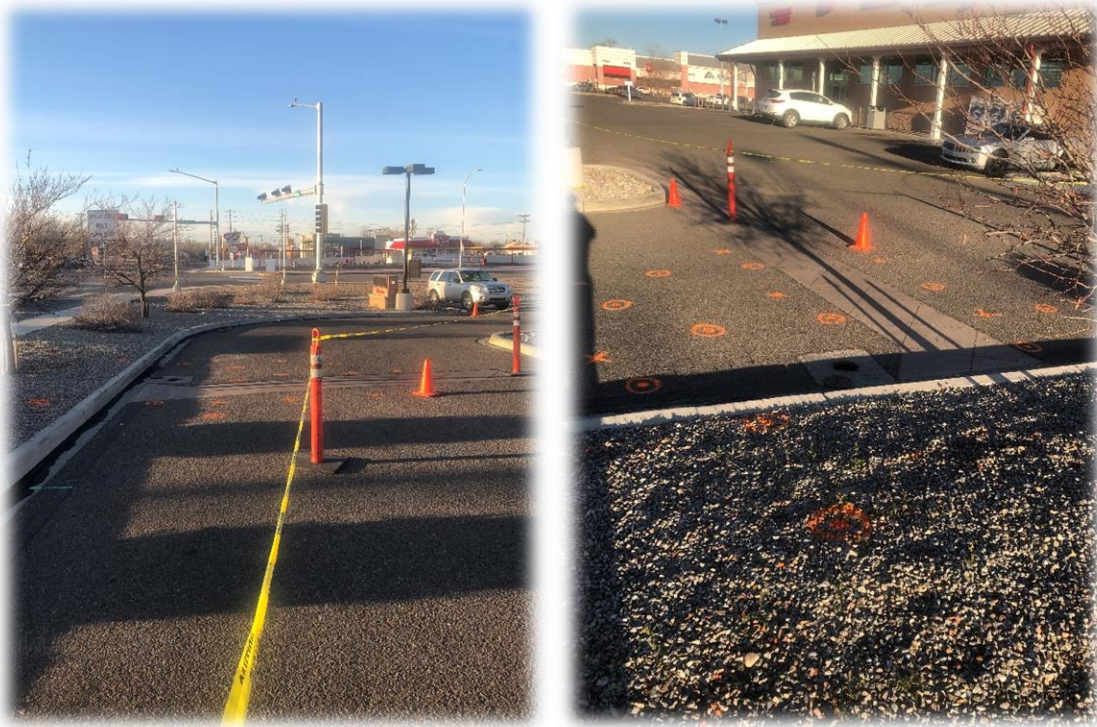
View of MW-11 injection area

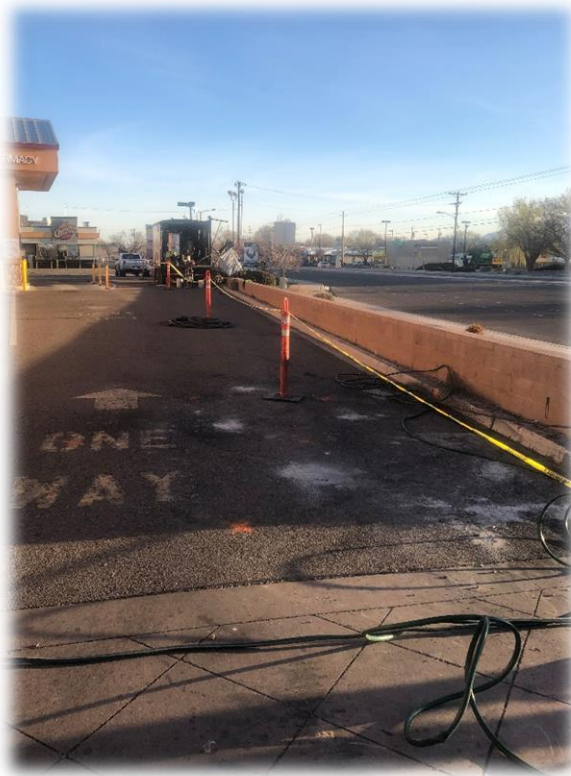
View of MW-08 injection area
