ABANDONED OR INACTIVE URANIUM
MINES IN NEW MEXICO

A report of investigation carried out
between August 1979 and May 1980 under
contract with the New Mexico Energy and
Minerals Department.

New Mexico Bureau of Mines and
Mineral Resources
Open-File Report 148

Mine name(s) NW $\frac{1}{4}$ 25, Decline and Open Pits County McKinley

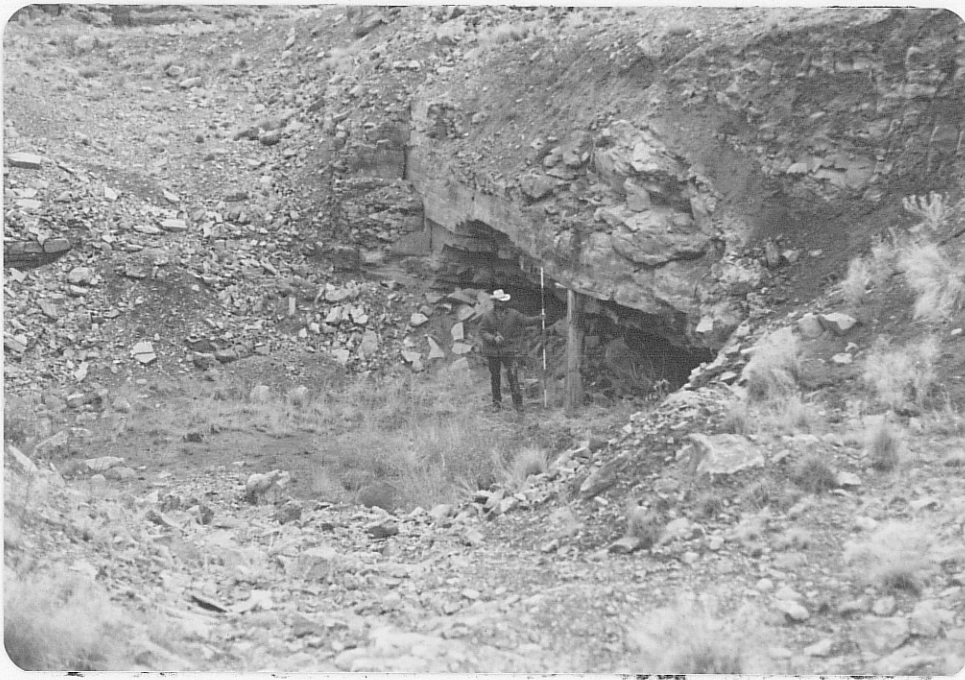
The workings are a continuation of those in sec. 26 (Hanosh) and extend from the section line eastward for 1/3 mile to the small drainage that forms a water gap in the Todilto bench in the NW $\frac{1}{4}$ 25. They are mostly open pits and trenches as shown in photos (a) through (c) with the expected assortment of spoil piles and mine dumps. Workings are up to 30' in depth, 100' across, and several hundred feet in length.

Photo (a) Looking NW at 35' deep pit with some "gophering" along the north face; site is just east of sec. 25-26 line. Scintillometer readings ranged up to 1,100 cps.

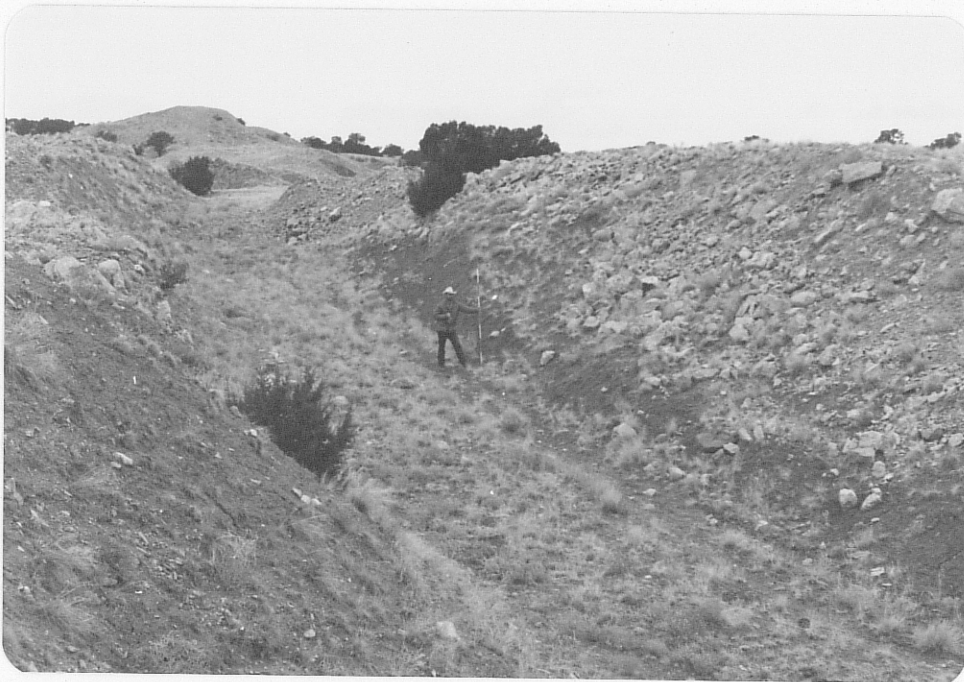
Photo (b) Looking west at "trench" created by two parallel 18' high waste piles.

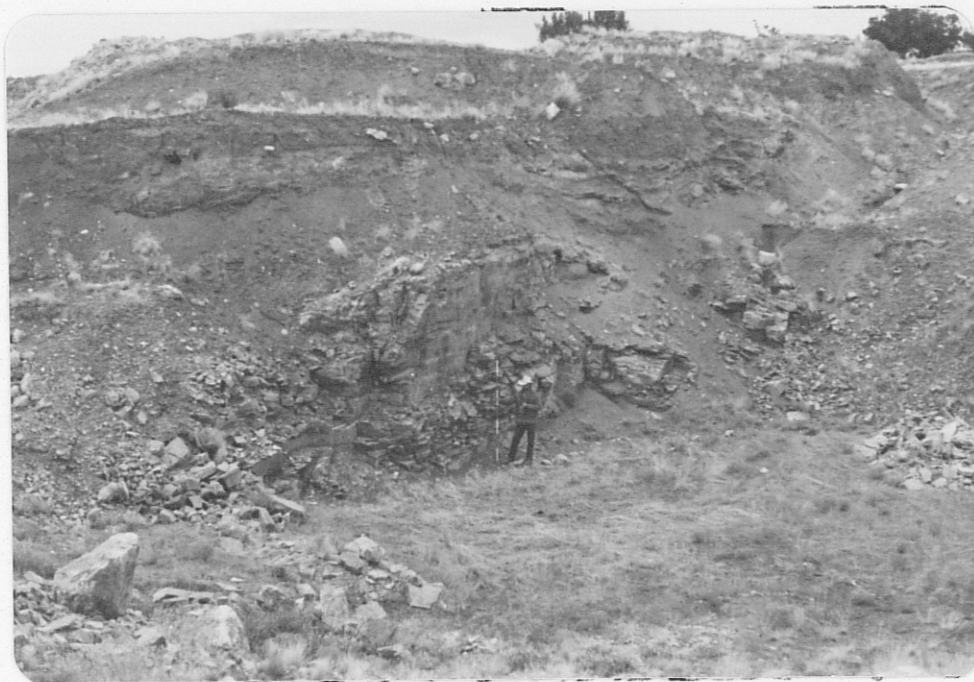
Photo (c) Looking SW at 30' deep, 100' diameter pit about 450' east of sec. 25-26 line; face counts range up to 2,000 cps. Highwall is half limestone, half overburden.

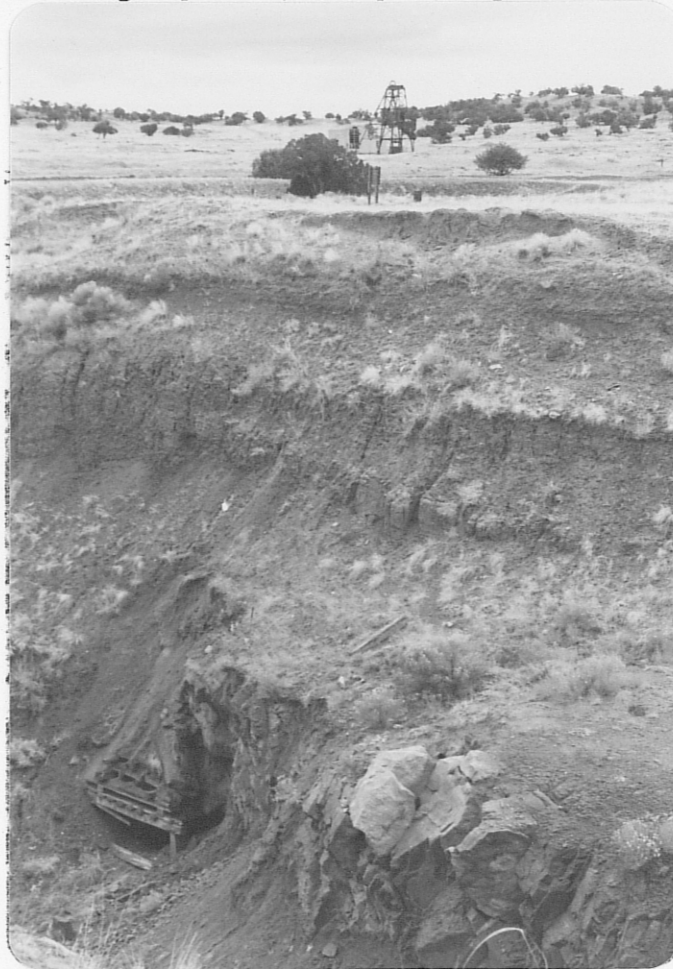
At the east edge of the complex is a decline (State Mine Inspector's term for this working) driven eastward at the bottom of a 40' deep box cut (photo d). Decline is timbered, but portal is nearly caved shut (photo e); no attempt was made to enter, but it appears original opening was about 6' x 6'; scintillometer response was 300-400 cps. Approximately 20' to west of the decline is the remains of a cribbed shaft (photo f). It probably represents a collapsed ventilation shaft or escapeway from a lower level working mined through the decline. It is unfenced, and at 22' deep it represents a hazard.

Photo (d) Looking northward into box cut with decline driven eastward at bottom. Close-up of decline is given on next page. Note section 25 head frame in background 1,000' away.

Addendum: A drainage by-pass was constructed to take the flow around the east edge of the workings and keep it out of the box cut with the decline (photo d). The flow re-enters the original stream bed just 500' south of the box cut, but some of the material used in diverting the stream and perhaps some of the waste material that was placed along its banks later is somewhat radioactive. In the example shown in photo (1) the waste material produced readings of 1,400 cps.

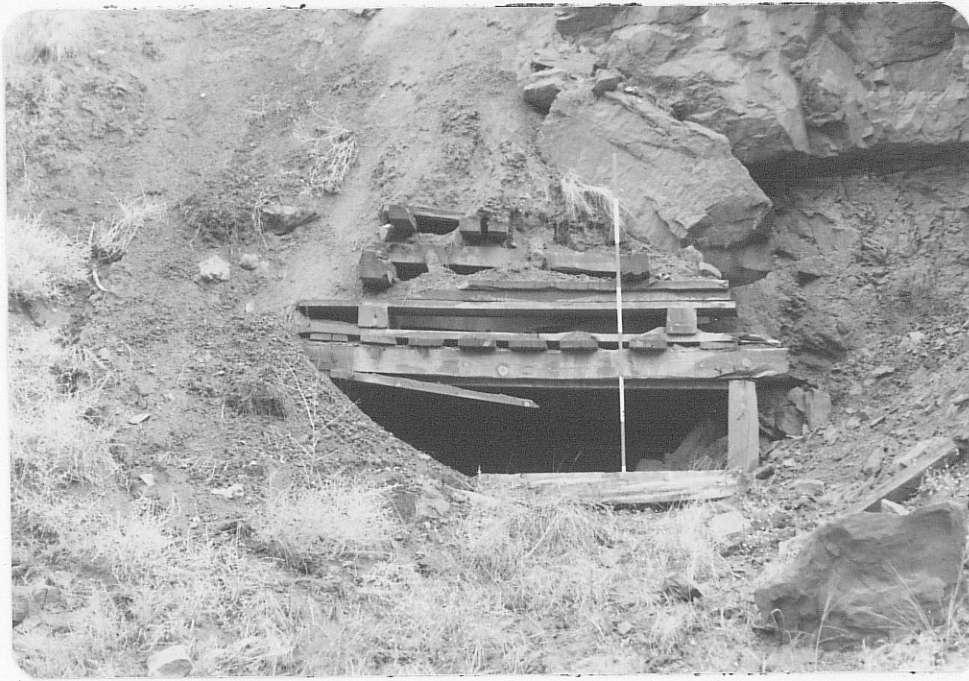
Photo (e) Close up of decline show in photo (d); present opening is less than 3' high. Note range pole for scale.

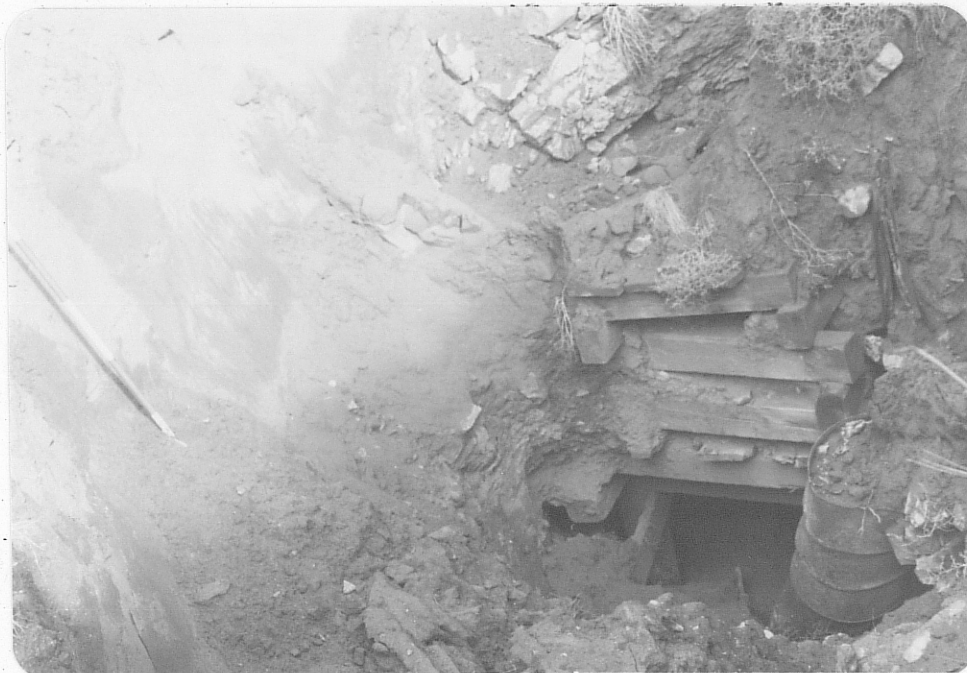
Photo (f) Caved vertical shaft 20' west of decline; hole is presently 22' deep. Note portion of range pole at left for scale.

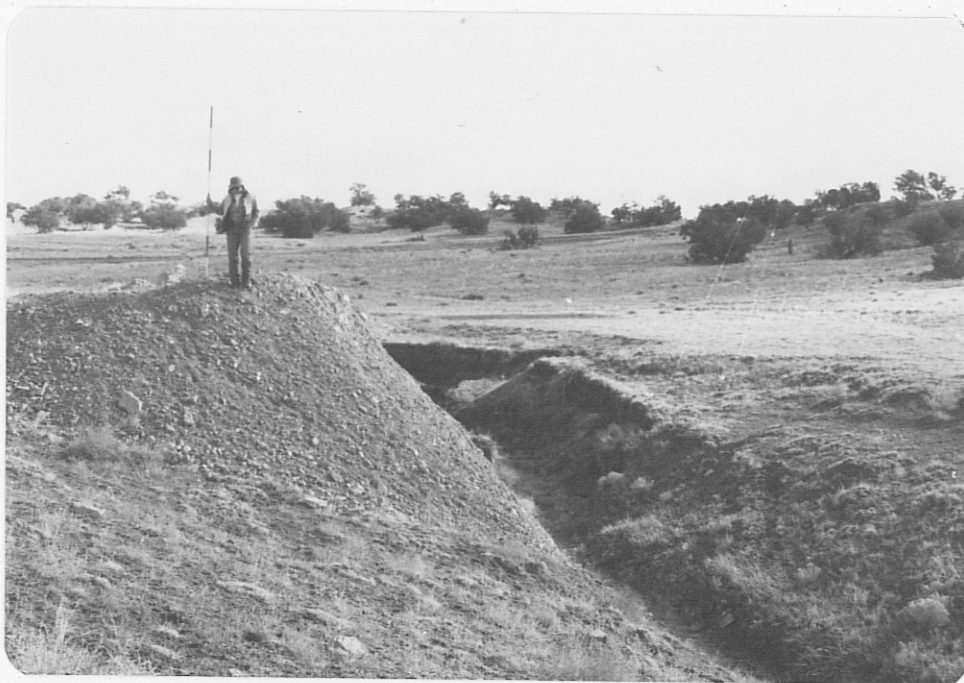
Photo (1) Looking northward at diverted drainage line flanked on west by waste pile.
